# Well CM-1 Evaluation

## Craigmont, Idaho

Prepared by Joe Baldwin  
Idaho Department of Environmental Quality  
State Office  
December 2007

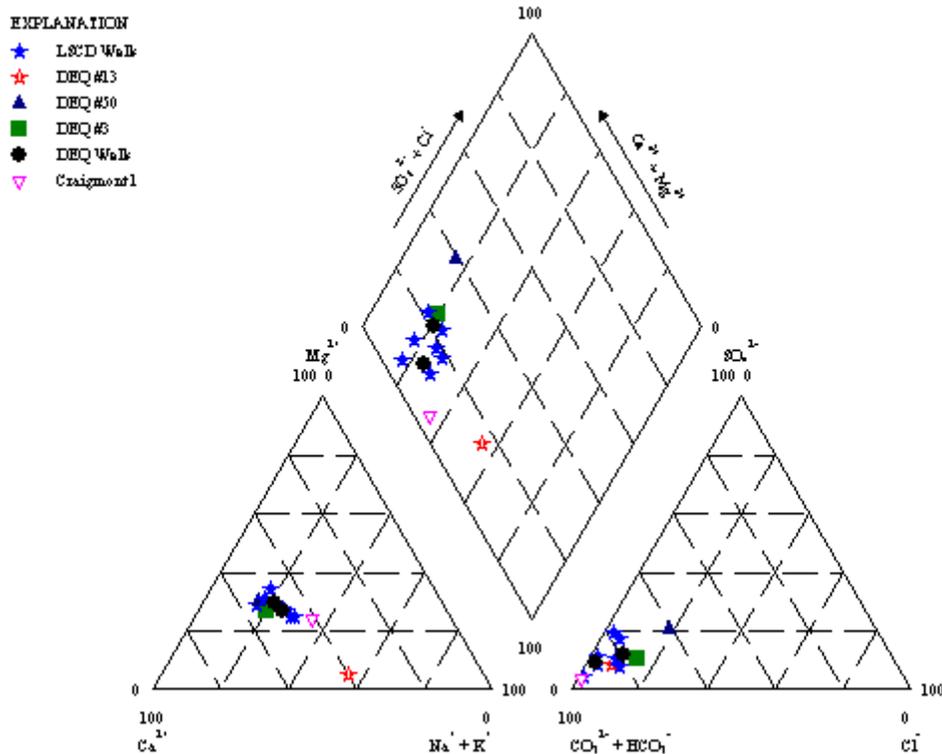
**Figure 2.** Piper diagram showing Craigmont well CM-1 water chemistry in comparison to other wells in the Clearwater Plateau area. **LSCD** is the Lewis Soil Conservation District. The District is cooperating with DEQ on a ground water sampling project on the Camas Prairie.

The water chemistry of well CM-1 is similar to wells in a DEQ sampling network on the Camas Prairie (Figure 2). All these wells have a calcium bicarbonate-type water. Well CM-1 has slightly more sodium and bicarbonate in proportion to other constituents than wells in the Camas Prairie sampling network. The nitrate at well CM-1 was 1.71 mg/L, well below the maximum contaminant level (MCL) of 10 mg/L for drinking water.

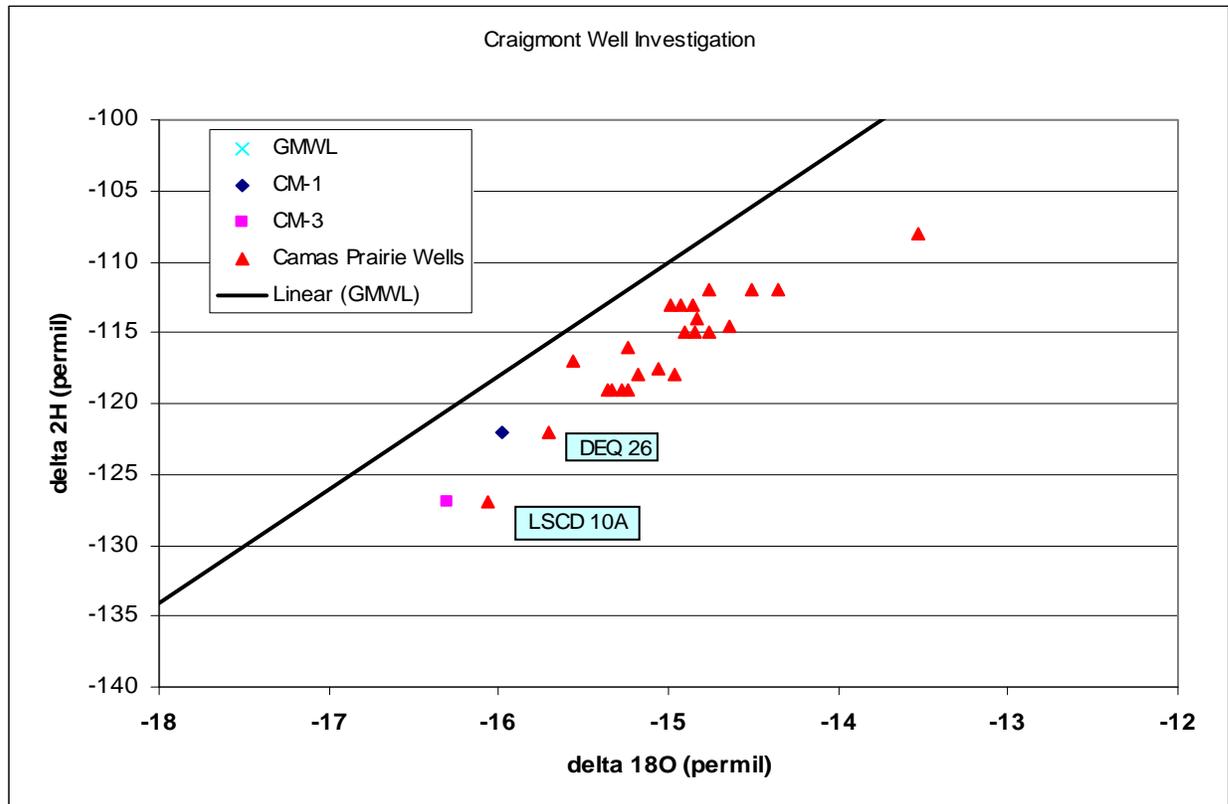
**Figure 3.** Plot of oxygen ( $^{18}\text{O}$ ) versus deuterium ( $^2\text{H}$ ) for Craigmont wells CM-1, CM-3, and wells currently being sampled by DEQ on the Camas Prairie.

Wells CM-3 and CM-1 plot in the lower left portion of Figure 4, indicating that these wells produce water from a deeper part of the aquifer than most other wells that have been sampled by DEQ. Well LSCD (Lewis Soil Conservation District) 10A is a flowing artesian well that also is believed to produce water from a deep portion of the aquifer; well DEQ 26 is screened from 115 to 136 feet below land surface and also appears to withdraw water from a deeper portion of the aquifer. The plotting position indicates that the water in wells CM-1, CM-3, DEQ 26, and LSCD 10A is older, i.e., the water has been in the flow system longer than at most other wells that have been sampled on the Camas Prairie.

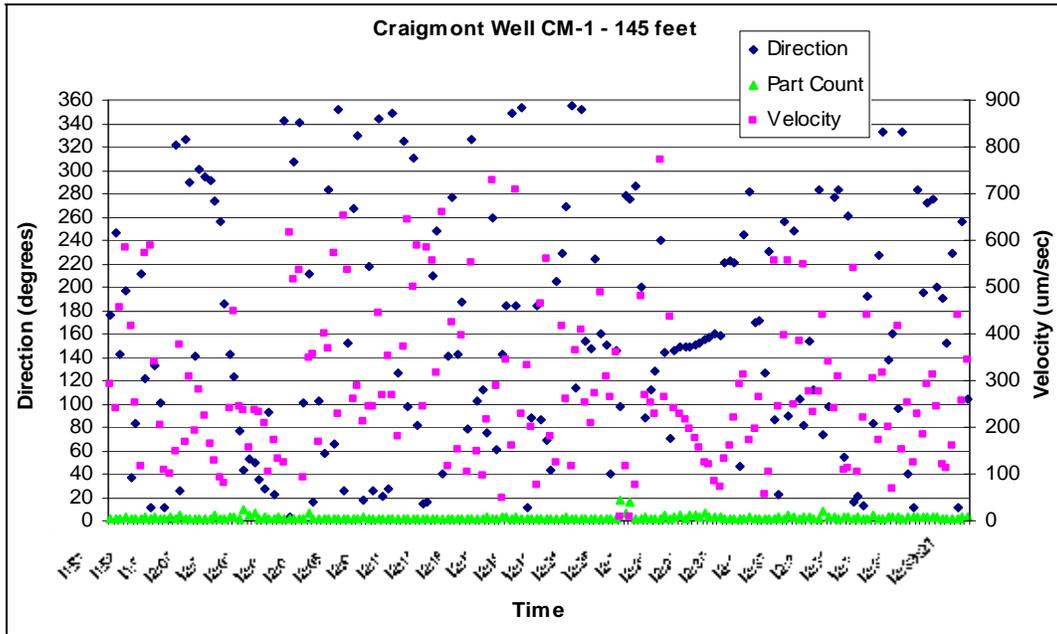
Figures 4 and 5 show the results of colloidal borescope surveys at 145 and 128 feet below land surface. No distinct flow direction and flow velocity pattern was evident at either depth, and the same was true for all other depths investigated. For comparison, Figure 6 shows an example of results from a survey in a different well that produced a distinct flow direction and flow velocity. This survey was conducted at a screened monitoring well completed in saturated sand and gravel at Blackfoot, Idaho.

Figure 4. Colloidal borescope survey of Craigmont well CM-1, 145 feet below land surface.

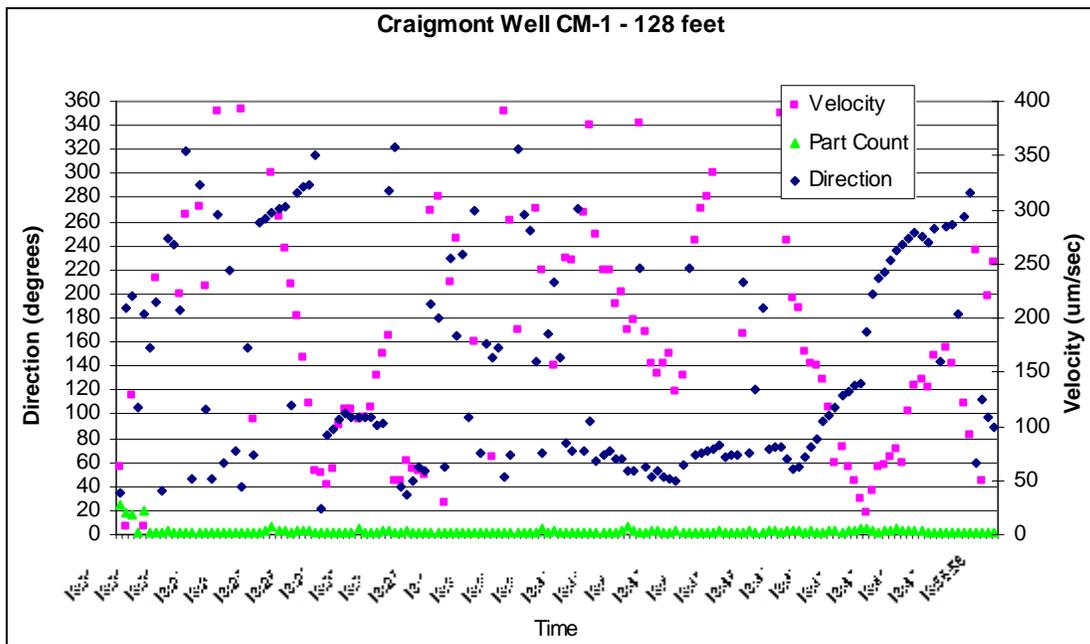
Figure 5. Colloidal borescope survey of Craigmont well CM-1, 128 feet below land surface.
