Bloomington Canyon Mine Preliminary Assessment Report Addendum

Bear Lake County
State of Idaho

Department of Environmental Quality

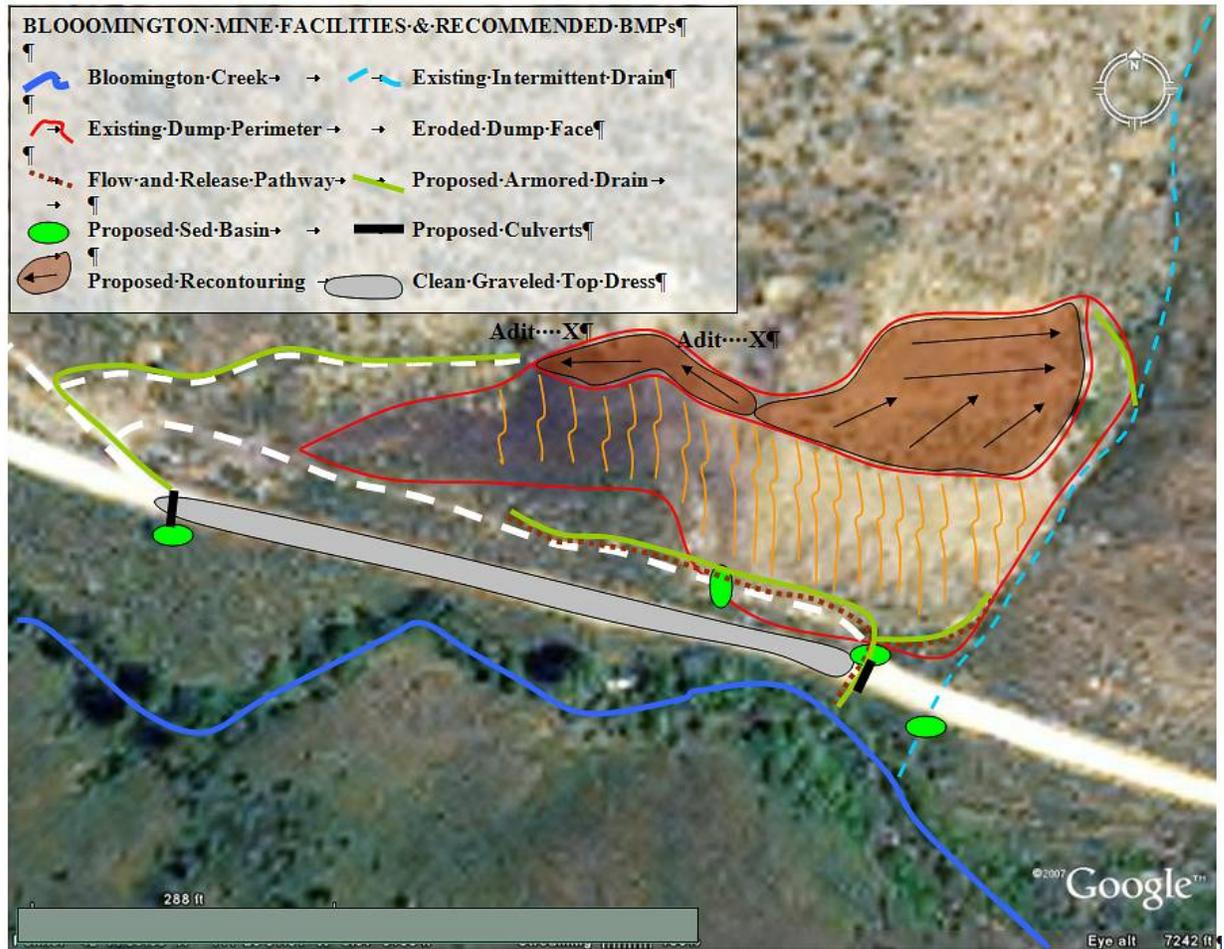
Figure 1. Bloomington Canyon Mine Site with Recommended Best Management Practices.

- Re-grade and dissect the upper surface of the mine dump from the brow to the hillside to drain towards and through two armored channels, one on each side of the dump. Figure 1 shows the Blooming Canyon Mine site and recommended best management practices (BMPs).
- Construct two armored channels and four sediment basins, one on the west side of the dump and one at the toe.

- Place clean gravel top dressing on that part of the county road effected by the erosion of the waste dump.
- No attempt to re-grade the face of the waste dump should be made, as it is very likely that disturbing the surface cohesion of the slope would cause significant short term releases of waste rock to reclaimed areas below and eventually Bloomington Creek. However, use of hydromulches containing tacifiers may expedite natural vegetation of the dumps face.

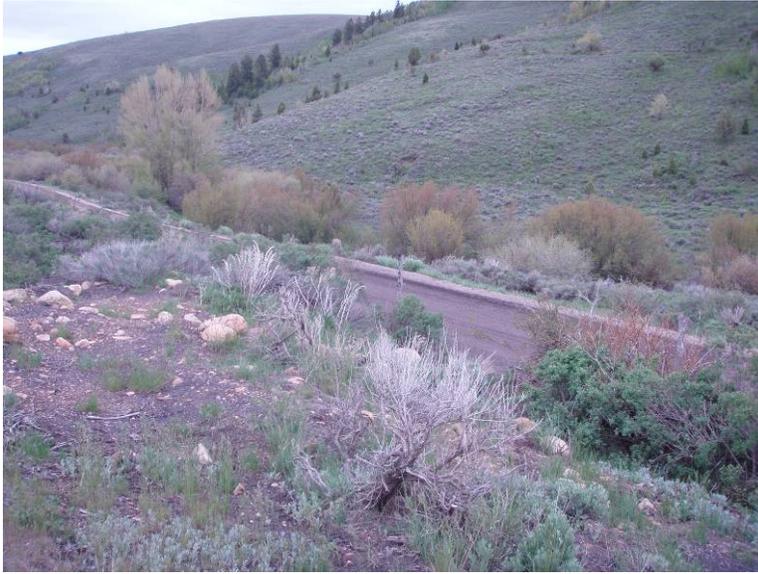
The Bloomington Canyon Mine or remnants, thereof, consist primarily of a waste dump and two mostly collapsed adits. The toe of the waste dump encroaches on the Bloomington Canyon County Road across which is the perennial Bloomington Creek.

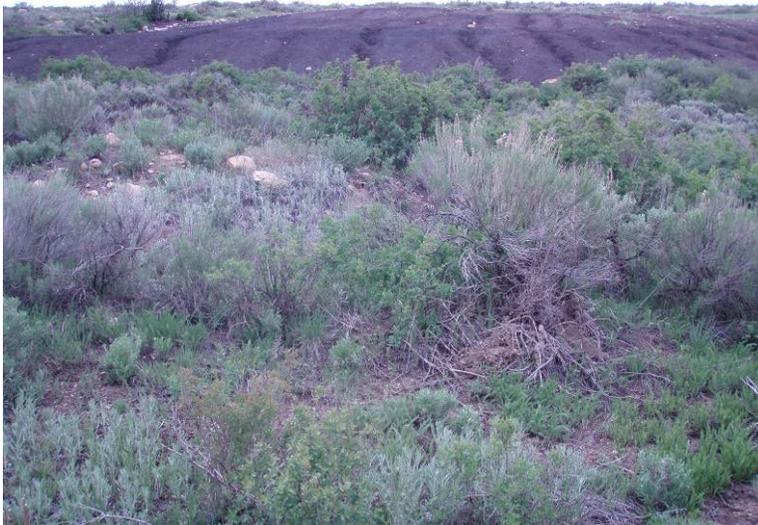
Looking up from the toe to the brow of the dump one will observe deeply incised rills in the face of the dump which run from the brow to a bench just above (approximately 15') and parallel to the county road.

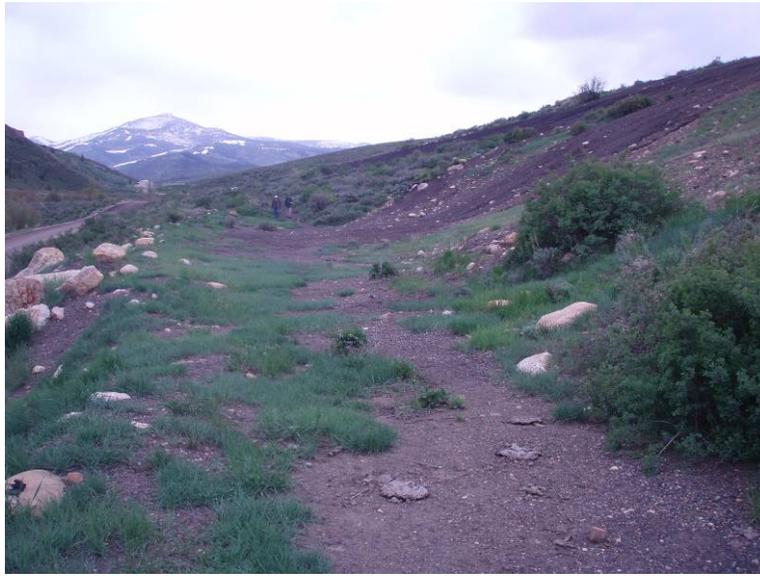
The bench noted is an extension of a historic access road. Rapid runoff from the dump face to this bench appears to be one plausible reason that vegetation has not established as lush of a cover here as elsewhere on the mine site. It may be possible to significantly reduce surface runoff velocities by recontouring and “roughing” up the lower portions of the dump, developing some swales on this bench, amending soils with large wood chips, and revegetating with both native grasses and shrubs.

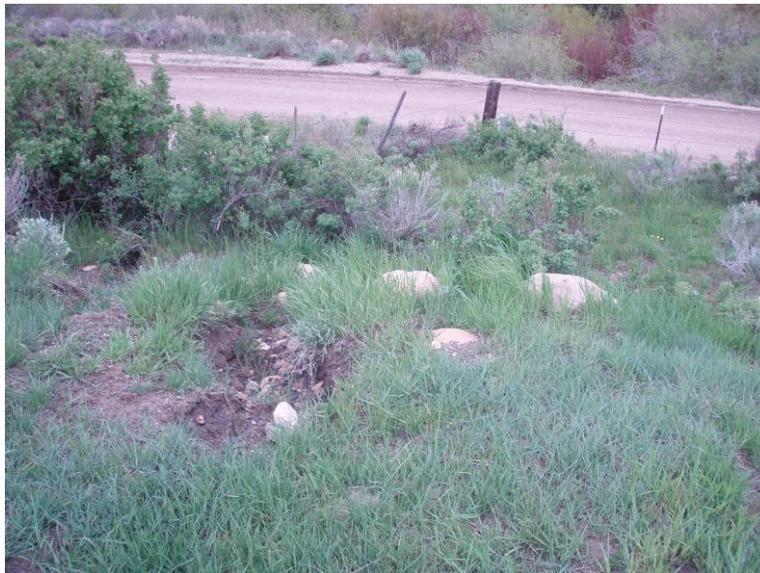
Sediment laden waters shed from the dump face confluence on the bench and are focused on one relief channel from the bench to the roadway below and then across to Bloomington Creek. Observations made on June 3, led DEQ to believe that there are two primary release mechanisms for mine wastes from the dump to Bloomington Creek. The first occurs during rapid runoff in the spring or during storm events when surface water flows carry the wastes from the dump across the road and directly into the river. The second occurs when residual deposits left by spring runoff and storm events on the road are bladed off of the road onto the fill slope between the road and the creek.

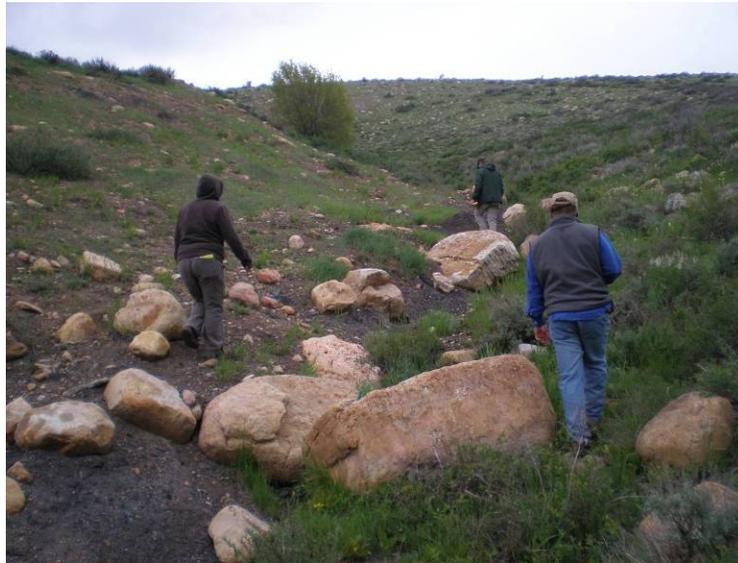
IDEQ's site inspection team climbed up from the bench to the upper surface of the dump along what appeared to be a fairly stable, well vegetated and coarsely armored ephemeral drain. Although this drain may not be well suited to carry all of the runoff from the dump surface, it seems that it would be an excellent model of size and materials that should be used for constructed drains from the lower bench to Bloomington Creek, and the west side of the dump to Bloomington Creek. With this in mind, it appeared logical that the upper surface of the mine dump from brow to hillside should be regraded and dissected to drain towards and through two armored channels, the one that exists on the east side of the dump, and another which needs to be constructed on the west side of the dump.

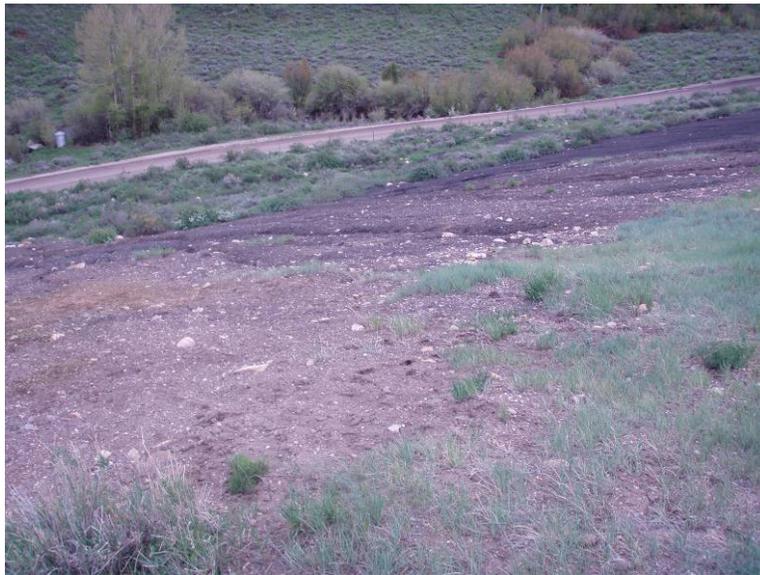
Looking from the brow of the dump down to the bench above the toe of the dump, IDEQ observed very sparse vegetation. The ineffectiveness of the vegetation to establish itself is likely to have resulted from high surface water flow velocities of runoff, wind, and the smooth surface of the face, which probably precludes the entrapments of the native seeds and organic debris necessary for natural re-colonization. Stimulation of vegetation by regrading the dump face, leaving a rougher surface, and amending the impacted surface with wood chips and other large woody debris may provide long term benefits for vegetation. However, it is very likely that disturbing the surface cohesion of this slope would cause significantly higher short term releases of mine waste to the reclaimed areas below and eventually Bloomington Creek. This would require some short term maintenance of the BMPs installed below. Therefore, IDEQ is recommending that no attempts are made to regrade these slopes. However, use of hydromulches containing tackifiers may expedite natural vegetation of the dump face.
