# **Banner Mine Area**

## **Preliminary Assessment Report**

Boise County  
State of Idaho

**Idaho Department of  
Environmental Quality**

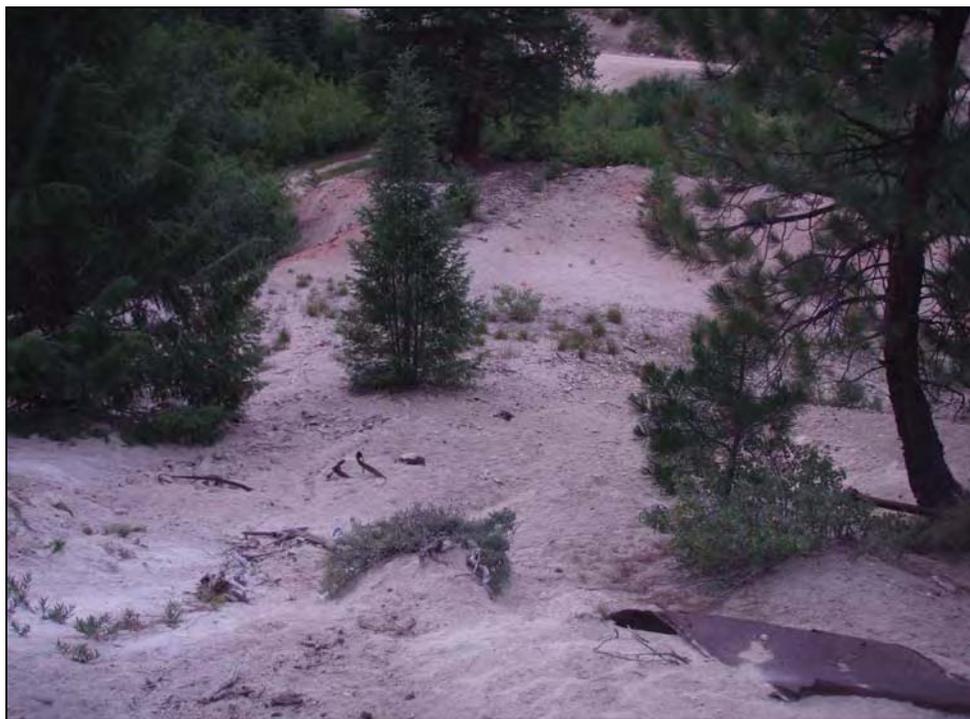
**Picture 3. View to SW. Former ore roasting furnace; scrap metal, bricks and tails.**

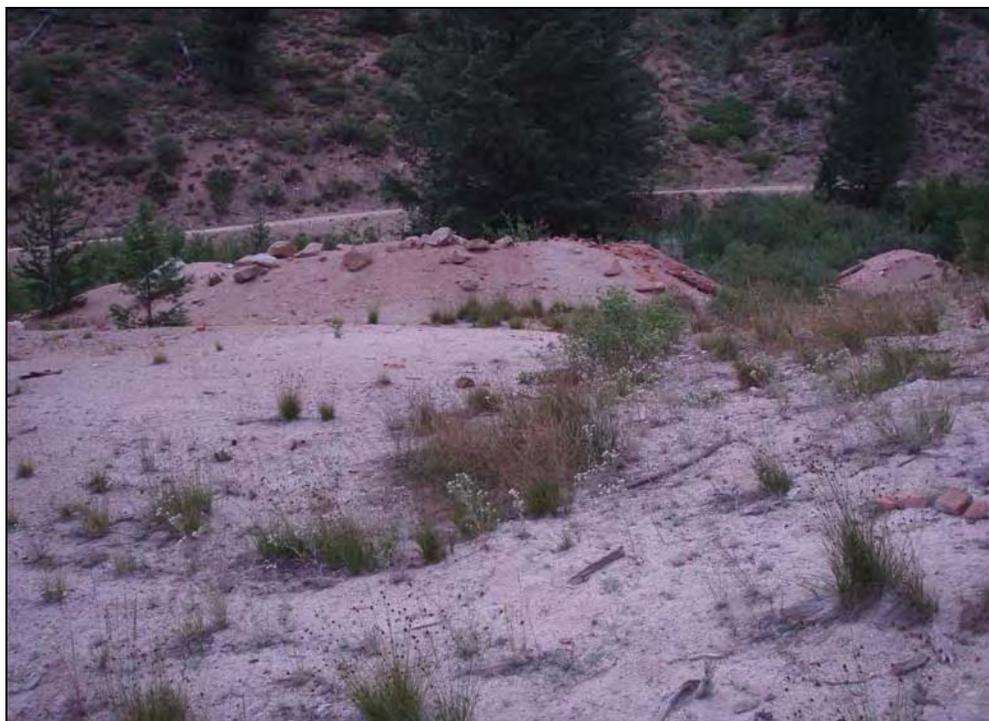
**Picture 4. View to N. Brick pile of former roasting kilns and tails, (sample collected).**

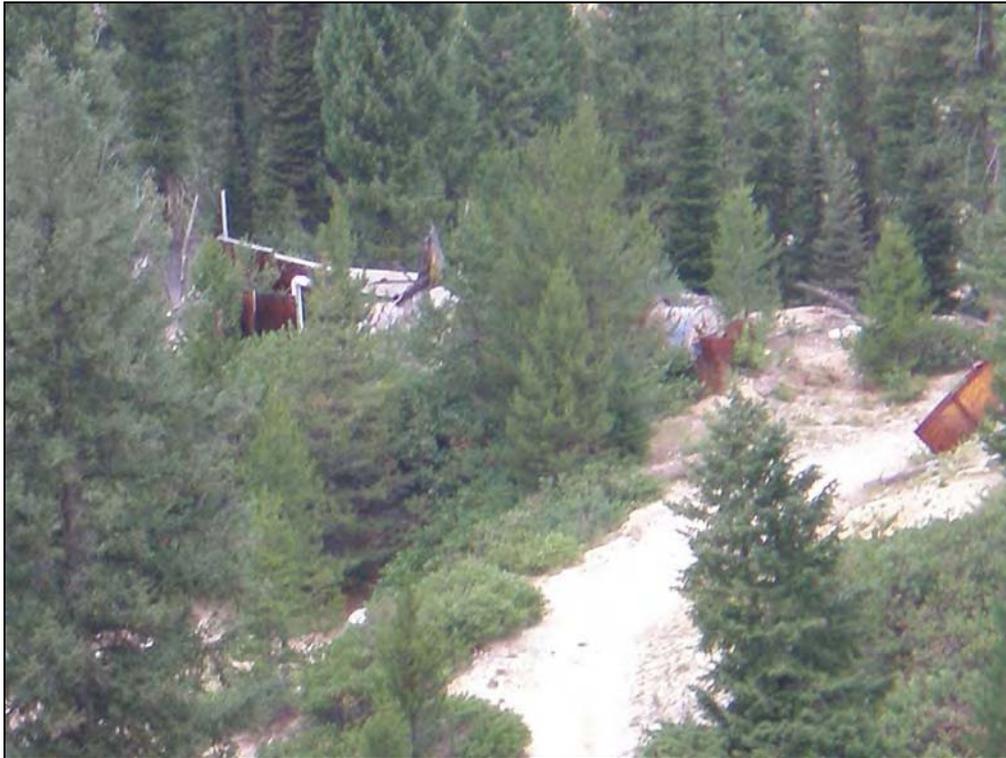
Picture 5. View to NW from Crown Point shaft. Mill building ruins, ball or rod mill & ore hopper (right).

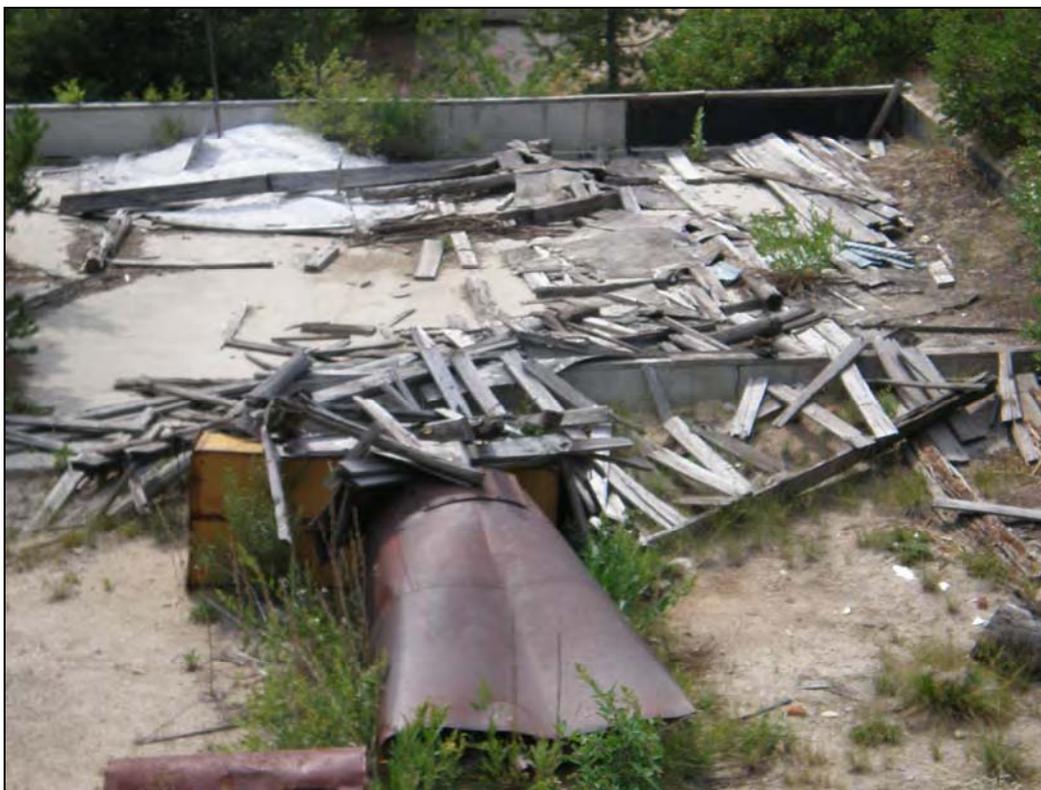
Picture 6. View to W. Mill foundation, scattered debris; white pile of lime (upper left).

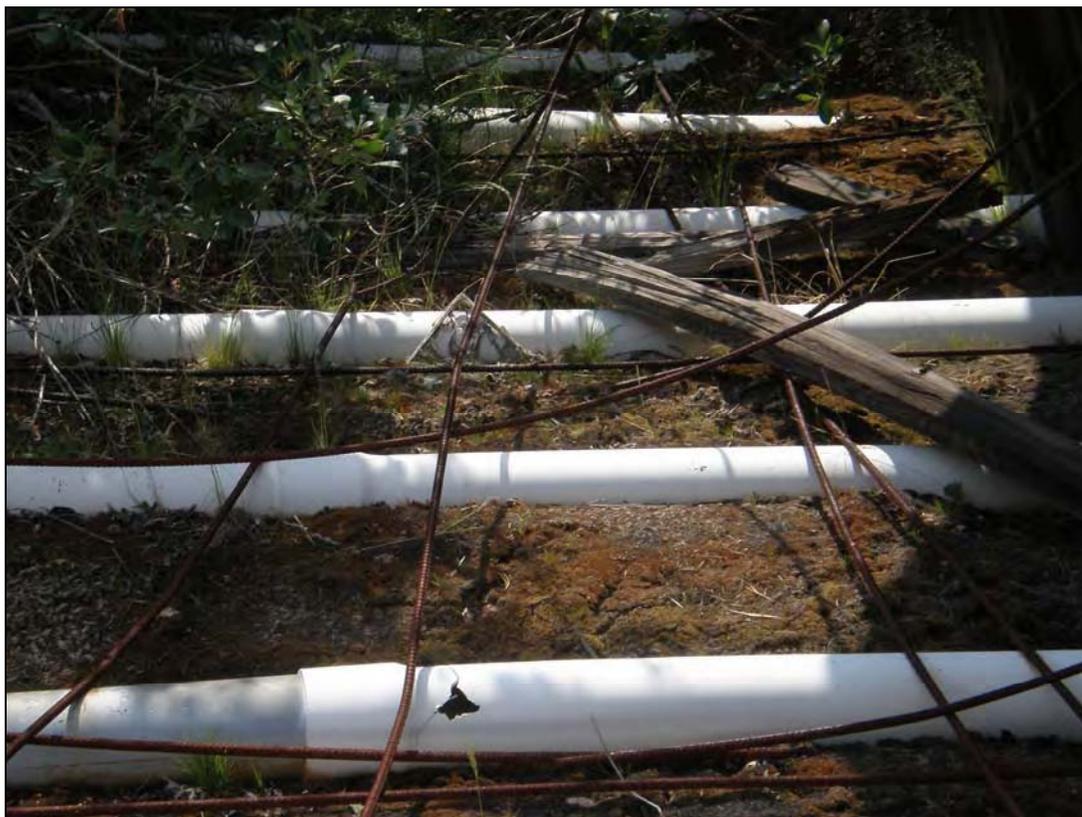
**Picture 7. View to W. Network of pipes within building foundation; treatment process unknown (sample collected).**

Sample **BNR-MS-SS3** was a composite sample collected from within the concrete foundation of the former building, located adjacent to the settling basin. The floor of the building supported a network of PVC pipes and an accumulation of soil and minor vegetation (moss).

Banner Mill tailings (treatment area) # 3: Excess cancer risk for residential and non-residential receptors is greater than the acceptable level of  $1E-05$ , as defined by the REM. The non-cancer hazard greater than the acceptable level (Hazard Index = 1) for only residential receptors.

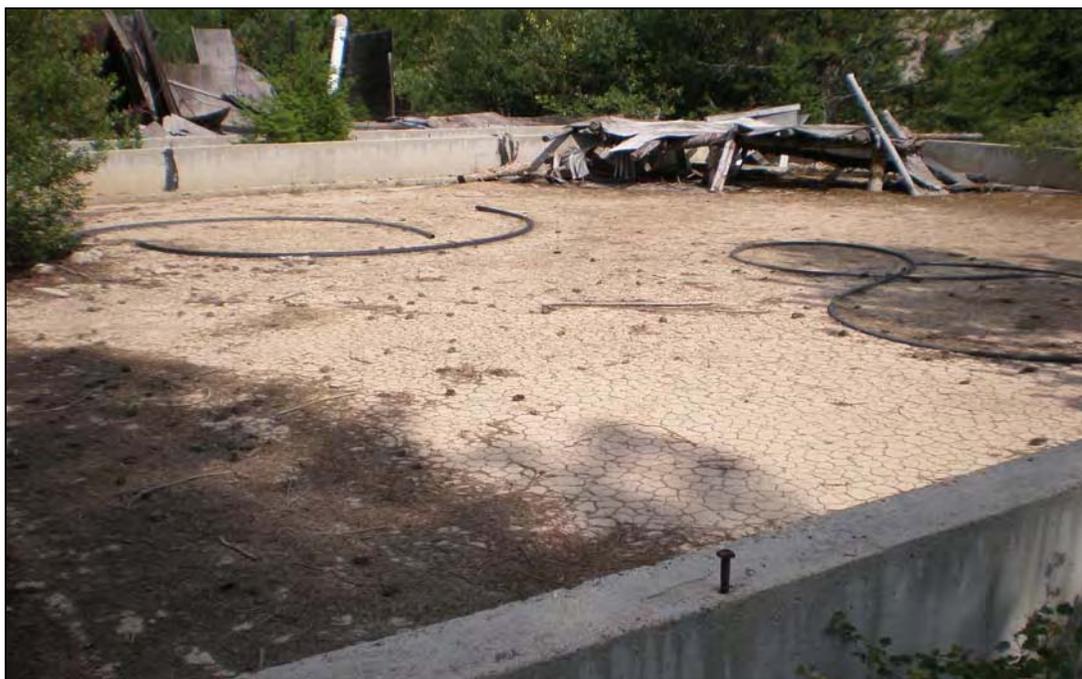
**Picture 8. View to NE. Settling basin (samples collected) with concrete foundation**

Banner Mill tailings (settling pad) # 2: Excess cancer risk for residential and non-residential receptors is greater than the acceptable level of  $1E-05$ , as defined by the REM. The non-cancer hazard greater than the acceptable level (Hazard Index = 1) for residential and non-residential receptors.

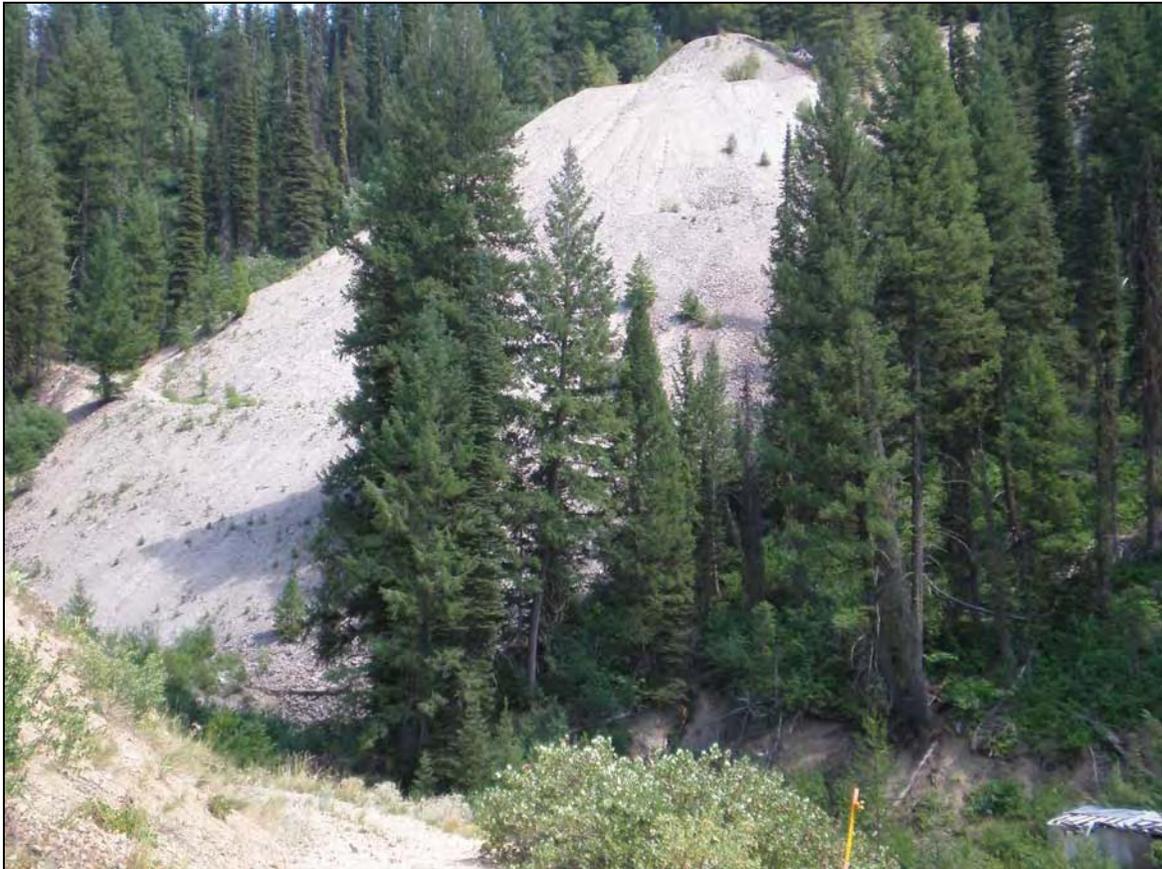
Historical records indicate the depth of the shaft at 600 feet with a mined length of nearly 450 feet. Purportedly, when the collar collapsed from excessive snow, the head frame and equipment fell into the shaft. A portion of the brick foundation of the hoist house remains at the top of the waste dump. A depression measuring 50 feet by 20 feet marks the shaft location. The waste dump is moderately sized, representing a volume of approximately 20,500 cubic yards of material.

**Picture 9. View to SE. Crown Point shaft waste dump; 200 level adit (lower center), core shack (lower right).**

Crown Point shaft waste dump: Excess cancer risk for all receptors is greater than the acceptable level of  $1E-05$ , as defined by the REM. The non-cancer hazard is greater than the acceptable level (Hazard Index = 1) for all receptors.

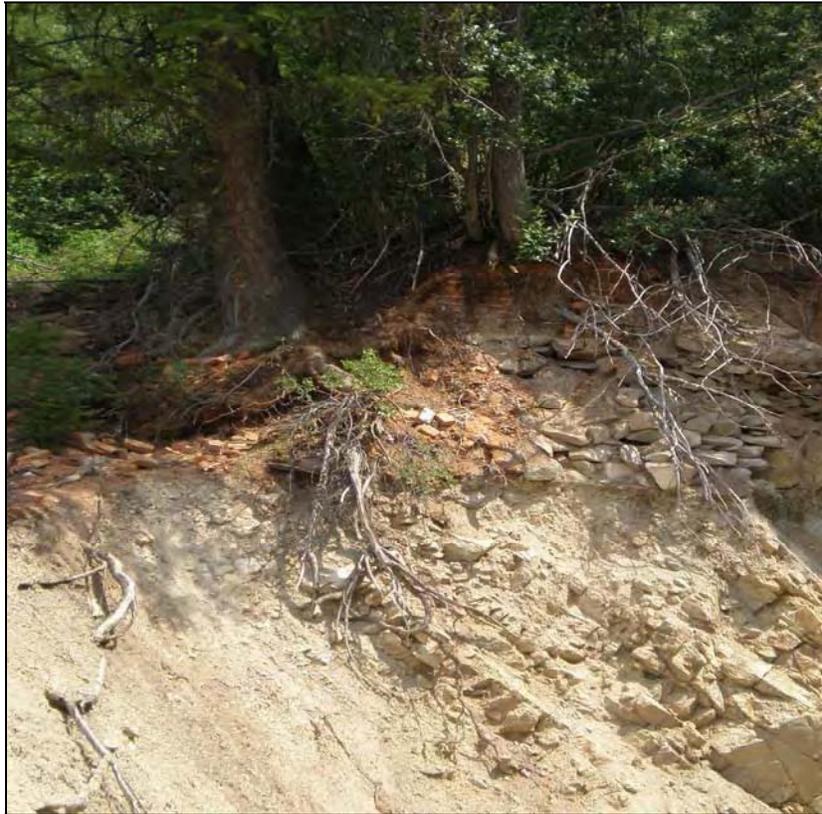
**Picture 10. View to SE. Crown Point shaft, bricks possibly from hoist house at upper center.**

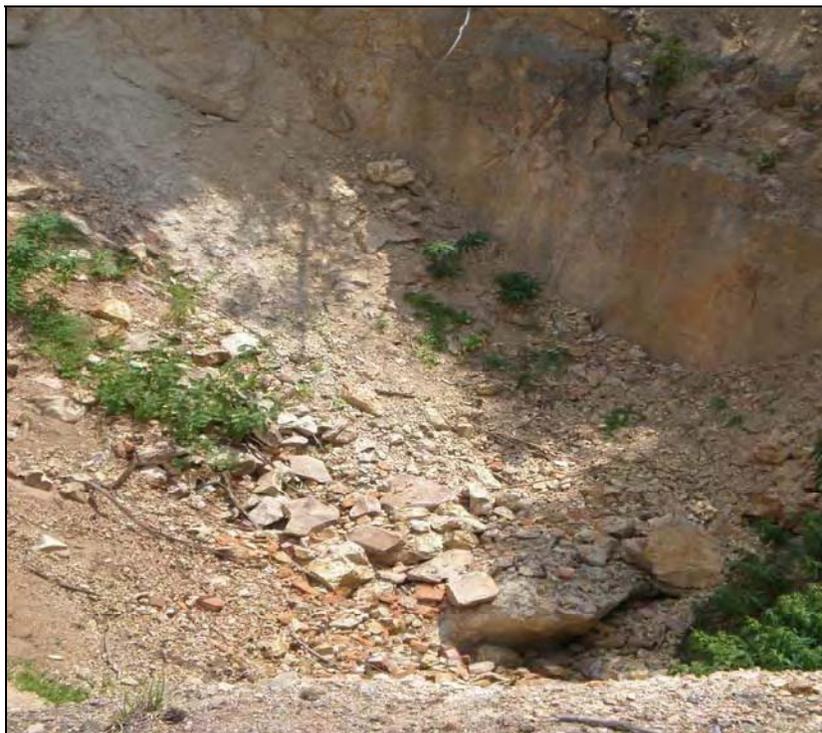
**Picture 11. View to S. Crown Point shaft collapse.**

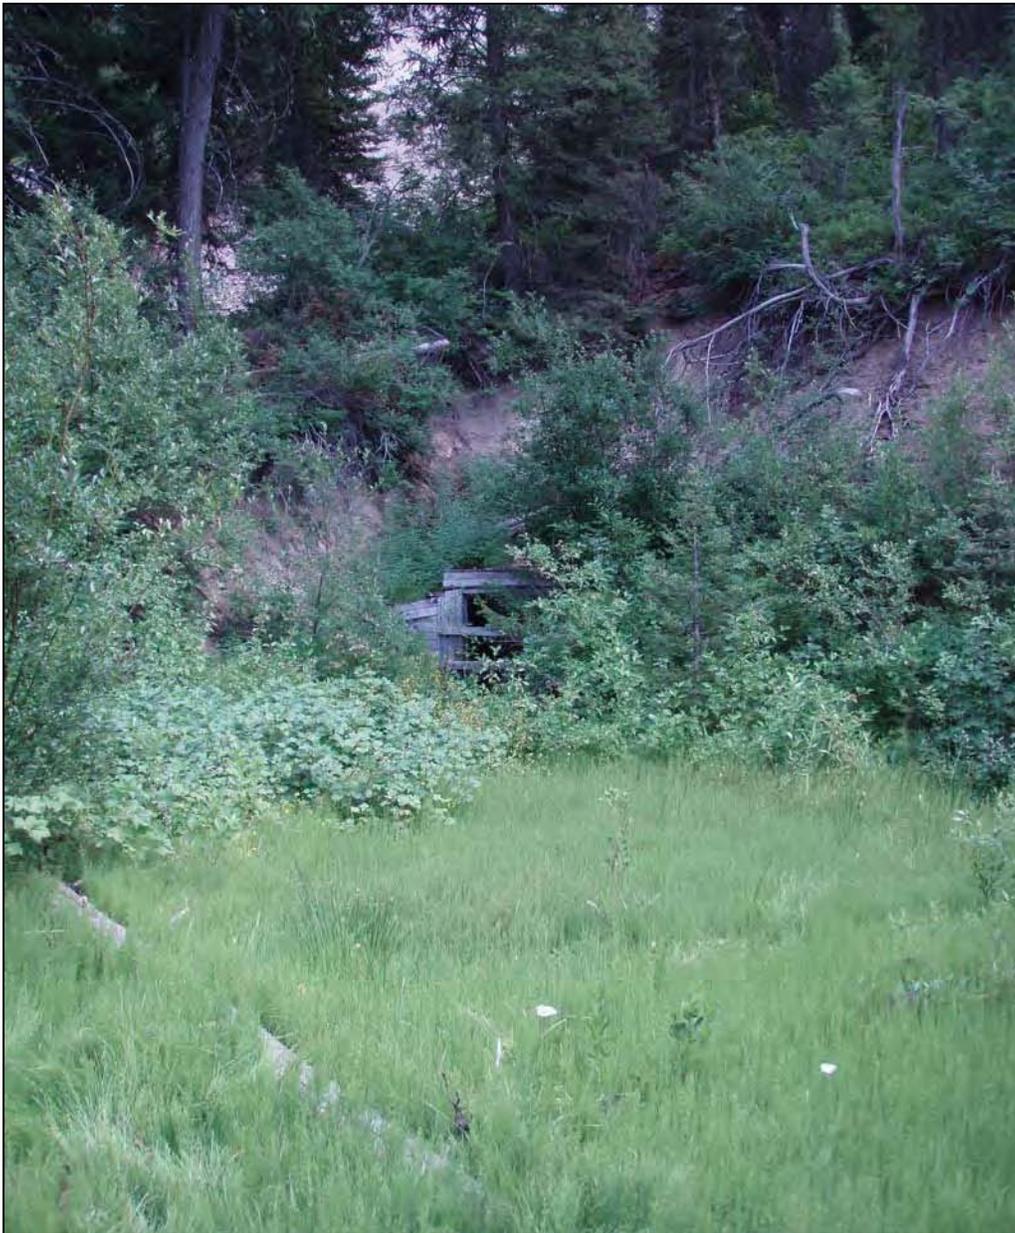
Arsenic concentrations in the water discharging from the Crown Point adit and to a lesser extent from the Banner tunnel may pose risks to human and ecological receptors. Analysis indicates that the Crown Point water is four times higher than the IDEQ Ground Water Standard and twenty times the IDEQ Drinking Water Standard. Effluent from the Banner Tunnel water slightly exceeds the IDEQ Ground Water Standard for arsenic. Banner Creek down gradient from the Crown Point adit discharge exceeds the IDEQ Drinking Water Standard for arsenic.

Hansen (1935) reported a discharge rate of 60 gallons per minute (gpm) “during October, the driest part of the year” (p. 12). When IDEQ observed the discharge in July 2007, the rate was estimated at 40-50 gpm. The discharge supported healthy vegetation and flowed westward into Banner Creek.

**Picture 12. View to SE. Boarded portal of the 200-level adit; landing area (foreground), drainage flows to right; (water sample CP-Adit-SW1 collected here).**

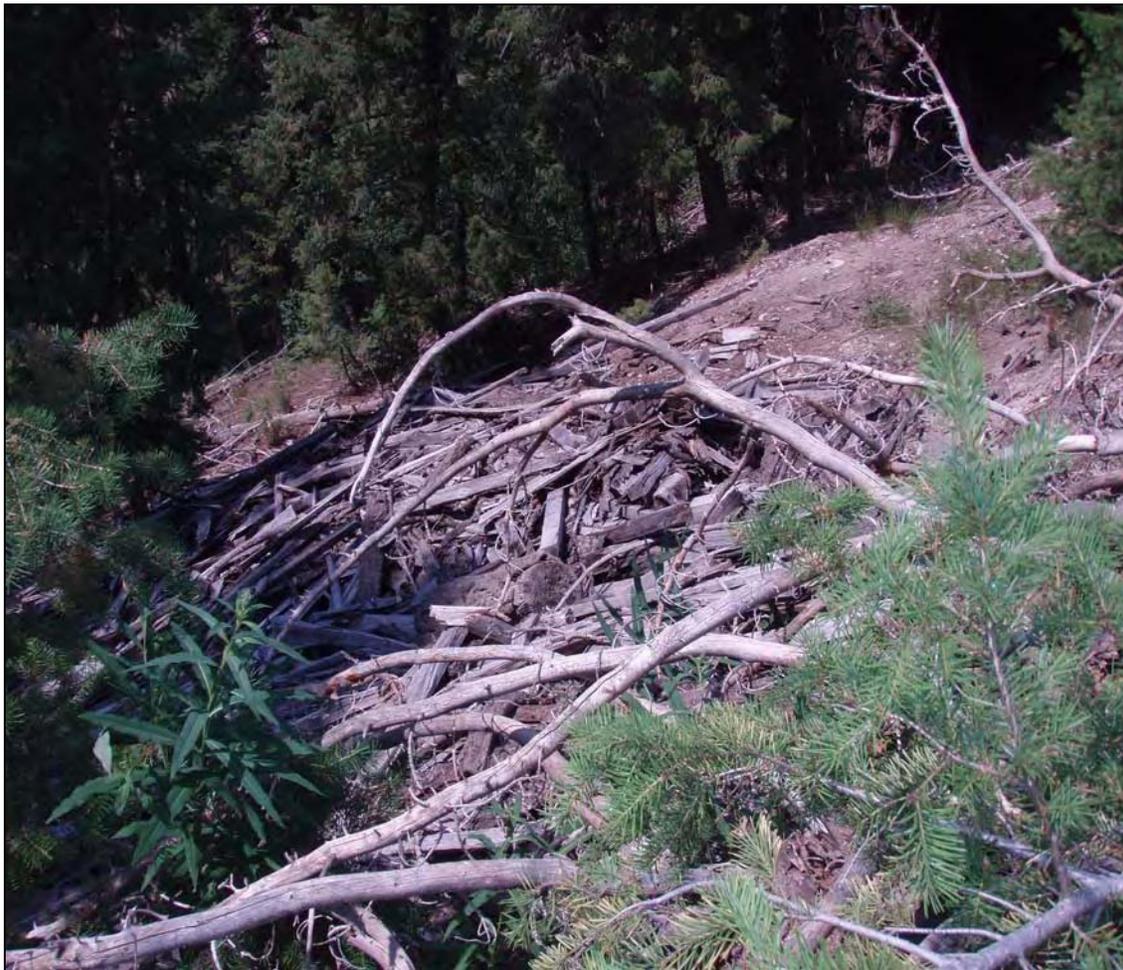
**Picture 13. View to N. Collapsed structure on the upper Wolverine waste dump.**

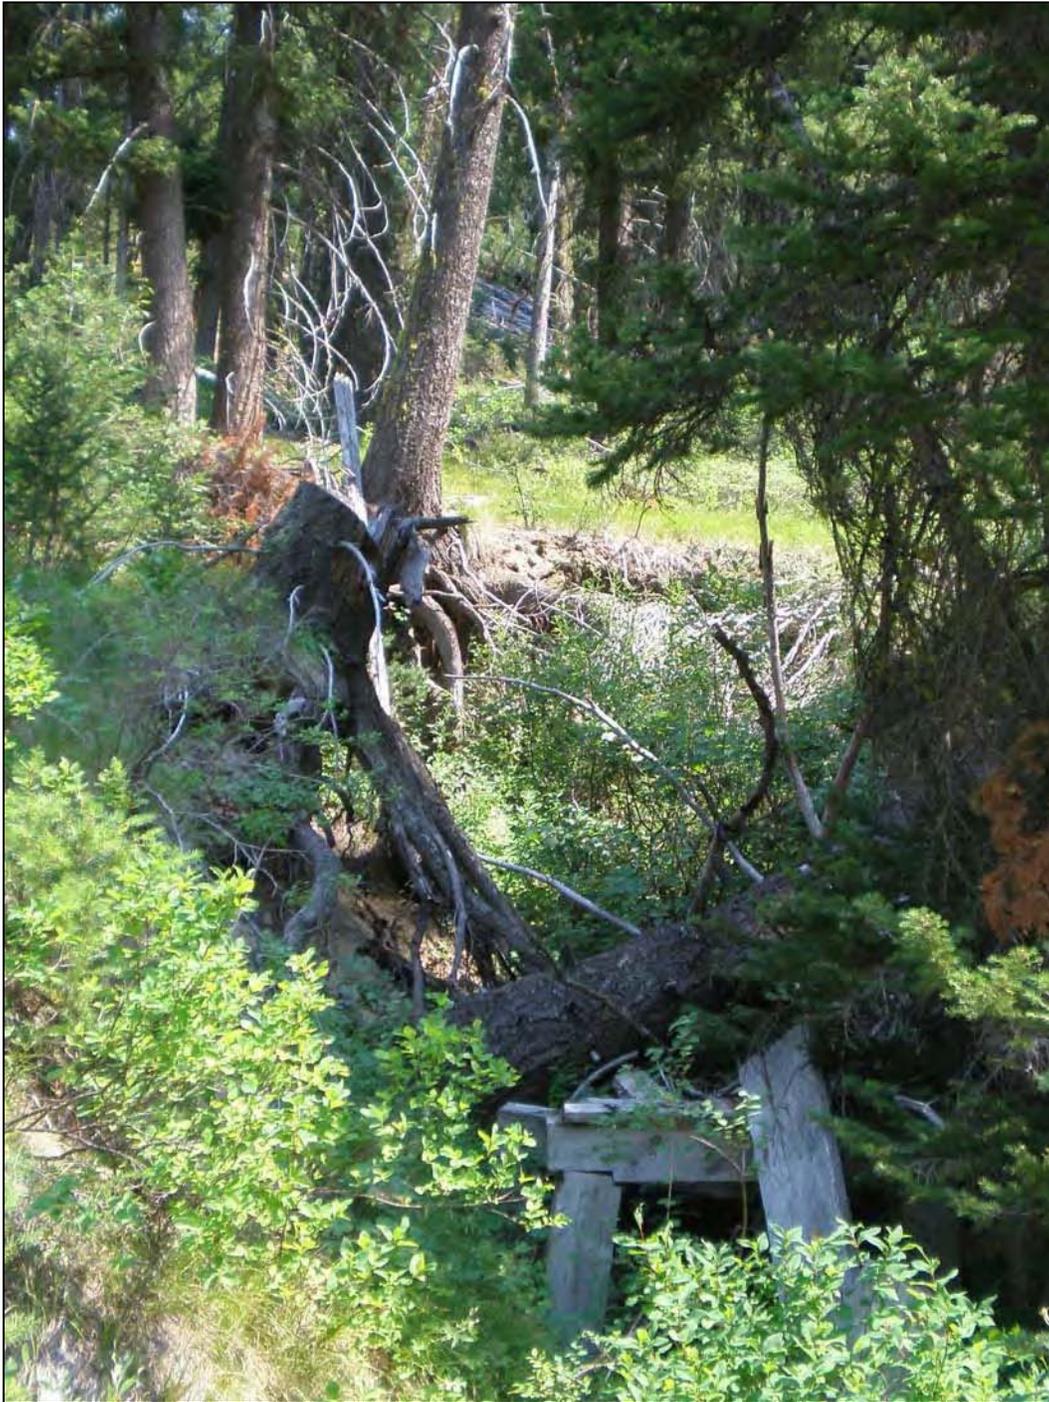
**Picture 14. View to SSE. Lower Wolverine adit (closed & dry); metal roofing of the collapsed structure near the upper Wolverine is barely visible (upper center).**

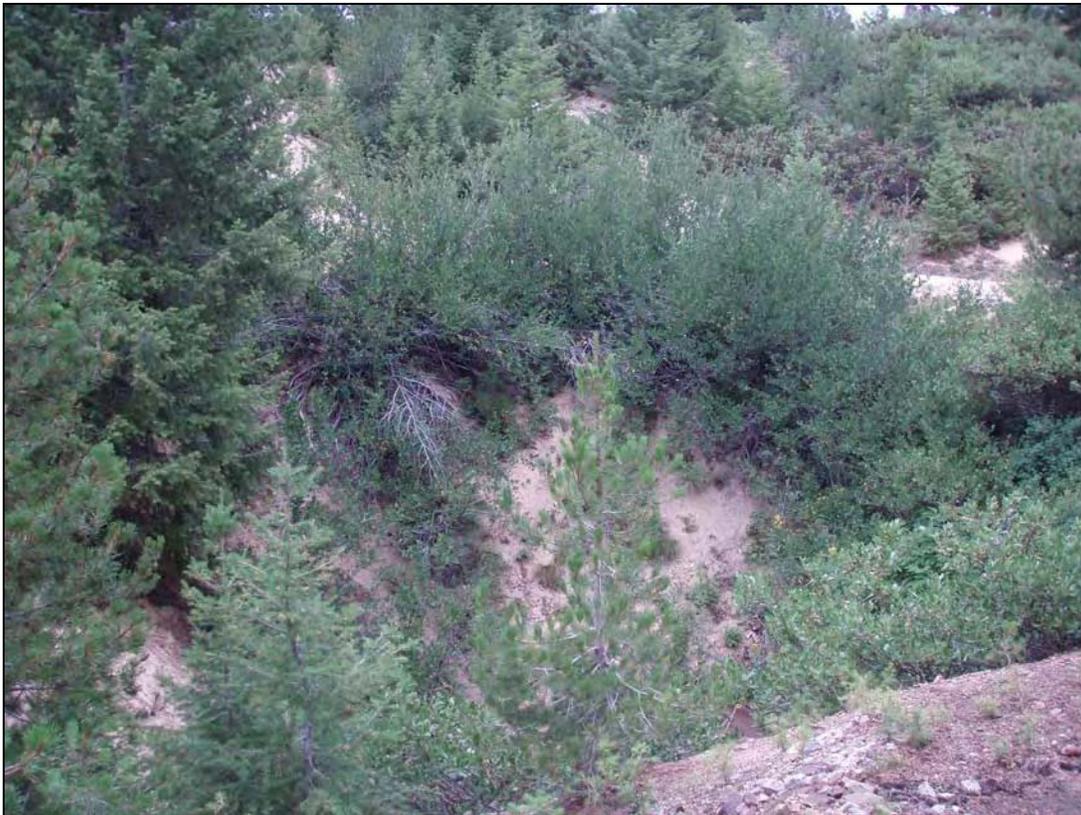
The Banner and Silver Chief veins were principally worked through the Banner long tunnel, the Banner shaft and the Silver Chief adit. The shaft was closed at the time of the site visit, but the location of the adit was not determined. Shallow surface workings such as bulldozer “cat” cuts and prospects were observed to the north of the shaft. The ground appeared reworked, exposing both country rock and ore.

**Picture 15. View to NW. Banner shaft (collapsed) adjacent to logging road (above).**

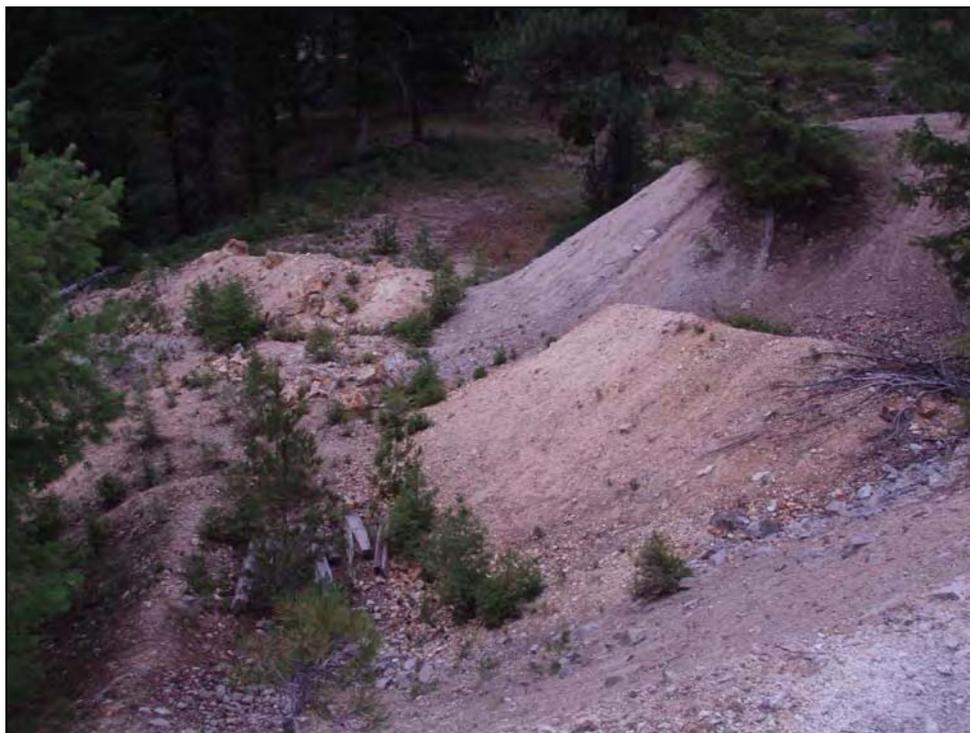
The shaft’s three-lobed waste dump had been extended beyond the property boundary to the south onto public lands. Abundant iron staining was present; sulfide minerals including sphalerite, galena and arsenopyrite were identified. The dump landing appeared to contain a higher ratio of ore to waste rock. The dump was estimated to contain < 3,000 cubic yards of material.

**Picture 16. View to S. Banner shaft waste dump (east side); iron staining.**

Banner shaft waste dump: Excess cancer risk for all residential and non-residential receptors is greater than the acceptable level of  $1E-05$ , as defined by the REM. The non-cancer hazard is greater than the acceptable level (Hazard Index = 1) for all receptors.

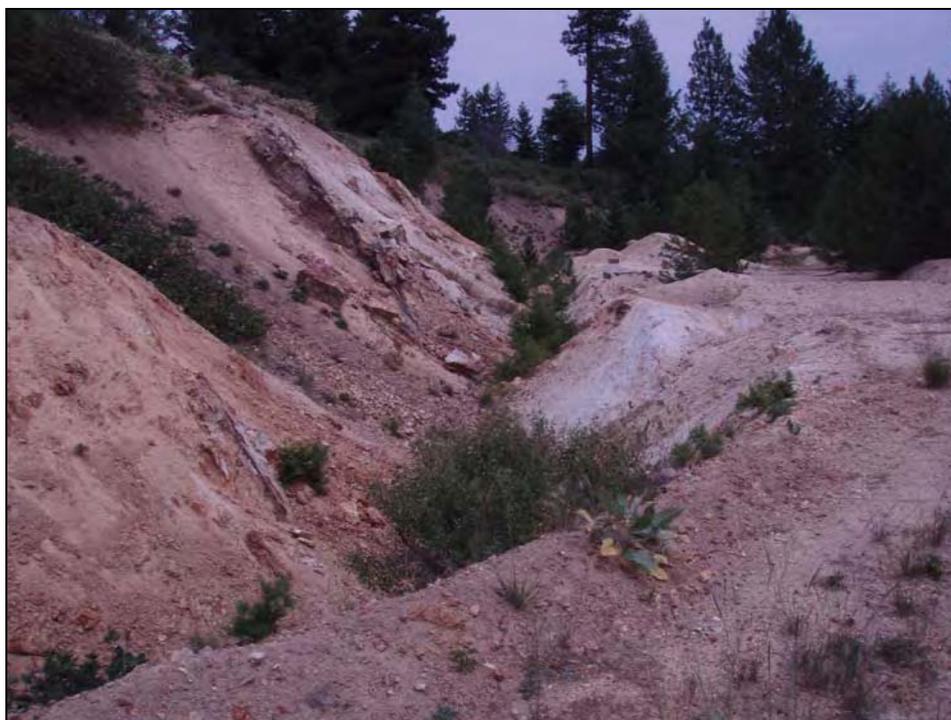
**Picture 17. View to N. exploration trenches & prospects near Banner shaft; background sample (BNR-WD2-BG) collected at upper right.**

Sample **BNR-WD2-BG** was a composite sample collected from an area above the Banner shaft. Though the area had been disturbed, recognizable waste rock features were not observed. Consequently, IDEQ concluded that the sampled area was not a dump and chose to include it as a background sample. The sample location was excavated approximately 6 more inches in coarse rock and soil. The buff to yellow colored sample was a composite of concentrate tails and sandy oxidized soil. Approximately 95% of the sample passed the 10 mesh sieve, less than 10% organic material was included.

Above the Banner shaft (background): Excess cancer risk for all receptors is greater than the acceptable level of  $1E-05$ , as defined by the REM. The non-cancer hazard is greater than the acceptable level (Hazard Index = 1) for all receptors.

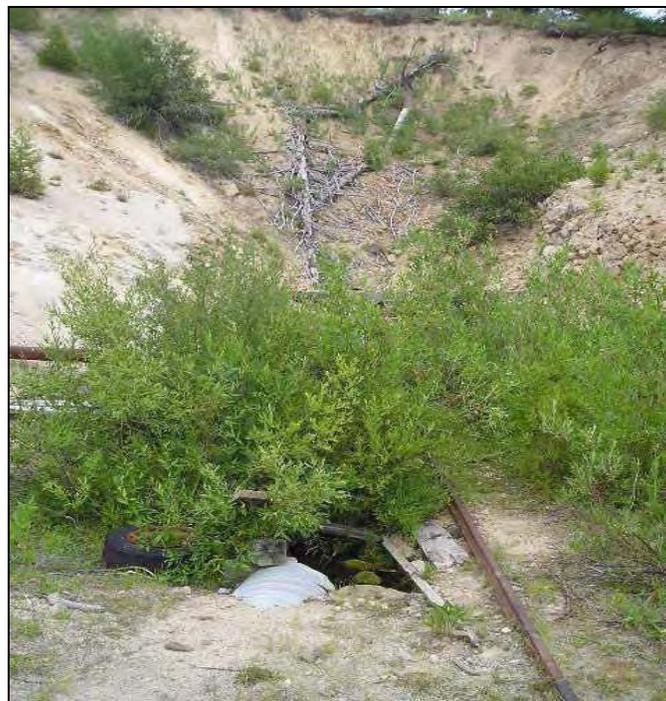
**Picture 18. View to E. Banner tunnel drainage through culvert into Banner Creek.**

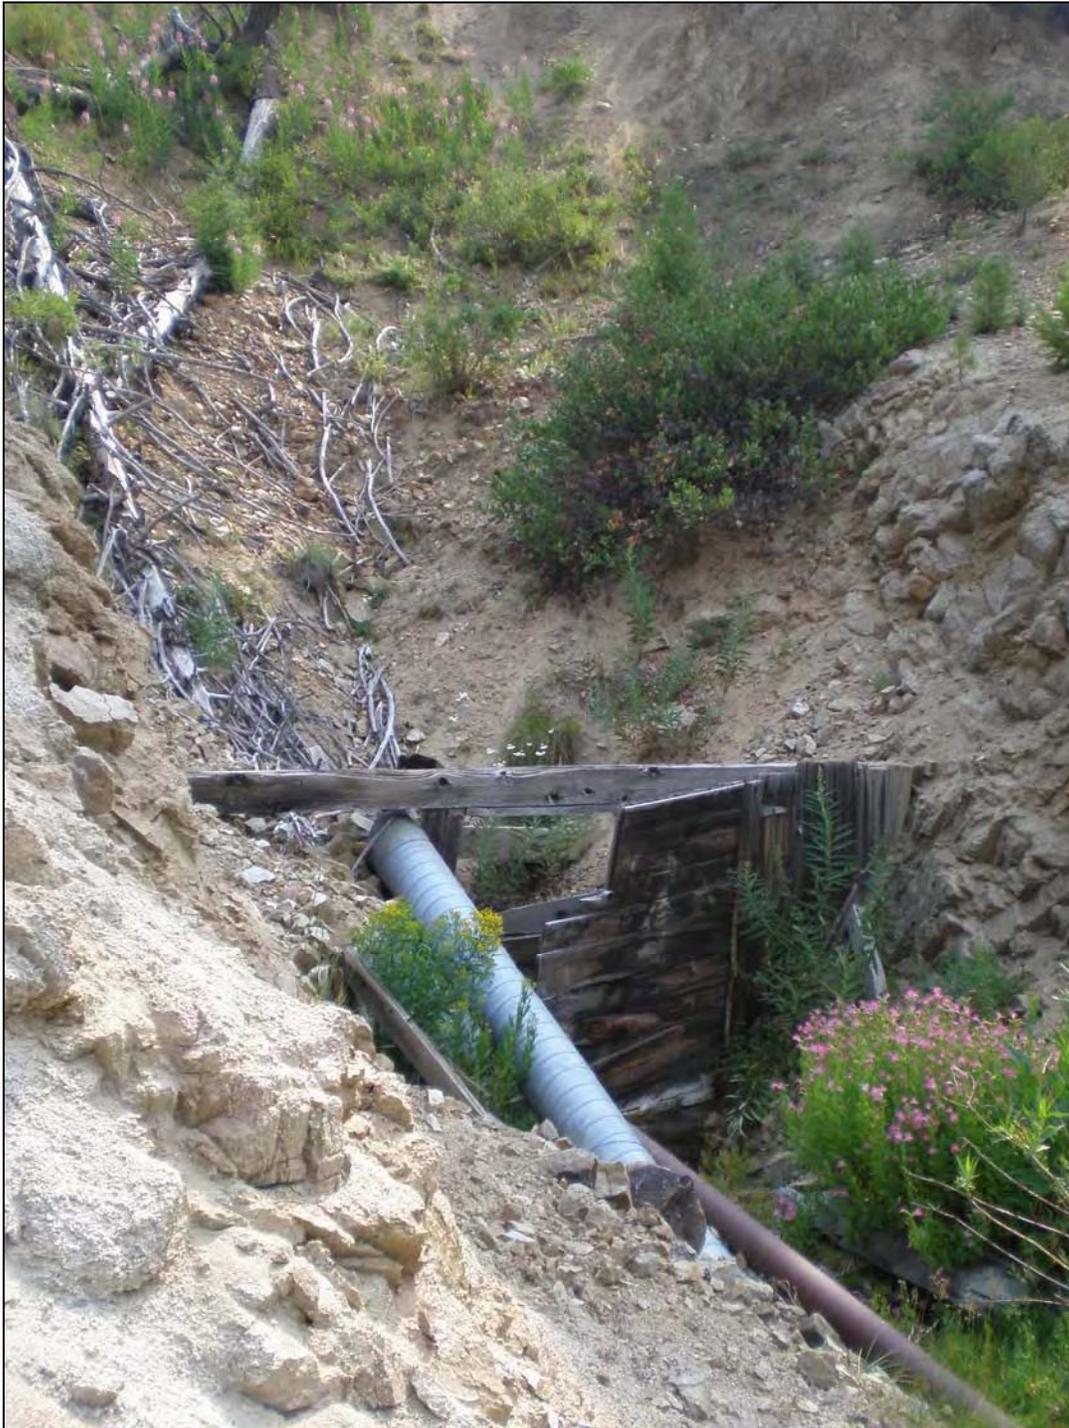
**Picture 19. View to E. Gated portal of Banner tunnel; collapsed adit; water discharges at right.**

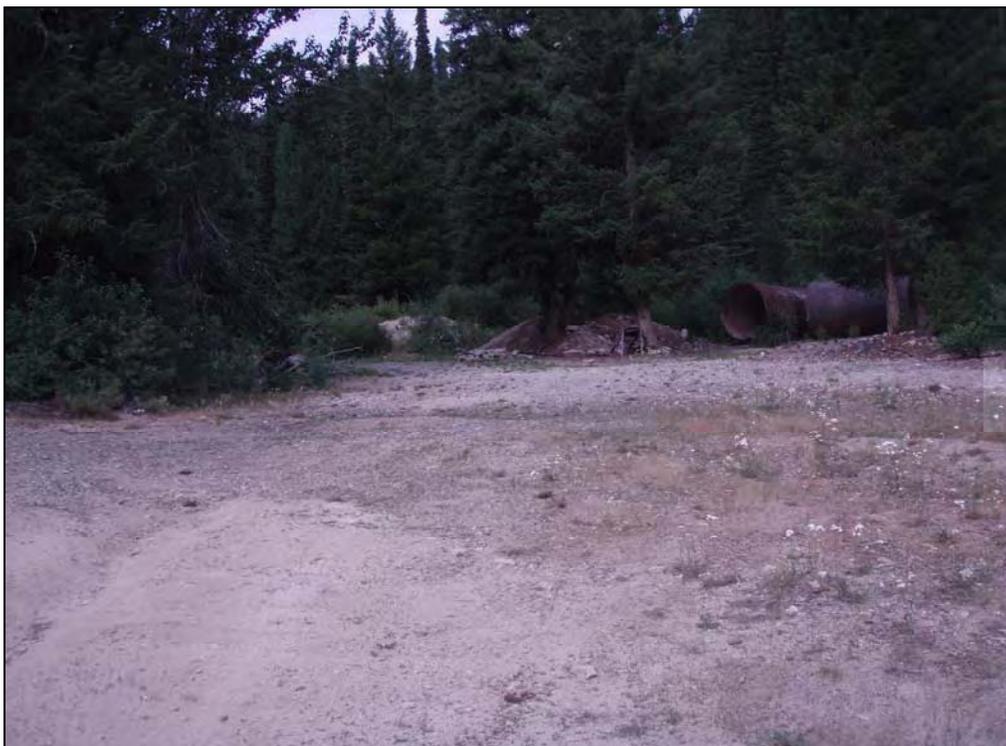
**Picture 20. View to E. Banner tunnel waste dump; boiler pipe (upper right).**

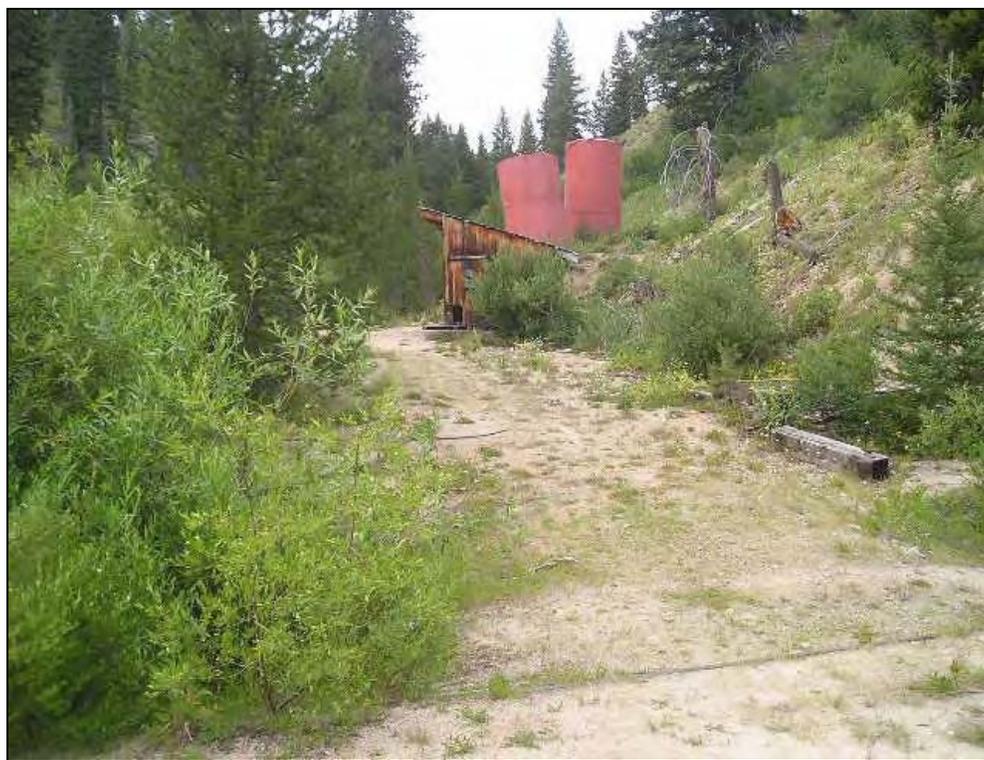
**Picture 21. View to N. Empty fuel storage tanks and compressor shed.**

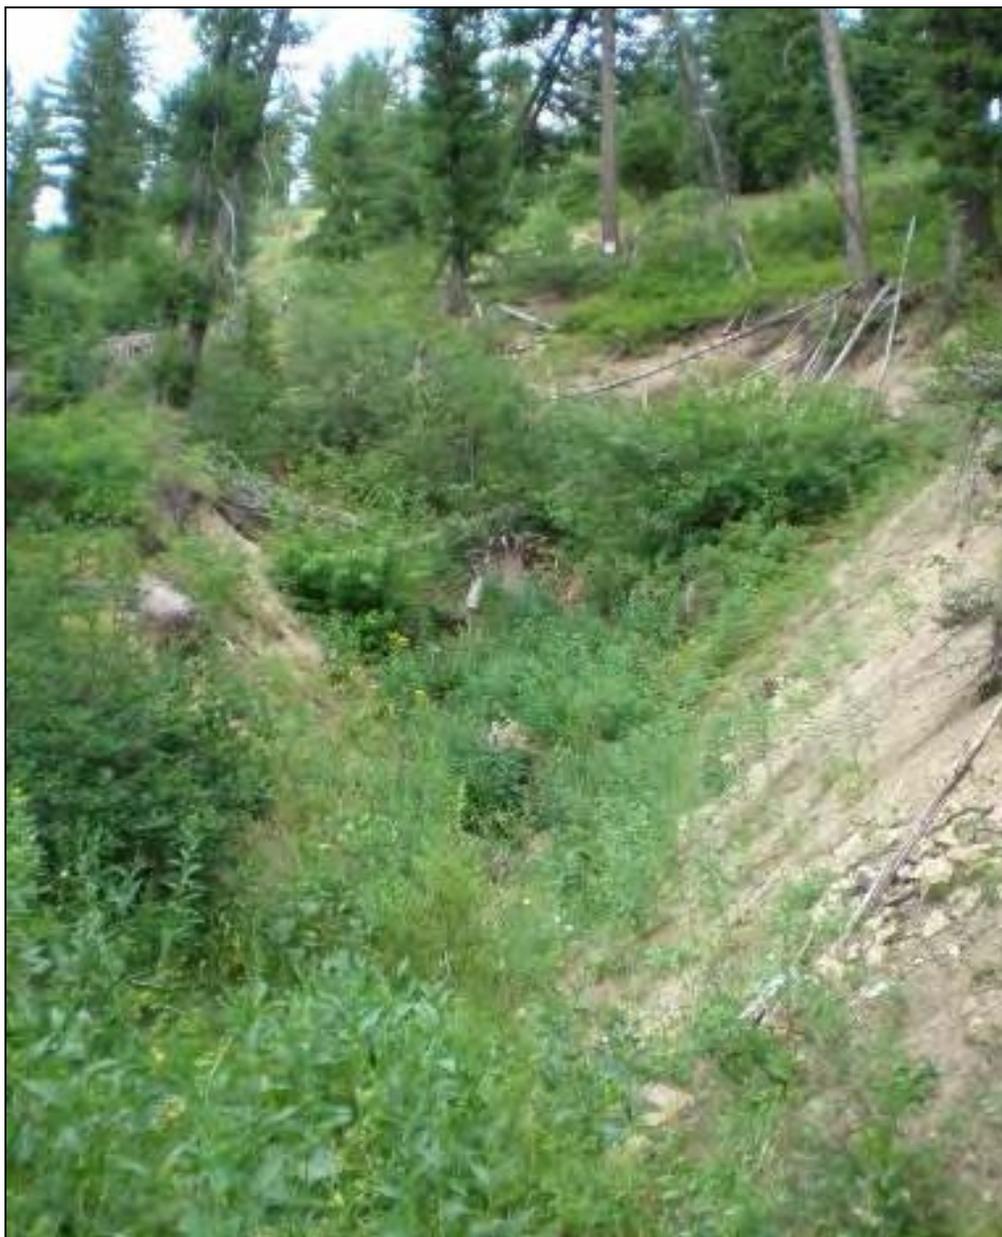
In addition to the long tunnel, two collapsed adits, a caved stope and an open stope (possible collapse of the long tunnel’s back) were noted. From the portal area, a jeep trail leads up an adjacent gulch to the east. An open stope was encountered along this trail, beneath a sign posted “Explosives”. Surface flow in the gulch appeared to be seeping into the stope. This opening is extremely dangerous, with steep and unstable walls. Its depth was estimated at <15 feet which gives credence to a direct connection to the Banner tunnel. The adits are located on the opposite flank of the gulch, approximately 50-75 meters, southeast. Both adits are caved. A small waste dump, estimated at <500 cubic yards of material appears to correspond to the larger of the two adits. Both workings sustain healthy vegetation.

**Picture 22. View to NE. Collapsed adit and caved stope (above); “private property” sign on tree at upper center.**

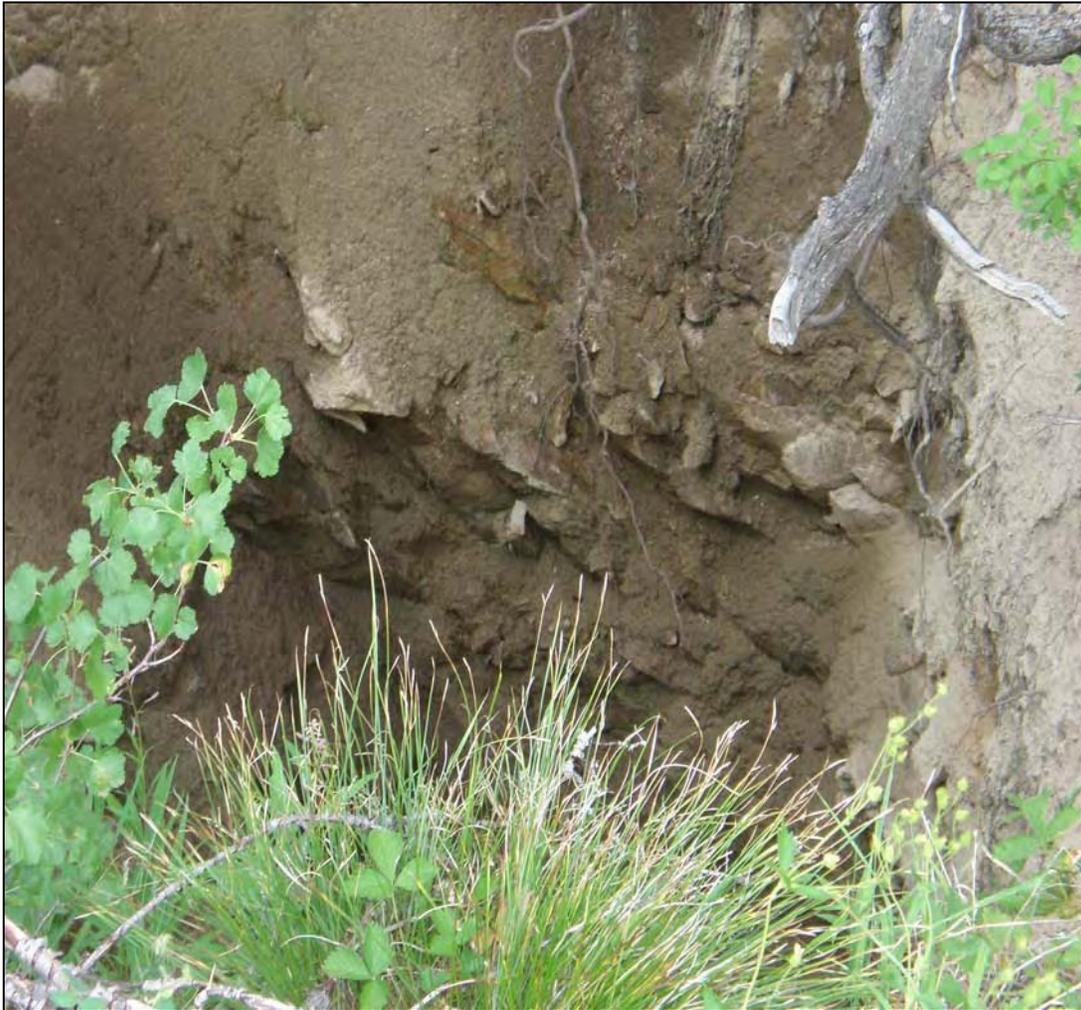
During IDEQ's site visit a number of the shafts and tunnels appeared collapsed beyond their portals. However, an open stope was identified above the Banner Tunnel. **This opening is extremely dangerous, and should be closed.** The caved stope has steep unstable walls and may be a collapsed portion of the Banner tunnel. Water from the adjacent gulch has seeped into the hole, further weakening the structure. Foundations, old equipment and miscellaneous debris remain at the mill site. The unknown extent and location of underground workings in the area indicates that subsidence should be considered a factor in future development plans.

**Picture 23. Open stope; darker soil on far wall is water saturated; noticeable sounds of flowing water emanating from base of the hole; possibly coming from the Banner tunnel.**
