**YELLOWJACKET MILL  
PRELIMINARY ASSESSMENT REPORT  
LEMHI COUNTY, IDAHO**

**STATE OF IDAHO  
DEPARTMENT OF ENVIRONMENTAL QUALITY**

December 2002

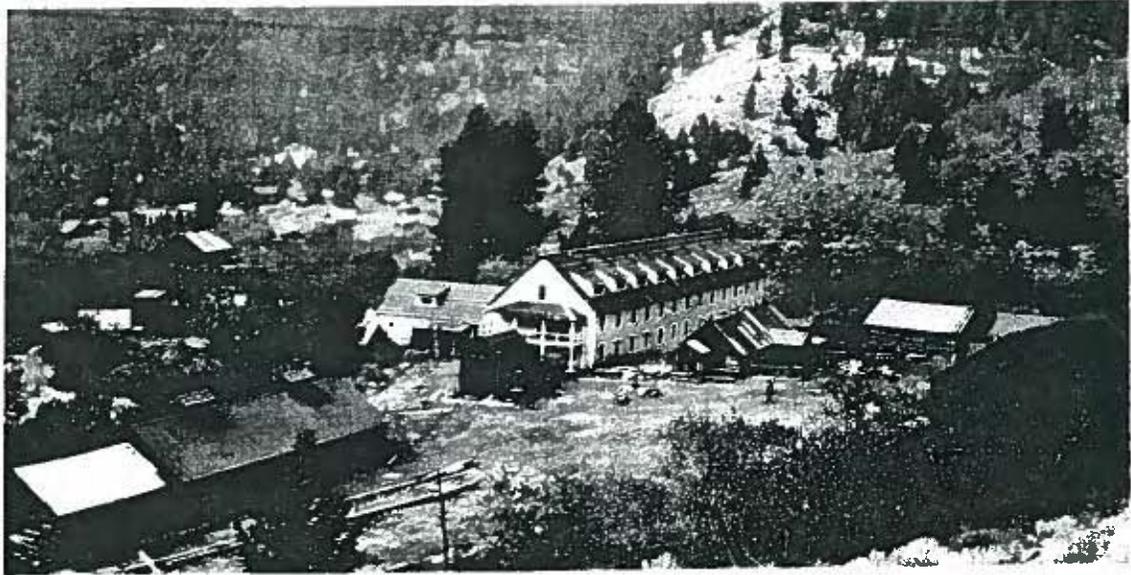
CP0560

Yellowjacket town site (August, 1926), hotel (center),  
blacksmith shop (lower left), miners cabins (upper left)

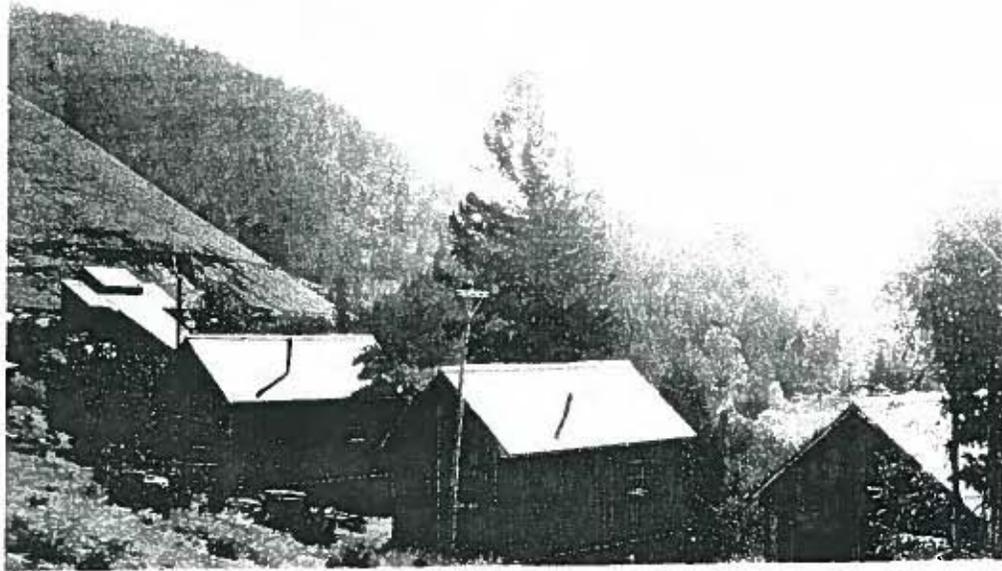
CP0541

Yellowjacket Mill (left center), flume visible on hillside above roofline of Mill

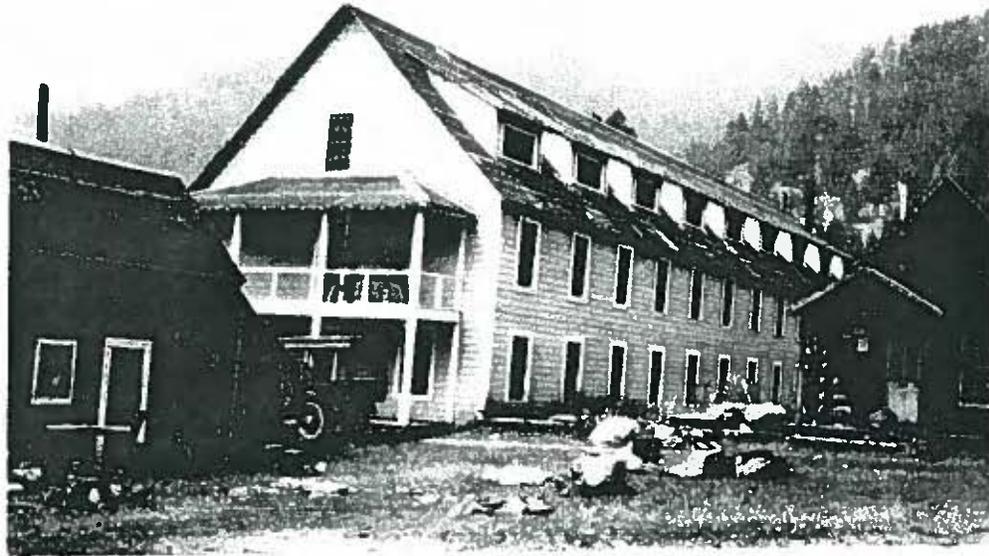
CP0563

Hotel and camp buildings, August 9, 1926

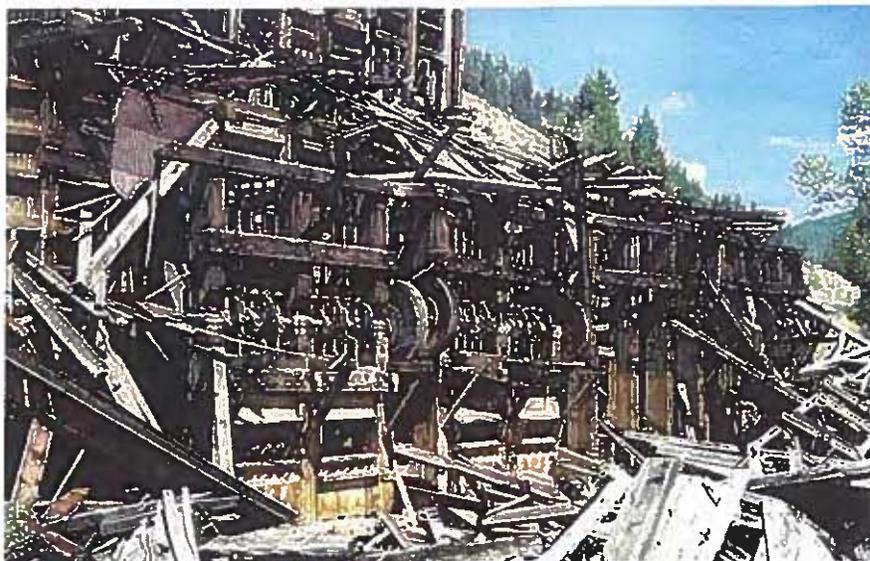
Mvc-001s

DEQ conducted a site visit on August 6, 2002. The owner of the property, Mymalee Steen, was present during the site visit. Mrs. Steen provided historical accounts of the townsite of Yellowjacket, the Mill and Mine. The Steens vacation on the property during the summer months, occupying a restored cabin (not pictured). She accompanied DEQ around the site. The site was not fenced and easily accessible from the adjacent Yellowjacket Road, but posted with "Private Property" and no trespassing signage. Site features include the old Mill, which is rapidly falling into ruin, and its associated tailings piles and other structures of the old mining camp (not included in this PA). The Steens are endeavoring to forestall the ravages of weather and time by restoring some of the original structures at the mining camp including the blacksmith shop, barn and icehouse. The Mill that once operated 60 stamps could not be inspected due to safety concerns (Photo Mvc-001s).

Mill - Stamp Batteries (24 stamps visible at center)

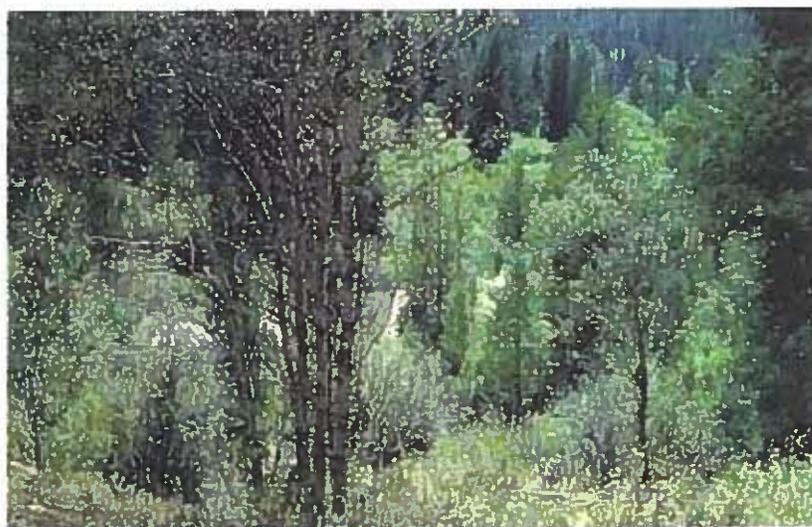
Mvc-009s

The tailings piles that supported a healthy growth of grasses, shrubs and trees (Photos Mvc-002s and Mvc-007s) appeared fine-grained in texture and composed primarily of silica.

Mill tailings (vegetative cover)

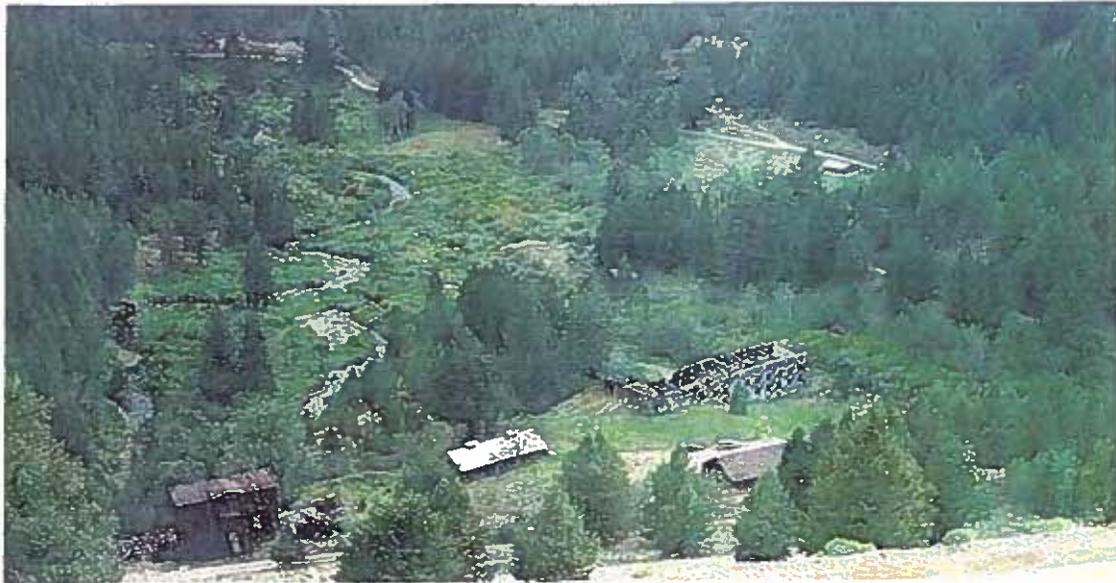
Mvc-007s

Mill ruins (lower left), blacksmith shop (tin roof), hotel ruins, barn (lower right).  
Tailings piles (below Mill) lie within Yellowjacket Creek, beaver dams in creek.

The remaining tailings are located in the flood plain of Yellowjacket Creek. DEQ collected a soil sample from one of the tailings piles lying adjacent to the creek (Appendix B). The creek appears to be eroding the old tailings, but discoloration of the water or creek bed is not evident.

One Probable Point of Entry (PPE) is the erosion of the tailings piles by Yellowjacket Creek. Direct observation revealed the incising of the tailings by the creek. Though not observed, a second PPE could be run-off across the site into Yellowjacket Creek.

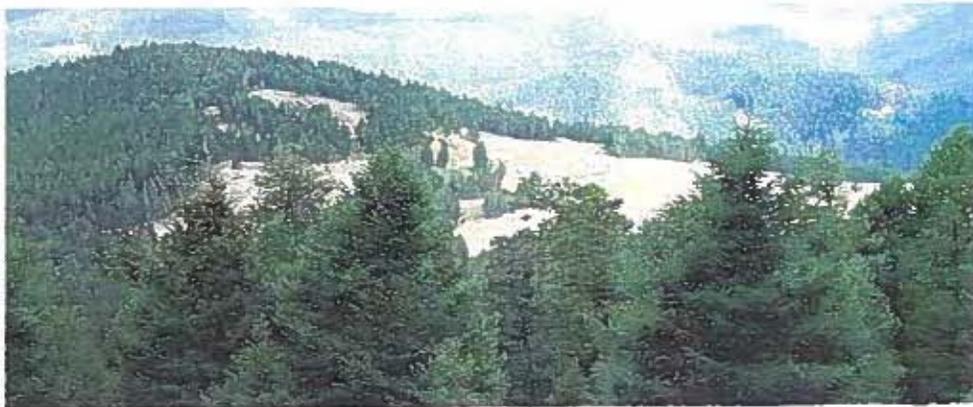
Mvc-009s

The Mine, located approximately 0.75 miles up the mountain from the Mill, was undergoing final reclamation activities. Reclamation oversight was provided by the U.S. Forest Service based at Salmon, Idaho. The ore deposits had been covered and graded to apparent natural contours (Photo Mvc-009s). The open pit area that is shown in the left center of the photograph remains visible, but has been graded to a relatively flat landing area with a scrape face.

Yellowjacket Mine Reclamation
