QUARTZBURG  
PRELIMINARY ASSESSMENT REPORT  
BOISE COUNTY, IDAHO

**STATE OF IDAHO**  
**DEPARTMENT OF ENVIRONMENTAL QUALITY**

September 2004

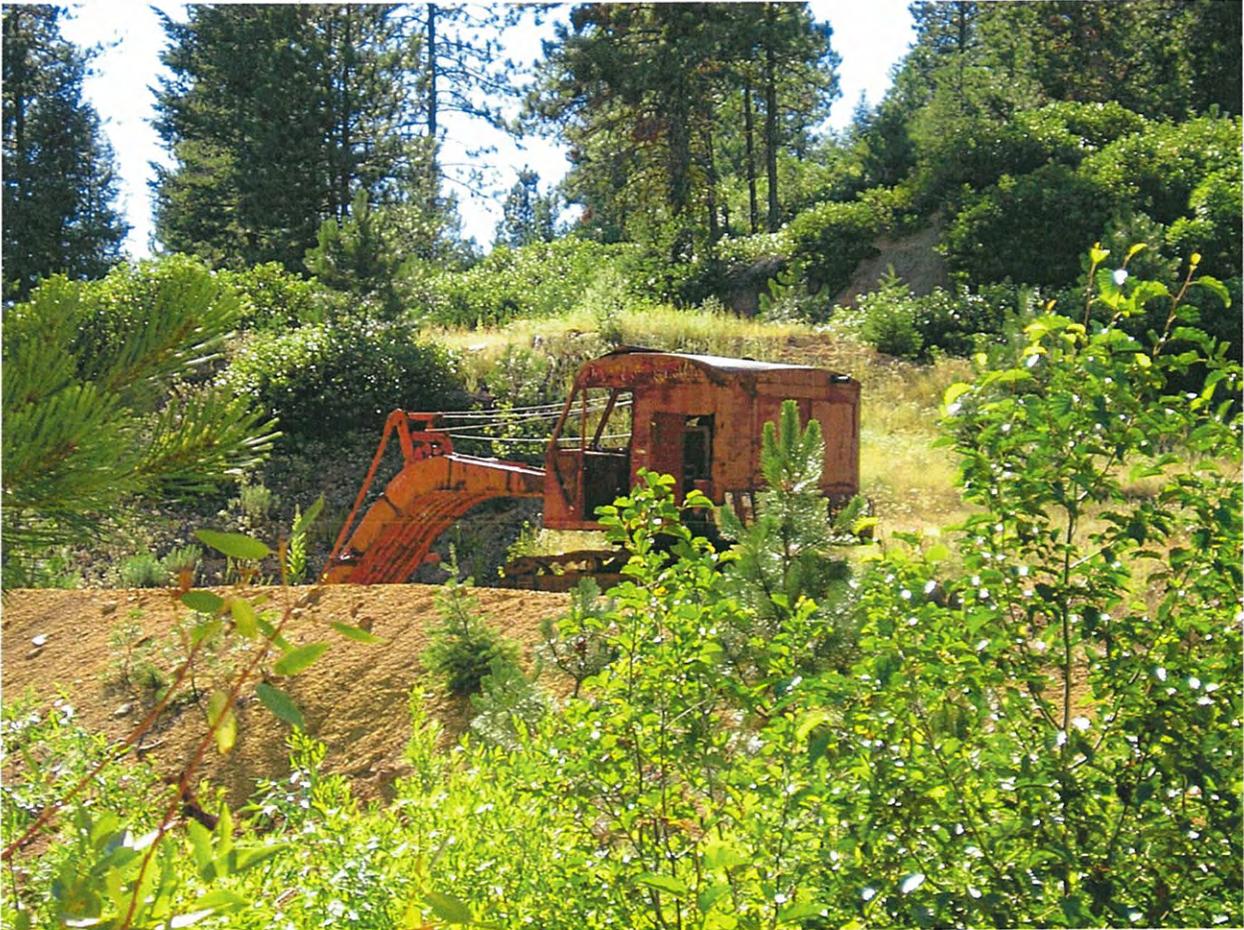
Photo 1

Abandoned machinery observed during the Quartzburg site visit. This machinery was located in between the Gold Hill Mine and the Iowa Mine along the main access road.

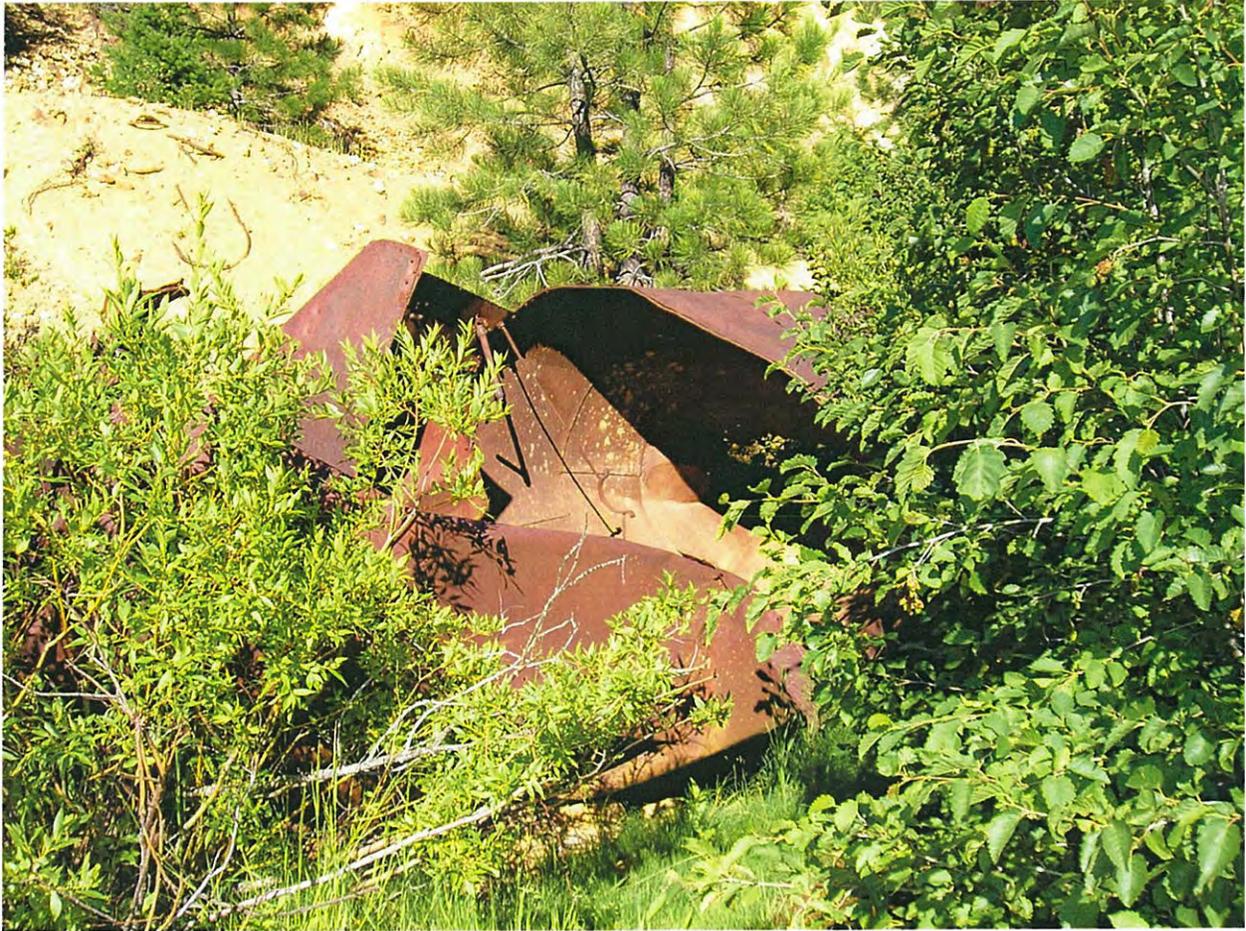
Photo 2

Scrap metal found at the bottom of the Gold Hill Mine. Appears to be the remnants of an old steamer.

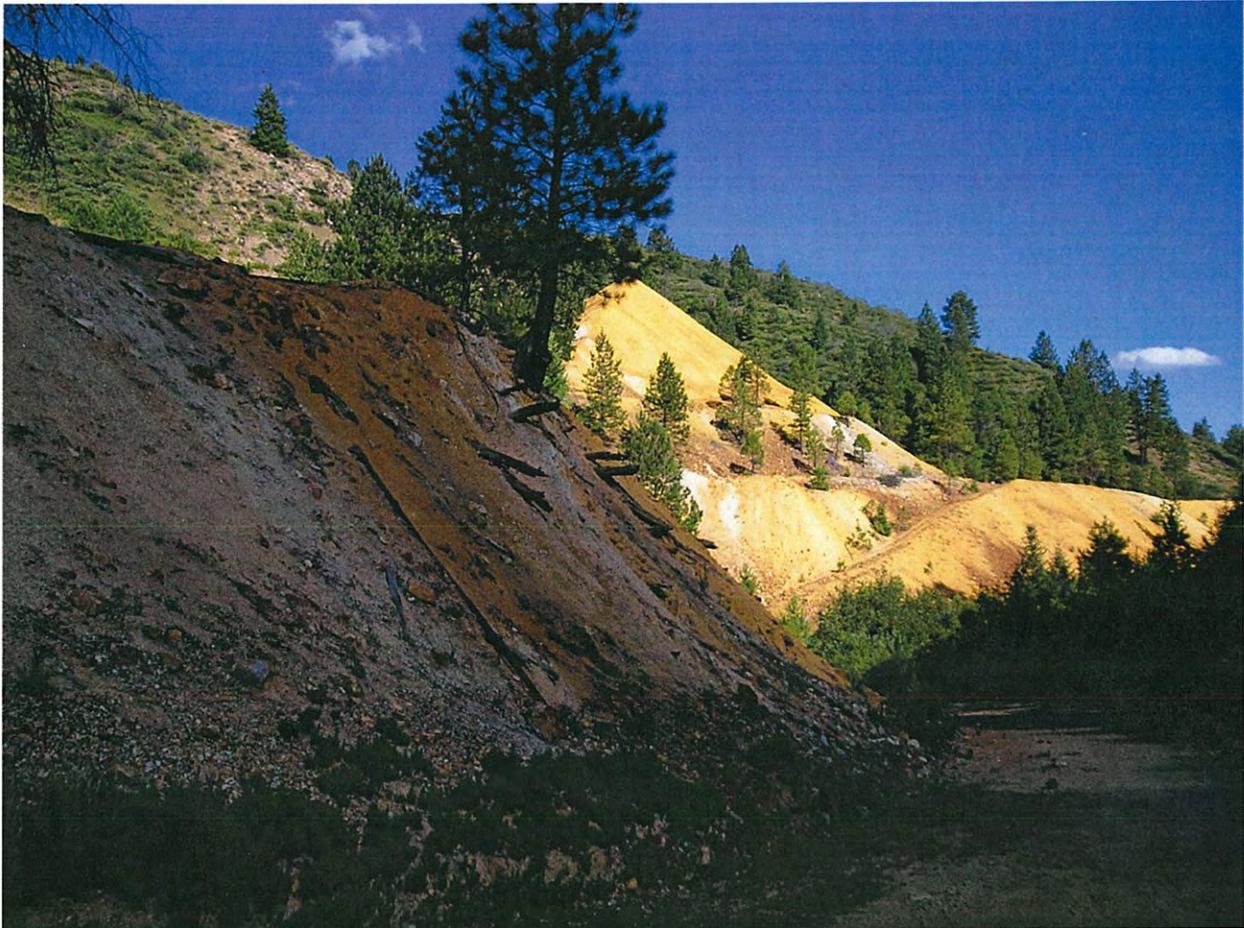
Photo #3

View looking southeast of Waste Pile #2 (distant) and the toe of Waste Pile #1 (close) at the Gold Hill Mine.

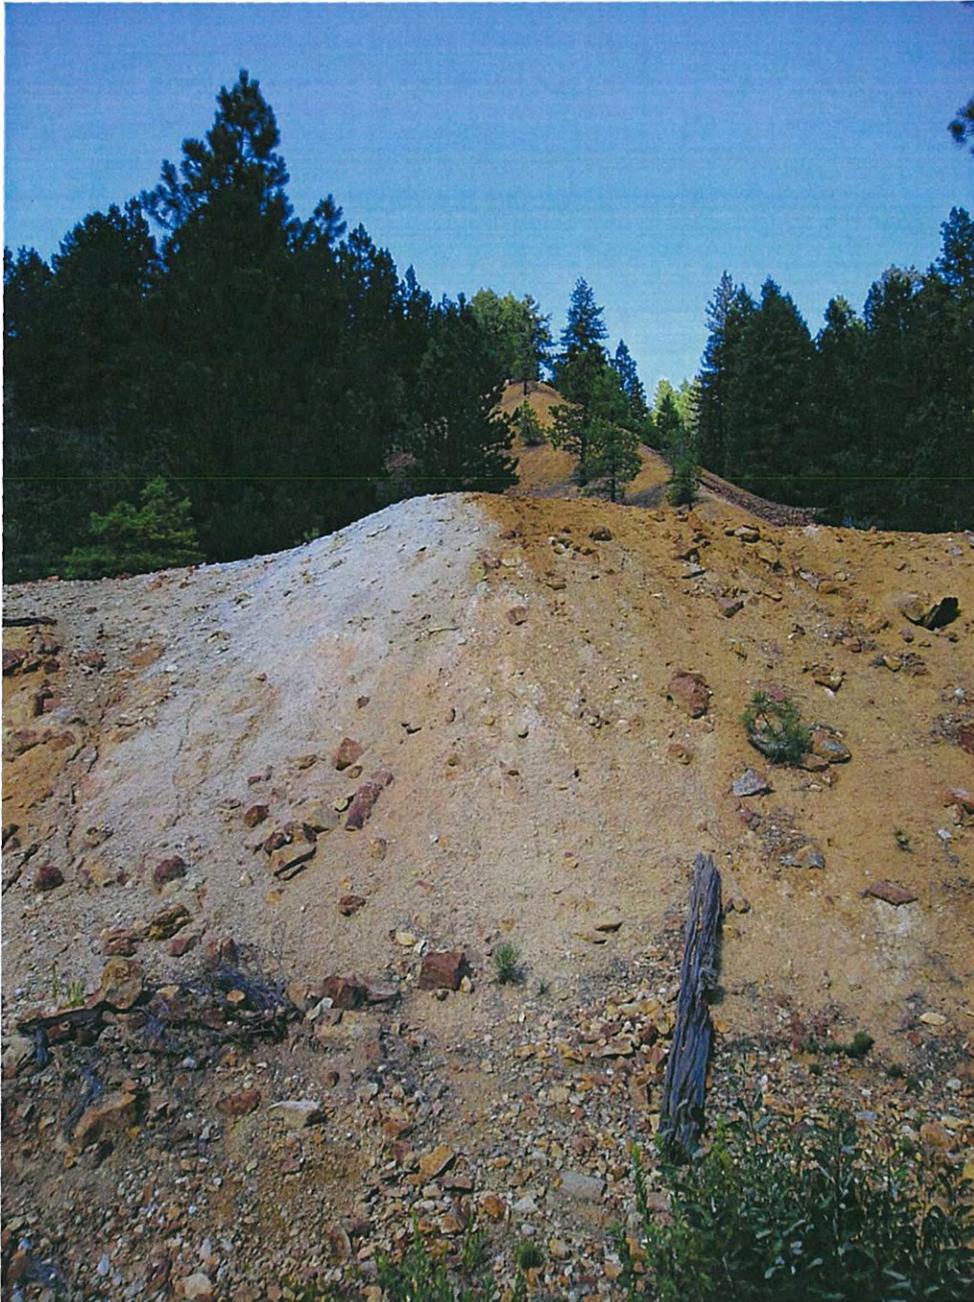
Photo #4

Waste Pile #1 has very little vegetation growing on it, and the few trees that are growing on the pile do not appear healthy (Pictures 4, 10 and 11). The material forming this waste pile had a reddish brown color and was uniform in grain size and distribution (Pictures 4, 10, and 11).

View looking up Waste Pile #1 at the Gold Hill Mine. Various bricks, wood debris, and metal scraps can be seen in the toe of the waste pile.

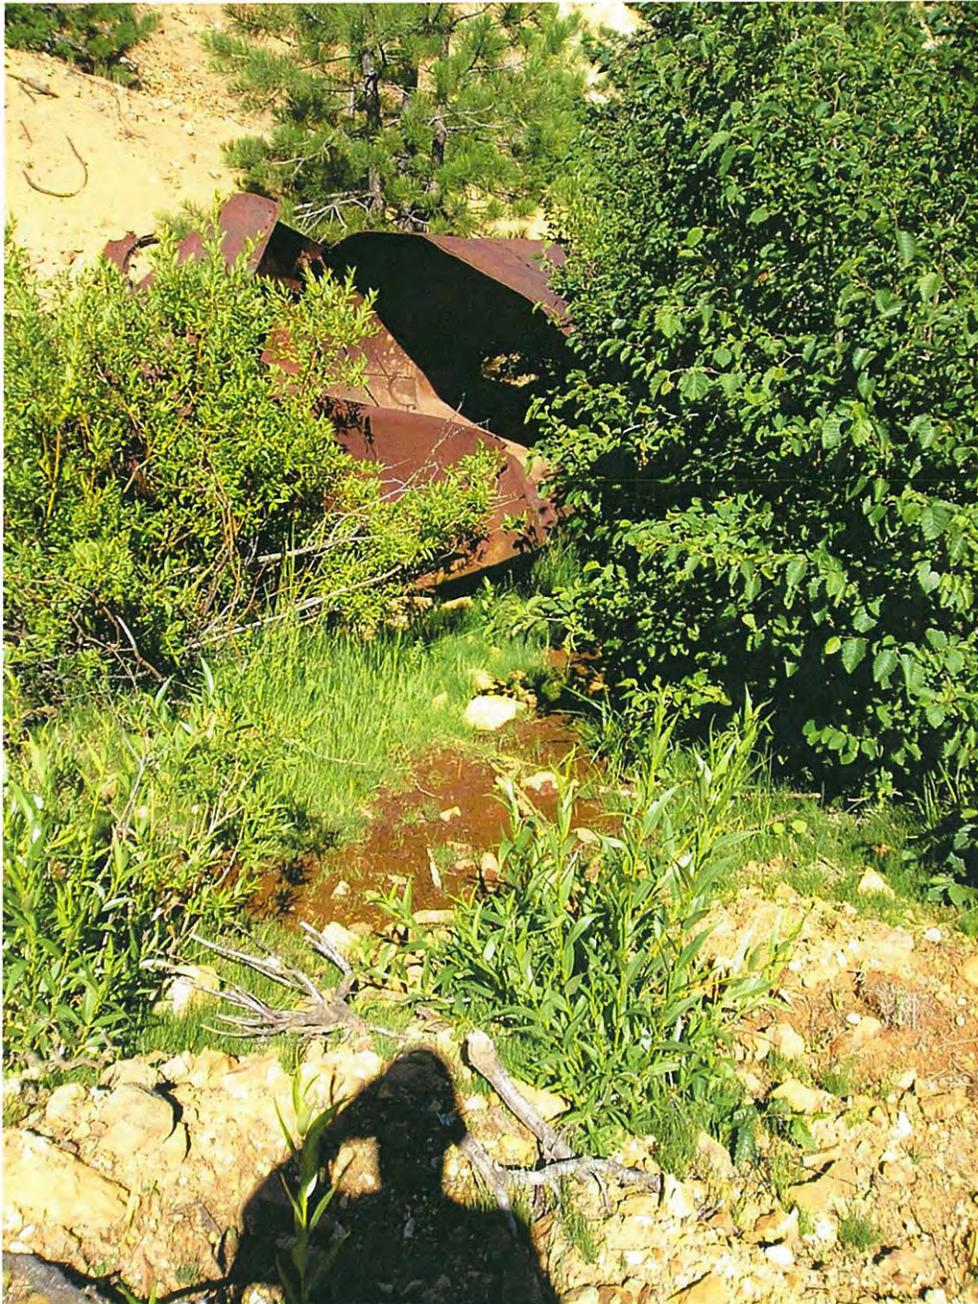
Photo #5

Ground water seeping from the toe of Waste Pile #1 at the Gold Hill Mine.

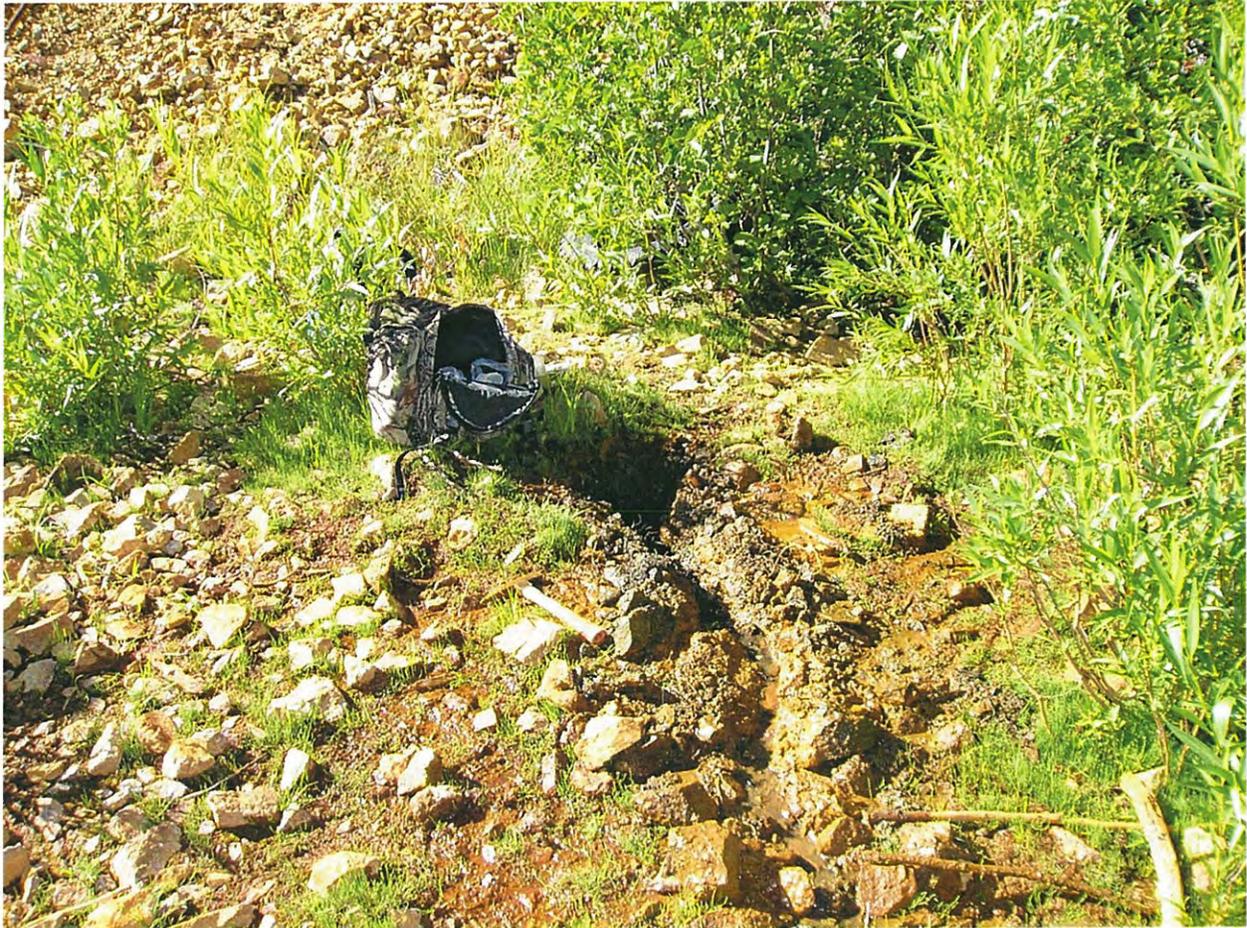
Photo #6

Water sample GH1 was collected at the toe of Waste Pile #1, as ground water seeped from the waste pile. No standing water was visible anywhere else on the waste pile or within the vicinity of the pile. No soil samples were collected directly on this waste pile.

Water sample (GH1) location. The toe of Waste Pile #1 of the Gold Hill Mine can be seen in the upper left corner of this photograph.

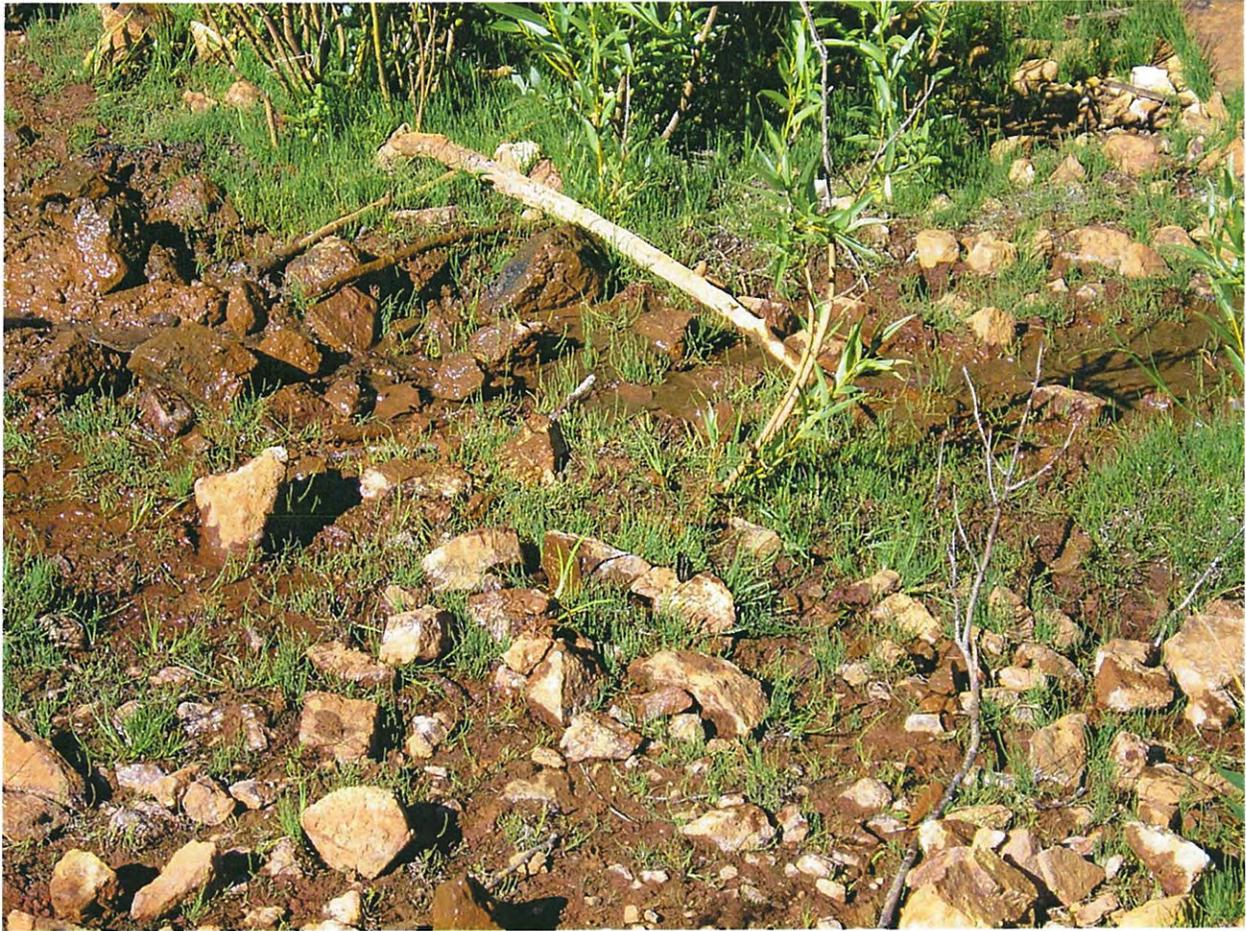
Photo #7

Another view of the ground water seepage coming from the toe of Waste Pile #1 at the Gold Hill Mine.

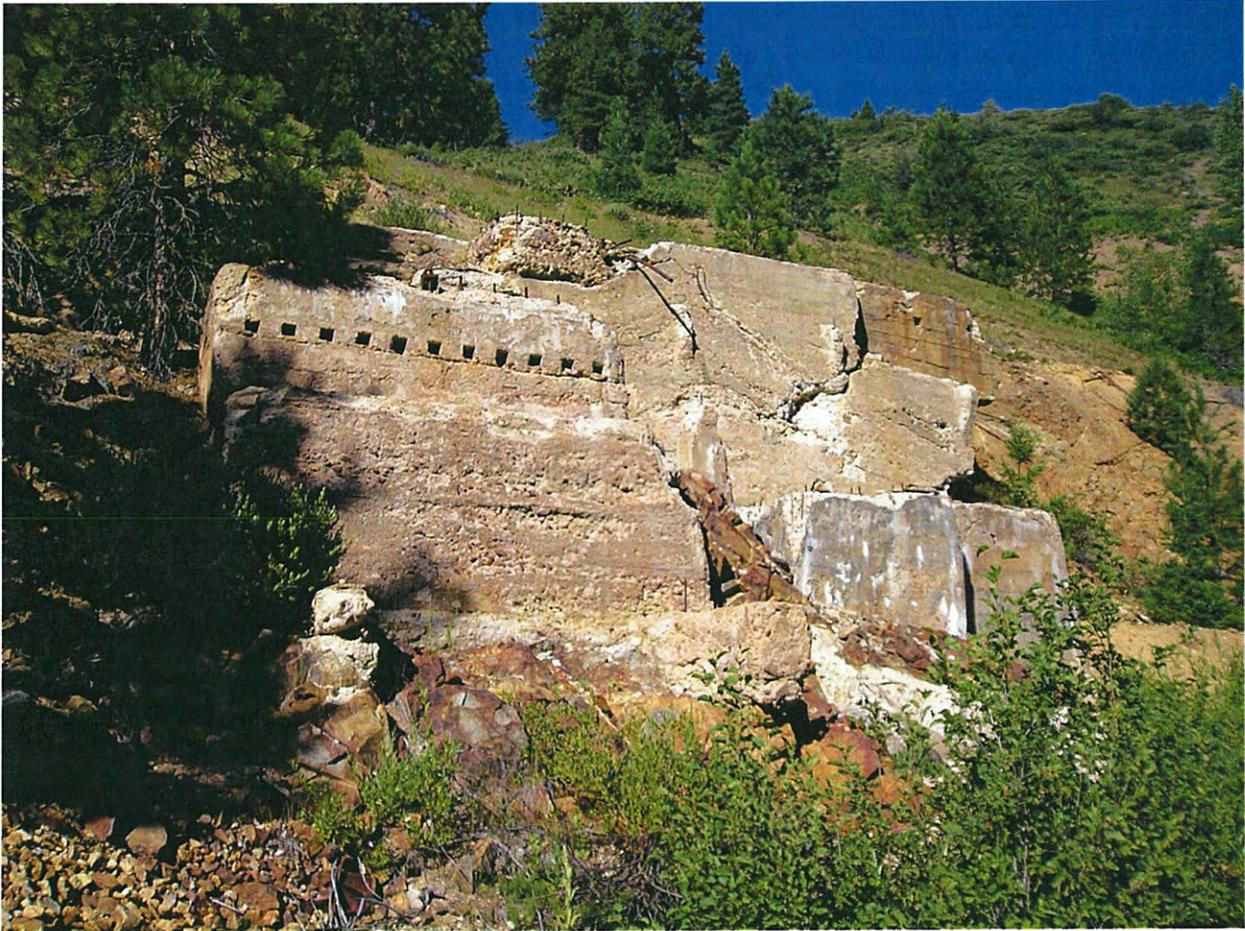
Photo #8

Remnants of an existing structure at the Gold Hill Mine. Waste Pile #1 borders this structure to the left of the photograph.

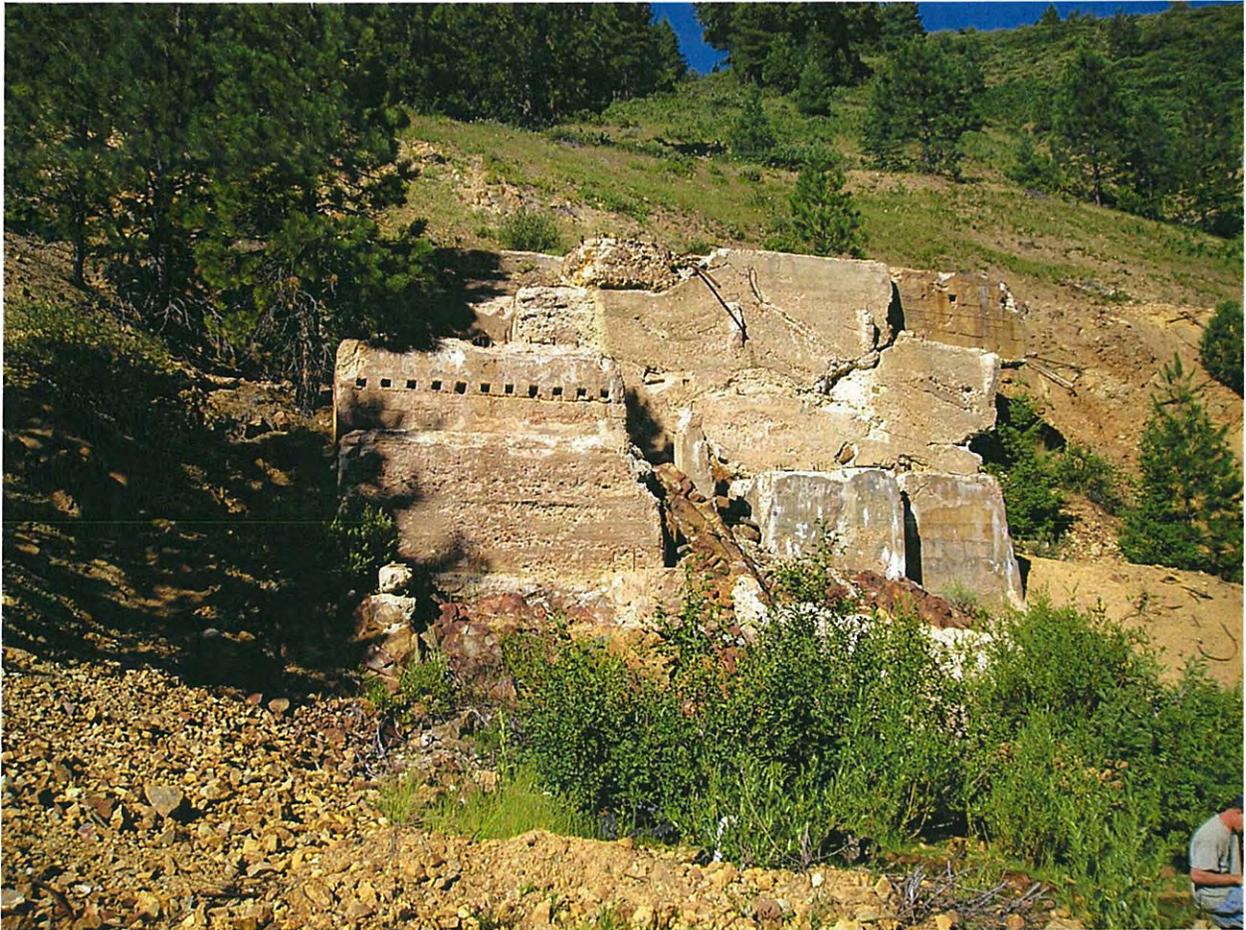
Photo #9

Another view of the foundation remnants of the structure at the Gold Hill Mine. The toe of Waste Pile #1 can be seen in the bottom left corner of this photograph.

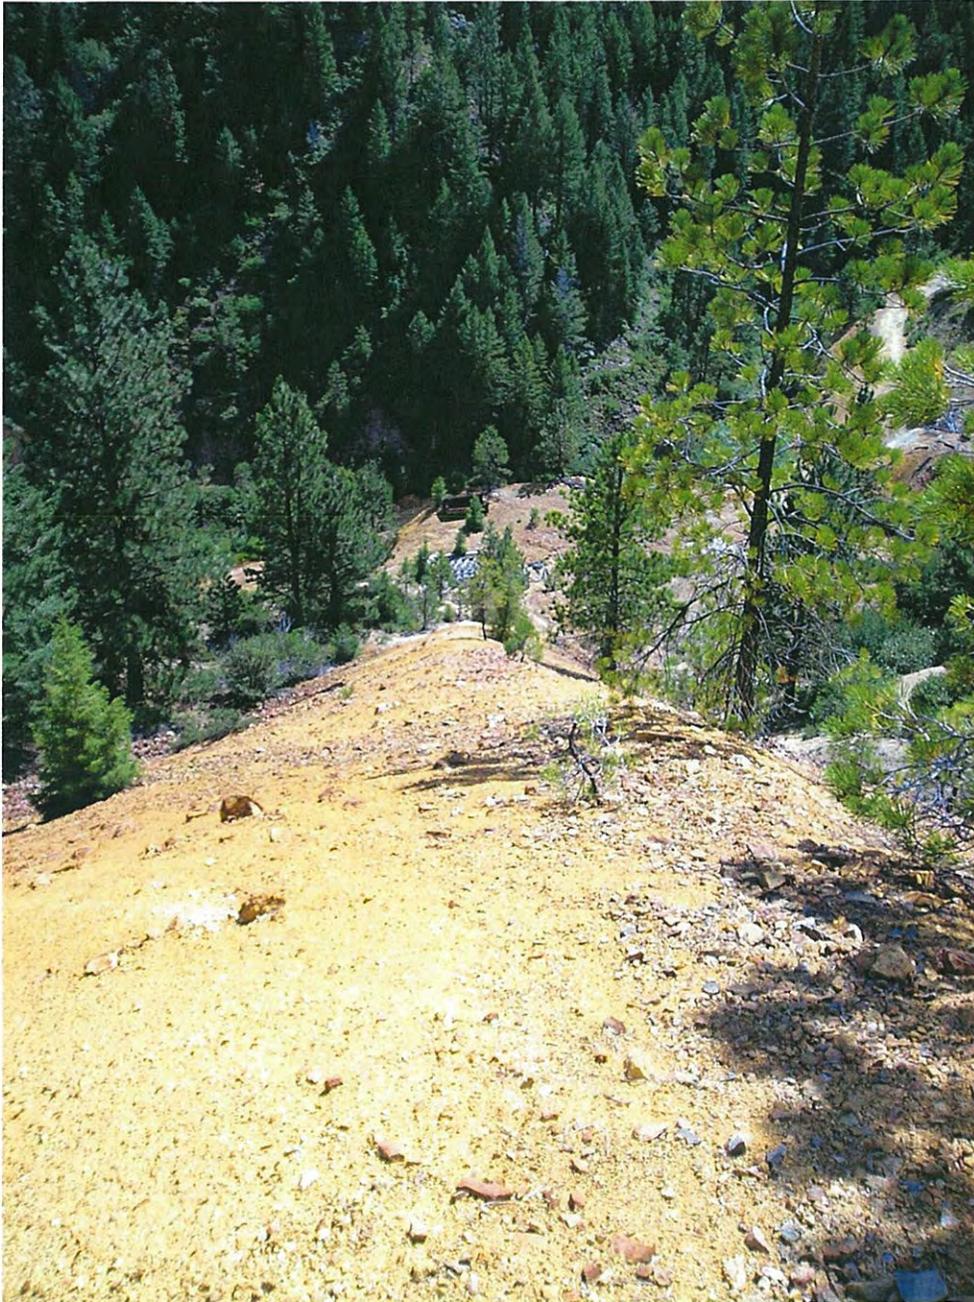
Photo #10

View looking down (west) Waste Pile #1 at the Gold Hill Mine.

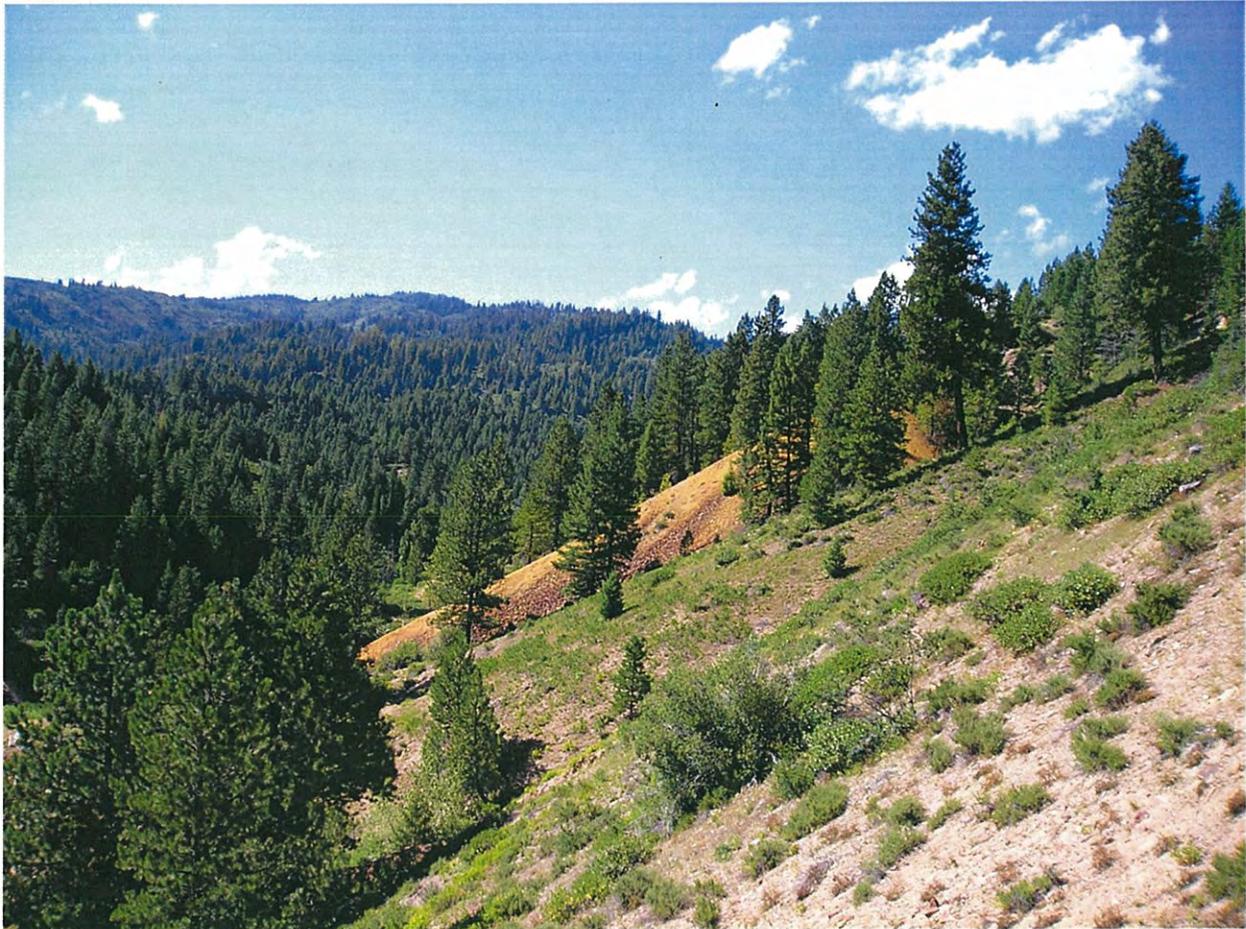
Photo #11

View looking north at Waste Pile #1 from the top of Waste Pile #2 at the Gold Hill Mine.

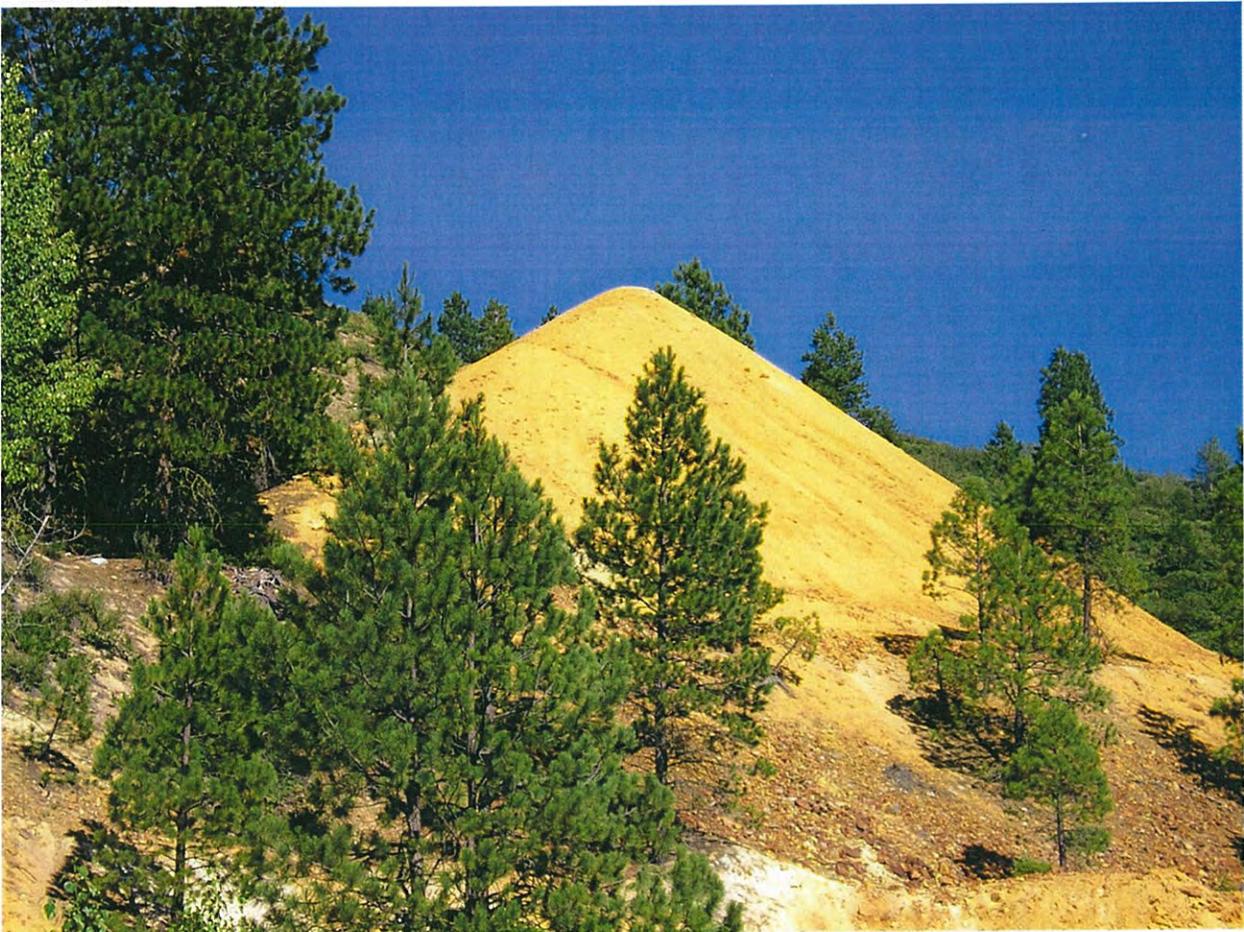
Photo #12

View looking south at Waste Pile #2 from the top of Waste Pile #1 at the Gold Hill Mine.

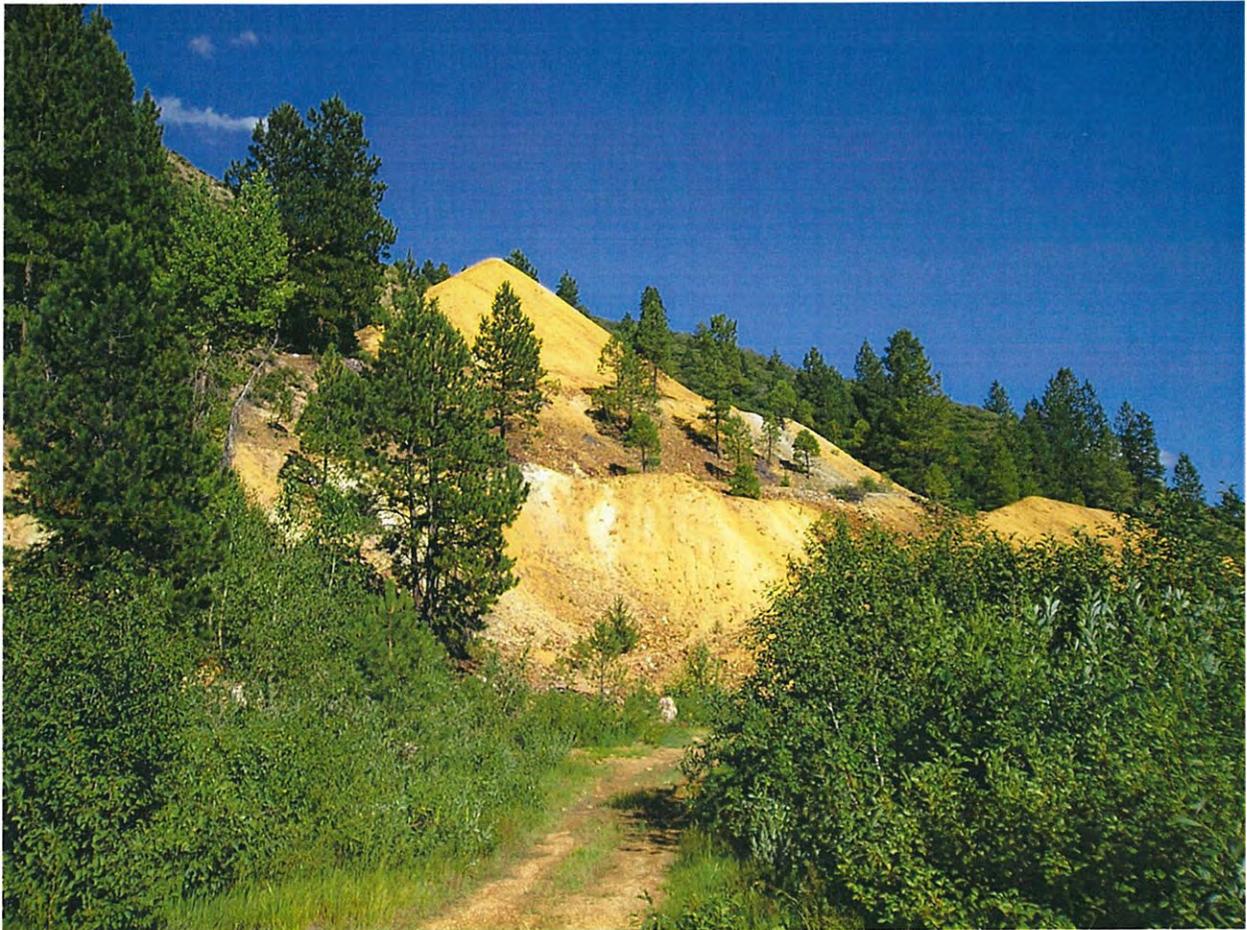
Photo #13

View looking southwest from the main access road showing the extent of Waste Pile #2.

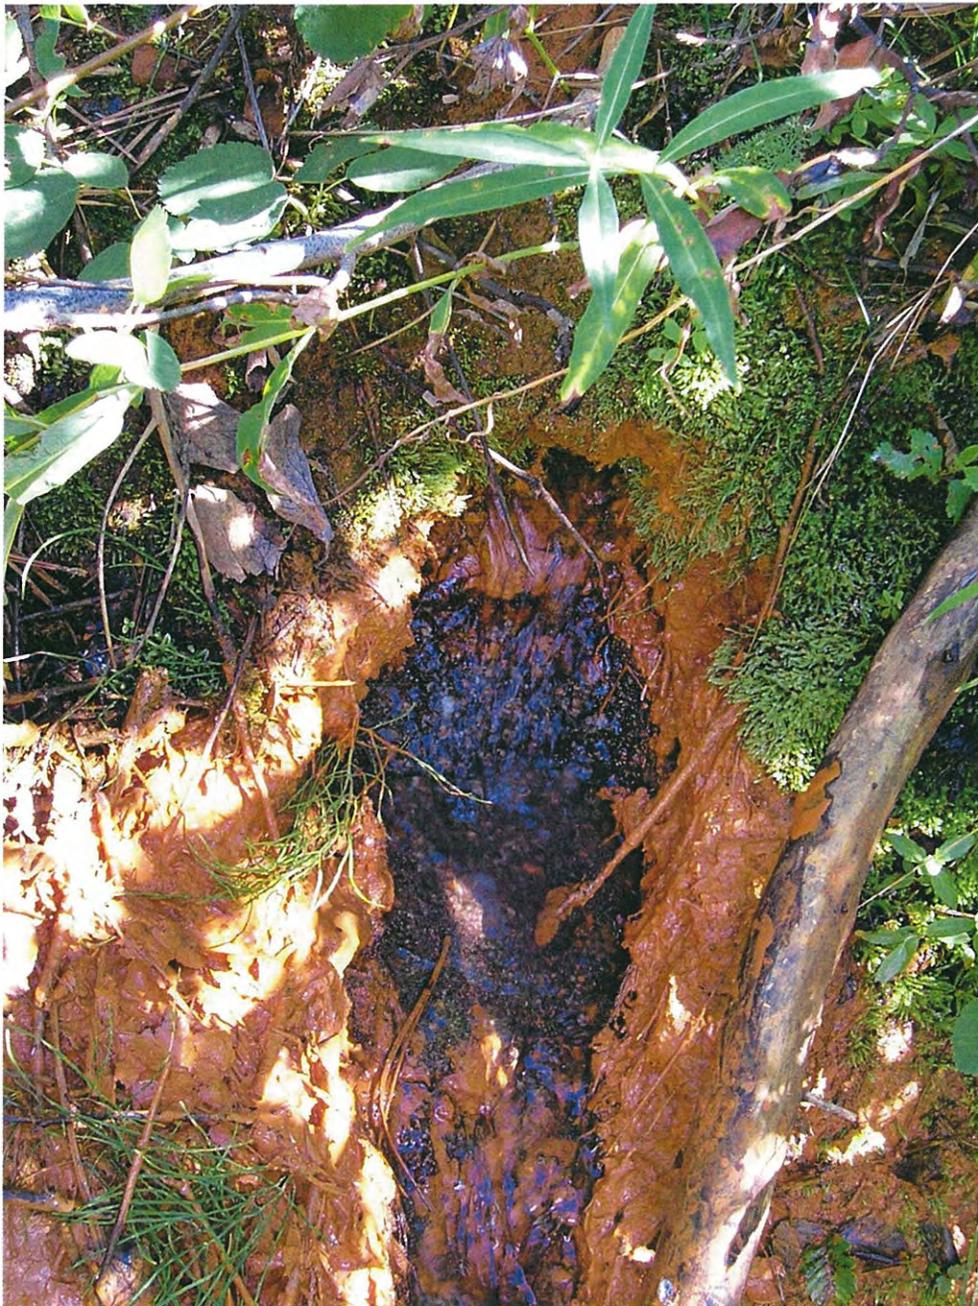
Photo #14

Ground water was observed seeping from the abandoned adit of the Iowa Mine (Pictures 14 and 15). Water sample IA1 was collected at this point (Figure 2-2). The ground water discharged along the access road where it flowed to the west towards Granite Creek. In between the discharge point and Granite Creek, a marshy wetland that resembled a previous tailing pond collected water before it continued to flow into Granite Creek. Water samples were collected upgradient from the spring (Sample #IA2) and downgradient of the retention pond (Sample #IA3).

Sampling location for sample IA1. This ground water is seeping from the buried adit for the Iowa Mine.

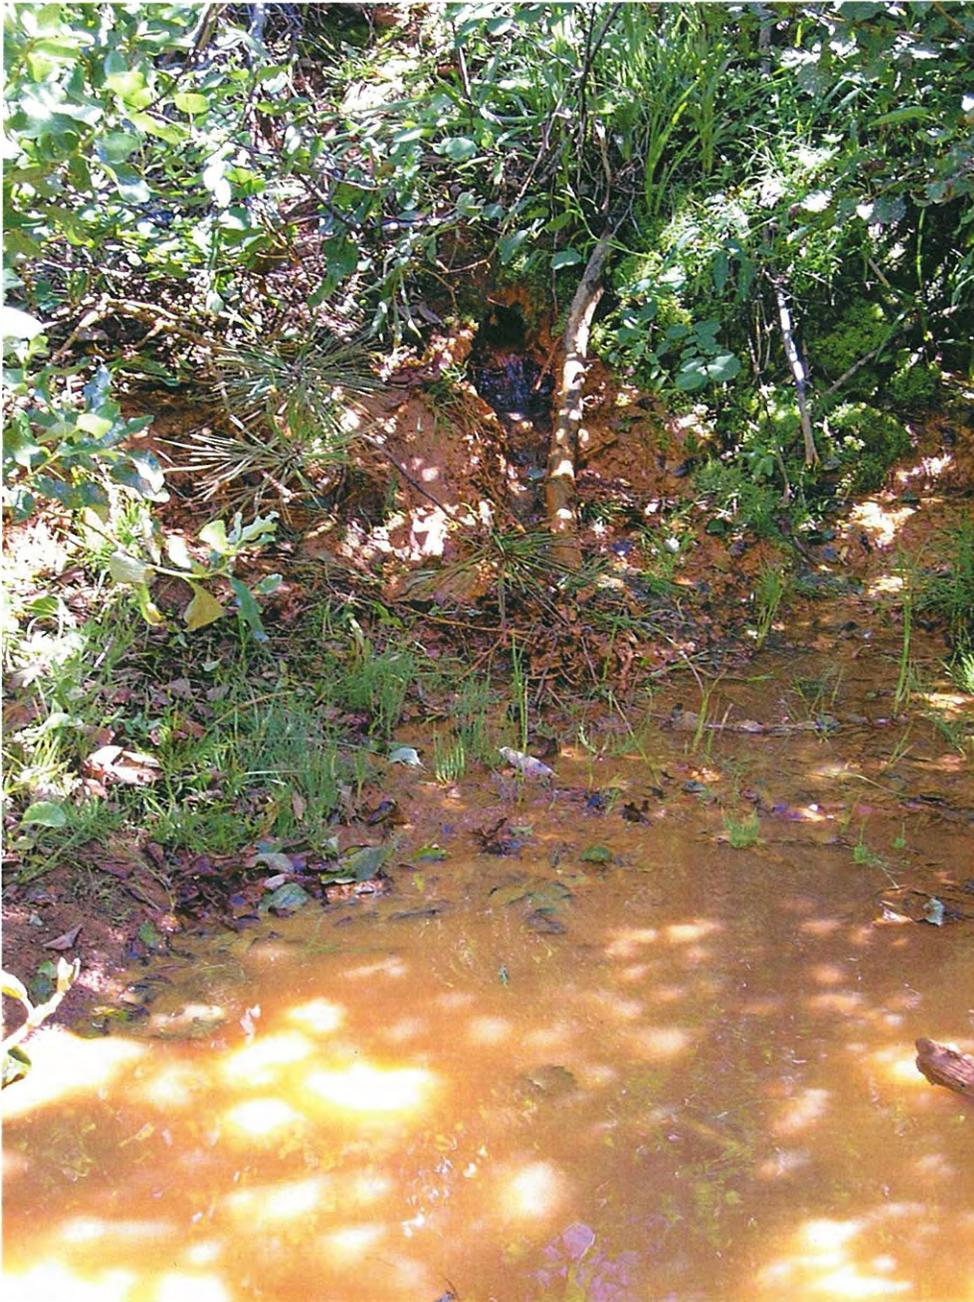
Photo #15

Another view of sampling location for sample IA1 from the Iowa adit.

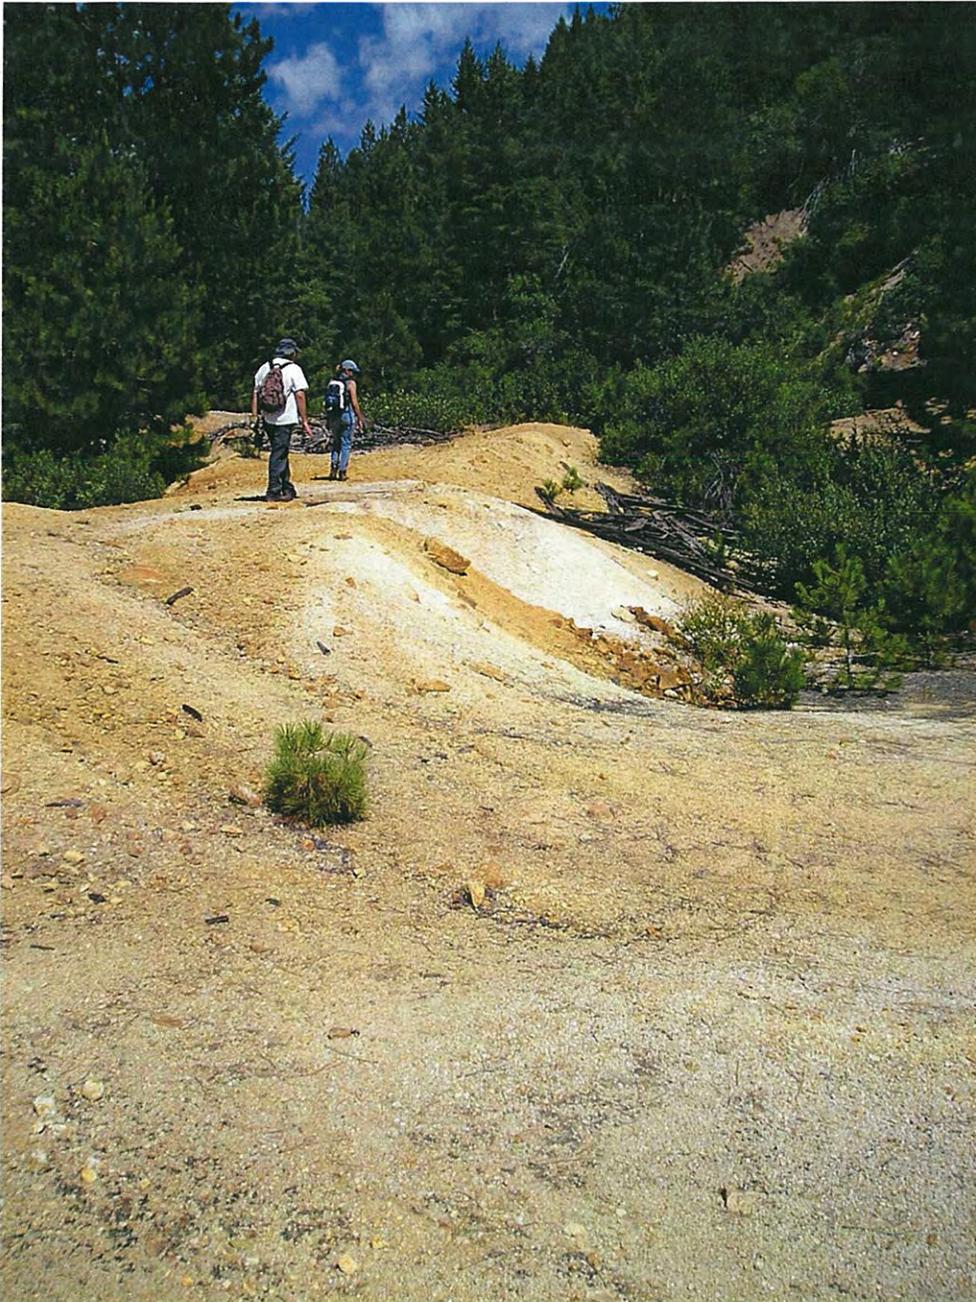
Photo #16

Iowa Mine waste dump. View looking west from the toe of the waste dump.

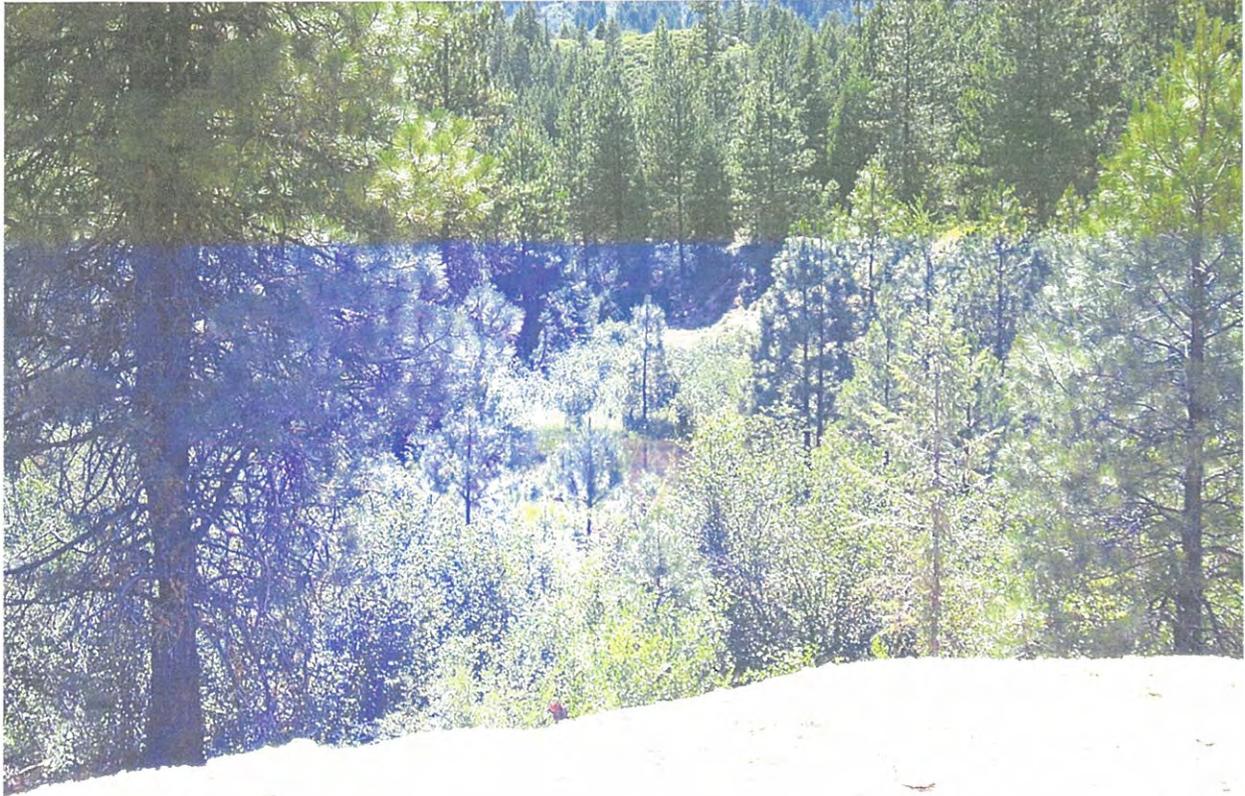
Photo #17

View looking east to a marshy area just east of the Iowa waste dump. Standing water was present in an old man-made pond.

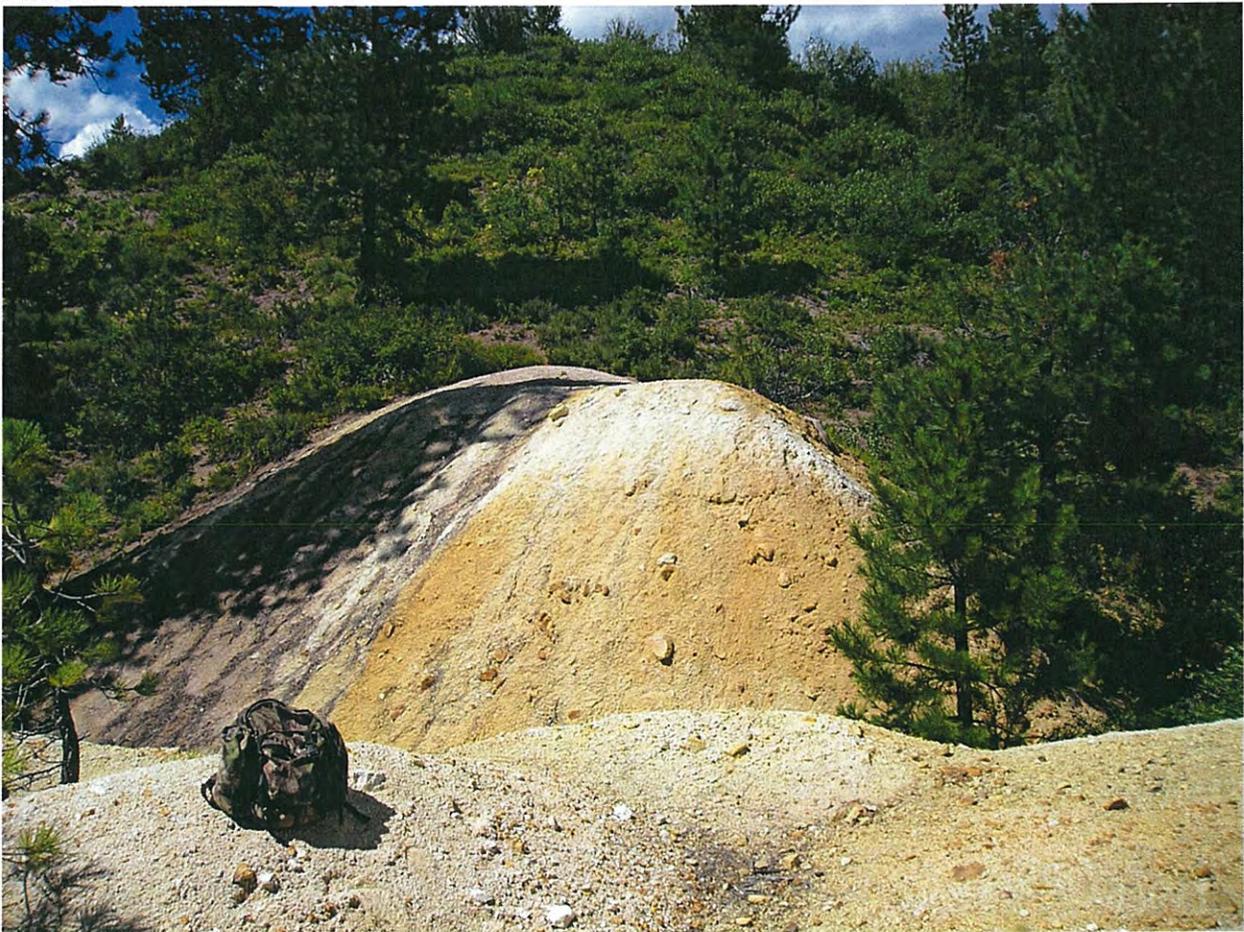
Photo #18

View looking north on the Iowa Waste dump. Several of these piles of waste rock created the present waste dump.
