QUARTZBURG  
PRELIMINARY ASSESSMENT REPORT  
BOISE COUNTY, IDAHO

**STATE OF IDAHO**  
**DEPARTMENT OF ENVIRONMENTAL QUALITY**

September 2004

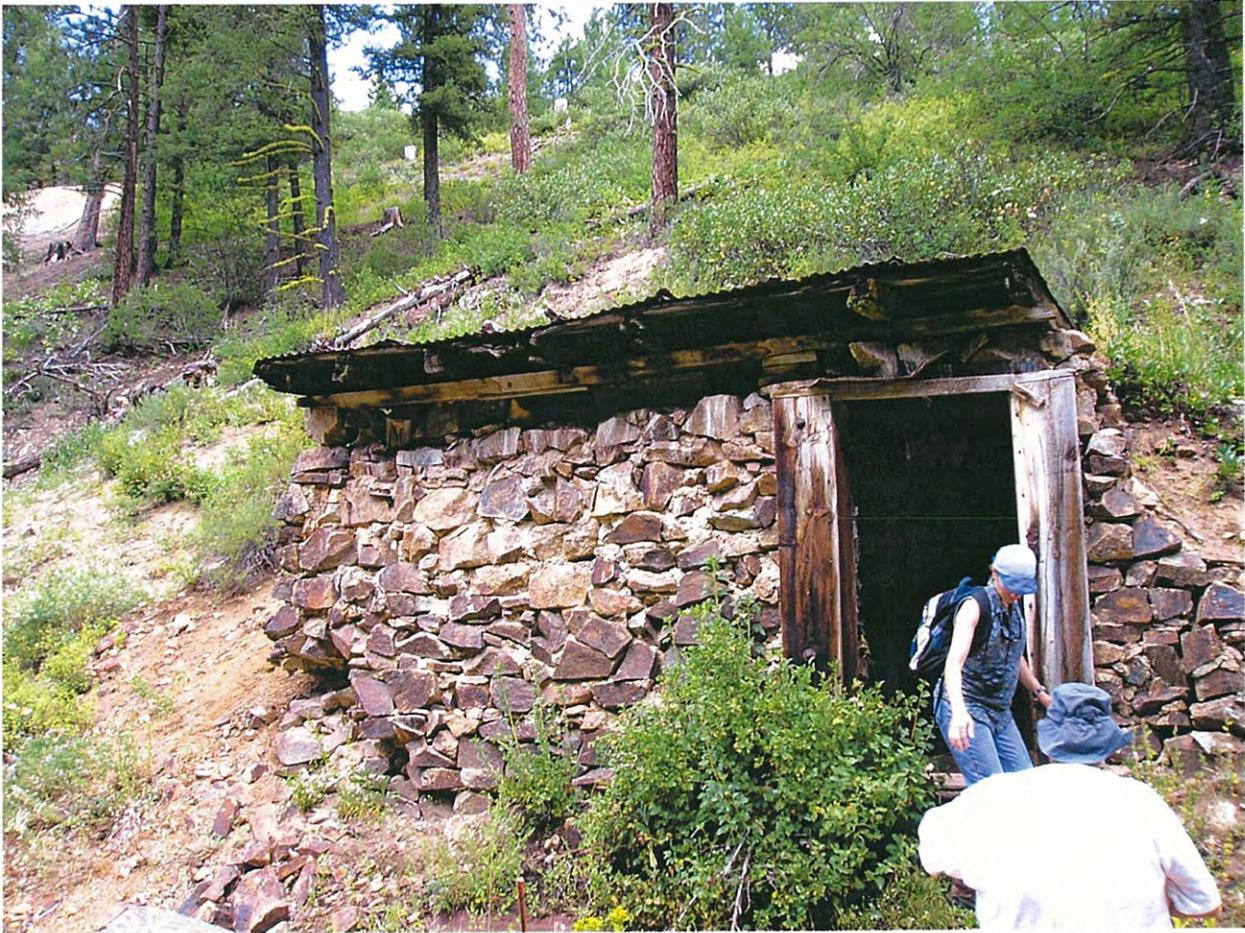
Photo #19

Existing structure observed during the Quartzburg site visit. This structure was located just north of the two mines visited during the inspection.
