Alder Creek Mining District Preliminary Assessment and Site Investigation

Idaho Department of Environmental Quality

December 2005

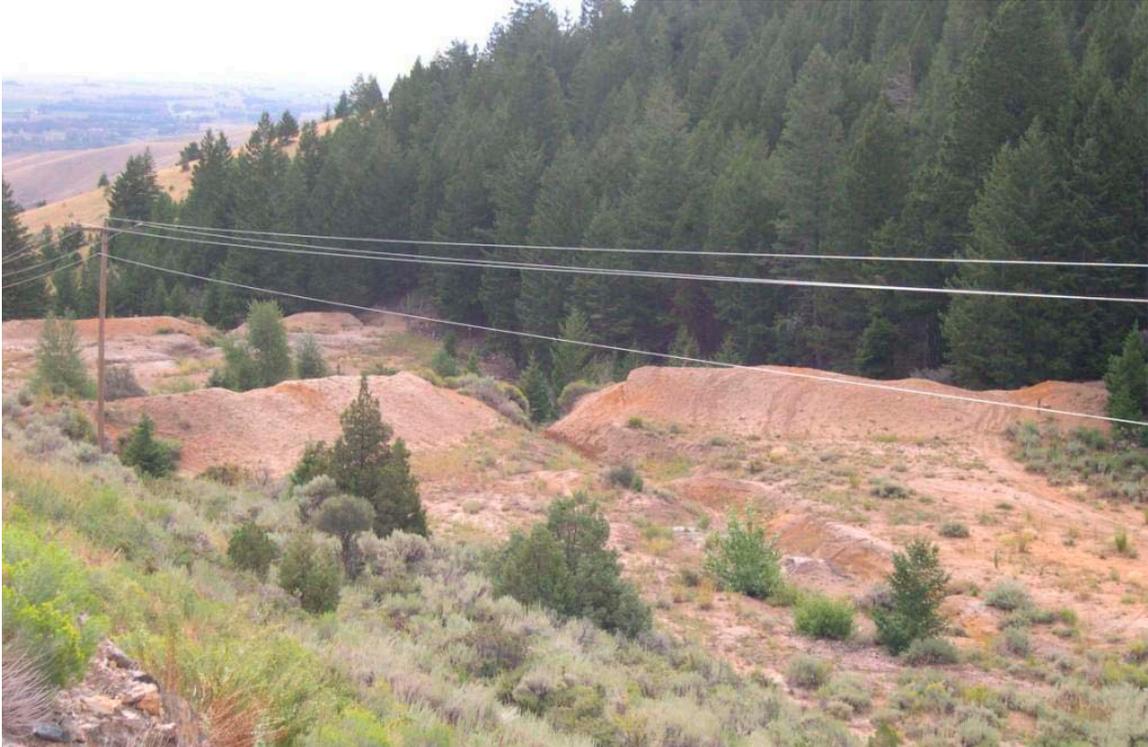
Photo 7. Tailing dams and fluvial morphology from the Rio Grande Canyons' ephemeral channel. This photo was taken from the P4 (see figure 7) location, facing east.

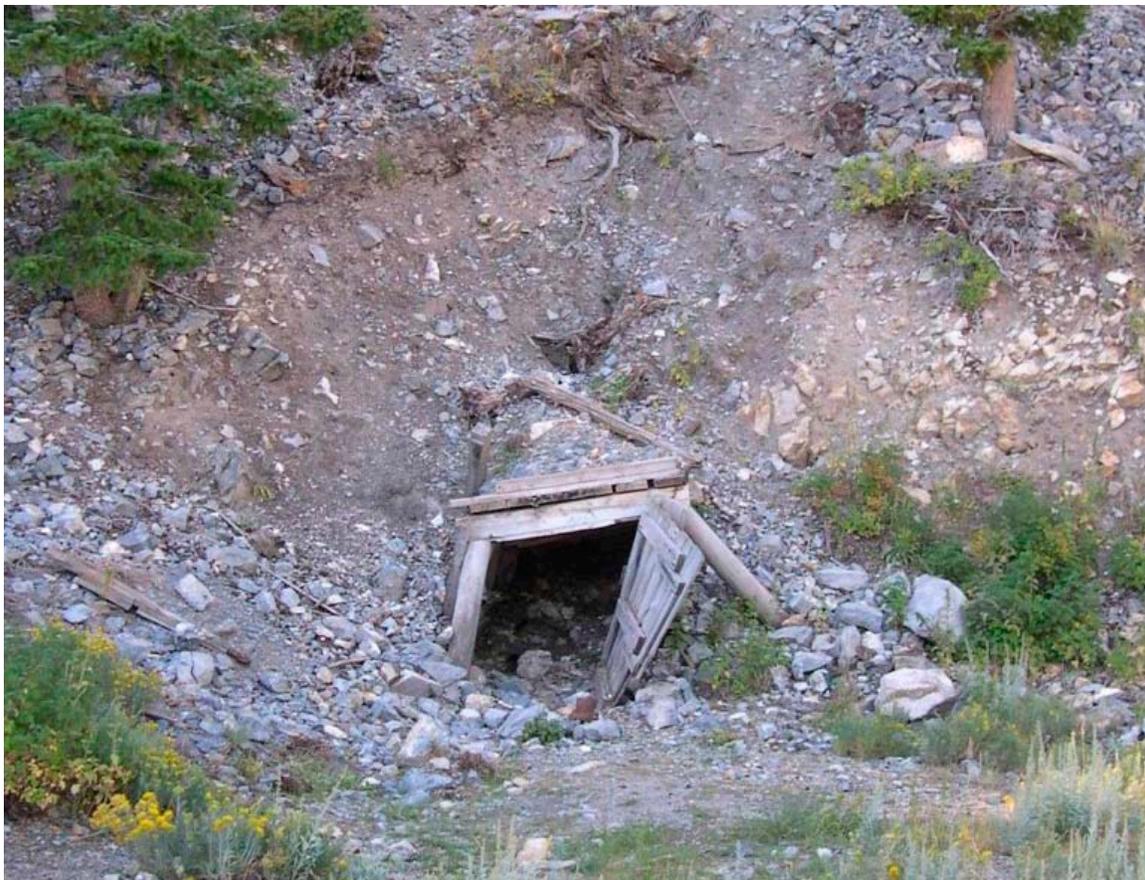
Photo 14. Main Alberta adit, collapsed beyond the portal.

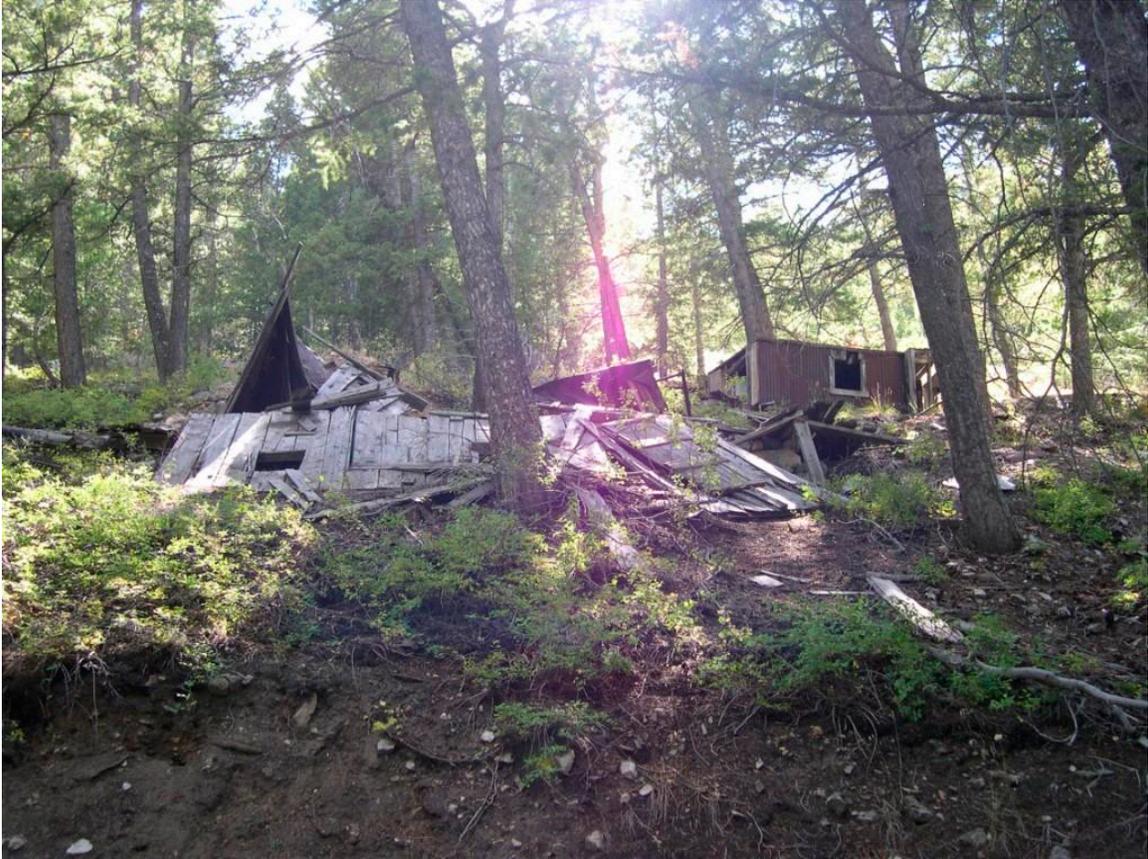
Photo 17. Collapsed structures between Alberta and the Headhouse.

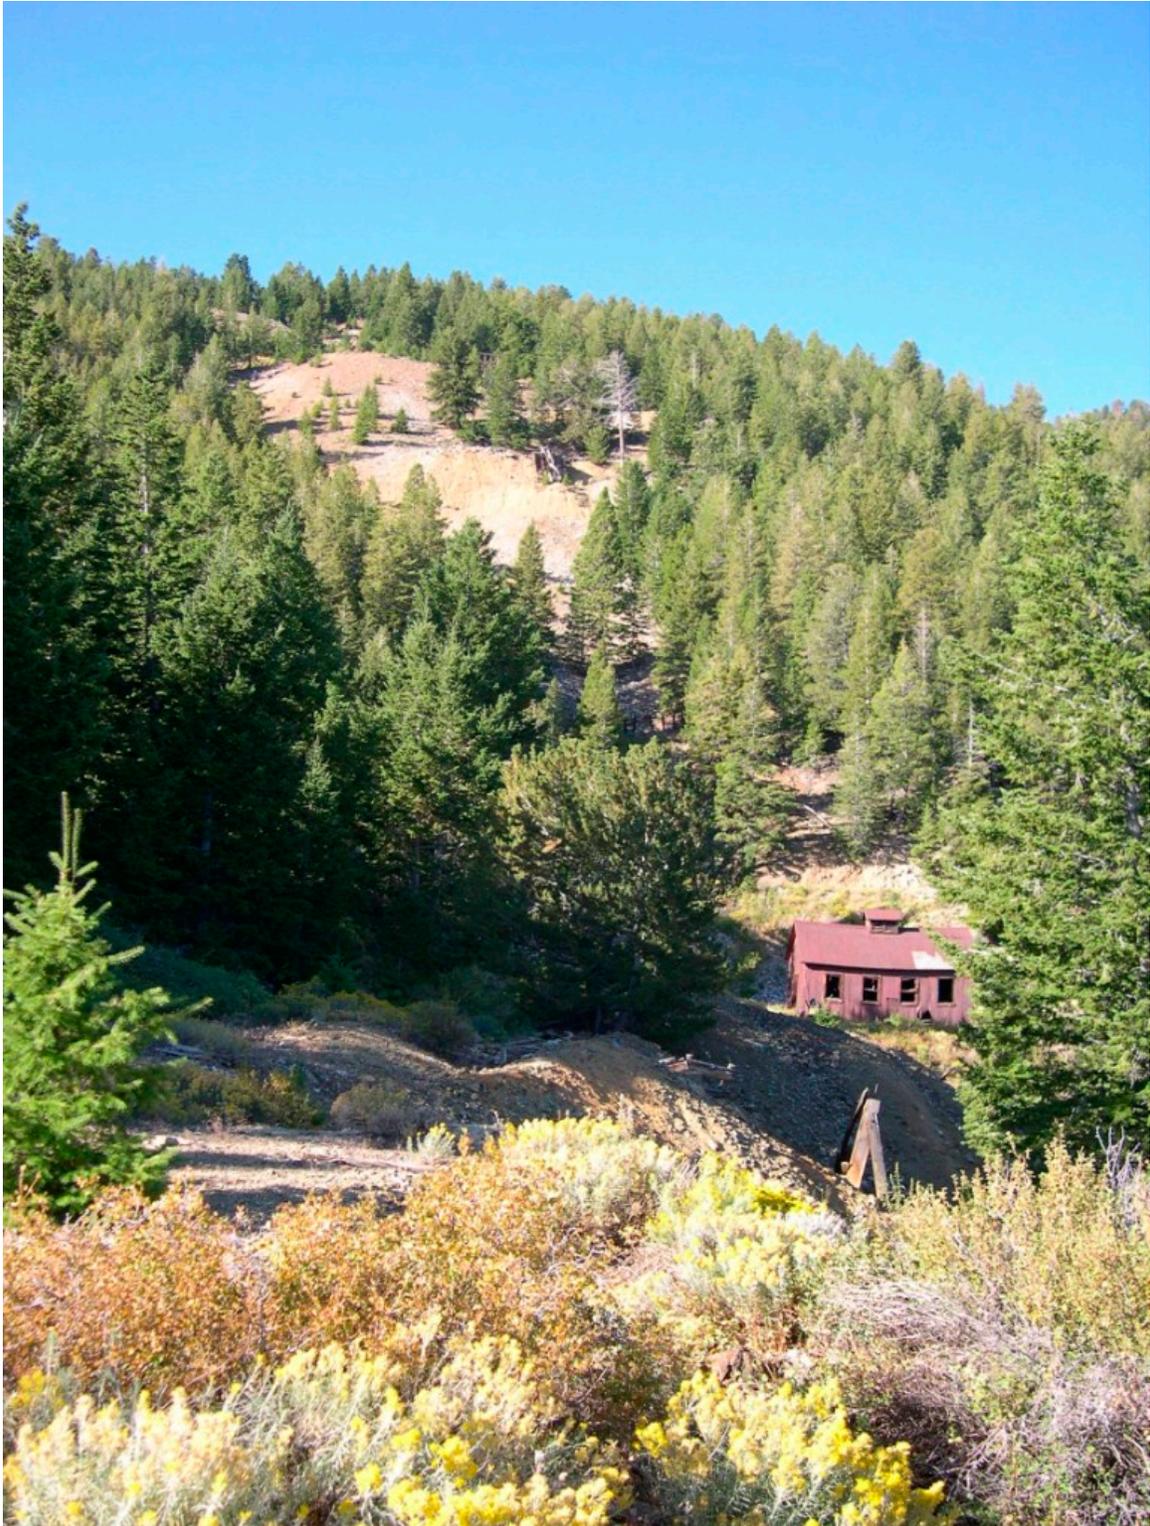
Photo 18. Photo taken from the P2 location (see Figure 11), facing southwest. Waste rock on the hillside above Alberta is from the North Tunnel and the 300 level.

construction activities dispersed much of the waste rock from these workings, it is estimated the waste rock encompasses approximately 10,000 cubic yards over 1.5 acres on the hillside above the Alberta level.

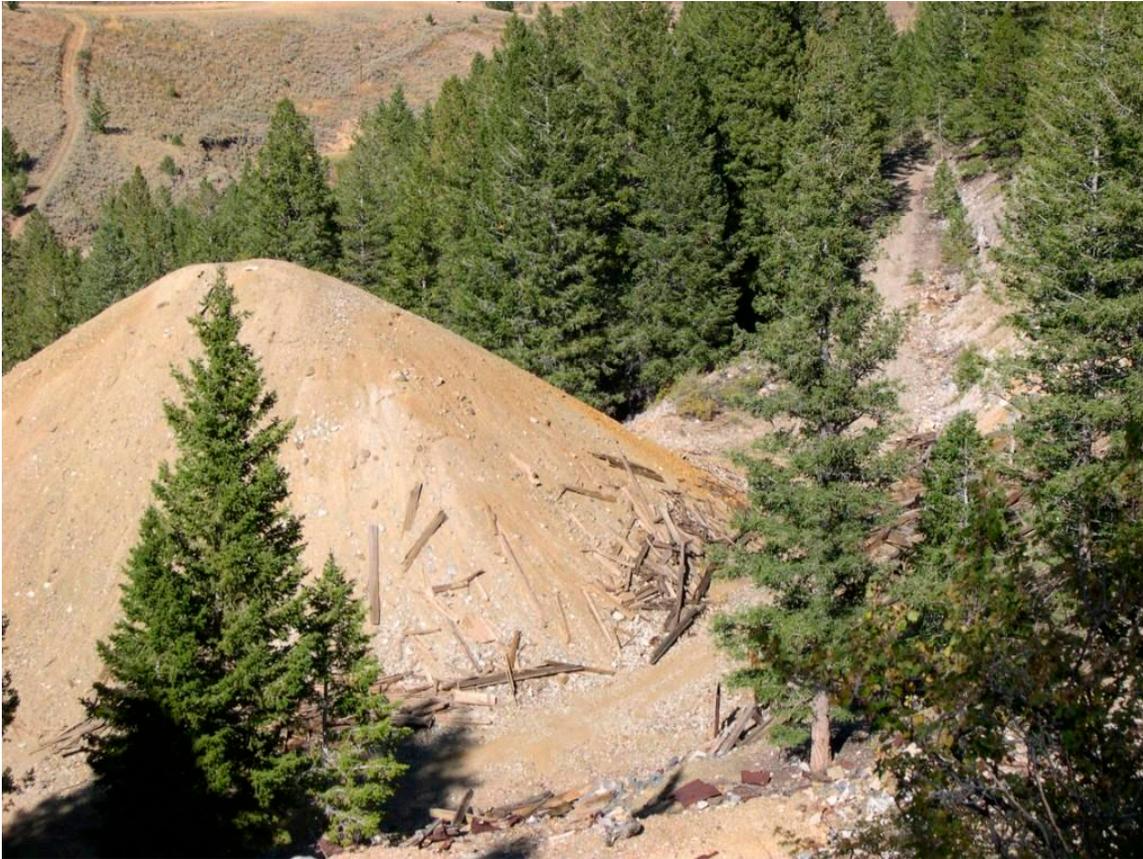
Photo 20. Photo taken from P2 location (see Figure 9), looking northwest at the lower waste rock pile and the collapsed ore bin.

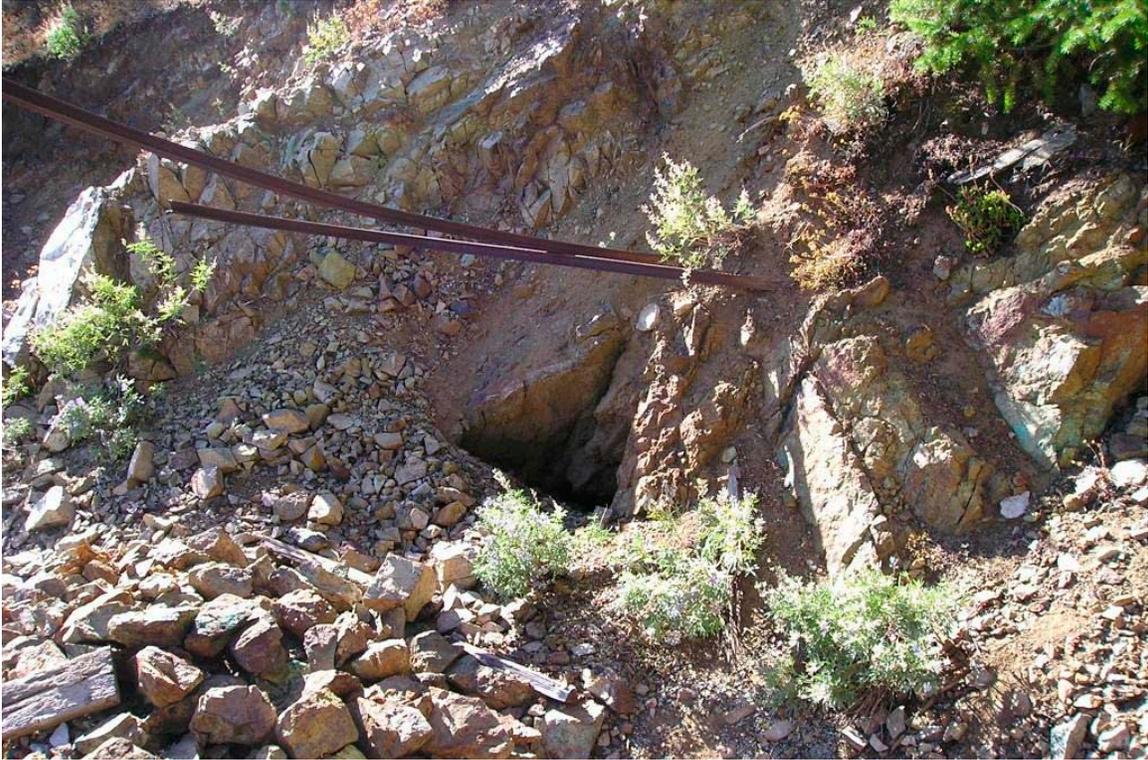
Photo 23. Air shaft with waste rock surround the area at the P5 location (see Figure 11). The black pipes coming out of the shaft are presumed to be circulation lines.

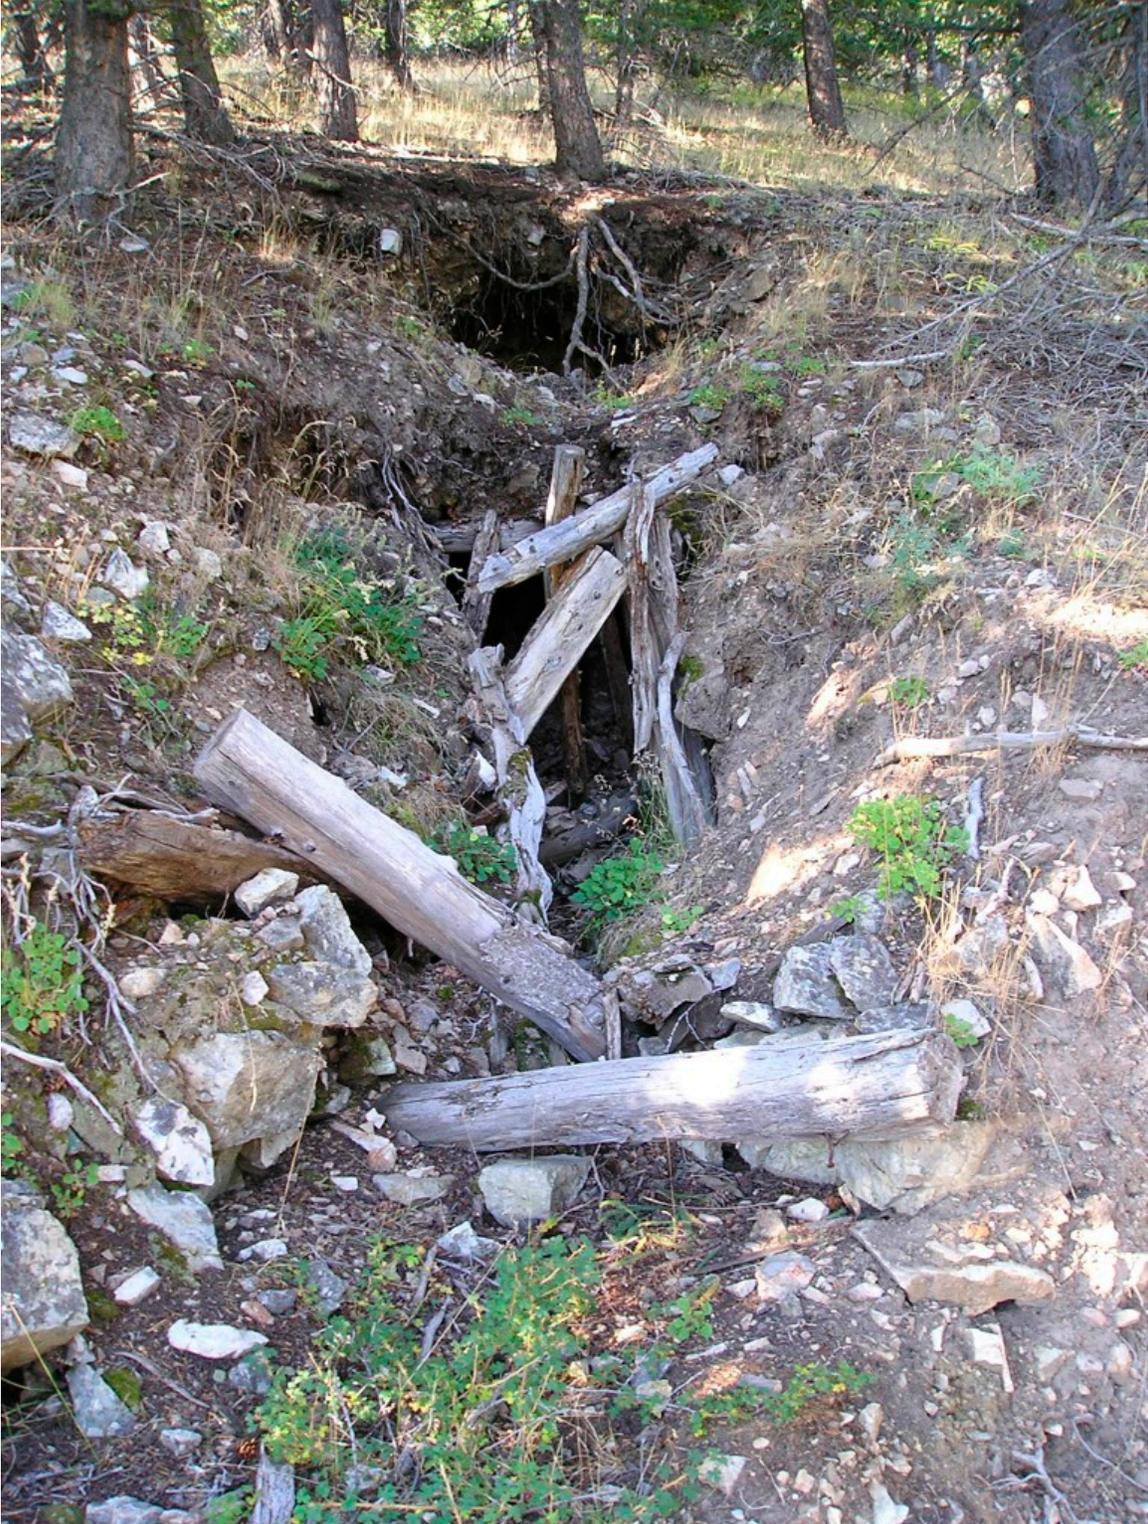
Photo 25. Collapsed shaft and/or adit at the P7 location (see figure 11).

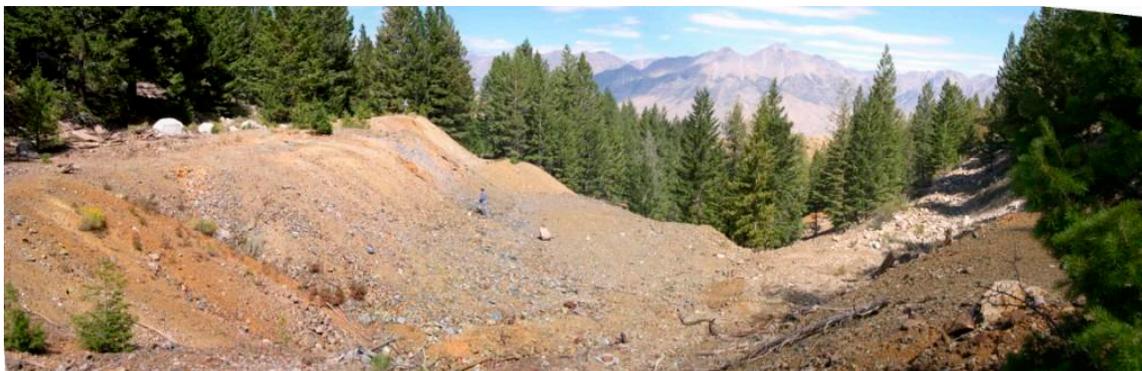
Photo 33. Waste rock piles located below the lower Bullion Adit. This panoramic photo was taken from the road facing north.

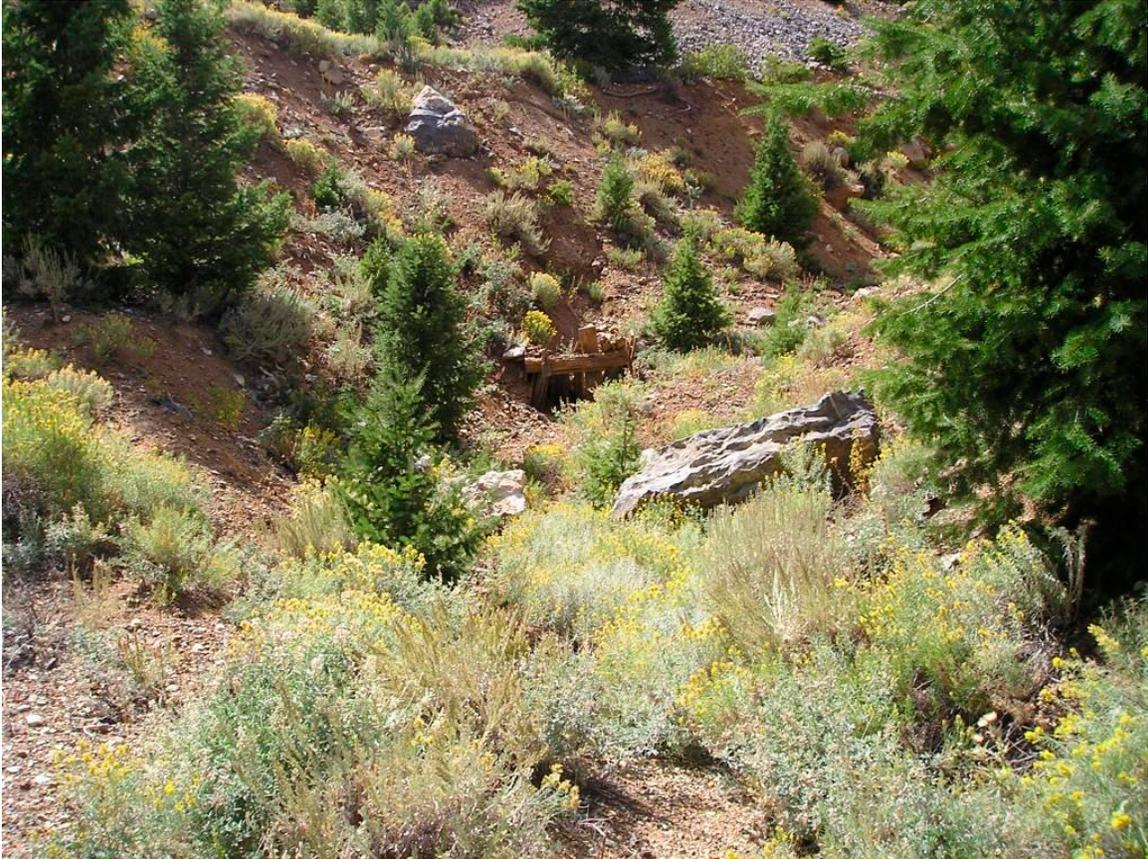
Photo 36. Photo of collapsed adit taken at the P3 location (see Figure 15).

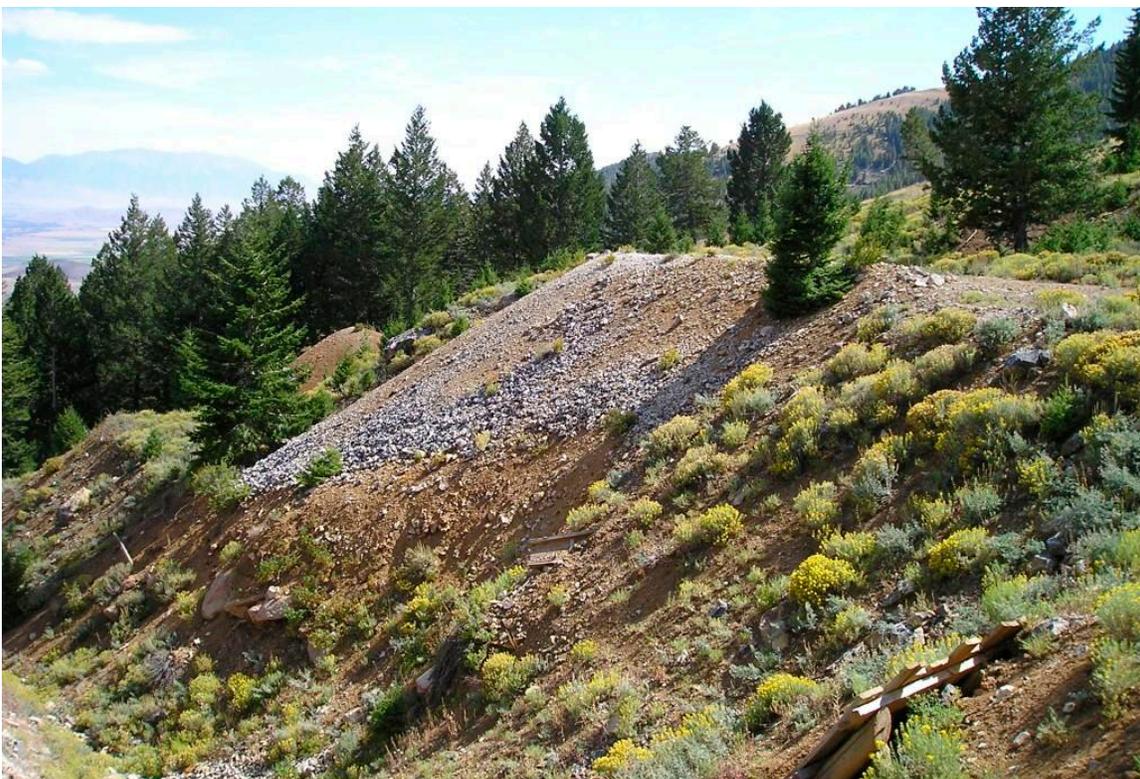
Photo 37. Photo taken at the P4 location facing north looking at the waste rock pile (see Figure 15).

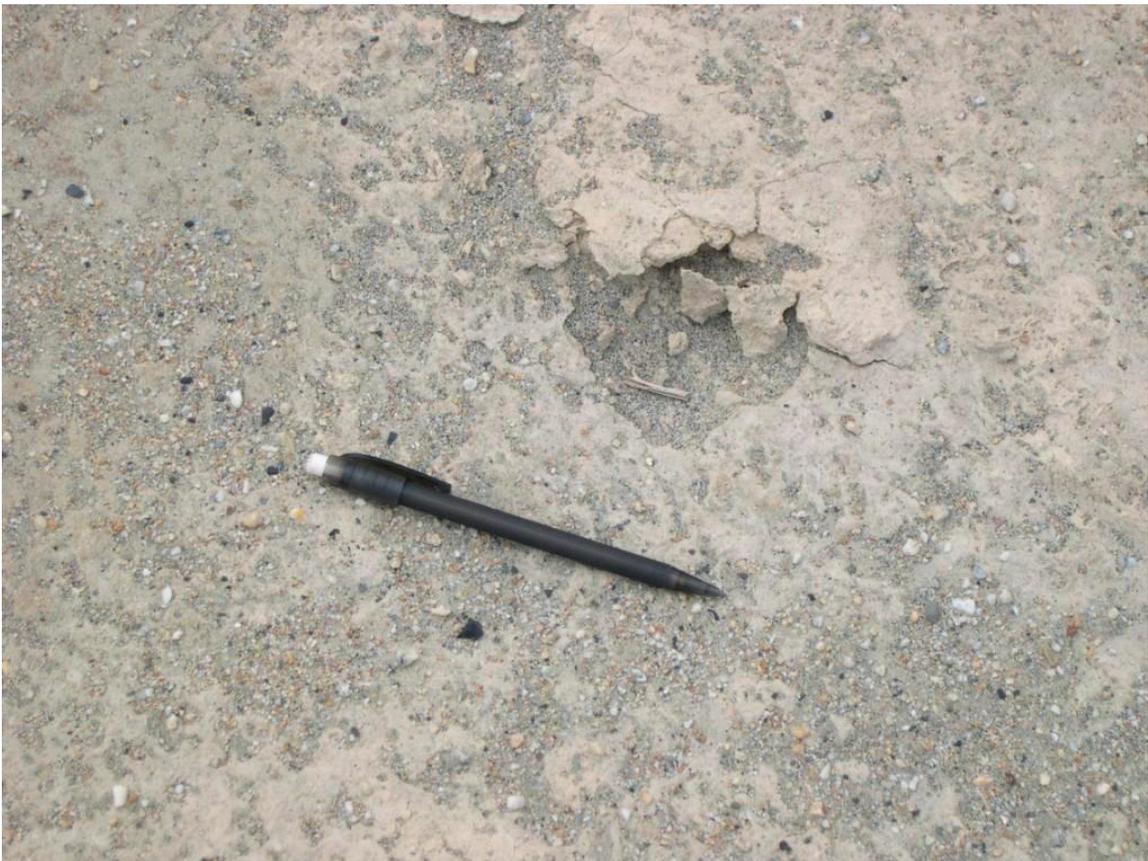
Deer have been identified on site, based upon both visual observation along the Smelter Road and by hoof prints found directly in the tailings at the Empire Mill site. Deer are believed to be attracted to the inorganic salts that form on the mine waste piles.

Photo 42. Deer hoof print in the tailings at the Empire Mill on August 17, 2005.

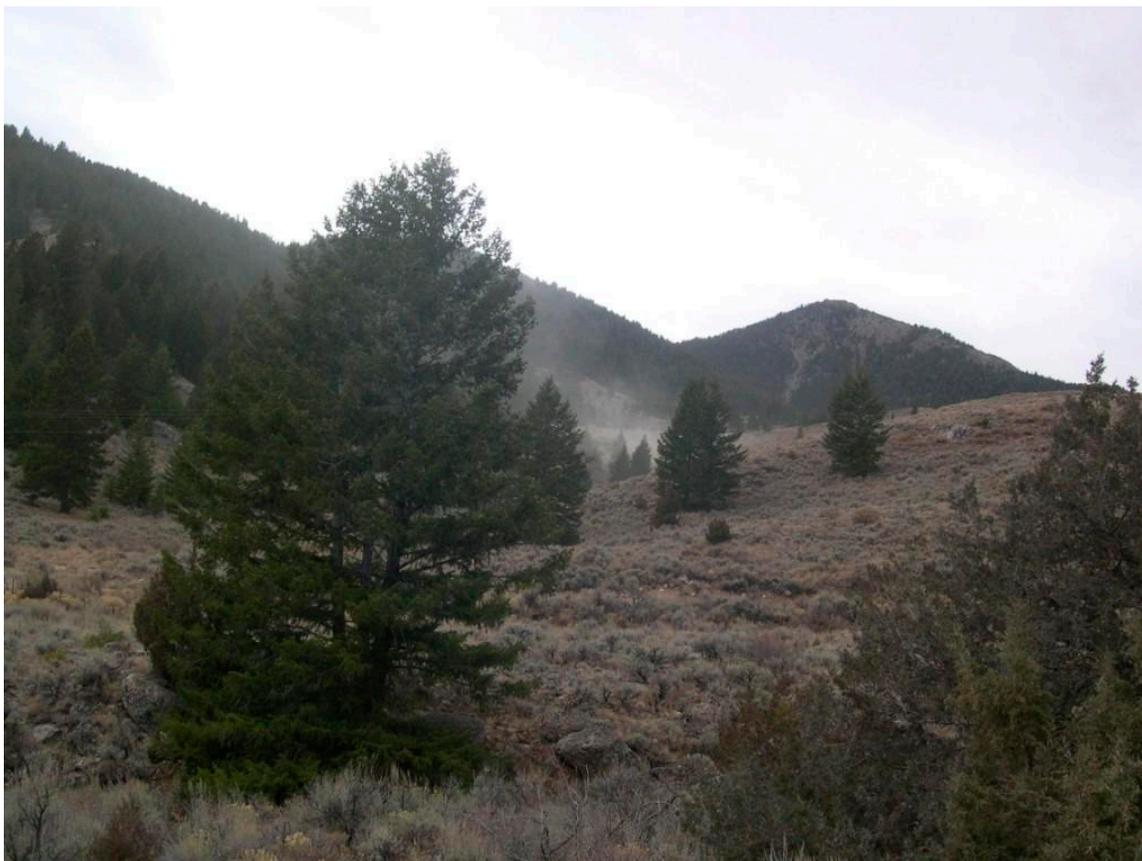
This wind-borne dust is viewed by DEQ as perhaps the most important exposure route for tourists on Mine Hill and residents of Mackay, and it should be closely evaluated for actual risks. During a DEQ site tour to an adjacent mining site on October 27, 2003, DEQ personnel Katy McKinley and Rensay Owen documented tailings being mobilized out of the tailings pond at this site. Again, on August 17, 2005, both Brian Gaber and Katy McKinley were on site performing the PA fieldwork when wind mobilized large amounts of tailings off of the tailings impoundment.

Photo 43. Photo taken by DEQ personnel on 10/27/03 looking up at the front of the tailings impoundment of the Empire Mill as tailings are mobilized by wind.

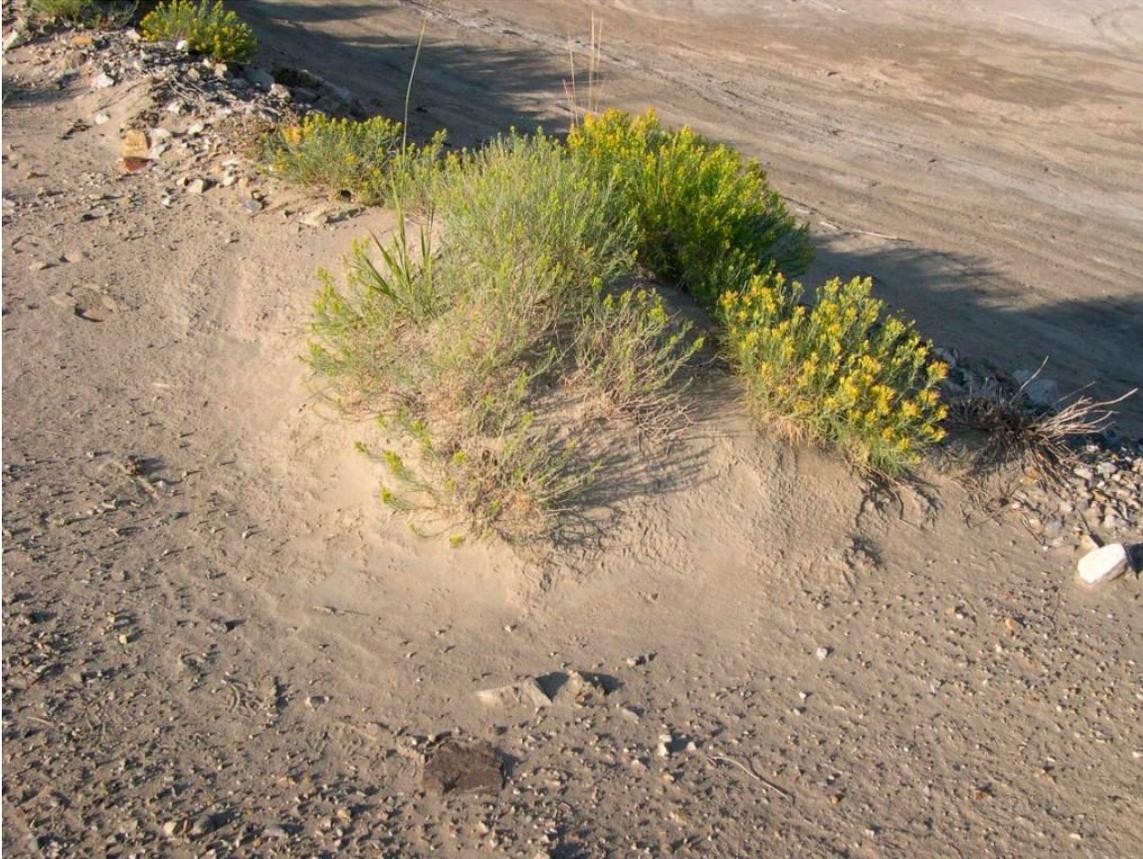
Photo 44. Photo taken of vegetation on the tailings dam as evidence of aeolian deposition of tailings.
