**RAMSHORN MINE  
PRELIMINARY ASSESSMENT REPORT  
CUSTER COUNTY, IDAHO**

**STATE OF IDAHO  
DEPARTMENT OF ENVIRONMENTAL QUALITY**

December 2003

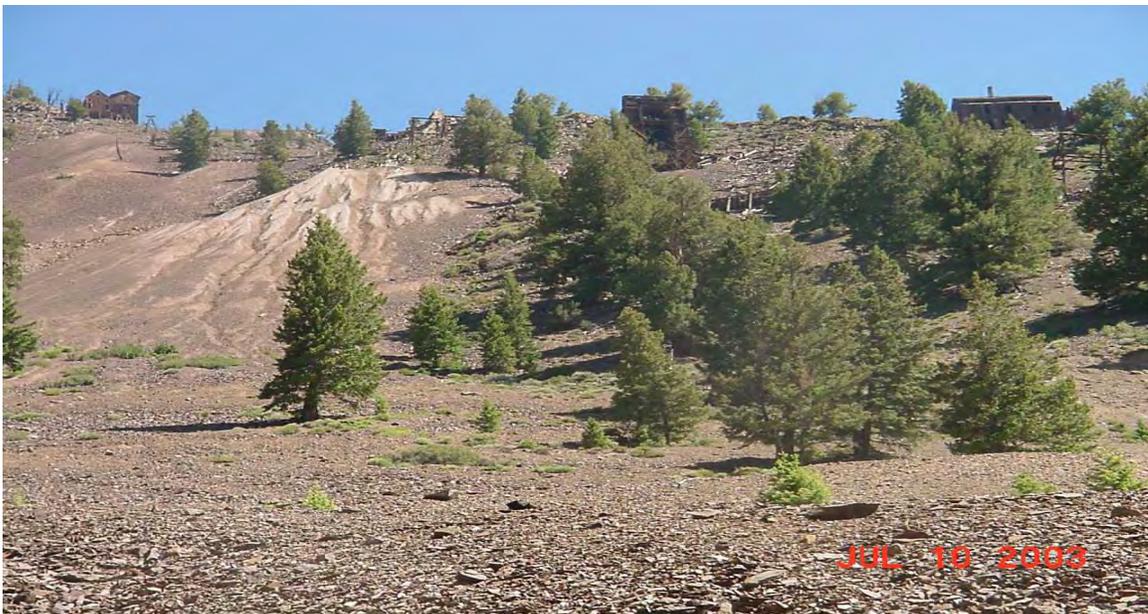
**Photo 1**

Upper Ramshorn Mine: tram shed top center, bunkhouse top right & Skylark Mine top left

- Photo 1 View to north, tramway loading shed (top center), bunkhouse (top right) and Skylark Mine buildings (top left).
- Photo 2 Possible remains of portal shed at Post Boy tunnel (lower adit).

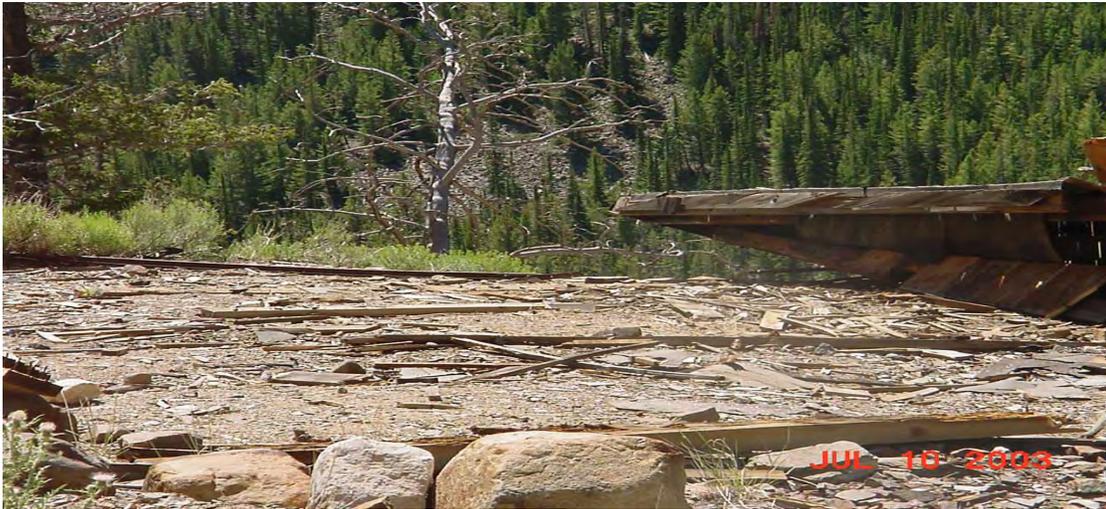
**Photo 2**

Possible remains of portal shed, adjacent to lower Ramshorn adit (Post Boy tunnel)

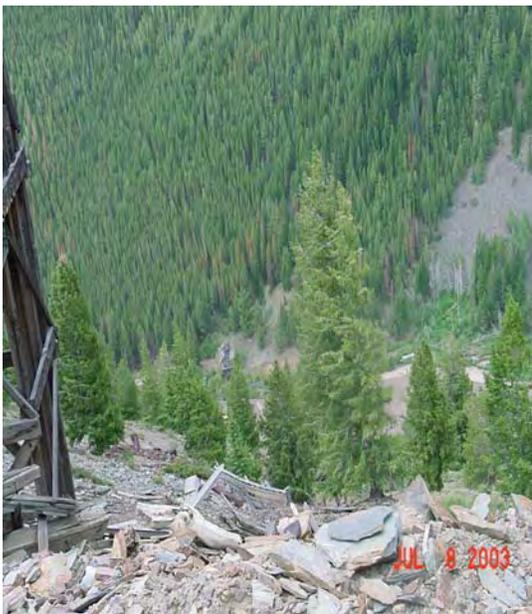
**Photo 3**

Ramshorn tramway from upper adit level to ore terminal building on Bayhorse Creek

- Photo 3 View to southeast, from upper adit to tramway terminus shed on Bayhorse Creek (note: steep slope).
- Photo 4 View to north-northwest, tramway frame supports still carry cables.

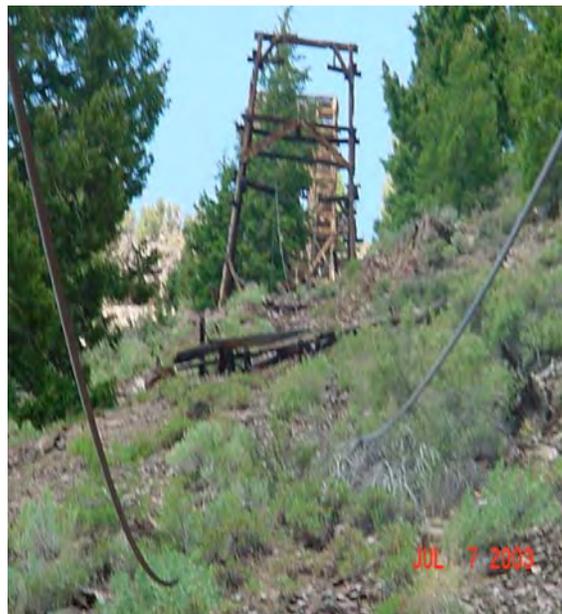
**Photo 4**

Tramway supports leading to upper adit

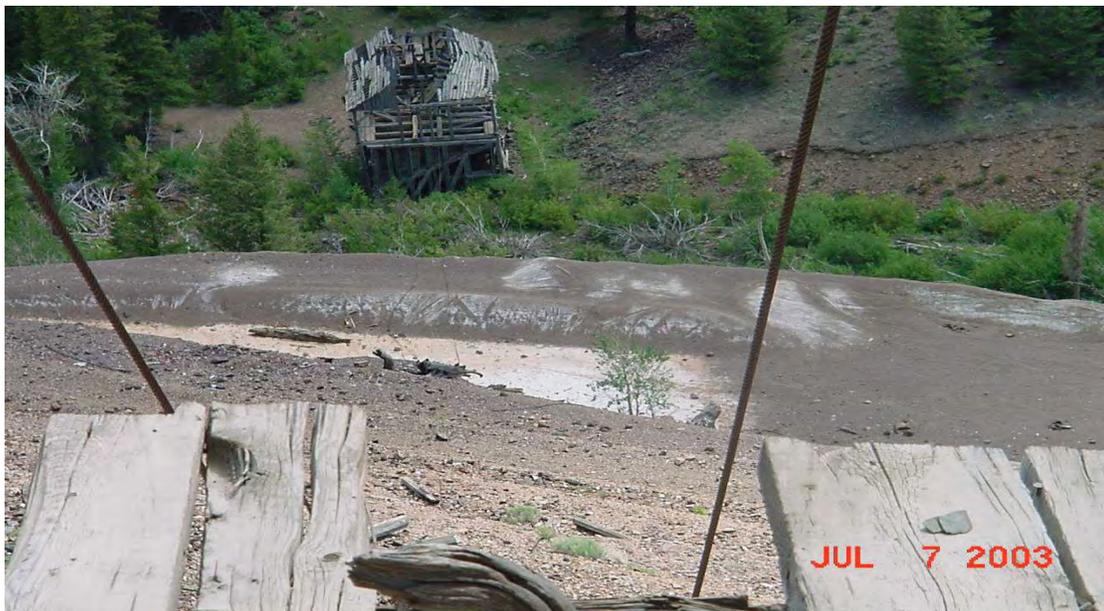
**Photo 5**

View from tramway loading shed, located at middle adit level (Post Boy tunnel), across tailings pile, tailings pond (center), across Bayhorse Creek (vegetation) to ore terminus building.

- Photo 5 View to south, from tramway loading shed at Post Boy tunnel level, across tailings pile and pond (center).
- Photo 6 View to north, middle adit (collapsed), black drain hose at lower left.

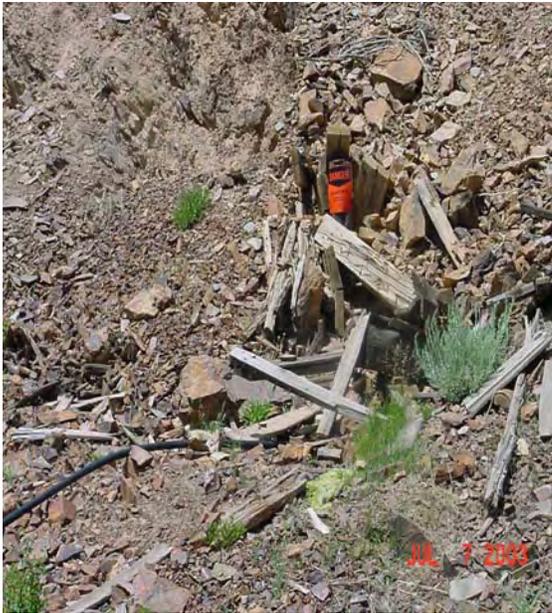
**Photo 6**

View to north, middle adit (collapsed), black drain hose at lower left.

DEQ identified a collapsed adit, posted with a warning sign. Emanating from the base of the adit was a two-inch rubber hose that apparently was used to drain water from the workings. Approximately 400 feet downhill from this adit, a second collapsed adit was identified. This is referred to as the lower Ramshorn adit. The remains of a portal shed including foundations, scattered boards and narrow-gauge rails were discovered adjacent to the lower adit. A waste rock dump, measuring approximately 100 cubic yards was

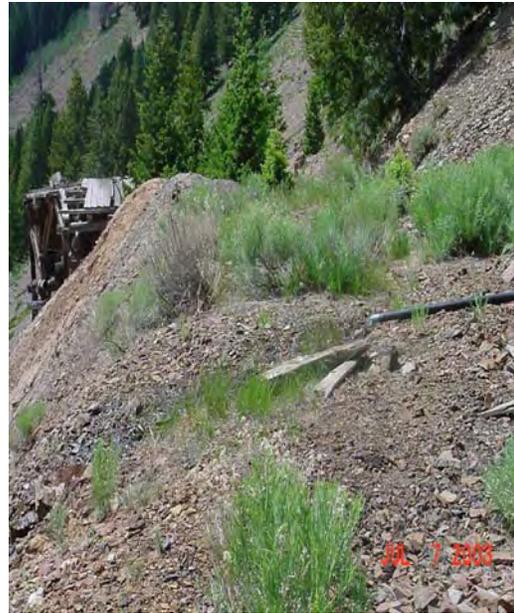
**Photo 7**

View to west, drain hose at right center, ore loading shed in left background.

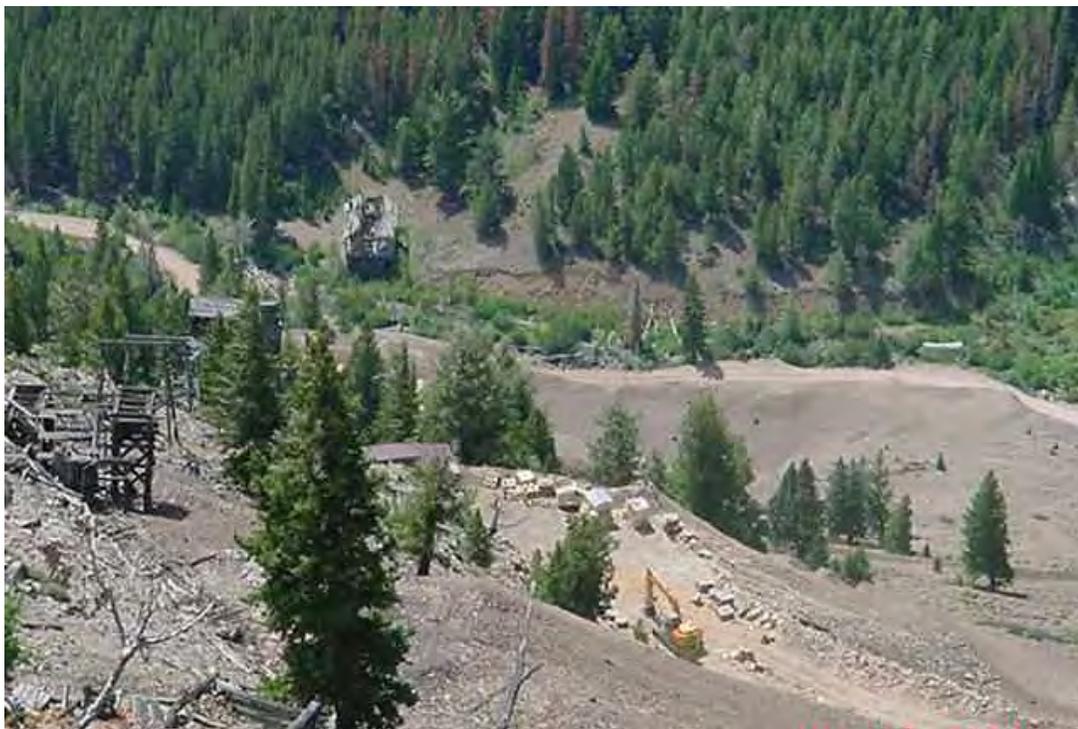
**Photo 8**

View downslope from Skylark Mine (close-up). Tram cable supports, loading shed and terminus shed (across road) at left center; upper adit sorting shed at left of The Rock Works' operation; extensive tailings pile adjacent to road.

- Photo 7 View to west, drain hose at right center, ore loading shed in left background.
- Photo 8 View downslope from Skylark Mine, close-up of The Rock Works' excavation operation at Ramshorn.

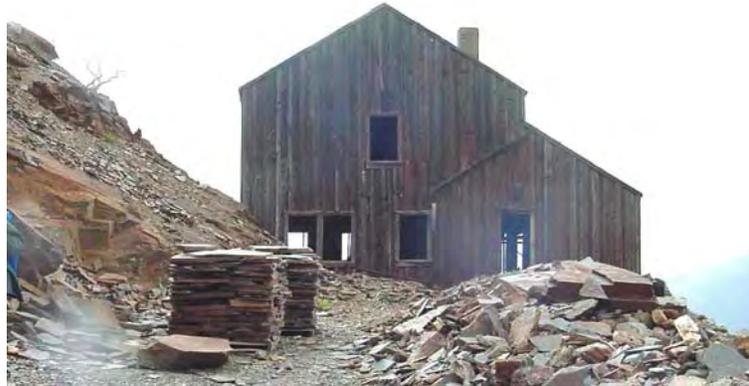
**Photo 9**

Ramshorn bunkhouse, upper adit level, Rock Works' slate stacked on pallets

- Photo 9 View to east, Ramshorn bunkhouse, upper adit level, Rock Works' slate stacked on pallets.
- Photo 10 Close-up drain hose flow from middle adit.

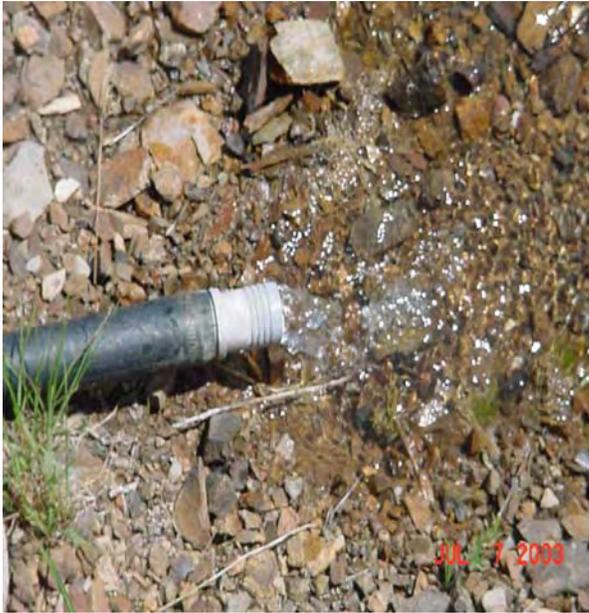
The DEQ collected a water sample directly from the drain-hose emanating from the middle adit. Sample analysis did not reveal any constituents of concern (Appendix B).

**Photo 10**  
Close-up of drainpipe flow from middle adit.

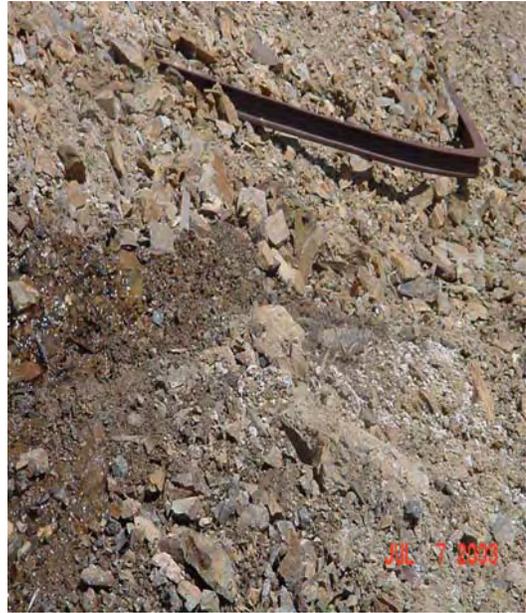
**Photo 11**  
Drainage onto ground, infiltration of slope is complete within six feet of release.

- Photo 11 Drainage onto ground (photo 10), infiltration of slope is complete within six feet of release from drain hose.
- Photo 12 Water flowing from seep in slope beneath Ramshorn Mine.

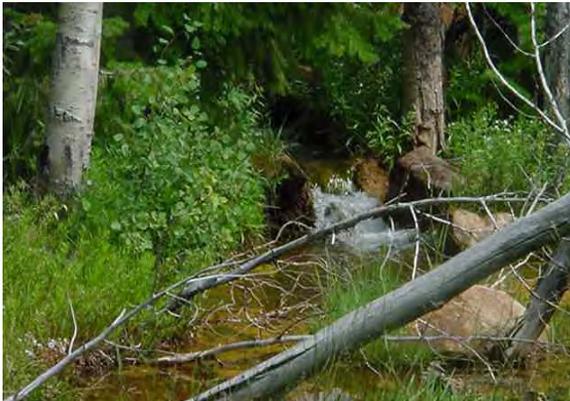
A seep was discovered approximately 300 feet east and 100 feet downslope from the Post Boy tunnel. This seep appeared to drain many of the Ramshorn workings, as the flow was estimated to exceed 300 gallons per minute. The rocks and soil below the seep were covered with a yellowish stain and algae appeared abundant.

**Photo 12**  
Water flowing from Seep, abundant vegetation.

A second PPE is the water emanating from the base of the slope beneath workings of the Ramshorn. The high volume of seepage suggests that many of the underground workings of the Ramshorn connect and drain to this point. Flow from the seep bisects waste rock dumps prior to discharge into Bayhorse Creek.

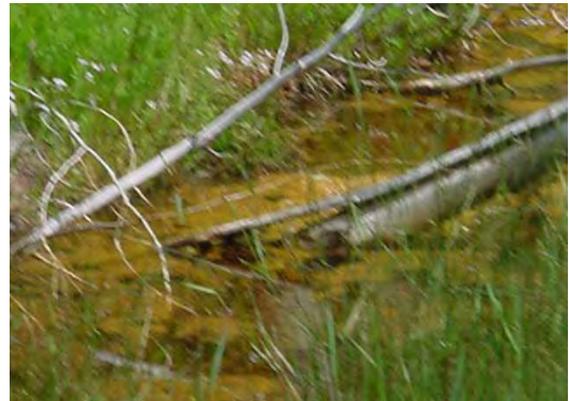
**Photo 13**  
Close-up (photo 12) of yellow staining

- Photo 13 Close-up (photo 12) of yellowish stains on rocks and soil. Abundant algae noted.
- Photo 14 Primary route of flow from seep (thick vegetation follows course), bisects waste rock and tailings piles.

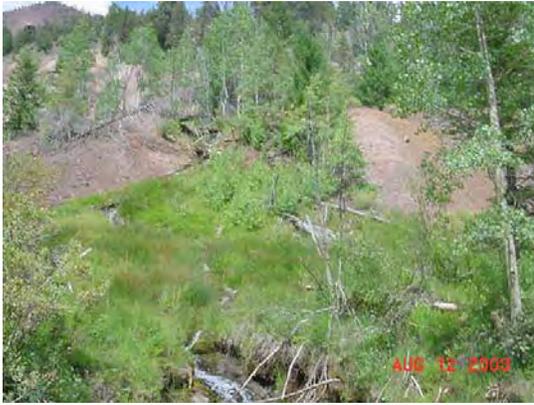
**Photo 14**

The main seepage route bisects a waste rock and tailings pile. Smaller volume flows were noted incising the lateral portions of the pile. The water flows approximately 150 feet through culverts to Bayhorse Creek.

Primary route of flow from Seep (center)

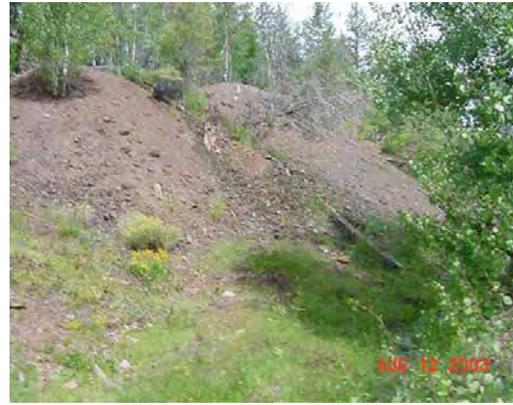
**Photo 15**

Seepage through rock and tailings piles

- Photo 15 Seepage through waste rock and tailings piles.
