**POST-REMOVAL REPORT**  
of  
**Talache Mine Tailings**  
**Atlanta, Idaho**

**MTI File Number: B61567R**  
**March 10, 2007**

Re: **Post Removal Site Control Report  
Talache Mine Tailings Site  
Atlanta, Idaho**

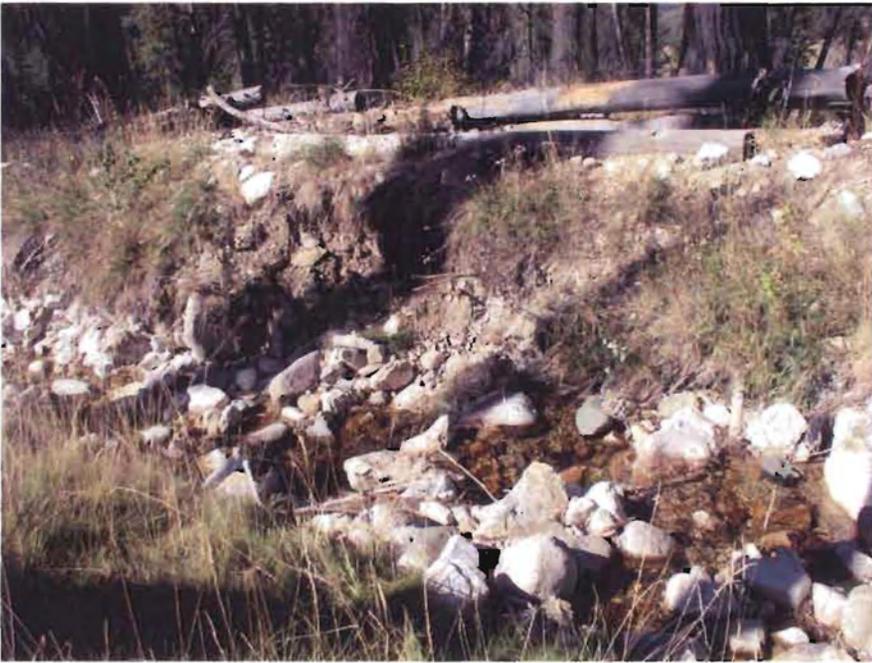
NOTE: A wind fallen tree was found to be located within the channel of the East Fork of Montezuma Creek near the diversion embankment. This fallen tree should be removed from the creek channel. It was also noted that just downstream from the diversion embankment, the north side of the channel bank had been undercut and

partially washed away during the 2006 spring runoff. Both the washed out area and fallen tree positions were flagged. See photographs of these two noted areas with issues in Appendix F.

E. Fork, Montezuma Crk, north side of channel wash-out

A wind fallen tree was found to be located within the channel of the East Fork of Montezuma Creek near the diversion embankment. This fallen tree should be removed from the creek channel. It was also noted that just downstream from the diversion embankment the north side of the channel bank had been undercut and partially washed away during the 2006 spring runoff. The creek channel should be stabilized within the area that was undercut.

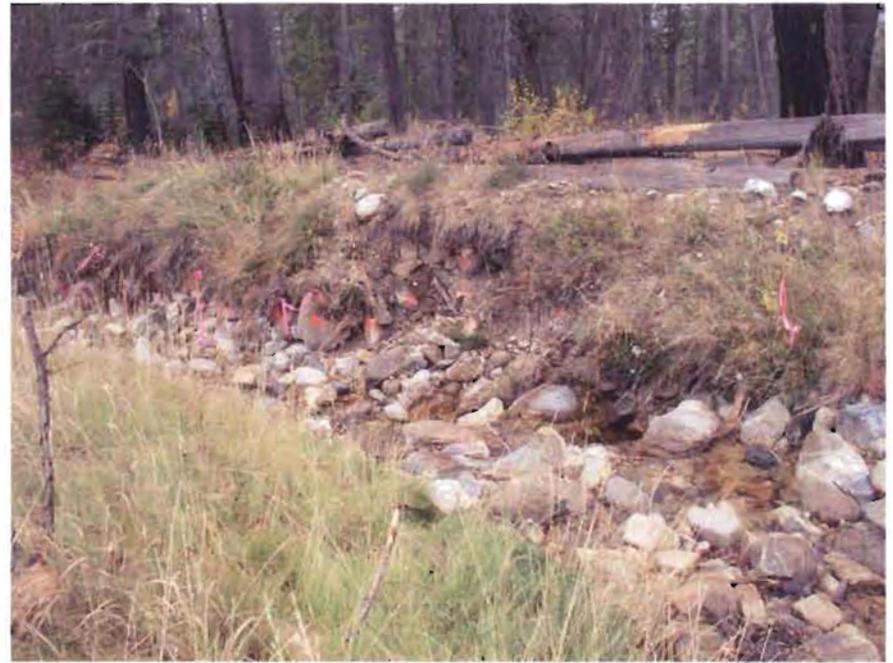
Wash-out area flagged for repair

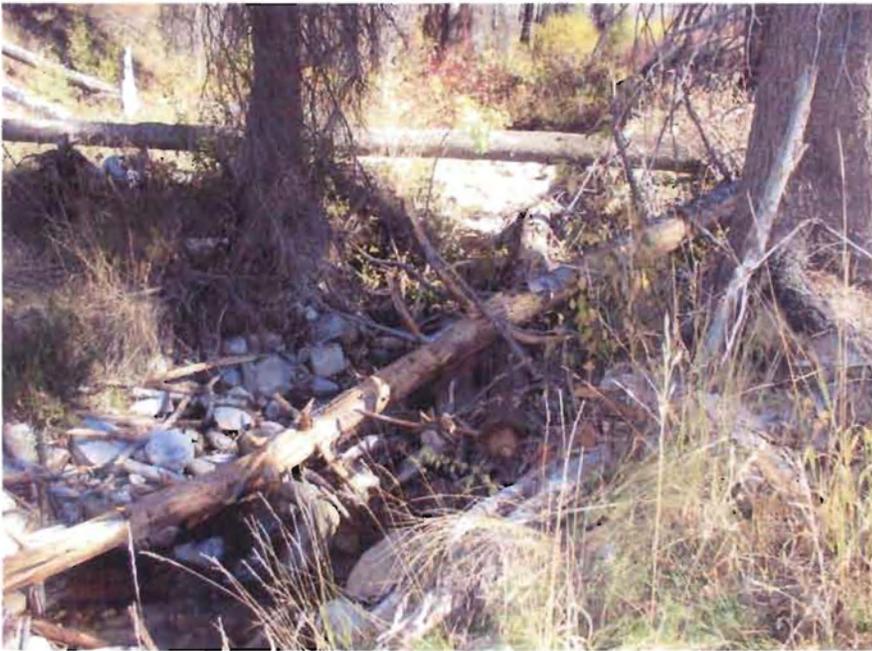
E. Fork Montezuma Crk, wind fall in creek channel just upstream from washout.

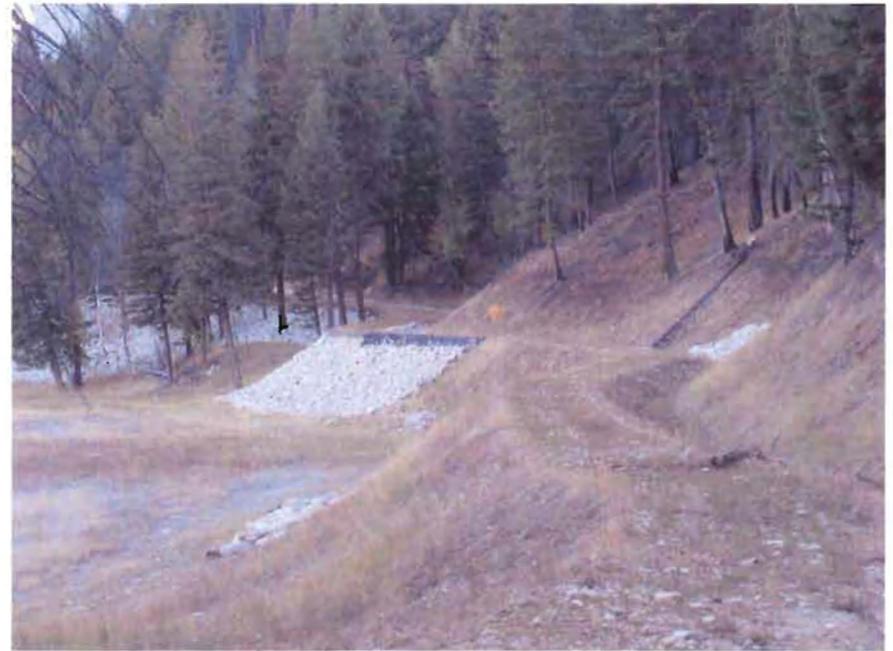
Nearly barren geo-fabric (black area in center of Photo) along E. side of UTP at top of rip-rap. Low growth of plants in some areas along diversion. Fabric OK.

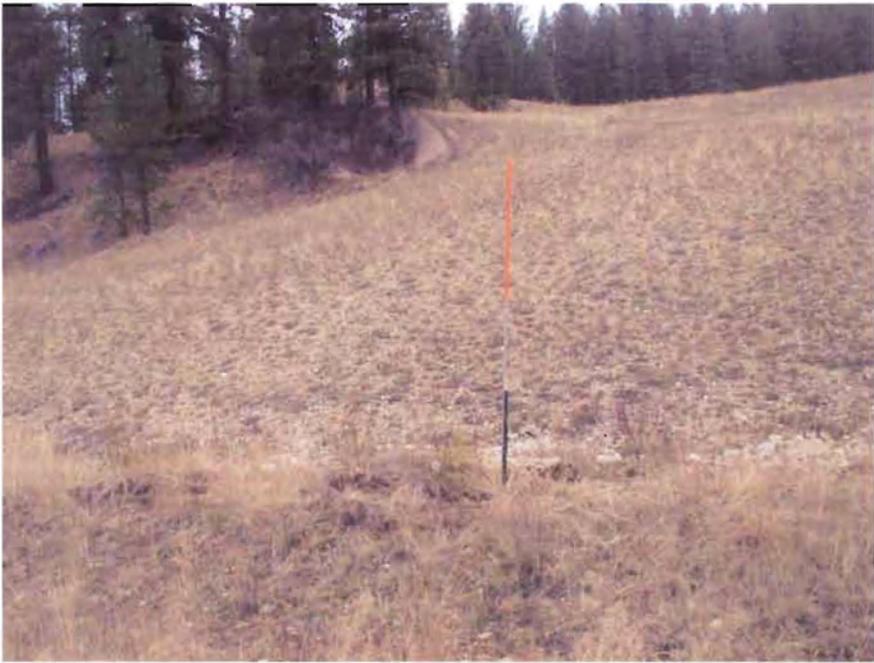
Marked location of Seep Water Sampling Point #1, just N. of toe of UTP

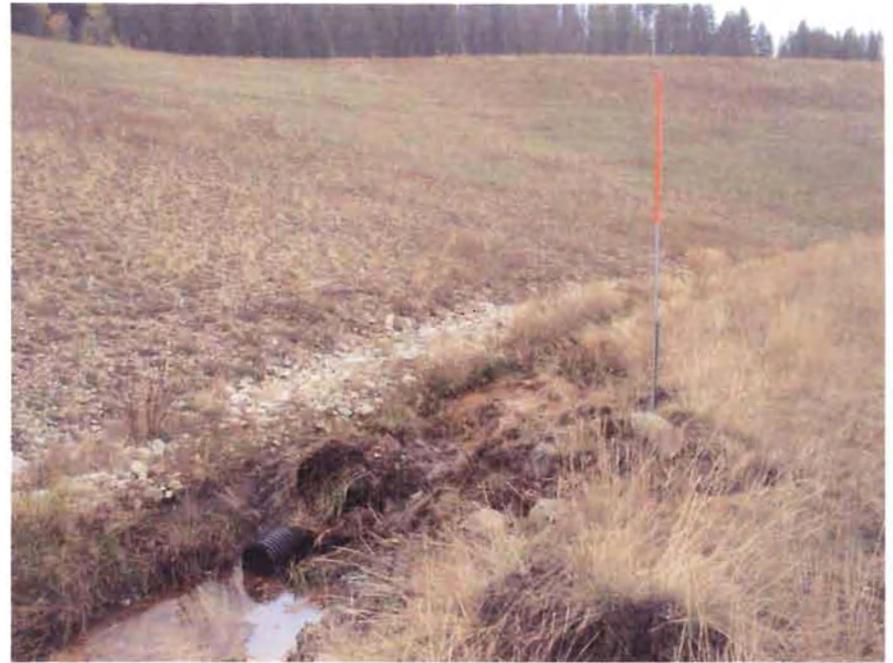
S.W. sampling point #1, exhibiting newly installed pipe for sampling.

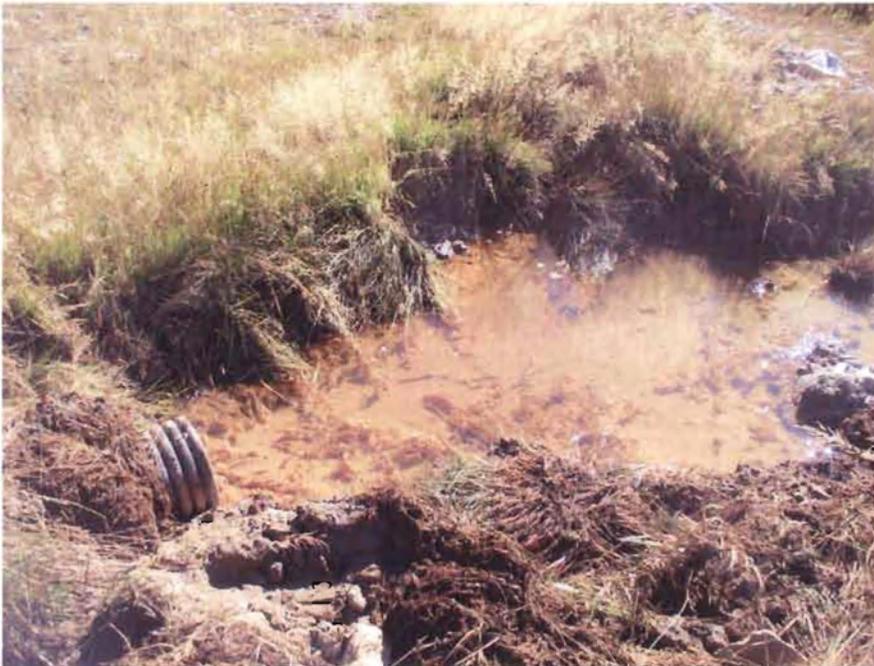
S.W. sampling point #1, inlet (south) end of newly installed pipe.

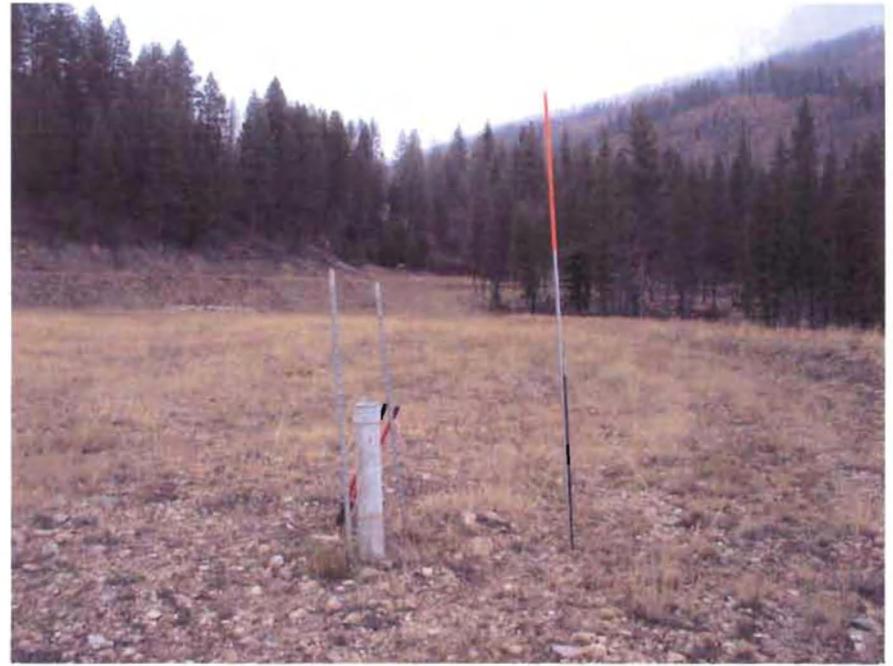
Marked location of UTP piezometer.

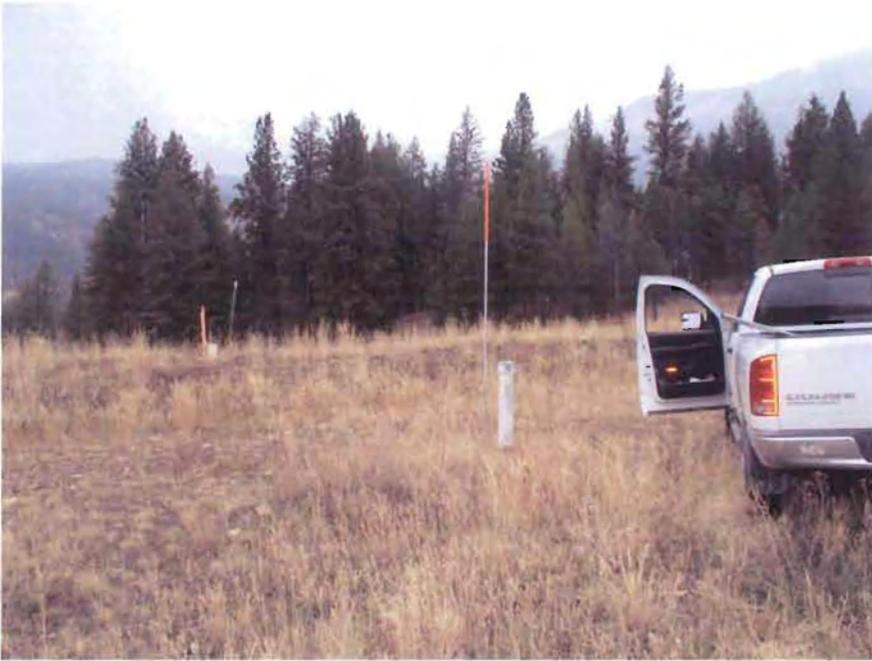
Marked location of LTP piezometer.

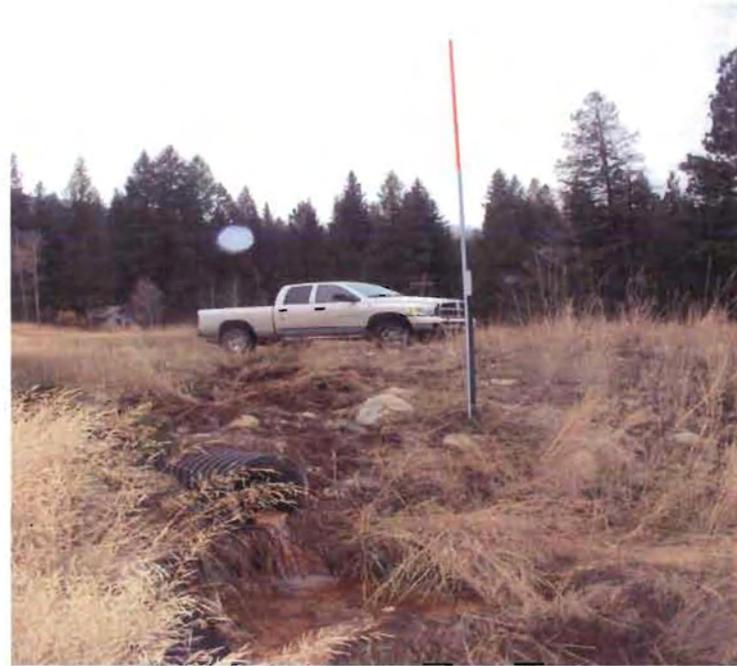
Marked location of newly installed sampling pipe at S.W. Sampling Point #2.

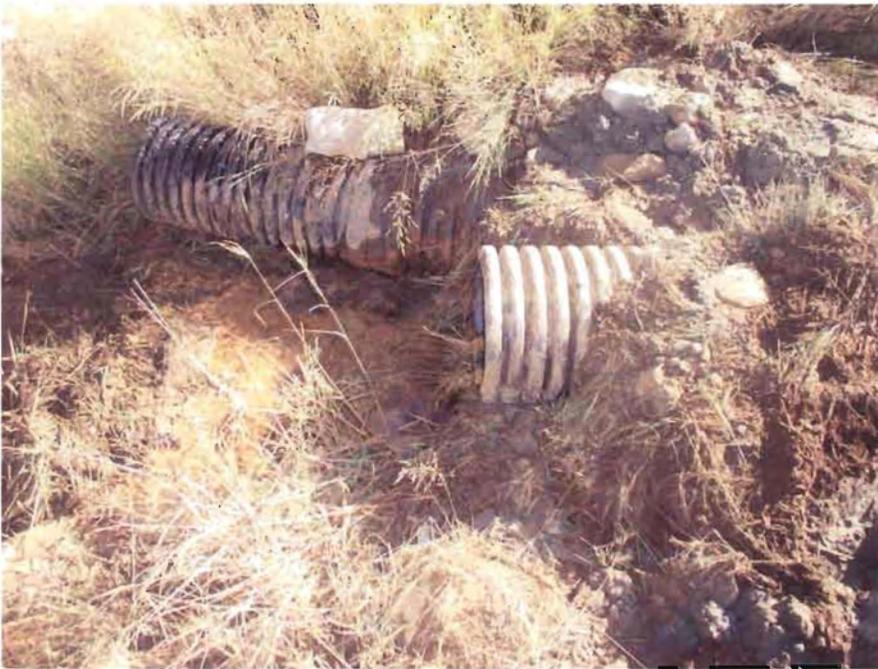
Side view of S.W. sampling Point #2.

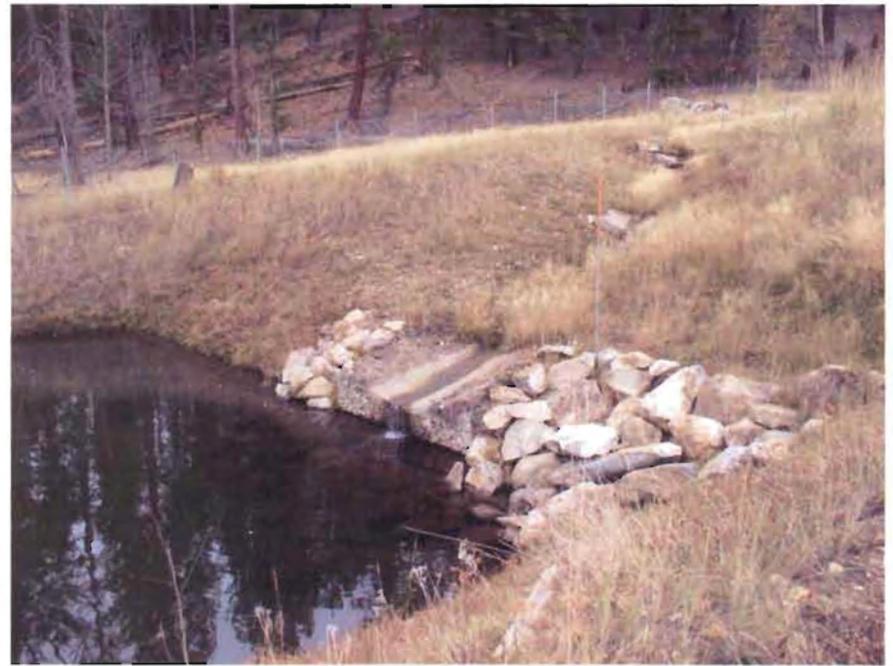
Sampling Point #3, lower tier of S.W. inlet trough to pond 2 (center of photo).

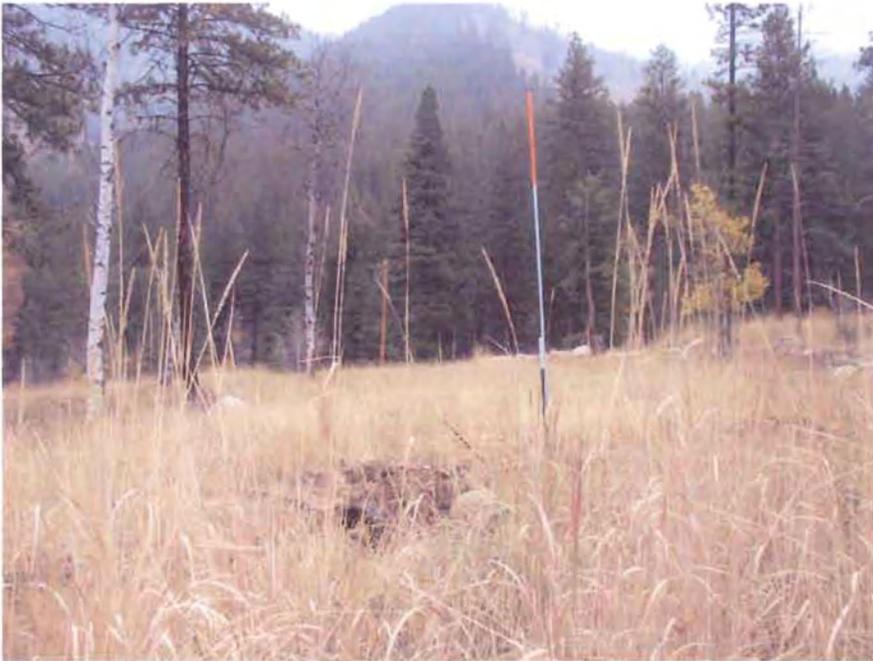
Marked location of Sampling Point #4, north of USFS Road.

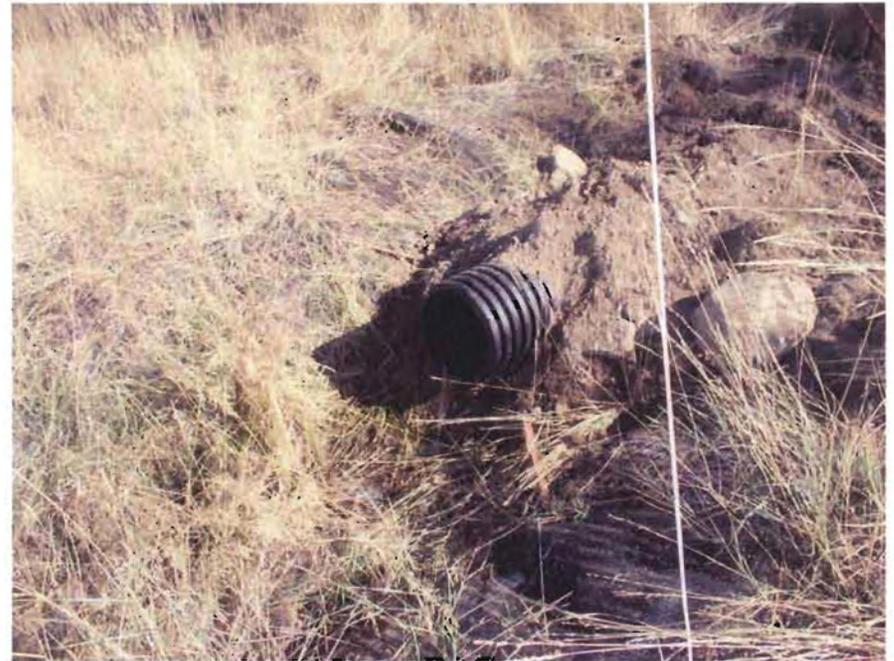
Newly installed pipe in ditch for sampling at Point #4.

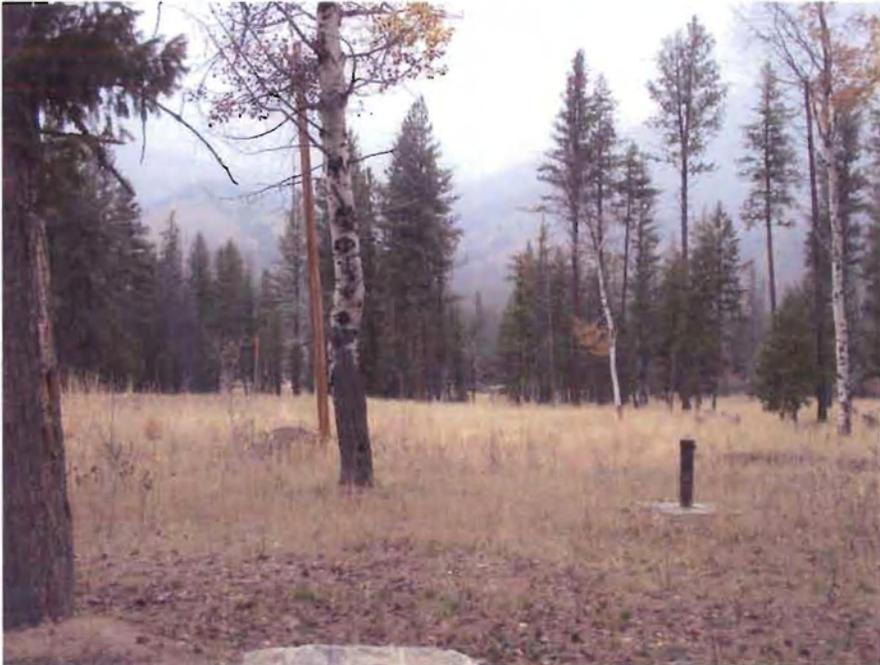
Monitoring well (MW-1) just N. of forest service road.

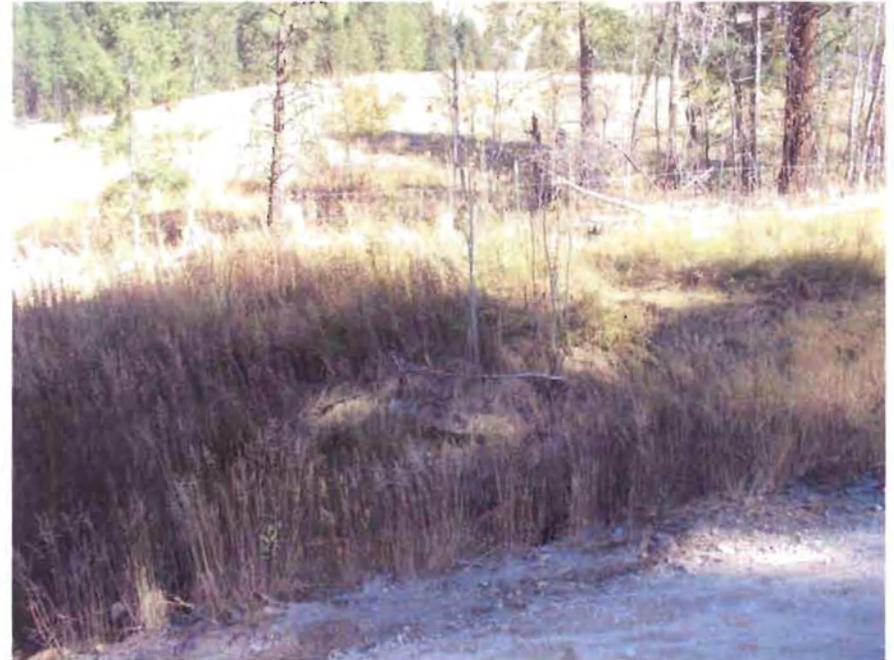
NOTE: An additional water seep was sampled at the request of USEPA. This seep was emanating from near the northwest corner of the toe of the LTP and appeared to be migrating from beneath the seep collection ditch. This seep flowed eastward for approximately 70 feet into the borrow ditch along the east side of the Montezuma Creek Road just up gradient from the inflow culvert which directs precipitation and UTP & LTP diverted runoff water into Montezuma Creek. The seep was identified from heavy iron staining. As described in the Site Characterization Report, this seep water may be emanating from the covered springs beneath the LTP.

General area of newly identified seep emanating from beneath LTP.

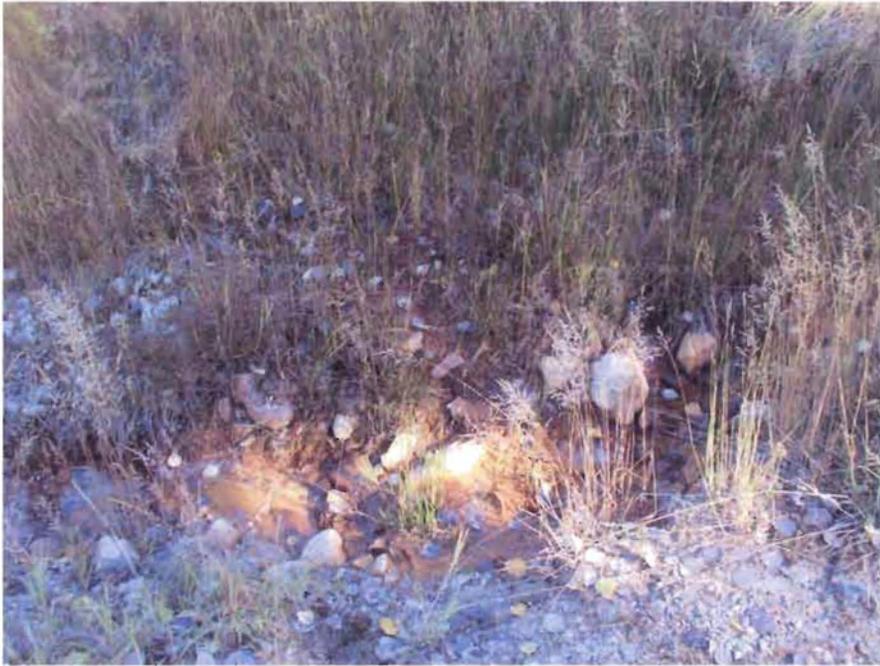
Visible Fe staining along road drainage ditch from newly identified seep.

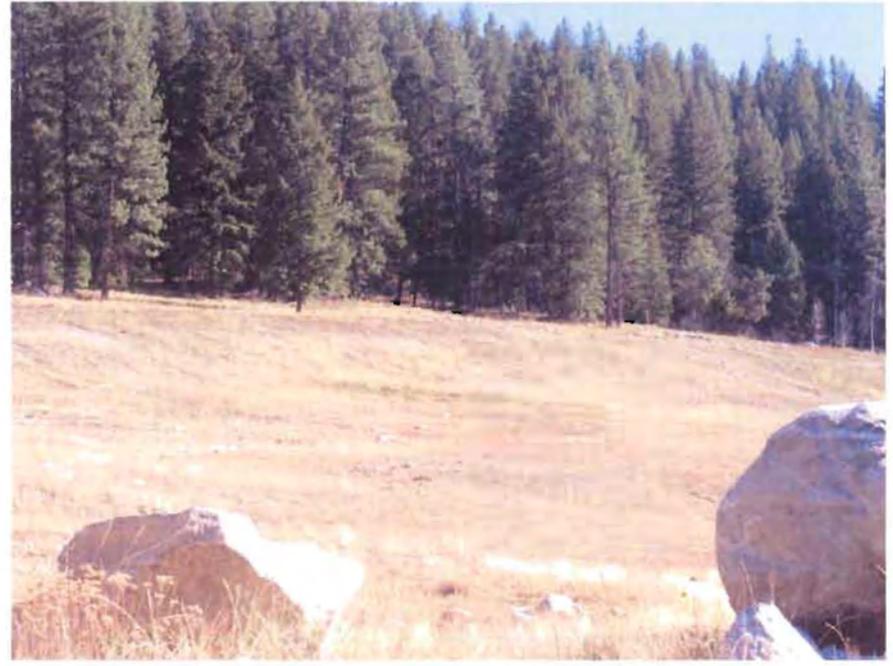
Near east end of Borrow source area.

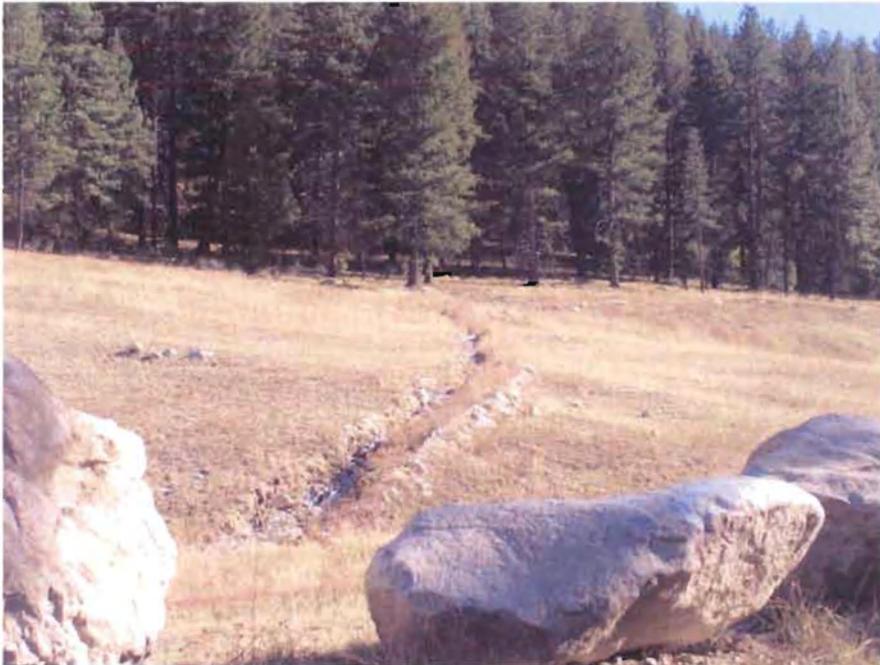
Near central area of Borrow Source area exhibiting runoff diversion ditch.

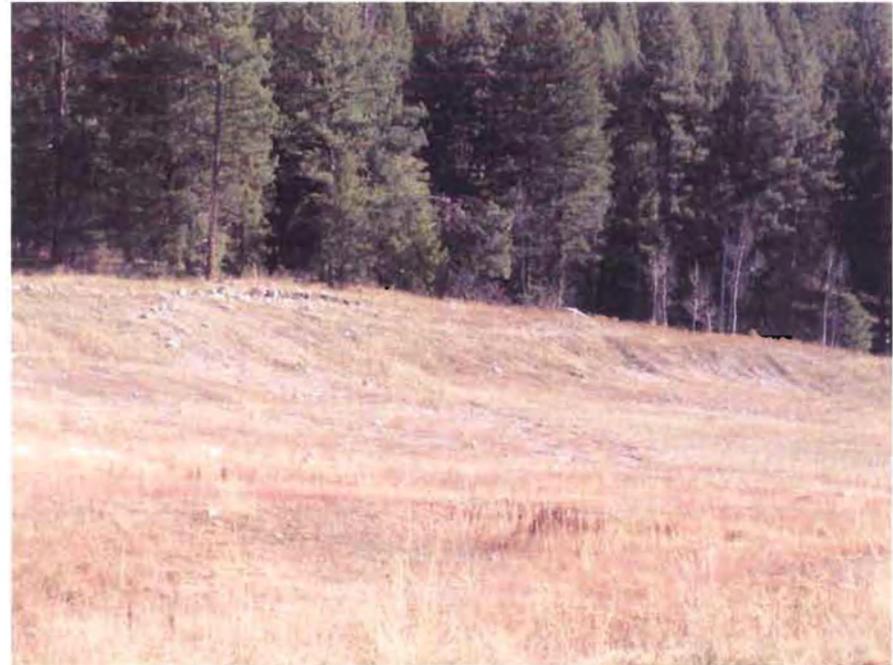
West end of Borrow source area.
