**COLUMBIA MILL
PRELIMINARY ASSESSMENT REPORT
LEMHI, IDAHO**

**STATE OF IDAHO
DEPARTMENT OF ENVIRONMENTAL QUALITY**

December 2002

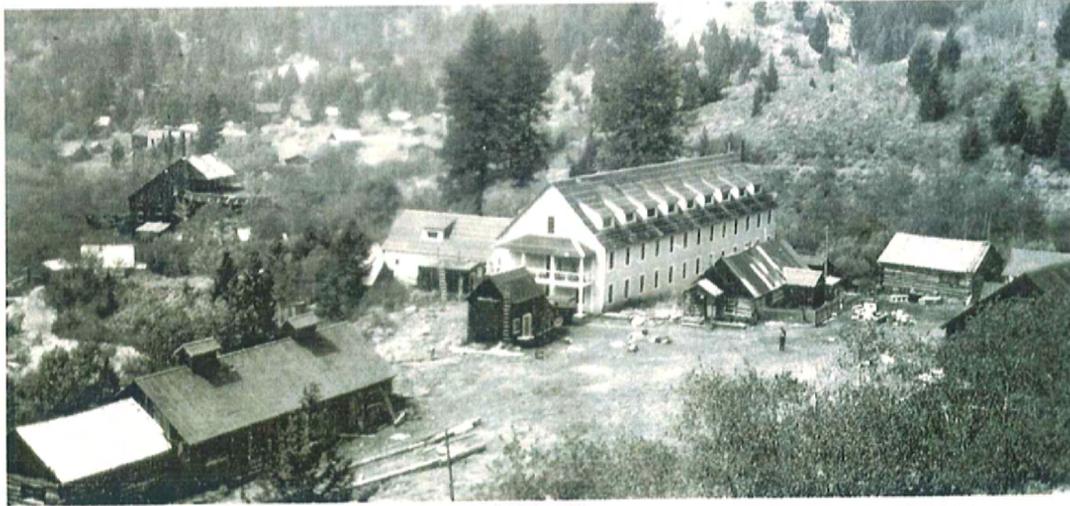
CP0560
Columbia Mill at left center

- CP0560 Reprint 1926, view to south, Mill building (left center), Yellowjacket hotel (center), blacksmith shop (lower left).
- Mvc-006s View to north, Mill ruins, kiln (center), cabin (right center), Yellowjacket hotel (far right).
- Mvc-009s View to south, Mill ruins (upper center), cabin (tin roof), tailings pile (below creek) lie within Yellowjacket Creek, beaver dams in creek.

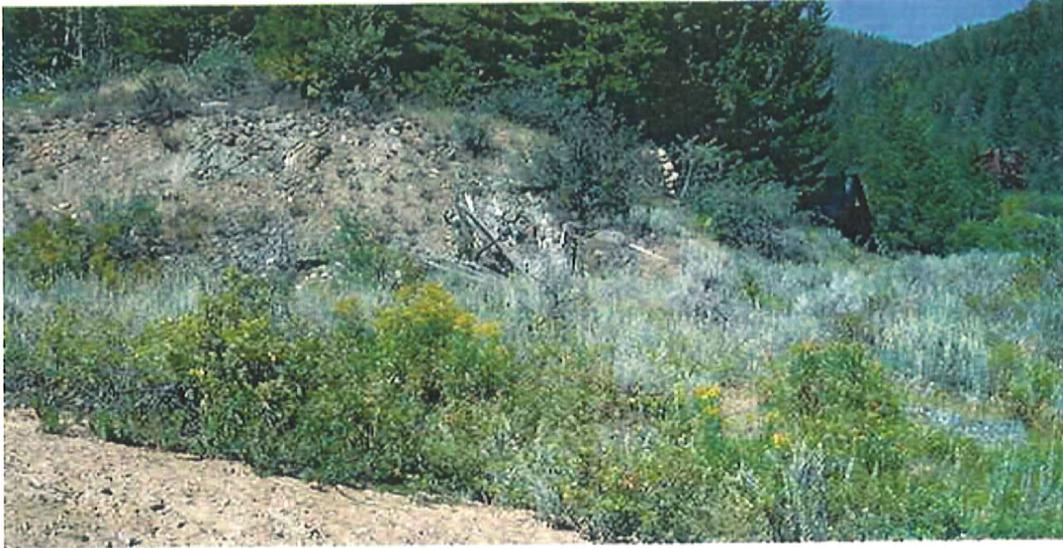
Mvc-006s

DEQ conducted a site visit on August 6, 2002. The owner of the property, Myrnalee Steen, was present during the site visit. Mrs. Steen provided historical accounts of the townsite of Yellowjacket, but little was known regarding the Columbia Mill. The Steens vacation on the property during the summer months, occupying a restored cabin (not pictured). Mrs. Steen did not accompany DEQ around the site. The site was not fenced, and easily accessible from the adjacent Yellowjacket Road, but posted with "Private Property" and no trespassing signage. Site features include the old Mill, kiln remains, a tailings pile, and an old cabin. The Mill building was apparently dismantled and removed, leaving only the remains of the kiln (Photo Mvc-006).

Mill ruins - kiln (center), cabin (right center), Yellowjacket hotel (far right)

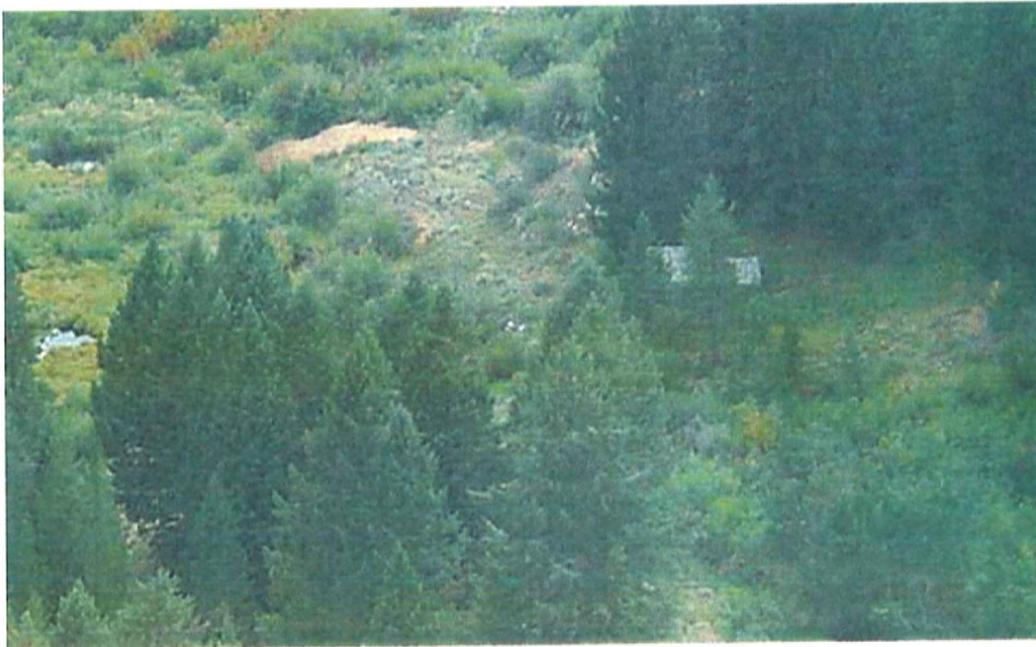
Mvc-009s

A healthy growth of grasses and shrubs covers approximately 85 percent of the tailings pile (Photo Mvc-009s). The tailings appear fine-grained in texture and are moderately compacted.

Mill ruins (upper center), cabin (tin roof), tailings pile (below Mill)
lie in Yellowjacket Creek, beaver dams in creek.

DEQ collected a composite soil sample from the tailings pile located adjacent to the creek (Appendix B). The creek appears to be eroding the old tailings, but discoloration of the water or creek bed is not evident.

One Probable Point of Entry (PPE) is the erosion of the tailings pile located by Yellowjacket Creek. Direct observation revealed the incising of the tailings by the creek. Though not observed, a second PPE could be runoff across the site into Yellowjacket Creek.
