**BULLION MINE
PRELIMINARY ASSESSMENT AND SITE INVESTIGATION REPORT
SHOSHONE COUNTY, IDAHO**

**STATE OF IDAHO
DEPARTMENT OF ENVIRONMENTAL QUALITY**

December 2004

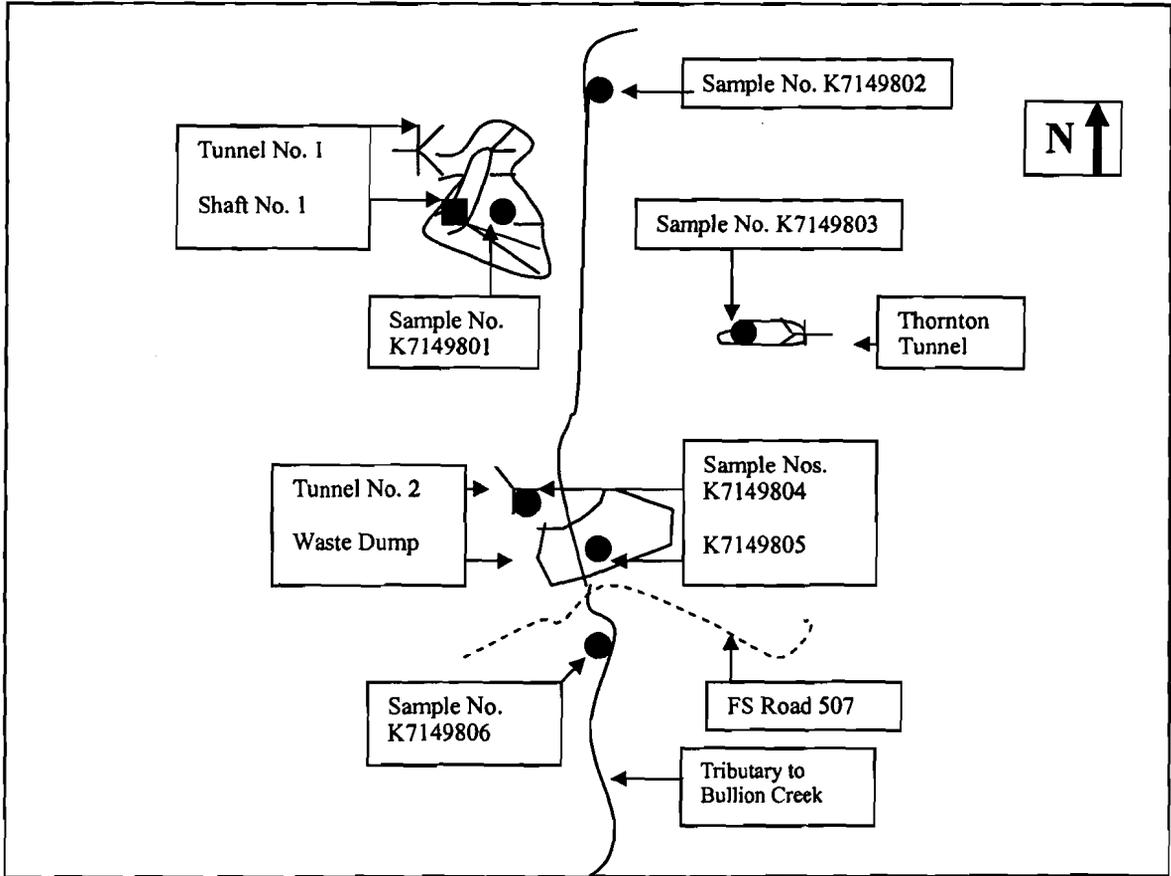
Figure 3-1. Upper Workings Diagram

The Bullion Mine was visited by John Kauffman of IGS on July 14, 1998. The IGS conducted a preliminary site investigation, which included limited sampling activities. Sampling locations are noted on the sketch diagrams of Figure 3-1 and Figure 3-2. Samples were collected from waste rocks dumps (red), surface water (blue) and sediment (yellow). Surface water samples results are listed in Table 3-2, while Table 3-3 includes the rock and sediment sample results.

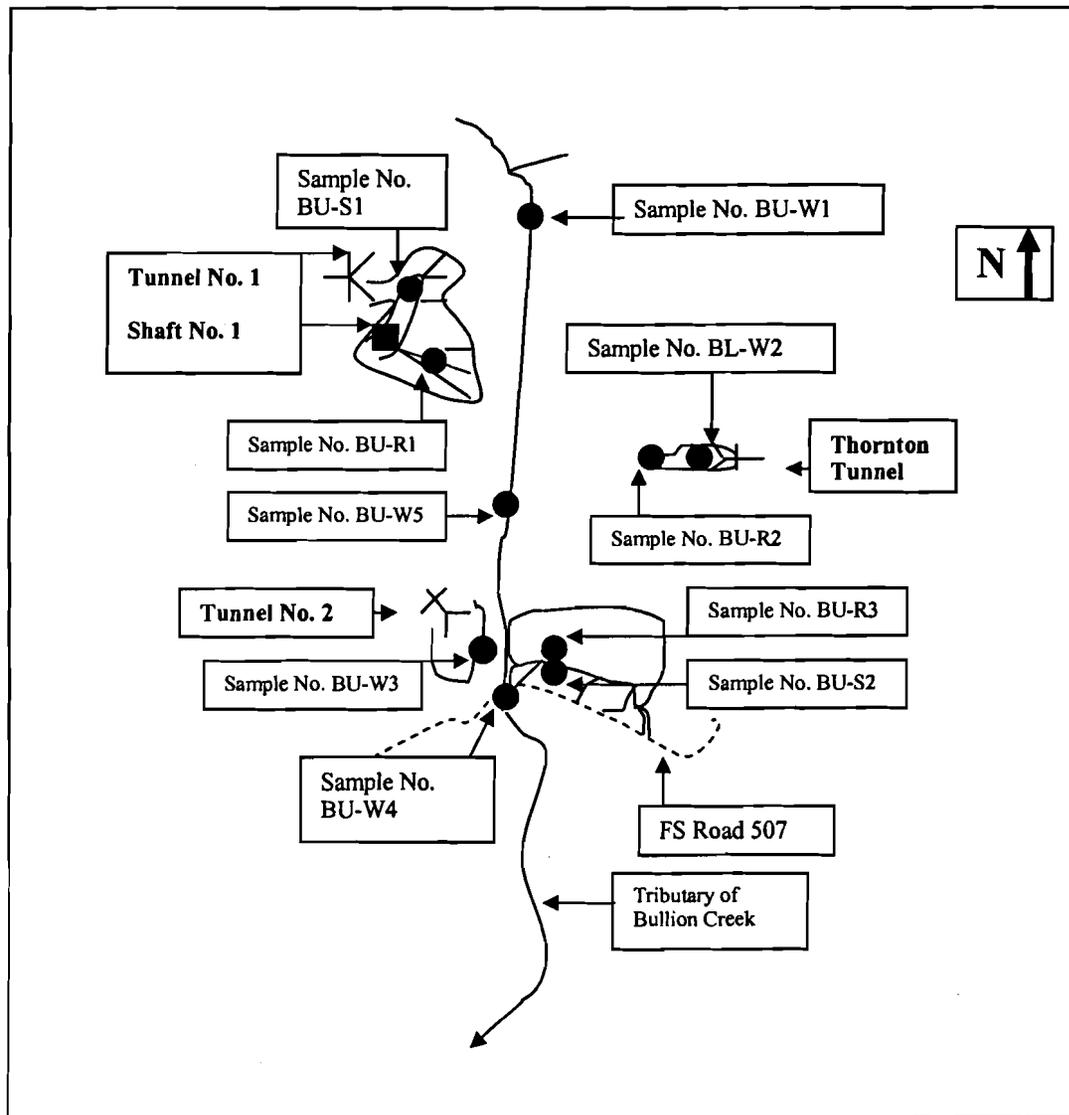
Figure 3-4. Upper Bullion Samples.

Samples were collected from waste rocks dumps (red), surface water (blue) and sediment (yellow), at the locations noted in Figure 3-4, Figure 3-5, and Figure 3-6. Surface water samples results are summarized in Section 4.2 (page 20) and listed in Table 4-1 (page 25). Rock and sediment sample results are summarized in Section 4.3 (page 26) and listed in Table 4-2 (page 27); Table 4-3 (page 28) includes TCLP sample results.

Data from sampling of soils, waste rock, sediments and surface water at the Bullion Mine indicate potential risk to recreational users from soil ingestion. While average arsenic soil concentrations indicate an approximate risk of $2.2E-03$ (using Region IX Preliminary Remediation Goals [PRGs] – residential scenario), one sample (BL-R4) on the south waste rock pile showed an approximate $1.5E-01$ risk (see Table 4-2). This high arsenic concentration appears in only one sample and is not considered indicative of ambient site conditions.

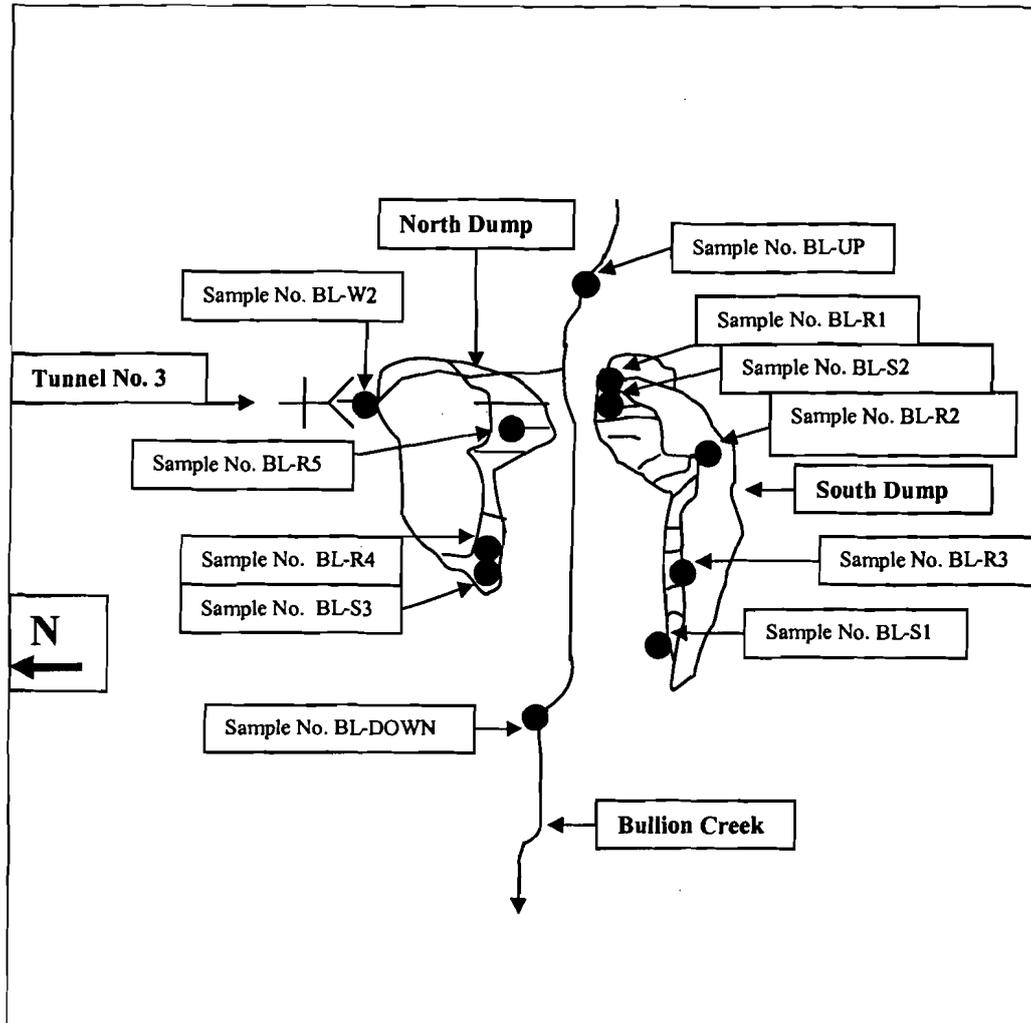
Figure 3-5. Lower Bullion Samples.

Water quality analyses indicate arsenic is above the Maximum Contaminant Level (MCL), in the Tunnel #2 and Tunnel #3 discharge, by 5 µg/L and 1 µg/L, respectively (see Table 4-1). However, surface water is not above MCLs for metals in any of the Bullion Creek samples. The detection limits were not adequate to fully evaluate impacts from cadmium for aquatic life (detection limit 2 µg/l – regulatory limit 1 µg/l) and mercury (detection limit .200 µg/l – aquatic life criteria .012 µg/l). Additionally, the single hit of copper cannot be fully evaluated due the lack of alkalinity data.
