**ABANDONED MINE
SITE INVESTIGATION
OF THE
IDORA MINE SITE
ALONG
BEAVER CREEK
IDAHO**

U.S. Army Corps of Engineers, Sacramento District and
U.S. Army Corps of Engineers, Omaha District

Bitterroot Restoration, Inc.
445 Quast Lane
Corvallis, MT 59828

July 23, 2003

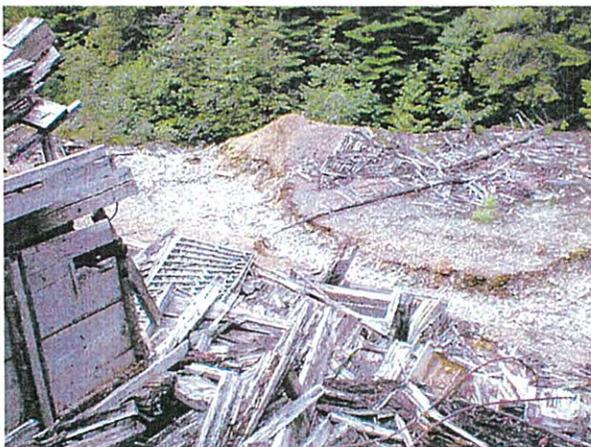
Photo of the Idora Mine looking down on Beaver Creek

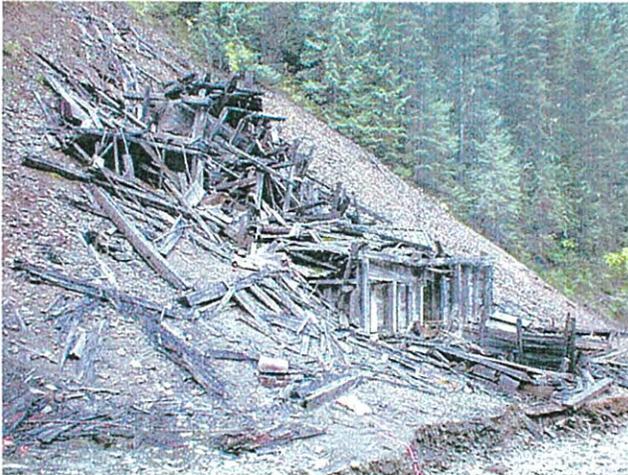
Idora Mine Site on Beaver Creek

Developed in the early twentieth century, the Idora Mine was active through the mid 1950s. The mine produced commercial quantities of silver and zinc, but the primary ore was lead. The mill site and tailings, located in and adjacent to Beaver Creek, are being actively eroded. Preliminary evidence indicates that the site is the source of a significant amount of heavy metal contamination to the downstream reaches, which contain residences, frequent recreation usage, and wildlife habitat.

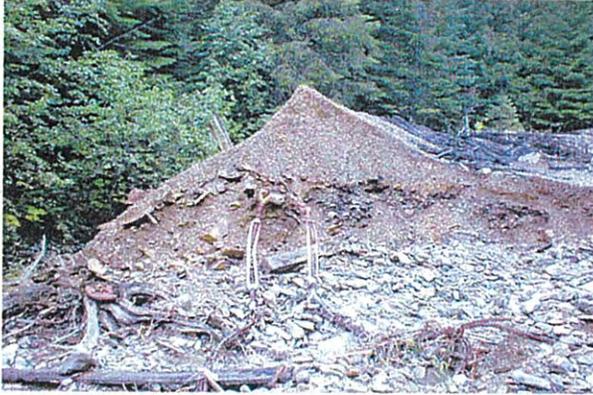
Tailings piles on Subreach 2

The stream gradient (8 percent) is moderately steep. The tailings piles are virtually devoid of vegetation. However, the remaining 80 percent of the subreach floodplain is well vegetated, both in terms of plant coverage and plant diversity. One habitat type, defined by the dominance of Western Redcedar in the overstory and Lady Fern in the understory, is found in Subreach 2. This short segment is approximately 400 feet long and ranges from 3,501 feet to 3,469 feet in elevation.

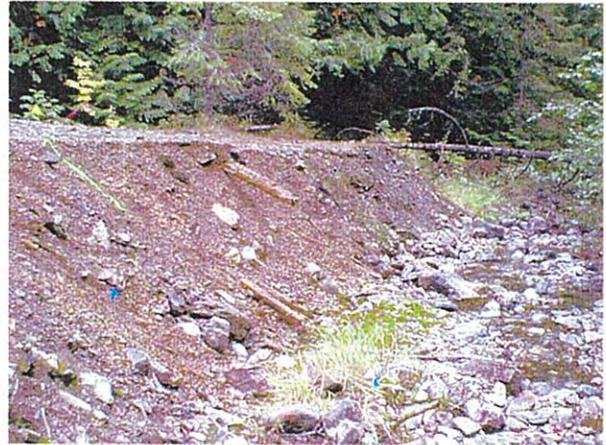
Subreach 3 is characterized by numerous braids cut down into terraced tailings. The stream incline is moderately steep, eight percent. Similar to Subreach 2, the area surrounding the stream is a barren tailings and waste rock terrace. Most of the floodplain, however, is well vegetated by numerous plants that fall into a single habitat type: Western Redcedar/ Lady Fern. This approximately 800 feet long segment ranges in elevation from 3,469 feet to 3,406 feet.

Creek braid cut into a terraced tailings pile on Subreach 3

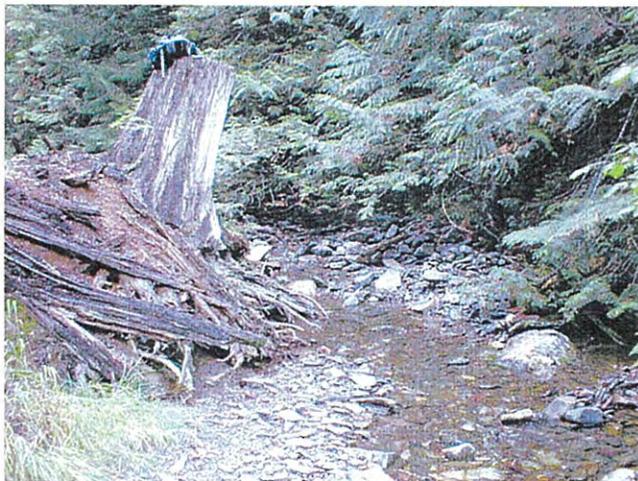
Forested hummocks pile and cedar forest on Subreach 4

Subreach 4 ranges from 3,406 to 3,375 feet in elevation. This 430 feet long subreach is confined on the right side by relatively high embankments and an old road. The left side is open, containing a wide cobbled floodplain. Forested hummocks (tailings piles) and cobble piles are interspersed throughout the floodplain as a result of aggradation. Subreach 4 is characterized as a boulder/log cascade sequence with a moderate (seven percent) incline. It is also classified as a Western Redcedar/ Lady Fern habitat type.

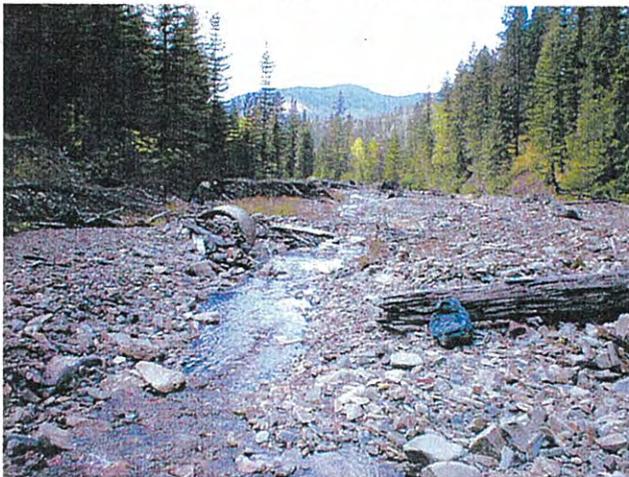
Subreach 7 is also located within a wide cobble floodplain. The top of Subreach 7 is 3,142 feet in elevation. The bottom of the subreach, at 3,068 feet in elevation, is at the confluence of Beaver and Carbon Creeks. Its lower end is populated with tailings and cobble piles. This approximately 1,500 feet long reach has a moderate incline (five percent) with numerous high flow scour channels. The wide, rocky floodplain associated with this subreach is sparsely vegetated. There are, however, a few bermed areas with grasses, forbs, and conifers. An estimated 30 percent of Subreach 7 is dominated by the Western Redcedar/Lady Fern habitat type. An additional 70 percent is categorized as an unclassified habitat type that is dominated by cobbles. This subreach lacks fine soil material.

Wide cobble floodplain on Subreach 7

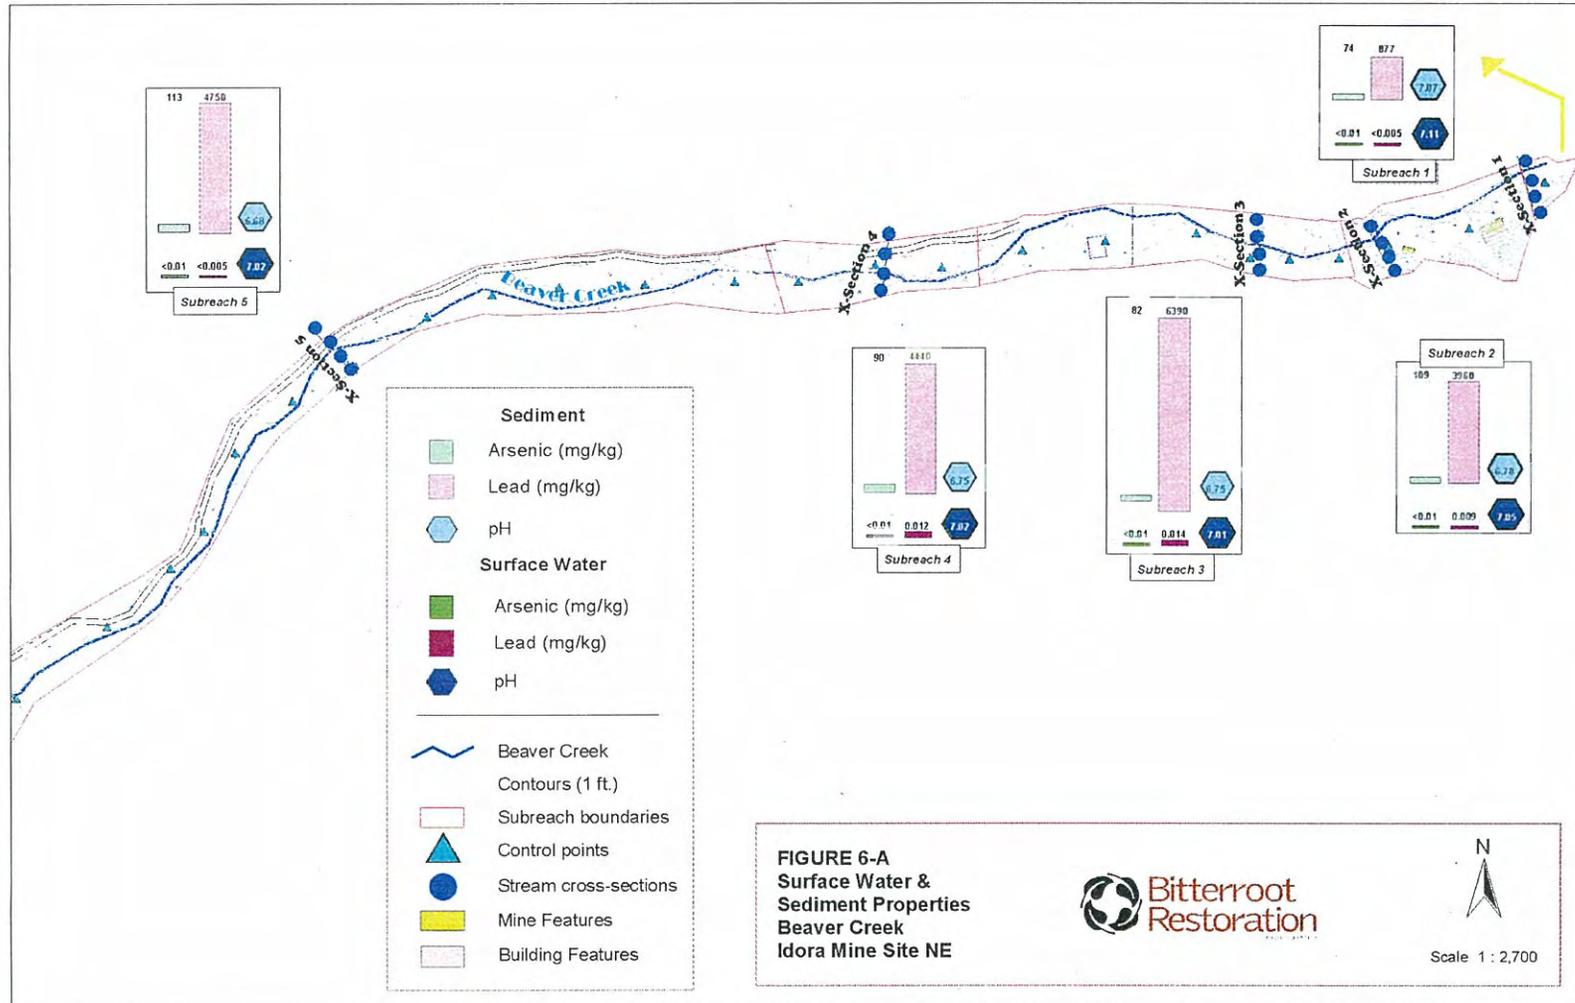
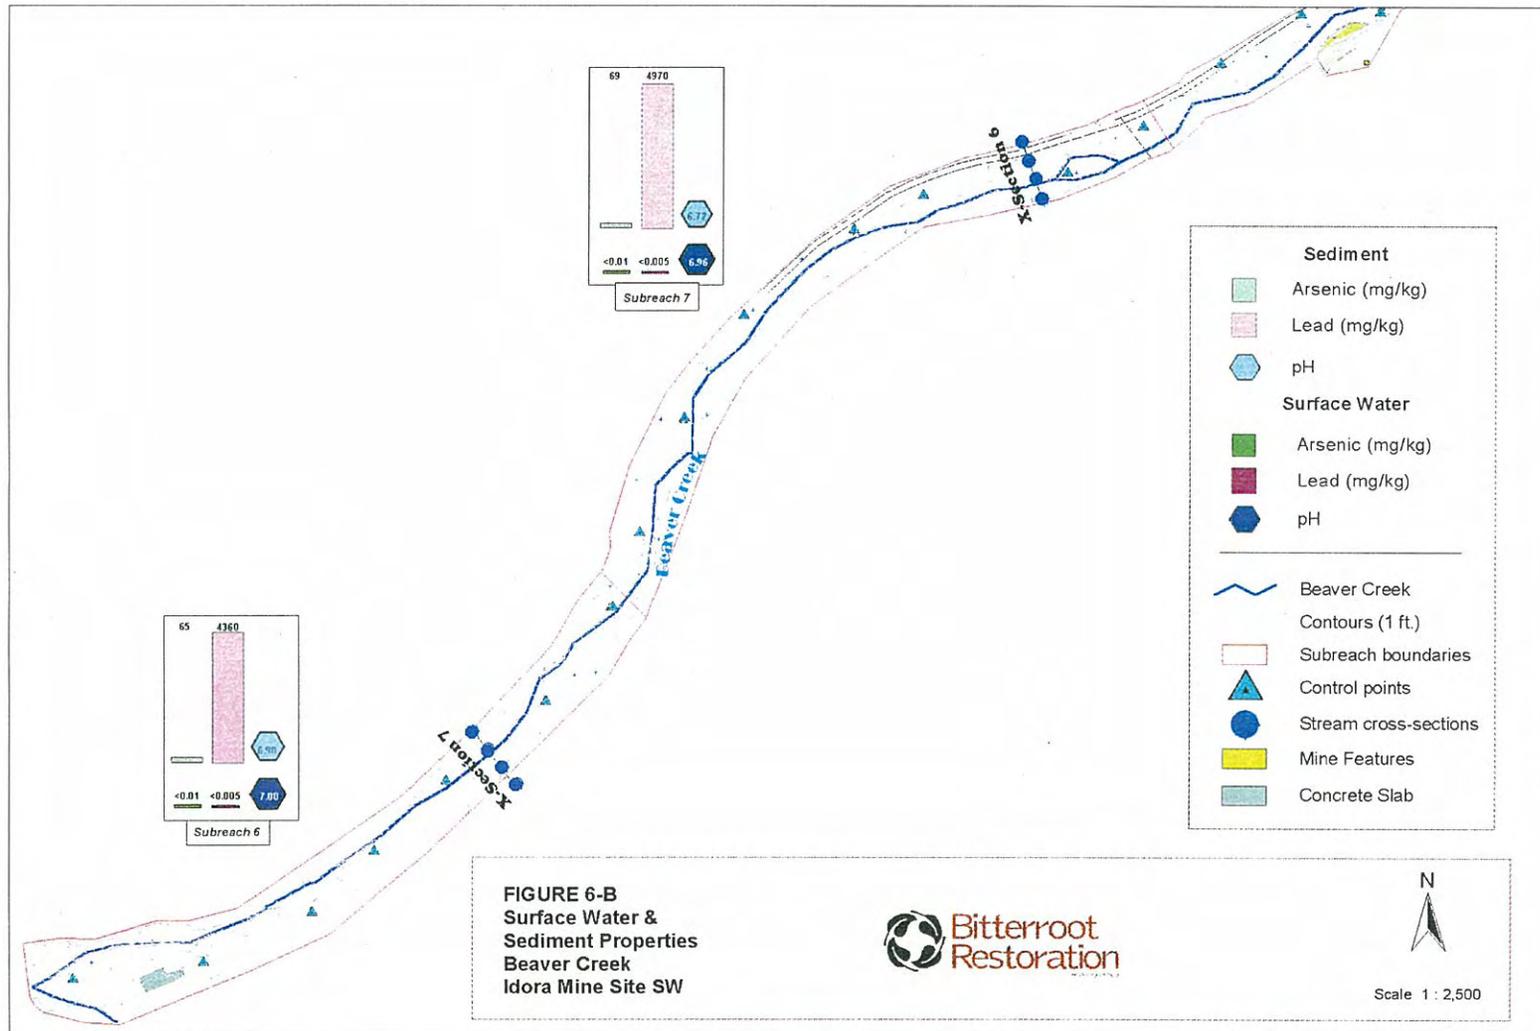
Seven sediment samples were collected and analyzed for total metals, pH and conductivity. These results (see Table 7.10 and Figures 6-A and 6-B) indicate that, like surface soil/mine waste samples, a significant percentage of streambed samples contained high concentrations of lead. Although other metal concentrations are elevated, they do not exceed the recommended thresholds for recreational users.
