Second Five-Year Review Report

Triumph Mine Tailings Piles Site

Blaine County, Idaho

May 27, 2009

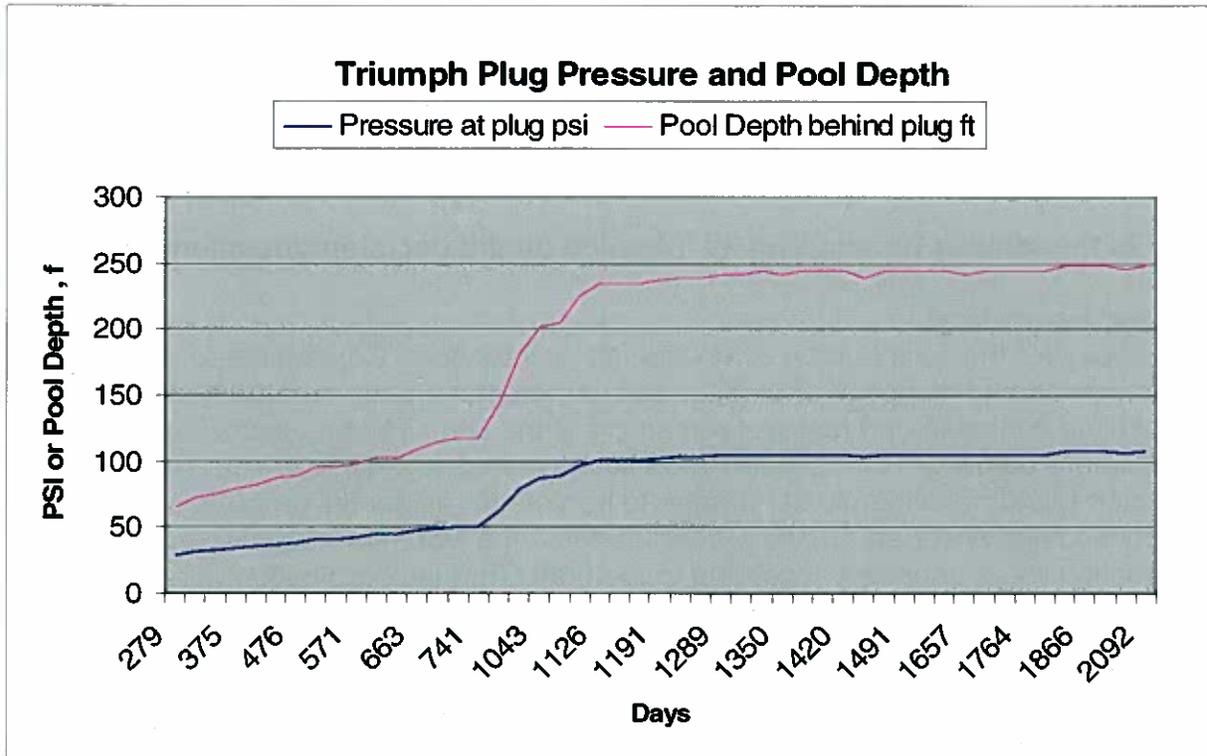
Figure 2. Triumph Mine Plug Pressure and Pool Depth Measurements.

Water pressure behind the mine plug continues to be monitored. Measurements taken from the date of plug installation (August 28, 2003) show that it took about 2 years (to July 2005 or 697 days after plugging) to reach about 50 pounds per square inch (psi) (Figure 2). The pressure stayed the same for about another half-year, and then began

a steady increase to a little over 100 psi in September 2006, 1,126 days after plugging. Since then, pressure has only slightly increased, to 110 psi, during the past two years. The mine water pool behind the plug seems to have stabilized, but will continue to be monitored. Seep surveys will also continue to be implemented. These are conducted in the late summer or early fall when green vegetation serves as an indicator for possible seeps.

Mine Water. The remaining components of the Mine Water remedy need to be implemented. A mine plug expert will likely need to be called in to assess the overall effectiveness of the plug and recommend next steps for ongoing O&M. DEQ intends to use expected Asarco bankruptcy settlement funds to address this task.
