NRCS CONSERVATION WORK

St. Joe & St. Maries Rivers
2009-2014

Prepared by: Keith Swallows
Soil Conservationist Technician
NRCS Field Office
Plummer, ID

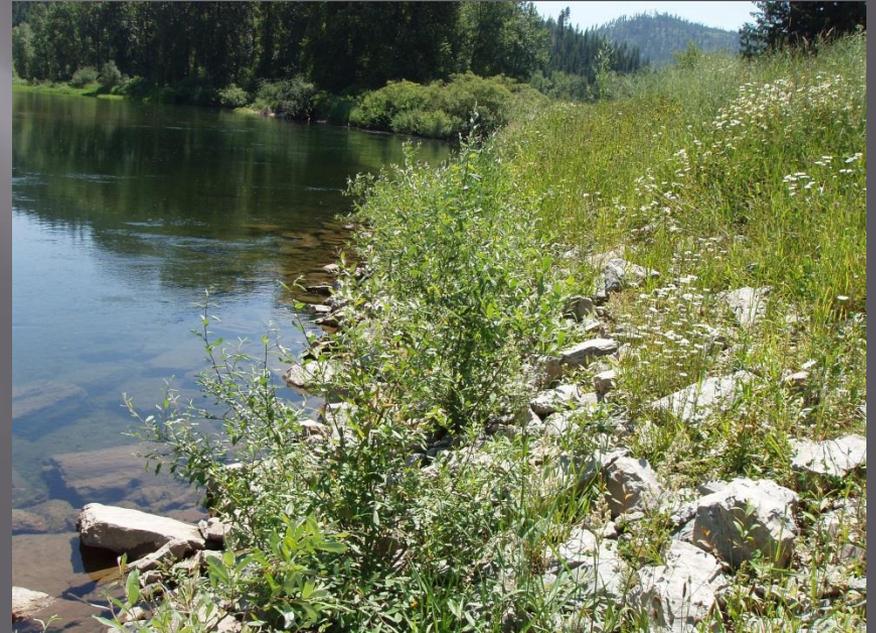
5 Years After Treatment

Willows and grass have almost fully established along protected bank.

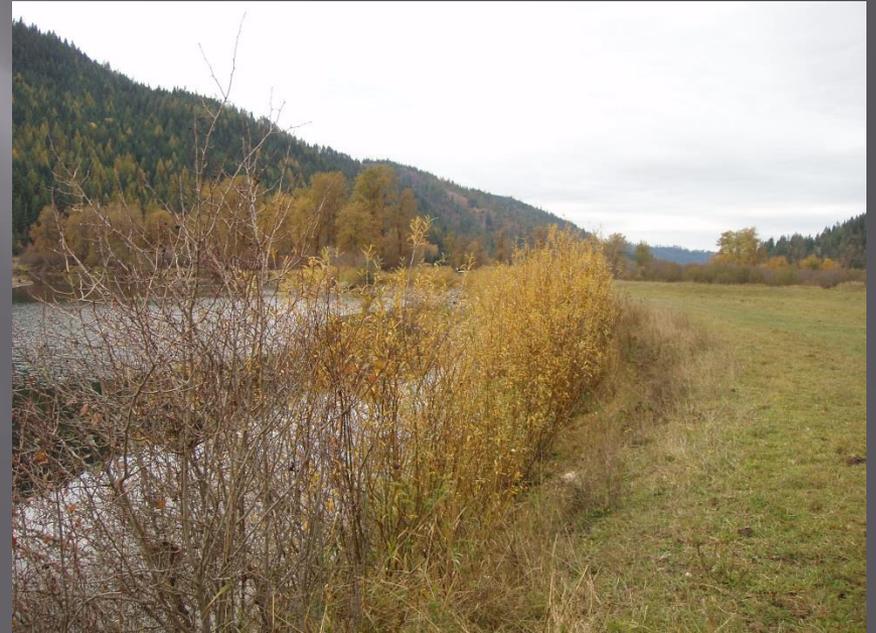
4 Years After Treatment

Willows have grown 6 feet in 4 years!

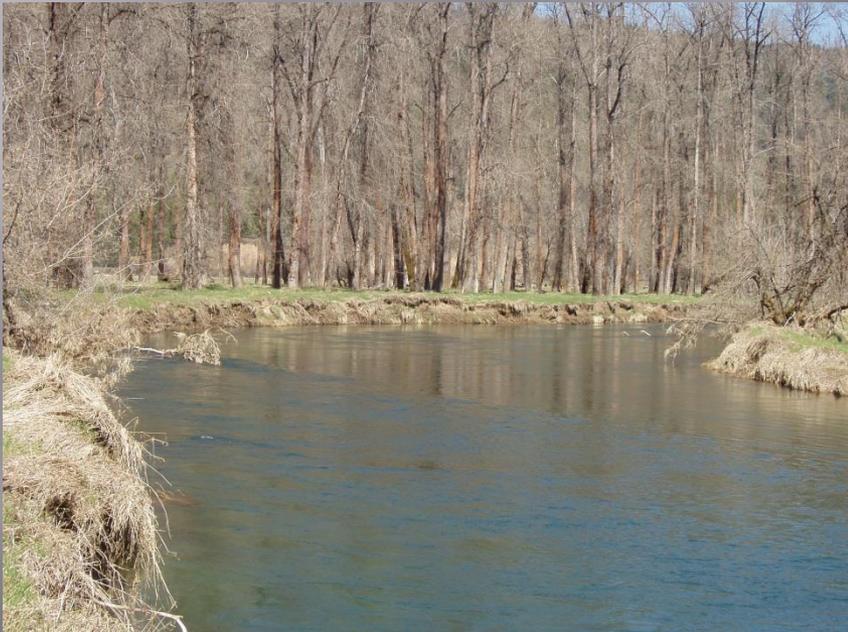
Before Treatment

Sloughing banks during Spring runoff. Bank erosion pins showed up to 15ft of bank was lost in some areas!

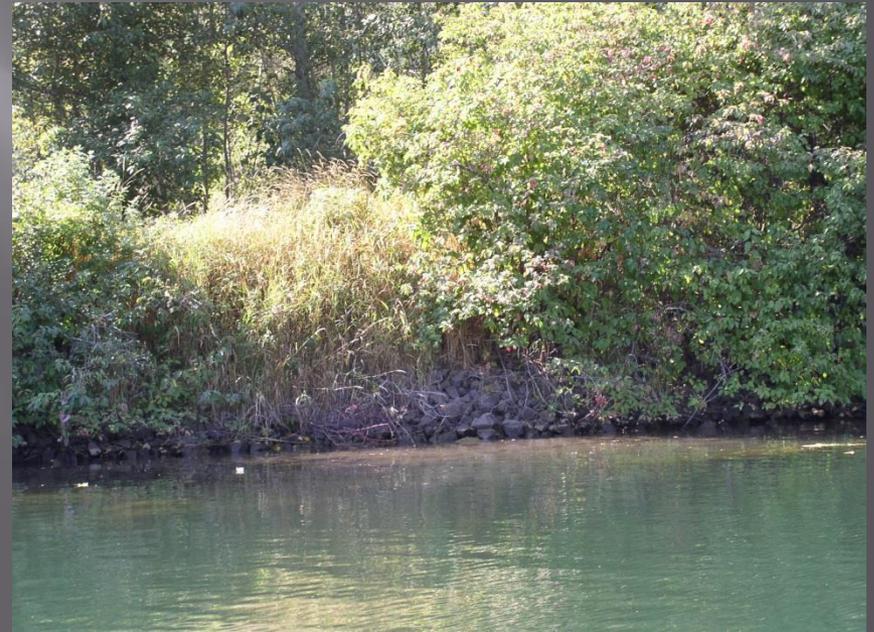
8 Years After Treatment

Planted vegetation & grass has almost entirely covered the rock and no erosion has occurred since treatment.
