# **Pahsimeroi River Subbasin Assessment and Total Maximum Daily Load**

2013 Addendum and Five-Year Review

(Hydrologic Unit Code 17060202)

**State of Idaho  
Department of Environmental Quality**

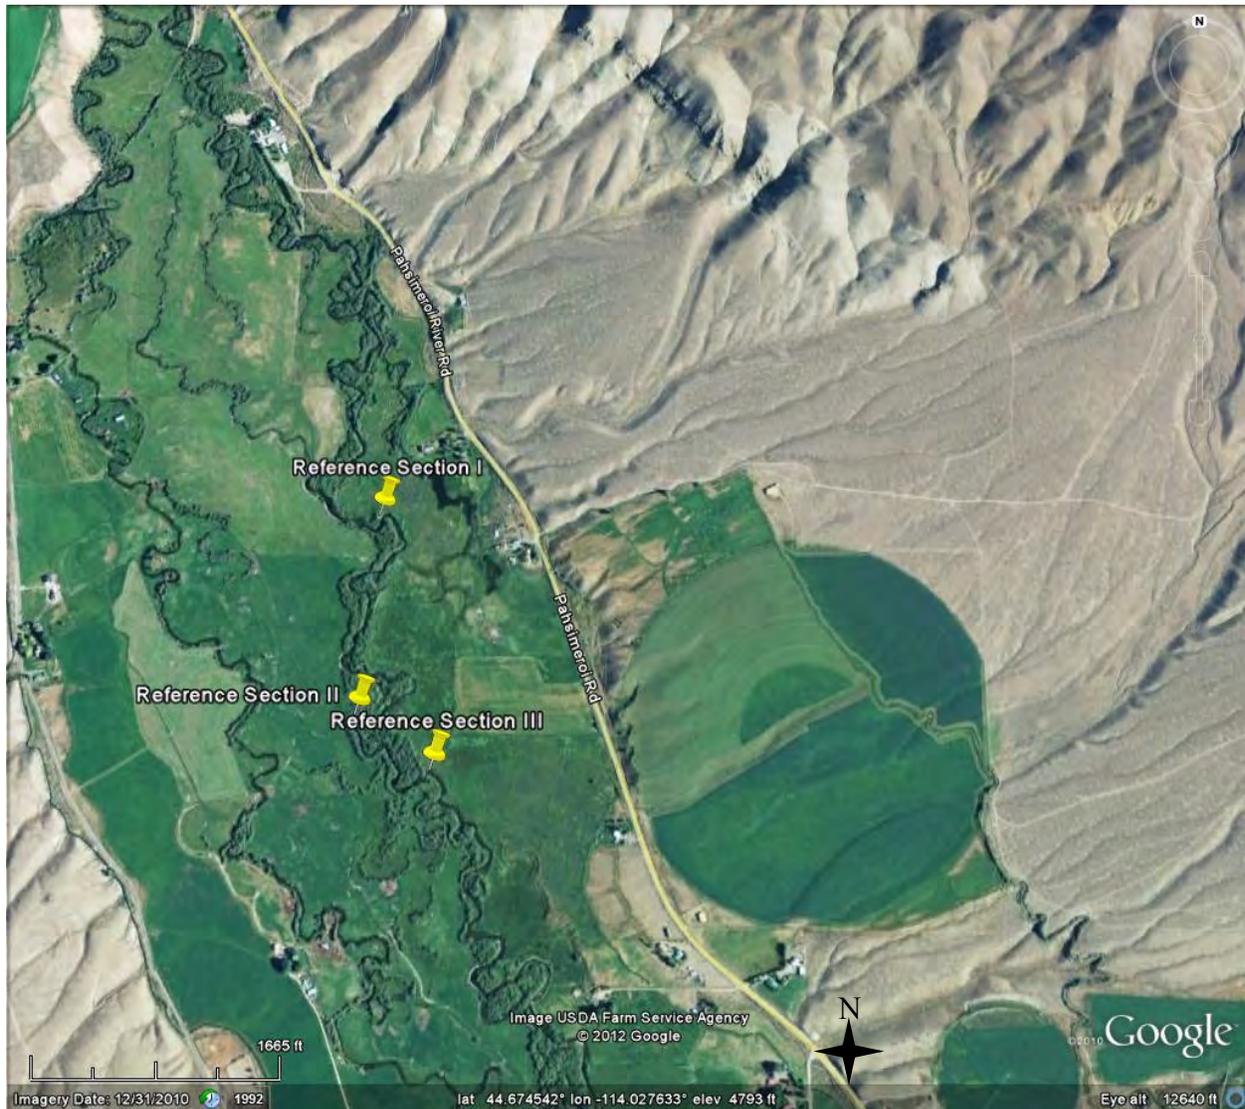
Figure 12. Map identifying locations for comparison of exclosure effects.

Between Ellis Lane and Burdstedt Lane in the AU Pahsimeroi River - Patterson Creek to mouth ID17060202SL001\_05 exclosures were added to limit cattle access to the vegetation and the river. Near-river vegetation has improved and become denser. Figure 12 is an aerial photo depicting the Pahsimeroi River subbasin upstream of the confluence with the Salmon River (north—off of photo) where exclosures were installed (NAIP 2011). Figures 13 to 15 depict the locations on a smaller scale and illustrate the before and after effects of the exclosures. The before photos were taken prior to the development of the 2001 TMDL.

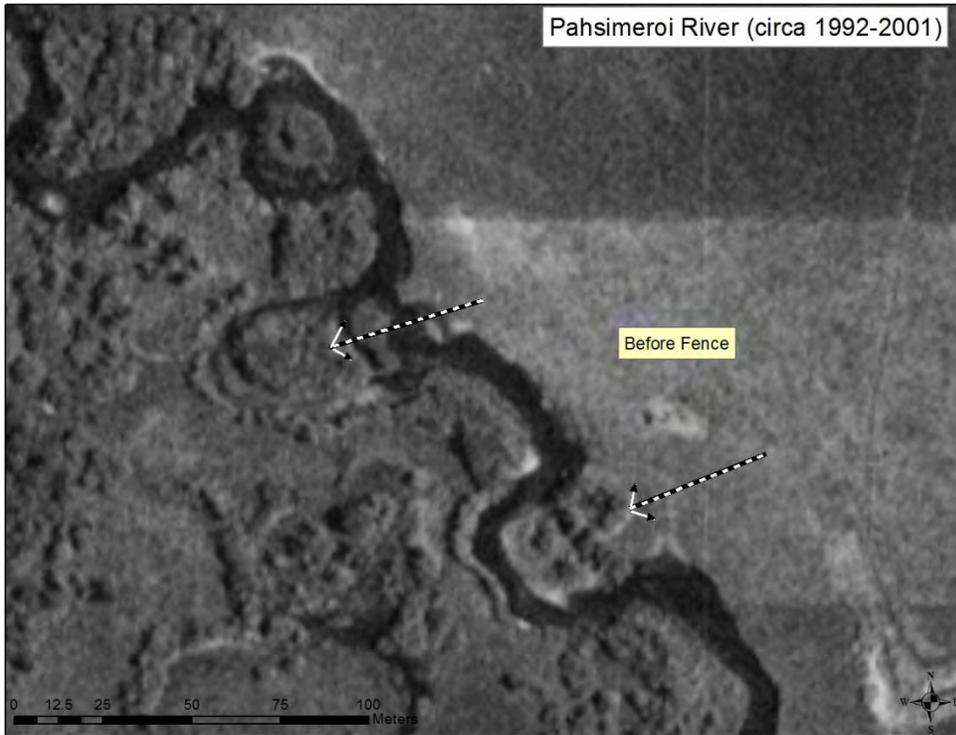
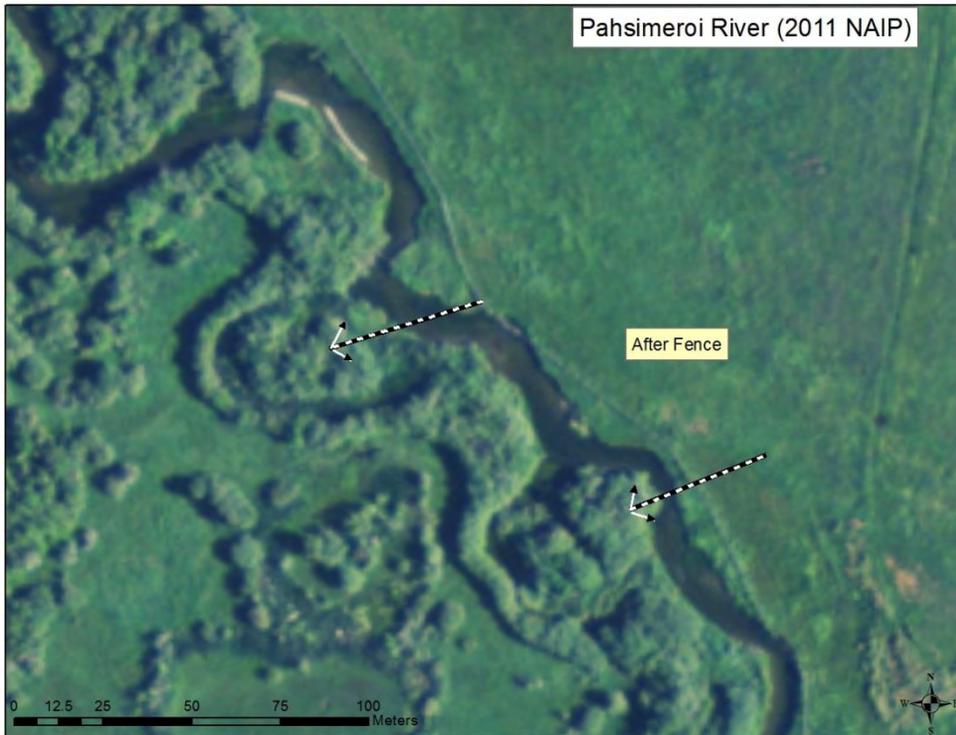
Figure 15. Reference Section III with arrows added to indicate and highlight areas of changing vegetation density before and after fence development.

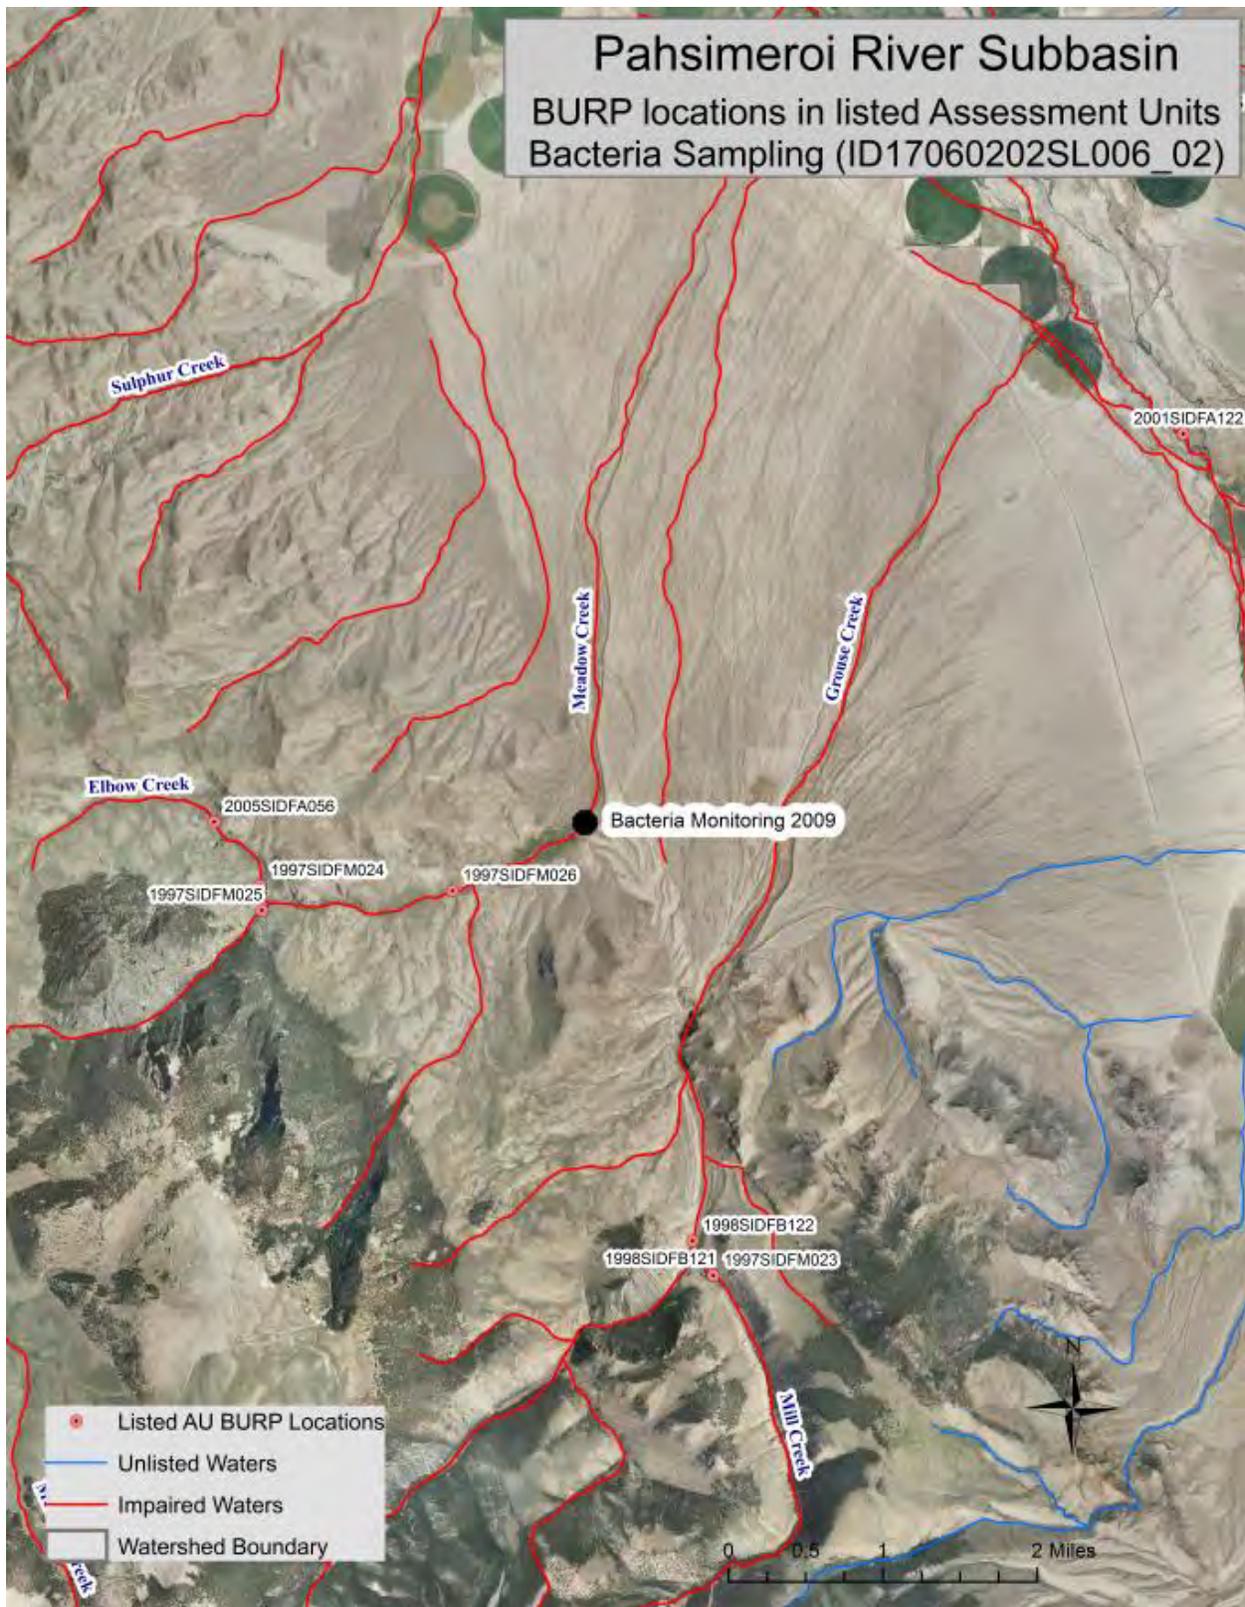
Figure 32. Bacteria monitoring—first- and second-order tributaries in AU ID17060202SL006\_02 (Meadow Creek).

The Meadow Creek – source to mouth (ID17060202SL006\_02) (Figure 32) consists of 1st- and 2nd-order tributaries, including Meadow and Grouse Creeks. The current *E. coli* geometric mean for this AU is within the State of Idaho standard. This AU is listed at Category 4c as there are in-holdings within the BLM lands. The 2009 *E. coli* monitoring below this in-hold, when water was present, found that the number of organisms was within the acceptable limits. This in-holding has been improved and further developed since 2001, as indicated by alterations in the road around the property. Of the 5 samples collected, none exceeded 25 organisms/100 mL; the geometric mean was 10 organisms/100 mL in August 2009 (Table 36). As such, this AU does not need a bacteria TMDL, but DEQ recommends that monitoring be conducted to confirm the on-going land use modifications.

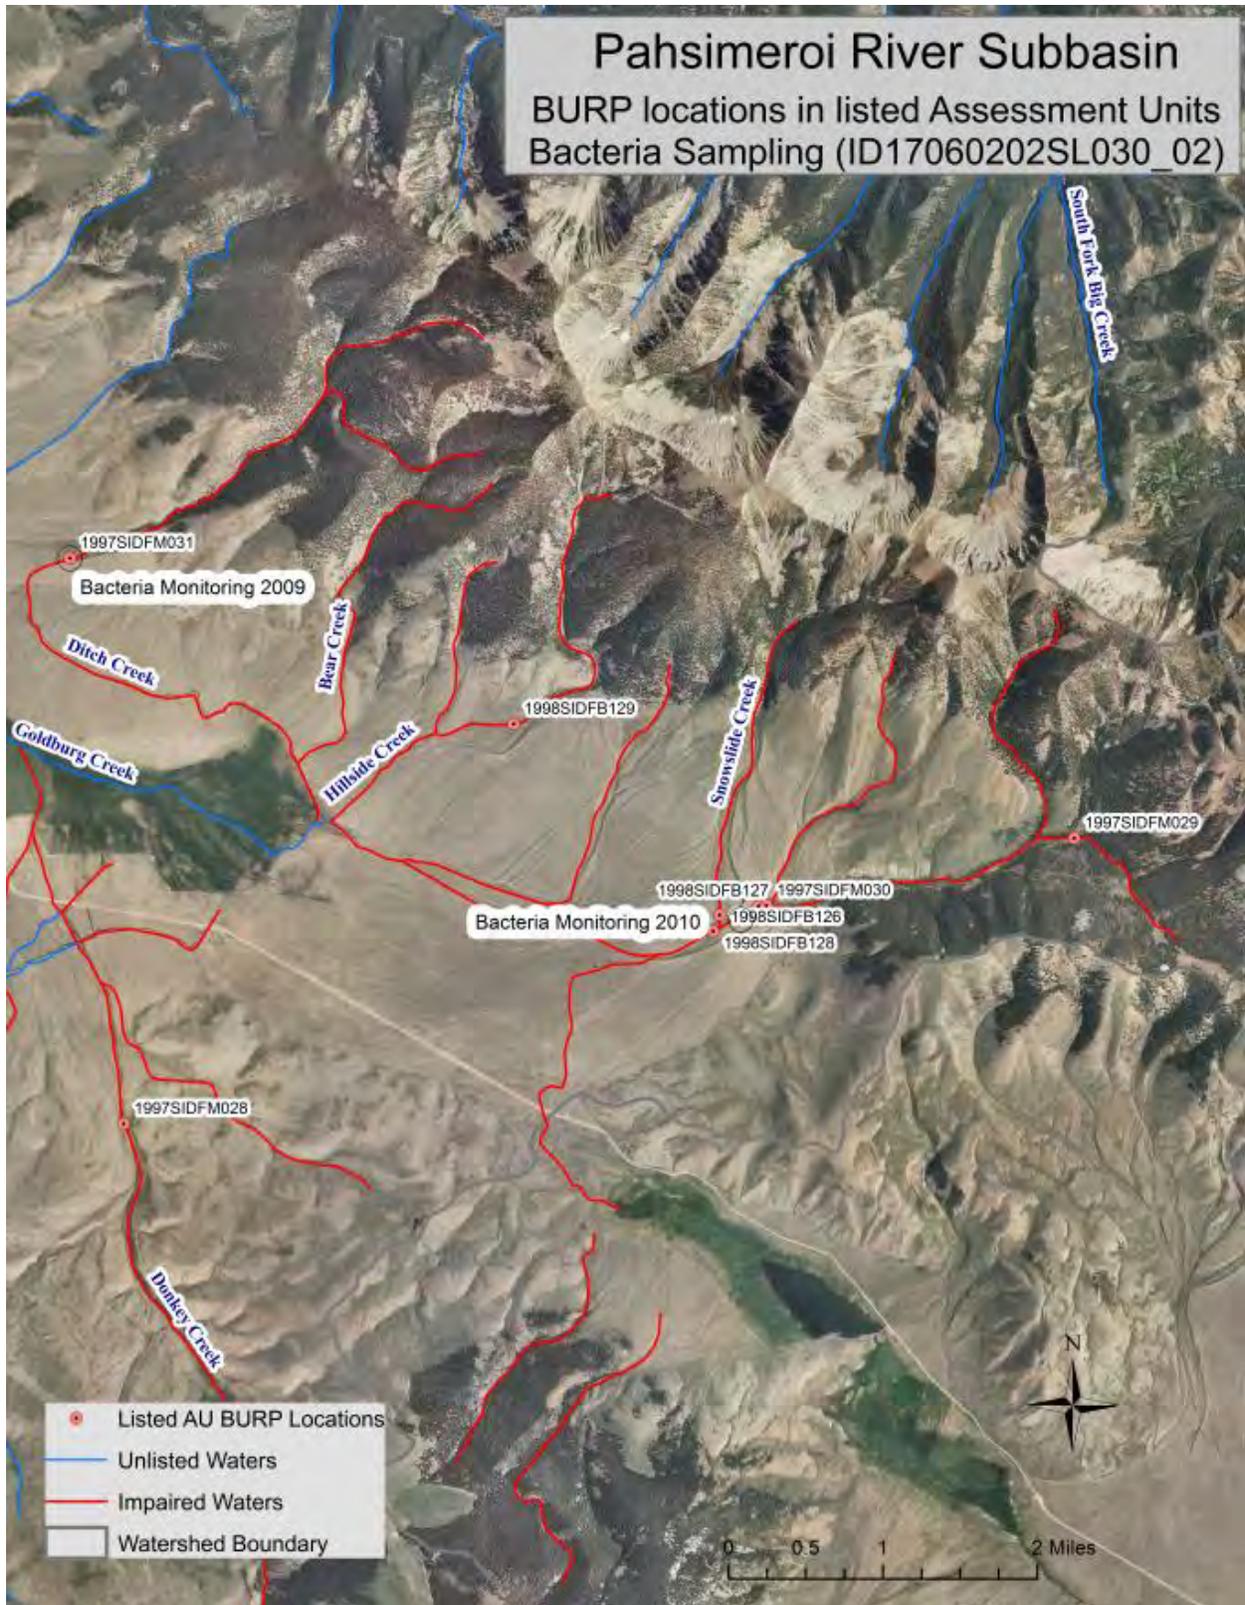
Figure 33. Bacteria monitoring—first- and second-order tributaries in AU ID17060202SL030\_02 (Goldburg Creek and tributaries).

The Goldburg Creek – source to Donkey Creek (ID17060202SL030\_02) (Figure 33) consists of multiple 1st- and 2nd-order tributaries, for example Meadow and Grouse Creeks. The *E. coli* geometric mean of 21 organisms/100 mL in 2009 for this AU is within the State of Idaho standard (Table 36). As such, this AU does not need a bacteria TMDL developed. These streams cross BLM land and State of Idaho land. The BLM has made concerted efforts to modify grazing allotments when stream reaches are listed in the Integrated Report and these modifications have been incorporated into the Upper Pahsimeroi and Goldburg Ten Year Grazing Permit Renewal EA (#ID-330-2007-EA-3275) (BLM Challis Field Office, personal communication, November 2012). Exclosure fences have also been installed to limit livestock access to the stream and limit bacteria pollution (K. Bragg, CSWCD, personal communication, January 2013).
