**Helena Site/ South Peacock Mine
Preliminary Assessment Report
Adams County, Idaho
TDD: 99-02-0009**

Contract: 68-W6-0008
February 2000

SUBJ: Site Recommendations
Helena/ South Peacock Mine Site
Council, Idaho

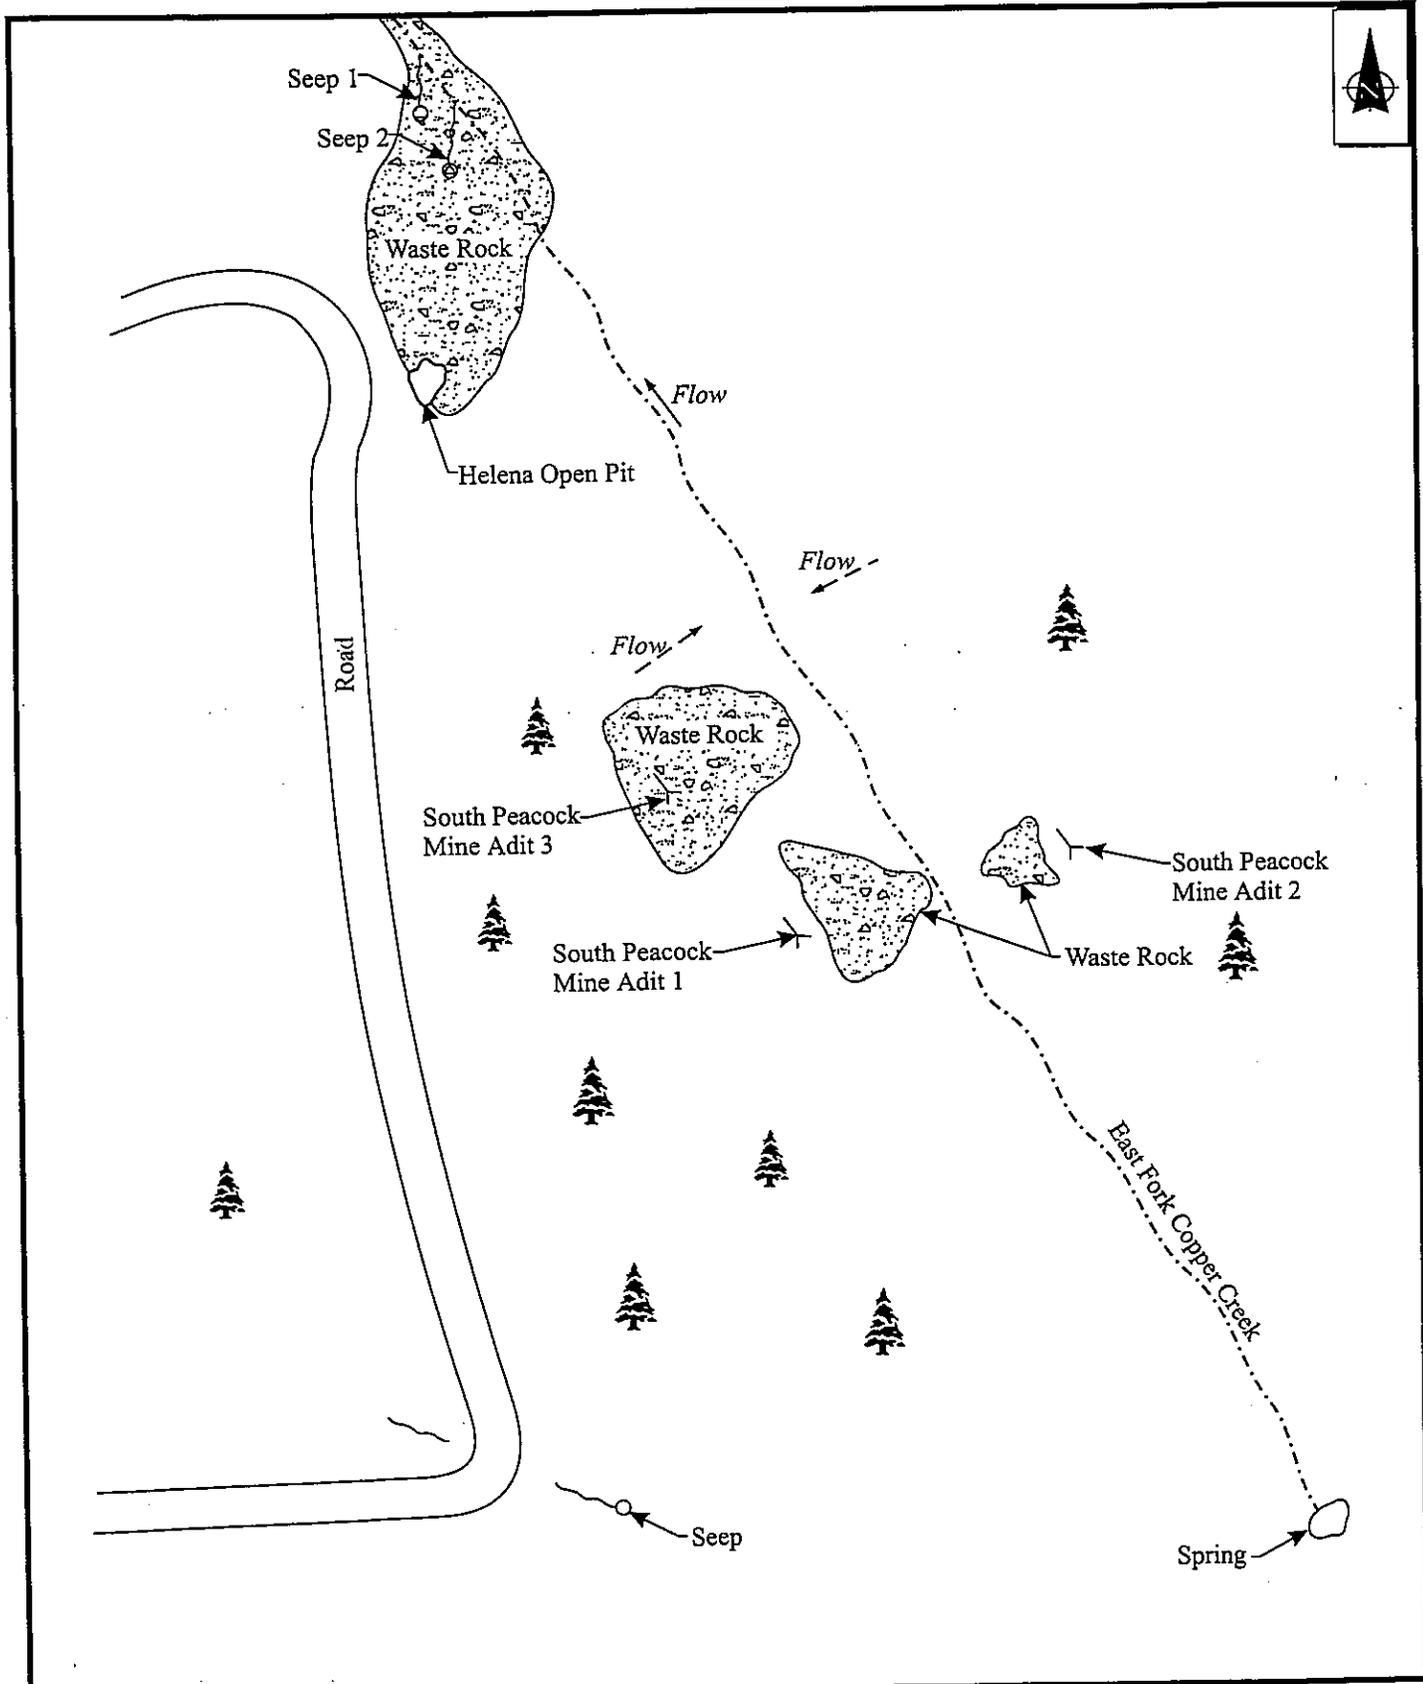
Figure 2-3
 SITE MAP

The sites are not fenced or gated and access is unrestricted. There are no structures or buildings present at either site. At the South Peacock Mine, there are two adits on the west side of the East Fork of Copper Creek, and one adit on the east side (Figure 2-3). The Helena Site is a large open pit mine located on the west side of Copper Creek. The slope at these sites ranges from 15 to 25 degrees (USGS 1990a).

The East Fork of Copper Creek flows through both the Helena and the South Peacock sites. At the South Peacock Mine site, which is upgradient of the Helena Mine site, each waste rock has its own probable point of entry (PPE; PPEs No. 1, 2, and 3). No seeps are associated with either the waste rock piles or the three adits (Figure 2-3).

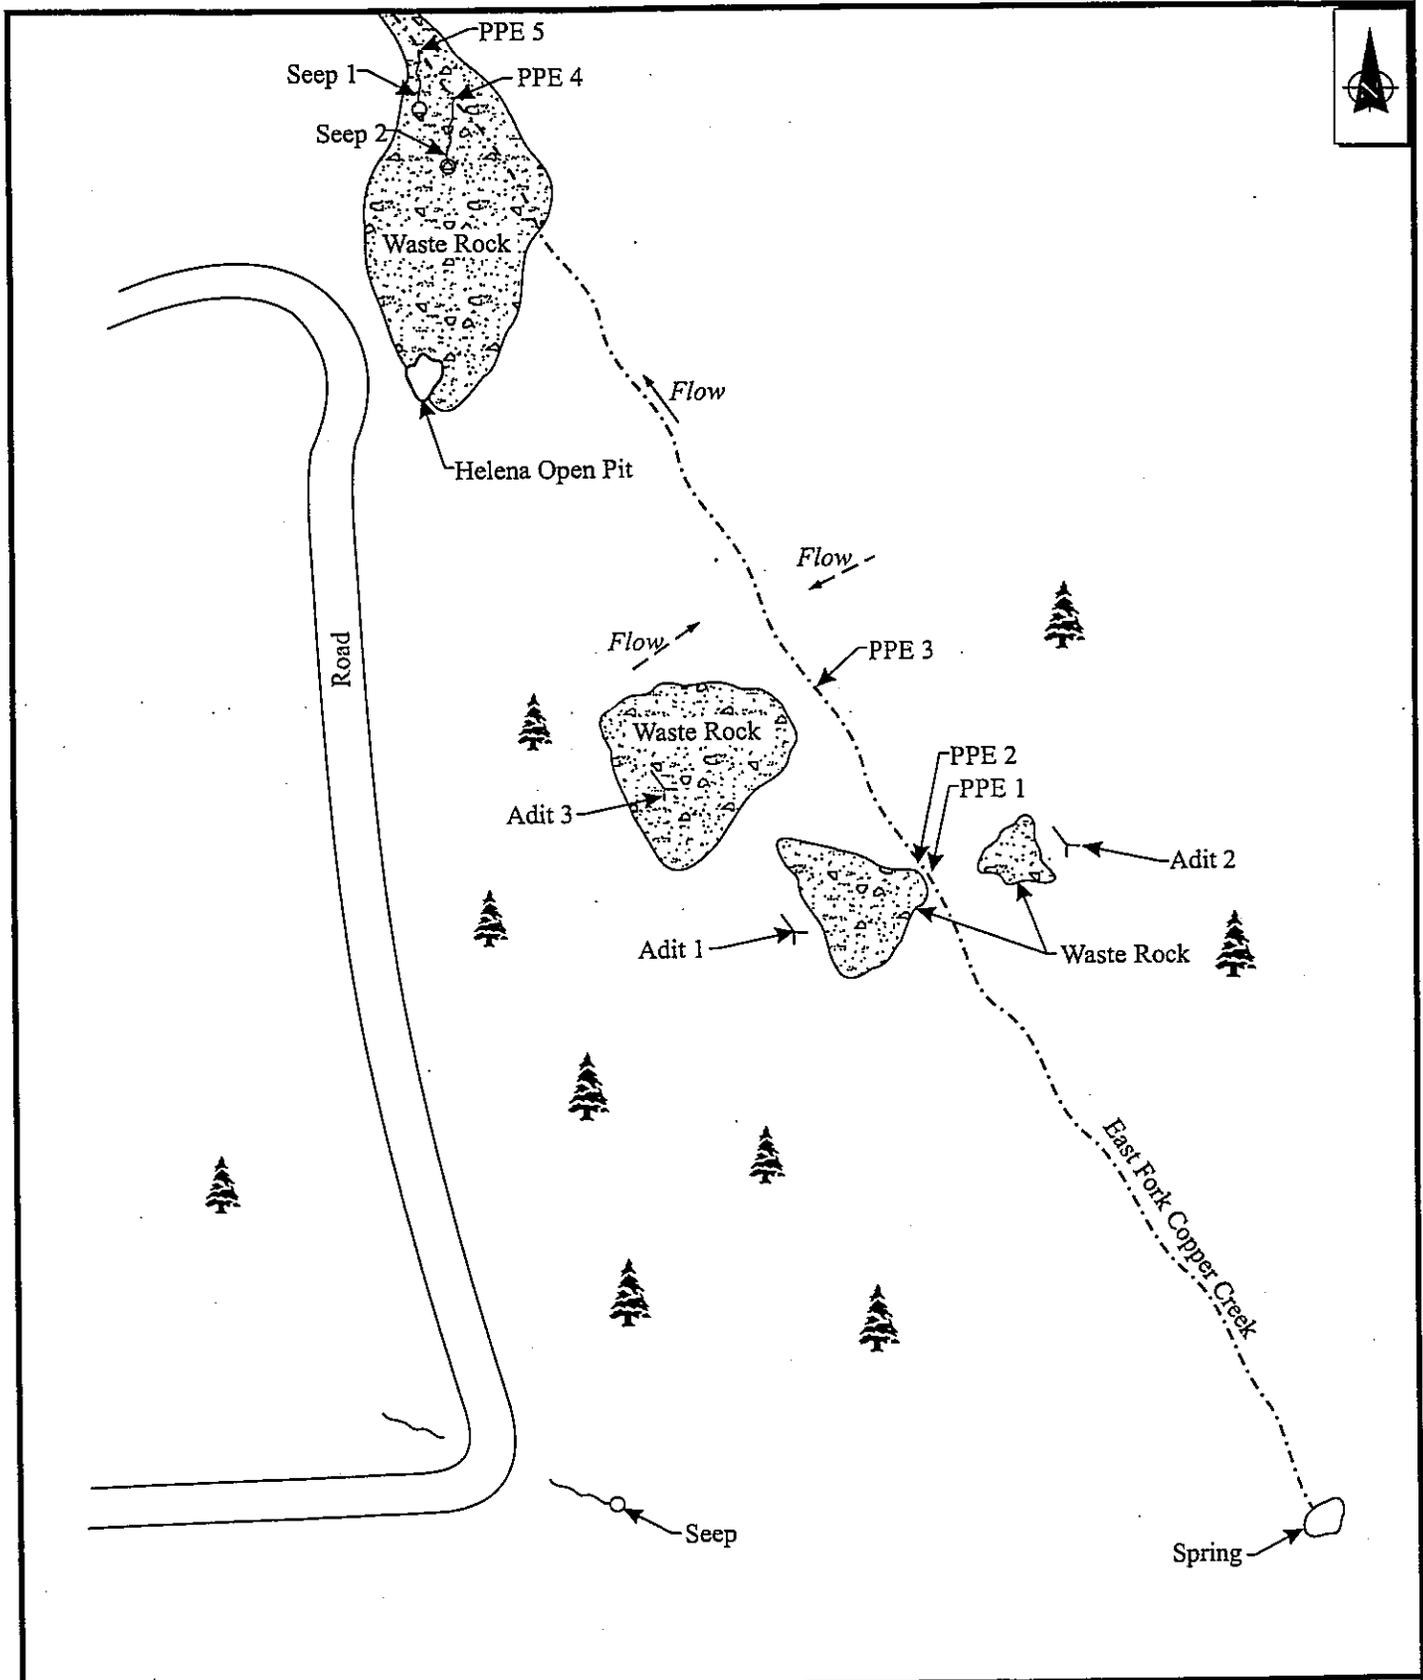
Figure 3-3
 SITE MAP

Copper Creek and flows downgradient into the creek. In both seeps, the START observed abundant algal and moss growth that was not observed in the main creek bed above the two seeps (Attachment A; photographs 16, 17, and 18). The points at which each seep enters the East Fork of Copper Creek are PPE 4 and PPE 5 (Figure 3-3). The target distance limit (TDL) begins at the PPEs and extends from PPE 5 in the East Fork of Copper Creek northward approximately 1.75 miles to Deep Creek. Deep Creek flows into the Snake River approximately 5.25 miles north of the confluence of Copper and Deep Creeks. The remainder of the TDL follows the Snake River for approximately 8 miles (Figure 3-2) (USGS 1990a and 1990b).

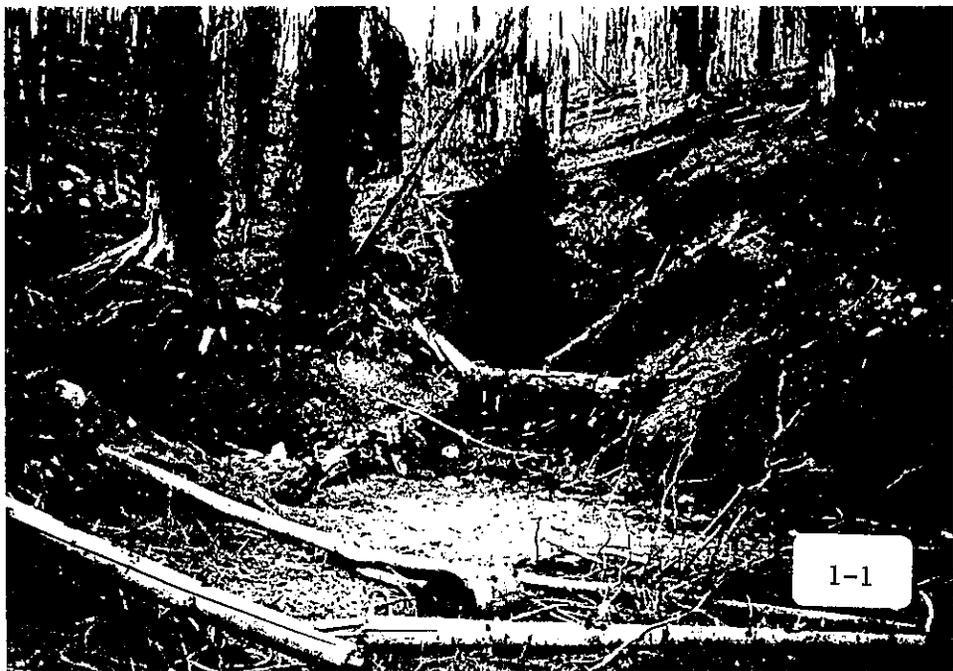
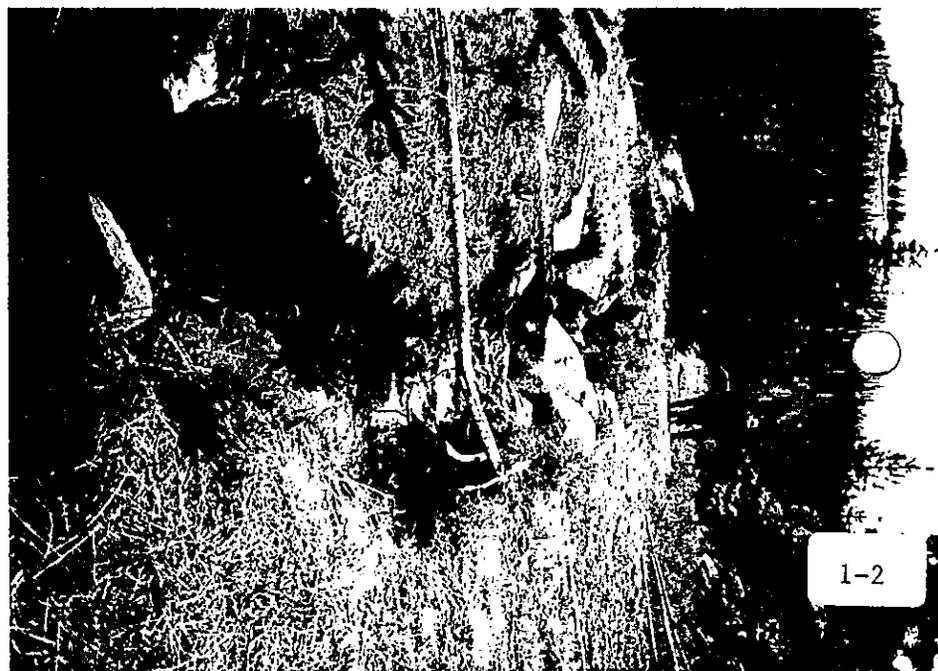
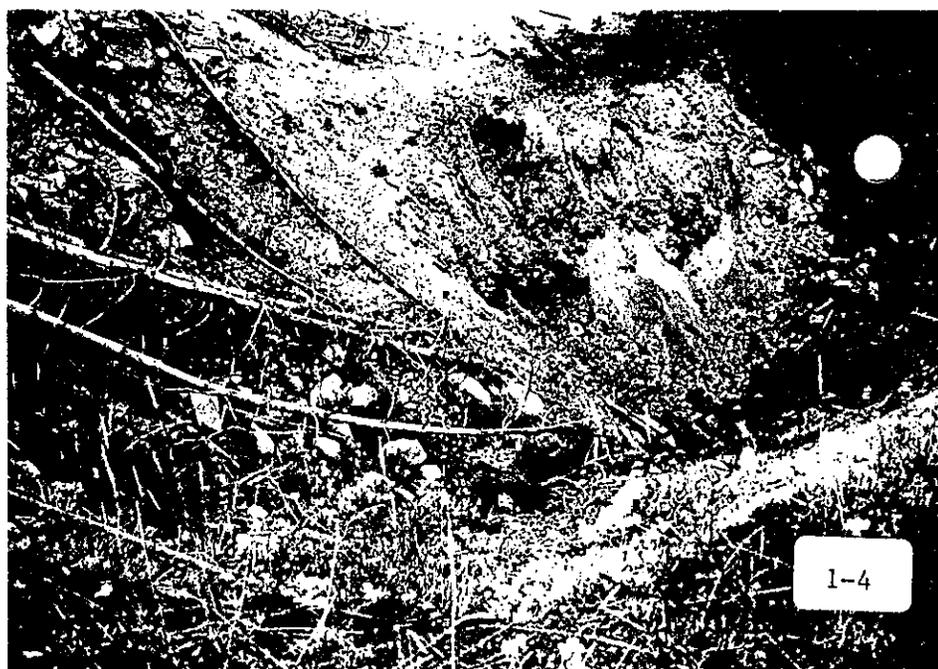
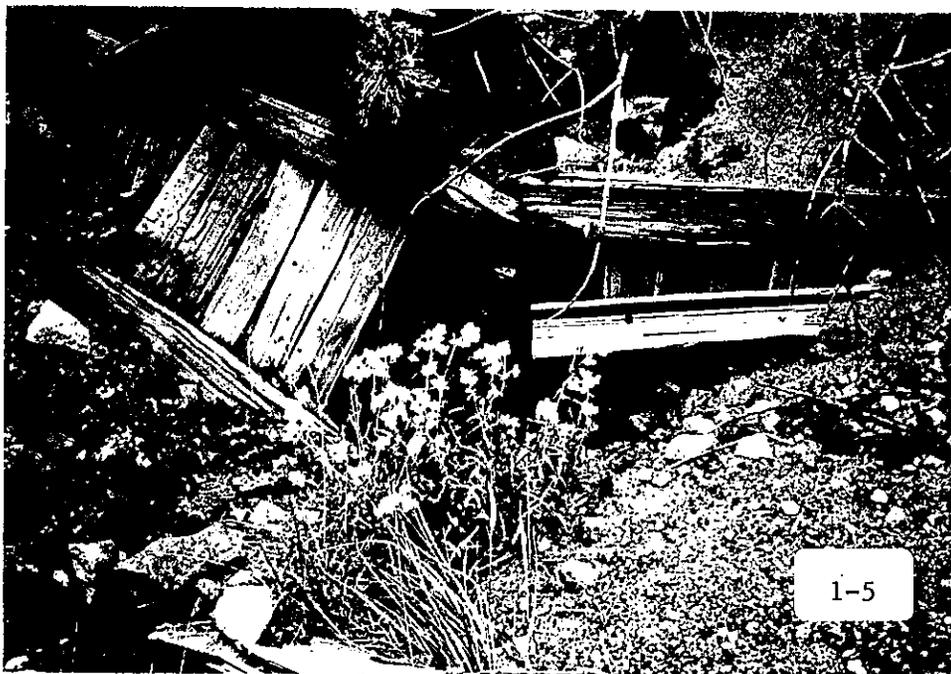
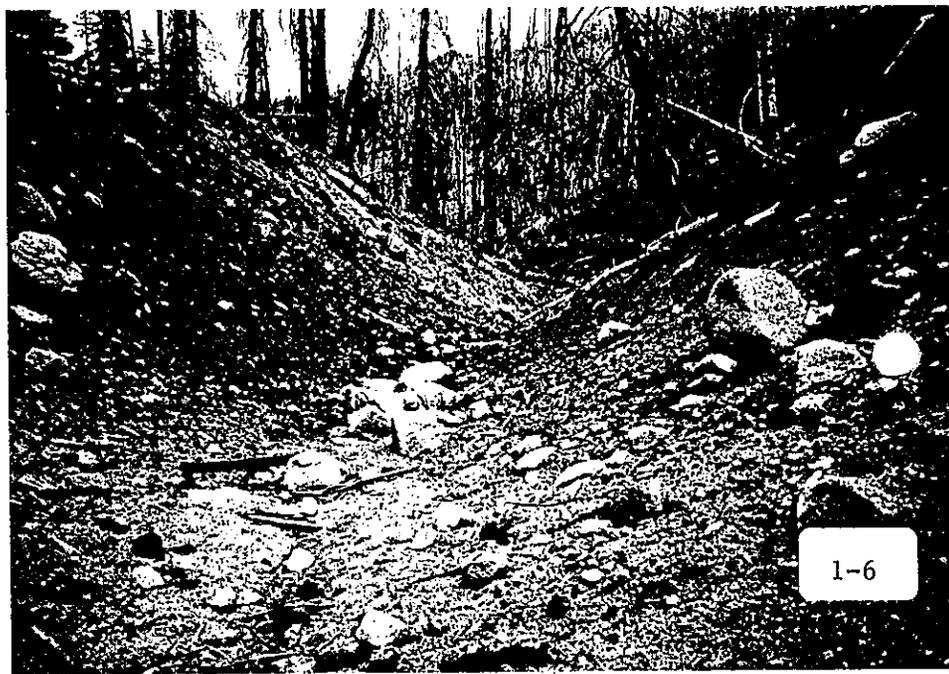
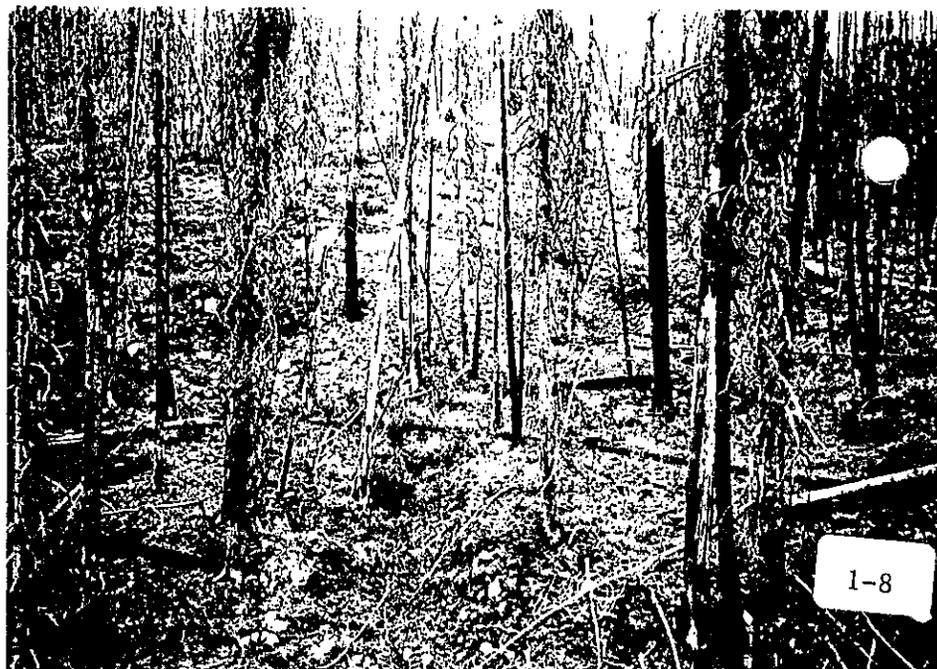
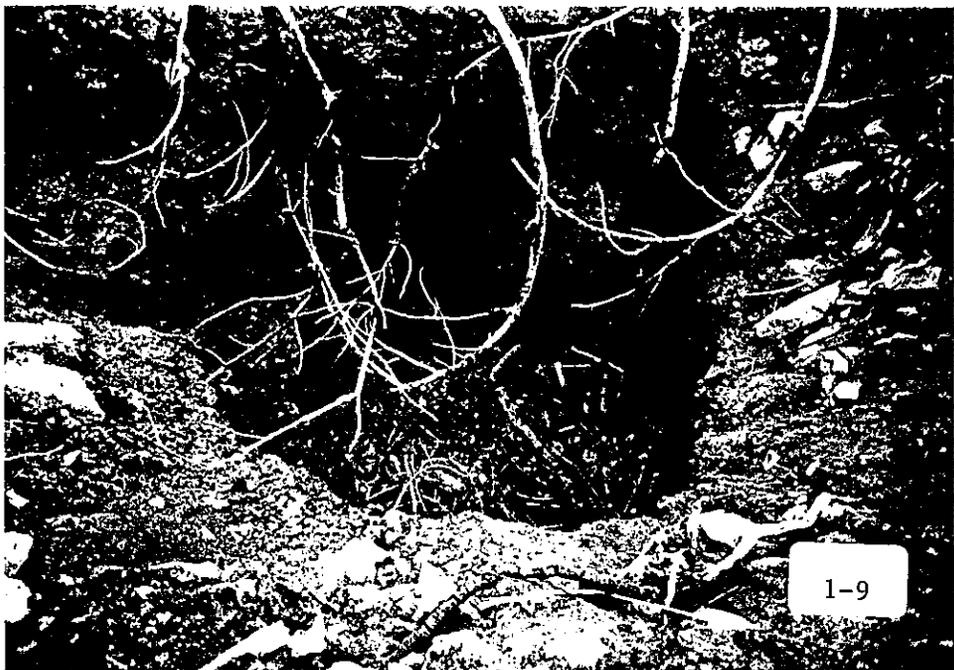
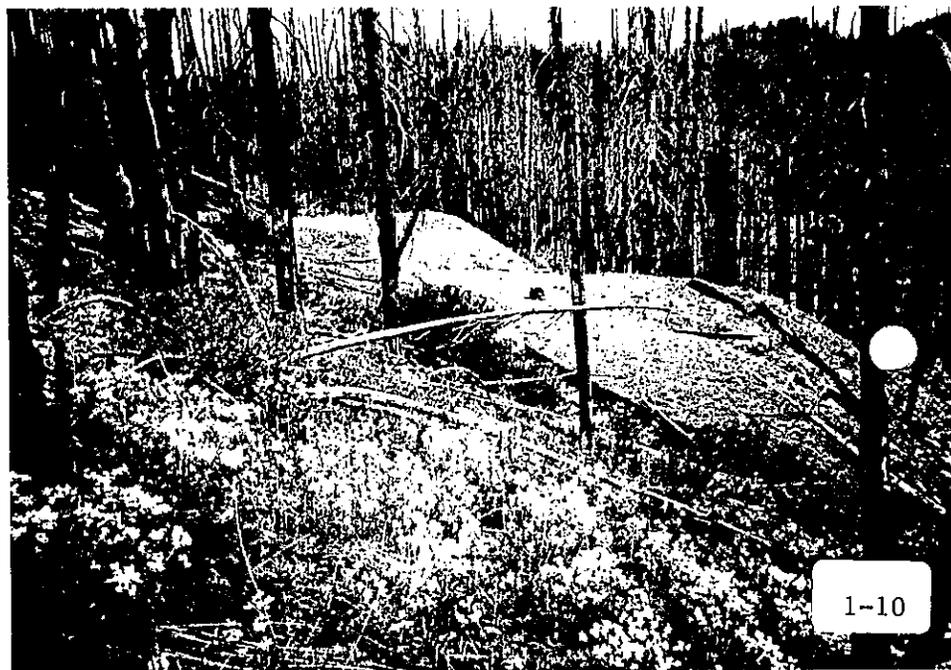
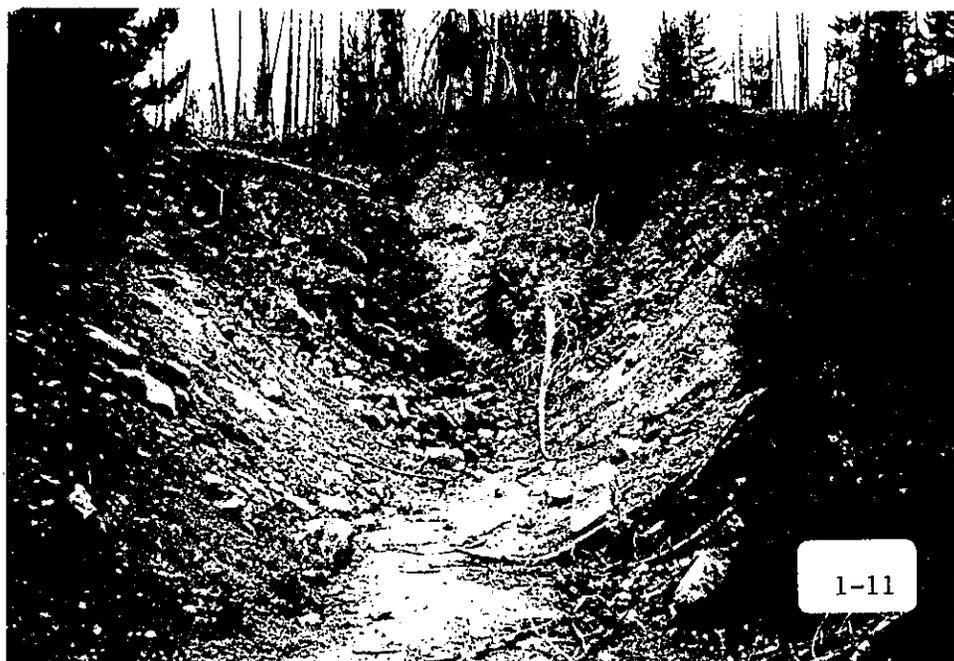
Photo No.	Direction	Date	Time	By	Description
1	E	10/7/99	13:45	LF	Possible adit with seep discharge, collapsed opening.
2	W	10/7/99	13:46	LF	Seep drainage.
3	Down	10/7/99	13:47	LF	Suspected waste rock at first adit, South Peacock Mine.
4	Down	10/7/99	13:57	LF	First adit, also collapsed with no observed discharge, South Peacock Mine.
5	Down	10/7/99	14:00	LF	Close-up of first adit, South Peacock Mine.
6	NW	10/7/99	14:03	LF	Waste rock at first adit, South Peacock Mine.
7	E	10/7/99	14:05	LF	East fork of Copper Creek which flows past the base of the adit waste rock drainage, South Peacock Mine.
8	E	10/7/99	14:07	LF	Second adit as viewed from the creek, South Peacock Mine.
9	Down	10/7/99	14:10	LF	Close-up of second adit, South Peacock Mine.
10	NW	10/7/99	14:23	LF	Waste rock near the third adit, South Peacock Mine.
11	SE	10/7/99	14:25	LF	View of third adit, South Peacock Mine.
12	E	10/7/99	14:27	LF	Close-up of third adit. No observed discharge, South Peacock Mine.

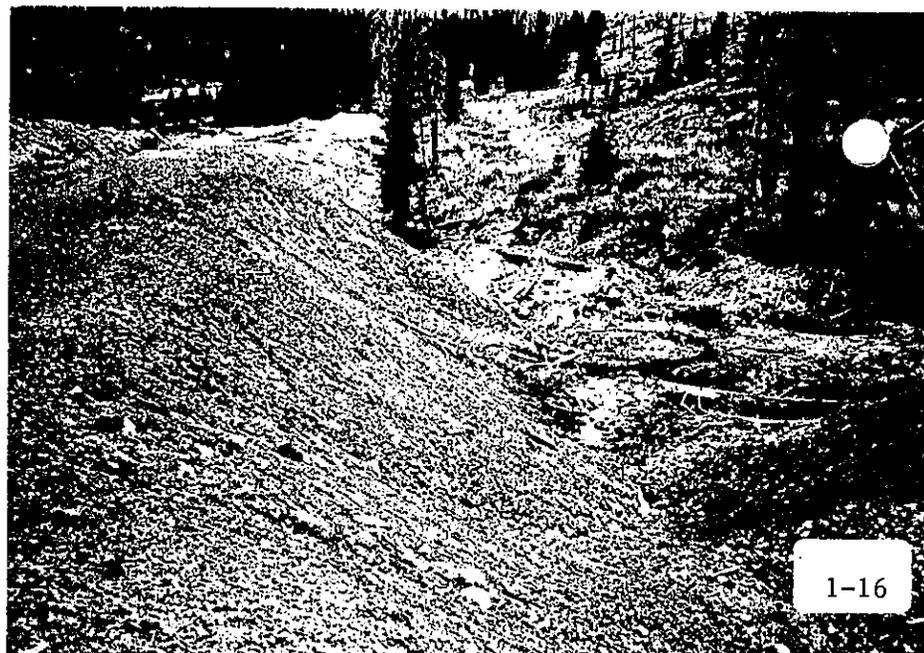
1-16

During the site visit, the START observed two separate groundwater seeps discharging from the waste rock pile at the Helena open pit. The first seep discharges approximately 30 feet above the East Fork of Copper Creek and flows downgradient into the creek. The second seep begins approximately 15 feet above the East Fork of Copper Creek and flows downgradient into the creek. In both seeps, the START observed abundant algal and moss growth that was not observed in the main creek bed upstream from the two seeps (Attachment A; photographs 16, 17, and 18). No other environmental concerns were noted by the START during the site visit.

13	Down	10/7/99	14:32	LF	Mine shaft, approximately 30 feet deep, South Peacock Mine..
14	E	10/7/99	14:40	LF	First photo of the Helena mine. Panoramic view of suspected mine pit.
15	S	10/7/99	14:45	LF	Mine pit at Helena site.
16	W	10/7/99	14:47	LF	Tributary to Copper creek adjacent to waste rock piles at Helena's open pit area (same creek as S. Peacock).
17	E	10/7/99	14:52	LF	Seep originating from waste rock, Helena Mine site. Flows to East fork of Copper Creek overland approximately 25 feet. Note algal growth.
18	Down	10/7/99	14:55	LF	Second seep originating in waste rock drainage, Helena Mine site. Note algal growth.
19	W	10/7/99	14:59	LF	East fork of Copper Creek from end of waste rock pile, Helena Mine site.
