Paris Canyon Mine
Preliminary Assessment Report Addendum
December 2009

Bear Lake County
State of Idaho

Department of Environmental Quality

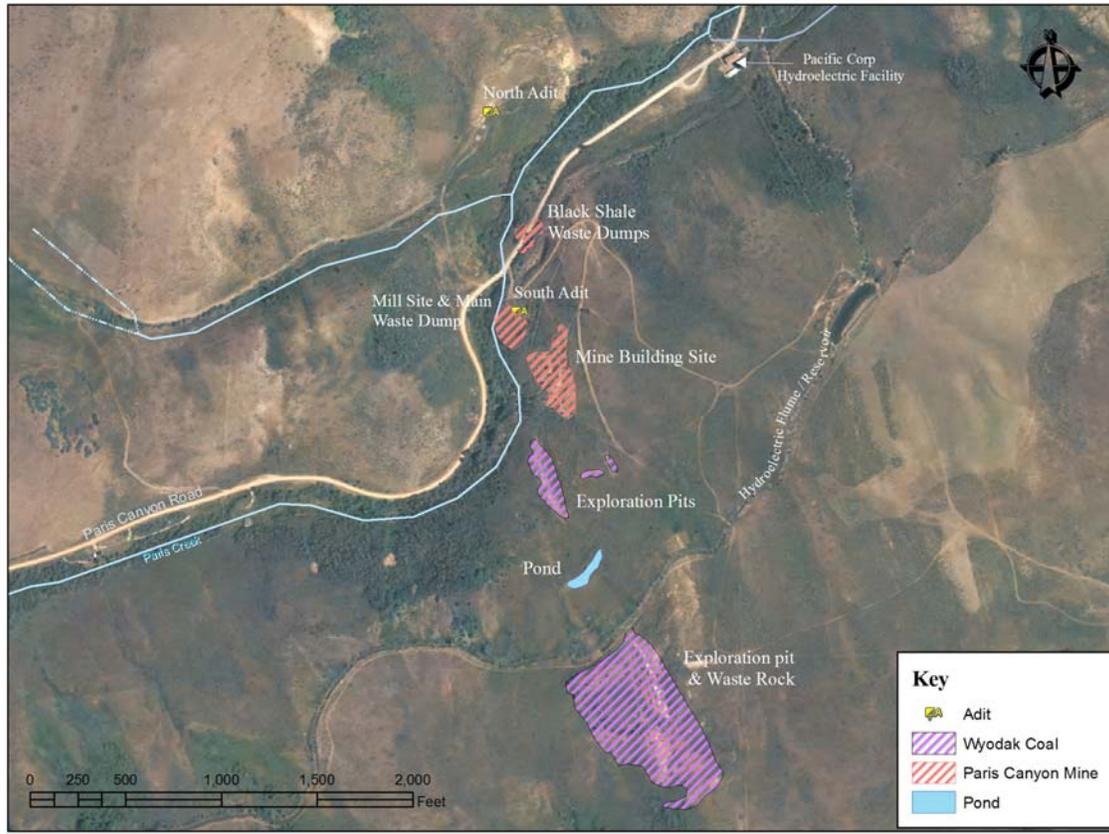
Figure 1. Paris Canyon Mine Site and Wyodak Coal Exploration Pits.

The main waste rock dump is located just east of the mill site. Figure 1 shows the location and approximate size of major mine features. The dump is composed of a mixture of waste rock and terminates within a few feet of Paris Creek. The main waste dump covers approximately ½ acre and contains less than 5,000 cubic yards (estimated) of waste rock. The vegetation is very lush on the waste dump and it does not appear likely that this area produces and delivers significant volumes of sediment to Paris Creek (Photo 4).

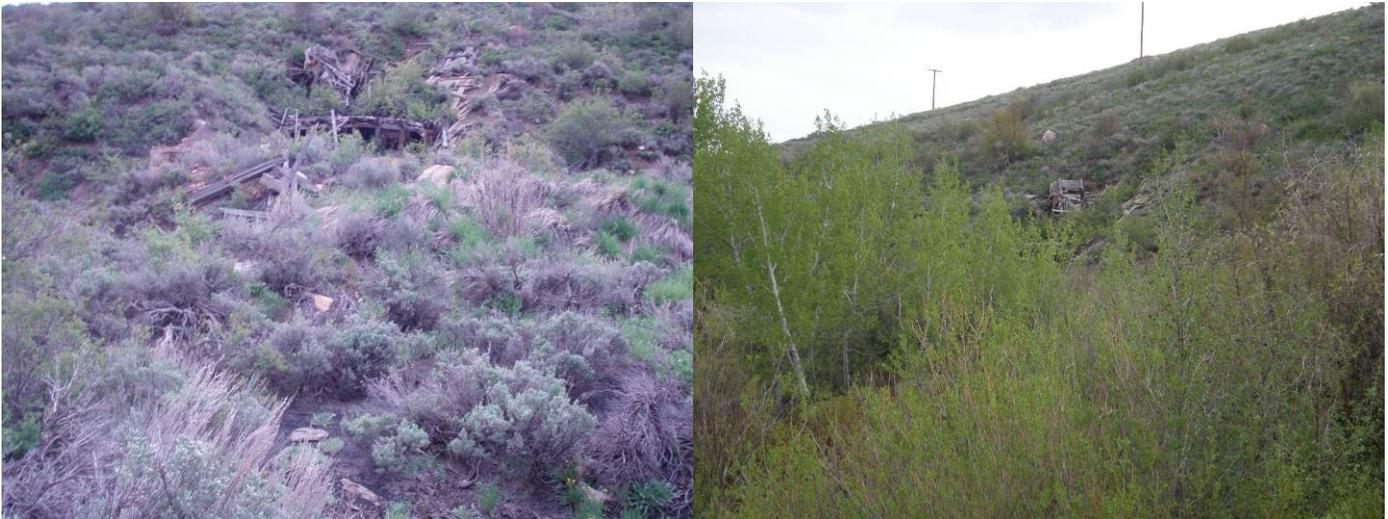
The DEQ inspection team visited the Paris Canyon Mine site on June 3, 2008 as a follow-up to the November 2007 PA (DEQ, 2007). No samples were collected during the 2008 site visit. Visual inspection of the site confirmed the 2002 interagency team findings. The south mine portal/adit is partially covered with timbers and brickwork; however, remains accessible to human entry. Concrete foundations, pits, brickwork, and other structures from the mill and tram system are abundant just below the south portal. Many of these structures are obscured from view when approaching the site from Paris Canyon road (down slope) and while traversing the mill site due to the abundant vegetation that has reestablished at the mill site. Many of these structures, along with the south adit, pose physical hazards to anyone entering the site. See photographs 1 through 3 in the Appendix.

Photos 1 & 2: The only significant remnants of the mill facilities and southern mine porthole are timbers and concrete foundations. The lush vegetative cover hides many of the physical hazards such as pits inside the facility footprint. There are no indications that significant production and delivery occurs from the mill site to Paris Creek from this location.

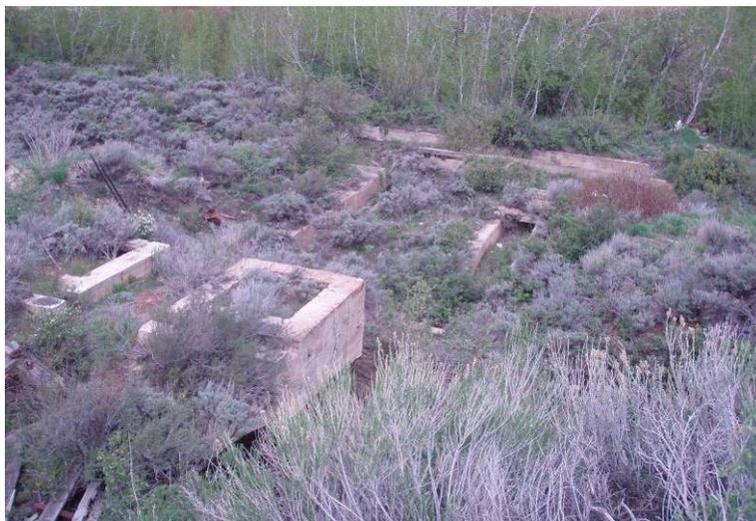
Photo 3: Concrete foundations of Paris Mill site probably contribute (somewhat) to the stability of the site. Removal of these structures, however, would likely result in significant disturbance of the soils, and release of residual mine or mill waste. Therefore, removal of the foundations and vegetation not recommended.

- Restrict public access to the south adit and mill site area to prevent illegal dumping.
- No excavation or foundation removal activities should be performed in the mill site area as removal of established vegetation and mill foundations is likely to result in increased short term erosion of mine wastes to Paris Creek.
- Relocate the black shale waste dumps to the bench south of Paris Canyon Road to prevent the black waste shale from migrating into the road and Paris Creek and limit public access.
- Cap the black shale waste with local soil and plant with native vegetation, once the waste rock has been moved.
- No reclamation work on the midlevel Wyodak exploration pits or pond.
- Regrade and re-vegetate the interior of the southern most Wyodak exploration pit and construct a series of armored retention basins (at least two) down the length of the pit to trap and retain sediment.

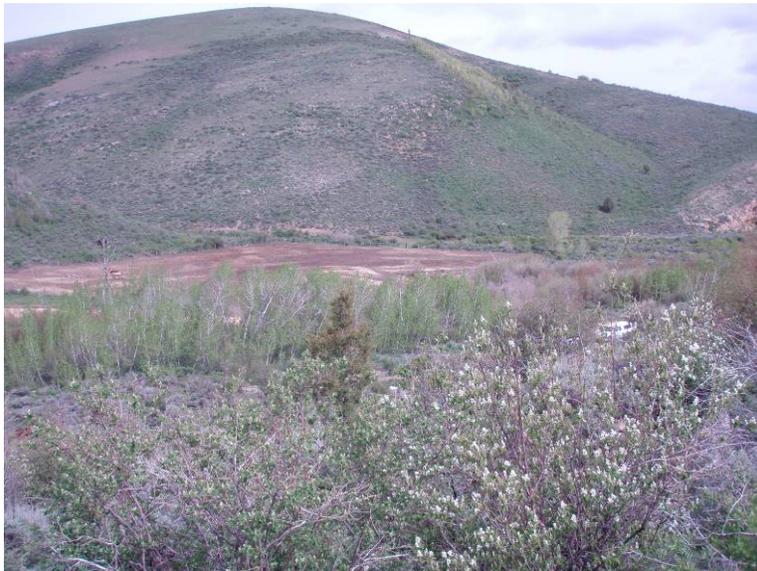
Photo 4: The main Waste Dump overlooks the Paris Canyon road and the feedlot which is north across the county road from the mill site. The lower Waste Dump is really a collage of small waste dumps and pits (DEQ 2004). The main waste dump covers approximately 1/2 acre and contains less than 5,000 cubic yards (estimated) of waste rock. The vegetation is very lush on these waste dumps and it does not appear likely that this area produces and delivers significant volumes of sediment to Paris creek. DEQ does not recommend any reclamation work be conducted on this area.

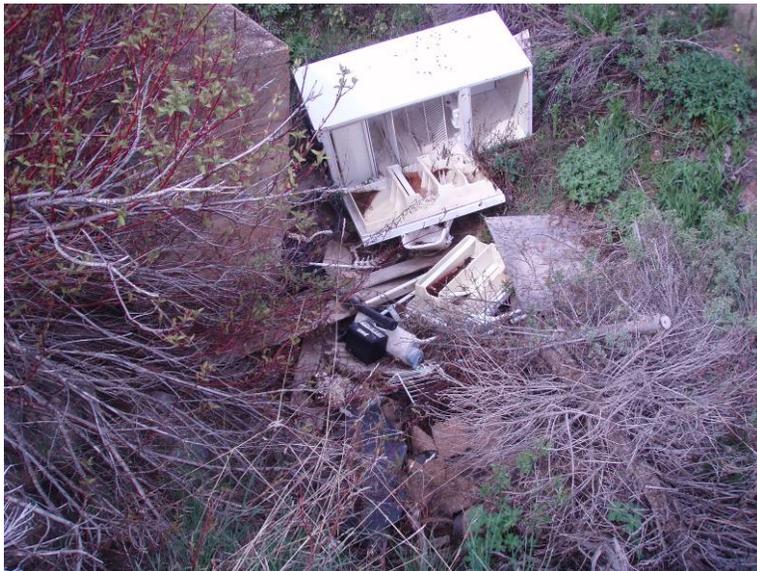
At the mill site and main waste dump area solid waste such as farm chemical containers, a refrigerator, tree limbs, car batteries, and other house hold items are being illegally dumped (Photos 5 and 6).

Photo 5: Immediately south of the County Road is the Paris Millsite. The Millsite is overgrown and although it terminates in the Paris Creek, the creek banks in this area are stable and do not need any additional work. There are however, numerous pieces of solid wastes including refrigerators, car batteries, agricultural chemical containers and other trash.

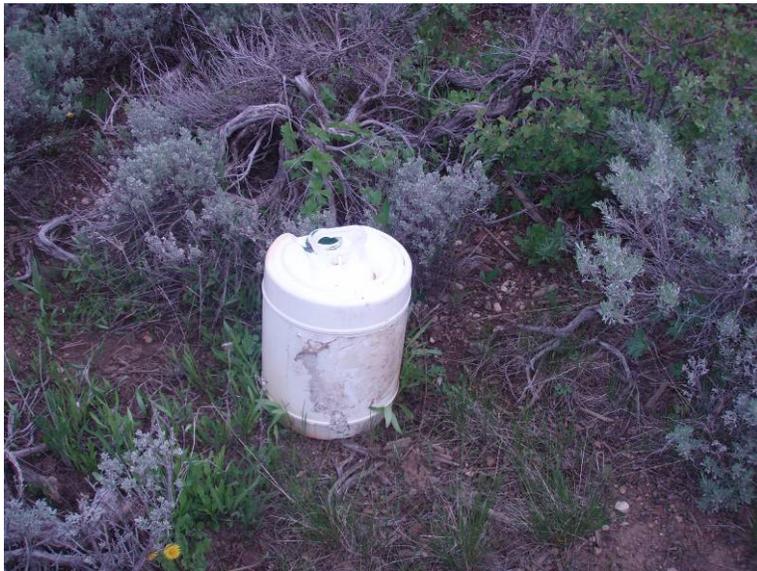
Photo 6: Agricultural chemical container dumped at mill site. Any remedial actions should consider what if anything can be done to restrict public access that results in illegal dumping at the site. Pacific Corp. may support construction of a locked gate adjacent to the county road.

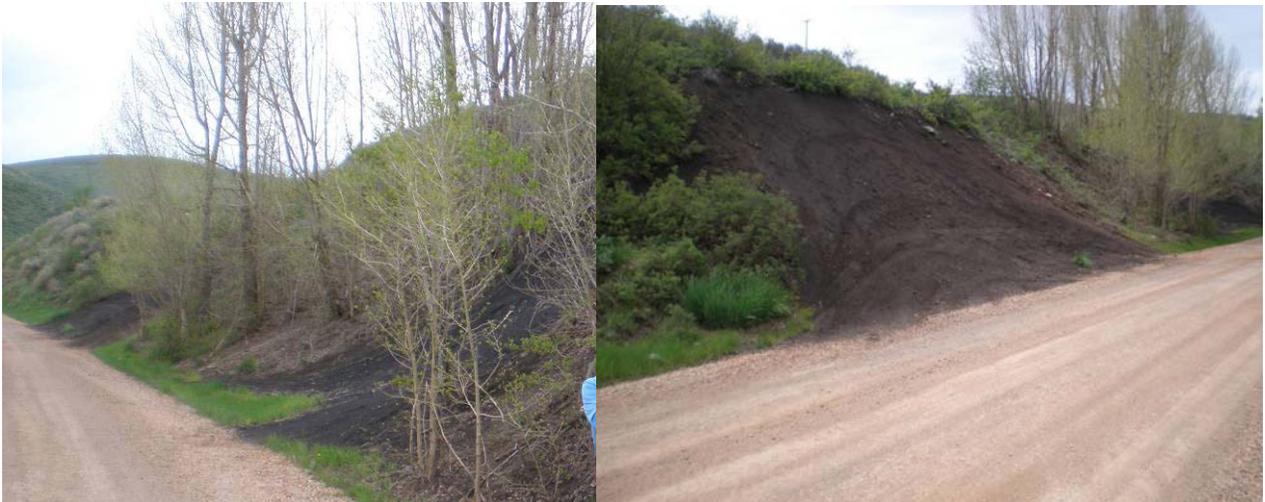
Two smaller black shale waste dumps are located approximately 300 feet north of the mill site. The larger of the two waste dumps is located on the south side of Paris Canyon Road, is cut by and eroding into the road. It is approximately 190 feet long, 50 feet wide and 20 feet high and contains less than 3,000 cubic yards (estimated) of waste rock. The north black shale waste dump is located on the north side of the Paris Canyon Road, is conical in shape, approximately 2,600 square feet in area, 15 feet tall, and contains less than 450 cubic yards (estimated) of waste rock. Vegetation is sparse on the south dump and is nearly nonexistent on the north dump (Photographs 7 through 10).

Photos 7 & 8: The south black shale waste dump has some vegetation growing on the top and at locations on the slope. The slope erodes in to the road and is used for off road vehicle recreation. The toe of the dump runs for approximately 190 feet along the broken in places by small stands of trees and brush. It was estimated that the dump contains less than 3,000 cubic yards of waste rock.

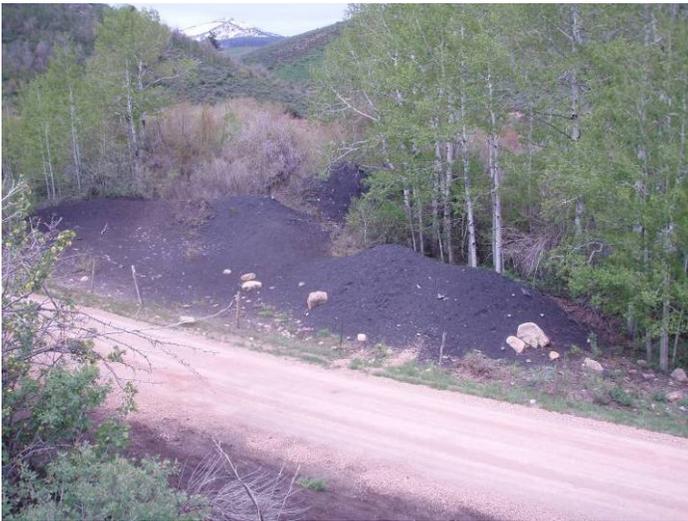
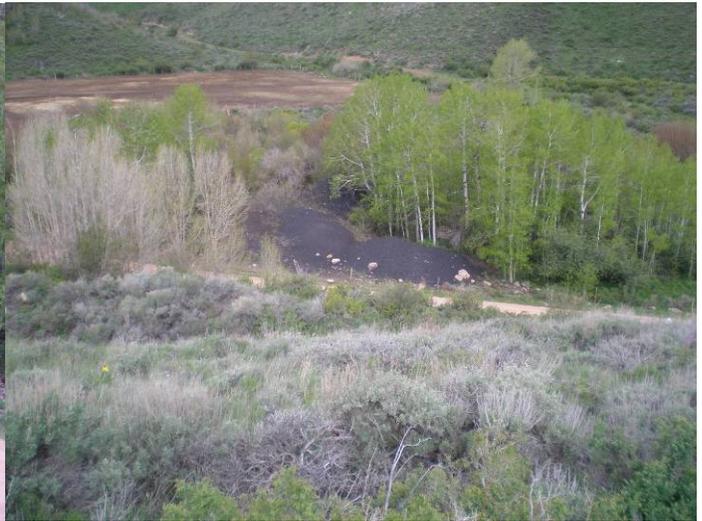
Photos 9 and 10: The north black shale waste dump is fenced and surrounded by a thick aspen grove, limiting public access and preventing disturbance by off-road vehicles. Very little to vegetation is found on this waste dump. Paris Creek is located just a few feet north of the dump.

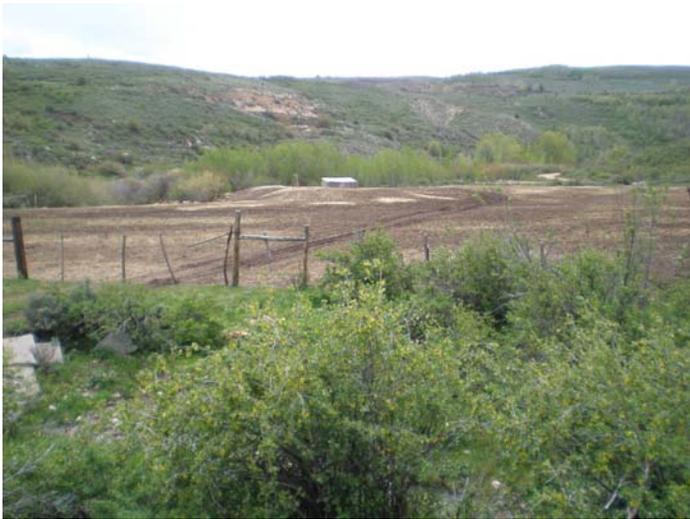
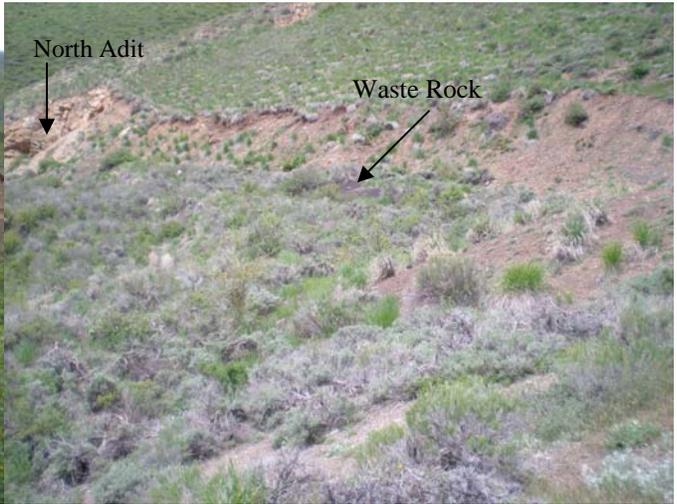
The north adit is located 0.2 mile north of the south adit and mill site, approximately 100 yards up slope from Paris Canyon Creek. The adit is partially collapsed, yet remains easily accessible for human entry. Many of the timbers remain in place at the adit entrance. Concrete foundations, wood, and iron workings are found scattered about the two terraces below the adit. A small black shale waste dump is located about 50 feet northeast of the adit (Photos 11 and 12).

Photos 11 &12: Looking northeast at the north adit of the Paris Canyon Mine. The fenced area currently has livestock. The north adit is partially collapsed and near the left edge of the photo. There is a small waste rock pile in the center of the photo 10. This was the only waste rock observed at this location. Approximate size of the waste rock is 20 to 30 yards, with no signs of the waste rock eroding into the creek bed.

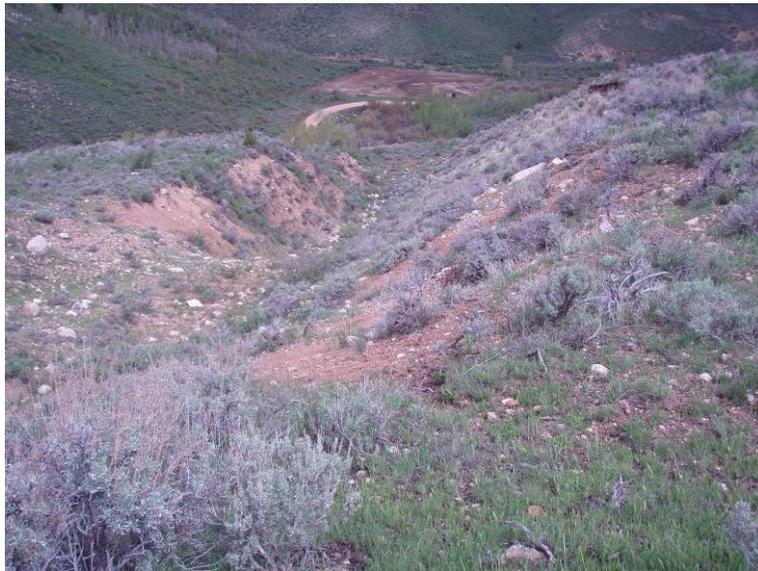
There is one large (approximately ½ acre) and two small pits just south of the main Waste Dump (Photo 13). Although these midlevel pits break up the landscape, native vegetation appears to have re-colonized and stabilized most of the slopes. Approximately 400 feet south of the midlevel pits is what appears to be a “cat cut” or small pit that was cut parallel to the contours across the ore deposit and water bearing structure (Photo 14). This cat cut was more likely developed as a cattle tank than as a genuine exploration. A surface water sample collected from this pond in

Photo 13: There is one large (approximately 1/2 acre) and two small pits just south of the lower Waste Dump. Although these midlevel pits break up the landscape, native vegetation appears to have recolonized and stabilized most of the slopes. It seems that if an effort was made to regrade these pits and their small waste dumps, the land disturbance would most likely cause a more significant release of mine waste to Paris Creek than presently occurs. IDEQ is recommending no reclamation work for these pits and small waste dumps.

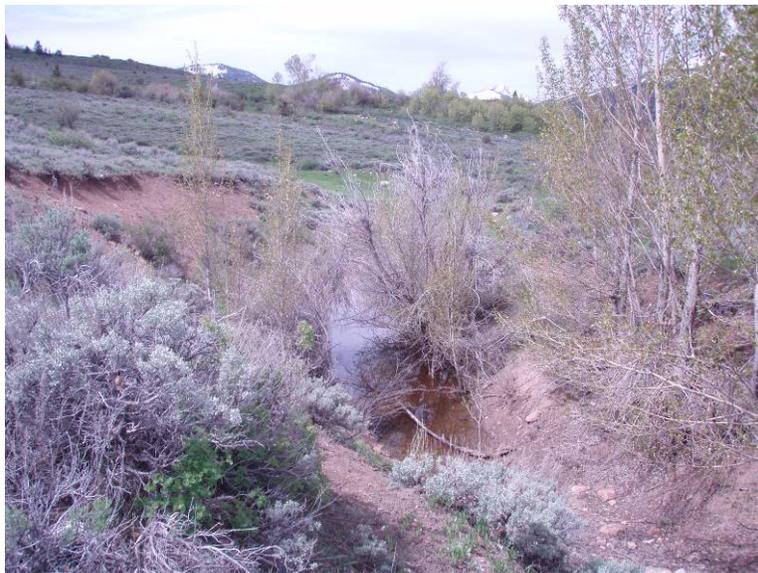
Photo 14: Approximately 400 feet south of the midlevel pits is what appears to be a “cat cut” or small pit the was cut parallel to the contours across the ore deposit and water bearing structure. This cat cut seems like it is more likely that it was developed as a cattle tank than as a genuine exploration. If ground water recharge drove reclamation efforts at the Paris Mine and Mill site this is a location that might bear some consideration. However, it is not likely that this feature could be too much of a driving force for ground water contamination. IDEQ is not recommending that any reclamation or remedial actions are applied to this feature.

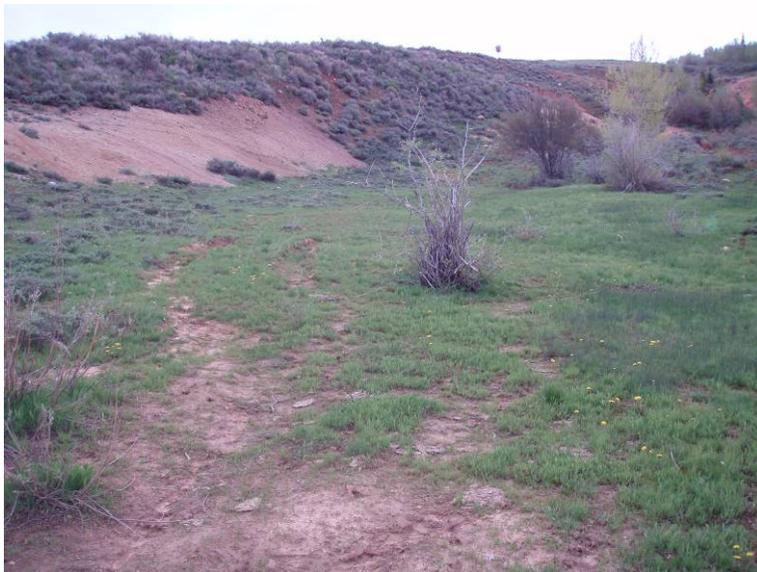
The upper pit is 400 feet south of the pond and on the opposite side of the Pacific Corp hydroelectric flume (Photos 15 through 17). The upper pit walls were sparsely vegetated with significant indications of rapid erosion present, which in turn are indications that there is a significant release of mine wastes to the Pacific Corp flume, and thence down to Paris Creek. However, a sample of pit soils collected and analyzed during the 2002 investigation (DEQ, 2004a) resulted in metal concentrations below the Area Wide action levels.

Photo 16: Looking southward from the "daylight" of the Upper Pit, there appeared to be fairly well vegetated slopes of the pit walls and dump slopes, surrounding a somewhat sparsely vegetated pit floor.

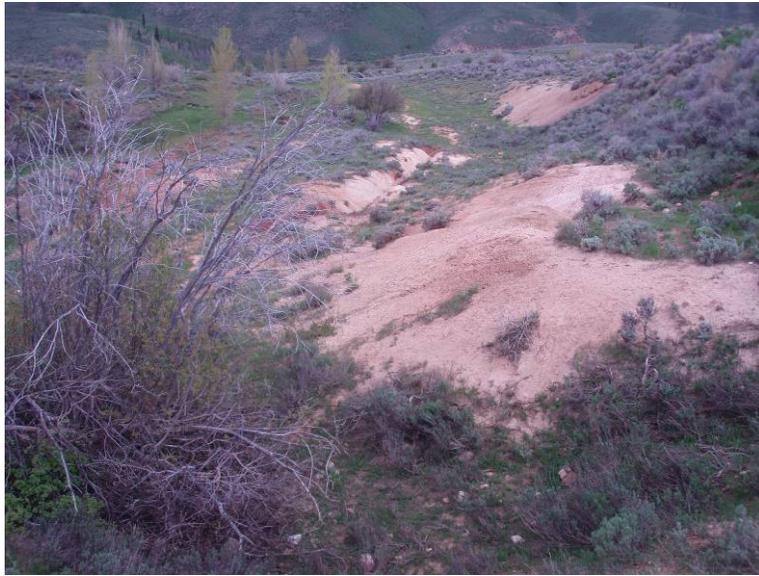
Photo 17: From the up hill boundary of the pit, one looks down the length of the pit towards the “daylight”. From this point, it was noted that the pit walls and dump slopes were not lushly vegetated. On the contrary there are significant indications of rapid erosion present, which in turn are indications that there is a significant release of mine wastes to the Pacific Corp flume, and thence down to Paris Creek. DEQ is recommending that a concerted effort is made to regrade and re-vegetate the interior of the pit, and to construct a series of armored retention basins (at least two) down the length of the pit to trap and retain sediment.
