IMPERIAL LODGE MINE & MILL SITE

PRELIMINARY ASSESSMENT REPORT

Blaine County
State of Idaho

Department of Environmental Quality

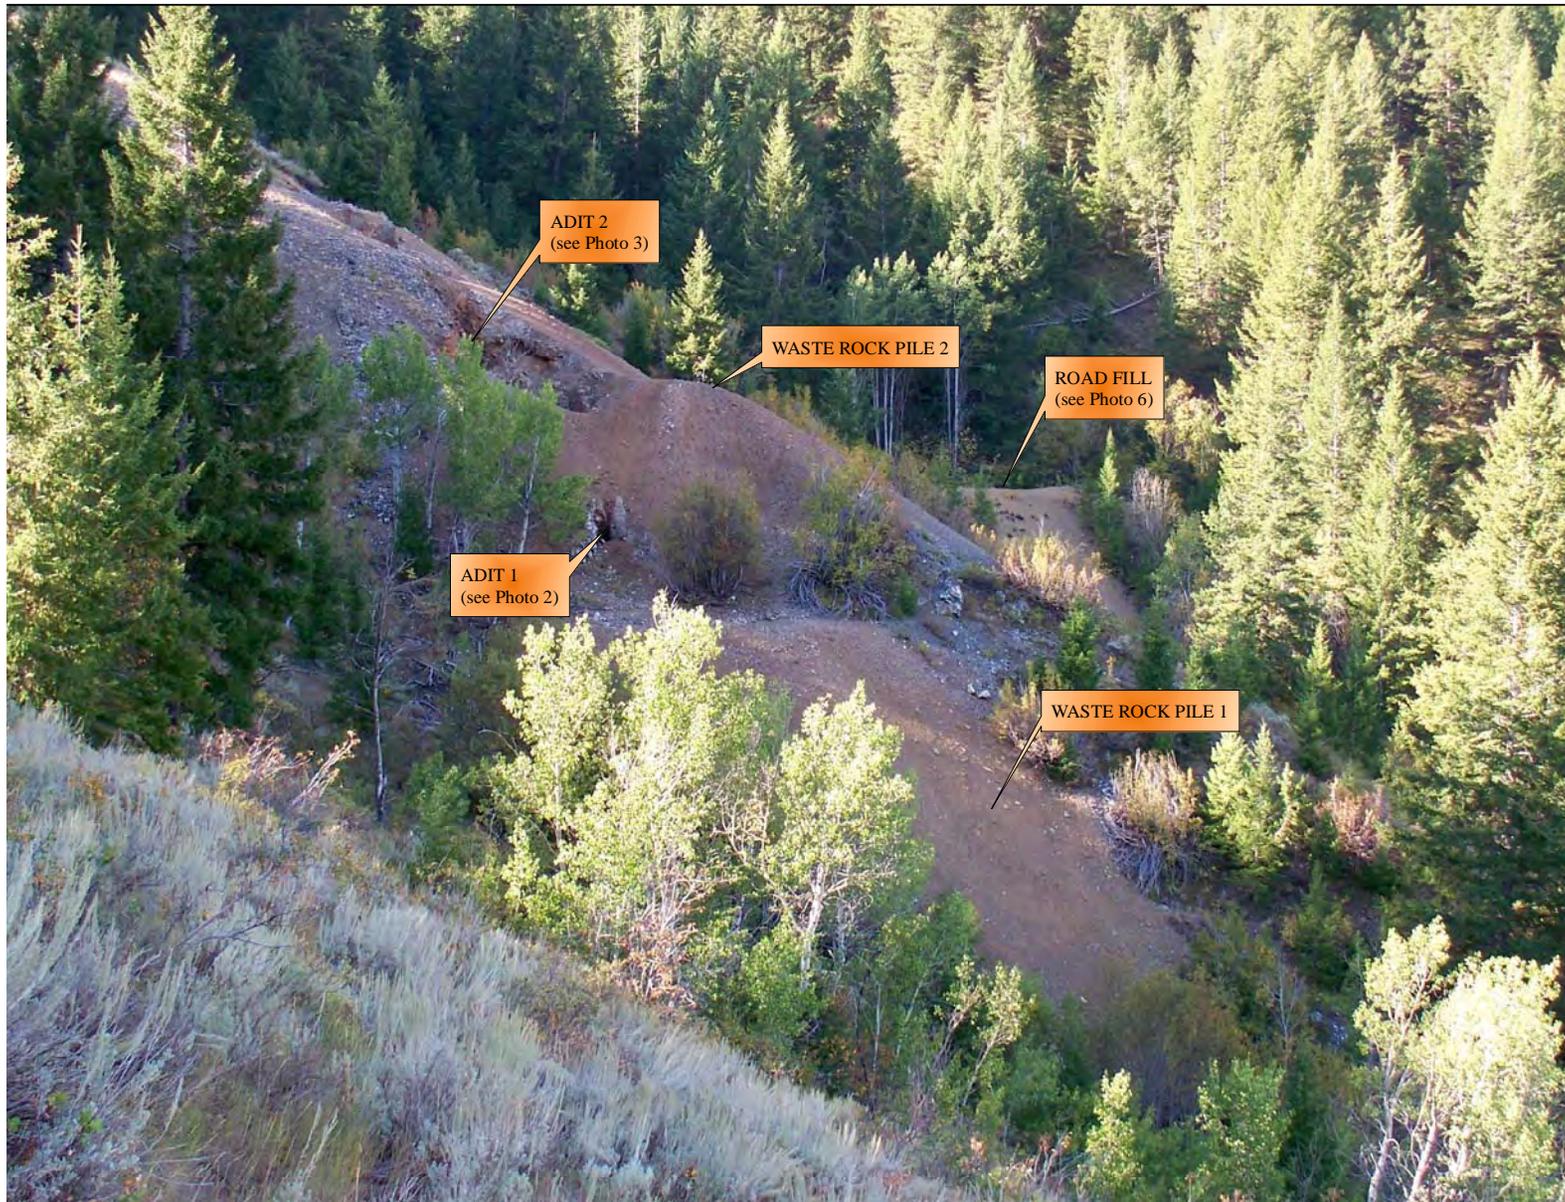
DEQ performed the site assessment for the Imperial Lode mine and mill site on September 18, 2009. The claim itself is 16.5 acres located on a north-facing slope in Imperial Gulch. The main workings are located approximately 600 feet south of the northern claim boundary. The investigation team noted three adits, one vertical shaft, four waste rock piles, a collapsed feature, a road fill that crosses a small drainage, a road, and a flat camping/parking area on the claim (Photo 1).

Photo 1. View looking east-southeast towards the main Imperial Lode mine workings.

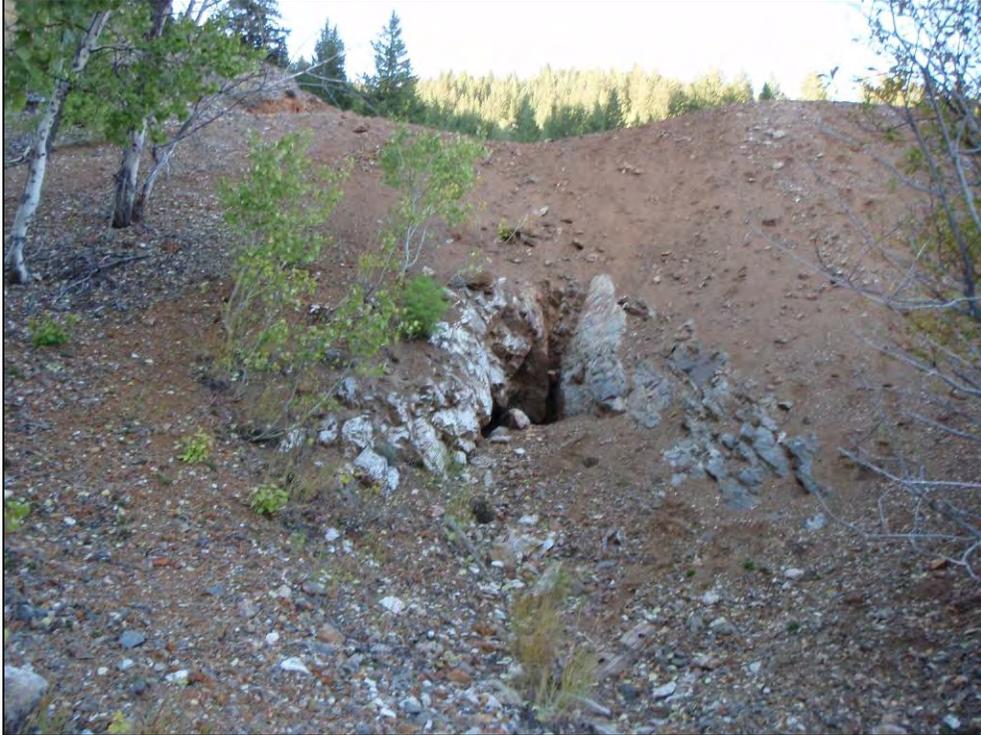
Adit 1 is located at the top of waste rock pile 1 (Photo 2). Based on its location in relation to waste rock pile 2 and the northern claim boundary this adit is probably the “shaft” noted by True (1882). The adit is partially buried by waste material from waste rock pile 2; however the adit remains partially open and accessible.

Photo 2. View looking southeast at Adit 1. Opening is accessible to humans. This mine opening is a dangerous physical hazard that should be closed or otherwise restricted.

However, IDEQ is recommending that you consider implementation of best management practices to control erosion and stabilize the mine waste dumps. DEQ suggests that the mine openings on the patented lode claim are closed or otherwise managed to restrict access as these are very dangerous physical openings.

Lastly, although the existence of numerous dangerous mine openings and physical hazards does not factor into DEQ's risk analysis of the site, closure or restricting access to these openings is warranted.

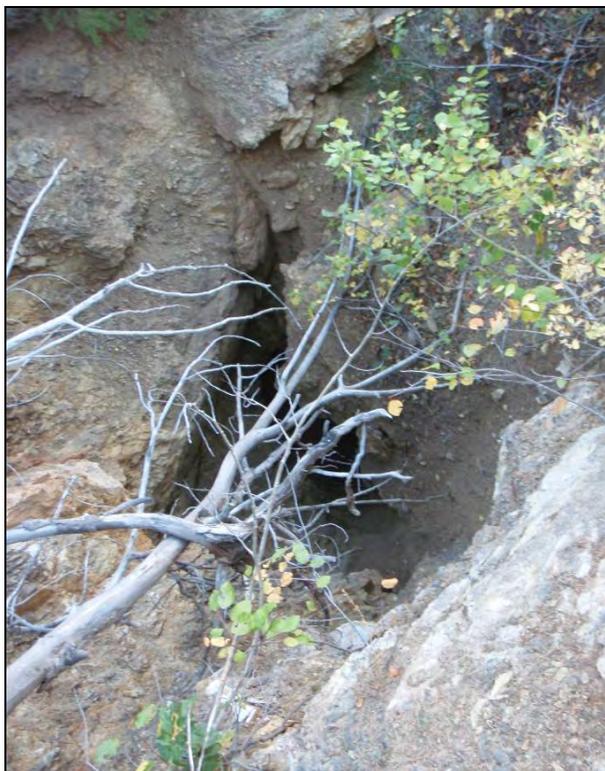
The vertical shaft is located approximately 200 feet south of Adit 2 along the ore strike at the edge of the trees (Photo 5). The shaft is fairly nondescript with only a small waste rock pile marking its location. This shaft is open and poses a significant danger for those hiking or hunting in the area not aware of its presence.

Photo 5. View looking down into shaft. Opening measures approximately 2.5 feet in diameter, and the ground surface nearby does not indicate its presence. This mine opening is a dangerous physical hazard that should be closed or otherwise restricted.

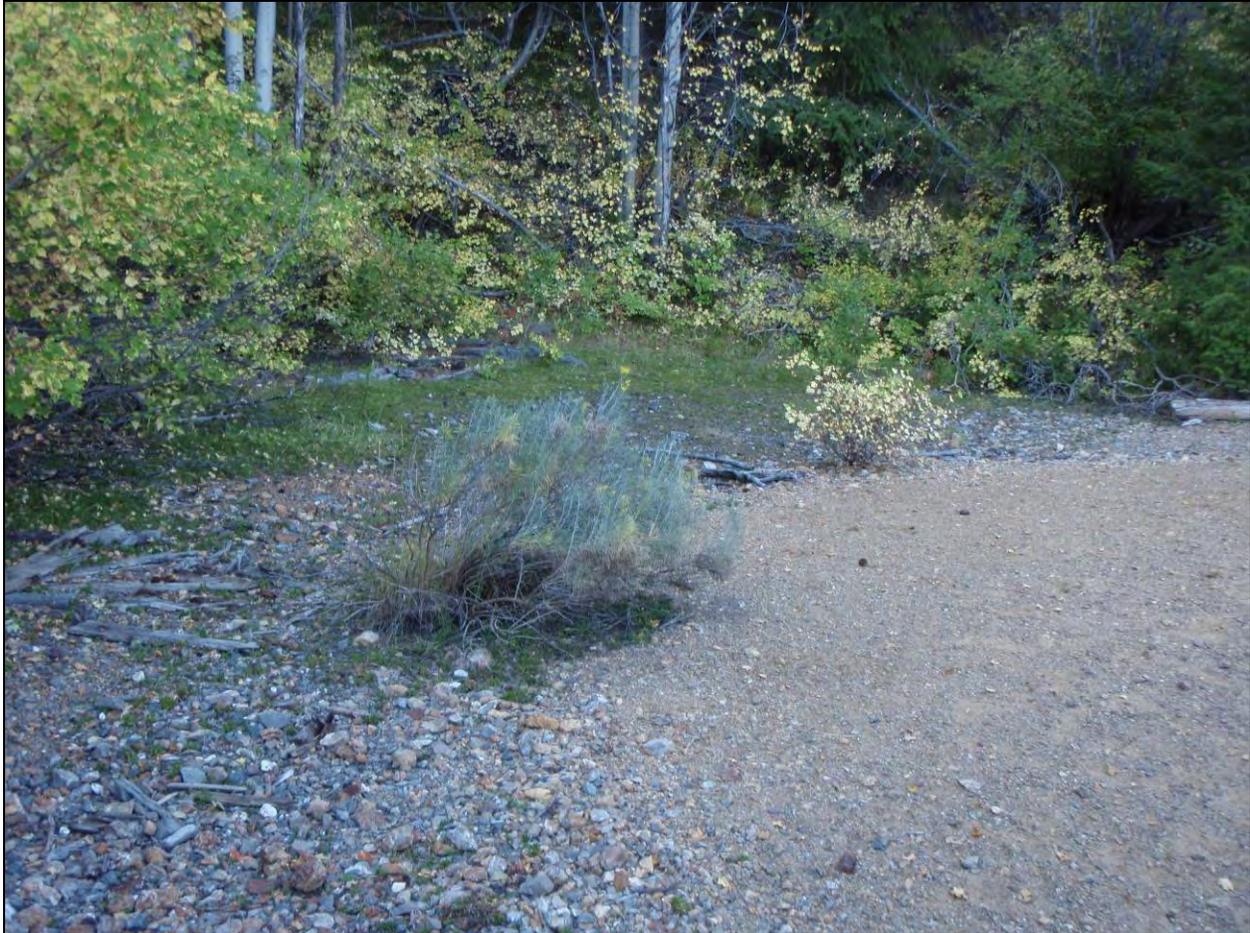
Near the western claim boundary about midway up the hillside, a small drainage was filled with what appears to be an unknown volume of waste rock in order to provide road access to the mine workings (Photo 1 and Photo 6). The road forms a small catchment basin on the upward side when moisture is present in the drainage. Rills are present on the downgradient side of the road fill, with little vegetation being present. A small overgrown road intersects the road fill and goes uphill and north along the claim boundary, then west onto public lands. The road is impassable to most motorized vehicles and is not visible in aerial photos.

Photo 6. View looking west along the road fill (see Photo 1). Lush vegetation on the upper half of the photo is an indication the old road forms a small dam causing water to pond from the drainage above.

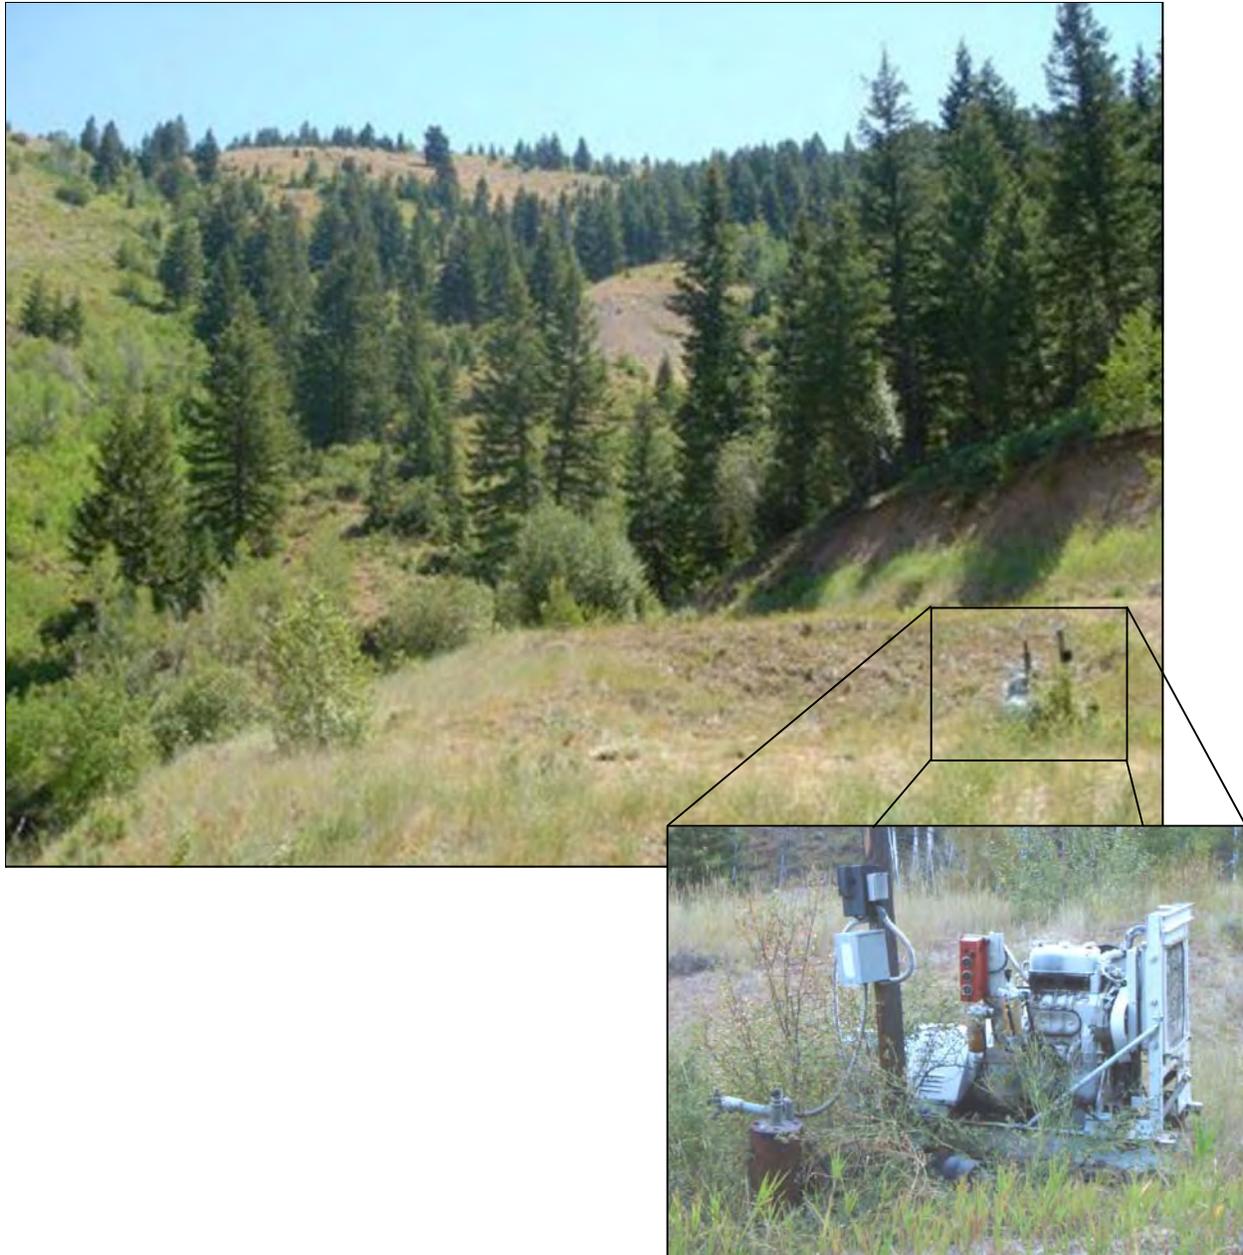
The flat cut into the hillside at the top of the access road (northwest corner of the claim) is well maintained and may have been developed for use to park several camp trailers and trucks or as a home site (Photo 7). A domestic well and generator are located here. The well casing looks to be in good condition. Based on information available on the driller's report (IDWR, 1992) the well was constructed in May 1992. It is 600 feet in depth, with 8 inch steel casing installed from 1.5 feet above land surface to 330.5 feet below land surface. The remainder of the borehole is uncased. Ground water was first encountered at 460 feet below land surface in a limestone and quartz formation.

Photo 7. View looking southeast along the cut (parking area) located on the northwest corner of the Imperial Lode claim. A larger view of the well and generator has been inserted in the right corner of the photo. The main workings are visible through the trees, near the photo's center.

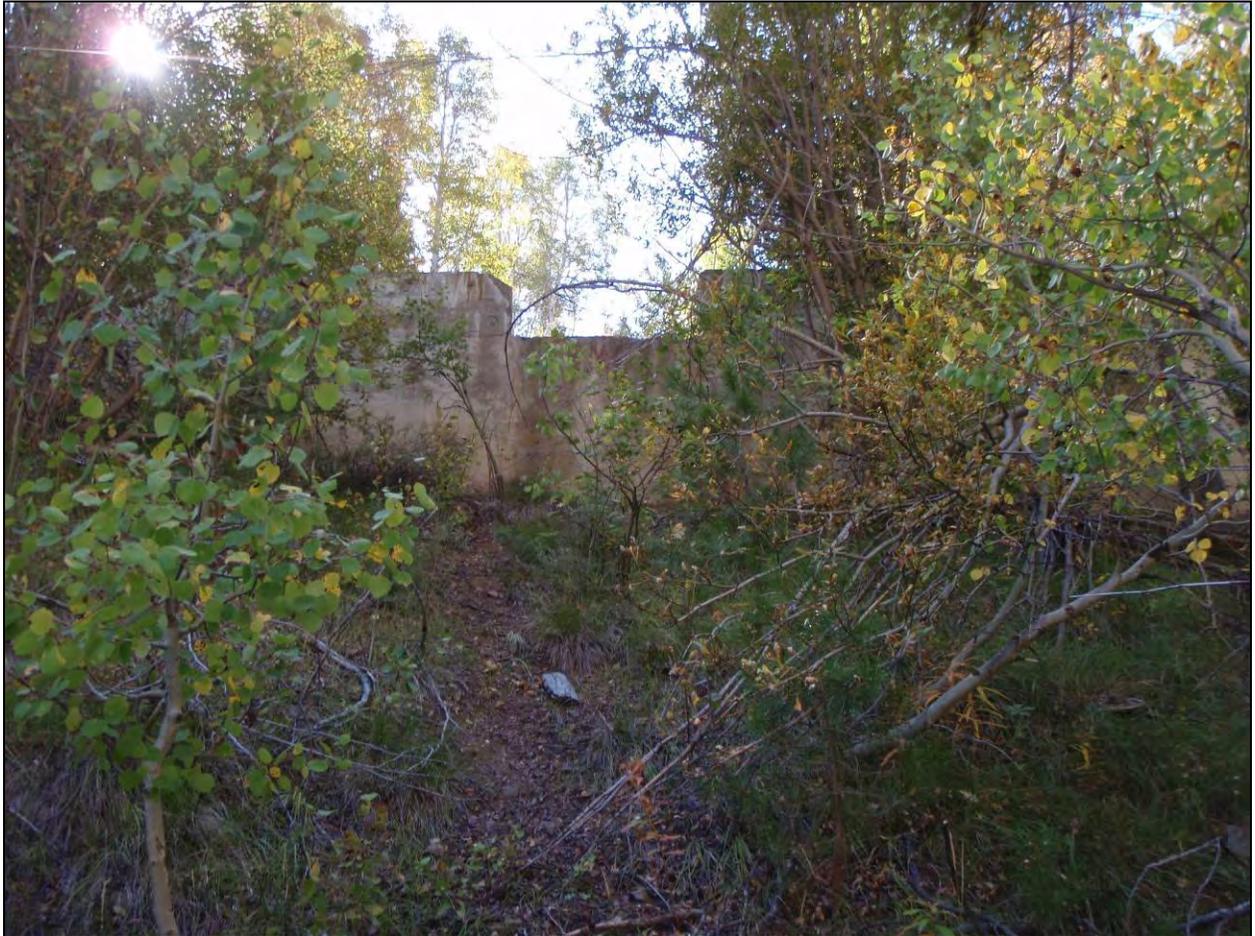
Umpleby and others (1930) stated a mill was constructed at the Imperial Lode claim in 1924. Although the parcel boundaries from the county ArcGIS database may be somewhat inaccurate, it appears that the mill site is located on lands administered by BLM. The site contains a large concrete foundation and timbers located approximately 340 feet north of the Imperial Lode claim and just above the floor of Imperial Gulch. The foundation is largely obscured from view, from the Imperial Gulch road, by a stand of aspens and dense undergrowth (Photos 8 – 11). Upon investigation a large three-level concrete foundation was constructed into the hillside measuring approximately 150 feet long, 50 feet wide, and 30 feet tall. Framing sized timber debris and other

Photo 8. View looking south from a few feet off the Imperial Gulch Road at the concrete walls/foundation of the assumed mill.

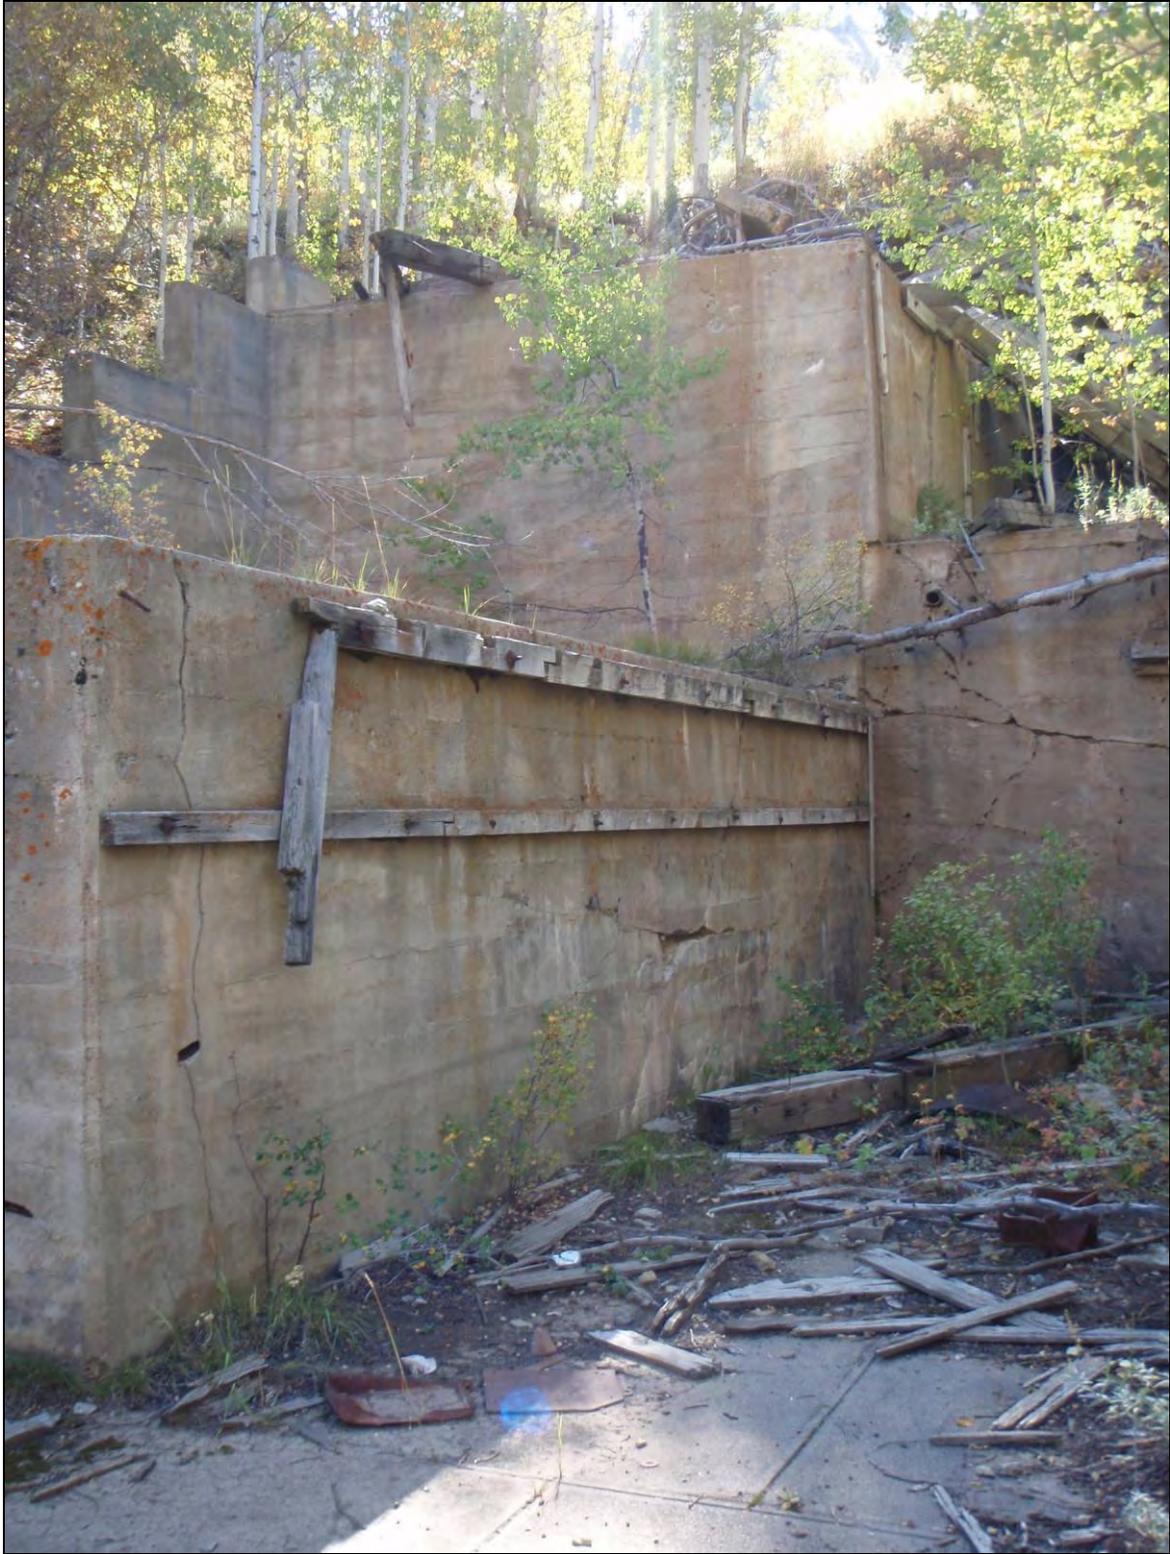
Photo 9. View of the mill foundation looking southeast from the lowest tier.

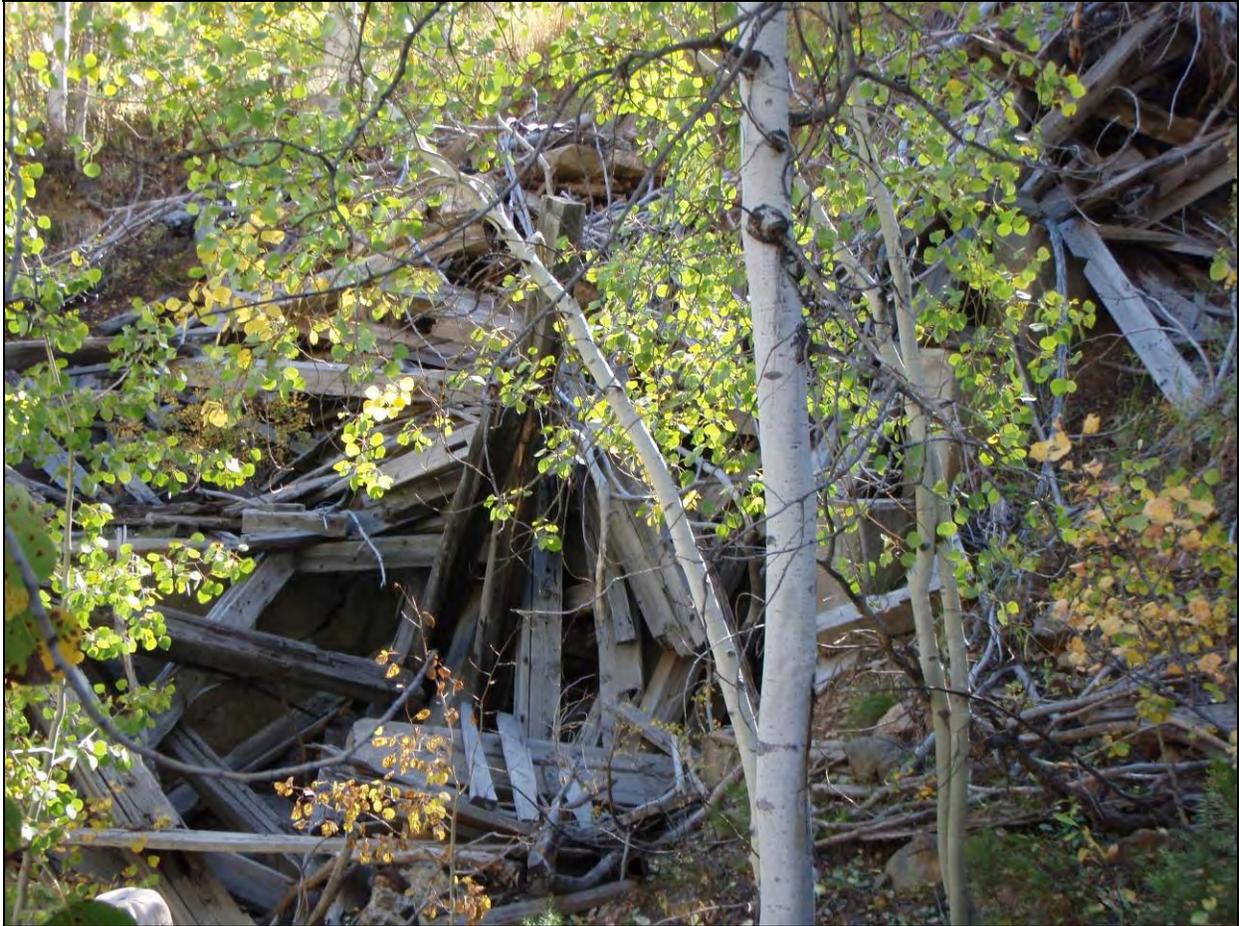
discarded/fallen timbers are located to the west of the foundation and several smaller wooden debris piles are located south and east of the foundation. East of the foundation approximately 150 feet a 15 foot diameter, non-descript deposit of fine-grained yellowish soil is found framed by cut lumber, fallen trees, and dense vegetation (Photo 12). The soil has a strong sulfur smell. A surface soil sample was collected from near the center of the soil pile. Sampling results are presented in the following section.

Photo 10. Pile of discarded/fallen timbers on the west side of the mill foundation.

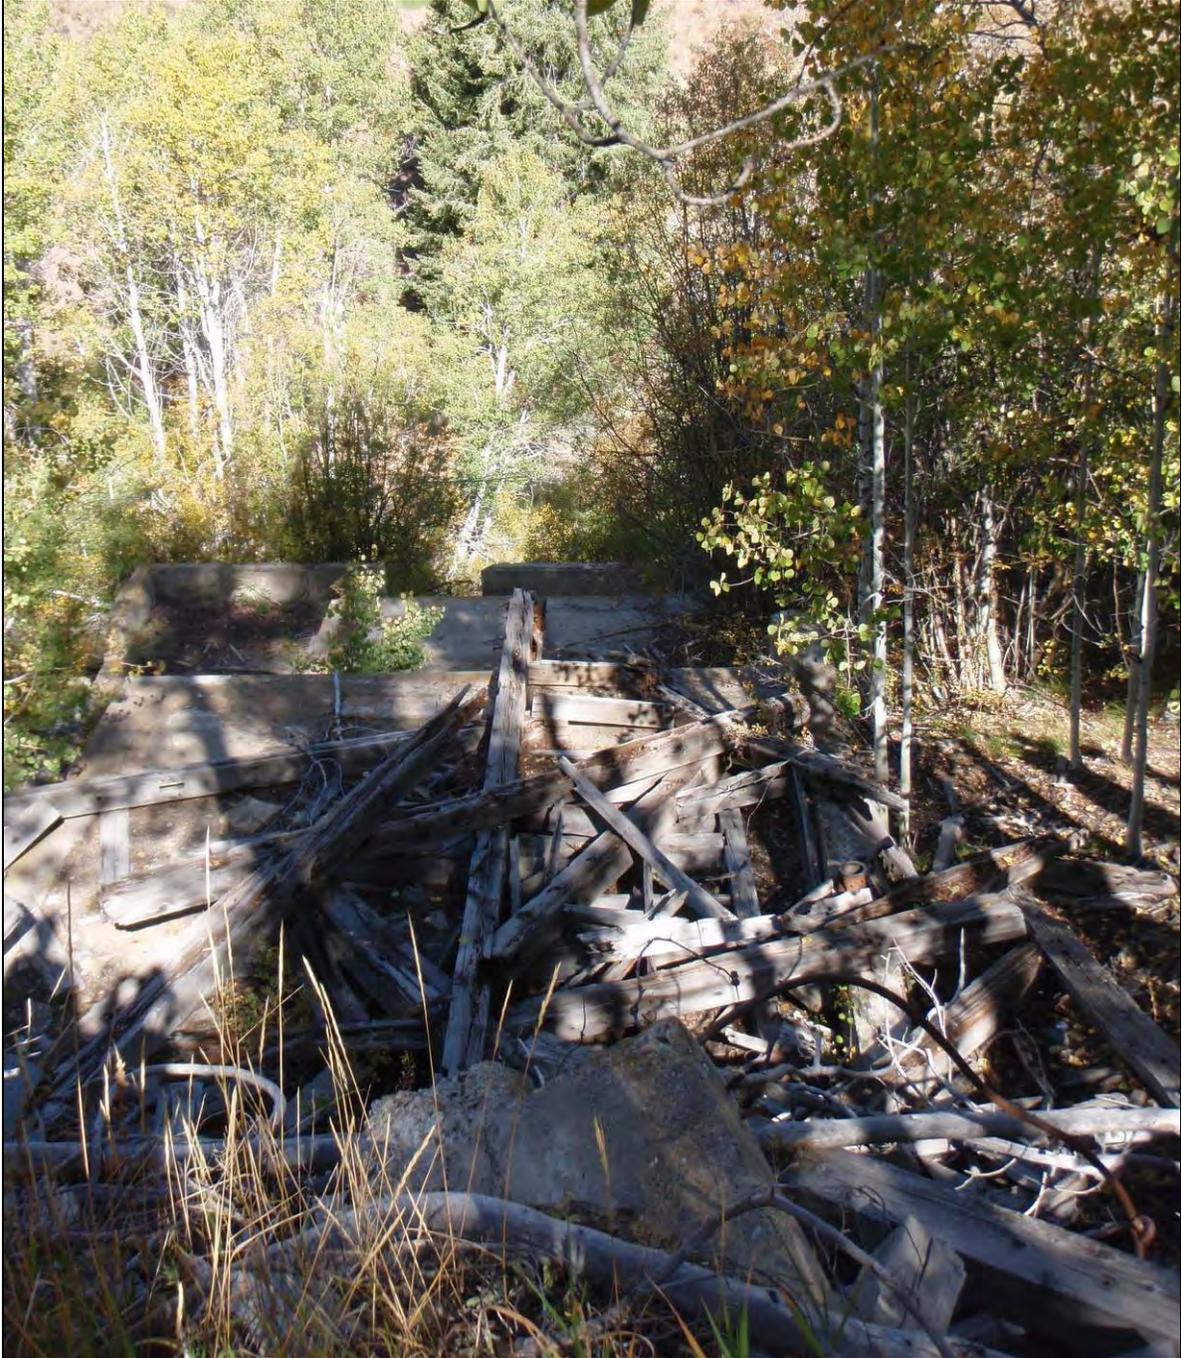
Photo 11. Discarded building material located on the southeastern corner on the mill foundation. View looking to the north.

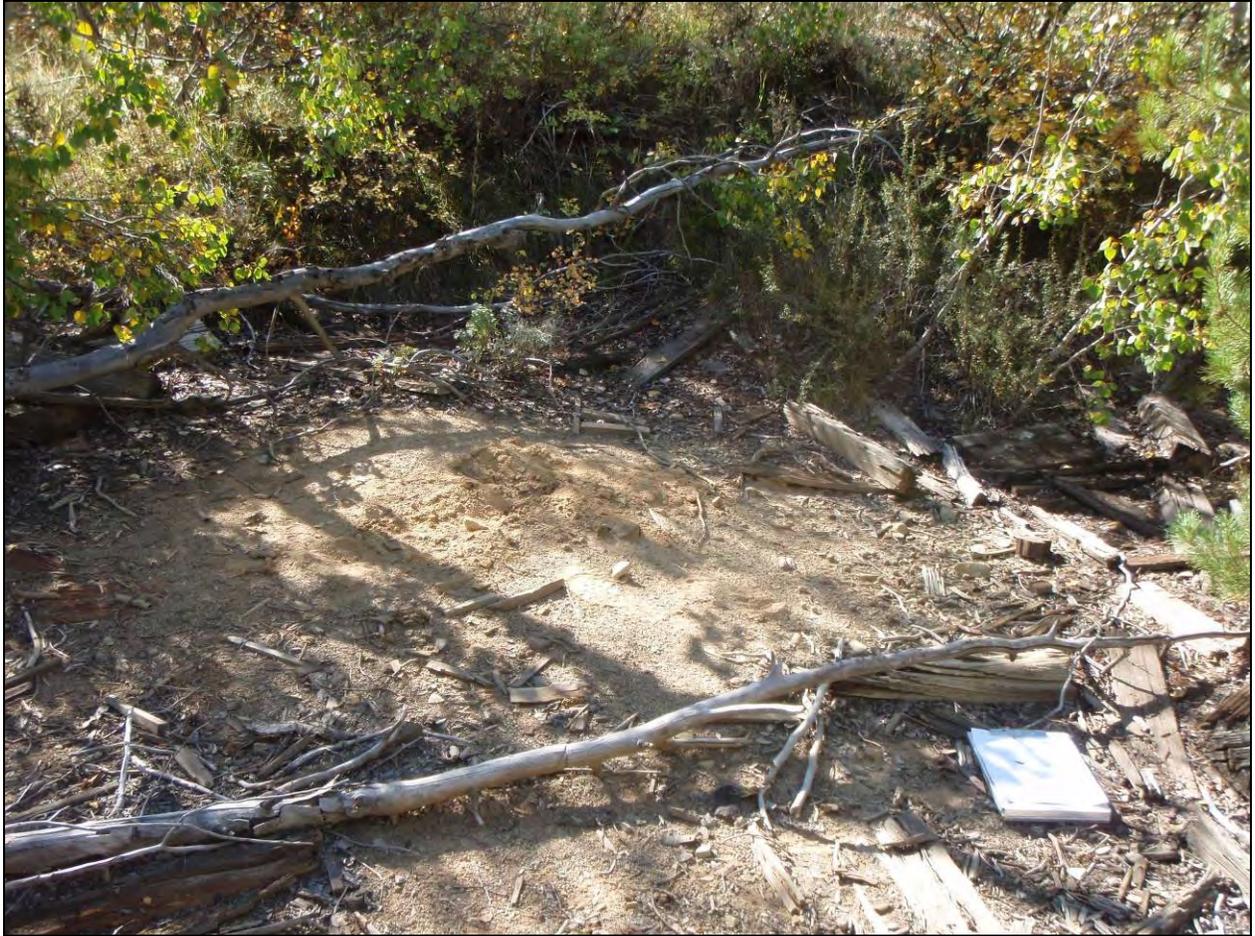
Photo 12. Surface soil sample ILWPSS1 location, east of the mill foundation. Sample collected from near the center of the photo. The small soil pile (< 3 cubic yards) is framed by cut timbers, fallen trees, and dense vegetation. A 9inch X 12inch field notebook is present for scale.

One surface soil sample was collected from a deposit of < 3 cubic yards of wastes on the Imperial Lode mill site (ILWPSS1). The wastes were yellow and had a strong smell of sulfur was suspicious. No samples were collected from the waste rock piles on the claim as these materials appeared to be country rock with little to no mineralization. No background sample was collected for this site. The mill site soil sample was approximately five pounds in size and was sieved through a No. 10 screen. The material passing was mixed in a clean bucket prior to placing it in a one gallon zip lock bag, which was then placed in a cloth mineral sample bag. Both bags were appropriately marked, and then documented on a Chain of Custody Form for submittal to SVL laboratories.

Levels of total antimony, arsenic, iron, lead, silver, and zinc exceeded both Idaho’s *Initial Default Target Levels* (IDTLs) and EPA Region 6’s Preliminary Human Health Screening Levels (HHSL) (EPA 2002) at the mill site. Selenium levels exceeded Idaho’s IDTLs. Table 1 summarizes laboratory analytical results for surface soil sample ILWPSS1.

Second, if the site is considered for future development as residential property, additional site investigation and analysis should be conducted and the conclusions and recommendations from that work is used to develop risk management plans or actions.
