# Red Elephant Mill Site Preliminary Assessment Report

Blaine County  
State of Idaho

**Department of Environmental Quality**

March 2007

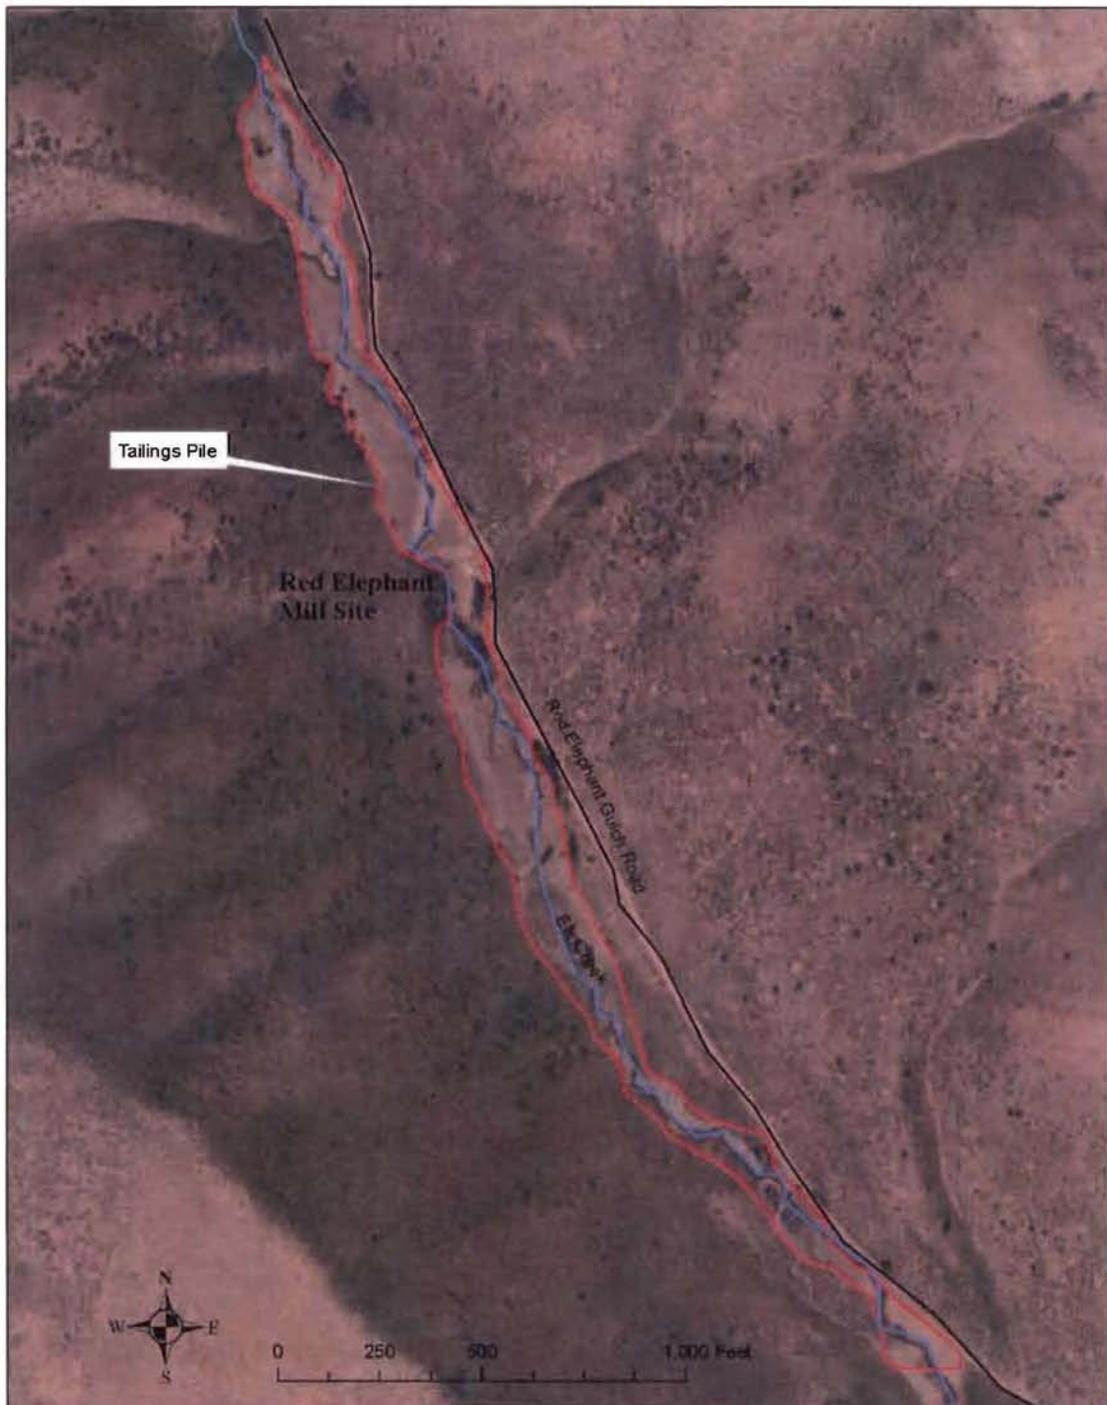
Figure 4. Aerial photograph of the Red Elephant Mill site.

The Red Elephant Mill is located in the lower reaches of Elk Creek in Red Elephant Gulch (Figure 4), about a half-mile above the confluence of Elk Creek and Croy Creek. Dispersed tailings deposits, broken tailings dams structures and mill ruins are the primary historic mine facility features of the lower Gulch. The floodplain of Elk Creek consists of tailings and associated earthen impoundment dams (all breached), while small ore piles and concrete foundations, measuring approximately 100 feet long by 60 feet wide, are the only indications of the previous mill's existence. Mitchell and Gillerman described the tailings as "approximately one-half mile long, 150 feet wide, and with an average of 3 feet deep" (2005, p.8).

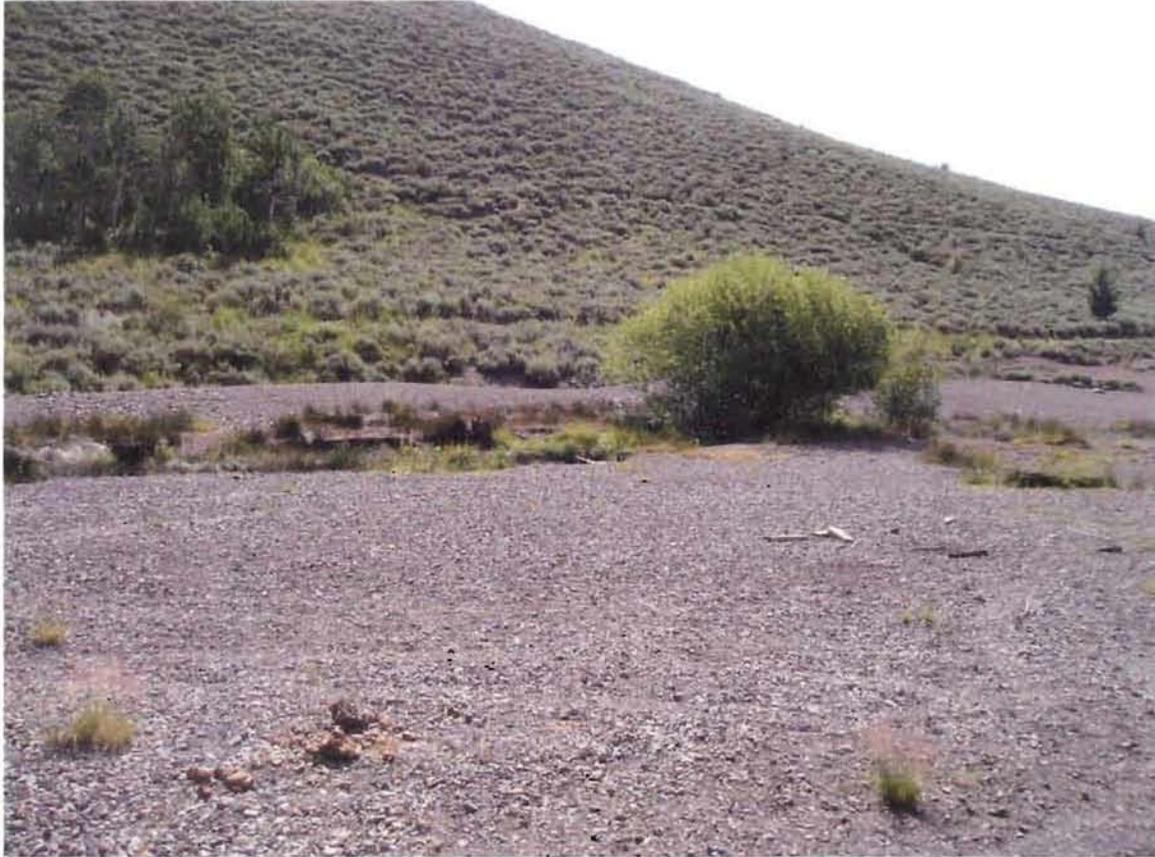
During DEQ's July 2006 visit, the volume of the mine waste piles associated with the Red Elephant Mill site were mapped at approximately 913,000 cubic feet. The area that the waste rock currently occupies is approximately 10.5 acres. The Red Elephant Mill site waste piles are located along Elk Creek, on the western side of Red Elephant Gulch Road, which allowed DEQ personnel the ability to make good observations and assessments (Photo 1, Photo 2).

Associated with the mill site is one large waste pile that defines the boundaries of the site. The waste pile is located within the stream channel of Elk Creek. All former structures at the site have been reduced to scattered rubble or removed.

**Photo 1. View looking east at the Red Elephant Mill site.**

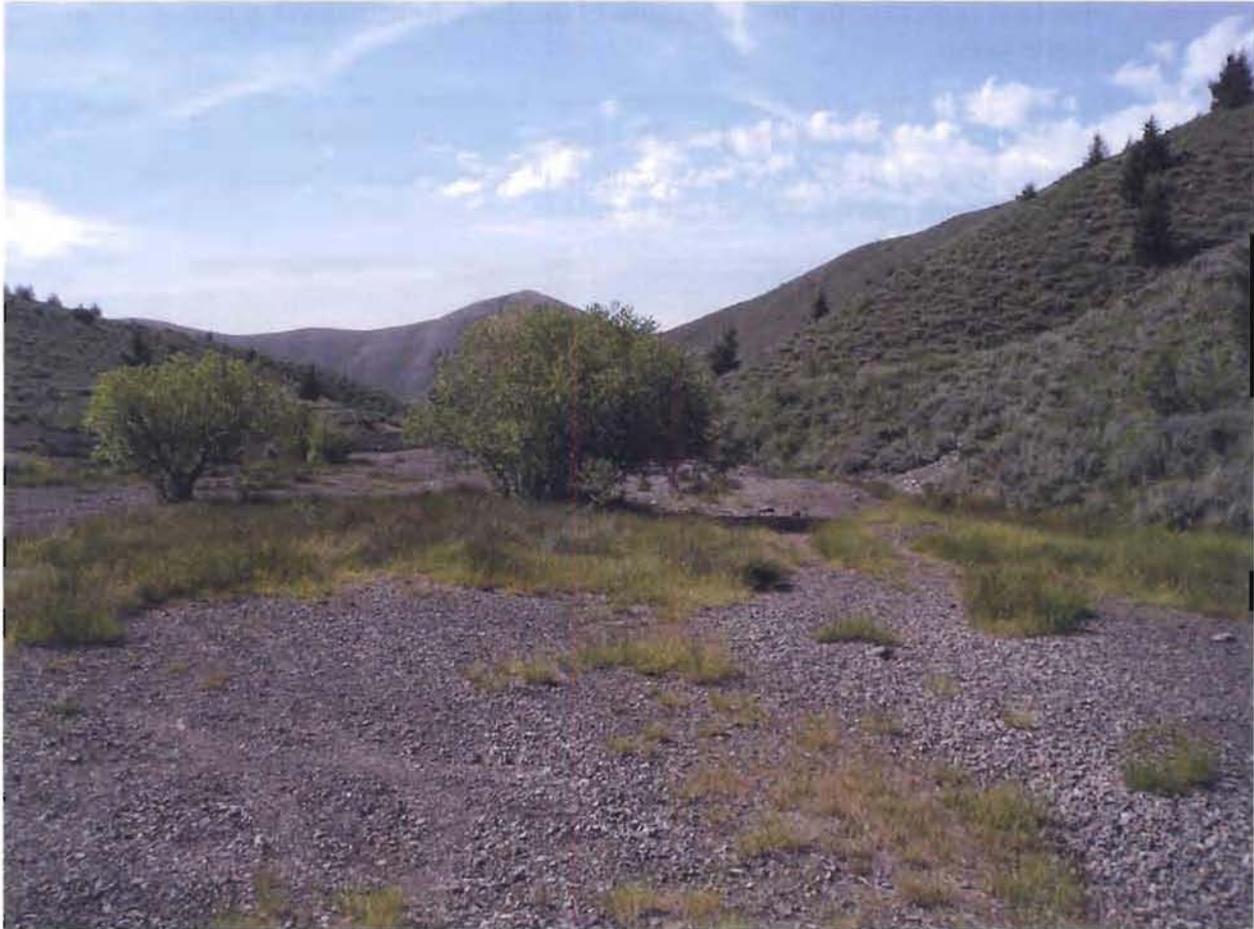
**Photo 2. View looking south on the Red Elephant Mill Site.**

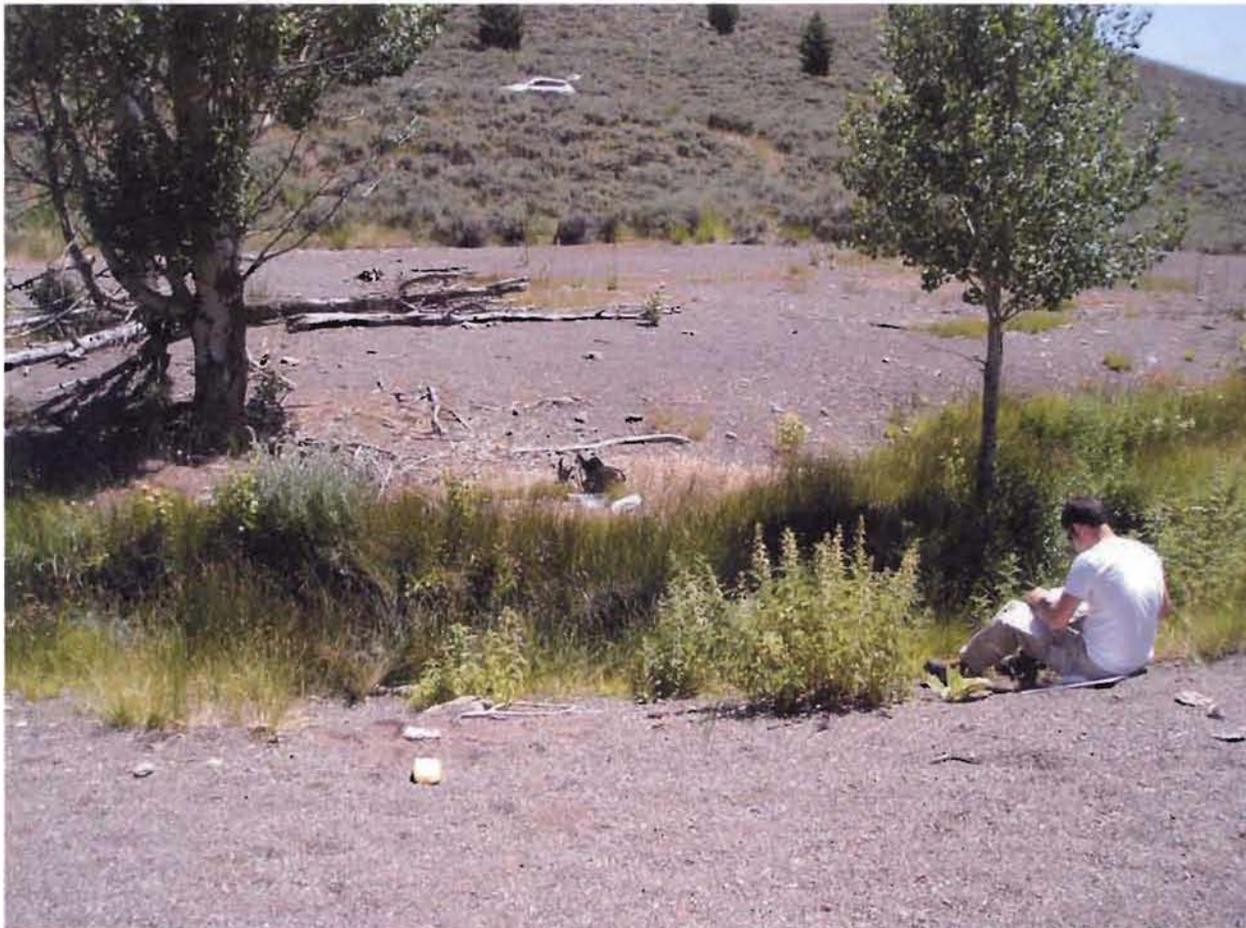
Vegetation has been partially re-established on the tailings. Small trees, grasses, and other shrubs have begun to cover the tailings pile (Photo 3). During the site visit, compost

was being land applied in the lower portions of the dump to help develop re-vegetation on the waste dump.

**Photo 3. View looking east across Elk Creek at the sampling location for samples RG02SW and GG02SD. This location is the downgradient side of the site.**

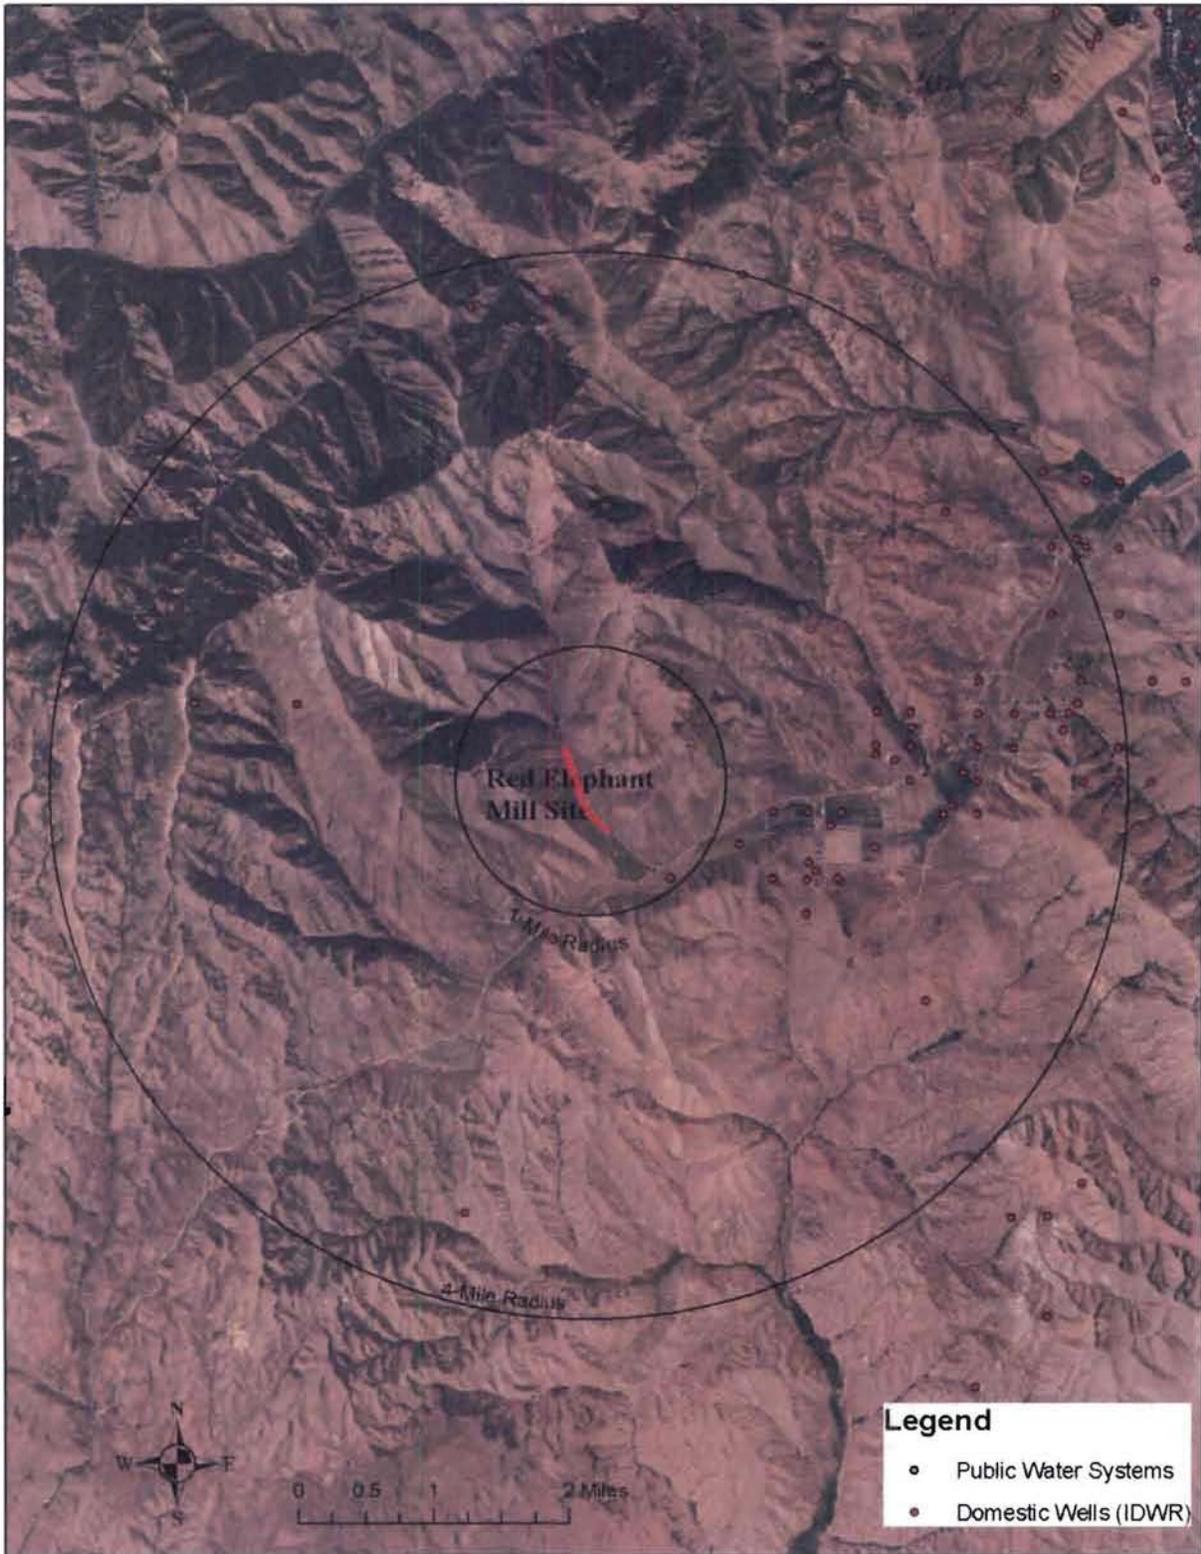
Figure 7. Domestic wells and public water system wells located with a 4-mile radius of the Red Elephant Mill site.

According to Idaho Department of Water Resources July 2002 records, 93 private drinking water wells are reported to be located within a 4-mile radius of the site. The majority of these wells are located within the Croy Creek drainage, closer to the nearby towns of Hailey and Bellevue (Figure 7). The closest domestic well to the site was located at the bottom of Red Elephant Gulch, directly down gradient from the site. The well was sampled and preliminary results from a related report indicate the water quality from this well has not been impacted from up gradient sources (START, 2007).

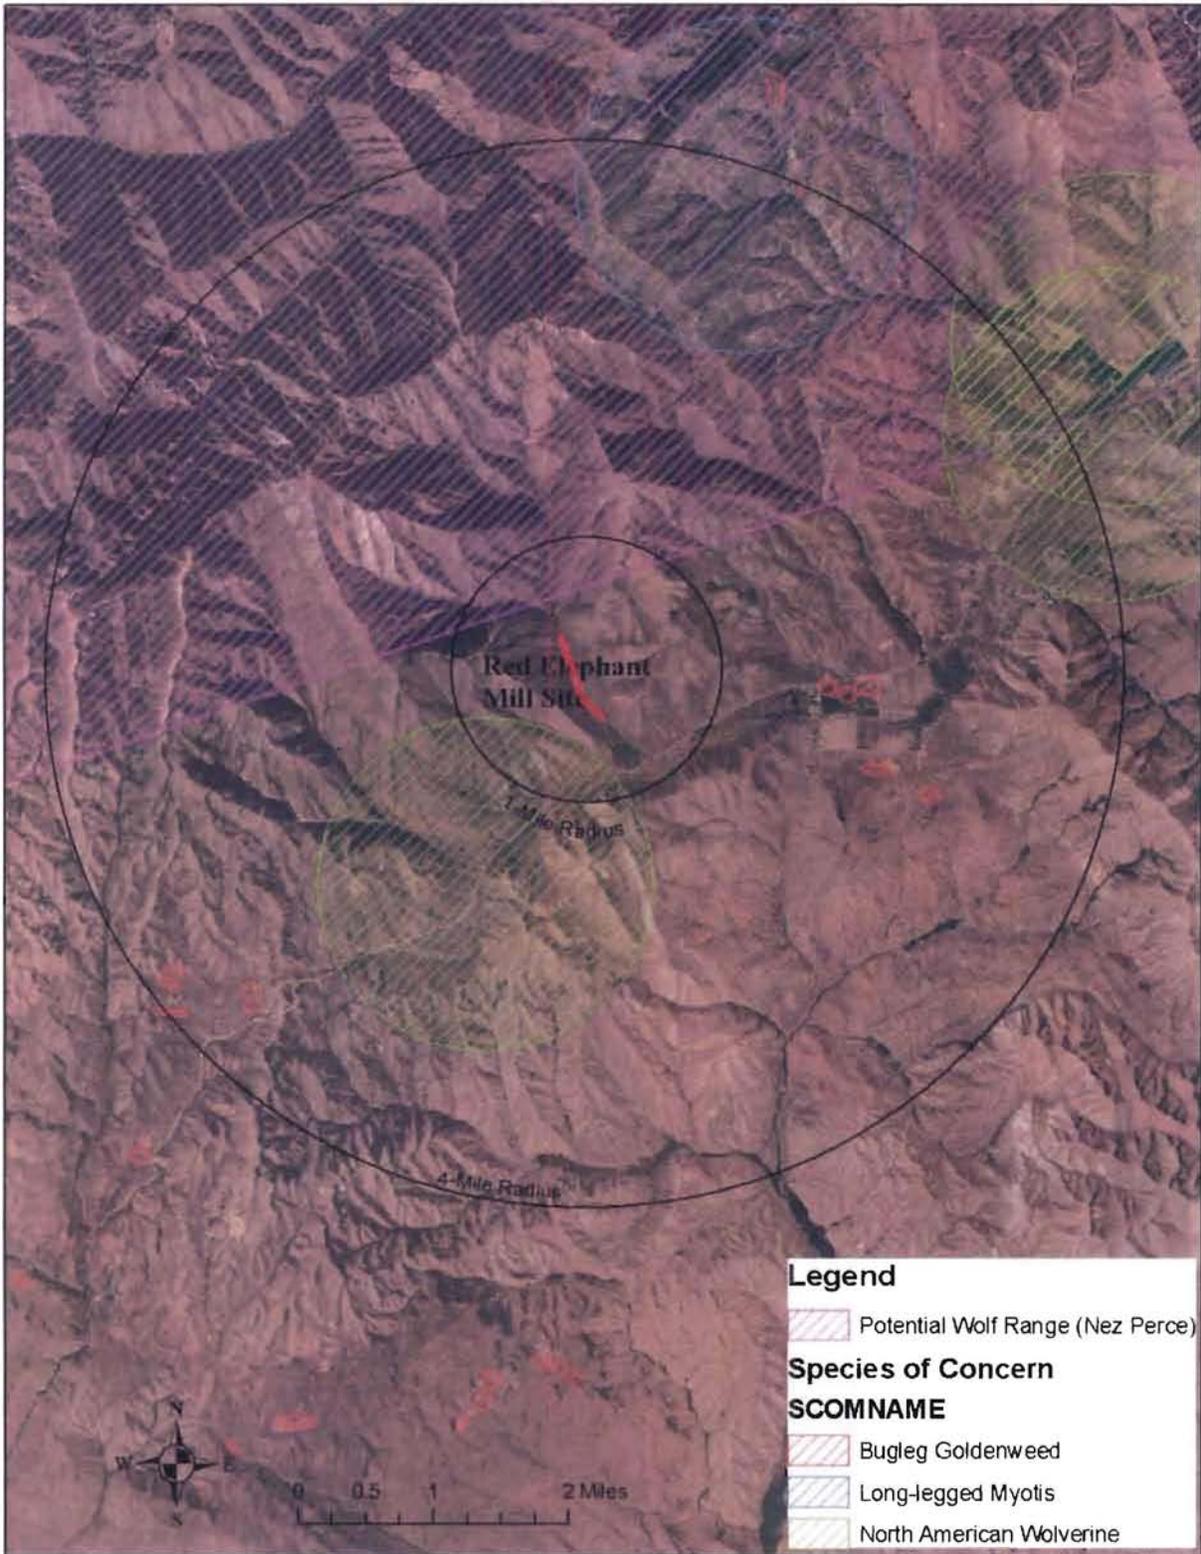
Figure 9. Sensitive species identified in the vicinity of the preliminary assessment site.

Bugleg goldenweed was the only plant species in the area were listed as a species of concern (F&G, 2002) within a 4-mile radius of the mining site (Figure 9). Animal species listed as a species of concern that are located within a 4-mile radius of the site include Gray Wolf, North American Wolverine, and Long-legged Myotis (F&G, 2002).
