State Lands Mill Site Preliminary Assessment Report

Blaine County
State of Idaho

Department of Environmental Quality

March 2007

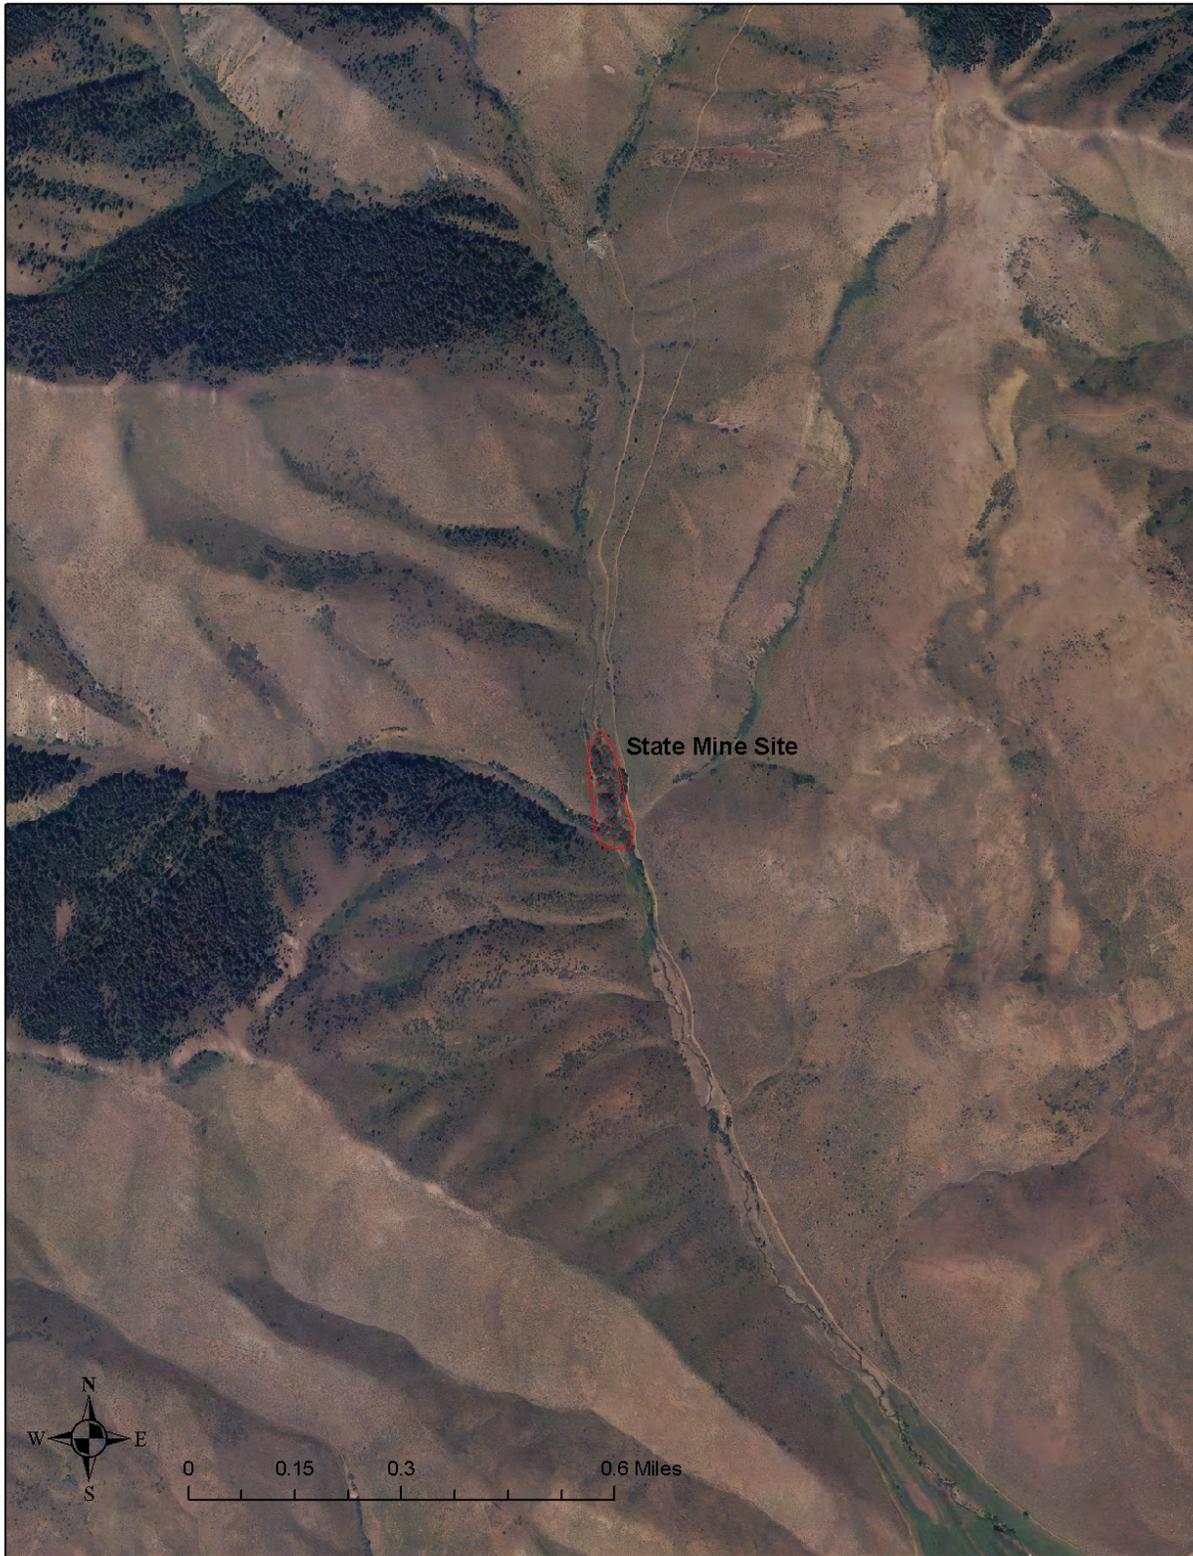
Figure 3. Aerial photograph of the State Lands Mill Site Area.

Figure 2 shows the topography around the site, and Figure 3 provides an aerial view. The mine facilities can be reached from Hailey by driving east along the Croy Creek Road, then north along the Red Elephant Gulch Road. No locked gates on the small road leading to the site are present to control public access; however, *no trespassing* signs are posted along the roadway through the entire site to limit the amount of human activity that may occur on the site. Throughout Red Elephant Gulch, numerous indications of

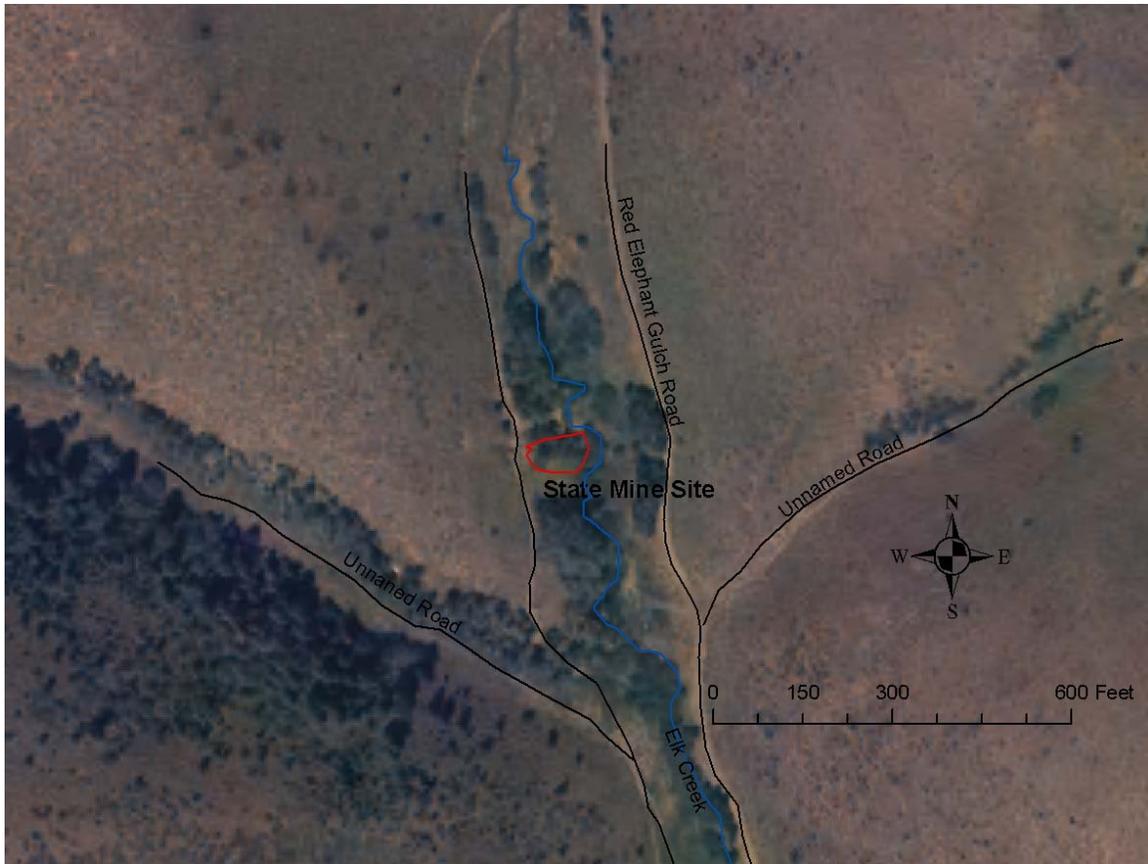
Figure 4. Aerial photograph of the State Lands Mill Site.

The State Lands Mill is located in the lower reaches of Elk Creek in Red Elephant Gulch (Figure 4), about one mile above the confluence of Elk Creek and Croy Creek. The Mill consists of fine-grained tailings, the wooden remains of a small structure and ore bin. The Mill area, which flanks Elk Creek, is heavily vegetated and measures approximately 75 feet long by 50 feet wide.

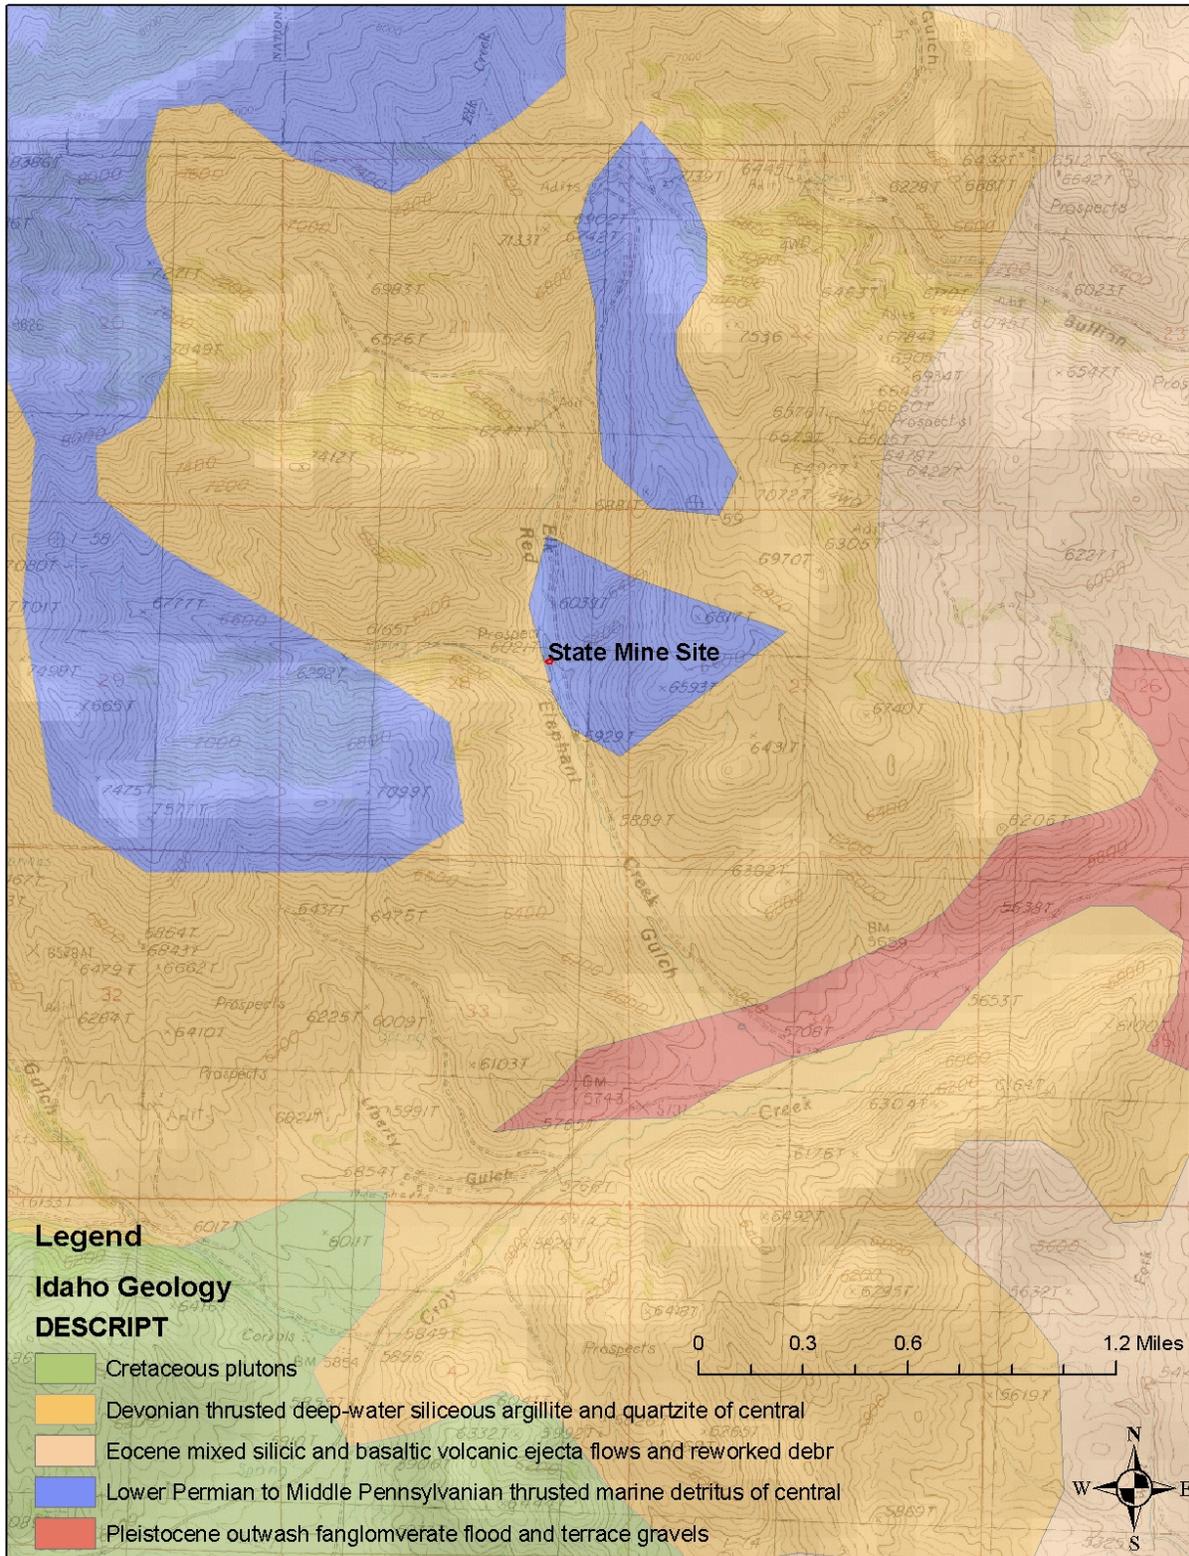
Figure 5. Geologic map of the State Lands Mill site area.

The most obvious and significant structural features of the area are the major faults or fault zones which divide the area into a number of distinct blocks...The age of the oldest faults are to be placed as pre-intrusive and possibly all the major faulting is pre-intrusive...All of the major faults are probably pre-mineral as well as pre-intrusive.

Southwest of the river the beds dip generally westward at inclinations that largely range from 20° to 40°. It's thus clear that the sediments form a broad anticline, of which the crest almost coincides with the Big Wood River Valley...The underlying Milligen formations shows a wide range in local dip and strike...

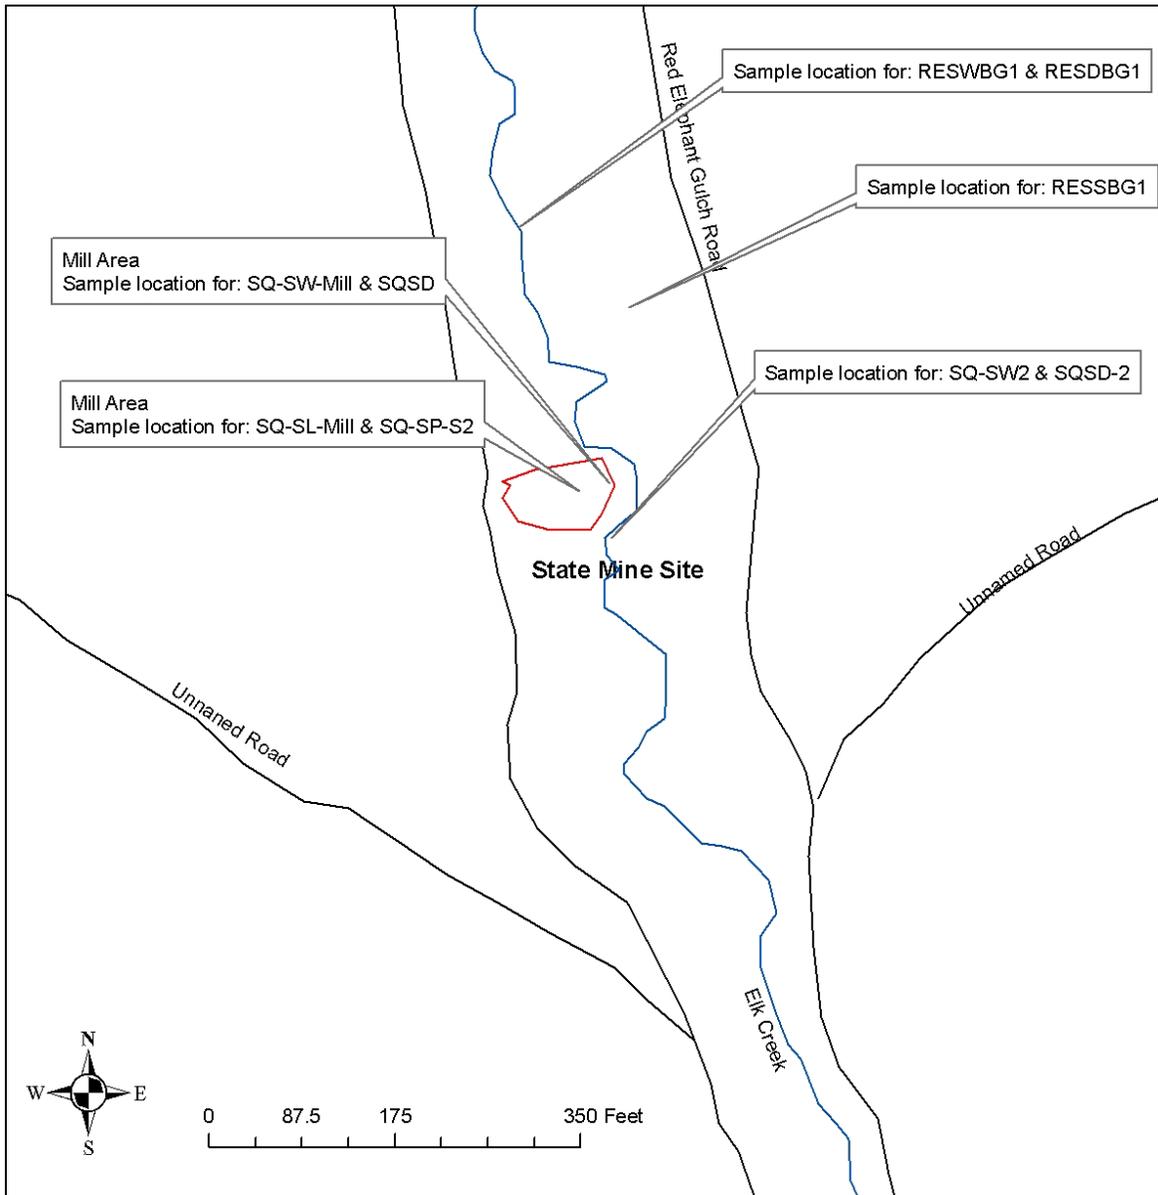
Figure 6. Small-scale sketch of the State Lands Mill site and environmental sampling locations.

As a result of an interview with the site owner regarding potential remediation efforts, DEQ conducted a site investigation on July 10, 2006 and September 14, 2006, which included a visual inspection of the State Lands Mill site and collection of three (3) water samples and six (6) soil and sediment samples (Figure 6).

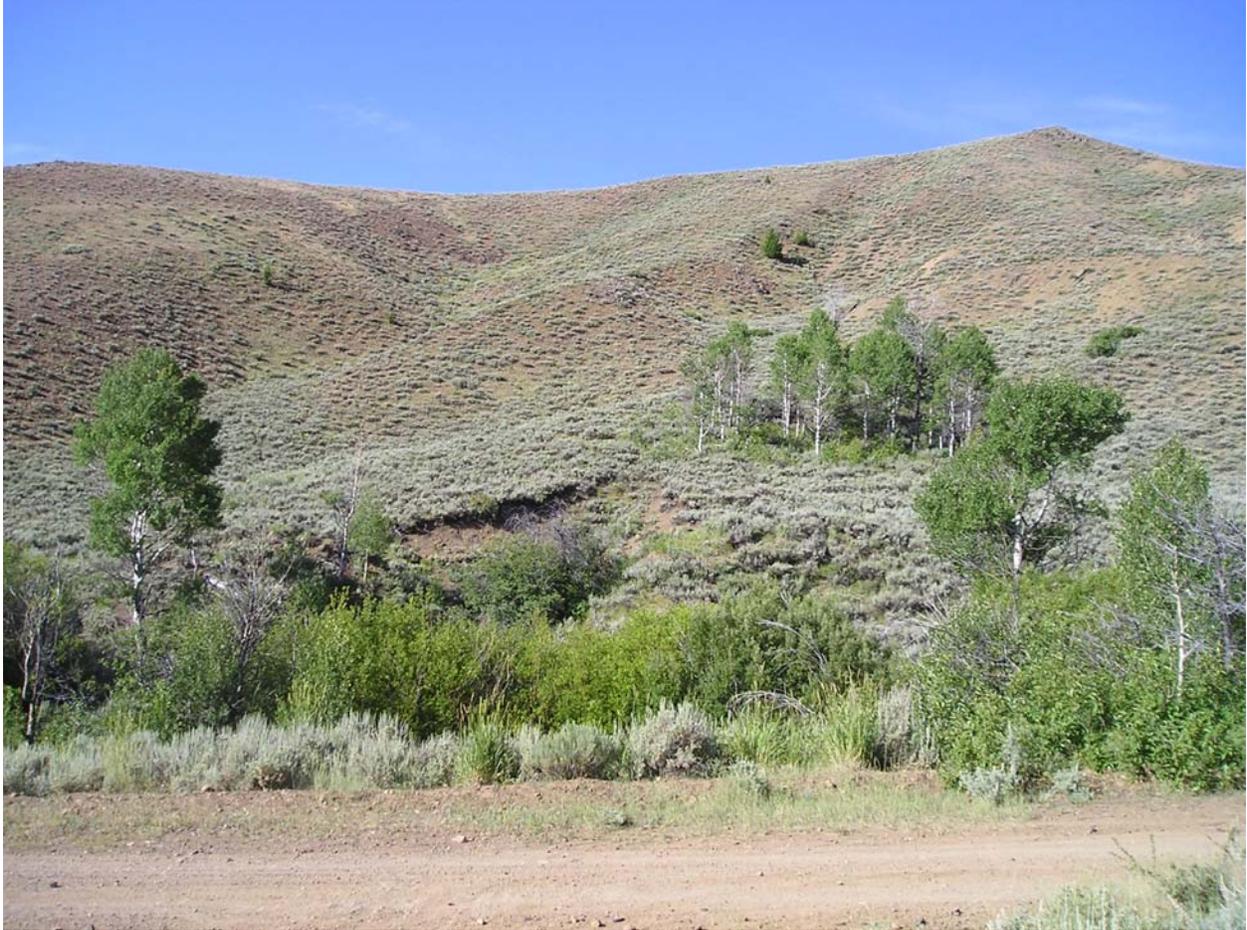
Photo 1. View looking east at the State Lands Mill Site.

During DEQ's July 2006 visit, the volume of the mine waste piles associated with the State Lands Mill site were mapped at approximately 500 cubic feet. The area that the waste rock currently occupies is approximately 1 acre. The State Lands Mill site waste piles are located along Elk Creek, on the western side of Red Elephant Gulch Road, which allowed DEQ personnel the ability to make good observations and assessments (Photo 1).

Associated with the mill site is one minor waste pile and scattered rubble that defines the boundaries of the site. The waste pile is located above the stream channel of Elk Creek. All former structures at the site have been reduced to scattered rubble or removed.

The State Lands Mill site has one significant waste pile that was inspected during the DEQ site visit. The remainder of the site is covered with vegetation, wood debris, a concrete foundation, and metal debris.

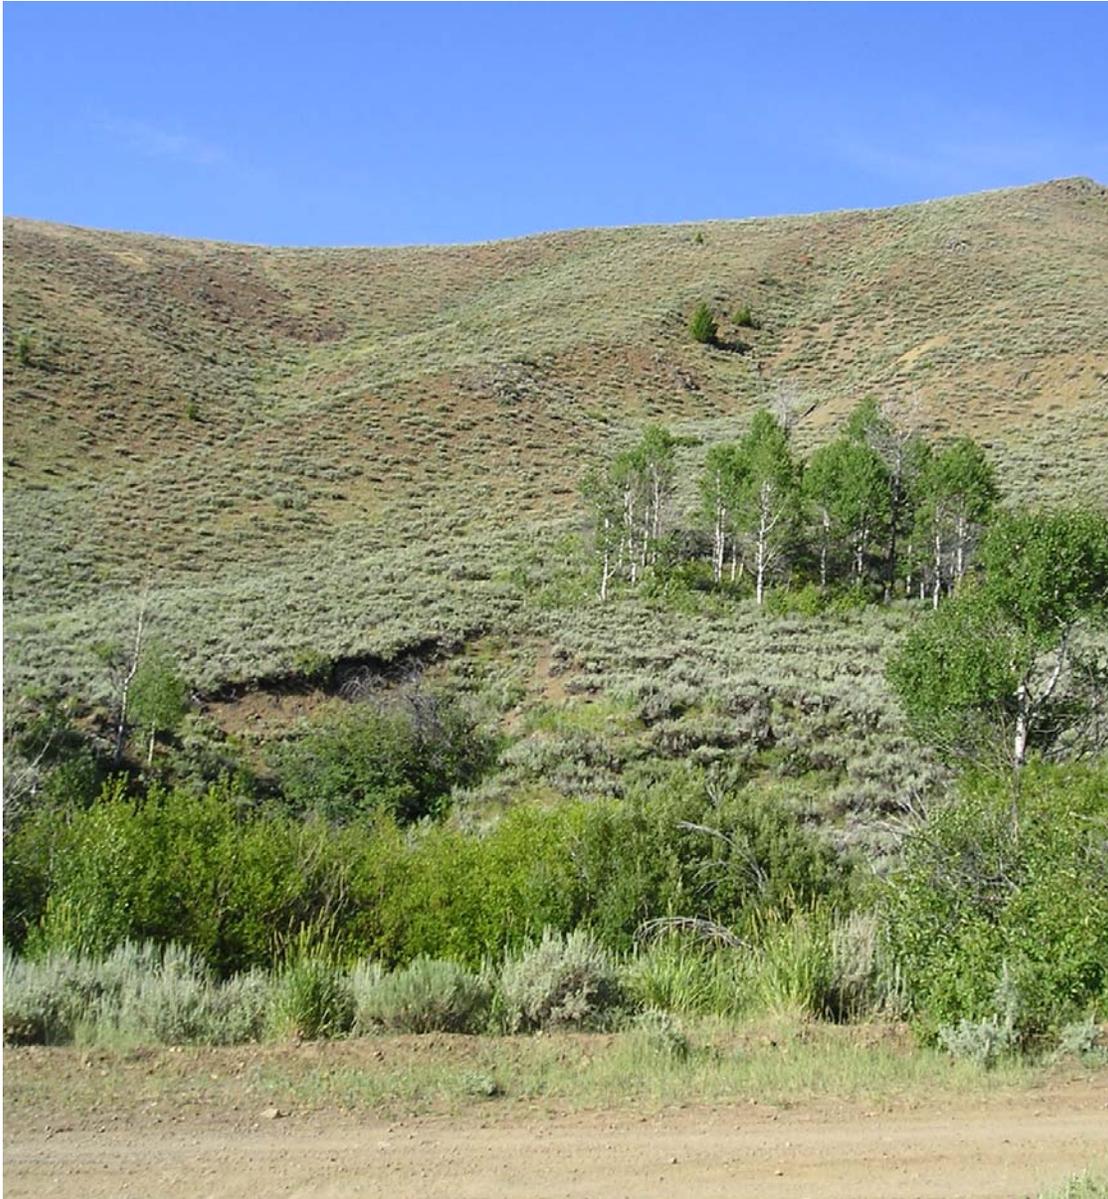
Photo 2. View looking east on the State Lands Mill Site.

The waste pile at the site is located on the east side of the drainage, above the flood plain for the north-south flowing Elk Creek. The dimensions and structure of the waste pile vary, as the material appears to be remains of a pre-existing milling operation. Generally, the waste pile was approximately 175 feet long, 50 feet wide, and 5 feet thick. Elk Creek currently flows near the waste pile, and runoff across the contaminated soils is evident.

The composition of the waste pile consisted of silt to coarse gravels, varying from light gray to dark brown in color. Less than 10% organic material was observed in the samples. No distinct segregation of the composition of the waste pile was observed as it appears the tailings have been partially re-worked during the milling operations.

One area of the waste material appeared to be ore grade material and was considered the remains of the stock pile used at the mill. The remainder of the site appeared to have multiple colored sediments, wood debris, metal debris, and the remainder of a concrete foundation.

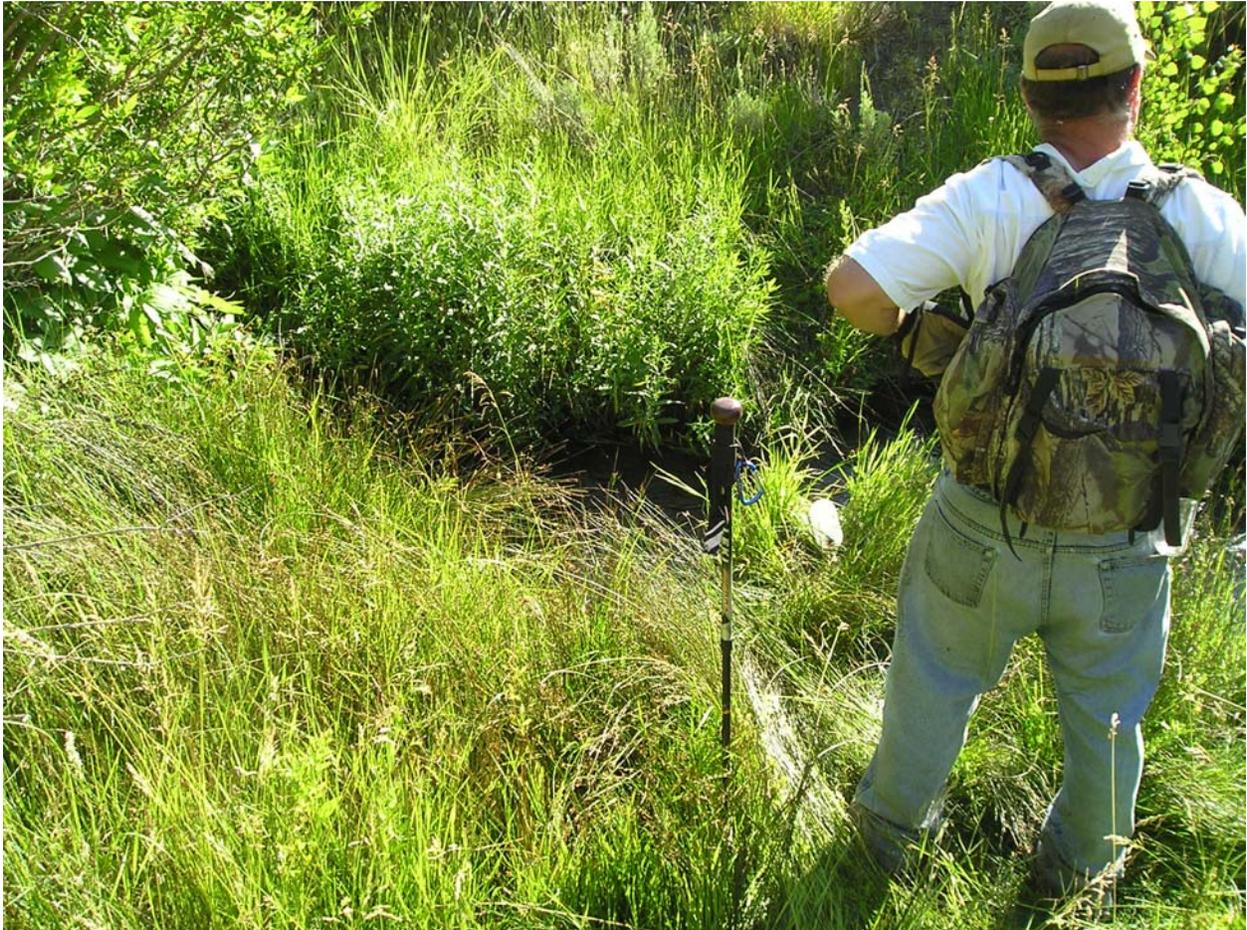
Photo 3. View looking east across Elk Creek at the sampling location for samples RESWBG1 and RESDBG1. This location is upgradient of the site.

Vegetation has slightly been re-established on the impacted soils. Small trees, grasses, and other shrubs have begun to cover the tailings pile (Photo 3). During the site visit, surface water was existing at the site above Elk Creek.

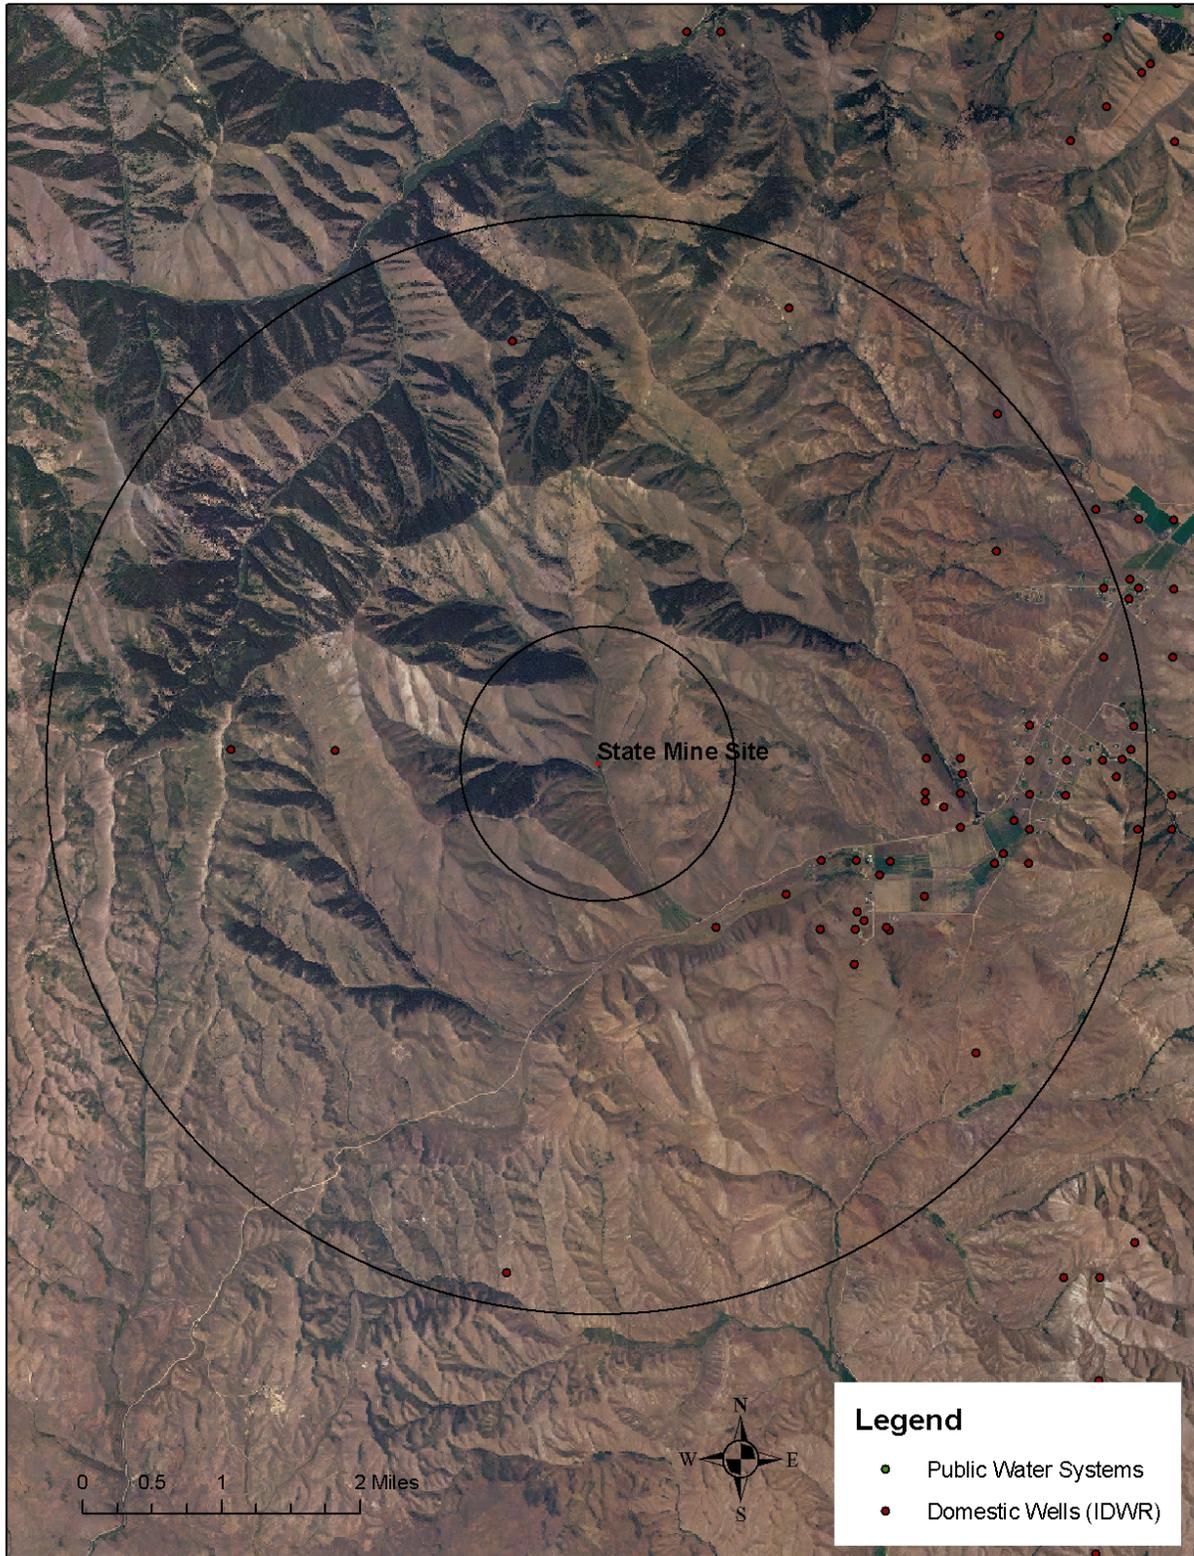
Figure 7. Domestic wells and Public Water System wells located with a 4-mile radius of the State Lands Mill Site.

According to Idaho Department of Water Resources July 2002 records, 93 private drinking water wells are reported to be located within a 4-mile radius of the site. The majority of these wells are located within the Croy Creek drainage, closer to the nearby towns of Hailey and Bellevue (Figure 7). The closest domestic well to the site was located at the bottom of Red Elephant Gulch, directly downgradient from the site. The well was sampled, and preliminary results from a related report indicate the water quality from this well has not been impacted from upgradient sources (START, 2007).

No public drinking water systems are located within a 4-mile radius of the site. The closest public water systems are located near the towns of Hailey and Bellevue, over five miles away. Based on historical monitoring data for the public water systems associated with the cities of Hailey and Bellevue, metal contamination does not appear to be a concern in the aquifer that supplies these systems (DEQ, 2006).

Due to the location of the majority of the wells, it is unlikely that any impacts related to the mining activities will be detected (DEQ, 2006). The wells that are located downgradient of the mine site, however, are of greatest concern. These wells are completed in the alluvial materials associated with the Elk Creek alluvial deposits, drawing water from a shallow aquifer directly below the site. Ground water impacts associated with this site would be a greater concern if more shallow wells were located closer to the site. Based on the analytical data collected from the closest well, and due to the current location of the other nearby domestic wells with respect to the site location, it appears these wells are a sufficient distance from the site to avoid any ground water impacts associated with this site.

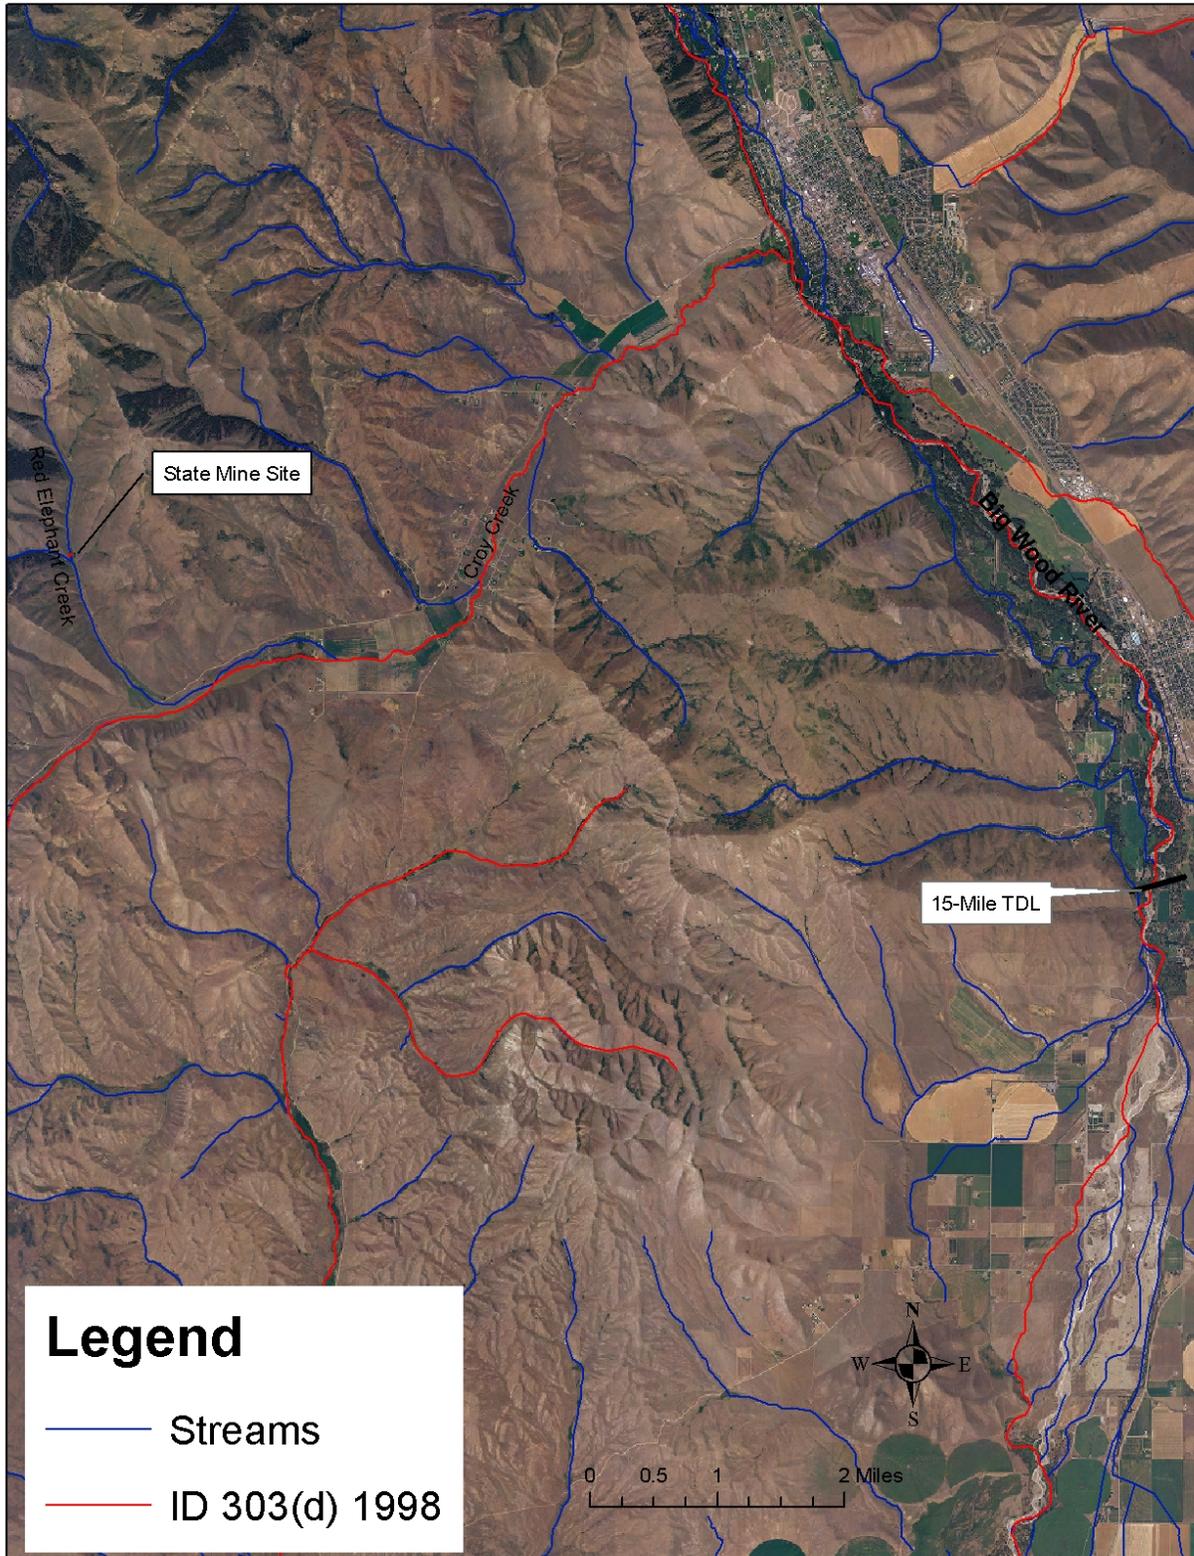
Figure 8. Surface water 15-mile Target Distance Limit from the Preliminary Assessment Site.

The State Lands Mill site area drains southward towards the east-flowing Croy Creek. Overland flow across or in the vicinity of the waste pile would flow directly into Elk Creek. Elk Creek is not currently listed on the EPA §303(d) list of impaired streams, but Croy Creek is currently listed for flow alteration, nutrients, and siltation.

Figure 8 depicts the drainage patterns of these water bodies as well as the 15-mile downstream Target Distance Limit (TDL) located on the Big Wood River.
