Independence & Saturn

Preliminary Assessment Report

Boise County
State of Idaho

January 2009

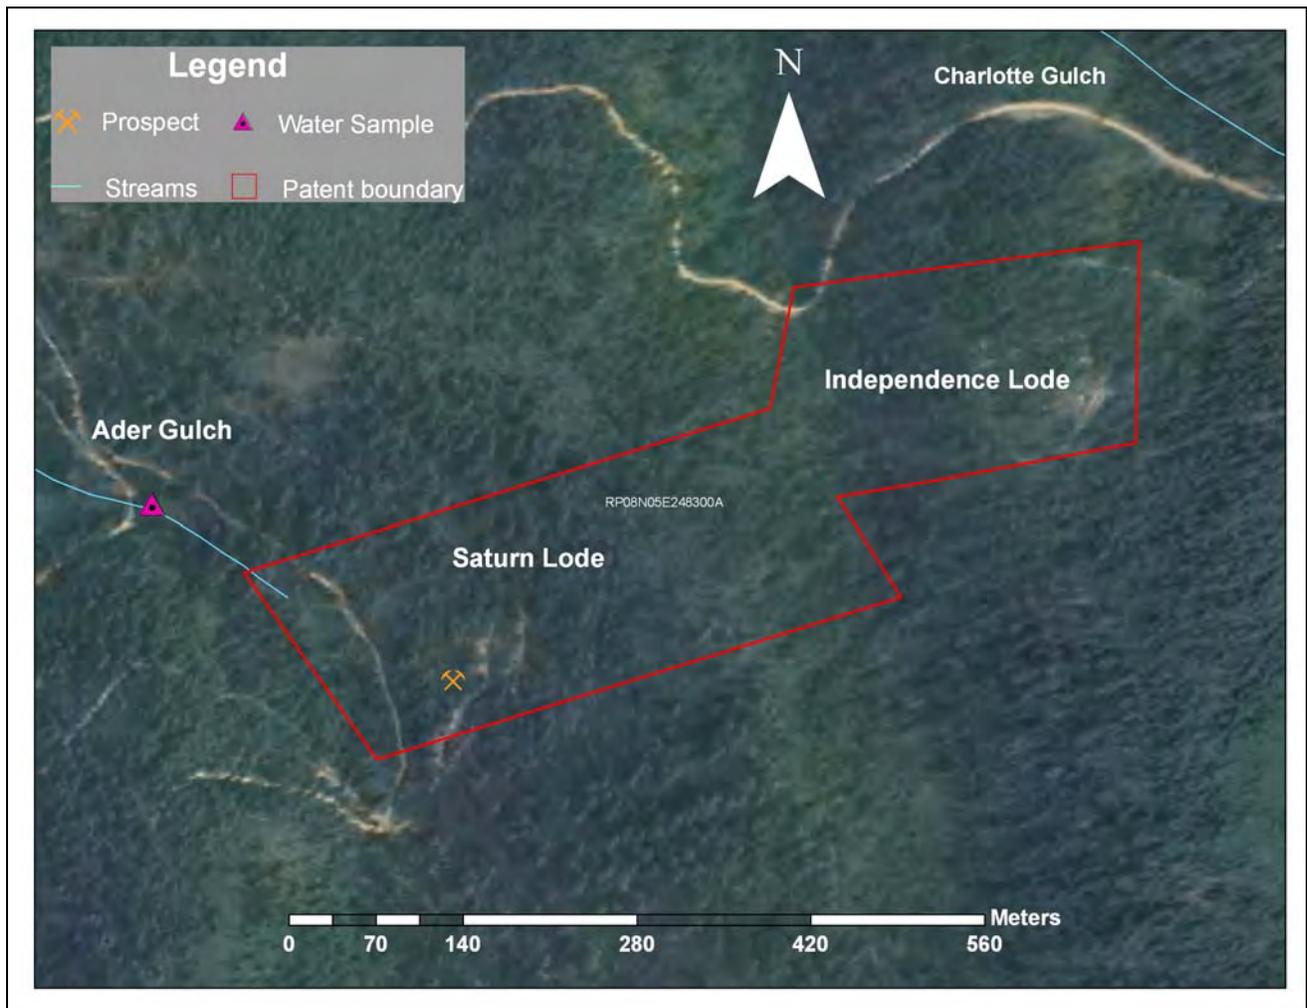
Figure 2: Patented Claims of the Independence & Saturn

Surface water field parameters were taken from the small creek in Ader Gulch. The water was clear and had no discoloration or odor. Field parameters taken at this point are as follows: pH = 7.73, Conductivity = 0.123mS/cm, Dissolved Oxygen = 12.75mg/L, Turbidity = 378 and Temperature = 18° C. The sample location is illustrated in Figure 2.

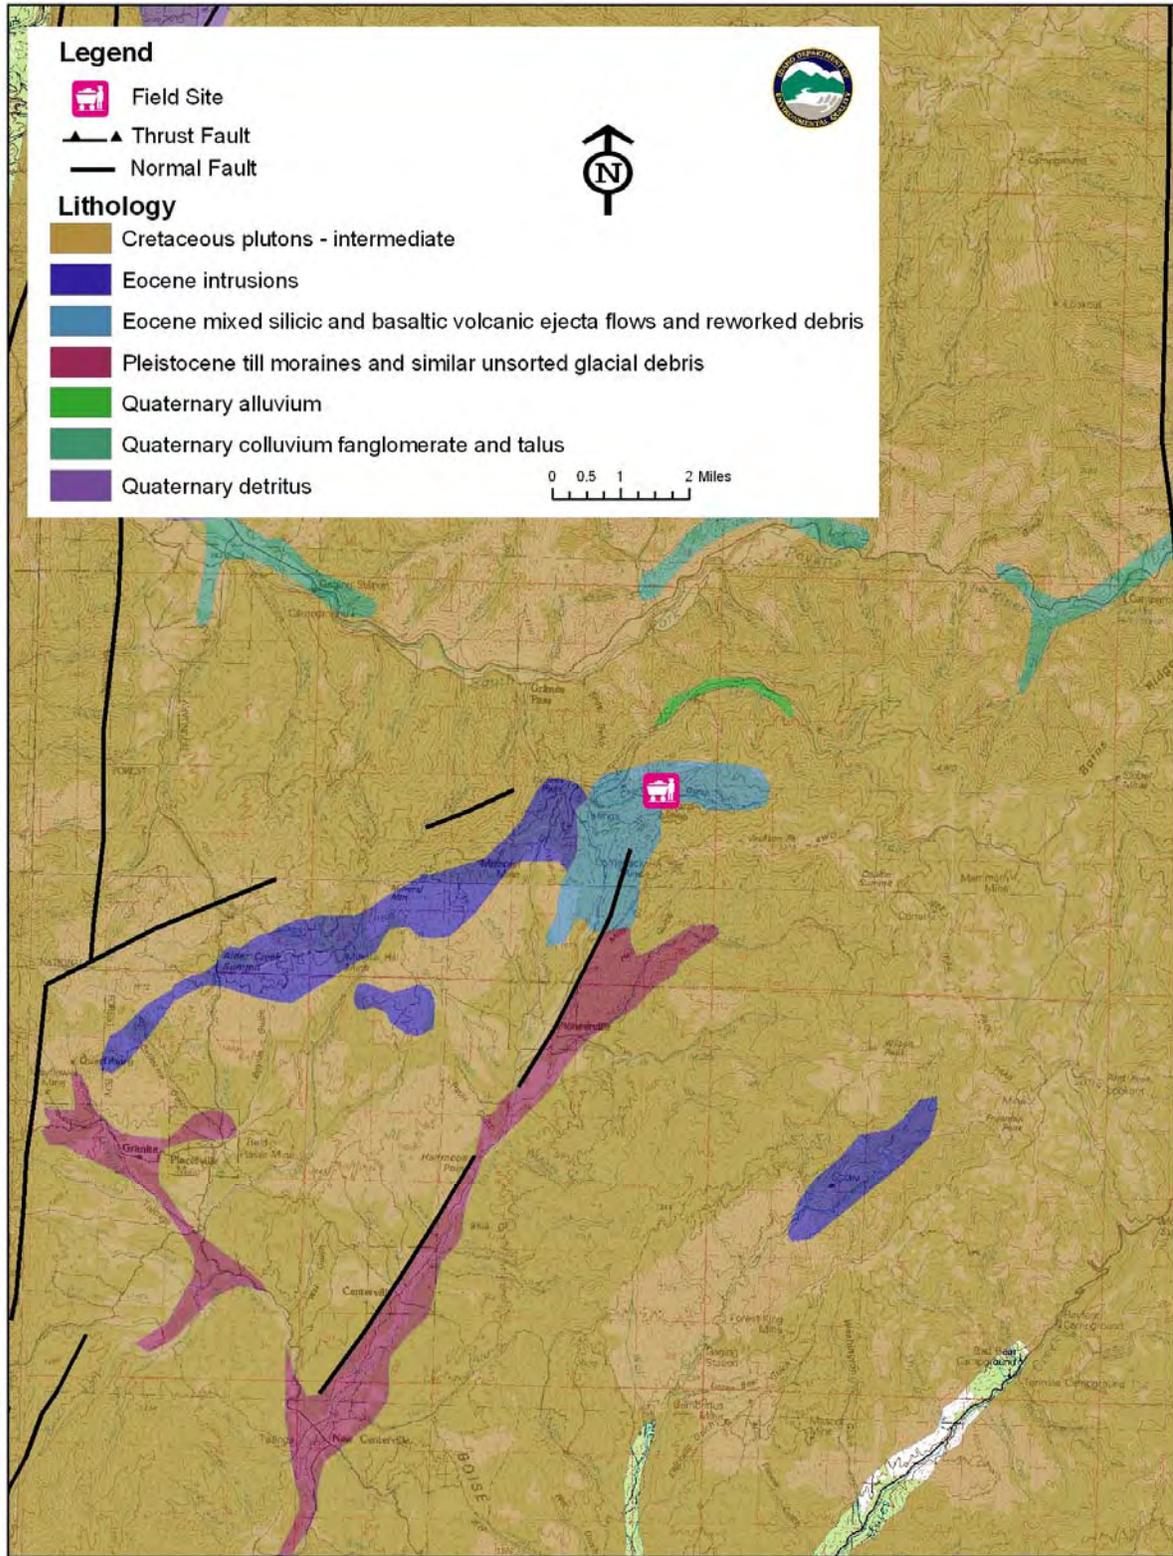
Figure 3: Geological Map of the Independence & Saturn Area

Figure 3 illustrates the lithology and structural geology at the Independence and Saturn and the surrounding area. Country rock in the area consists primarily of Cretaceous biotite granodiorite and muscovite-biotite granite (Kiilsgaard & McCarthy, 2001). Relatively large masses of Tertiary (Eocene) diorite and quartz monzonite intrude the granitic basement. Dikes, primarily rhyolite, generally follow a northeast trend. Northeast-trending faults of the Trans-Challis fault system cut the area into elongate blocks.

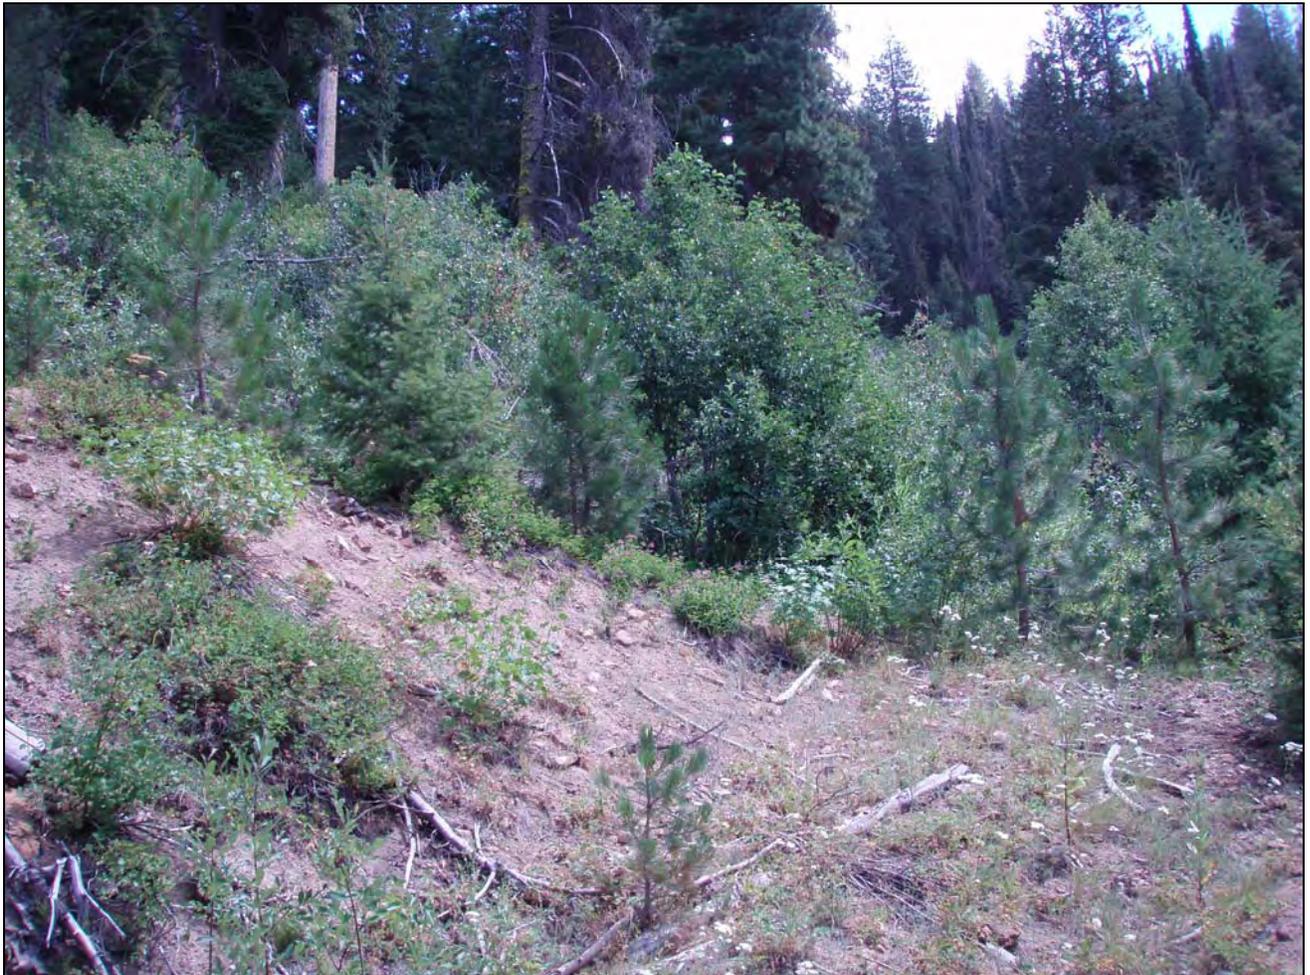
Photo No. 1: Looking east. Previously logged area on the Saturn claim.

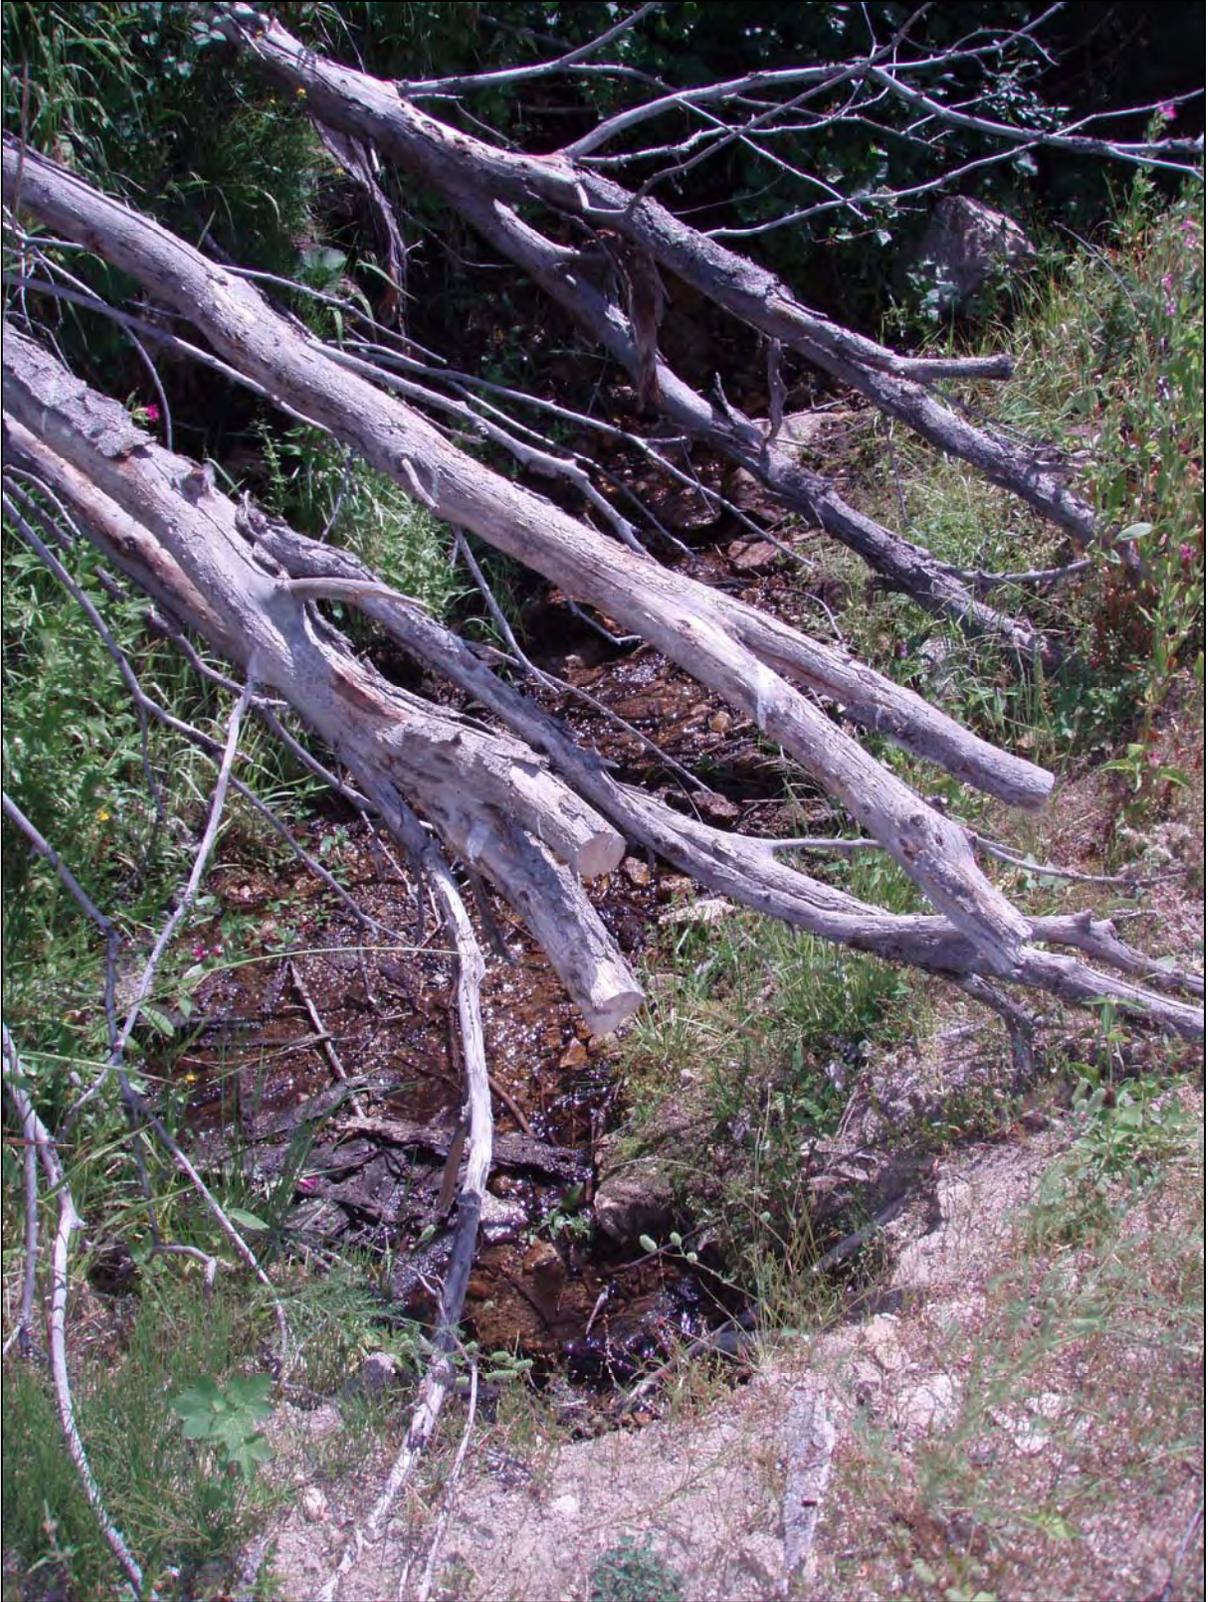
Photo No. 2: Looking north. A small creek flows down Ader Gulch, near NW corner of Saturn claim. Field parameters were collected at this location.

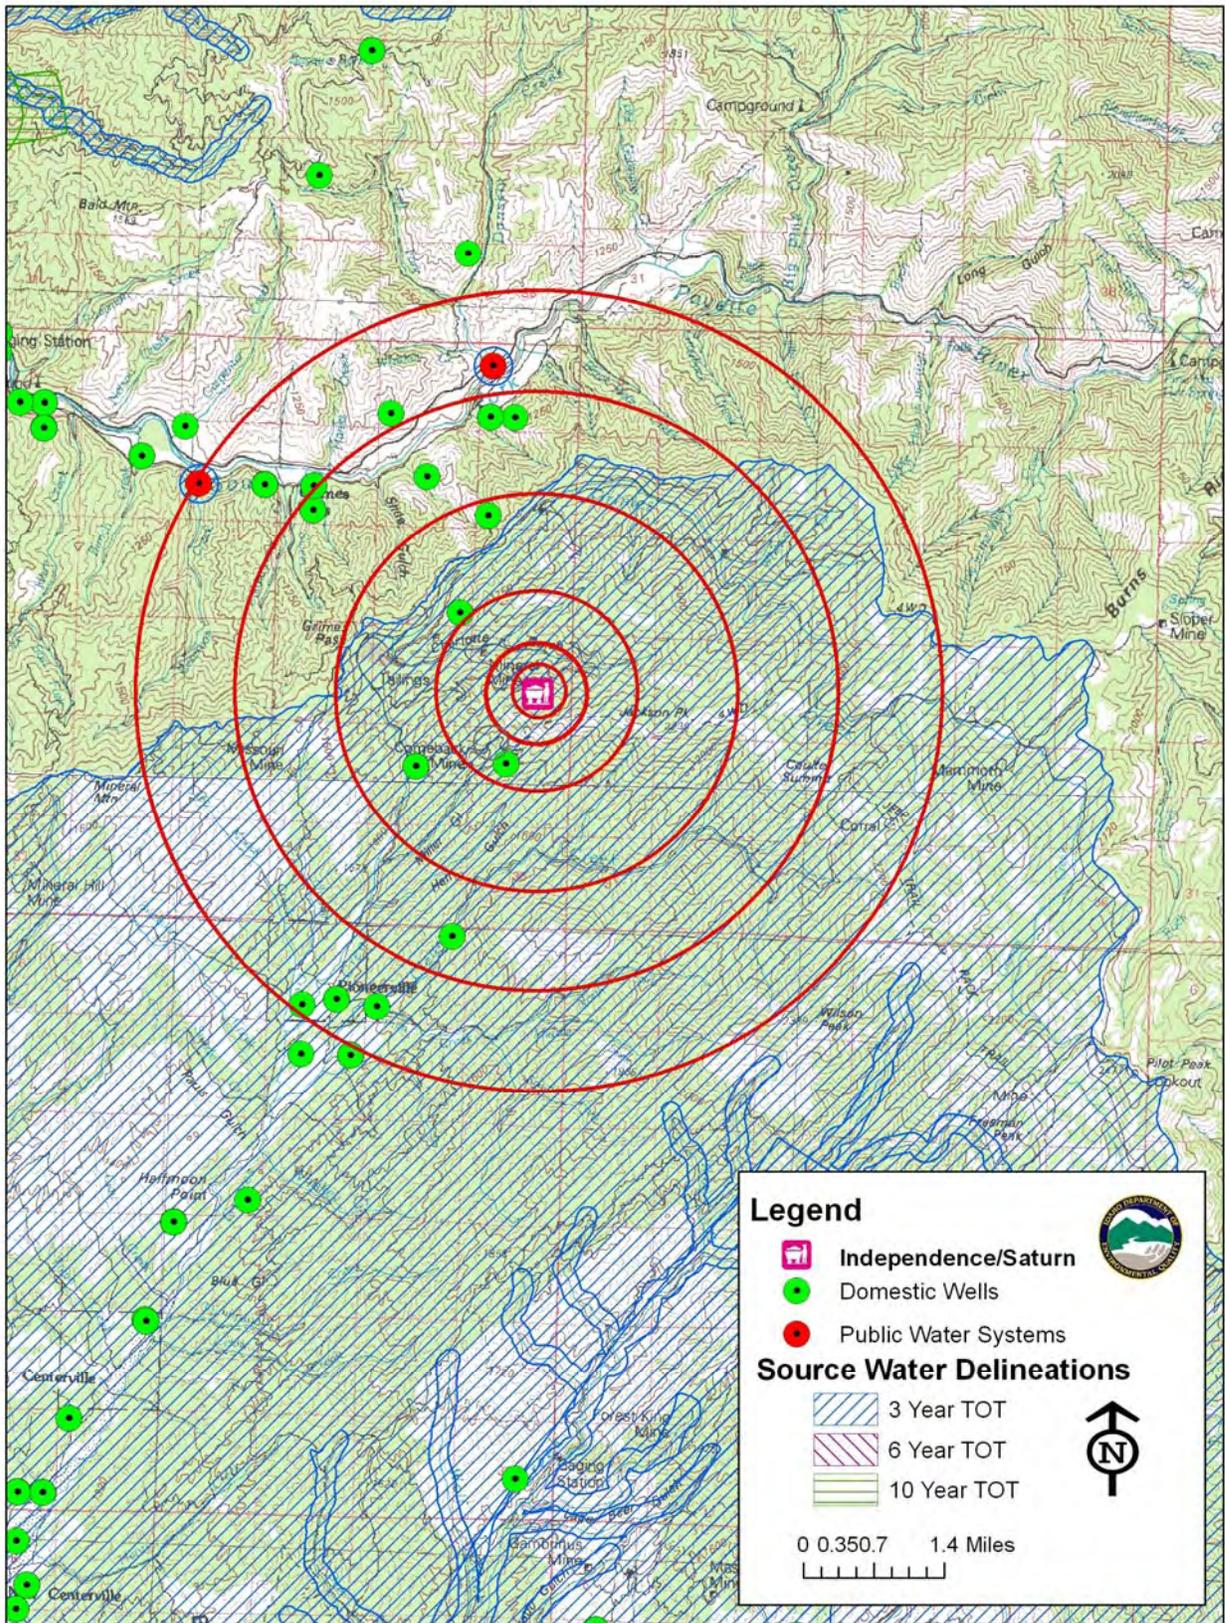
Figure 4: Drinking water wells within 4-mile radius of the Independence & Saturn mine

According to Idaho Department of Water Resources July 2002 records, there is one private drinking water well located within a 1-mile radius of the site; approximately 0.85 miles to the south-southwest near Miller Gulch. No wells were sampled during this assessment. Drinking water wells are illustrated in Figure 4.

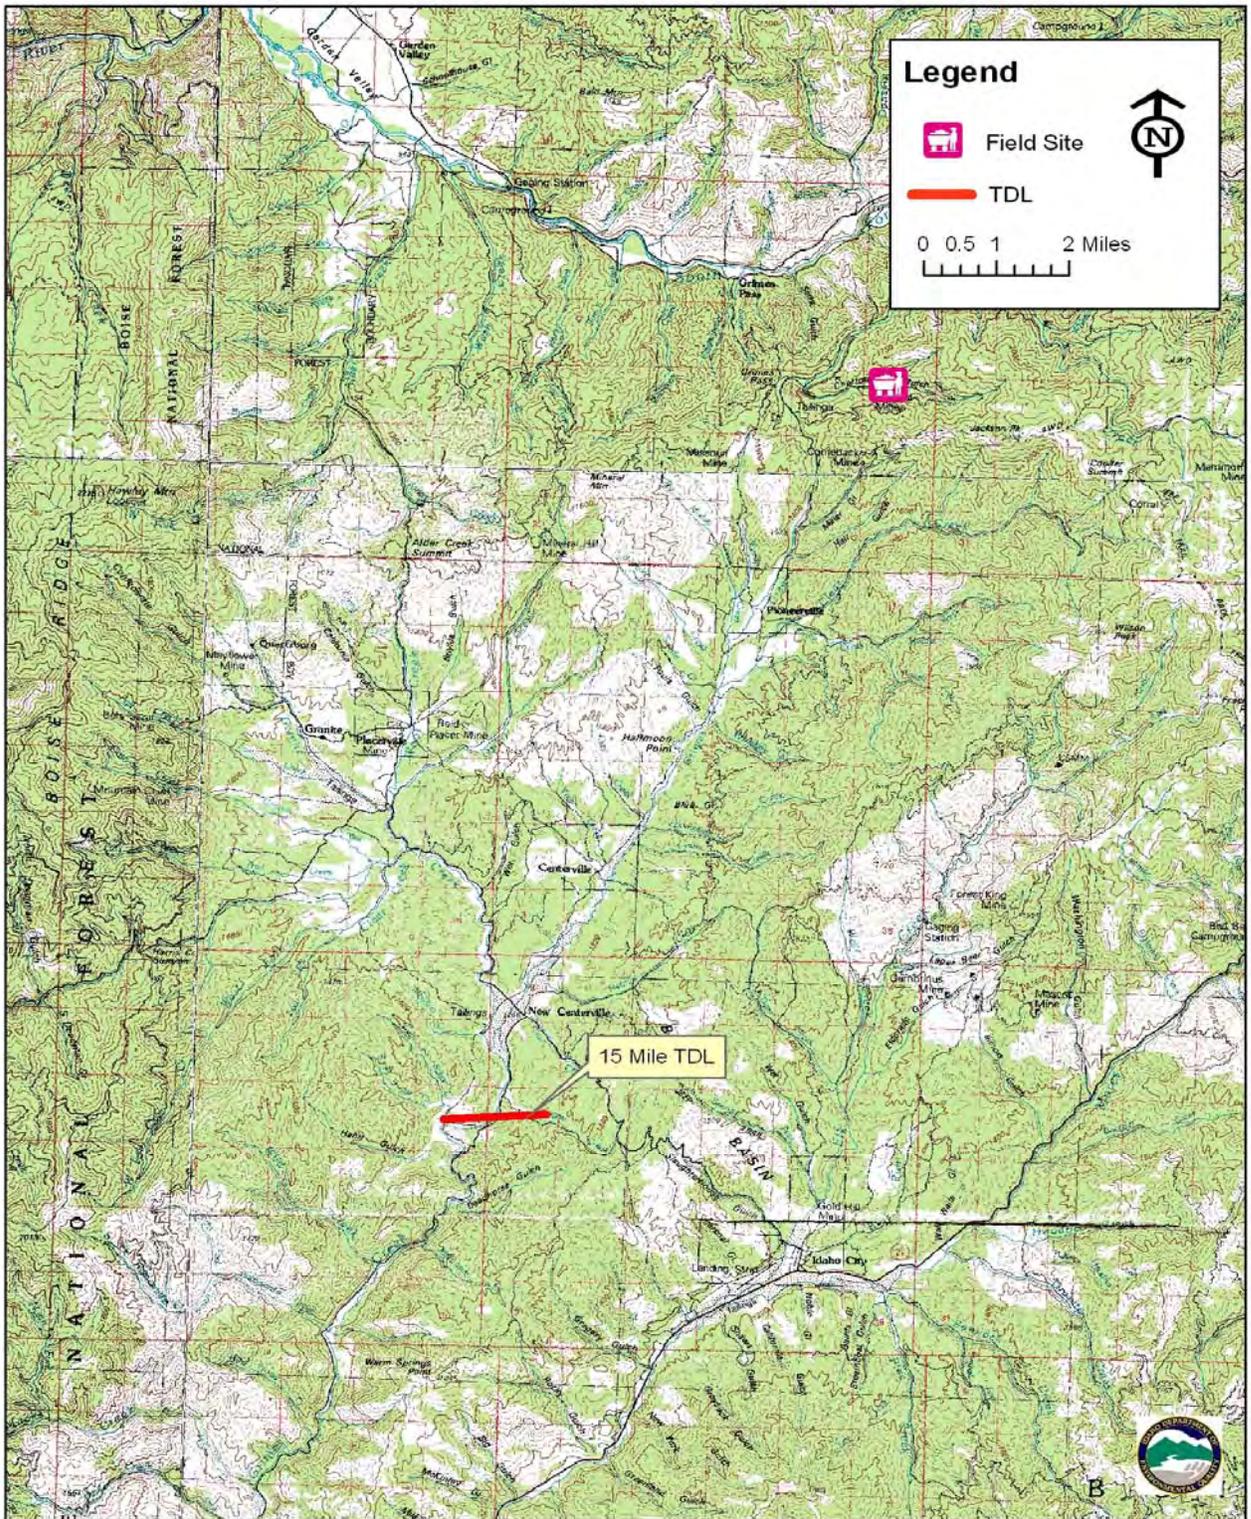
Figure 5: Surface Water - Target Distance Limit

Ader Gulch is a perennial tributary to Charlotte Gulch, a tributary to Grimes Creek (see Figure 5). Ader Gulch flows northwest where it merges with Charlotte Gulch at 0.6 miles which in turn merges with Grimes Creek at 1.7 miles. The Grimes Creek drainage contains several miles of stream alteration caused by placer mining operations. Placer tailings evidenced by gravel windrows line the channel of Grimes Creek and its many minor tributaries, including Charlotte Gulch. Grimes Creek briefly flows west then trends south-southwest before reaching the 15-mile TDL. Grimes Creek is an EPA CWA §303(d) listed stream for sediment and temperature, indicative of the extensive stream alteration caused by the placers.

Wetland surveys near the site were reviewed (USFWS, 2007) along with aerial photographs (see Figure 5). Wetland mapping data pertaining to Charlotte Gulch and Grimes Creek was not available. Therefore, no wetlands are represented within the downstream 15-mile Target Distance Limit (TDL).

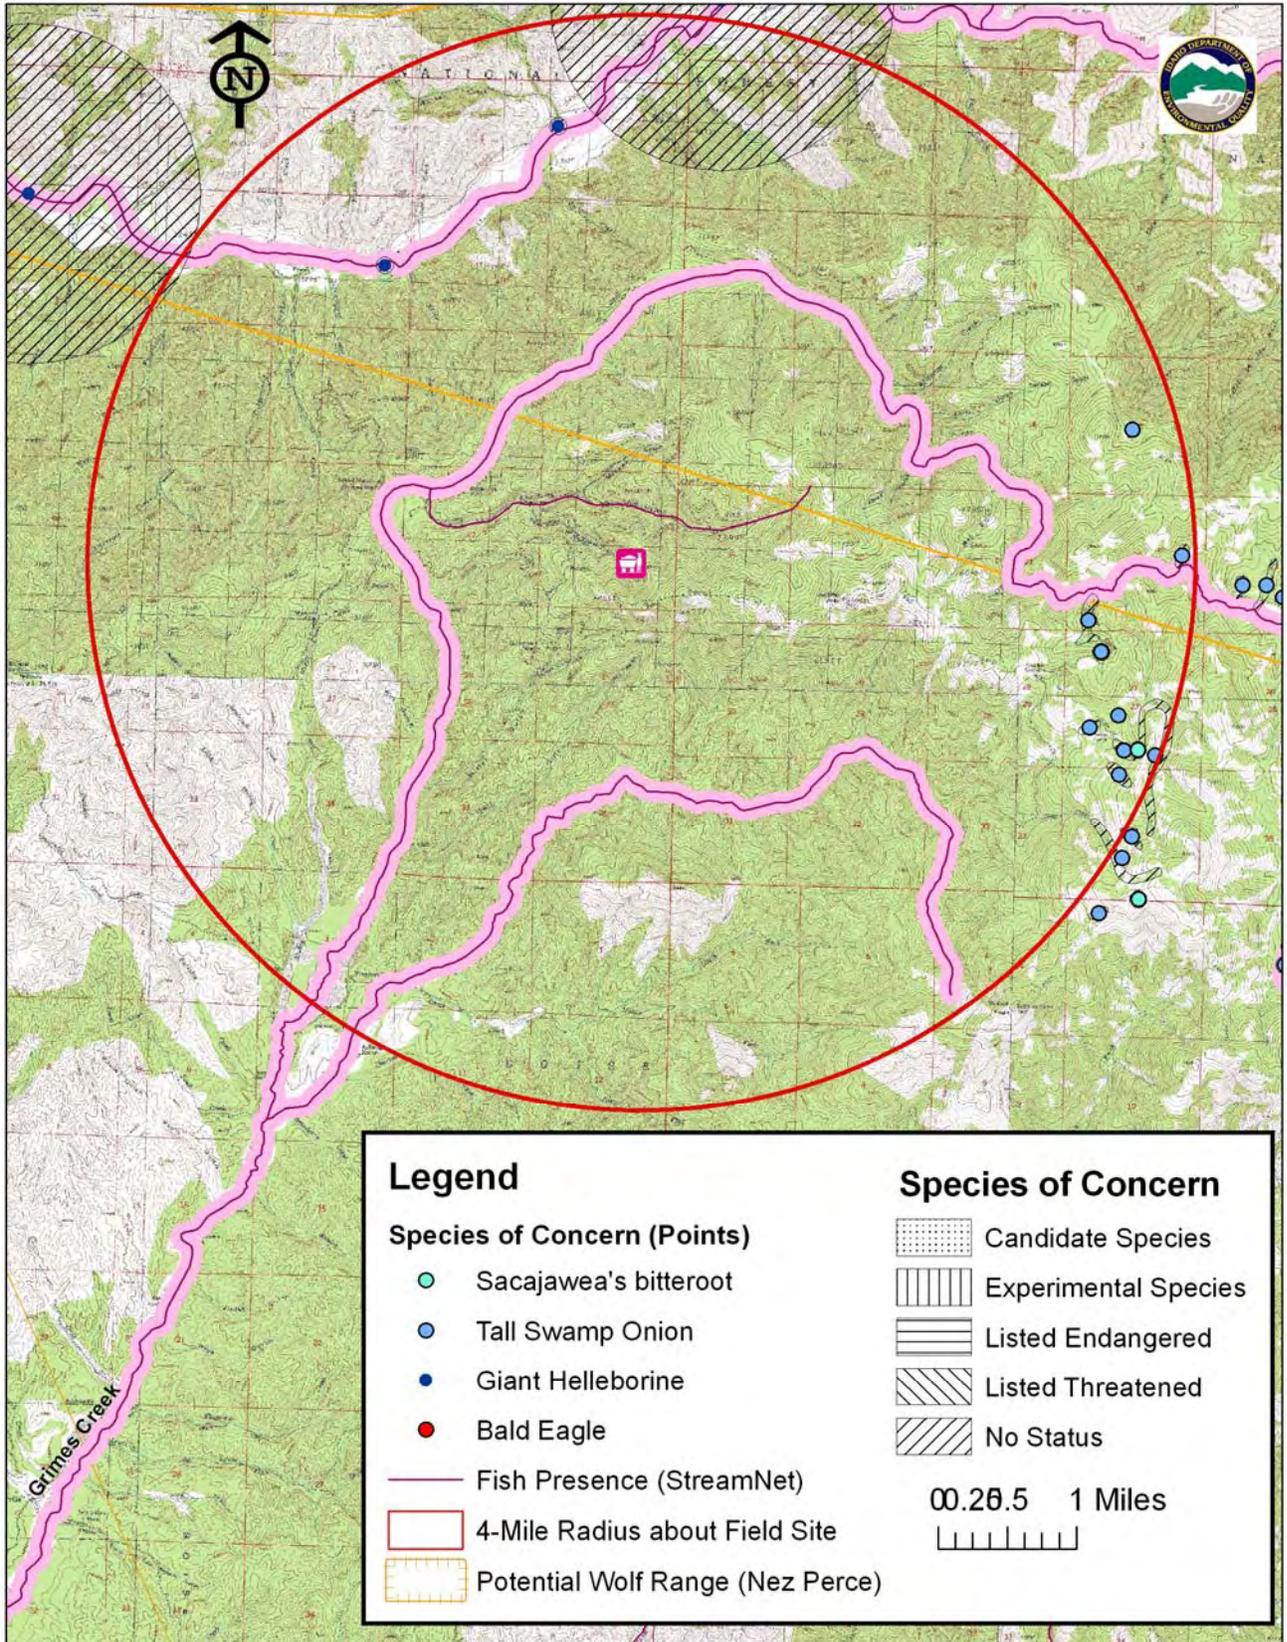
Figure 6: Species of Concern within 4-mile radius of the Independence & Saturn claims

Bald Eagle [*Haliaeetus leucocephalus*] wintering areas lie along the South Fork of the Payette River, to the north. Two state listed plant species; the Giant Hellebore orchid [*Epipaticus gigantea*] is found along the South Fork of the Payette River and the Tall Swamp Onion [*Allium validum*] flourishes in the headwaters of Grimes Creek. These relationships are illustrated in Figure 6.
