OSBORNE MINE
PRELIMINARY ASSESSMENT REPORT
BOISE COUNTY, IDAHO

STATE OF IDAHO
DEPARTMENT OF ENVIRONMENTAL QUALITY

October 2003

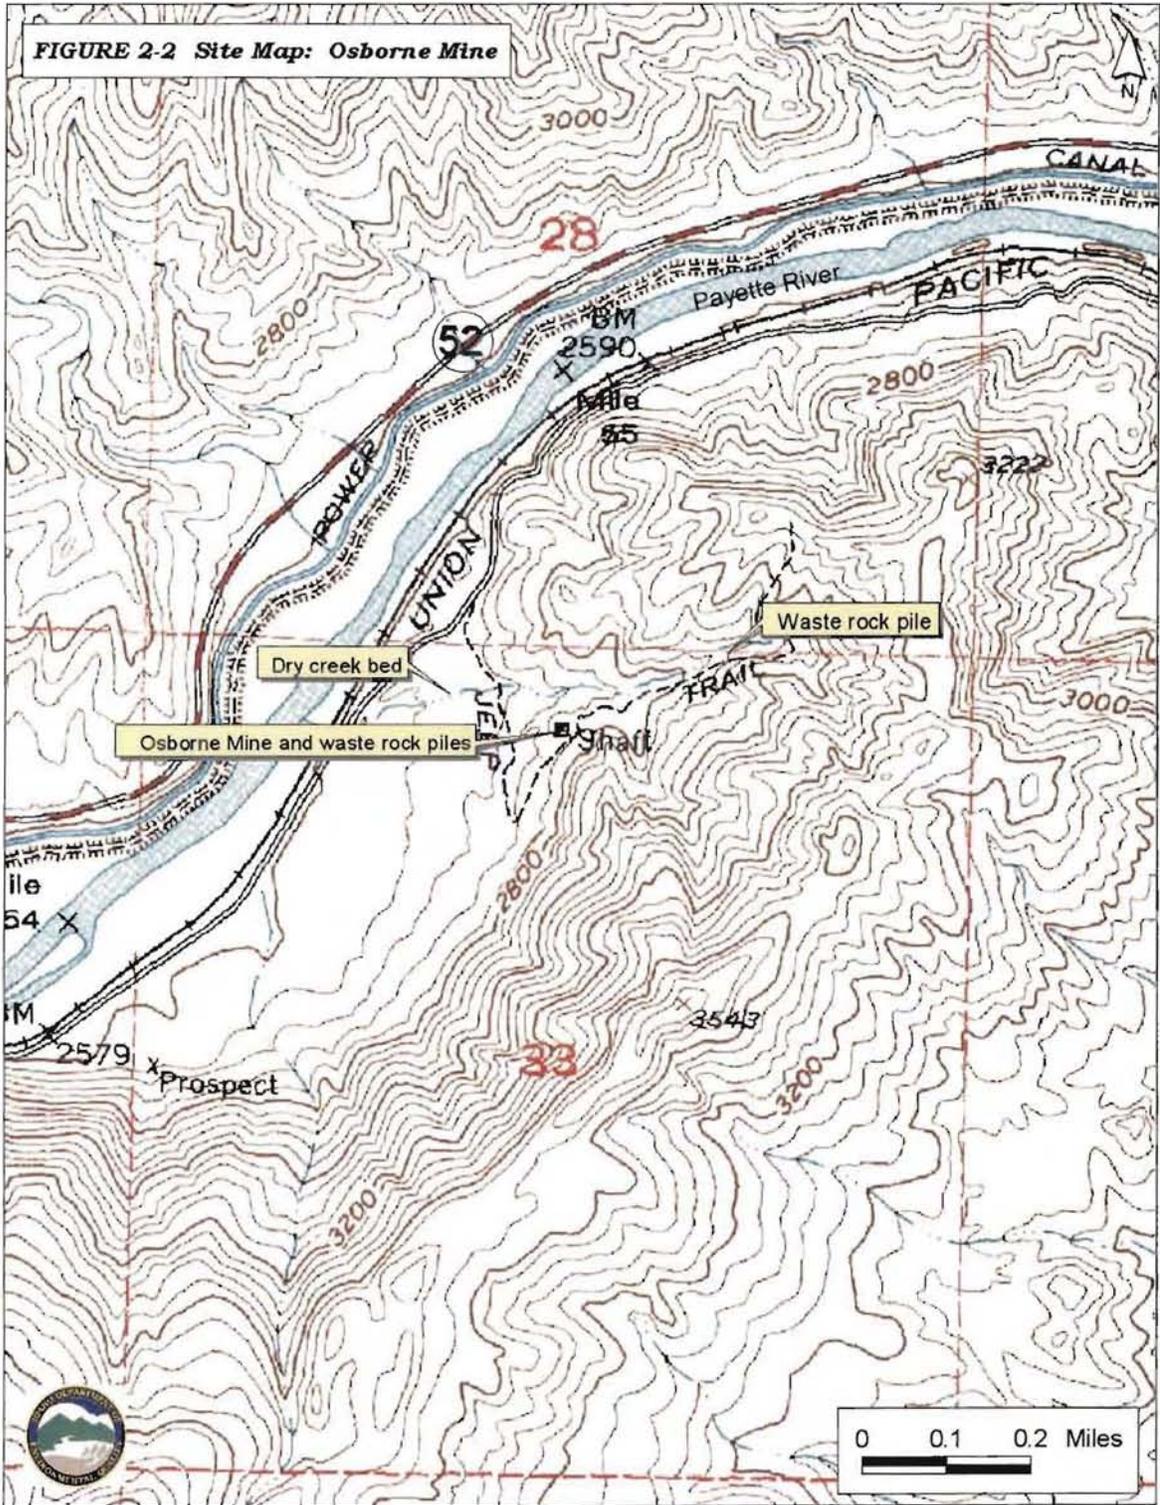
Site features include an old concrete foundation, a collapsed shaft, and three worked surface areas (see Figure 2-2, Site Map). Waste piles are located near two of the worked surface areas and immediately downhill of the shaft and foundation. Refer to site photographs (Nos. 1-5) in Appendix A.

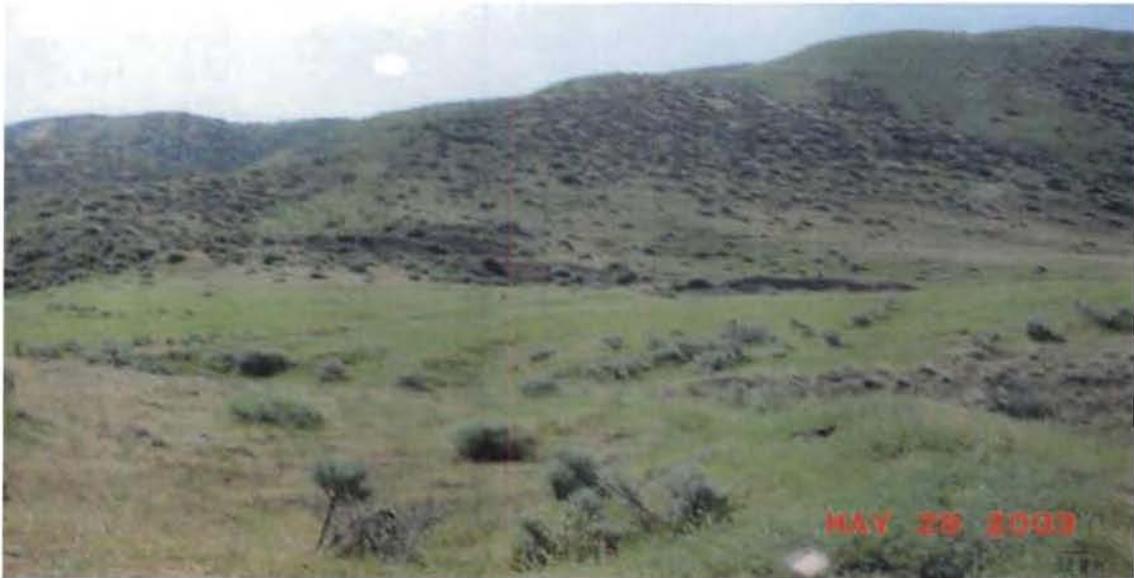
Photo No. 1

Looking east towards the former Osborne Mine shaft and waste dumps. Vegetation has covered up and stabilized most of the waste dumps. The dry creek bed is present in the foreground.

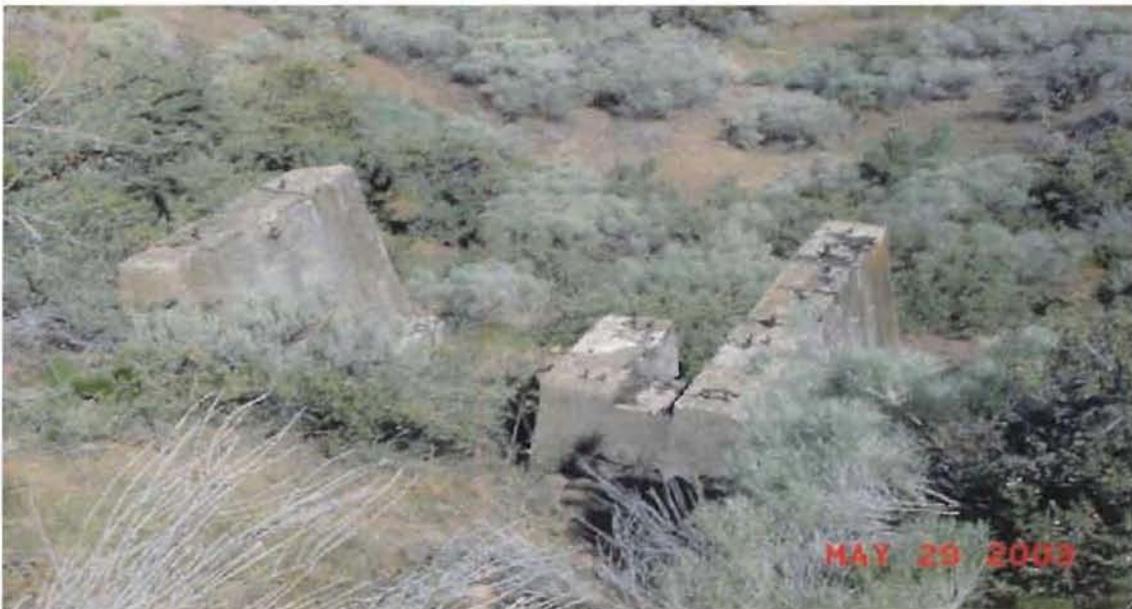
Photo No. 2

Looking west towards the concrete foundations and remnants of the inclined shaft of the Osborne Mine.

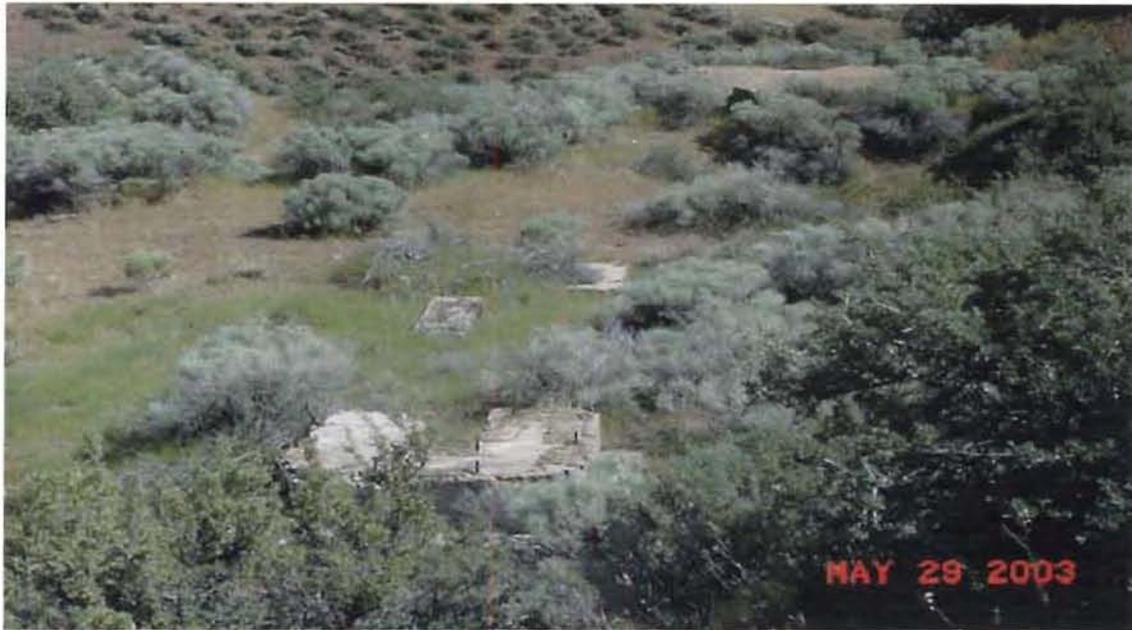
Photo No. 3

Looking Northeast towards the concrete remains of the former shaft at the Osborne Mine. Ephemeral stream is in the background.

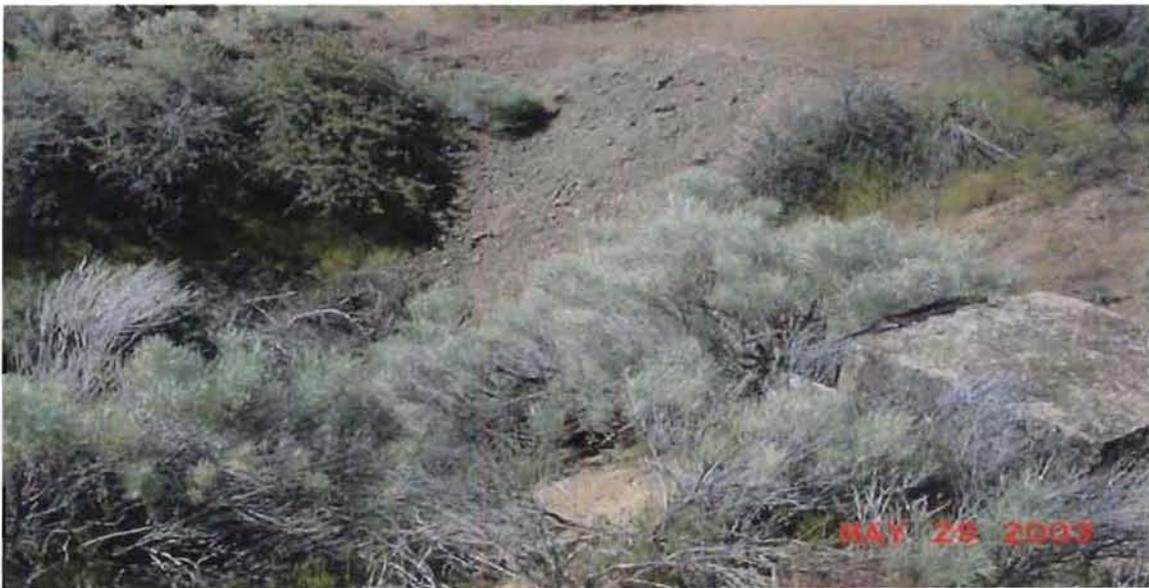
Photo No. 4

No surface water was observed during the site inspection in May 2003. The mine shaft is completely caved-in and no water appeared to be draining from the closed mine. A small spring was observed in one of the ephemeral stream's tributaries, however, it dried up within 50 yards. One potential Probable Point of Entry (PPE) would be the dry creek bed located north of the Osborne Mine shaft, which could hold run off from the waste piles before flowing west towards the Payette River.

Looking downhill onto the caved-in opening of the former shaft. No water was observed in or around the former shaft opening.

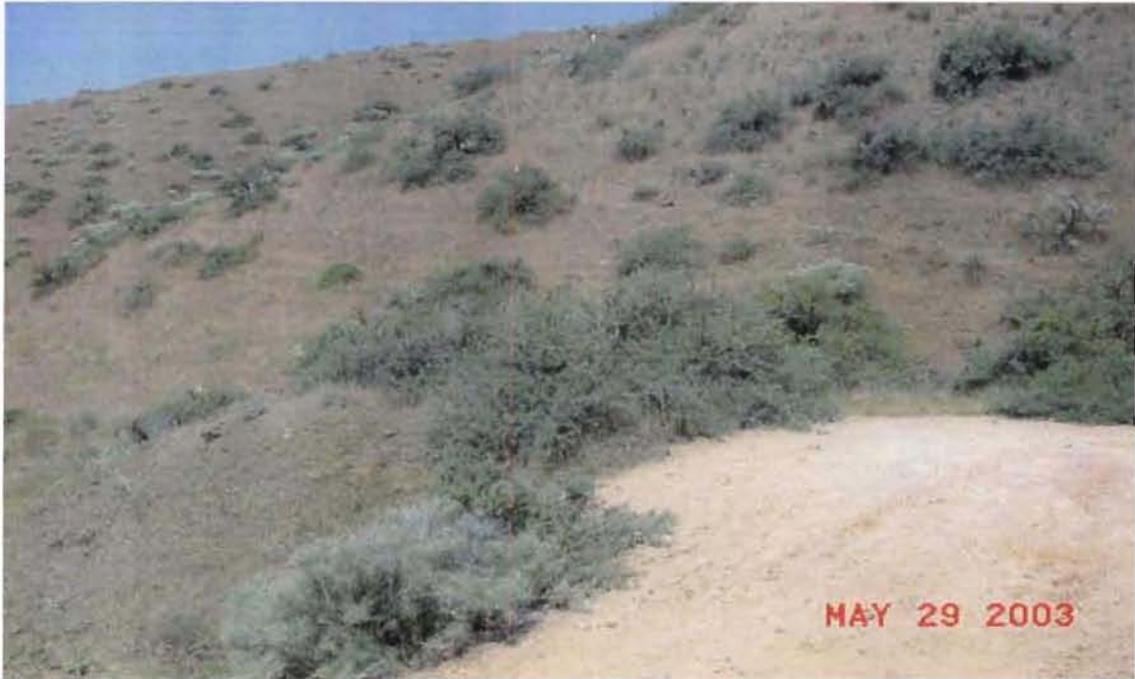
Photo No. 5

An opening was made approximately 400 yards up the gulch to the east-northeast. The outcrop is heavily iron-stained. The remaining waste rock pile is still visible near the dry gulch (see Appendix A, Photo No. 5). The second main lode lies south of the shaft. It has had the most development and has one drift 1,300 feet long. A third lode was opened in the bottom of the gulch about 100 yards north of the shaft.

Looking north towards the waste rock pile (in the foreground) located approximately 400 yards up the gulch from the Osborne Mine shaft. The mine survey marker is located on the slope in the background. The deer antler was found on this hillside.
