**REDBIRD MINE
PRELIMINARY ASSESSMENT REPORT
CUSTER COUNTY, IDAHO**

**STATE OF IDAHO
DEPARTMENT OF ENVIRONMENTAL QUALITY**

February 2004

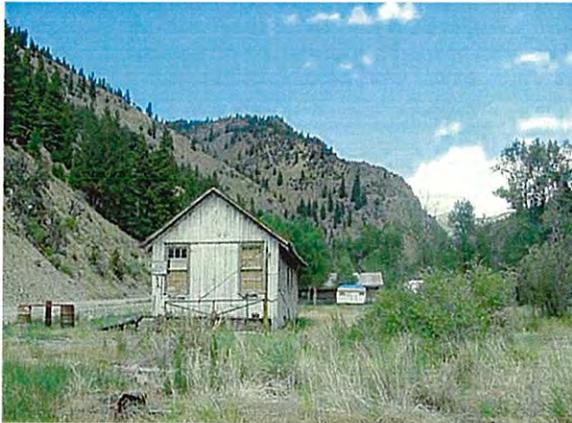
Shop building (left), office beyond small trailer

- Photo 1 View to north, shop building (left), office beyond small trailer.
- Photo 2 View to south, dry shed (left), powerhouse beyond.
- Photo 3 View to east, 9th level portal, steel door removed for access.

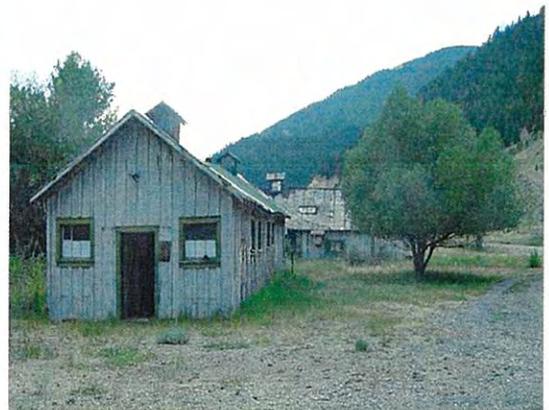
Photo 2

Dry shed (left), powerhouse beyond

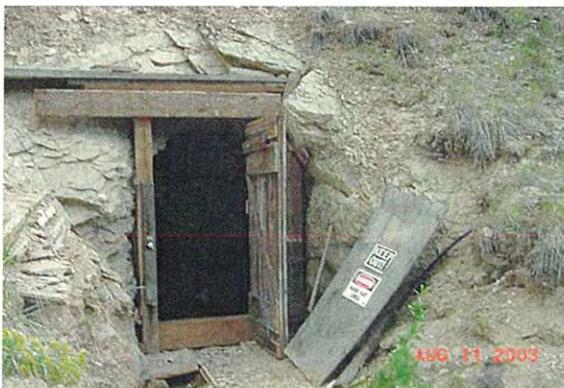
Photo 3

9th level portal, steel door removed for access

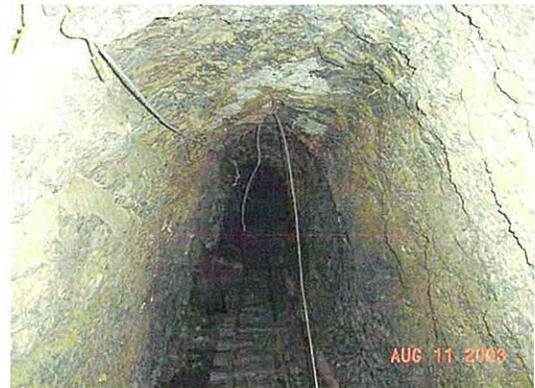
9th adit, electrical cable, haul track (center).

- Photo 4 View to east, 9th level adit, electrical cable, haul track (center).
- Photo 5 View to west, haul track and waste rock dump, located below 9th level adit, dry shed visible in background beyond rail.

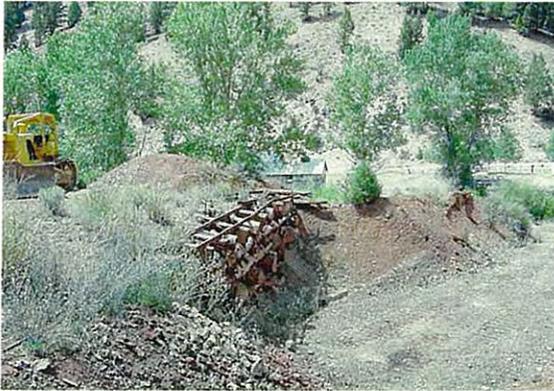
Photo 5

Haul track & waste rock dump below 9th adit, dry shed visible in background beyond rail

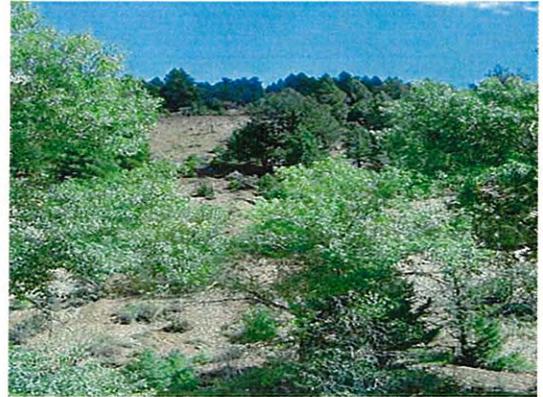
Waste rock dump scattered below 3rd adit

- Photo 6 View to east, waste rock dump scattered across hillside below 3rd level adit.
- Photo 7 View to southeast, electric powered substation (fenced area), containing three pad-mounted transformers, three pole-mount type transformers (beyond fence at lower left).

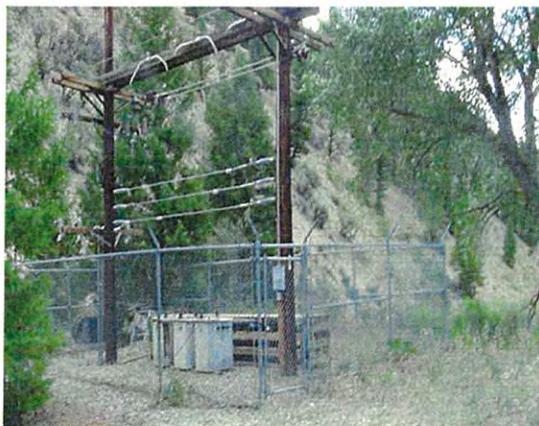
Photo 7

Three (3) pole-mount and three (3) pad-mount types of transformers were identified within and adjacent to an electric powered substation. The transformers were not labeled "No PCBs" and dates of manufacture were not determined. Consequently, since the date of manufacture and the type of dielectric fluid are unknown, it must be assumed that the transformers are PCB Transformers (CFR, 2003).

Electrical Power Substation (fenced), three transformers beyond fence (lower left)

Soil Exposure Pathway: Special circumstances exist at the Redbird, where six PCB transformers were identified. The Idaho office of the EPA, Region 10, must be notified of the storage of PCB transformers, such that their disposition can be handled under the provisions of TSCA (Toxic Substances Control Act).

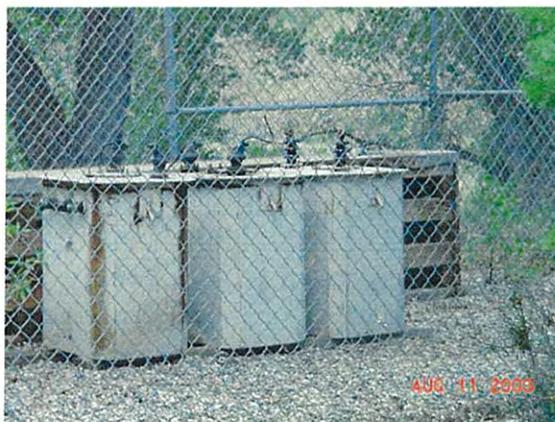
Photo 8

Close-up of electrical transformers

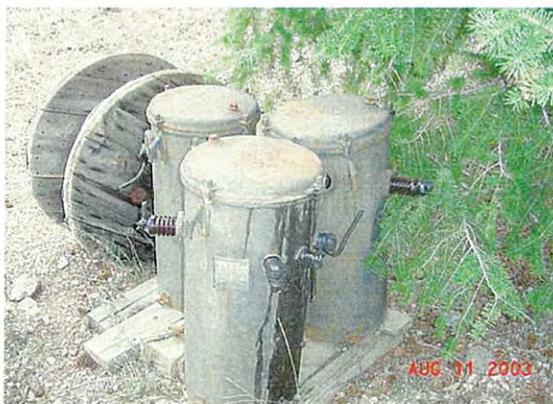
Photo 9

Transformers on pallet, oil residue on side of canister, active leak not identified

The three pole-mount types of transformers were equipped with a sight glass to indicate the volume of oil contained. Oil levels were observed in each transformer, while one appeared to have leaked. The soils surrounding the pallet and the adjacent fenced enclosure were scrutinized, but no obvious oil staining was observed.

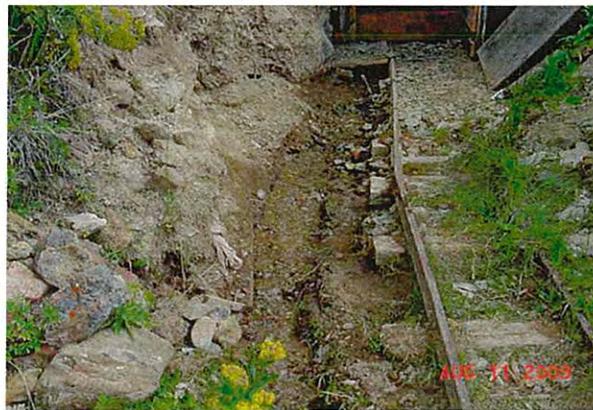
Photo 10

Redbird’s underground workings are sufficiently interconnected to channel ground water through the workings to the 9th level portal. The resulting adit discharge flows westward to Squaw Creek. DEQ collected an aqueous sample directly from the adit flow. Analytical results (total metals) identified an elevated level of lead (0.010 mg/L).

Adit discharge flows at left of track rail, flowering plants growing at margin (bottom left)
