IDAHO CHAMPION GROUP LODE AND PACIFIC GROUP LODE CLAIMS

PRELIMINARY ASSESSMENT AND SITE INSPECTION REPORT

Idaho County
State of Idaho

March 2011

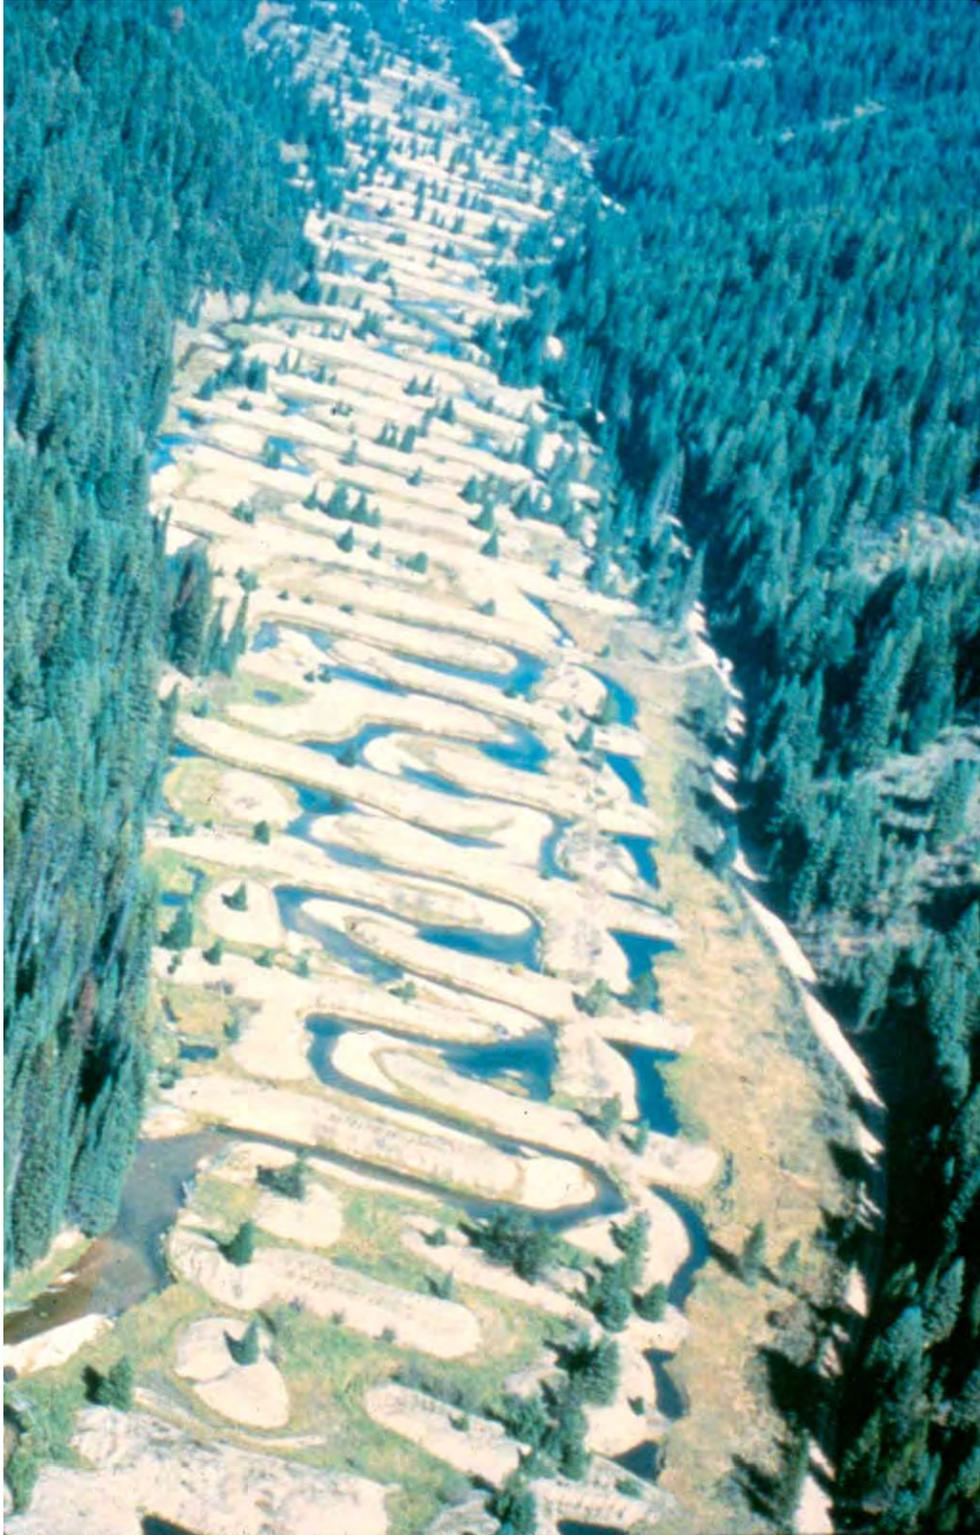
As is evidenced in Photo 1, Crooked River was extensively dredge mined in the past. These historic dredging activities left an interesting and permanent pattern which Crooked River now flows through. Photo 1 was taken many decades ago, as these dredge piles are now covered with vegetation.

**Photo 1. Aerial view of Crooked River and the legacy of dredge mining for gold.
Photo provided by the Nez Perce National Forest**

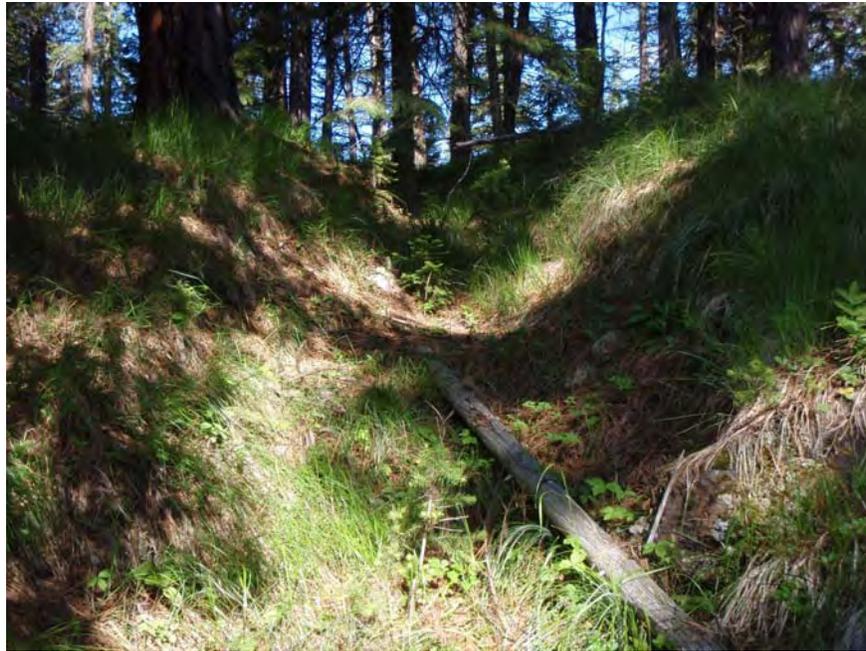
**Photo 2. Idaho Champion Adit 1, exploratory trench at Lat. 45.75865°N,
Long. -115.5052°W (6/29/10)**

The following photograph illustrates what appeared to be an exploratory trench dug at the highest point on the claims. No evidence of a dump or live water was present.

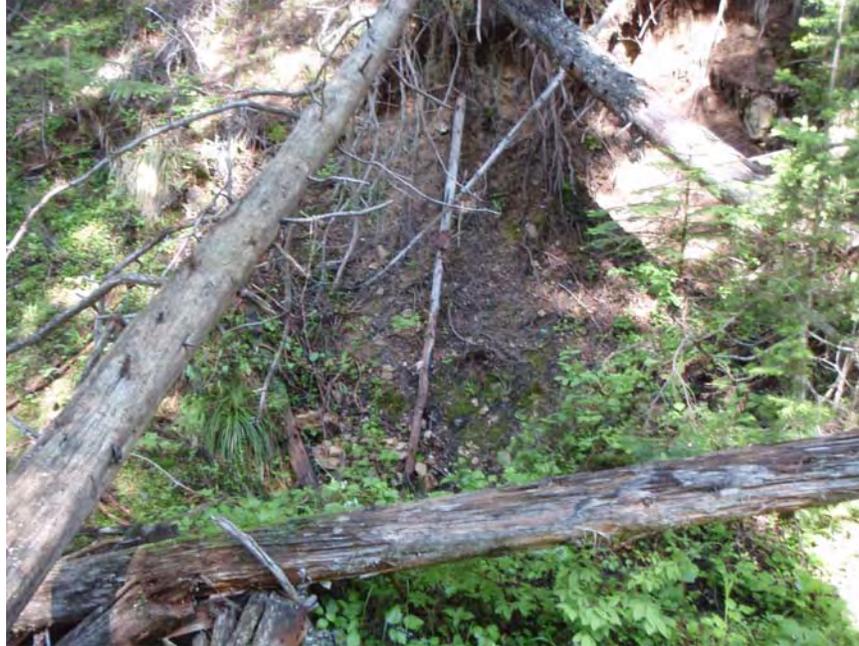
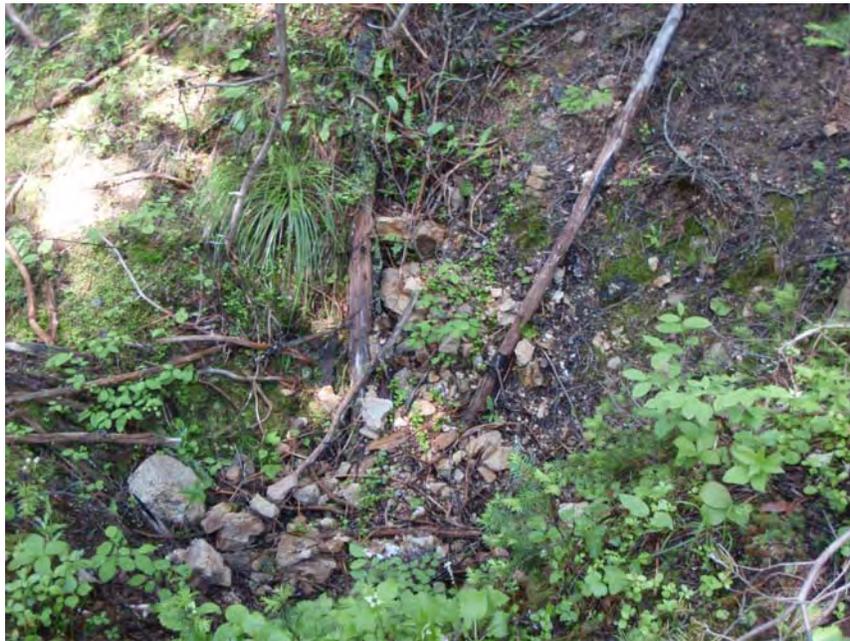
**Photo 3. Collapsed Idaho Champion Adit 2 located at Lat. 45.75610°N,
Long. -115.51777°W (6/29/10)**

The following photographs show a depression, identified as Adit 2, located directly above an access road/ORV trail. Live water flowed along the road but no water flowed from the collapsed adit.

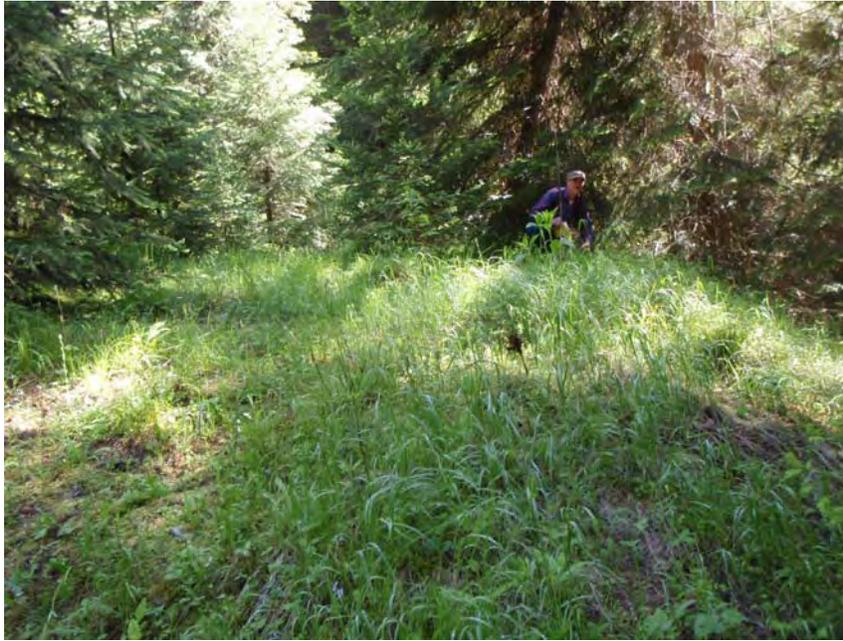
Photo 5. Possible waste dump associated with Idaho Champion Adit 2 located at Lat. 45.75626°N, Long. -115.5177°W (6/29/10)

The waste dump shown in the following photo appeared to be associated with Idaho Champion Adit 2. It was well vegetated with six inches or more of duff over the country rock. No mineralized material was present and no evidence of vegetative stress due to contaminants was noted.

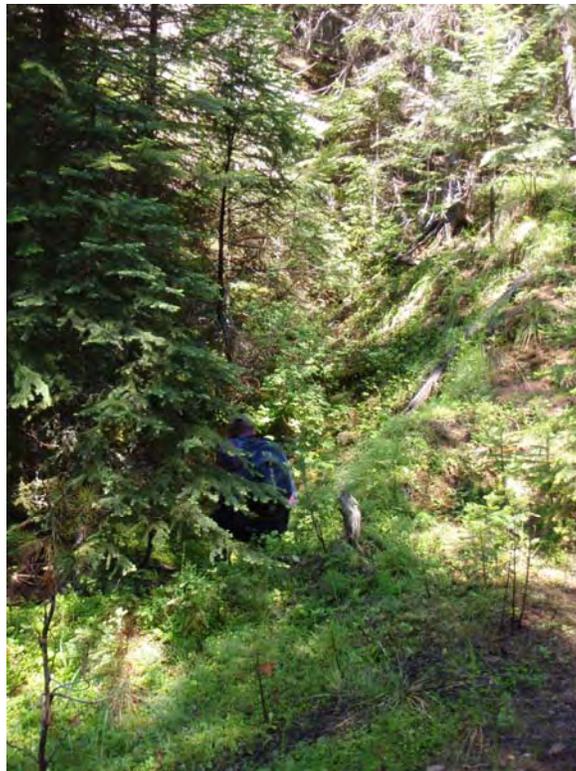
Photo 6. Collapsed Idaho Champion Adit 3, Lat. 45.75586°N, Long. -115.51688°W (6/29/10)

Idaho Champion Adit 3 was well vegetated with no water being generated from the adit. No mineralized material was present at this site.

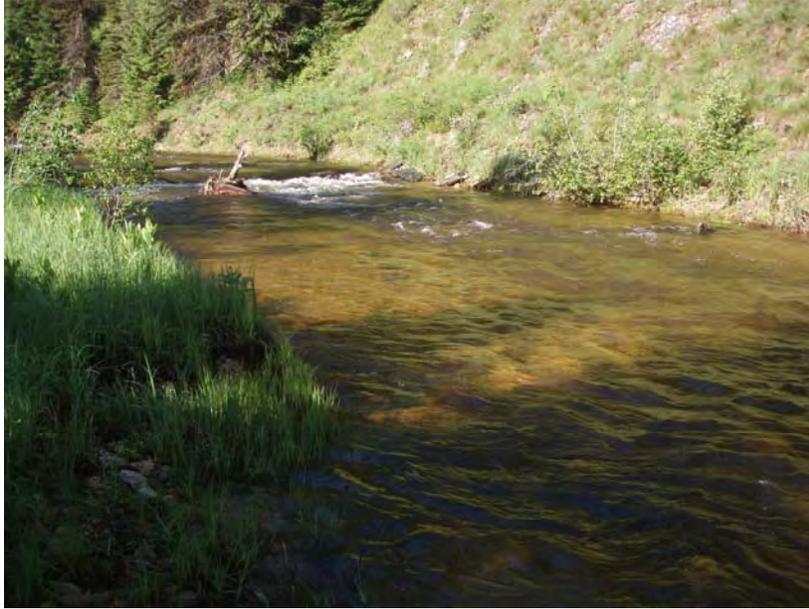
The following photo below shows where sample CRSW1 was collected which is the probable point of entry (PPE) in Crooked River below the Idaho Champion and Pacific Group Lode claims. There were no indications of stress due to contaminants in riparian or wetland flora.

Photo 7. Crooked River downstream of the perennial influence from the Idaho Champion Group. Surface water quality sample CRSW1 and stream sediment sample CRSD1 were collected here, Lat. 45.76045°N, Long. -115.53805°N (6/29/10)

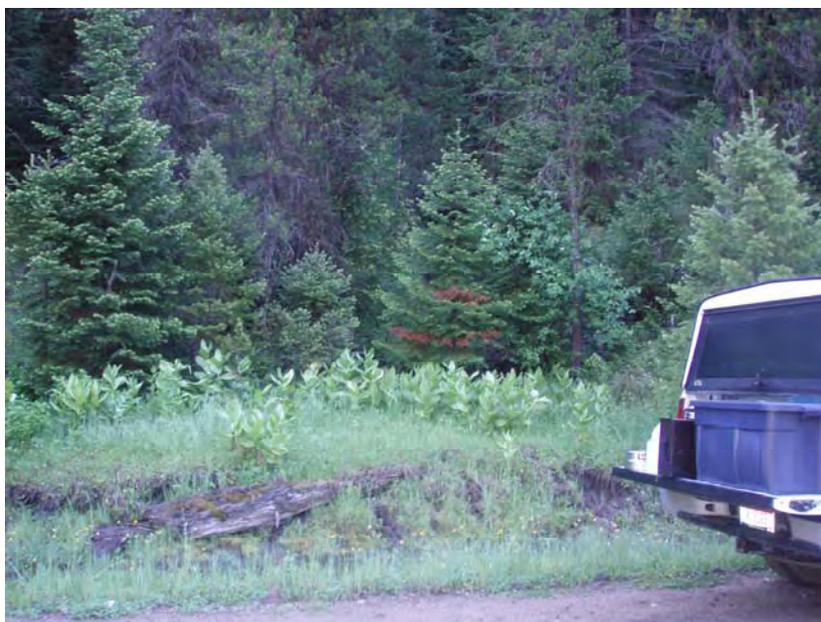
The northern most perennial stream that runs off the Idaho Champion Group flows into wetlands and a riparian area alongside Crooked River Road and stream. The flow of this stream was less than 20 gallons per minute (gpm). There were no indications in the riparian or wetlands flora of stress due to contaminants. Samples ICSW1 and ICSD1 were collected from this stream. Sediment accumulating at the base of the flow was dark brown to buff with approximately 50 percent passing the #9 mesh screen. The sediment contained less than 20 percent organics and was screened and dried for analysis.

Photo 8. Water quality sample ICSW1 and sediment sample ICSD1 were collected at Lat. 45.75900°N, Long. -115.53631°W (6/29/10)

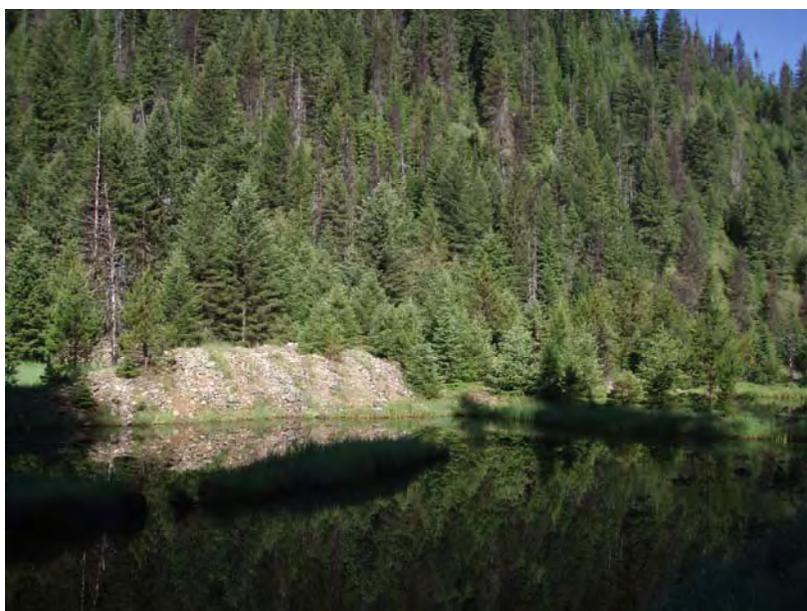
Photo 9. Pond located across Crooked River Road from perennial stream no. 1 (6/29/10)

DEQ observed a pond created by the placer deposits from historic mining along the Crooked River. Vegetation appeared to be well established on the top and toe of the placer deposits.

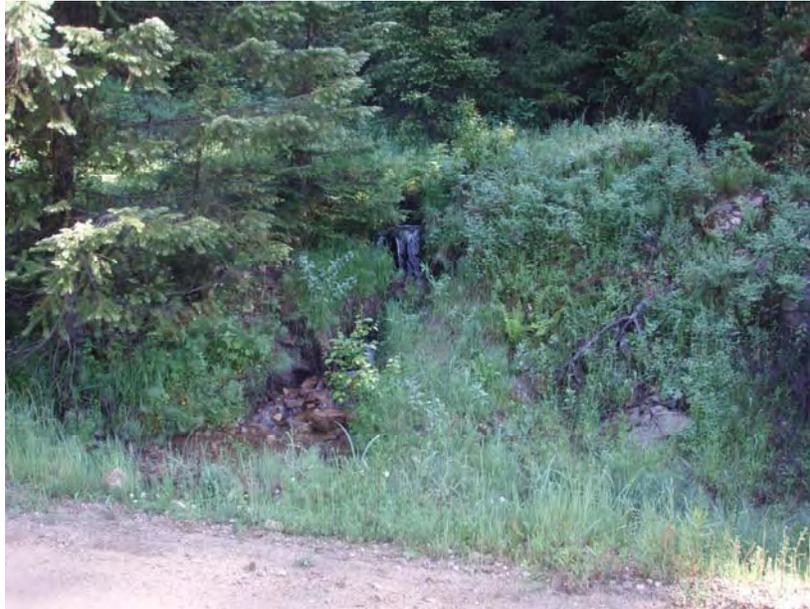
The second perennial stream DEQ observed is located along Crooked River Road upgradient from the northern most perennial stream. Flows in this perennial stream were greater than 50 gpm. No indications were found of stress due to contaminants in the riparian or wetlands flora.

Photo 10. Idaho Champion perennial stream no. 2. Water quality sample ICSW2 and sediment sample ICSD2 were collected here, Lat. 45.75529°N, Long. -115.53368°W (6/29/10)

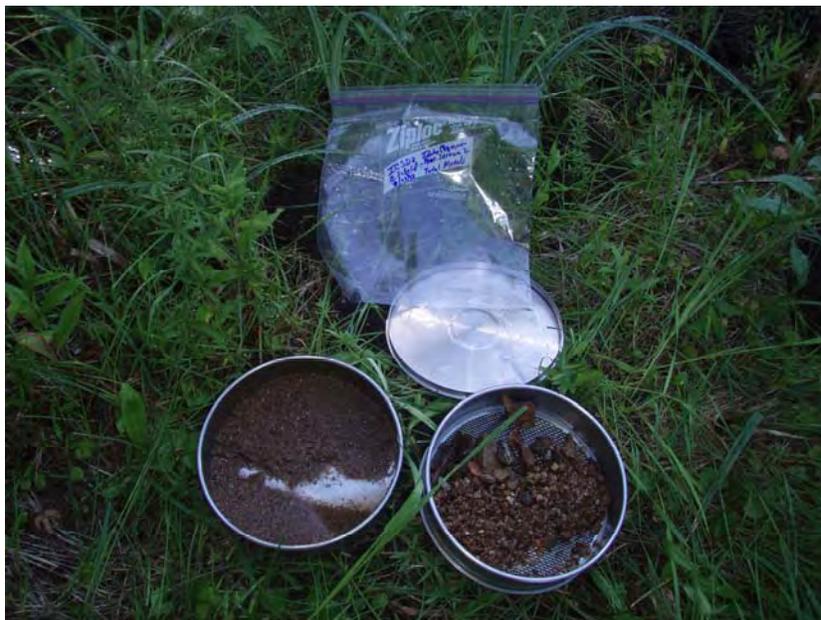
Photo 11. Sediment sample ICSD2 collected at Lat. 45.75229°N, Long. -115.53368°W (6/29/10)

Sediment accumulating at the base of the flow was dark brown to buff with approximately 50 percent passing the #9 mesh screen. The sediment contained less than 20 percent organics and was screened and dried for analysis.

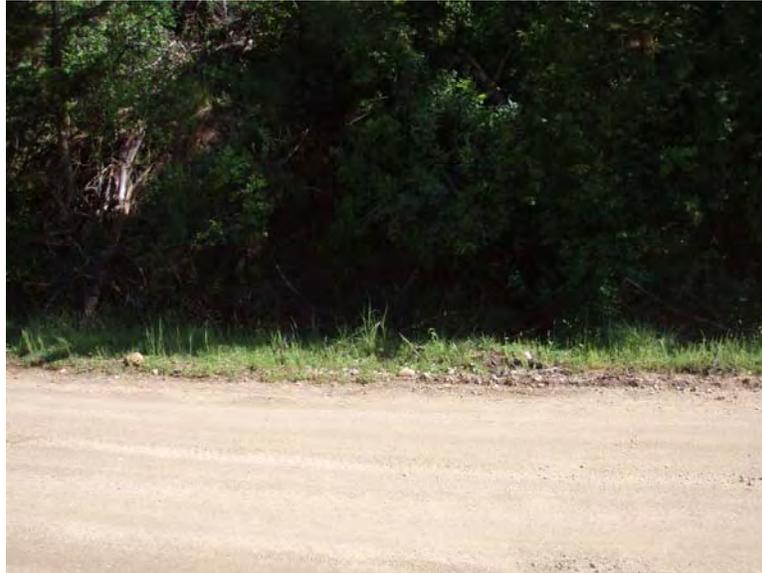
The third perennial stream DEQ observed is located along Crooked River Road upgradient from the two previously mentioned perennial streams. Flows in this perennial stream were less than 20

gpm. There were no indications in the riparian or wetlands flora of stress due to contaminants. Water quality sample ICSW3 and sediment sample ICSD3 were collected from this location.

Photo 12. Idaho Champion perennial stream no. 3. Samples ICSW3 and ICSD3 were collected from this location, Lat. 45.75275°N, Long. -115.52749°W (6/29/10)

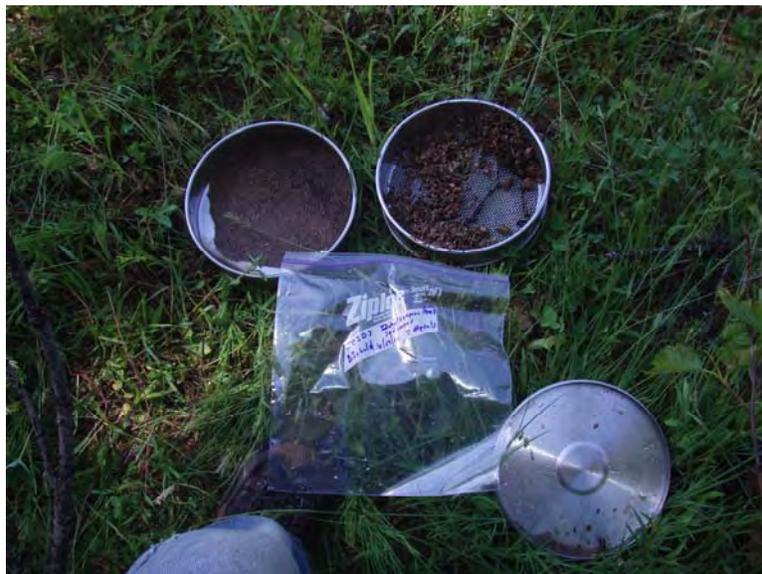
Photo 13. Sediment sample ICSD3 after passing through the #9 mesh screen taken at Lat. 45.75275°N, Long. -115.52749°W (6/29/10)

Sediment accumulating at the base of the flow was dark brown to buff with approximately 50 percent passing the #9 mesh screen. The sediment contained less than 20 percent organics and was screened and dried for analysis.

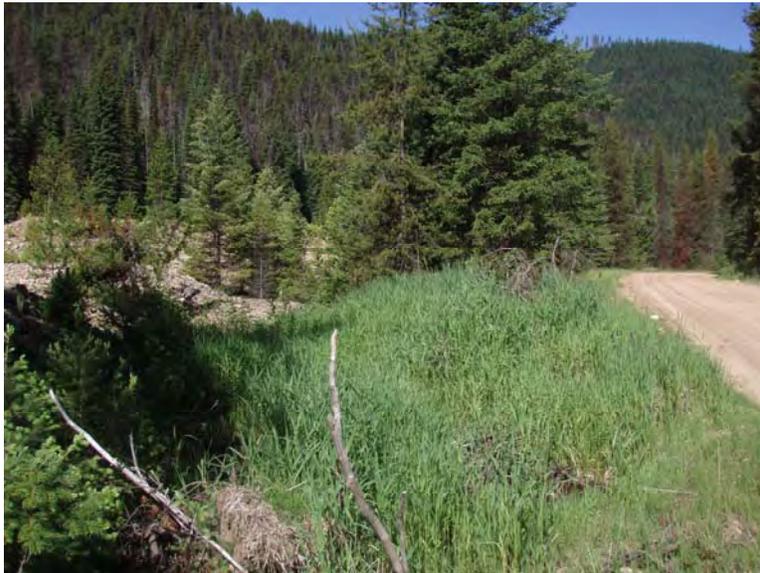
Photo 14. Riparian area developed in placer tailings between Crooked River Road and Stream. (6/29/10)

As illustrated in the following photo, all vegetation was lush and healthy in appearance. No vegetative indication of stress due to contaminants was apparent.

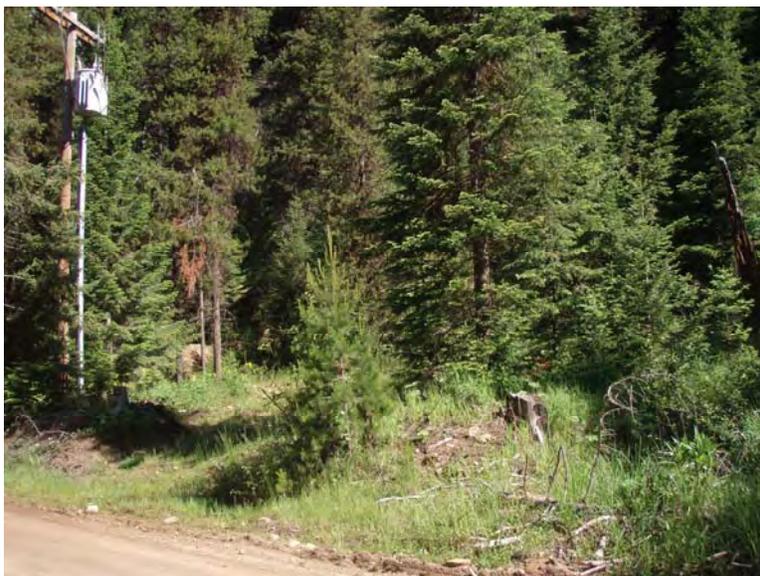
Photo 15. Idaho Champion perennial stream no. 4 samples ICSW4 and ICSD4 were collected at this location, Lat. 45.75145°N, Long. -115.52045°W (6/29/10)

Idaho Champion perennial stream no. 4 is located adjacent to the remnants of the Idaho Champion mill site and the few collapsed adits found on the property. Samples ICSW4 and ICSD4 were collected at this location.

Flows in perennial stream no. 4 were greater than 20 gpm. There were no indications in the riparian or wetlands flora of stress due to contaminants. Sediment accumulating at the base of

the flow was dark brown to buff with approximately 50 percent passing the #9 mesh screen. The sediment contained less than 20 percent organics and was screened and dried for analysis.

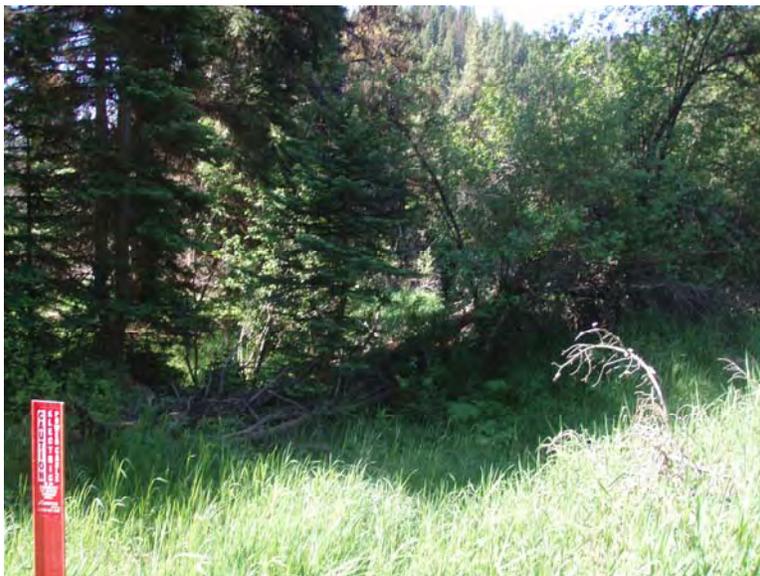
Photo 16. View across Crooked River Road from perennial stream no. 4 sampling site, Lat. 45.75145°N, Long. -115.52045°W (6/29/10)

Flows from the perennial stream that runs through the mill site enter wetlands and riparian areas adjacent to Crooked River Road and Stream. As stated, there were no indications of contaminants or stress in floral communities. There were, however, numerous sightings of brook trout and salmonids in ponds that developed in the placer tailings areas.

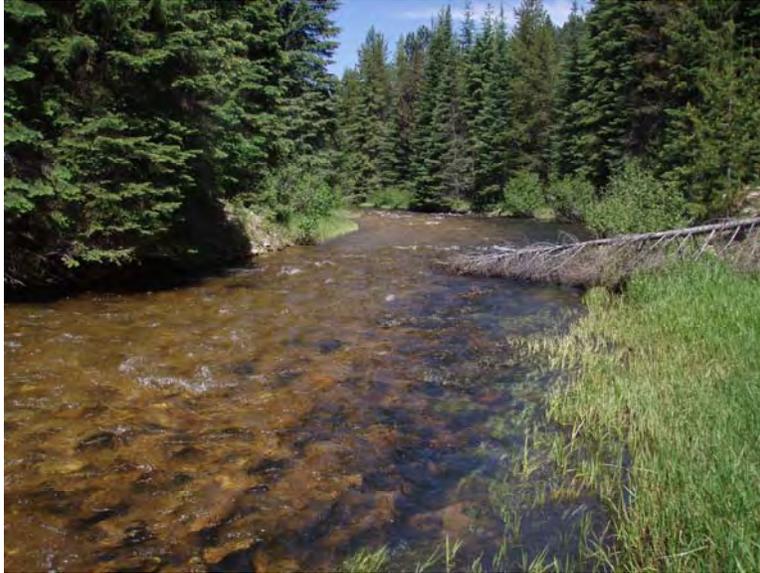
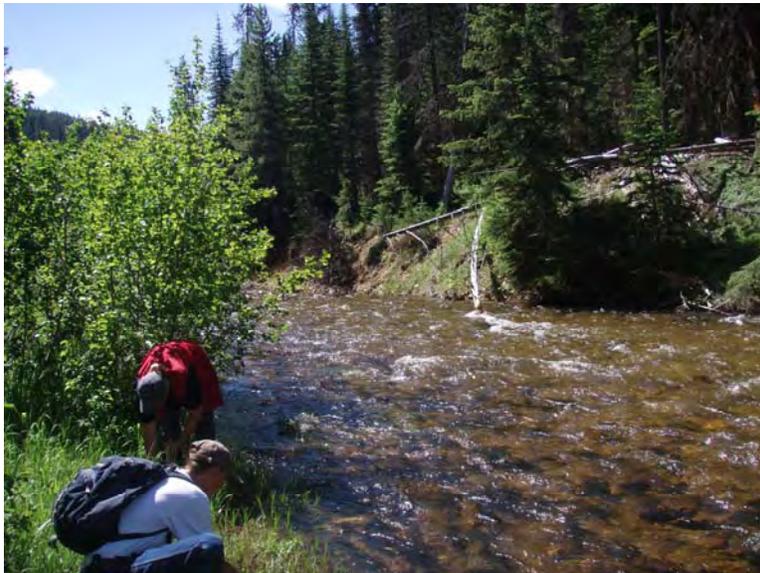
Photo 17. Crooked River sampling location upstream of the Idaho Champion Group, Lat. 45.75865°N, Long. -115.5052°W (6/29/10)

Background water and sediment samples (CRSW2 and CRSD2) were collected from Crooked River upgradient from the mine and mill site. Flows in the river were not measured. Although it was apparent the placer/dredging operations had a great impact on the morphology of the stream and adjacent upland, riparian, and wetland areas, there were no indications in the riparian or wetlands flora of stress due to contaminants.

Sediment accumulating in a depositional area along the stream was dark brown to buff with approximately 50 percent passing the #9 mesh screen. The sediment contained less than 20 percent organics and was screened and dried for analysis.
