RE: Preliminary Assessment Report and Recommendations for Determination for Elk No. 1, Wolverine, All on Back, Alberta 1, Alberta 2, Alberta 4, Alberta 5, Alberta 6, Spotted Deer 1, Spotted Deer 2, Spotted Deer 3, and Spotted Deer 4 patented mining claims

ABBREVIATED PRELIMINARY ASSESSMENT CHECKLIST

Site Name: Elk No. 1, Wolverine, All on Back, Alberta 1, Alberta 2, Alberta 4, Alberta 5, Alberta 6, Spotted Deer 1, Spotted Deer 2, Spotted Deer 3, Spotted Deer 4

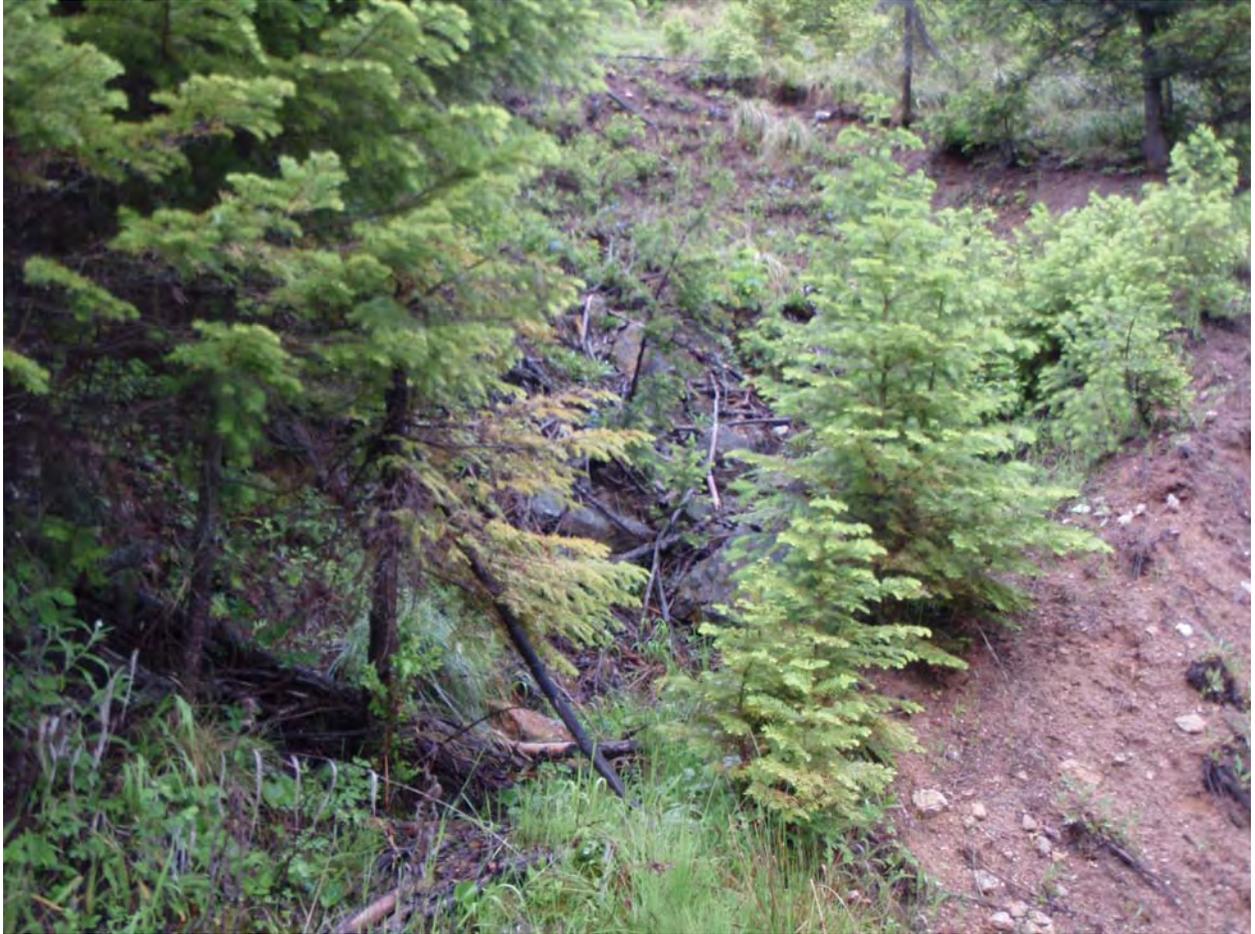
Adit 1. The bottom of the disturbed area now has a road through it. No dump or tailings pile remains. The bottom right hand side of the photo is the actual road cut.

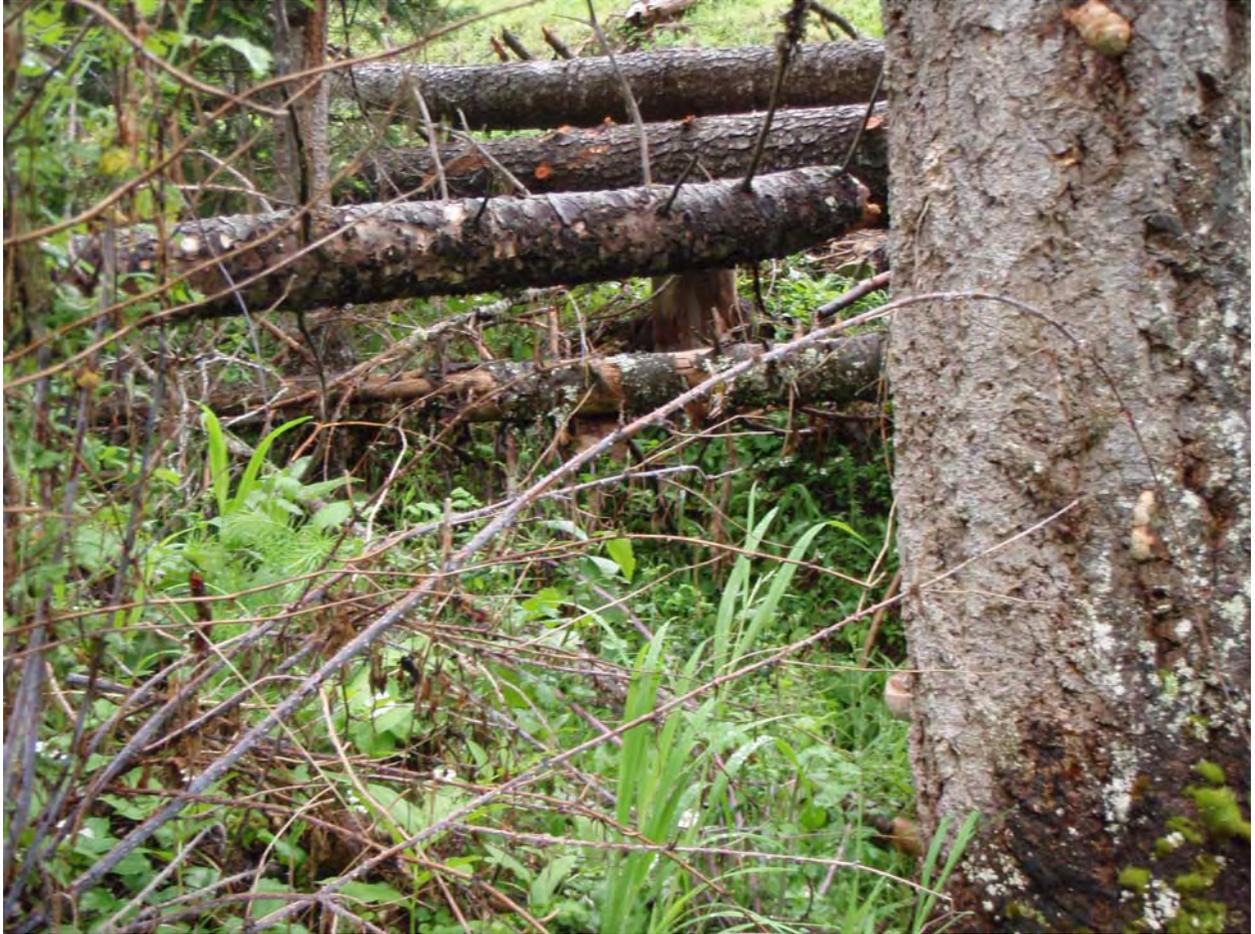
Adit 2. A shallow depression exists identifying this adit. The small amount of waste material indicates very little excavation occurred. As is evident, the depression is now well vegetated as is the waste material.

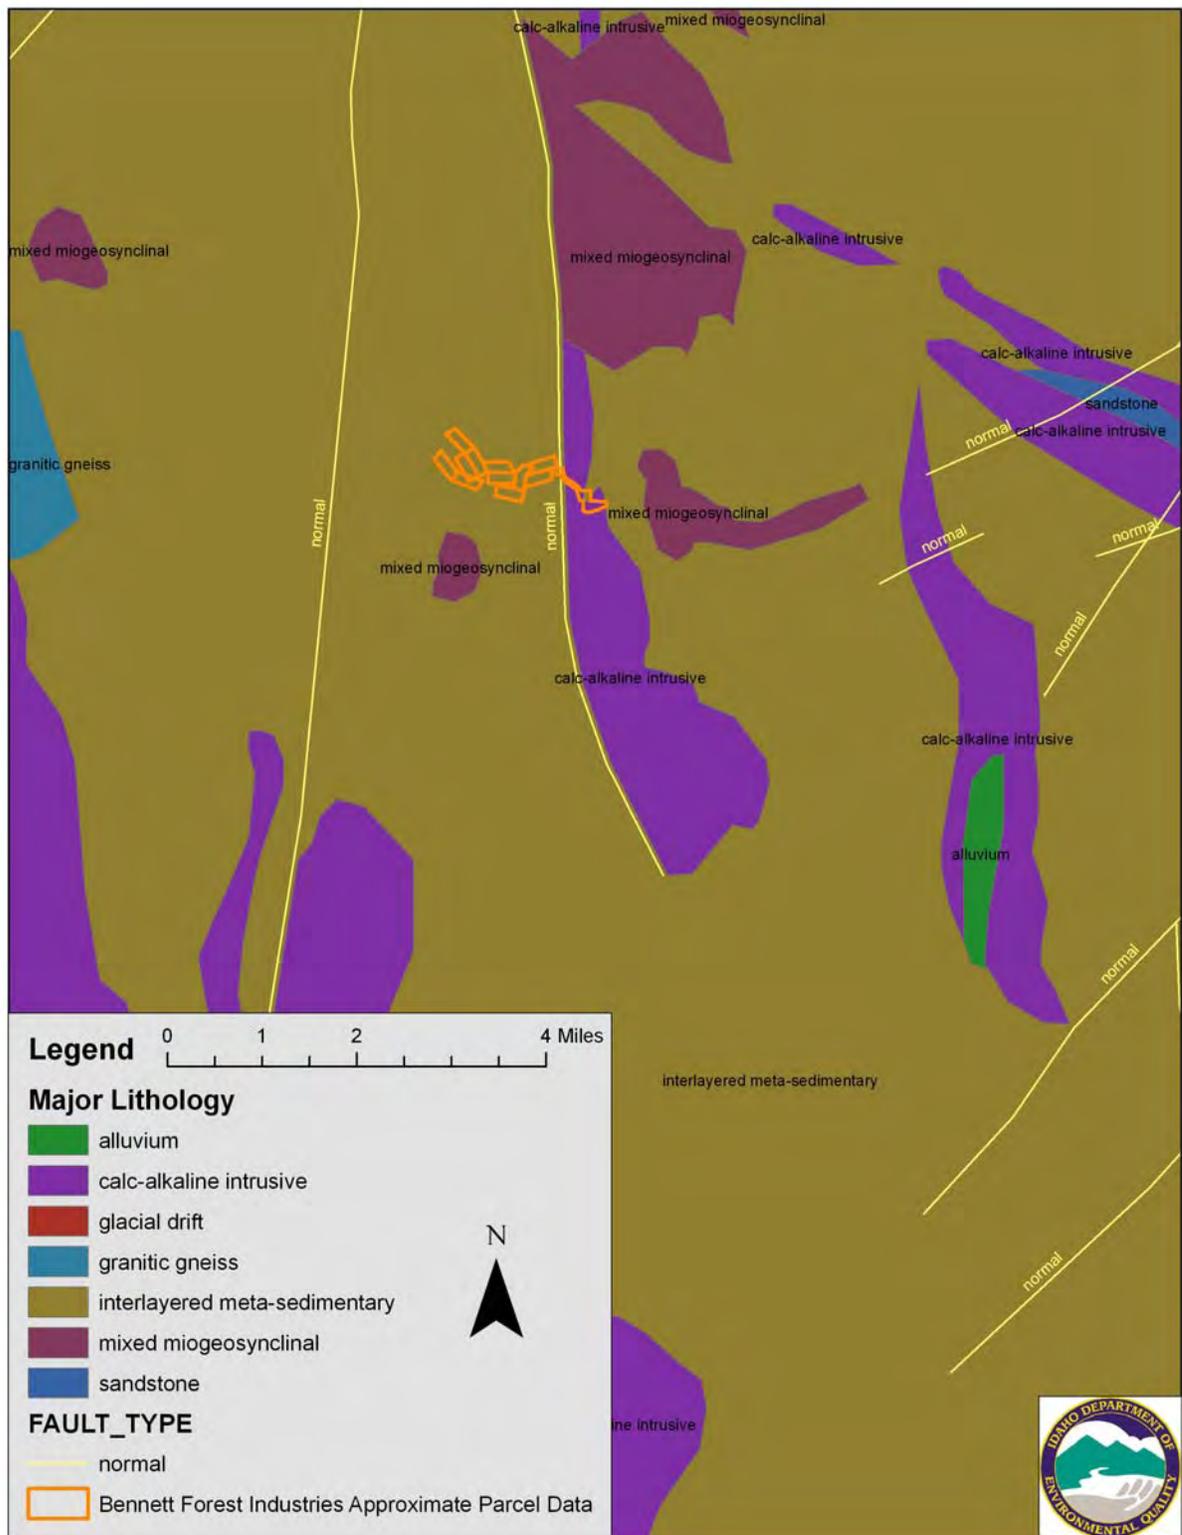
Figure 2. Major Lithology of the Bennett Forest Industries property. (Map source: Idaho DEQ GIS ArcSDE 9.3.1 Geodatabase)

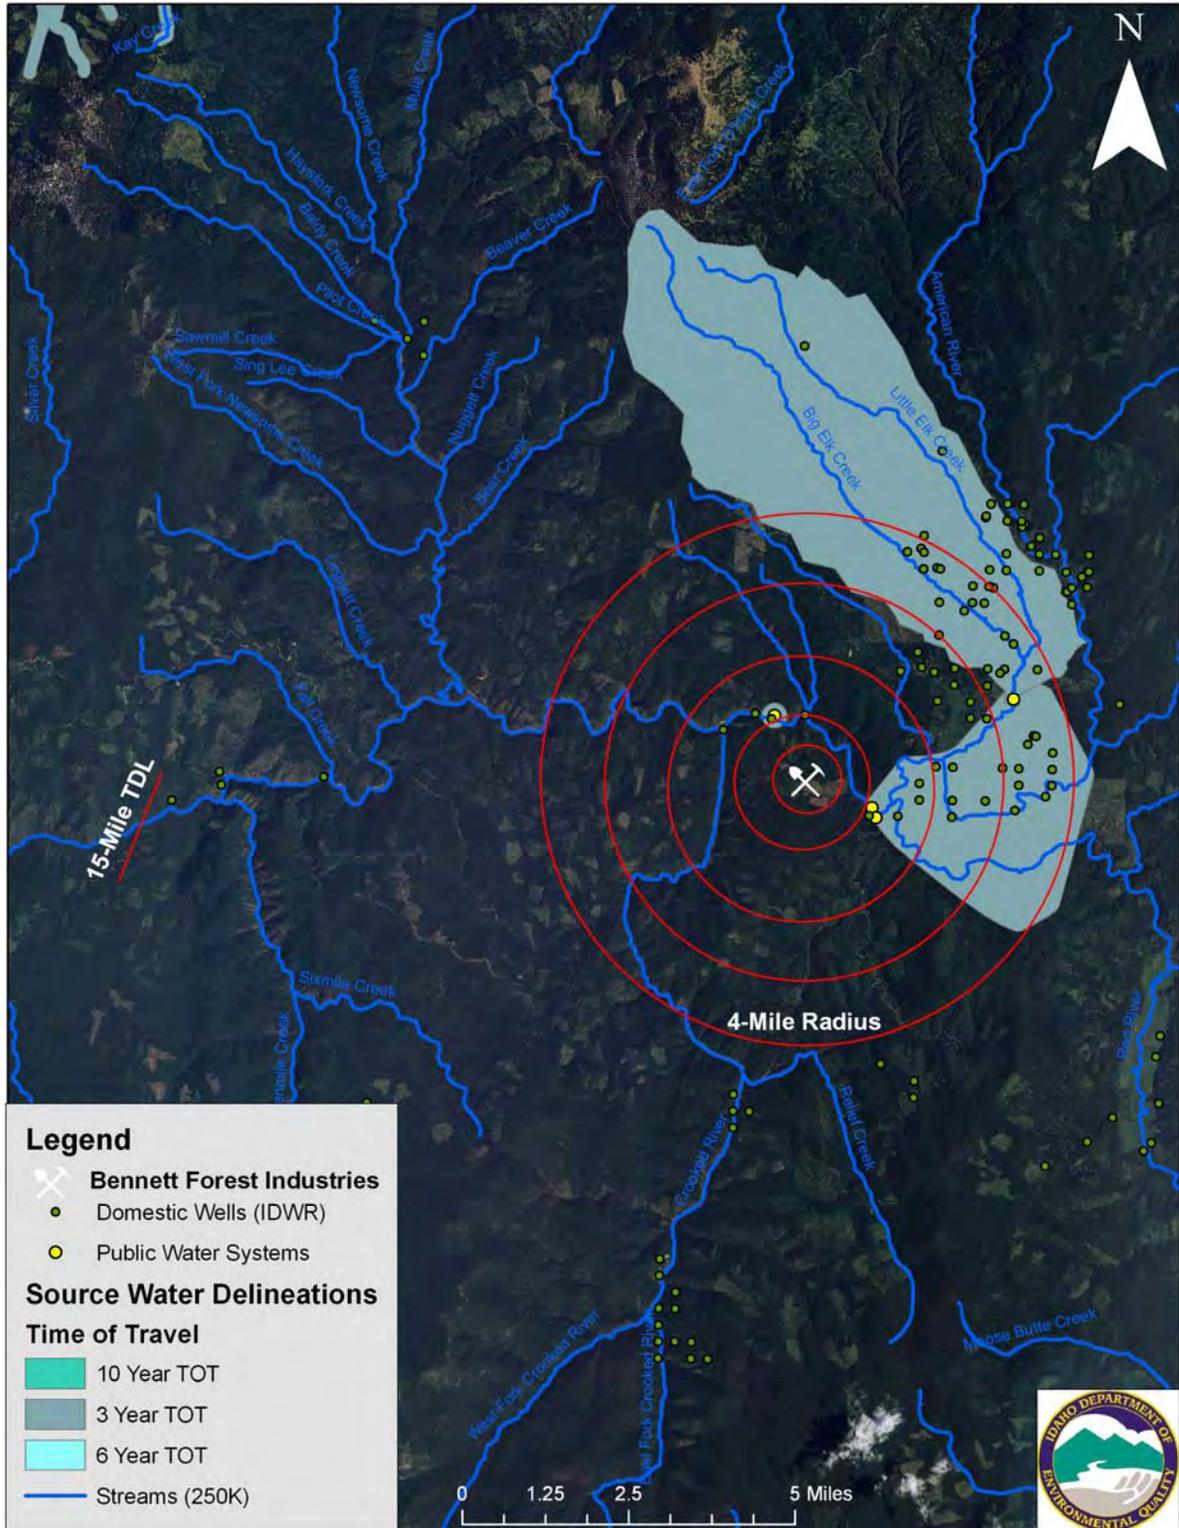
Figure 3. Drinking water well locations and source water delineations. 15-mile Target Distance Limit (TDL). No evidence of wetlands within the TDL. (Map source: Idaho County 2004 NAIP)

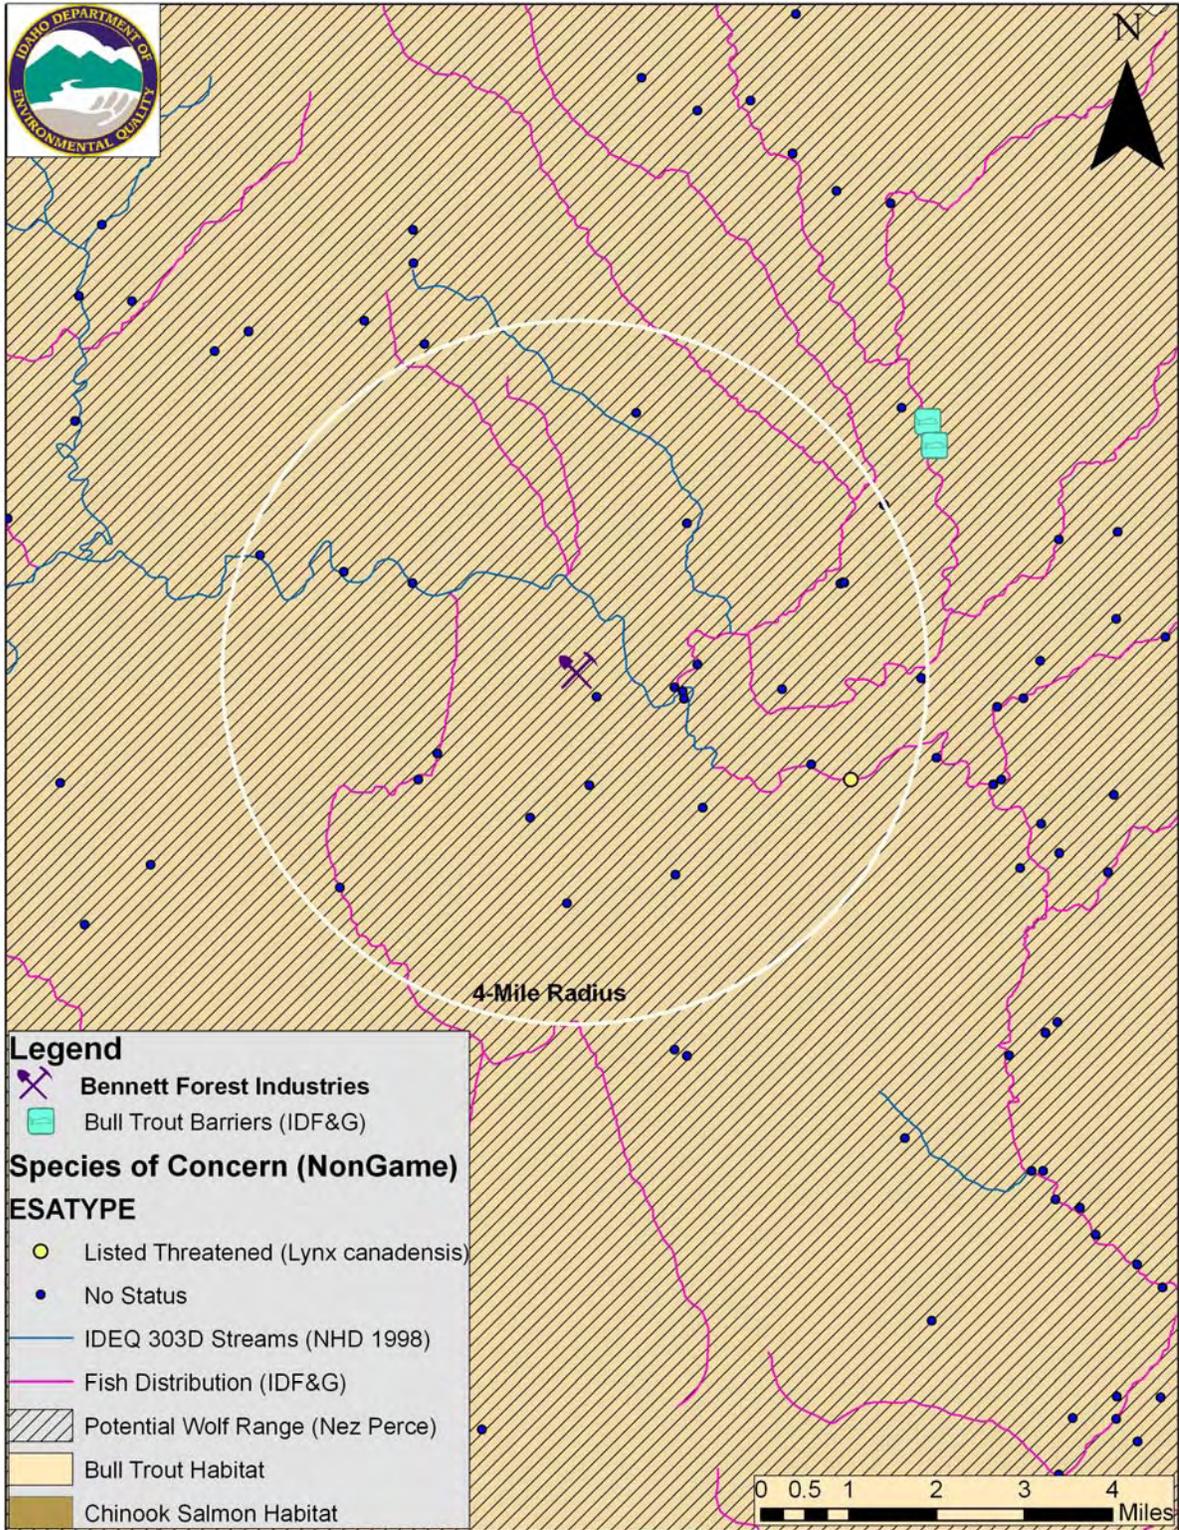
Figure 4. Sensitive species near Bennett Forest Industries. (Map source: Idaho County 2004 NAIP)
