**SONNEMANN MINE & MILL
PRELIMINARY ASSESSMENT REPORT
OWYHEE COUNTY, IDAHO**

**STATE OF IDAHO
DEPARTMENT OF ENVIRONMENTAL QUALITY**

December 2002

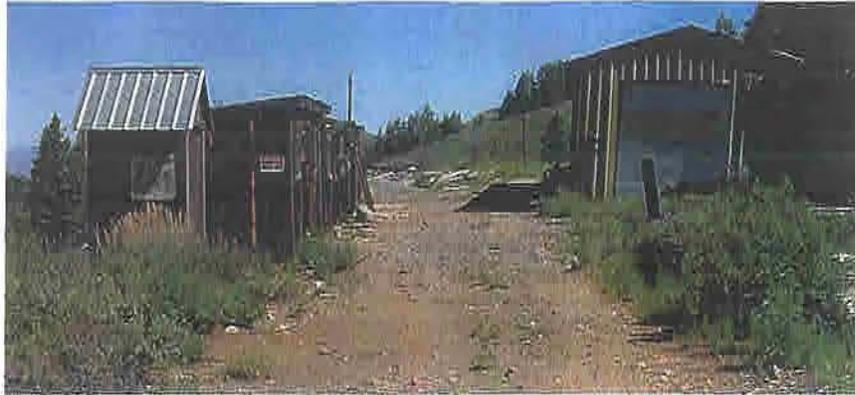
Main entrance, wooden sheds (left), metal maintenance building (right)

All of the structures show evidence of vandalism, but the maintenance shop and hillside shed (not pictured) appear serviceable. The southeast-driven adit has a timbered portal, is covered with plywood sheets and is blocked by a locked gate (Photo Mvc-846).

- Mvc-839 View to east, from top of Upper Bay State Tunnel Dump. Upper and middle tiers of tailings impoundment, thickness of tiers delineated.
- Mvc-844 View to north, of main entrance to Sonnemann facility. Older wooden sheds (lab?) on left, newer metal maintenance building on right. Adit drainage faintly visible just beyond shadow of maintenance building roof, adjacent to ore chute at center of photo.

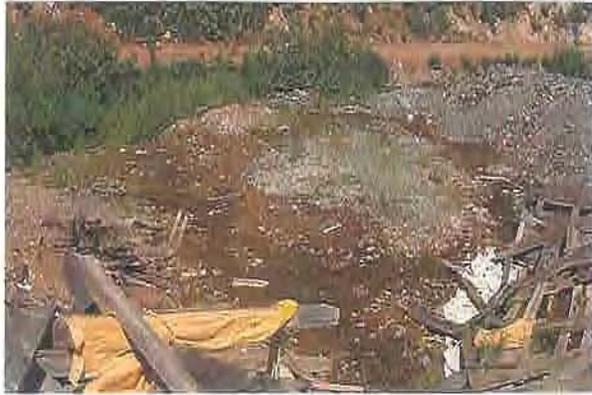
The adit, discharging water at an estimated rate of 90-100 gallons per minute, flows across the dump through the mill area below the portal and into Williams Creek (Photos Mvc-845 and Mvc-852). The remains of a collapsed ore chute and narrow-gauge rails rest on the portal-level bench above the mill.

From top of collapsed ore chute,
adit drainage to Williams Creek (bushes)

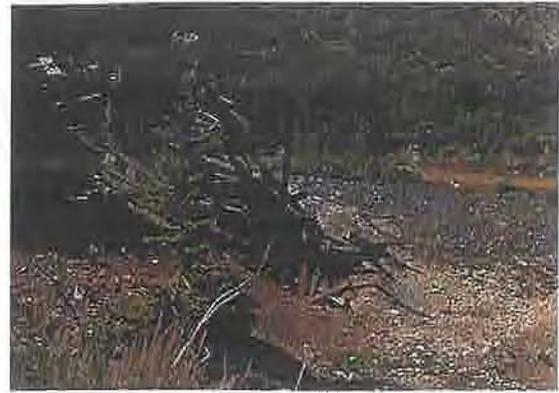
Ore chute debris (left),
adit drainage (background center)

- Mvc-852 View to southwest, collapsed ore chute on left, mine drainage at center, Williams Creek Road in background.

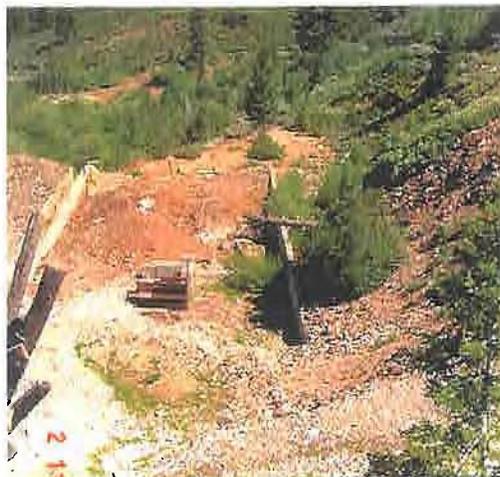
On the lower bench, the foundation walls are all that remain of the mill buildings. Waste rock and what appears to be usable ore have been deposited across the mill site (Photo Mvc-847).

Mill Foundation

The waste rock/ore was disposed within the mill foundations and in the dump, which measures at least 450 feet in length, 75 feet in width and 50 feet in thickness. The workings appear to parallel a faulted carbonate (limestone/marble) alteration zone that intersects the Cretaceous granodiorite host rock, similar to the Bay State Group. Sulfide minerals (chalcopyrite, arsenopyrite, pyrrhotite, marcasite, pyrite, galena and sphalerite) along with limonite and iron staining were identified on the waste/ore dump.

- Mvc-847 View to north, panoramic across mill ruins to tailing pile (barren area beyond brush), white areas along western side of tailings appears to be leached salts.

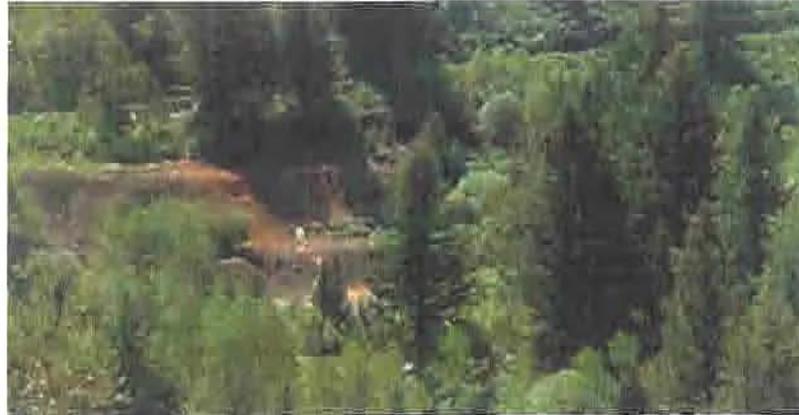
Mvc-839
3-Tier Tailings Pile

A three-tiered tailings pile or impoundment, located at the northern perimeter of the site, lies adjacent to a westward flowing tributary drainage. The tailings impoundment appears to have been employed in three stages (Photo Mvc-839).

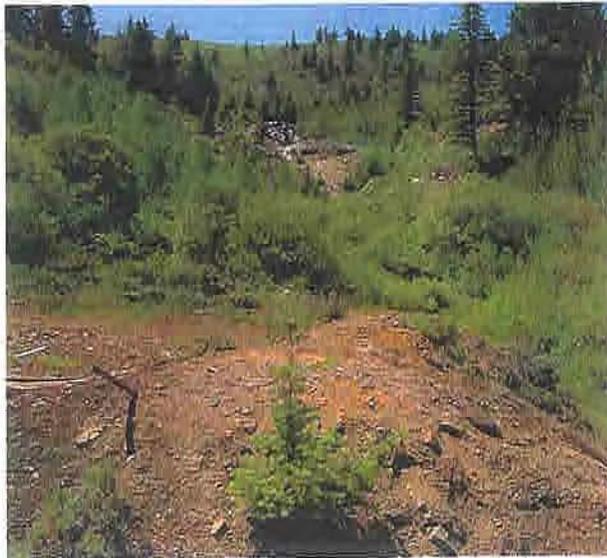
Mvc-851
View to south, slurry piping (?) in foreground

The fine texture of the tails coupled with discarded piping suggests emplacement was accomplished via slurry, possibly from a flotation milling process (Photo Mvc-851).

- Mvc-851 View to south, across site, slurry pipe (?) in foreground on middle tier of tailings, ore stockpiles and mine buildings at center, Williams Creek Road in background.

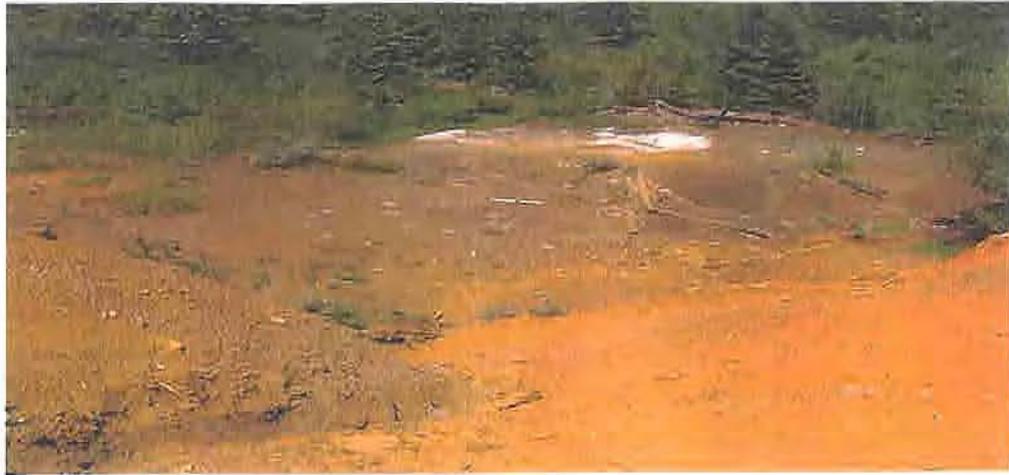
Along the southwest portion of the bottom tier, a crusty salt-like precipitate has formed (Photo Mvc-849). The impoundment was contained with boards and a berm along the north side of the tailings. The top tier measures at least 175 feet in length, 60 feet in width, and 20 feet in thickness; the middle tier measures at least 200 feet in length, 45 feet in width, and 10 feet in thickness; and the bottom tier measures at least 75 feet in length, 75 feet in width, and 3 feet in thickness.

Upper tier (foreground), middle tier (center), and white precipitate on lowest tier.

The tailings are fine-grained, appear gummy to the touch and exhibit a white crusty precipitate on the surface of the lowest tier immediately adjacent to Williams Creek. At the time of the site visit DEQ was unable to sample the tailings pile.

- Mvc-849 View to west, from top tier of tailings pile, foreground shows evidence of blowout style erosion to the creek beyond. "Salt" deposits shown on lowest tier of tailings in background. Williams Creek meanders to the edge of this tier near the salt accumulation.

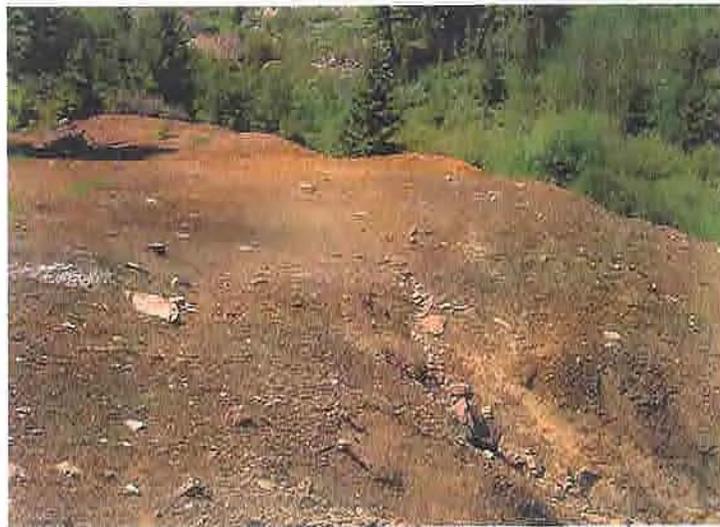
The Williams Creek floodplain and associated wetlands extend into the bottom tier; an unnamed creek appears to be incising the northern portion of the impoundment. Evidence of channeling (blowout) of the top tier suggests historic erosion of the impoundment by tributary drainage from the east (Photo Mvc-850).

Channeling of upper tier in foreground (right)

- Mvc-850 View to south, from tailings pile towards mill ruins. Mill foundation wall (dark rectangle) adjacent to ore stockpiles and Williams Creek Road in background. Immediate foreground shows blowout erosion of tailings.

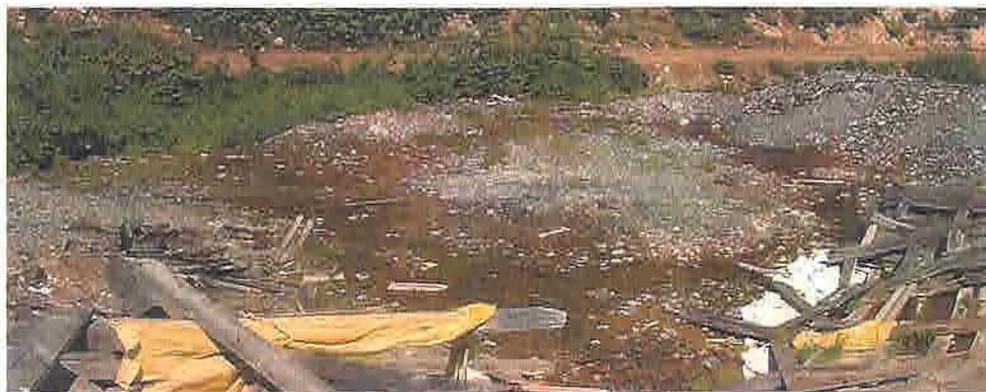
Mvc-845

At the time of the site visit, water was observed flowing from the adit at 90-100 gallons per minute across the dump and into Williams Creek (Photo Mvc-845). One Probable Point of Entry (PPE), adit drainage, is located approximately 100 feet west-northwest from the portal into Williams Creek.

From top of collapsed ore chute, adit drainage to Williams Creek (bushes)
