**RECOMMENDATIONS FOR CHANNEL  
MANAGEMENT, PINE CREEK, SHOSHONE  
COUNTY, IDAHO**

**Bureau of Land Management  
1808 North 3rd Street  
Coeur d'Alene, Idaho 83814**

9 September 1996

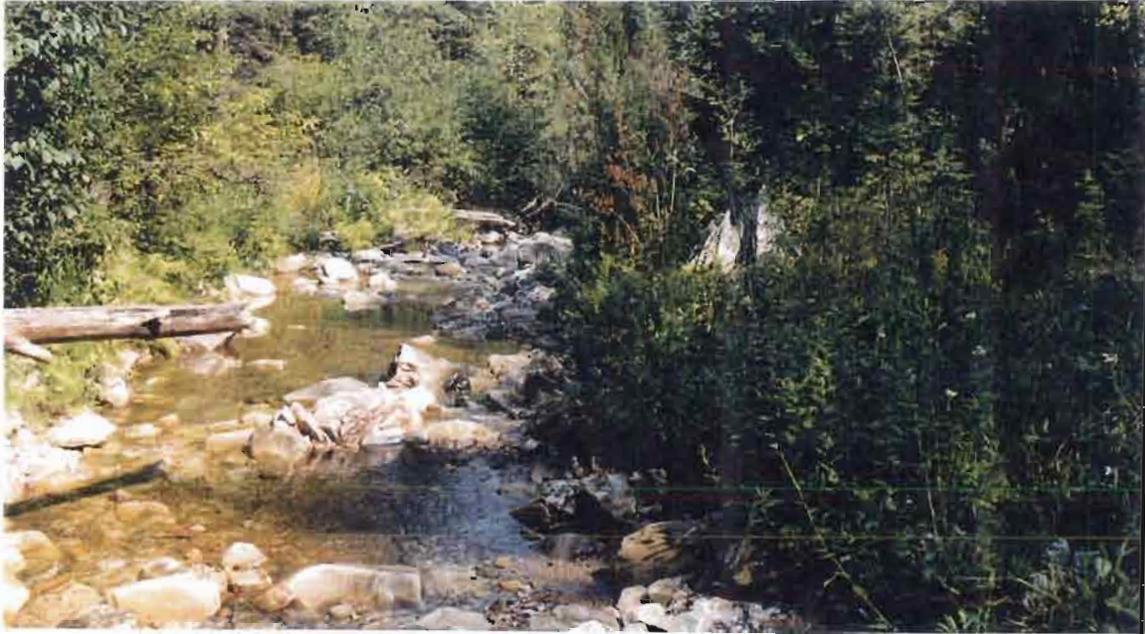
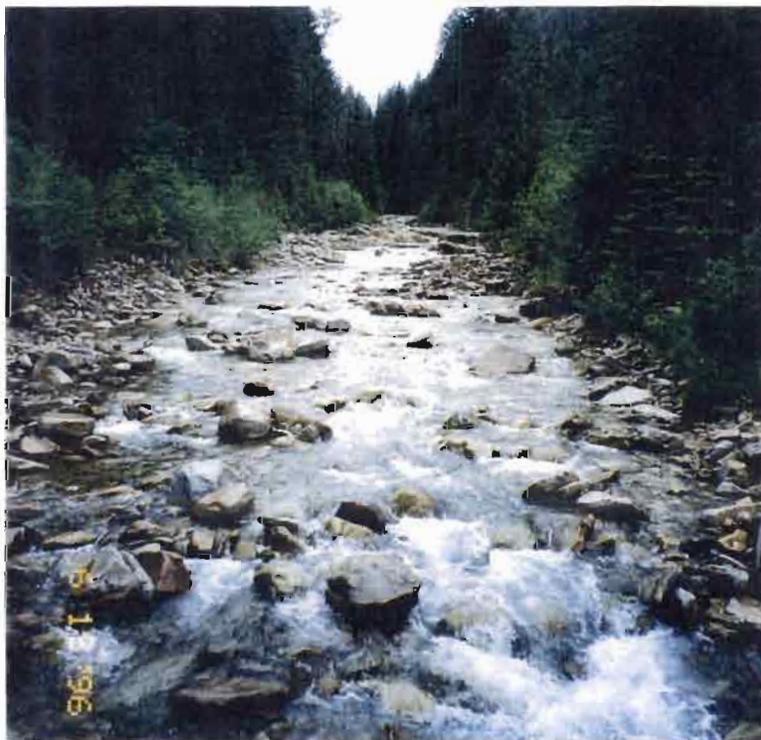
**FIGURE 3**  
**STABLE CHANNELS IN UPPER EAST**  
**FORK AND WEST FORK BASINS UPSTREAM**  
**OF ANY MINING SEDIMENT INFLUX**

**Top: view of upper East Fork of Pine Creek upstream from proposed repository site at the Constitution mine. Channel remained stable during 1996 floods. Bottom: view upstream of West Fork Pine Creek above confluence of Middle Fork.**

In our field investigations, we observed the change in channel conditions upstream and downstream of mining related sediment inputs, and compared these upstream reaches with unmined channels. Our observations of the channels of the Upper East Fork, Gilbert Creek, Douglas Creek, Highland Creek, and the West Fork above the Calusa Creek confluence (Figure 3), all either unmined basins or at locations above the influence of mining sediment, indicate similar transport characteristics. All of these channels appear to show the passage of relatively high coarse sediment loads, clearly related to the 1996 floods. However, these steep channels typically remained very stable, with minor bank failures, bank toe scour, or reworking of previous flood deposits. In several cases, notably the West Fork above Calusa Creek and Gilbert Creek, small amounts of channel widening and reworking of what we have interpreted to be deposits from the 1974 flood, were observed. This interpretation is based on the presence of narrow vegetation stands in or adjacent to the channel of generally uniform size (implying similar ages), which contrast markedly with other streamside vegetation. The lack of obvious source areas for

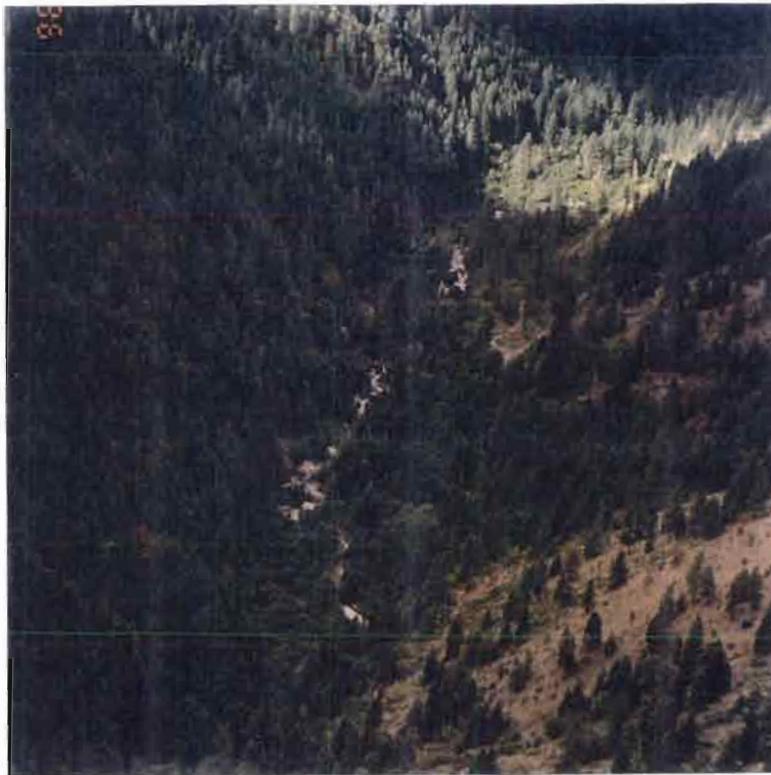
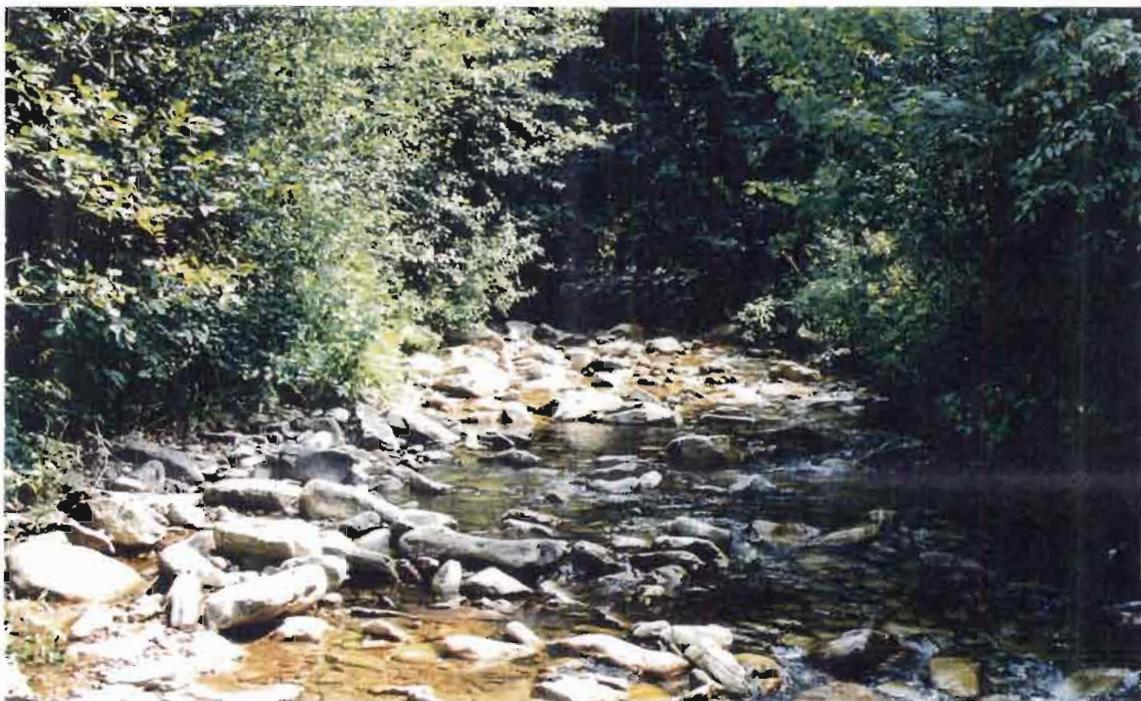
**FIGURE 4**  
**PHOTOGRAPHS OF DOUGLAS CREEK**

**Top: oblique aerial view of sediment deposits in lower gradient alluvial reaches of Douglas Creek. Bottom: view of stable, undisturbed channel of Douglas Creek about 1000 feet upstream confluence with East Fork.**

Douglas Creek provides a useful comparison with Highland Creek. They are comparable in drainage area (6.3 vs. 5.0 mi<sup>2</sup>), relief, basin aspect, and fire history, but they differ in two respects: the presence of sediment storage sites in downstream reaches of Douglas Creek (discussed below) and in mining history. The Douglas Creek basin has not been subject to mining or extensive road construction, while the Highland Creek basin has been heavily mined, involving removal of vegetation, construction of roads and industrial development, and most importantly, discharge of waste rock into the channel (Figure 6). Thus, Douglas Creek illustrates the sediment transport regime likely prevailing in Highland Creek prior to mining and the resultant increased sediment yield, although with a reach in which deposition is more likely before reaching the East Fork channel.

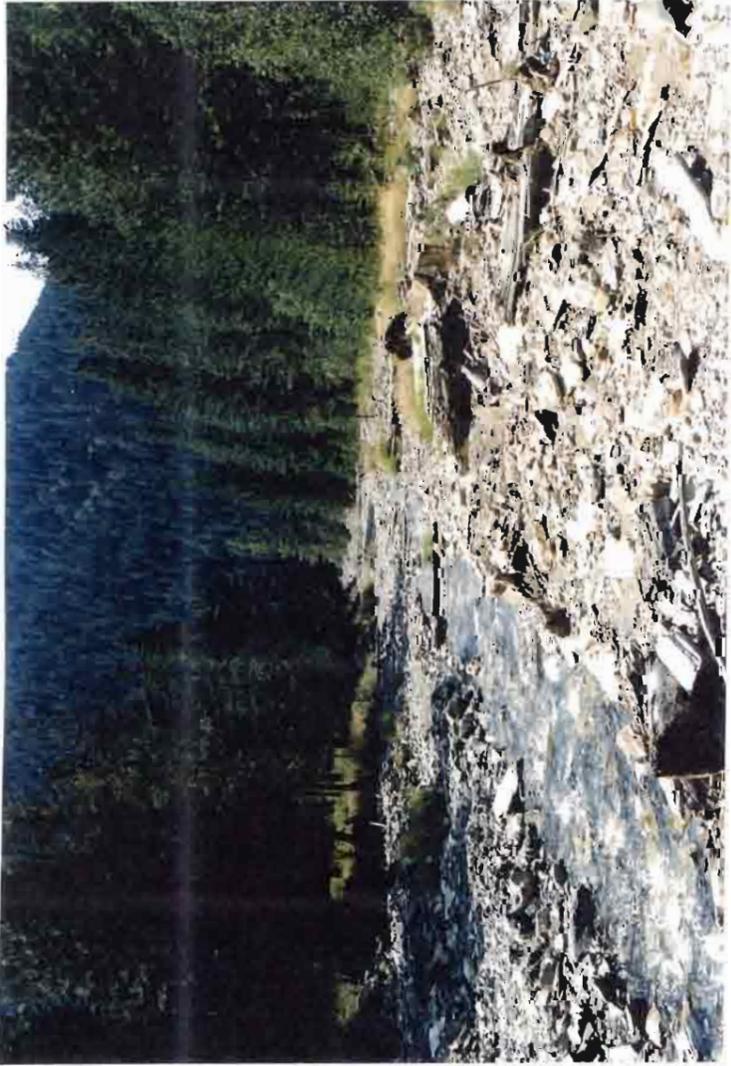
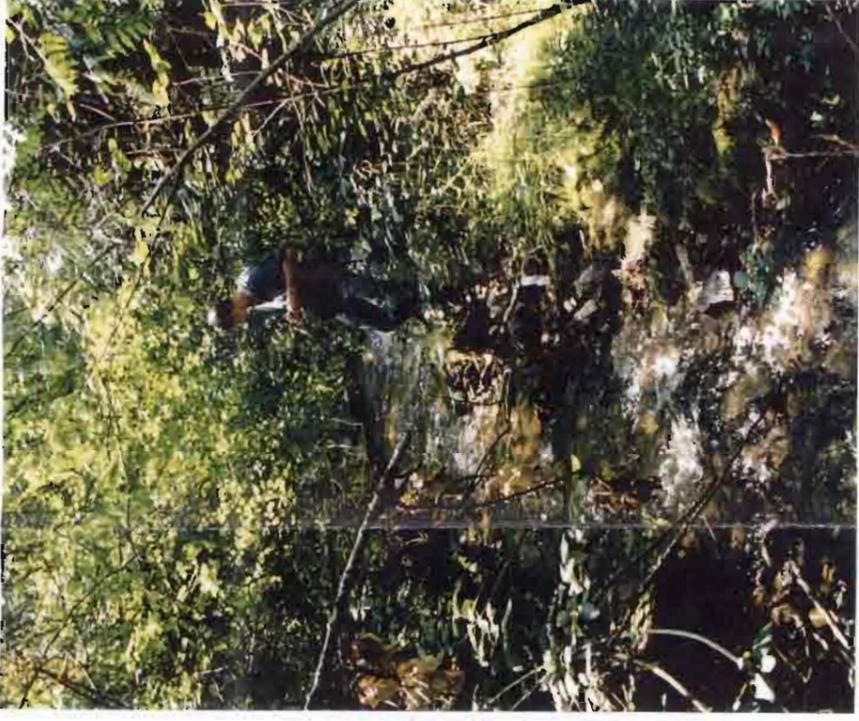
**FIGURE 5**  
**PHOTOGRAPHS OF HIGHLAND CREEK**  
**Channel impacted by mine wastes and**  
**in undisturbed upstream reach**

Top: view of sediment deposits and wide, open channel along lower Highland Creek about 1000 feet upstream confluence with East Fork. Bottom: view of partly buried cedar stumps showing aggradation of creek channel.

Top: view of undisturbed reach of Highland Creek just upstream of Highland-Surprise mine. Note narrow channel with dense riparian lining the banks. Bottom: oblique aerial view of lower Highland Creek and confluence with East Fork Pine Creek. Note sediment deposits and lack of streamside vegetation.

In contrast to Douglas Creek, the active, open channel of Highland Creek occupies most of the canyon bottom, with relatively little riparian vegetation remaining. The freshly deposited sediment varies in width, but is commonly 40 to 80 ft wide (Figure 5). We observed cedar stumps buried under aggraded sediment (typically about 2-ft thick) along the length of the Highland Creek channel downstream of mines, as illustrated about one-half mile upstream from the East fork confluence (Figure 5). The fresh channel deposits included a large fraction of dark Pritchard Formation lithologies, implying that much of this sediment was derived from mine rock waste dumps. In contrast, the channel upstream of the Highland-Surprise Mine is narrow (typically 10-

15 ft wide), with a continuous, dense riparian corridor along bank (Figure 5), similar to the channel of Douglas Creek.

The channel morphology and evidence of aggradation downstream of the mines indicates a greatly increased sediment load in Highland Creek. This increased sediment load has overwhelmed the sediment storage capacity of the valley bottom, and is being transported through the reach to the mainstem East Fork (Figure 5), forming an alluvial fan at the confluence.

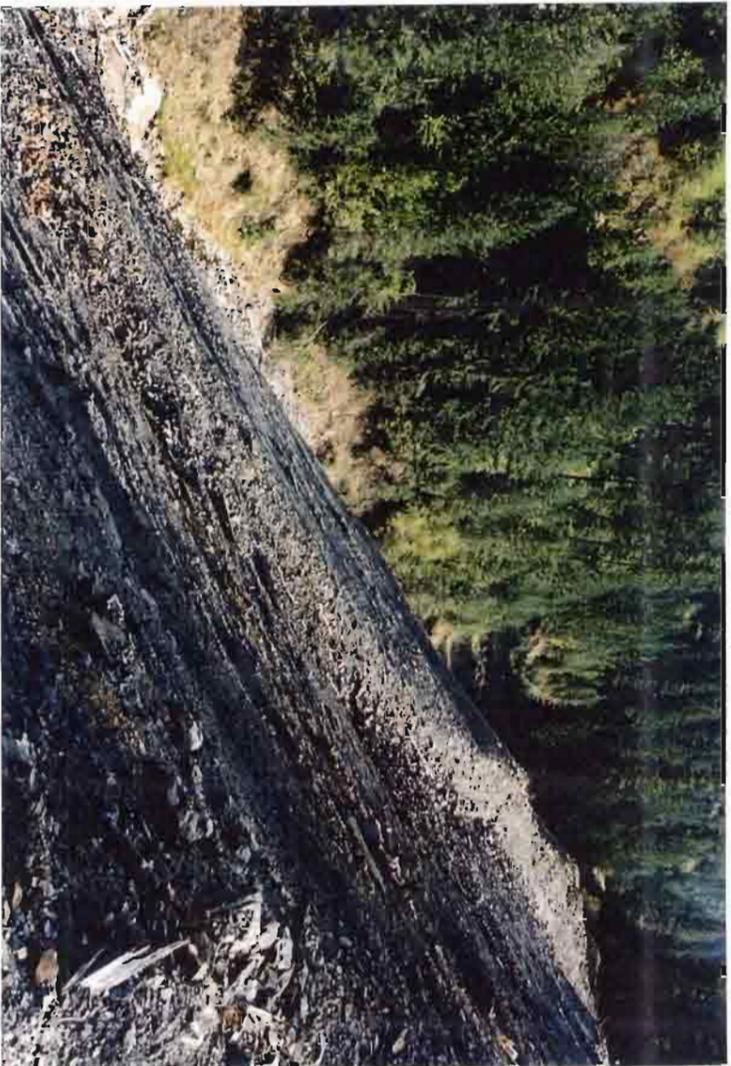
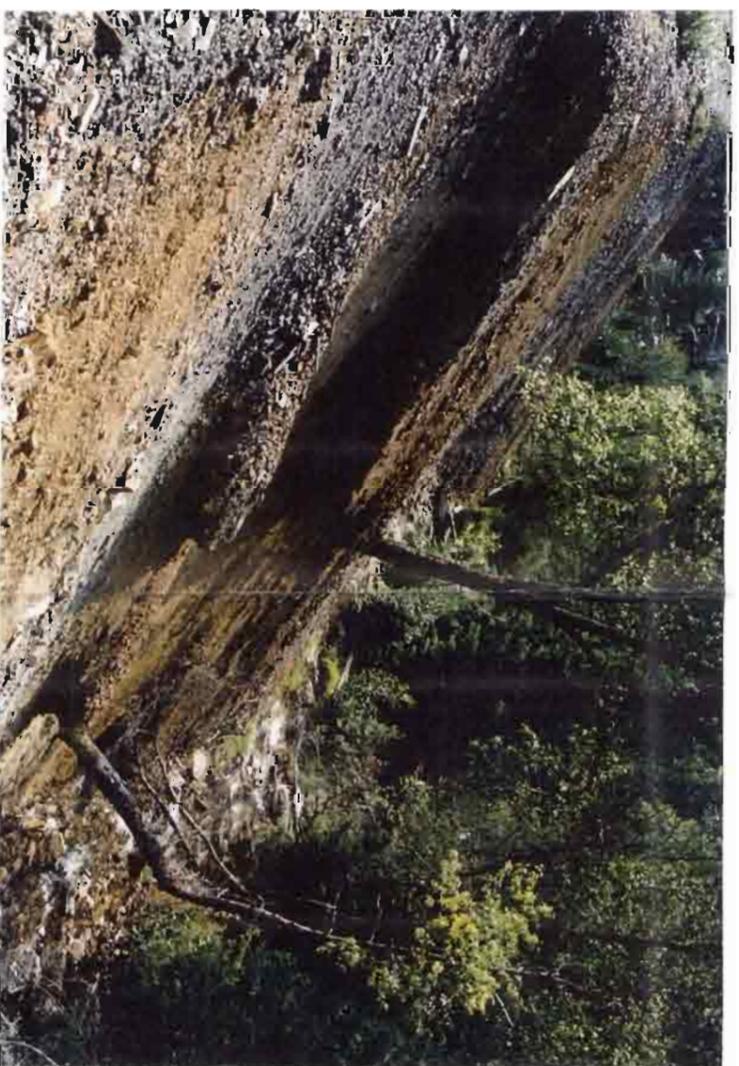
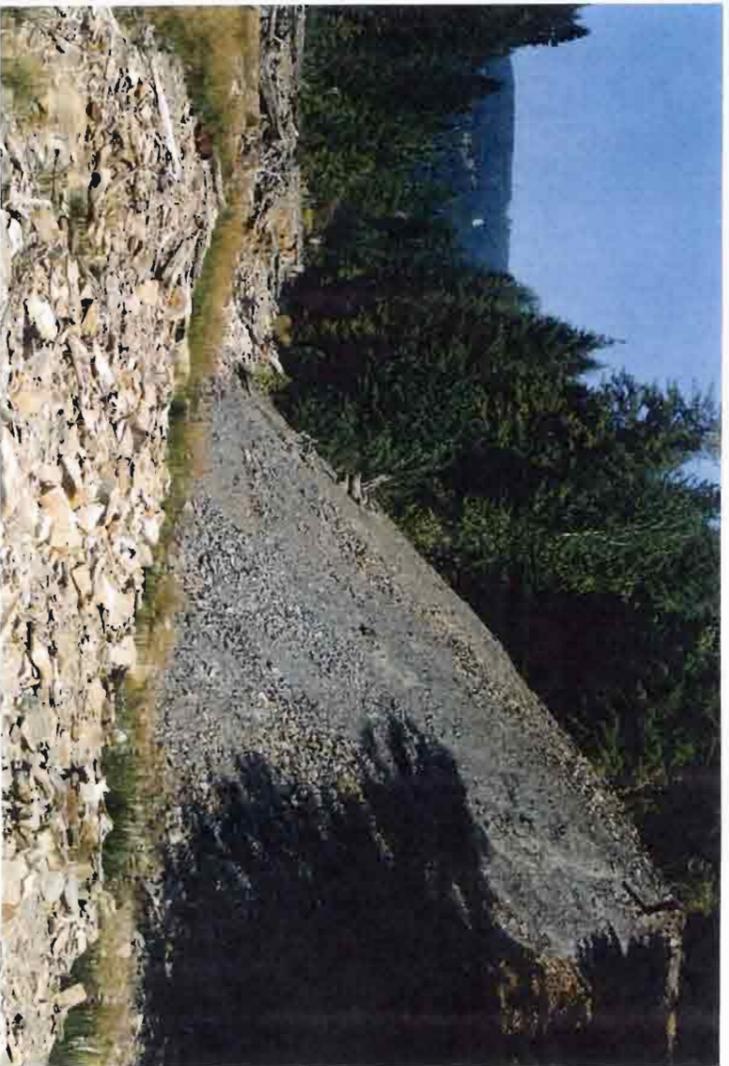
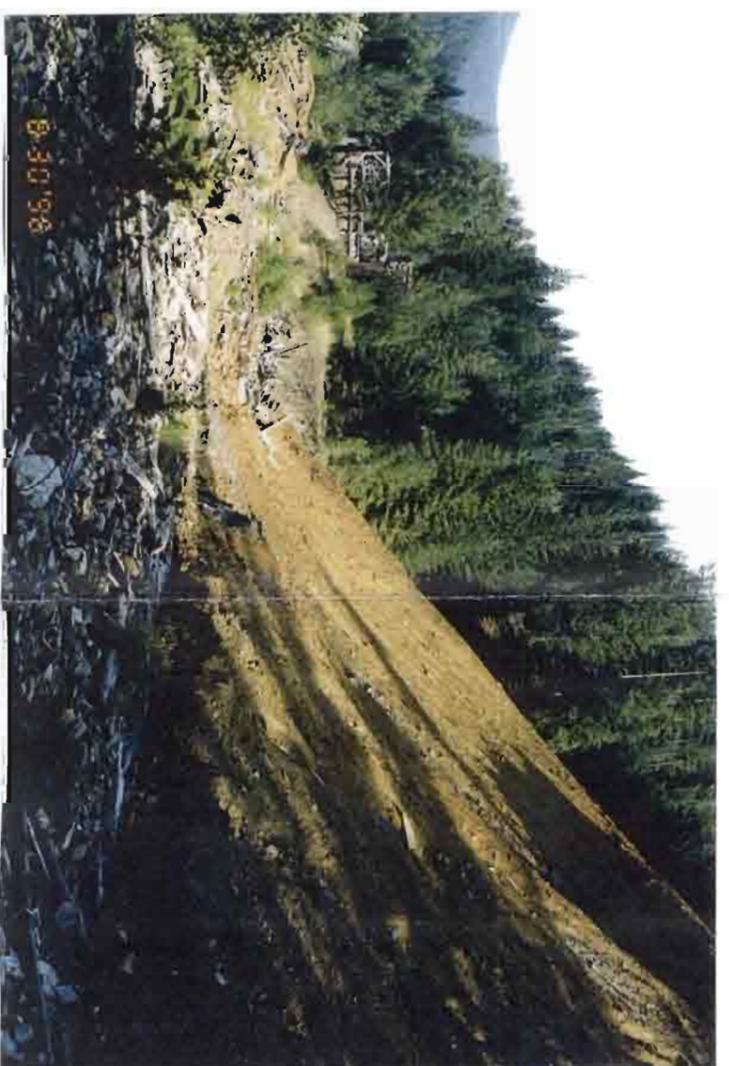
**FIGURE 6**  
**PHOTOGRAPHS OF HIGHLAND CREEK**  
Mine rock dumps directly contributing sediment to creek channel

Top: view of large rock dump at Sidney-RedCloud mine on Red Cloud Creek.  
Bottom: view of rock dump at Star-Antimony mine on Highland Creek about 2000 feet upstream of confluence.

Top: view of eroding rock dump upstream of main mine buildings at the Highland-Surprise mine. Bottom: view upstream of lower rock dump below main mine buildings at the Highland-Surprise mine.

Nabob, Denver, Highland, and Gilbert Creeks all appear to be significant contributors of sediment to the East Fork, and all have mine sites with rock waste piles visibly contributing coarse sediment to the channels (Figures 2 for mine locations, Figure 6 for Highland Creek rock dumps, Figure 9 for Denver Creek rock dumps, and Figure 10 for rock dumps in Gilbert and Nabob Creeks). The implication is that the significantly increased sediment loads resulted from the uncontrolled introduction of mining sediment (Table 1).

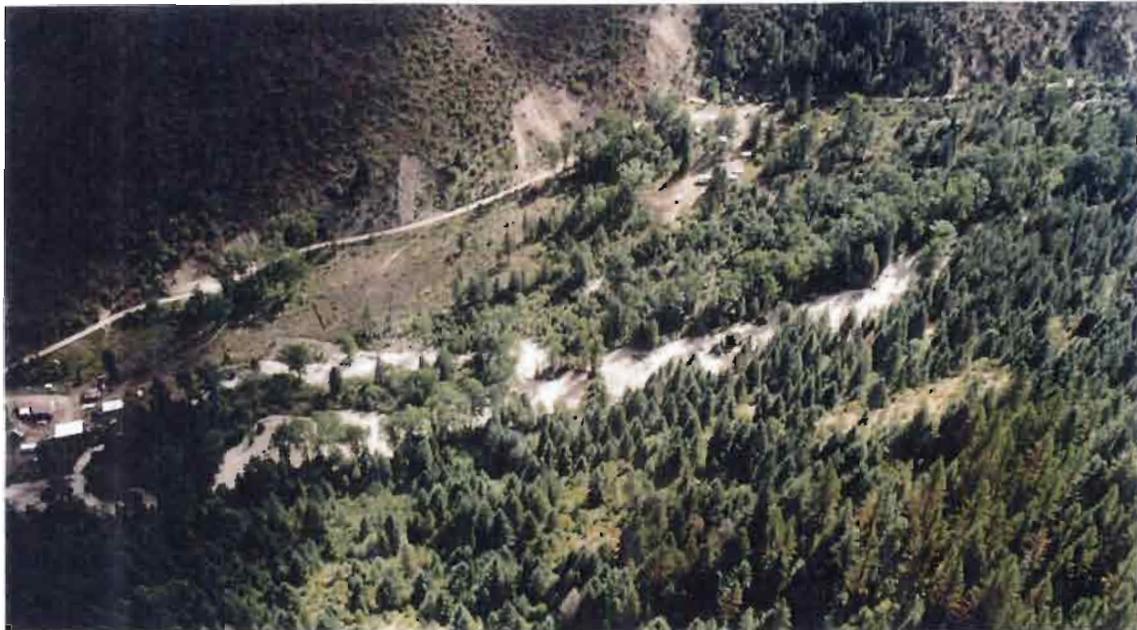
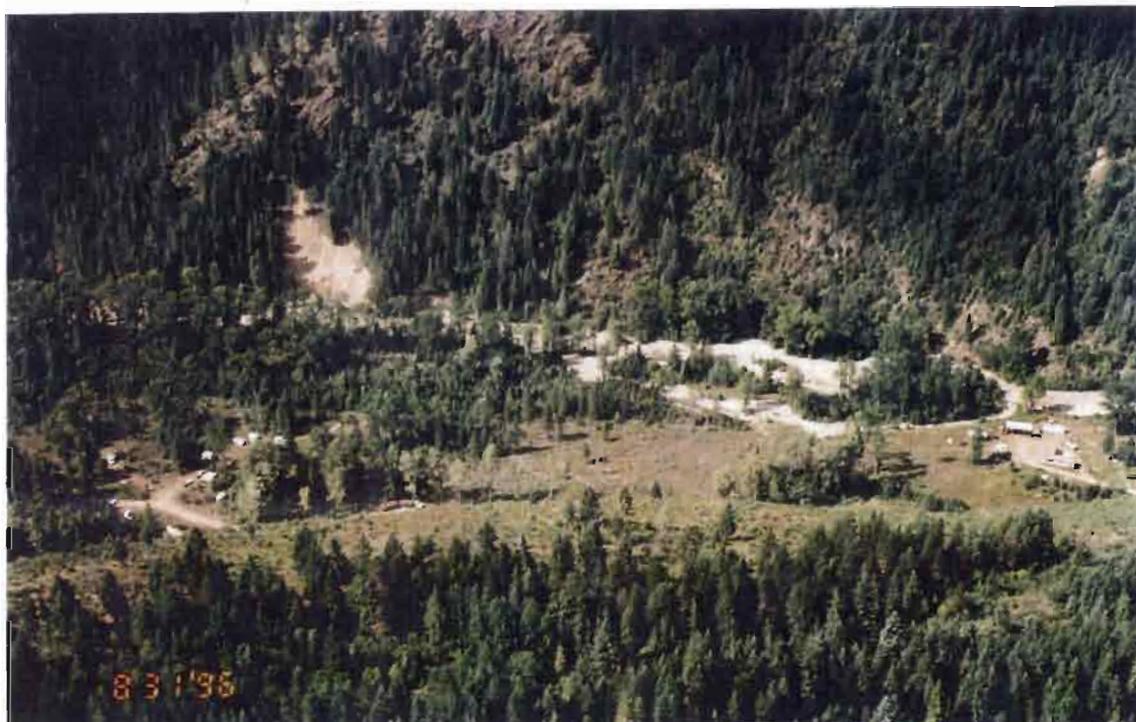
**FIGURE 7**  
**PHOTOGRAPHS OF TRAPPER CREEK**  
**Hillslope failure and floodplain sediment storage**

**Top: oblique aerial photograph of Trapper Creek showing sediment deposits from 1996 floods in braided channels of alluvial reach. In 1975, another flood channel occupied the right side of the floodplain, where the trailers are currently located at the upper center of the photo. Bottom: oblique aerial photograph showing large hillslope failure downstream of Hunter Creek confluence.**

In contrast to the upper, generally undisturbed basins just discussed, Trapper Creek produced large volumes of sediment, much of which was deposited near the confluence with the East Fork. The sources of the bedload sediment in Trapper Creek are not as obvious as on Highland Creek, as the basin was virtually unaffected by mining. However, the basin was burned earlier this century, higher elevations have been subject to timber harvest, and roads have been constructed through the basin, especially in higher elevations. It is unknown the degree to which these factors have changed runoff and sediment yield.

We observed at least four active hillslope failures, each of which could contribute substantial volumes of coarse sediment to the channel. The largest of these failures, downstream of the Hunter Creek confluence in the alluvial reach (Figure 7), was also visible on 1975 aerial photographs. It is unclear the extent to which sediment delivery from these failures reflects high natural sediment delivery in an unusually wet year or the extent to which they reflect human activities.

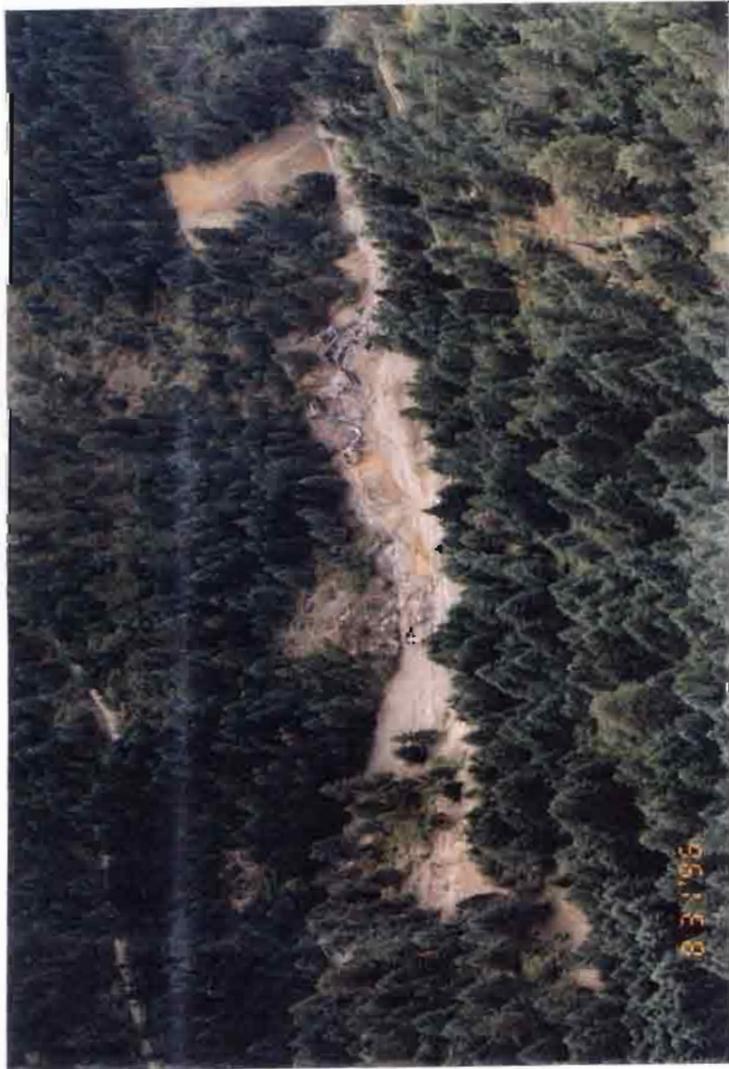
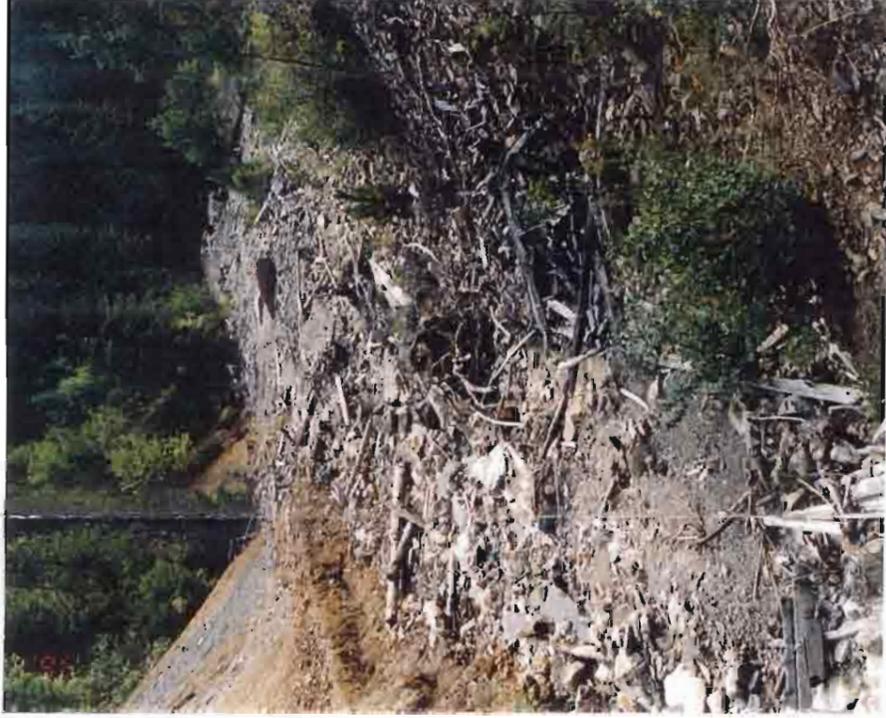
**FIGURE 9**  
**PHOTOGRAPHS OF DENVER CREEK**  
 Effects of mining sediment on stream channel

Top: oblique aerial photograph of Little Pittsburg mine on Denver Creek showing sediment deposits behind building, erosion, and rock dump downstream. Building to left of center is same as one shown in lower photo. Bottom: view to collapsing mine buildings, trapping sediment.

Top: view of erosion and sediment deposition downstream of Hilarity mine on Denver Creek. Toe of rock dump is visible on left. Bottom: view upstream of sediment choked channel of Denver Creek near confluence with the East Fork Pine Creek.

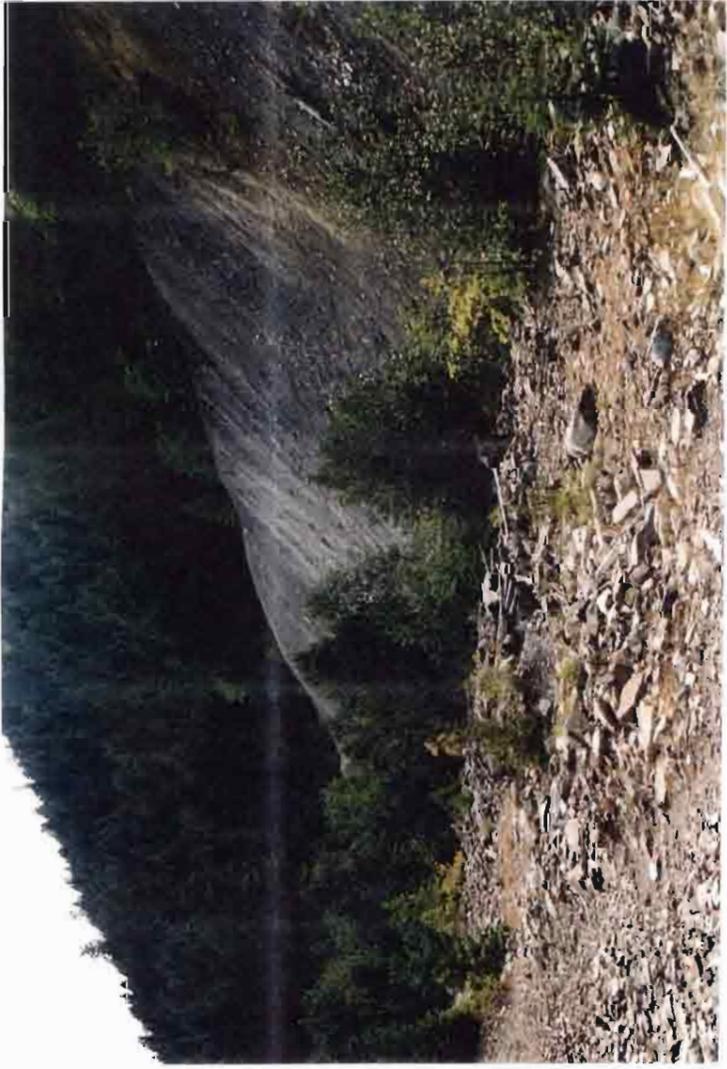
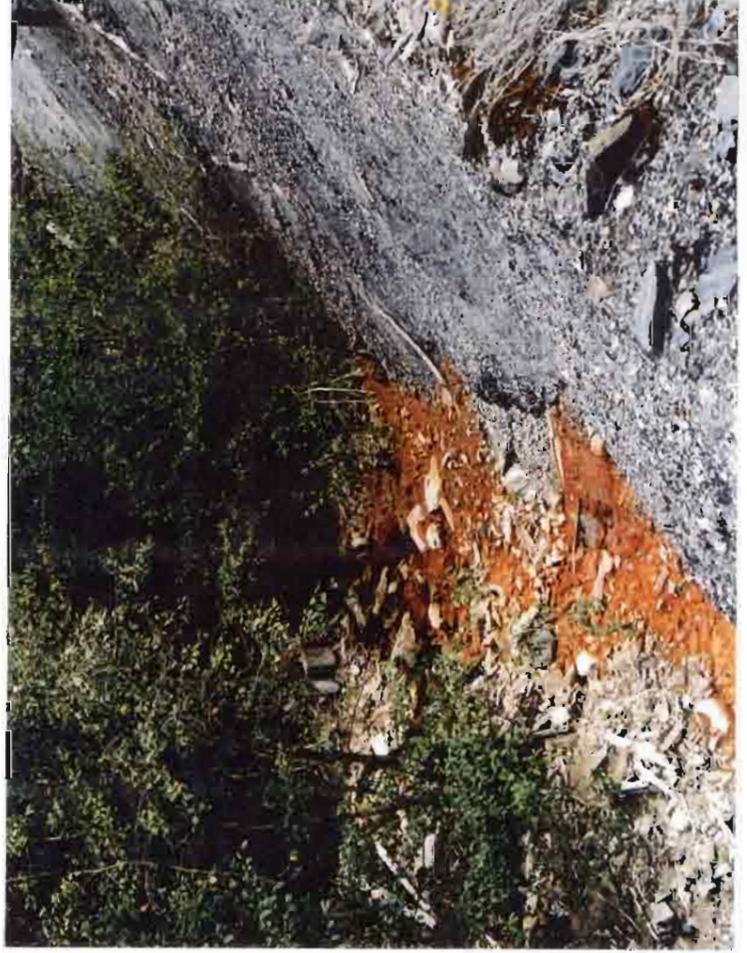
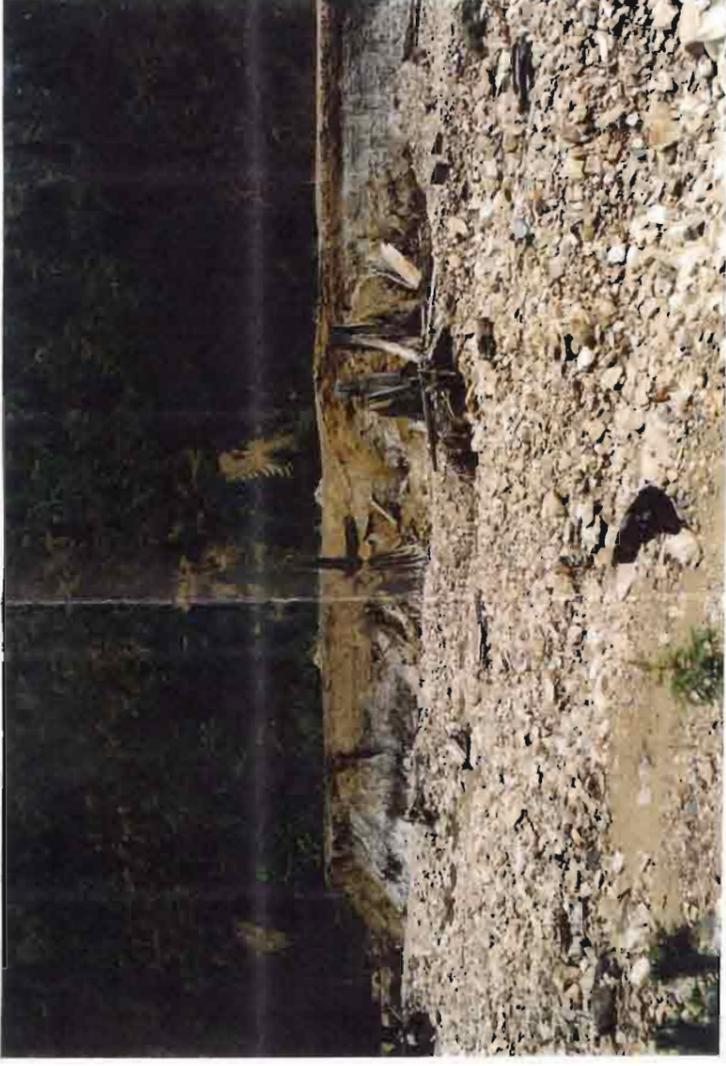
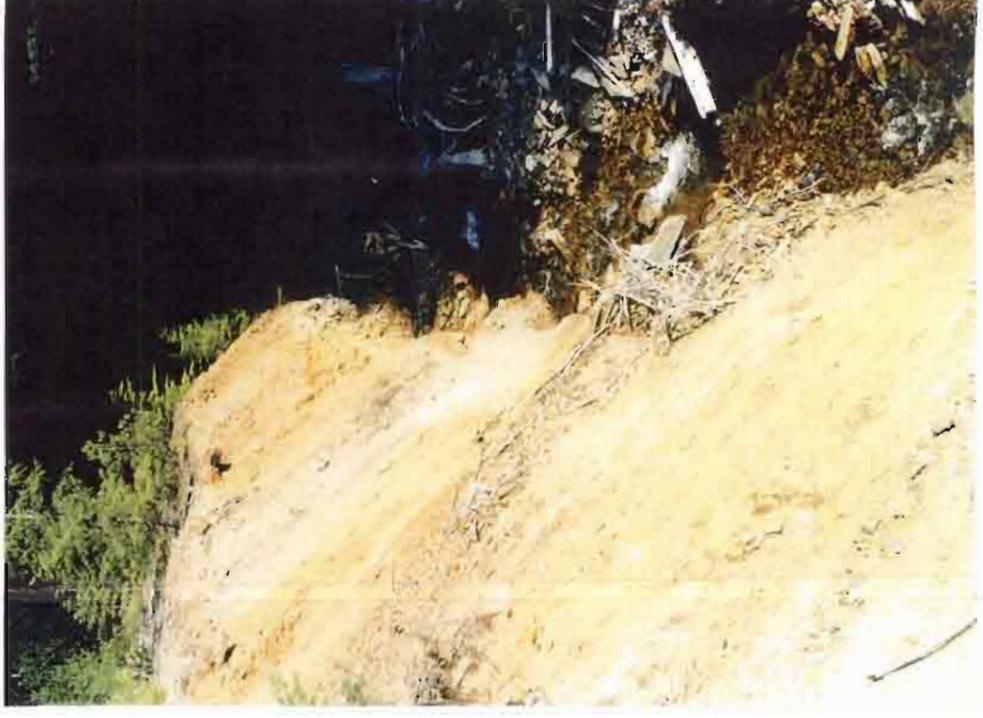
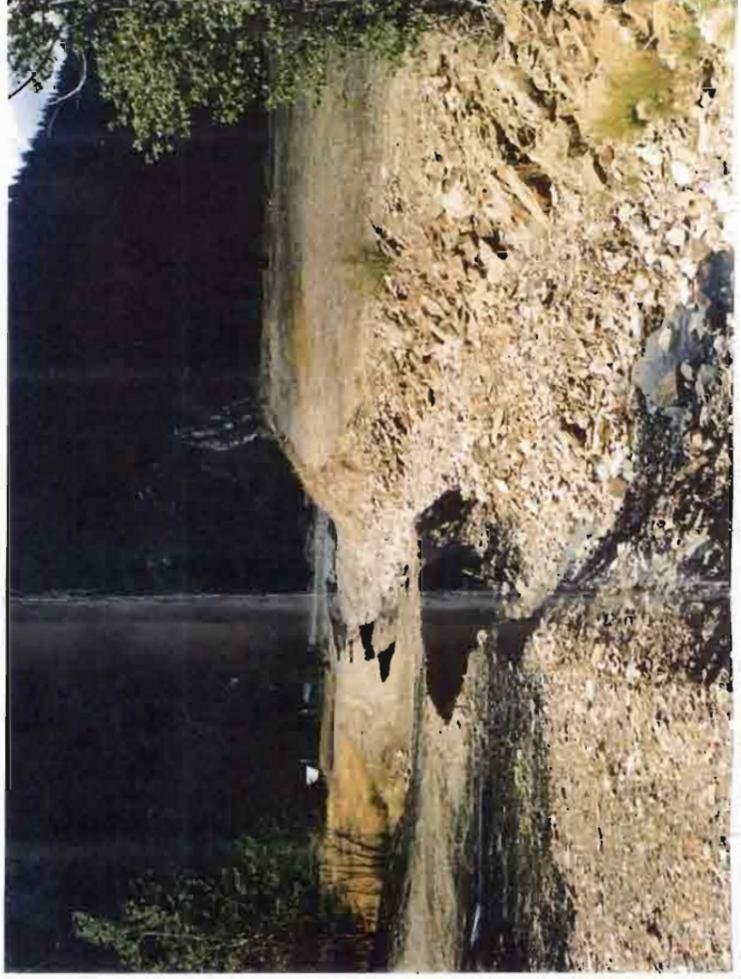
**FIGURE 10**  
**EAST FORK AND**  
**TRIBUTARIES**  
Effects of mining sediment  
on stream channels

Top: view upstream along Gilbert Creek showing rock dump from Constitution mine. Channel is along toe of slope, behind alders. Bottom: view of leachate from rock dump on Gilbert Creek.

Top: view of erosion of tailings at Douglas Mill on mainstem of East Fork Pine Creek. Bottom left: view downstream along Nabob Creek showing channel erosion from 1996 floods. Note riprap on right bank protecting capped tailings pond. Bottom right: eroding rock dump at Nevada Stewart mine on Highland Creek.

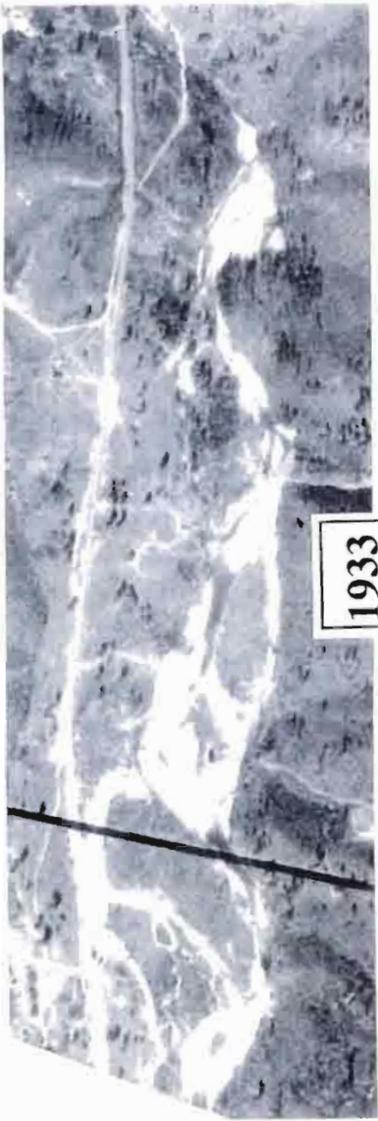
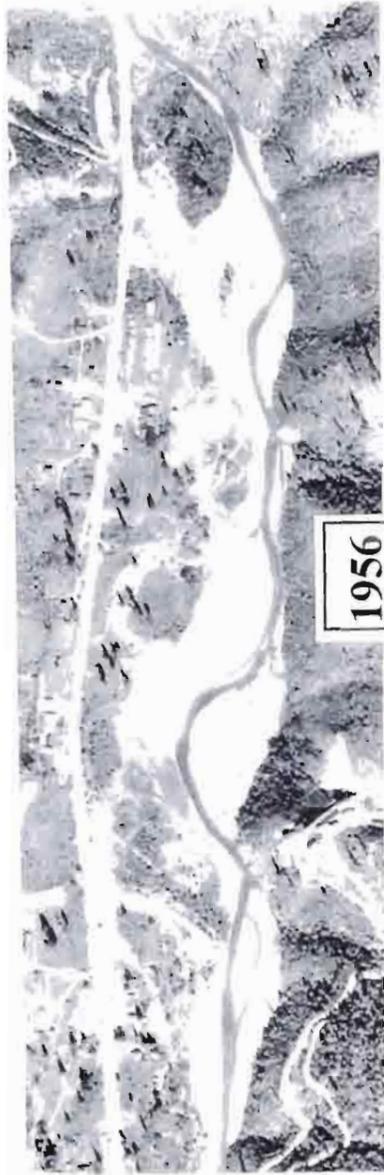
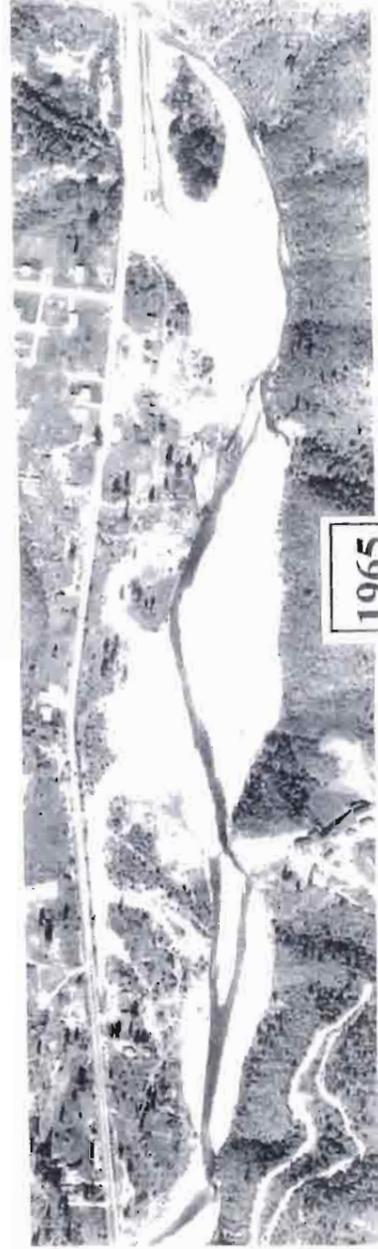
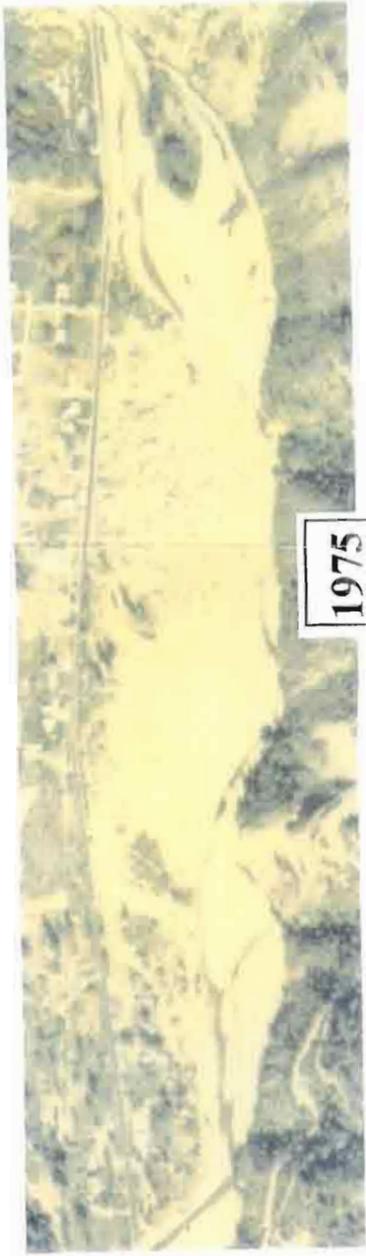
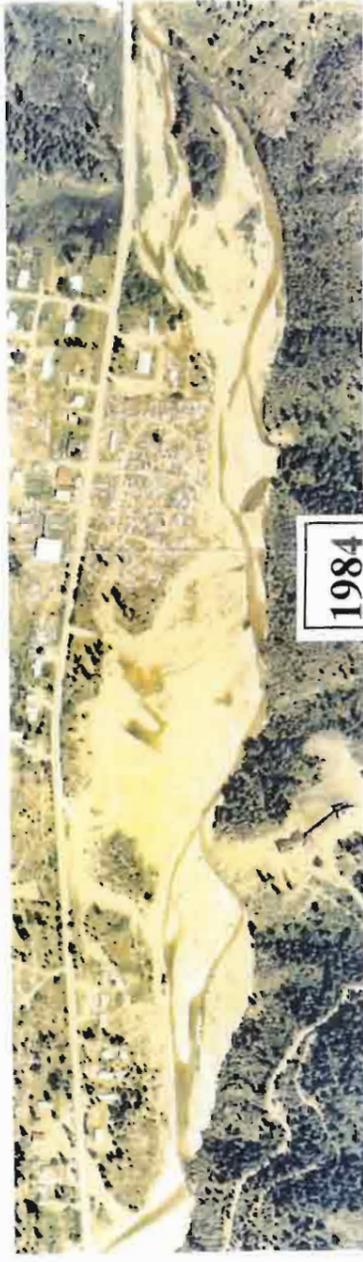
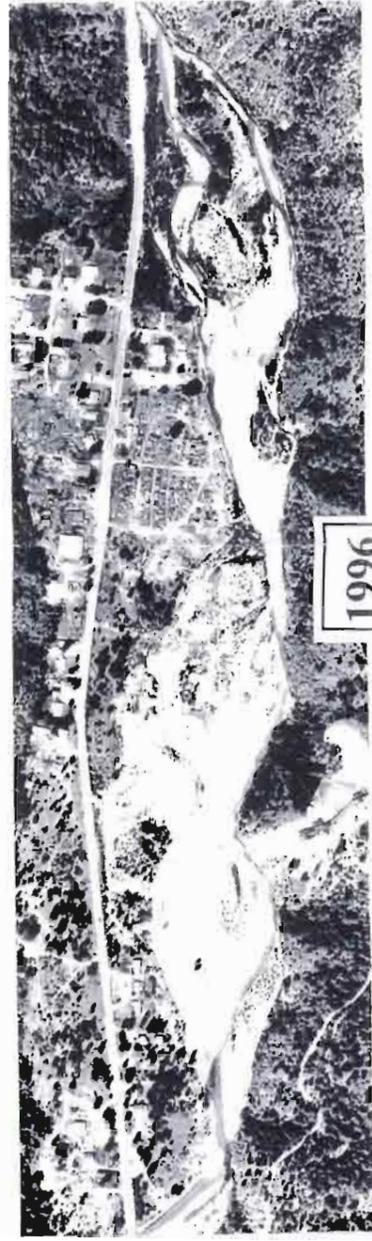
**FIGURE 11**  
**LIBERAL KING REACH -- MAINSTEM PINE CREEK**  
Sequential historic aerial photographs

1933, 1937, 1956, 1965, 1975, 1984, and 1996 are shown in Figure 11. In 1933, the channel was generally narrow, sinuous, and braided in a number of locations. High flow channel scars between the channel and the County road are likely remnants of the 1917 flood or even earlier events. The channel flowed through an area along the left bank now occupied by tailings. Some gravel bars were open and unvegetated, but most were vegetated. By 1937, the channel had widened, migrated laterally in several locations, particularly on the outside of bends, and cut a new channel upstream of the lower bridge, apparently washing out the road. Most of these changes probably occurred in the December 1933 flood. By 1956, the channel had widened, with more unvegetated bars and fewer vegetated bars. The channel was less sinuous, and it had shifted to the east at Liberal King Mine, eliminating the braided channel downstream of the mine.

In 1965, the meanders downstream of the mine had greater amplitude and wavelength, with lateral migration into a partially vegetated (and thus formerly somewhat stable) floodplain surface. A new channel was cut (apparently during the December 1964 flood) to the west upstream of the Pine Creek highway bridge crossing, leaving a vegetated floodplain remnant as a island. Riprap had been placed to protect the highway. In 1968, the channel had shifted eastward against the hillslope downstream of Liberal King Mine, and the west braid at the island (upstream of the bridge) appeared to contain a large percentage of the flow. A junkyard was constructed on active flood deposits and occupied about 90 percent of the floodplain width at that point.

In 1975, the channel had widened upstream of the Liberal King Mine, with erosion of vegetated floodplain surface near the residence during the 1974 flood. The main channel remained on the right side of the valley floor at the mine. Most flow was in the west braid at the island, with the channel directly adjacent to the highway riprap. In 1983, some additional widening was evident, the braid upstream of the mine was more distinct, and the tailings pile was distinctly visible.

By 1991, the active channel had shifted from the west channel to the east channel at the island upstream of the bridge. the west channel was filled with young vegetation. The channel continued to widen towards the residence on the left bank upstream of the mine and began to erode the tailings area. The 1996 photos and our field observations indicate that erosion of the left bank floodplain continued during the floods of February 1996. It is interesting to note that young riparian vegetation is becoming reestablished on certain gravel bars throughout the reach, much of which apparently survived the recent flood. BLM staff constructed a small berm upstream of the Liberal King mine, in order to divert flow into the old left channel and away from the tailings pile to enable removal to proceed this fall.

We conducted additional review of the historical aerial photographs of this reach to develop recommendations for restoration of channel stability. A sequence of aerial photos from
