Coeur d'Alene Lake Subbasin Assessment Update 2011 Addendum and Update

**Coeur d'Alene Lake and River TMDL
Subbasin Assessment Update**

**Prepared by:
Coeur d'Alene Regional Office
Department of Environmental Quality
2110 Ironwood Parkway
Coeur d'Alene, ID 83814**

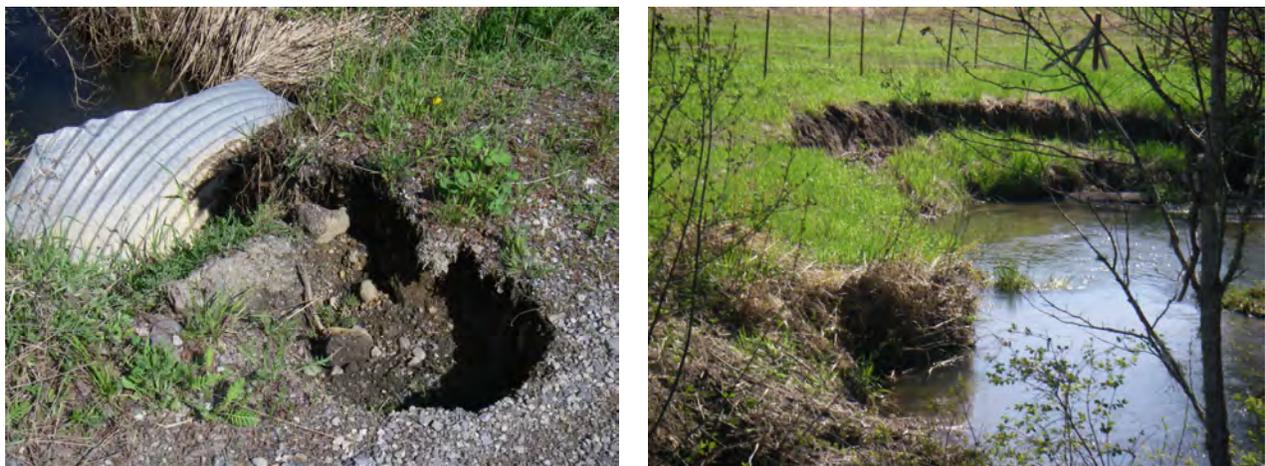
Figure 8. Failing culvert on Cougar Creek (left) with downstream channel instability (right)

Overall, sites that showed significant bank erosion in 2000 appeared to be in the process of recovering as a result of lack of livestock pressure on the streambanks. Streambanks that were vertical had side slopes of 40 percent or less with grassy/shrub cover over greater than 70 percent of the bank (Figure 7). In some places, the channel was beginning to meander — although the road and hay field put constraints on this process. There was, however, significant erosion occurring upstream of the 2000 survey reach . One source was found at a site just upstream of the survey reach, where a culvert was failing and there was significant bank erosion downstream of the culvert (Figures 8 & 9). Above this site, Cougar Creek is channelized alongside numerous ranchettes along Cougar Creek. As a result, the channel is deeply incised in this reach and there were frequent, bare-vertical banks (Figure 9). In addition, inspection of an unnamed tributary to Cougar Creek revealed significant streambank erosion and sedimentation as a result of heavy livestock pressure and failing culverts.

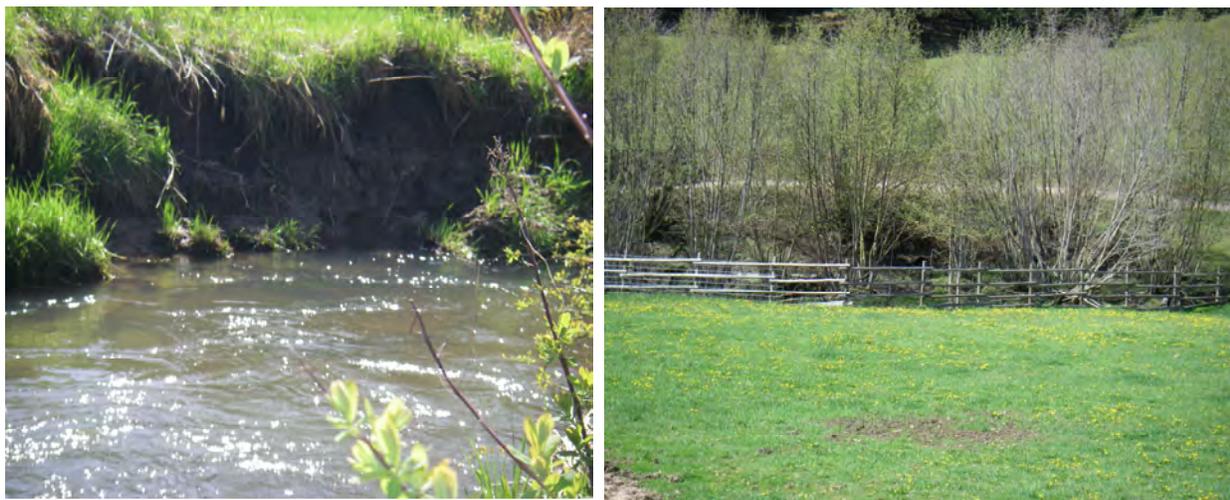
Figure 9. Channel incision on Cougar Creek

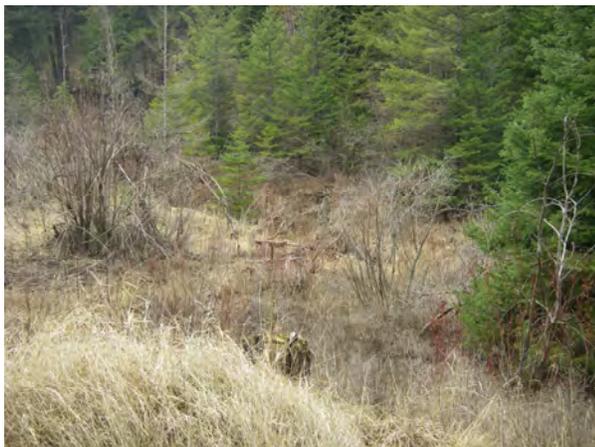
Figure 10. Most of Kid Creek is in good condition with abundant riparian vegetation (left), no excess fine sediment in the channel bed, and good access to the floodplain (right).

In 2000, the Kootenai-Shoshone Soil and Water Conservation District conducted a stream erosion survey along the entire channel of Kid Creek (ID17010303PN03_02). The analysis started from the Worley Highway District office and ended at the mouth. Results of the survey indicated much of the study reaches were in good condition with abundant riparian vegetation. In areas where there were erosion problems, adjacent land uses had much influence on the stream (Smith 2002). In 2009, DEQ and the Idaho Soil Conservation Commission conducted a visual stream survey of Kid Creek, in an effort to evaluate changes in erosion characteristics of the stream since the 2000 survey. In general, the results of the visual stream survey were: 1) there were numerous culverts along the creek which posed a challenge to fish passage; 2) although there were localized areas of concern, the stream condition was about the same as it was in 2000 — with abundant riparian vegetation, good stream bank stability, no excess fine sediment in the channel bed, and good access to the floodplain (Figures 10 - 12). As seen in 2000, however, there were still isolated areas of erosion concerns. For example, in the headwaters, where there was no canopy cover and the stream was over-widened — suggesting this creek underwent lateral recession since 2000 (Figure 10). In the last 0.5 mile — although there was good canopy cover — the stream was incised, with bare, vertical banks, and active bank erosion (Figure 10). Just upstream was a horse ranchette, where horses had full access to the creek. In this reach, there was no riparian vegetation, the stream was over-widened, and the banks were trampled. In addition to localized erosion problems, there was one large culvert near the mouth of the stream had failed, and the stream flow was under the culvert (Figure 11).

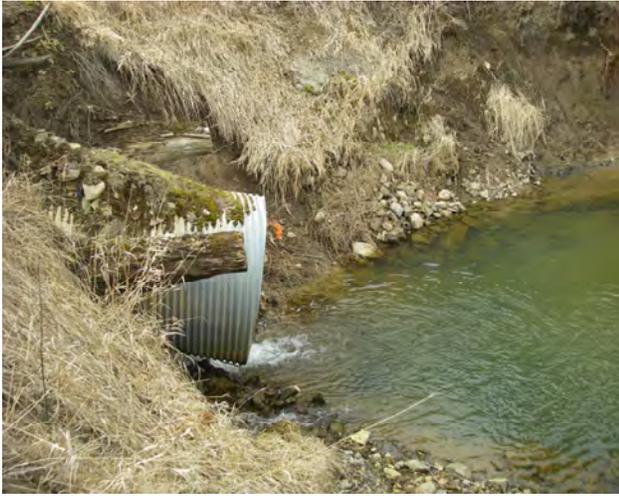
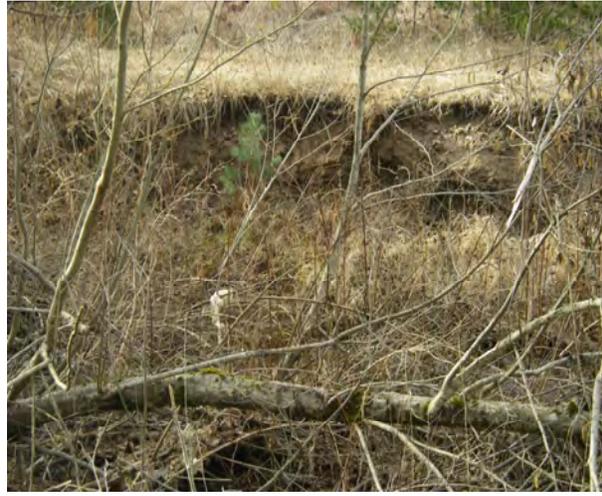
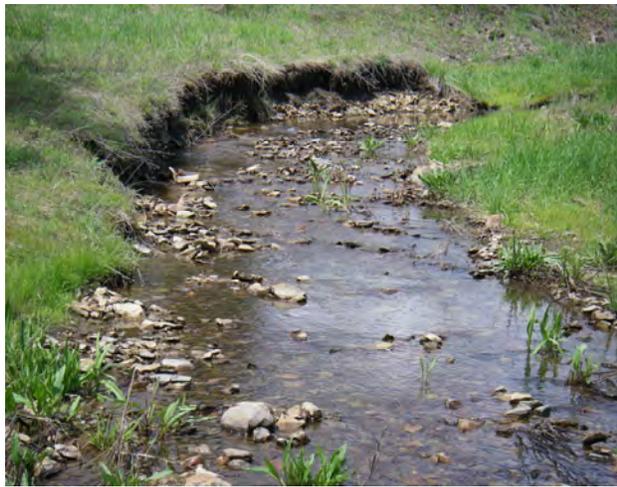
Figure 11. Failed culvert near the mouth of Kid Creek (left) and incised channel near the mouth of Kid Creek (right) Figure 12. Over-widened channel at the headwaters of Kid Creek (below).

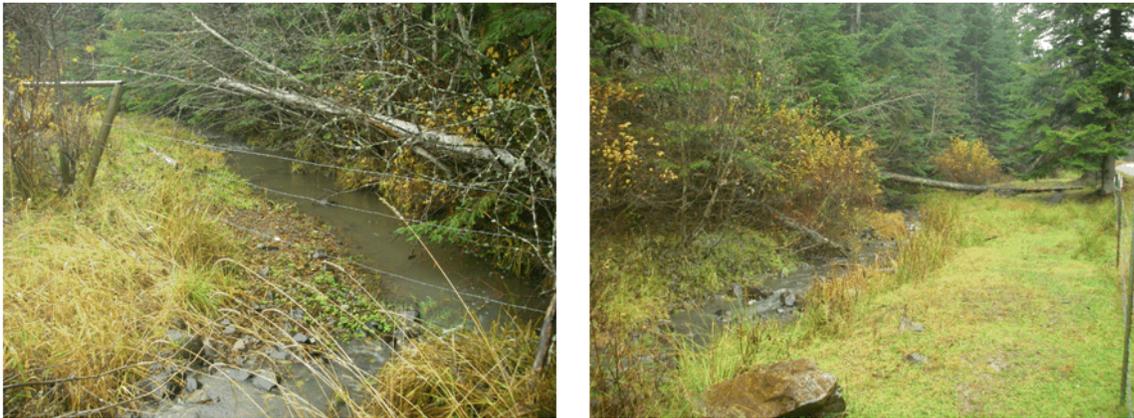
Figure 13 Thompson Creek stream banks and riparian vegetation.

In October 2009, DEQ Coeur d'Alene Regional Office visited Thompson Creek (ID17010303PN25_02) to evaluate whether sediment is impairing beneficial uses. Portions of the stream that were evaluated were those most likely to be impaired due to removal of riparian vegetation or impacted by other land use activities. Most portions of the stream were fenced to exclude cattle access and to restrict public access. It was observed that cattle had limited access to the stream, and there was neither over-grazing nor bank trampling. Riparian vegetation was at or near full potential in 80-90 percent of the area observed. Where woody vegetation was lacking, grasses, sedges and forbs dominated. Areas of stream bank lacking vegetative cover resulting in exposed soil were not observed. The current conditions demonstrated a low bank erosion hazard index and near bank stress index (Rosgen, 2006) (Figure 13). No large depositional features were noted and the substrate was not imbedded. These condition ratings support findings that sedimentation within the watershed is not impacting beneficial uses.

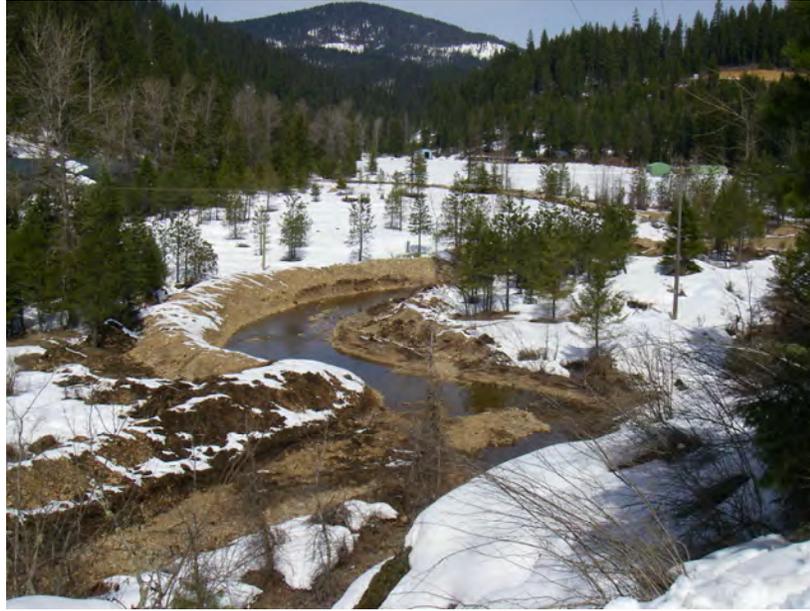
Figure 15: A 2008 photograph of Stella Creek showing significant channel modification.

Other concerns on Stella Creek were an estimated 1,400 feet of stream channel that was diked along Stella Creek without a permit (Figure 15). Comparisons of areal photos between 2006 and 2009 show visible channel widening as a result of the modification, restricted access to the floodplain, and subsequent streambank erosion. These modifications have changed the stream flow and sediment transfer regime of the creek, which will likely increase sediment loading to Wolf Lodge Creek downstream, particularly during high flow events.

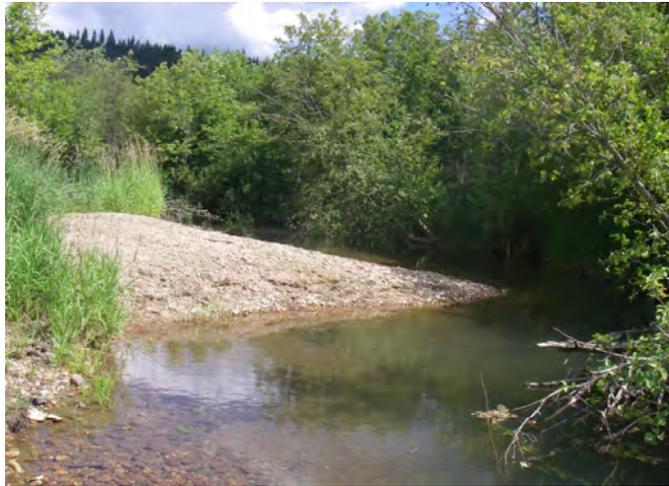
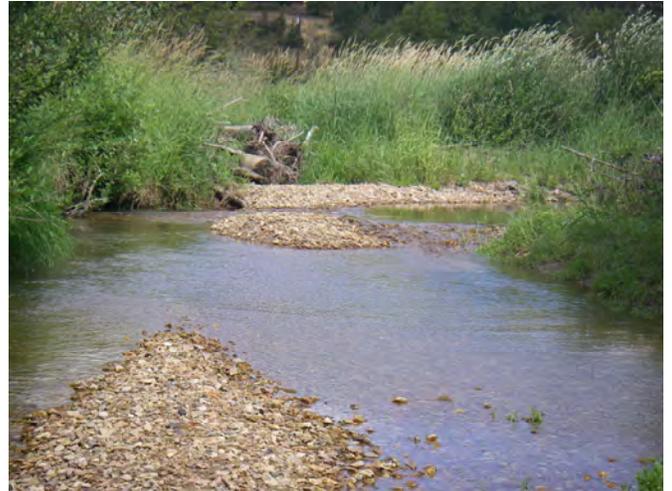
Figure 16: Large point bar on lower Wolf Lodge Creek deposited during the 2008 runoff season – result of excessive bedload in the stream (left). Depositional zone just above a bridge in lower Wolf Lodge Creek. This site is partially dredged every year (right).

In 2008, DEQ conducted a survey of lower Wolf Lodge Creek (ID7010303PN29_03), which included field observations and bank erosion evaluations using looking at the bank erosion hazard index (BEHI) and near bank stress (NBS) characteristics as identified by Rosgen (2006). The lower Wolf Lodge Creek assessment unit starts on private property below the confluence with Stella Creek about ½ mile downstream from the U.S. Forest Service property. The assessment unit ends just upstream of the Wolf Lodge Creek campground, and it does not include any tributaries to Wolf Lodge Creek. Results indicated localized areas where the channel is relatively unstable, with moderate/high BEHI and moderate NBS causing significant bank erosion. The instability was most evident where the channel flows through private property. Along this reach, there are numerous homes in the floodplain, and lateral channel movement is restricted. Although excessive fine sediment was not observed in the channel substrate, excessive bedload existed within much of the channel as evidenced by instream depositional features. These features force lateral flow causing streambank erosion, loss of riparian vegetation, and channel widening (Figures 16 - 17). This process was very evident following the 2008 runoff season, where bankpin studies and field observations showed significant amount of depositional features along lower Wolf Lodge Creek and loss of 3 feet or more of streambank in places. As the creek enters an alluvial fan further down the watershed, it has a stable, braided channel morphology. Riparian vegetation is abundant, and stream bank stability is good.

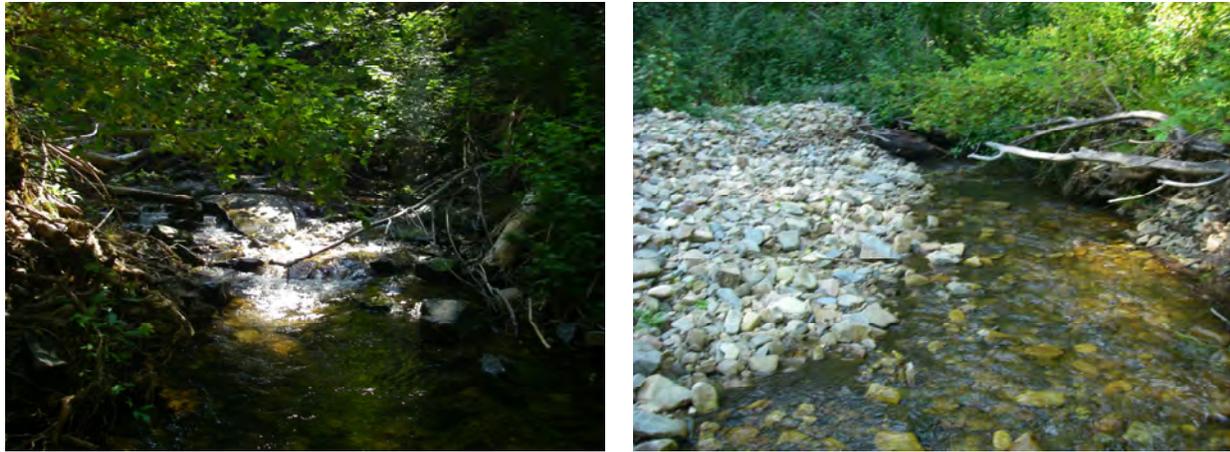
Figure 18. Marie Creek September 2008. Instream depositional features in Marie Creek (right)

Marie Creek (ID17010303PN31_02) is a major tributary to Wolf Lodge Creek that drains 11,321 acres. In September 2008, DEQ conducted a field visit of the Marie Creek watershed. As was observed in the Wolf Lodge Creek watershed, on a watershed scale, the forest canopy is recovering from historic logging activity, and riparian zones are free from recent logging activity. In addition, much of the riparian area of the watershed was forested. Along much of the stream, the stream banks were well vegetated and stable (Figure 18). However, instream depositional features above bankfull elevation were present, albeit at less frequency than that observed in Stella Creek. Associated with these features were lateral erosion and undercutting of stream bank and large woody debris accumulation into the channel. No excessive fine sediment was observed.

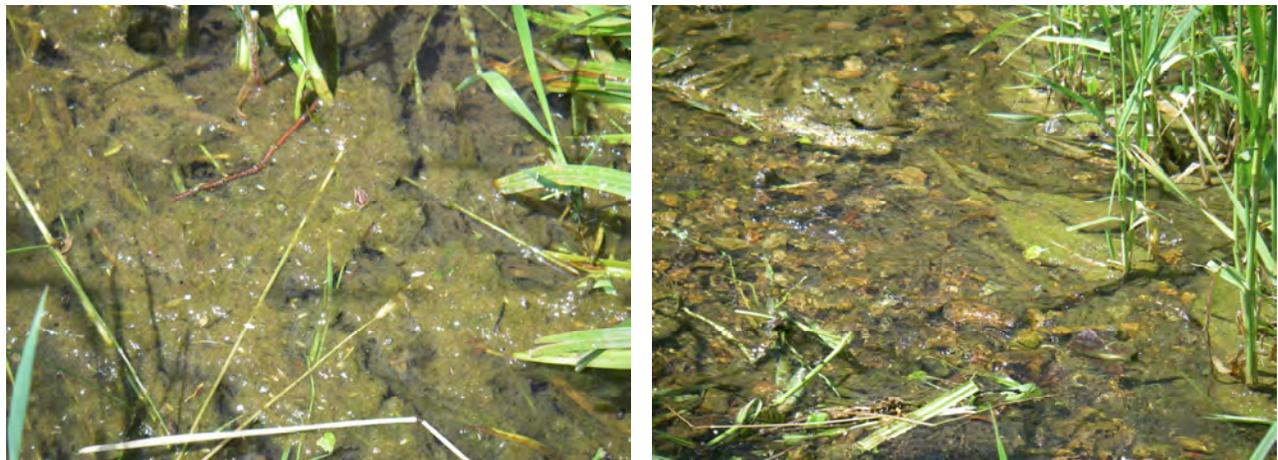
Figure 19. Excess visible slime growth on Blue Creek. Photos taken June 23, 2009

In 2008-2009, Idaho DEQ conducted instantaneous suspended sediment and nutrient monitoring of 13 tributaries to Coeur d'Alene Lake during winter rain-on-snow events, spring runoff, and during the summer low-flow season. Results of this monitoring project are in the *Coeur d'Alene Lake Tributaries 2008-2009 Nutrient and Sediment Monitoring Final Report* (Appendix D). The results concluded the highest instantaneous suspended sediment and nutrient concentrations were observed during early rain-on-snow events. Although this is a concern for TP loading to Coeur d'Alene Lake, the higher flows and colder temperature are not conducive to aquatic plant growth during the winter and early spring months. However, dissolved Ortho-P:TP during base flow period in tributaries to Coeur d'Alene Lake are above that of reference streams in the region suggesting bioavailable phosphorus may be a concern for beneficial uses for the streams and for loading to the lake. After a very high runoff year, field observations were inconclusive for excess aquatic vegetation growth — except on Blue Creek, where growth was abundant (Figure 19).

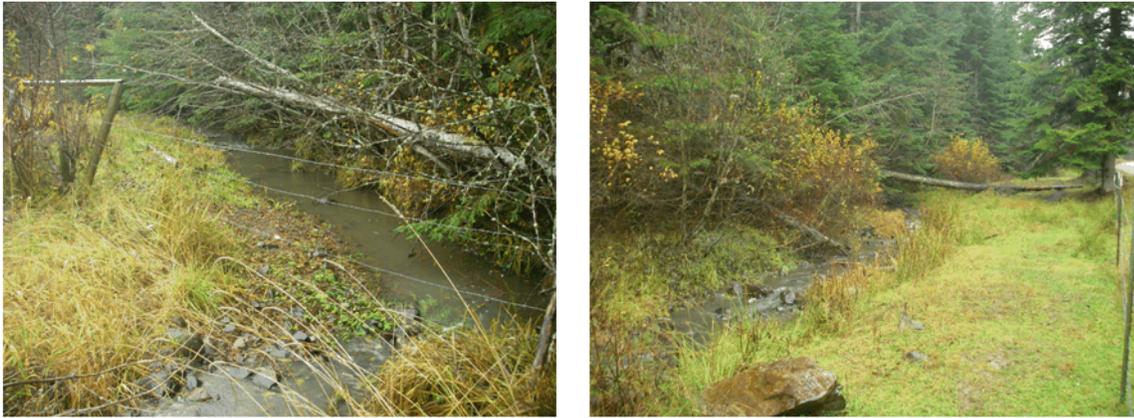
Figure 2. Thompson Creek stream banks and riparian vegetation.

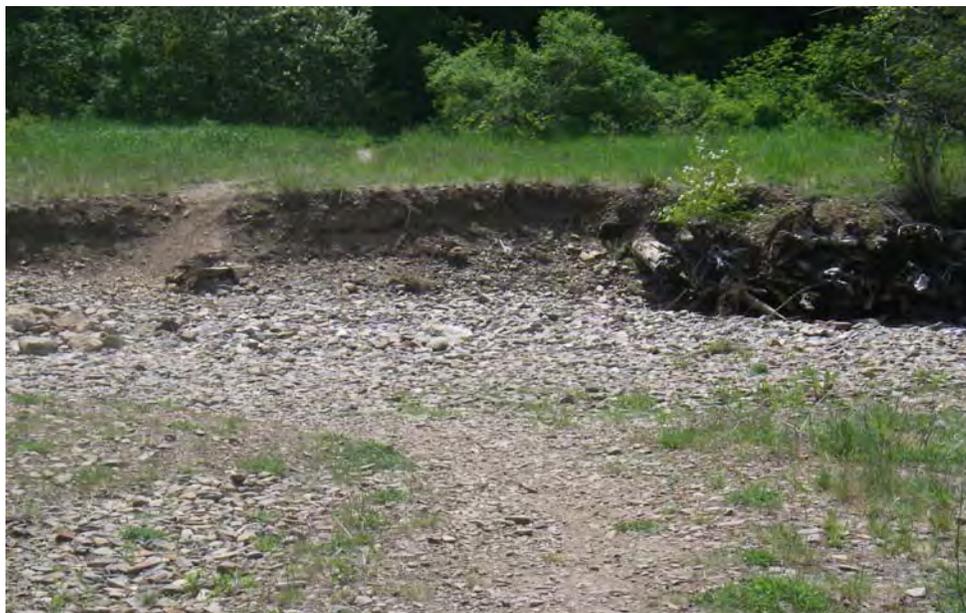
Beauty Creek channel in August 2008. All flows are subsurface.

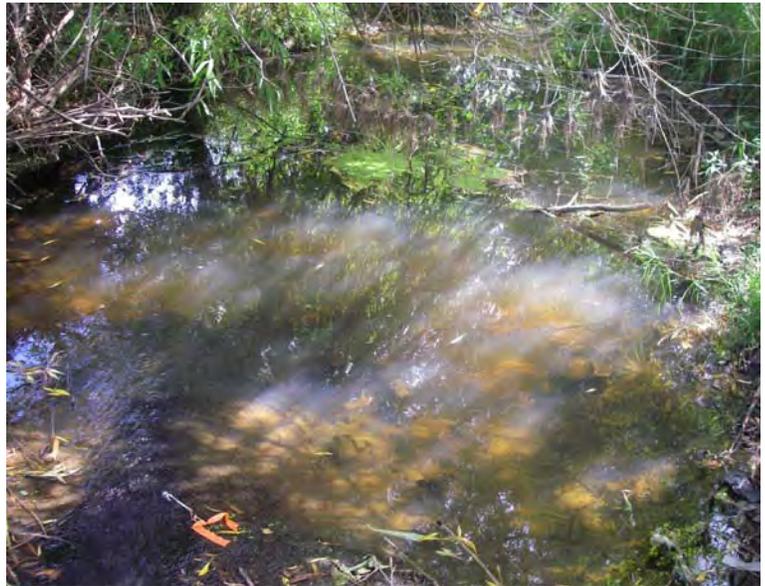
Bellgrove Creek on August 7, 2009

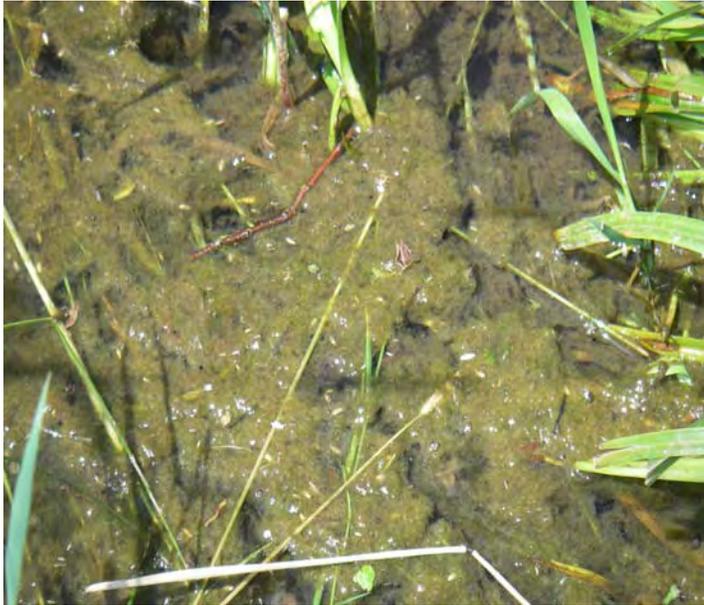
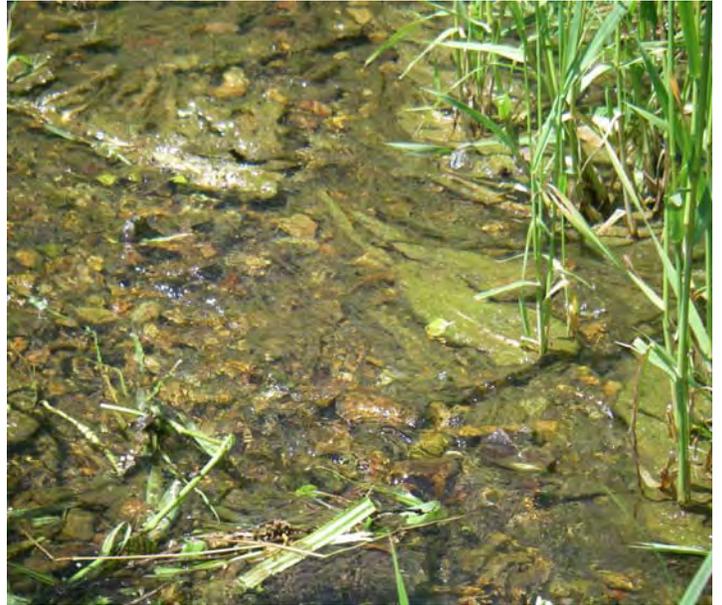
Excess visible slime growth on Blue Creek. Photos taken June 23, 2009

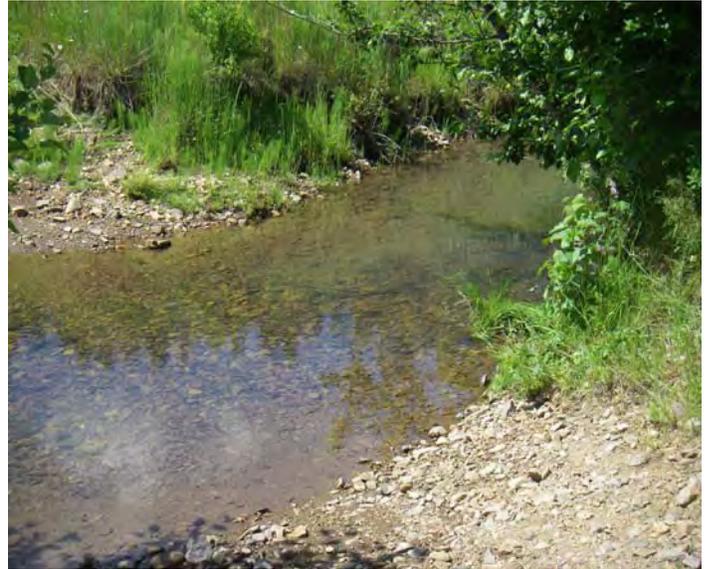
Carlin Creek on June 26, 2009

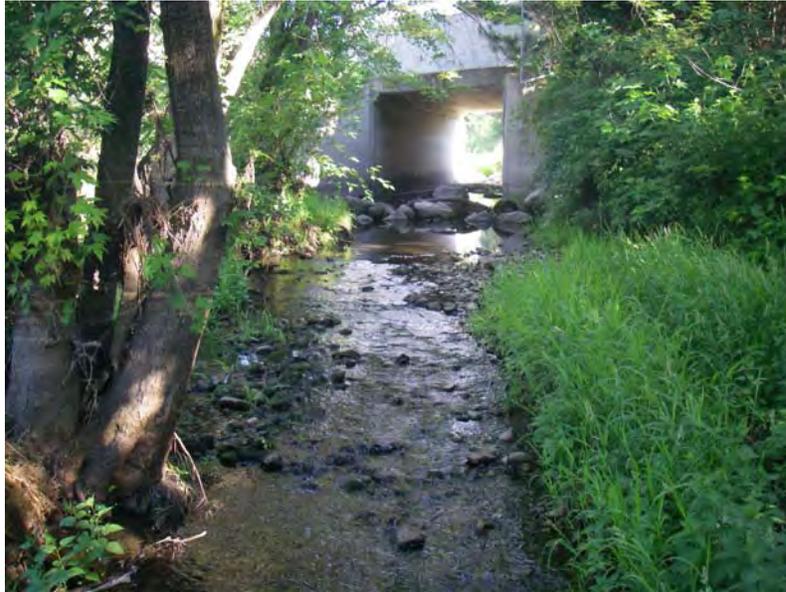
Fernan Creek in August 2008.

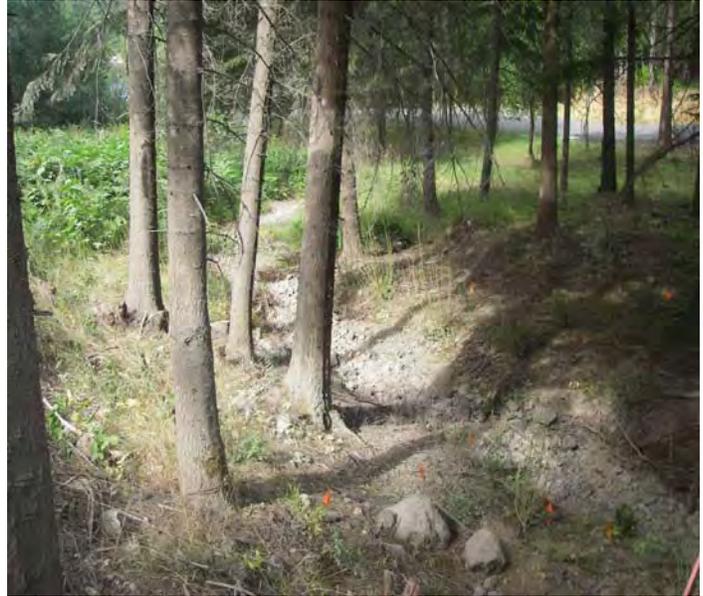
Dry stream channel of Gotham Creek. Photo taken in August 2009.

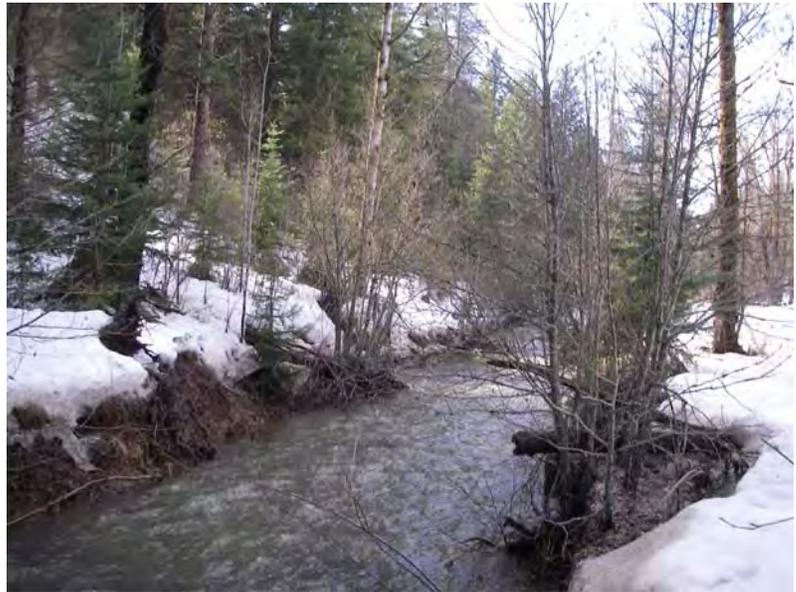
Stinson Creek during March 2009 runoff.

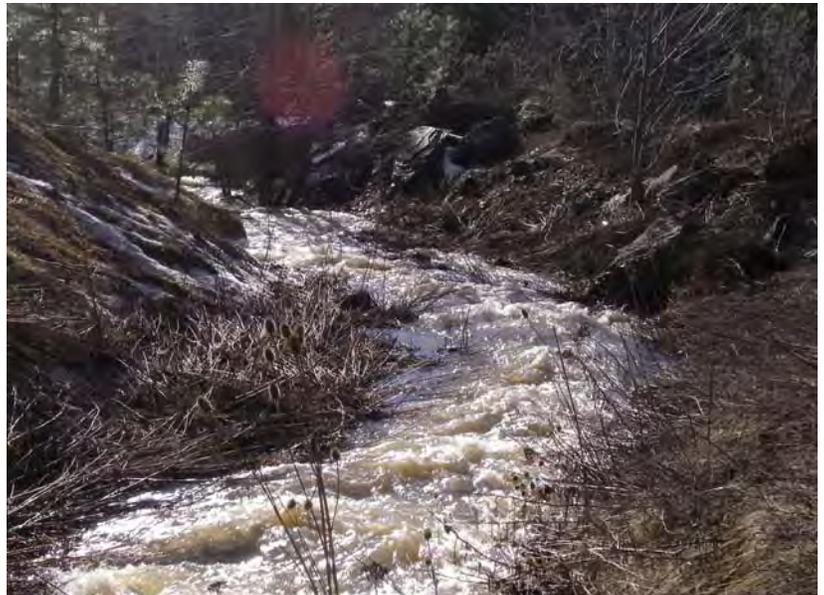
Unnamed Creek into Bennett Bay during February 2009 rain-on-snow event.

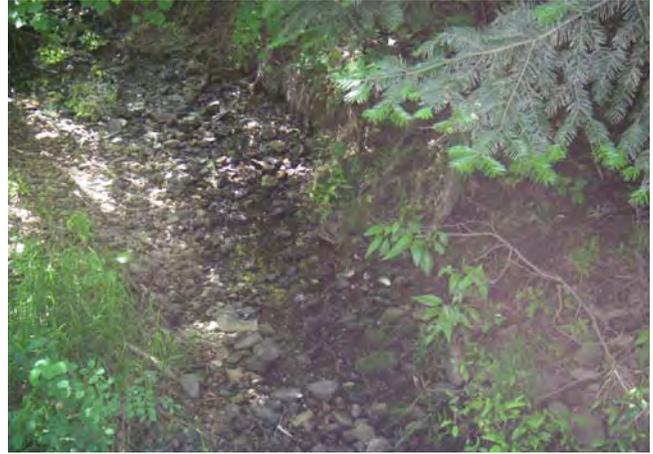
Unnamed Creek into Powderhorn Bay in June 2009.
