Upper and Lower Henrys Fork

TMDL Five-Year Review

Hydrologic Unit Codes 17040202 and 17040203

**State of Idaho
Department of Environmental Quality**

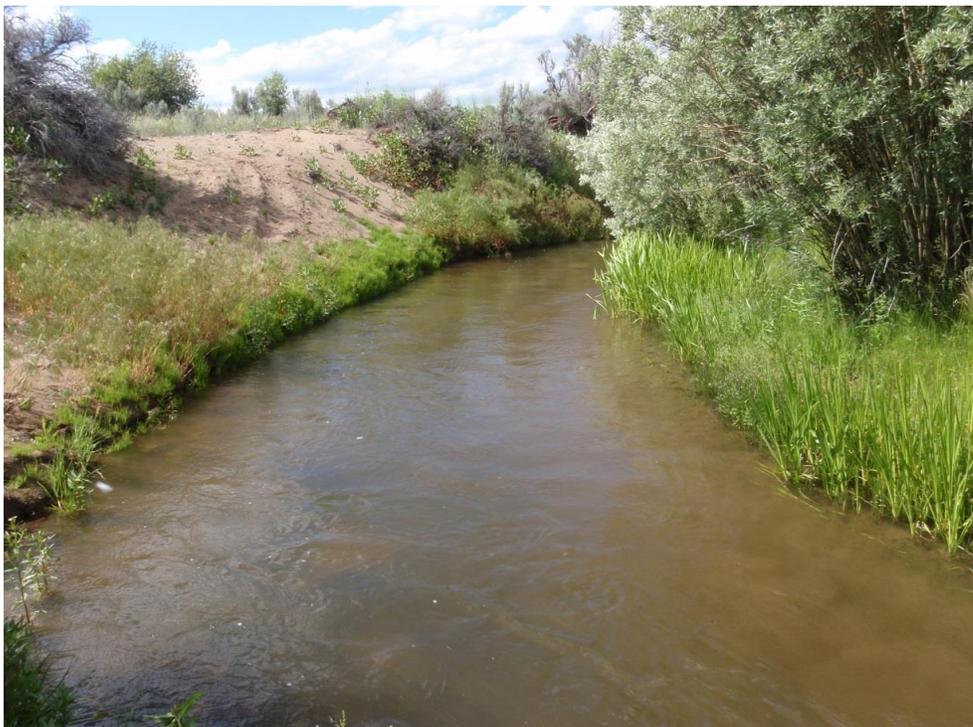
Sheridan Creek – Site 1

STREAMBANK EROSION INVENTORY CALCULATION WORKSHEET					
Stream: Sheridan Creek		Stream Segment Location (DD)			
Assessment Unit: ID17040202SK045_03		Upstream N	44.427880		
Segment Inventoried: Reach 1 above Willow Creek		W	-111.634930		
Total Reach: 424m (1391 ft)		Downstream N	44.429350		
Date Collected: 16-Jun-15		W	-111.631380		
Field Crew: Jack M. & M. Shumar		Notes: C Channel, meadow.			
Data Reduced By: M. Shumar					
Current Load Streambank Erosion Calculations					
Right, left or both bank measurements	2	Both Banks	Inventoried Segment		
Inventory/Thalweg Length (LBB) (stream flowpath distance)	1391.00	ft	Inventoried Segment		
TMDL Margin of Safety	10	%	Total Reach		
Bulk Density (BD)	85	lb/ft ³	Total Reach		
Length of Similar Stream	36580	ft	Total Reach		
Estimated Distance inventoried	2782.00	ft	"		
Total Erosive Bank Length	638.10	ft	"		
Percent Erosive Bank	22.9	%	"		
Eroding Area (AE)	1239.87	ft ²	"

30.0	207.9	3.9	27.2	YES	21
Percent Erosion Reduction (%)					88
Total Erosion Reduction (tons/yr)					201

The new SEI methods have determined that Duck Creek is currently meeting its sediment load capacity and requires no reductions. Further SEI and BURP analysis is needed before we commit to delisting this water body. Sheridan Creek, however, appears to have degraded since the 2010 TMDL and requires an 88% sediment load reduction compared to the previous 80% reduction. However, multiple SEIs were completed on each stream, and the highest required reduction was used to provide the most cautious approach. Regardless, the declining BURP scores in section 3.3.1 combined with degrading SEI measurements indicate that Sheridan Creek requires additional work before it can meet its sediment load goals.
