Big Lost River Subbasin Total Maximum Daily Loads

Addendum to the Big Lost River Watershed Subbasin Assessment and TMDL

Idaho Department of Environmental Quality

August 2011

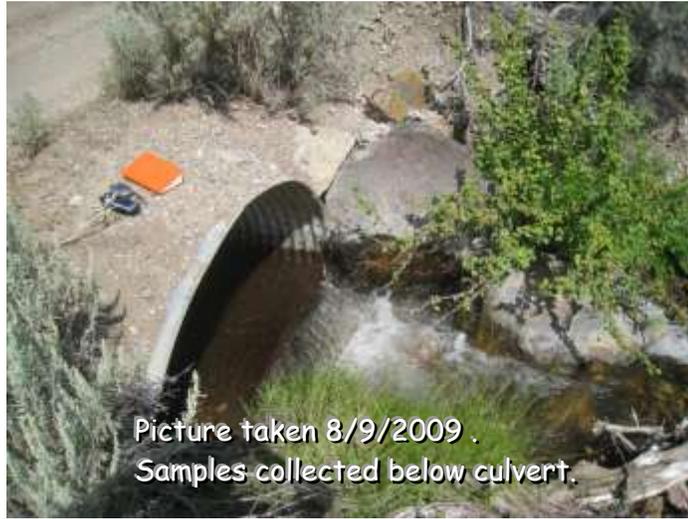
Photo 22

Picture taken 8/9/2009 .
Samples collected below culvert.
