STATE OF IDAHO
DEPARTMENT OF
ENVIRONMENTAL QUALITY

Subject: Site Assessment of the Hoffstetter Mine, Elk City Mining District,
Idaho County, Idaho

ABBREVIATED PRELIMINARY ASSESSMENT

Site Name: Hoffstetter Mine

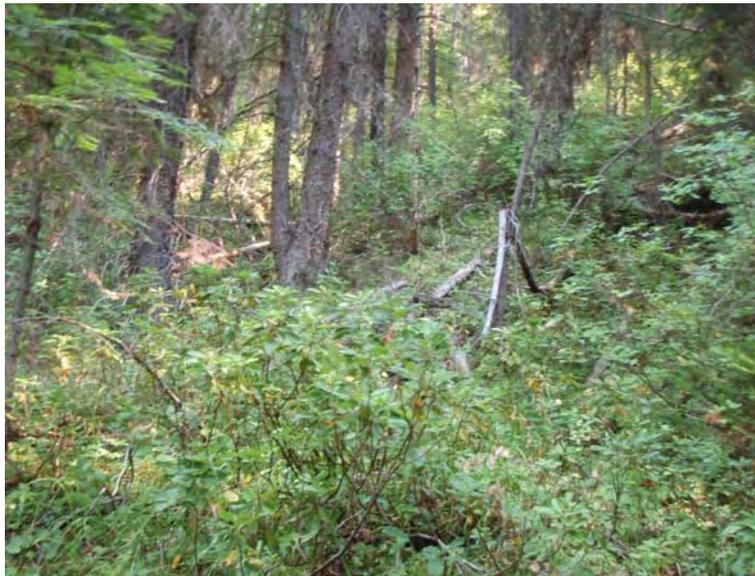
The adits are within 30 feet of each other. Vegetation is well established and healthy. Adits and waste dump are very well vegetated with mature trees such as Douglas fir, white fir, spruce, lodge pole, and duff covering the waste dump.

Photo 1. View of Hoffstetter Mine Adits 1 (right side) and 2 (left side) and surrounding hillside.
Latitude 45.83812°N, Longitude -115.40919°W

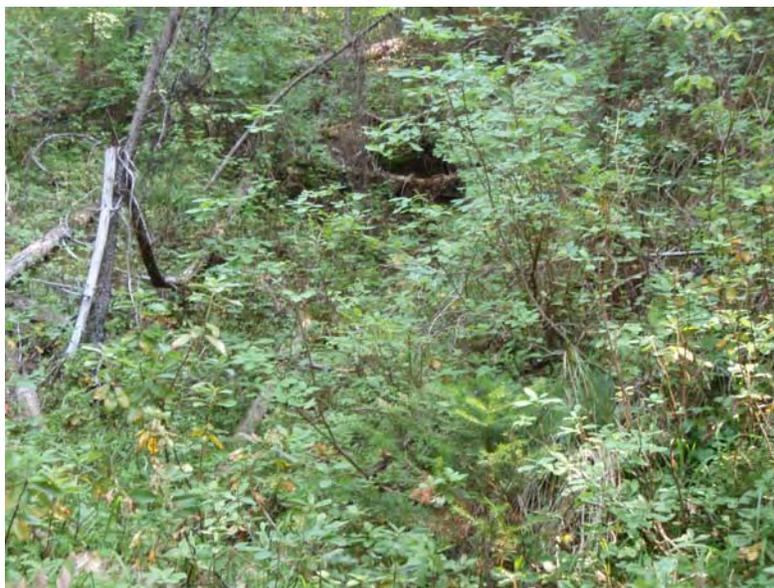
Adit 1 has a black plastic pipe coming out of it with a trickle of water. The adit is collapsed. There is a cabin approximately 100 yards up gradient from the mine.

Photo 2. Hoffstetter Mine Adit 1.

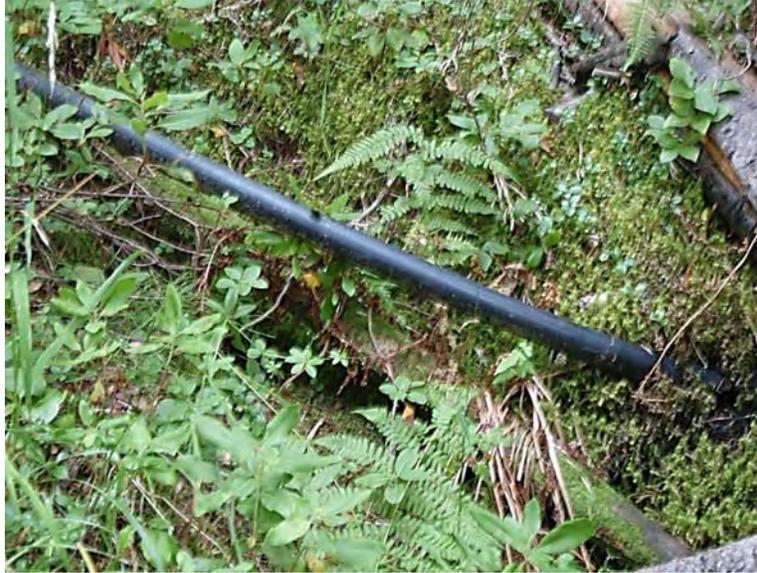
Adit 1 had a plastic pipe exiting it with a trickle of water coming from it. The water goes subsurface within 20 feet. Surface water sample HFAD1SW1 was collected from the pipe for analysis. Sample analysis for surface water sample HFAD1SW1 for total recoverable metals indicated none of the metals concentrations exceeded any of the Idaho water quality standards parameters for ground water, surface water, and aquatic biota. Water chemistry results for the surface water sample taken from Adit 1 are shown in Table 1. Adit 2 had a trickle of water which went subsurface within 10 feet.

Photo 3. Pipe coming from Adit 1.
Surface water sample HFAD1SW1 was taken from this pipe.
Latitude 45.83805°N, Longitude -115.40925°W

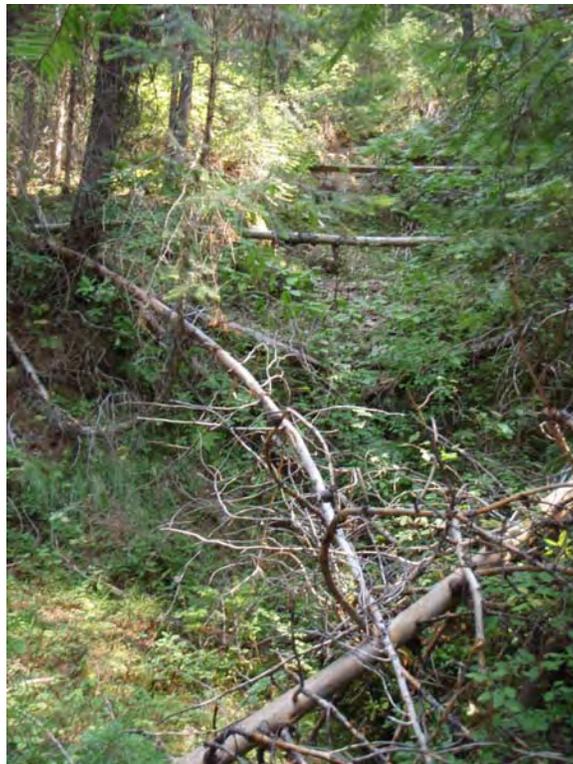
Water was observed trickling from the mouth of Adit 2. The water goes subsurface within 10-15 feet. The adit is collapsed.

Photo 4. Hoffstetter Mine Adit 2.

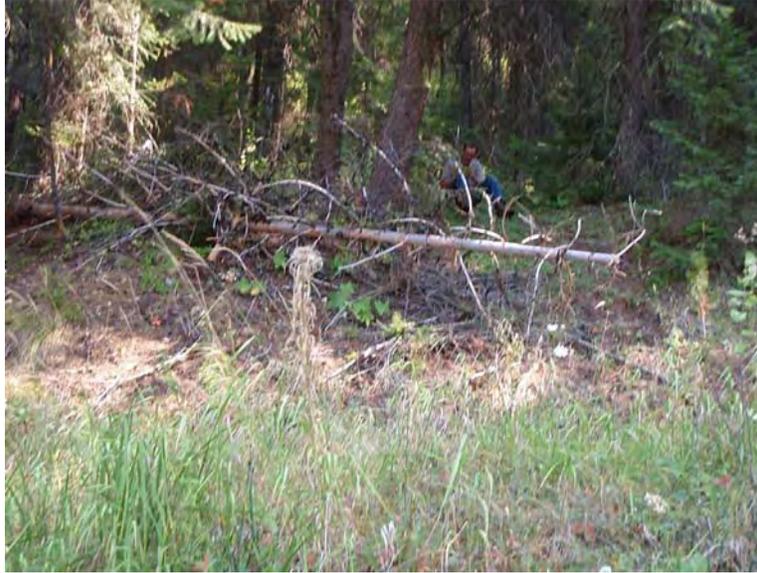
The Hoffstetter Mine waste dump is well vegetated with mature trees (Douglas fir, white fir, spruce, lodge pole) and a healthy layer of duff. The waste dump is composed of country rock where visible with no mineralization evident. The waste dump appears to be a combination from both tunnels. The area of the waste dump measured 50 feet by 12 feet by 8 feet which equals approximately 178 cubic yards of material.

Photo 5. Toe of Hoffstetter Mine waste dump.
