# Blackfoot River Subbasin Assessment and Total Daily Maximum Loads

Addendum

State of Idaho  
Department of Environmental Quality  
October 2012

**Prepared by  
Idaho Department of Environmental Quality  
Pocatello Regional Office  
444 Hospital Way #300  
Pocatello, ID 83201**

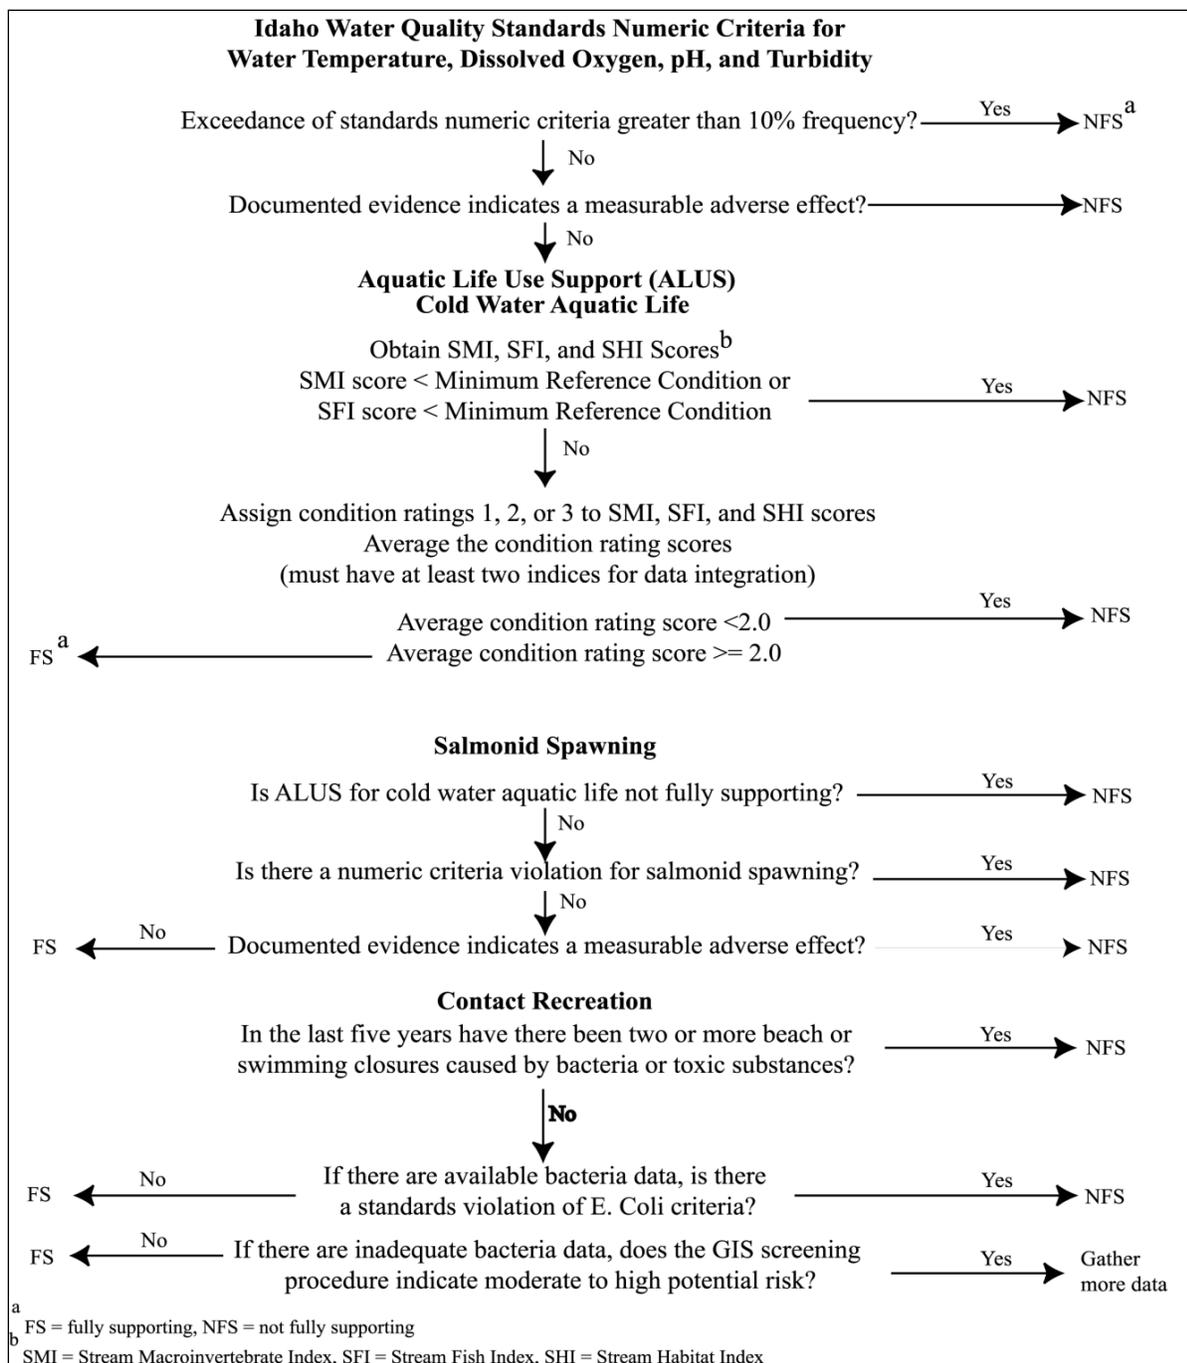
**Figure 1. Steps and criteria for determining support status of beneficial uses in wadeable streams (Grafe et al. 2002).**

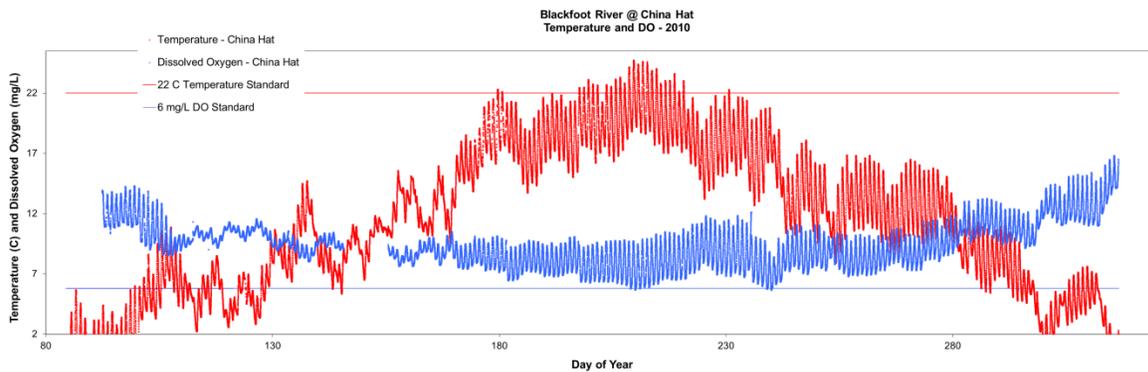
Figure 2 shows the temperature and DO data collected during 2010, a year in which flows in July and August were 88% of normal. Temperature and DO vary daily and seasonally. The graph illustrates the inverse relationship of water temperature and DO concentration. Figure 2 shows in 2010, exceedance of the minimum DO standard occurred primarily during July and August, which is also the case for all years in which DO exceedances occurred.

**Figure 2. Blackfoot River temperature and dissolved oxygen levels in 2010.**

In 2010, the water temperature standard was exceeded on 23 days, and there were exceedances of the DO standard on 7 days (Figure 2). On the upper Blackfoot River, the only anthropogenic cause that has been identified for reduced DO levels is elevated temperature due to shade reduction along the river. Neither excess nutrients nor surplus aquatic vegetation have been found in the main stem river. As shown in Table 14, reduced flow in dry years does result in increased temperatures and decreased DO because of diminished assimilative capacity. In 2007,

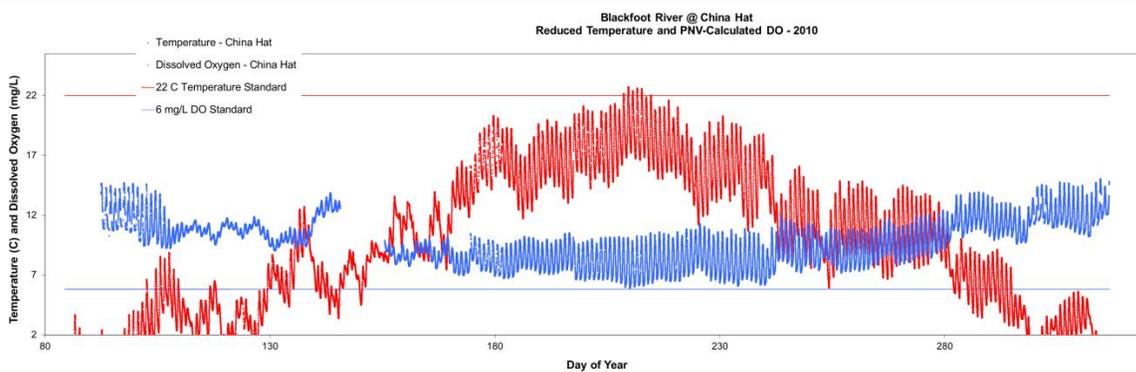
Figure 3 shows the projected effects of a 2 °C reduction in water temperature that might result from implementing the temperature TMDL. In this simulation, the temperature-oxygen solubility relationship is used to calculate new DO levels from the 2 °C reduction in water temperatures. These calculations suggest that the number of days the DO standard would be exceeded would drop from 7 to 1 and that the minimum DO values during those exceedances would go from 5.6 to 5.9 mg/L.

**Figure 3. Recalculated dissolved oxygen levels based on 2 °C temperature reduction.**

This simulation takes into account only the explicit relationship between temperature and oxygen saturation potential and thus, minimizes the corresponding positive change in DO levels. In the field, actual improvements in DO arising from a similar decrease in temperature are likely to be greater because of increased shading and corresponding changes that will likely decrease photosynthesis and respiration rates. In addition, bank stabilization associated with implementing temperature TMDL will improve riparian habitat and move the river toward more allochthonous inputs, thus improving metabolic dynamics.

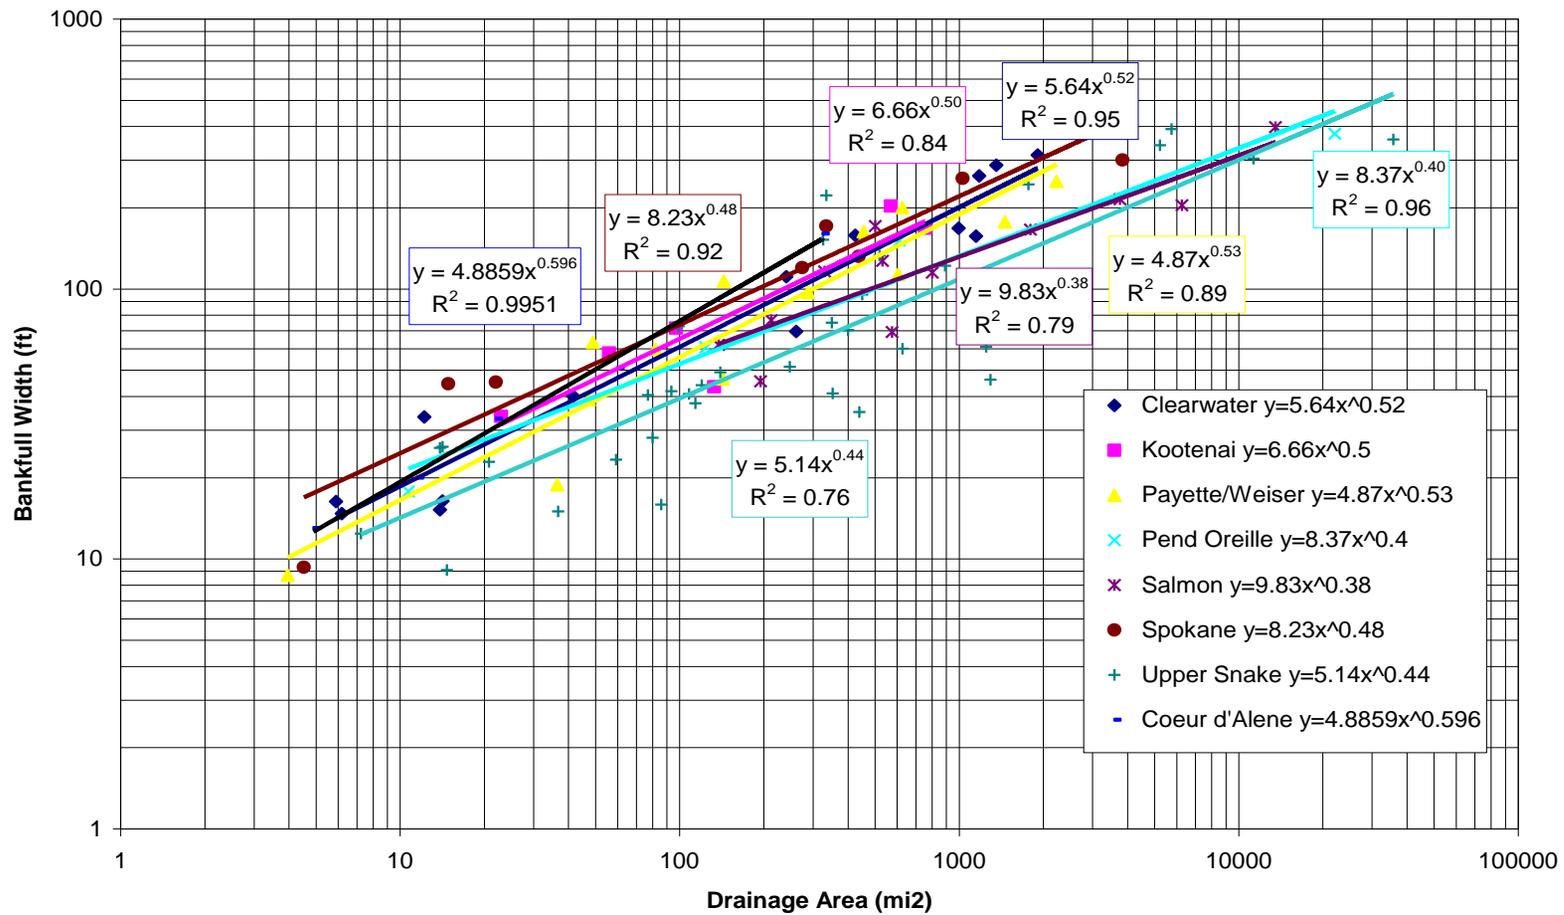
Idaho Regional Curves - Bankfull Width

This natural width factor (i.e., near stream disturbance zone or bank-full width) may not be known or discernible from the aerial photo work described previously. Accordingly, this parameter must be estimated from available information. DEQ uses regional curves for the major basins in Idaho and data compiled by Diane Hopster, Idaho Department of Lands, to estimate natural bank-full width (Figure 4).

Figure 4. Bank-full width as a function of drainage area.

For each stream evaluated in the load analysis, natural bank-full width is estimated based on drainage area of the Upper Snake Basin regional curve from Figure 4 (Table 16). Although estimates from other curves could be examined, the Upper Snake Basin regional curve was ultimately chosen because of its proximity to and inclusion of the Blackfoot River subbasin. Additionally, existing width data should be evaluated and compared to these curve estimates if such data are available. However, for the upper Blackfoot River subbasin only a few BURP sites exist, and bank-full width data from those sites represent only spot data (three measured widths in a reach only several hundred meters long) that are not always representative of the stream as a whole. DEQ measured channel widths at various locations along the upper Blackfoot River using aerial photographs from the ArcGIS mapping system. In general, DEQ found aerial photo width measurements to be smaller than the bank-full width estimates from the Upper Snake Basin regional curve and chose not to make natural widths any larger than these aerial photo estimates. The load analysis tables contain a natural bank-full width and an existing bank-full width for every stream segment in the analysis based on the bank-full width results presented in Table 16.

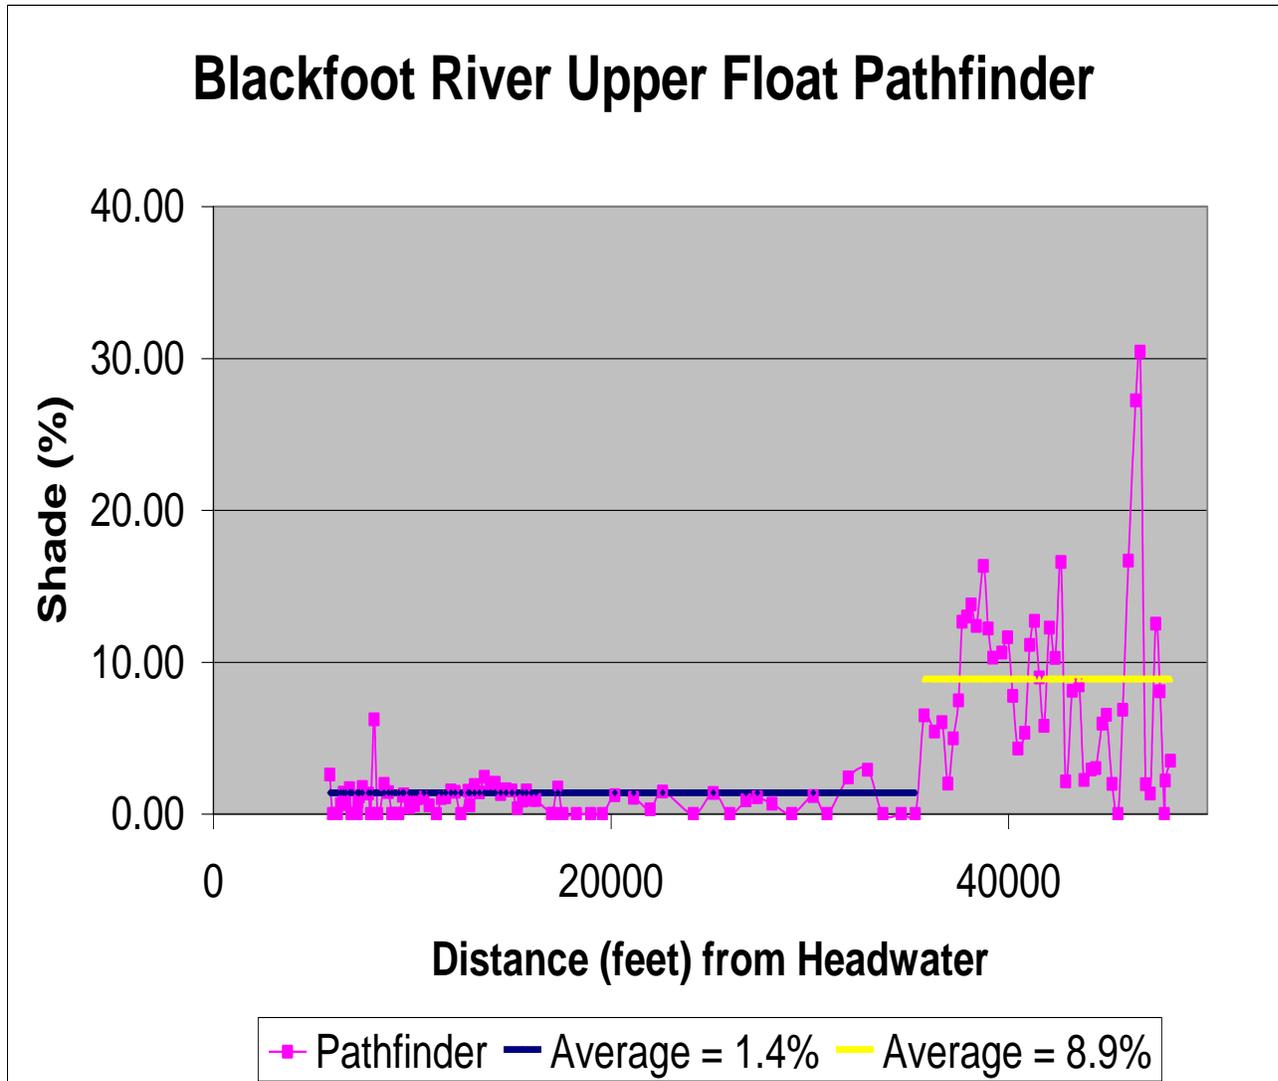
Figure 5. Solar Pathfinder shade measurements from Diamond /Lanes Creek confluence to Slug Creek bridge.

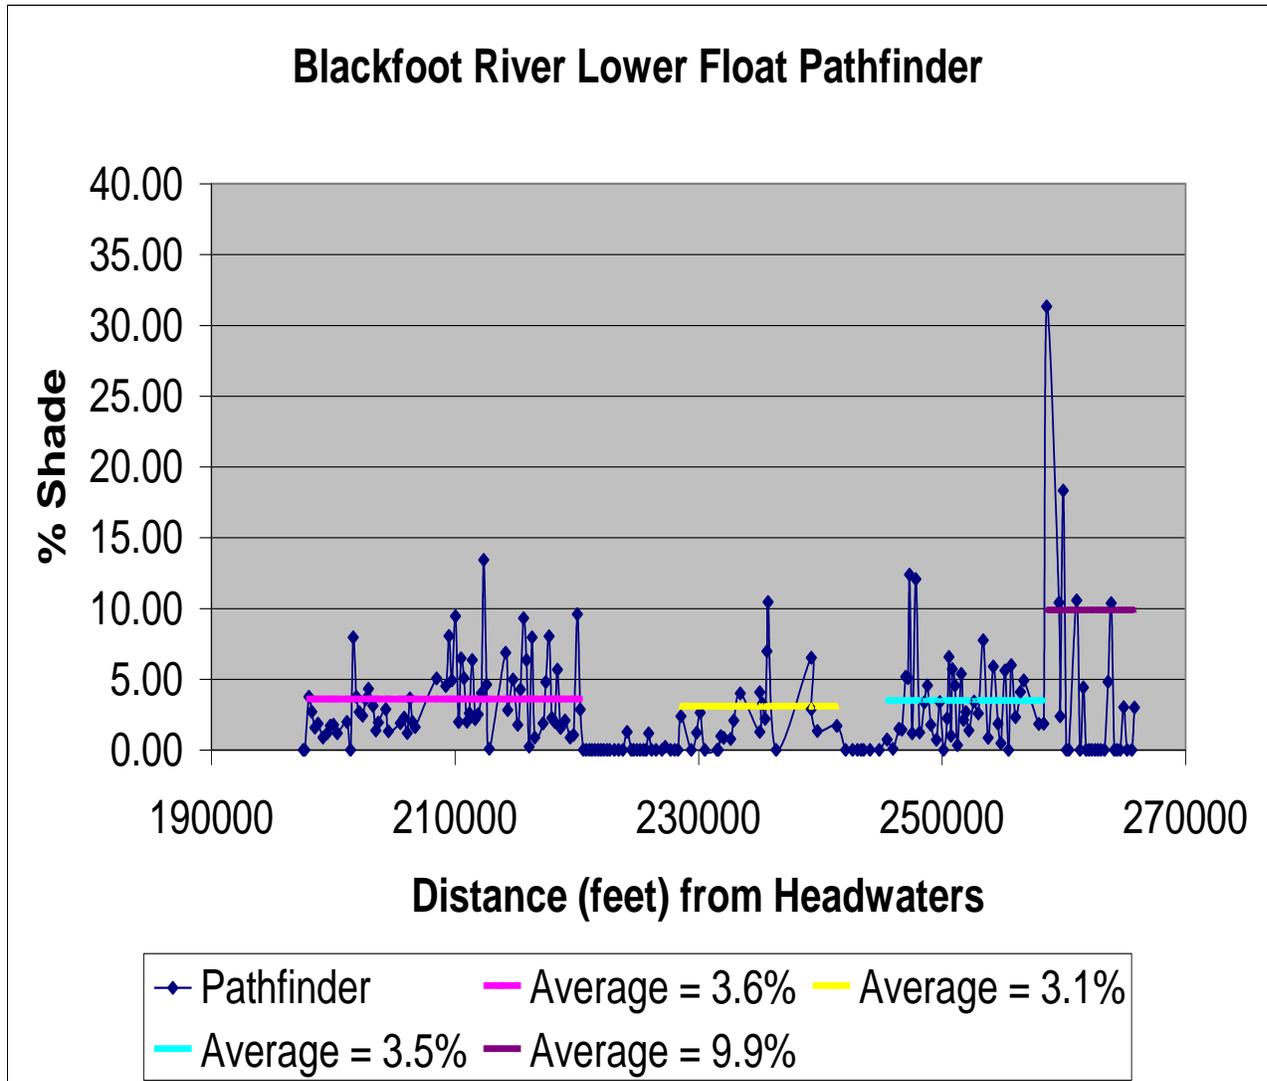
The lower region receiving Solar Pathfinder measurements begins at about 37.4 miles from the headwaters (Figure 6). Here, shade levels averaged 3.6% until mile mark 41.7 where the shade levels were not recorded again until mile 43.3. Shade decreased slightly at this point to an average of 3.1%. After another small gap in data recording, shade was again measured at 3.5% from mile 46.5 to mile 48.9. At about 49 miles downstream, shade levels increased again to an average of 9.9%. In the load analysis, these existing shade levels are rounded to the nearest whole number.

Figure 6. Solar Pathfinder shade measurements from Fox Hills Ranch to Blackfoot Reservoir.

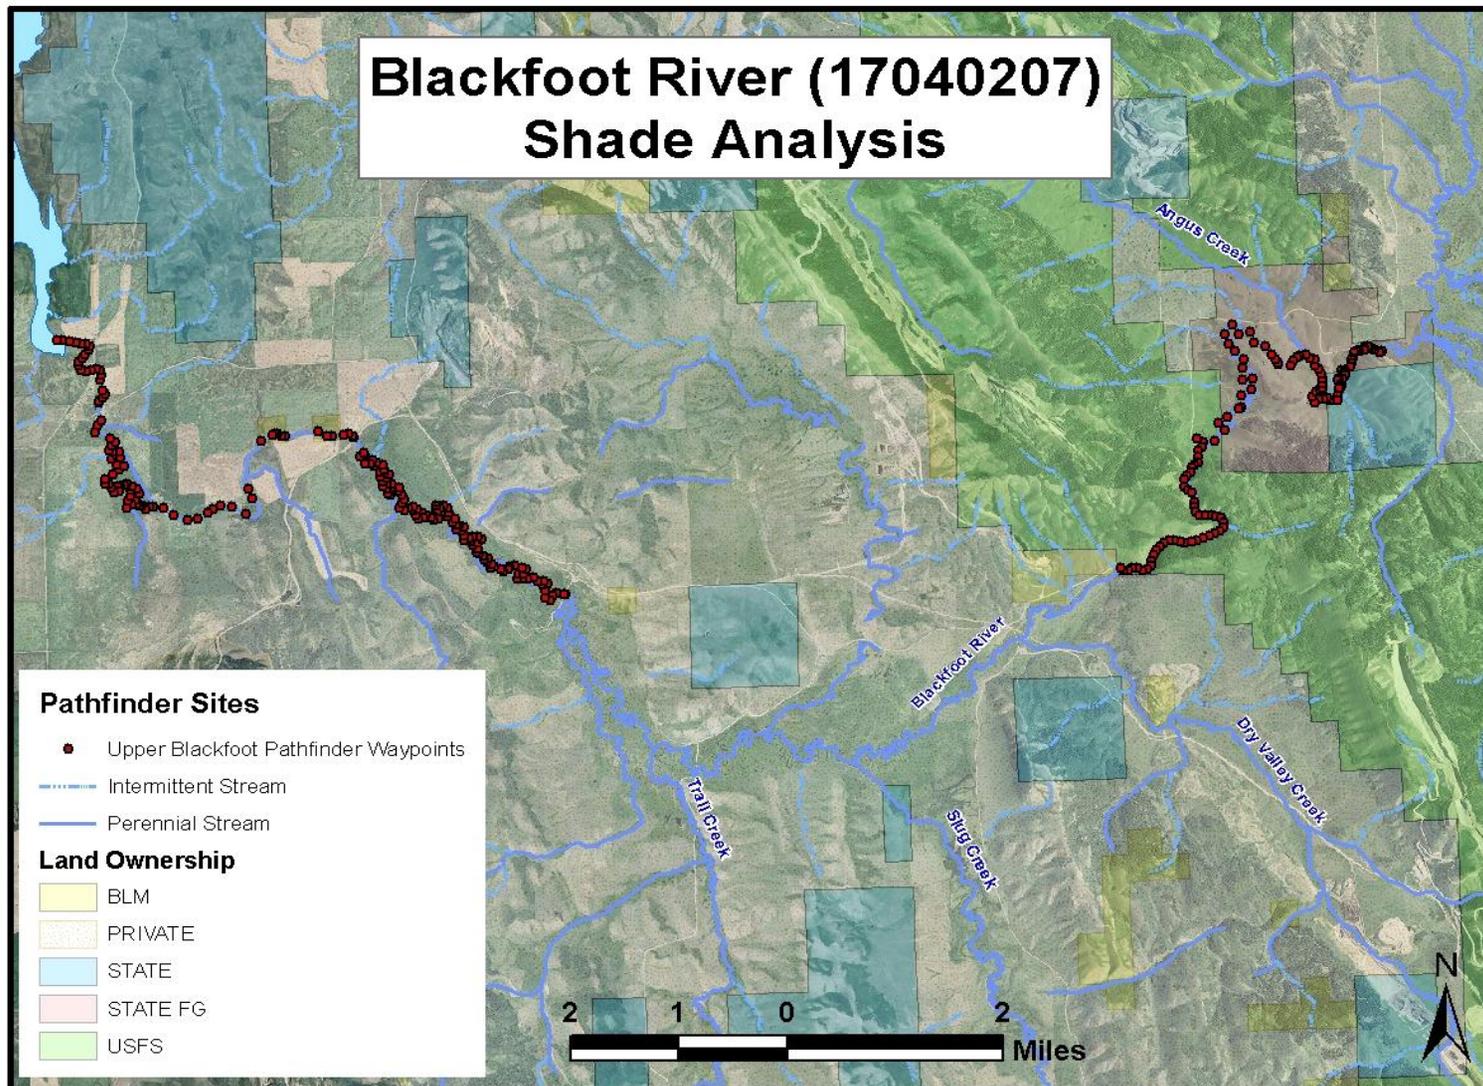
The small gaps described above and the middle portion of the upper Blackfoot River under examination did not receive Solar Pathfinder measurements (Figure 7). Existing shade in these areas required aerial photo interpretation where shade levels are estimated to the 10% shade class. In this case, interpreted shade levels were assumed to be within the 0%–9.9% class interval. The accuracy of the aerial photo interpretations was field verified by comparing the Solar Pathfinder measurements made above and below this middle segment of the river.

Figure 7. Location of Solar Pathfinder measurements for the upper Blackfoot River.

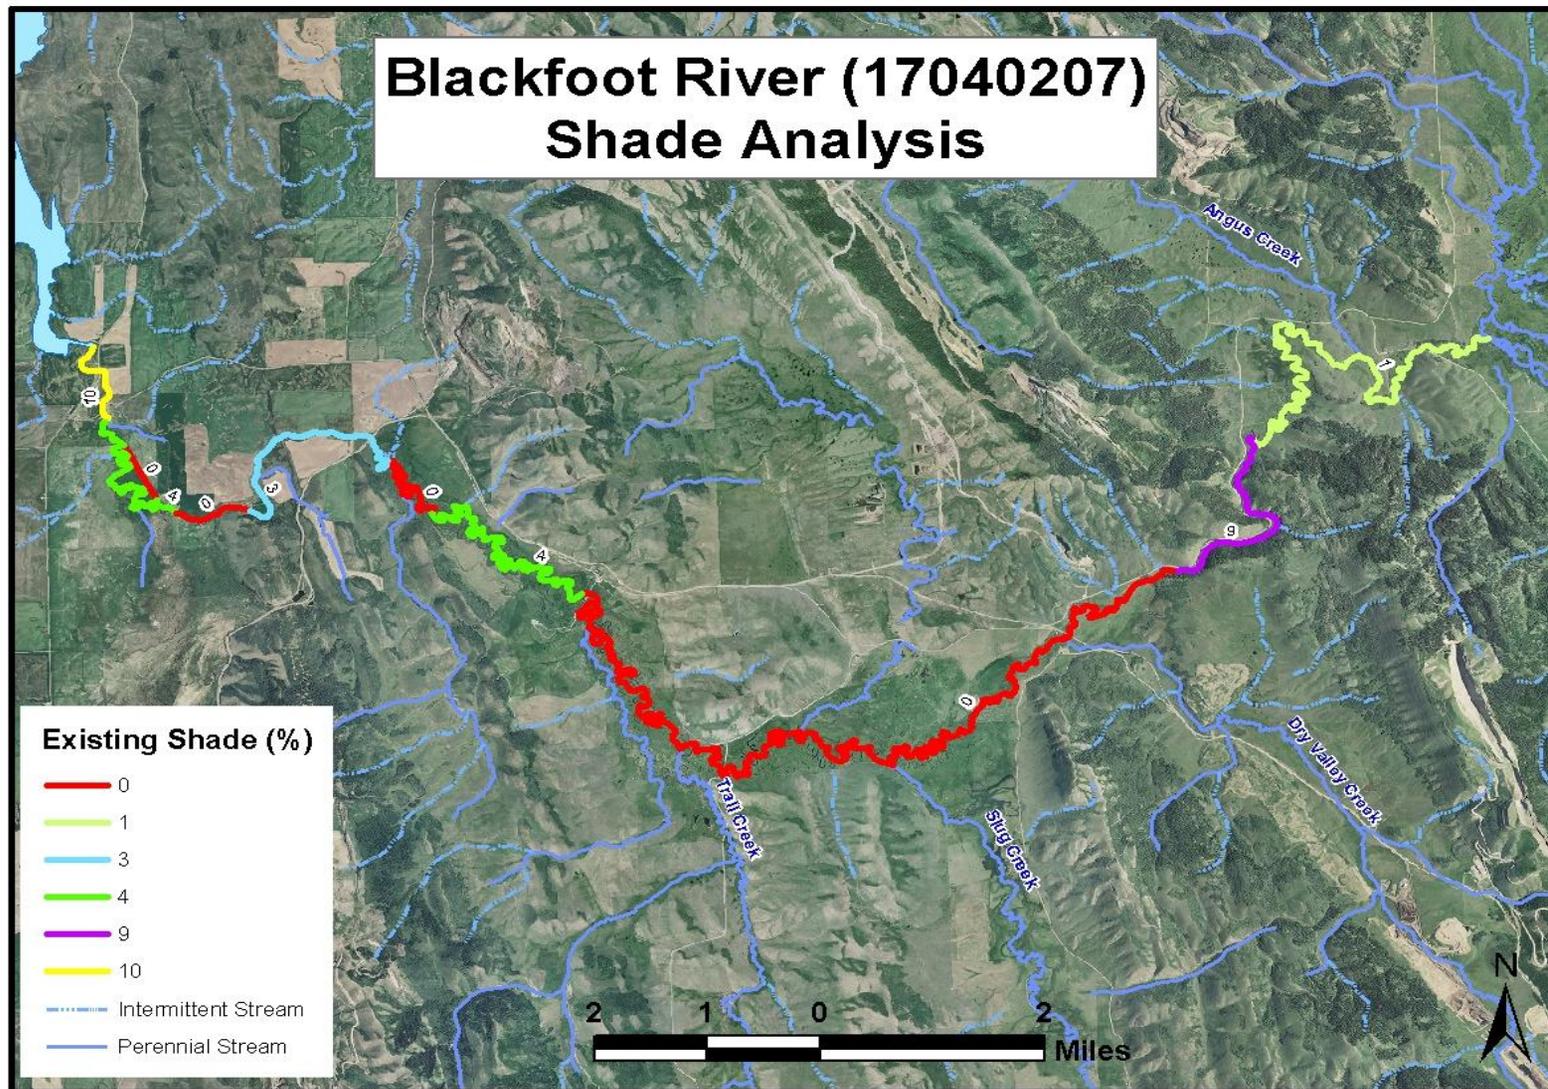
Figure 8. Existing shade estimated for the upper Blackfoot River by Solar Pathfinder measurements and aerial photo interpretation.

Effective shade monitoring can take place on any reach throughout the upper Blackfoot River and be compared to estimates of existing shade as seen on Figure 8 and described in Table 17. Those areas with the largest disparity between existing shade estimates and shade targets should be monitored with Solar Pathfinders to verify the existing shade levels and to determine progress towards meeting shade targets. Note that many existing shade estimates have not been field verified and may require adjustment during the implementation process. Stream segments for each change in existing shade vary in length depending on land use or landscape that has affected that shade level. It is appropriate to monitor within a given existing shade segment to see if that segment has increased its existing shade towards target levels. Ten equally spaced Solar Pathfinder measurements within that segment averaged together should suffice to determine new shade levels in the future.

Average existing shade on the upper Blackfoot River generally varies from 1% to 4% (Figure 8). In “The Narrows” region and again close to the reservoir, topography helps raise that existing shade to 9%–10%. The middle region and several smaller areas, where no Solar Pathfinder data were collected, were placed in the 0% shade class (0%–9.9%) consistent with Solar Pathfinder results from the rest of the river. Target shade for the river, based on the Geyer willow/sedge community type, varies from 17% to 24% depending on channel width (Figure 9). Thus, the river generally lacks most of the desired shade needed to maintain natural temperatures. However, due to the large channel widths, the lack of shade results in only a 16% increase in solar load.

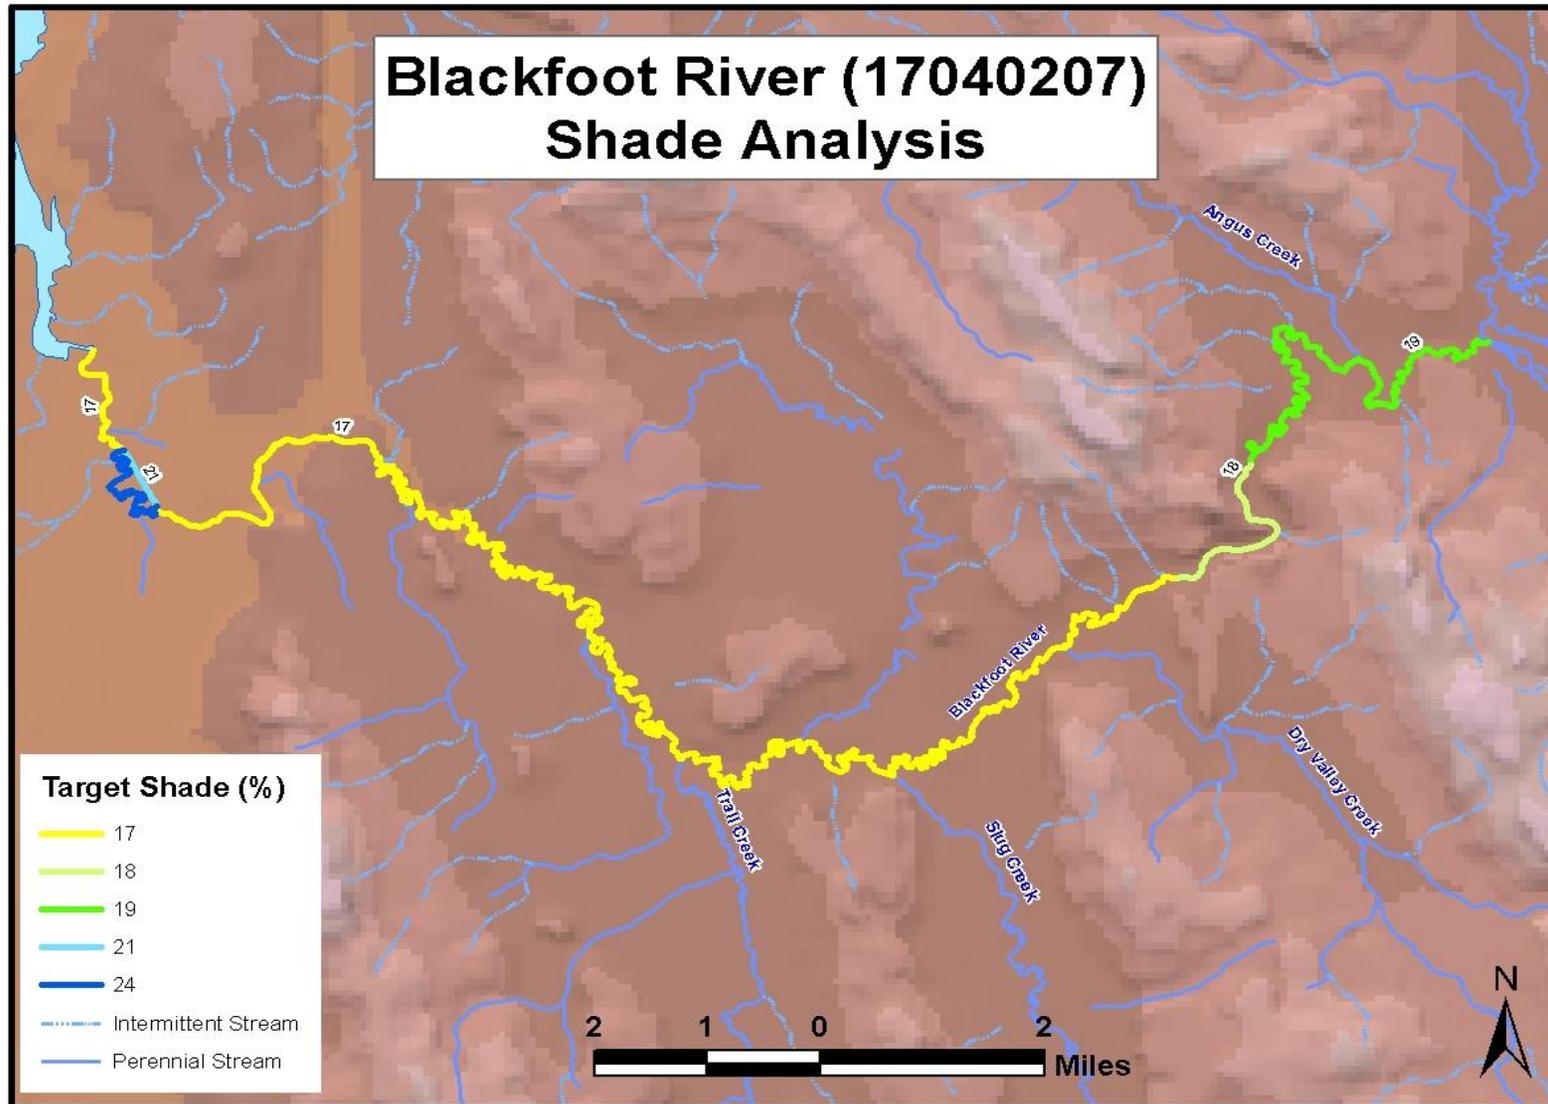
Figure 9. Target shade for the upper Blackfoot River.

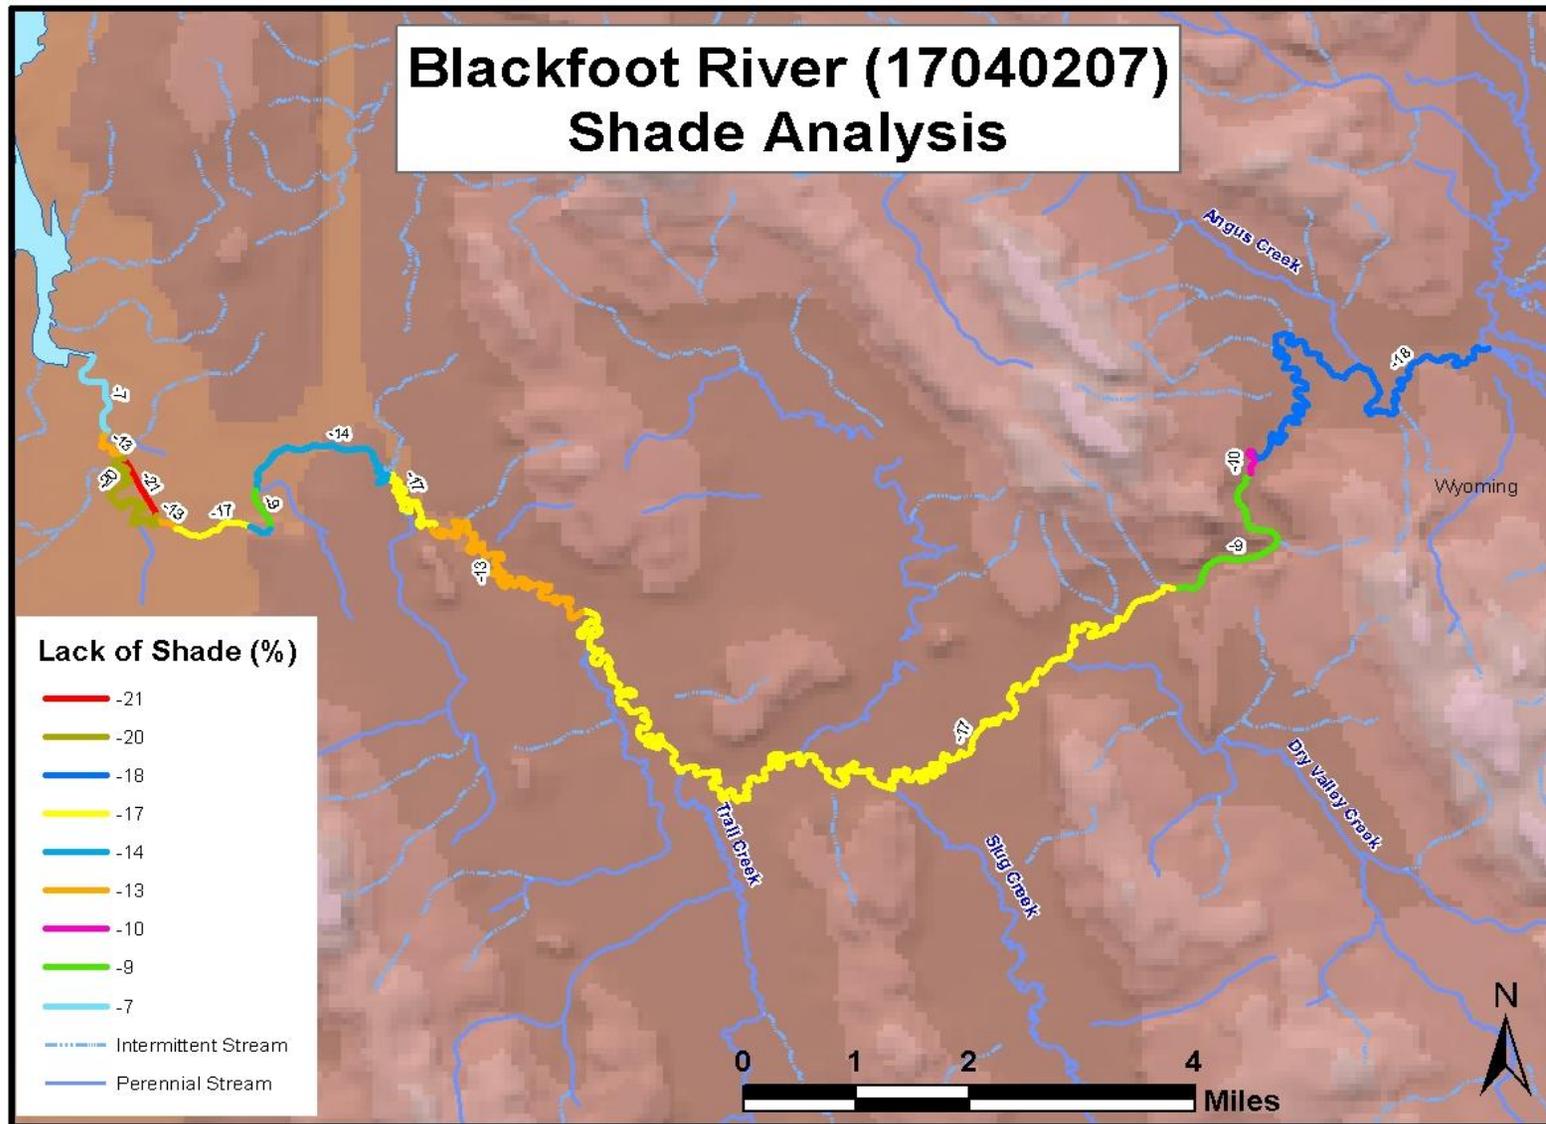
Figure 10. Lack of shade (difference between existing and target) for the upper Blackfoot River.

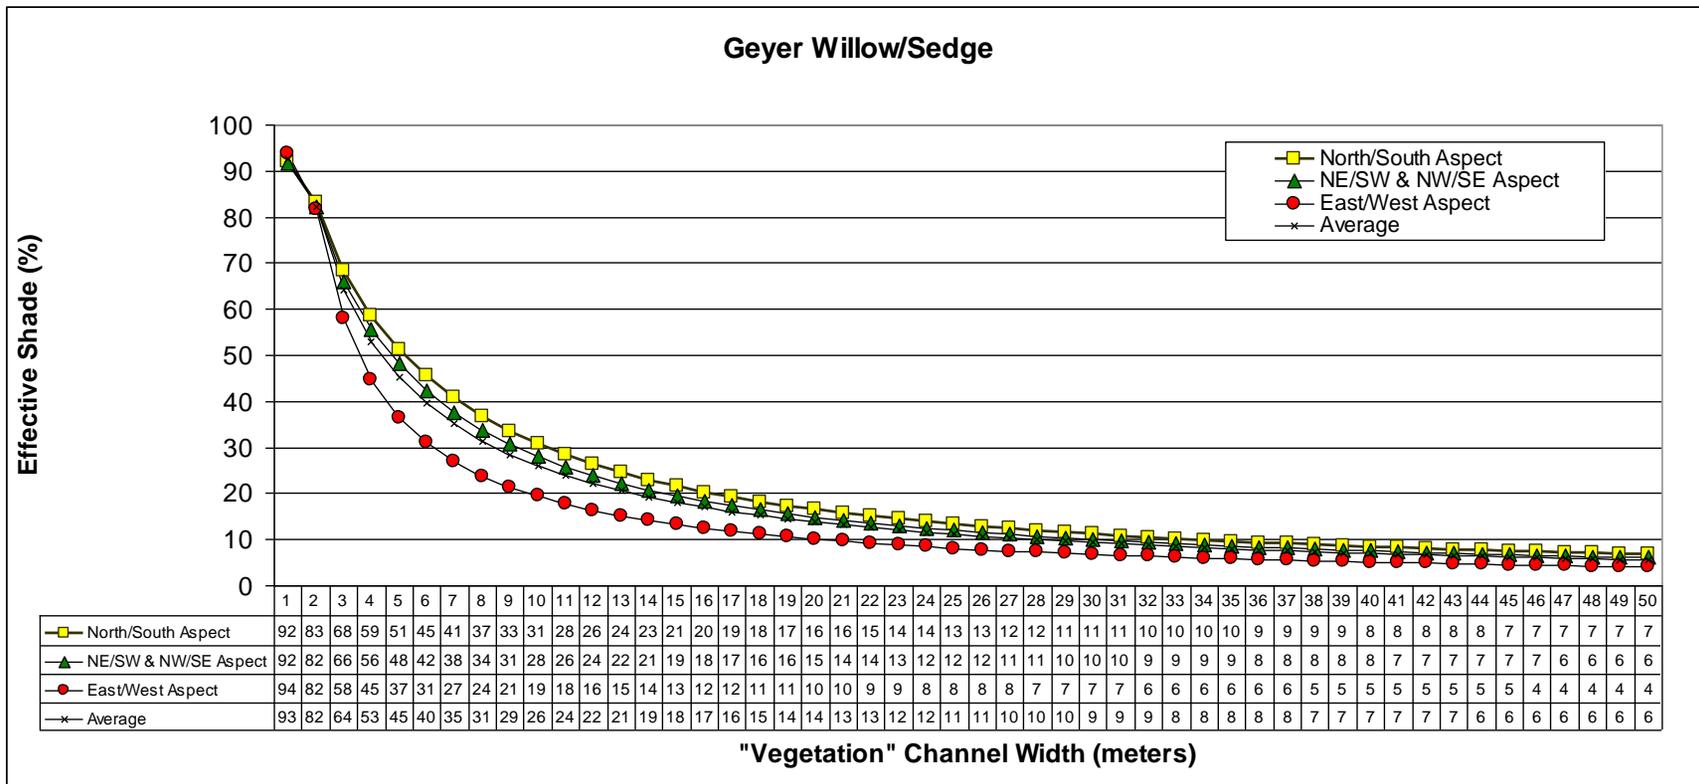
Figure C-1. Shade curve for the Geyer willow/sedge community vegetation type.

The Geyer willow/sedge community shade curve is based on information provided by Hansen and Hall's (2002) *Classification and Management of BLM's Riparian and Wetland Sites in Eastern and Southern Idaho*. Hansen and Hall (2002) describe a Geyer willow (*Salix geyeriana*)/beaked sedge (*Carex rostrata*) habitat type, ranging in elevation from 5,200 to 7,200 feet and occupying broad, level floodplains of riverine systems, or it may be found in narrow bands along smaller streams in open, U-shaped canyons. Geyer willow habitat types occupy intermediate elevations between Drummond's willow (*Salix drummondiana*) types at higher elevations and lower elevation communities dominated by yellow willow (*Salix lutea*). Geyer willow and Booth's willow (*Salix boothii*) dominate the overstory shrub layer of the Geyer willow/beaked sedge habitat type, although both species may not be present on all sites. Other subordinate shrub species may include mountain alder (*Alnus incana*), sandbar willow (*Salix exigua*), and Drummond's willow. The understory is dominated by sedges (*Carex* sp.), and there may be a variety of forbs present. The shade curve (Figure C-1, Appendix C) is based on a community comprised mostly of Geyer willow (50%) and Booth's willow (39%) with smaller amounts of Drummond's willow (6%), planeleaf willow (*Salix planifolia*) (3%), sandbar willow (1%), bog birch (*Betula glandulosa*) (1%), and quaking aspen (*Populus tremuloides*) (0.1%) (Shumar and De Varona 2009).

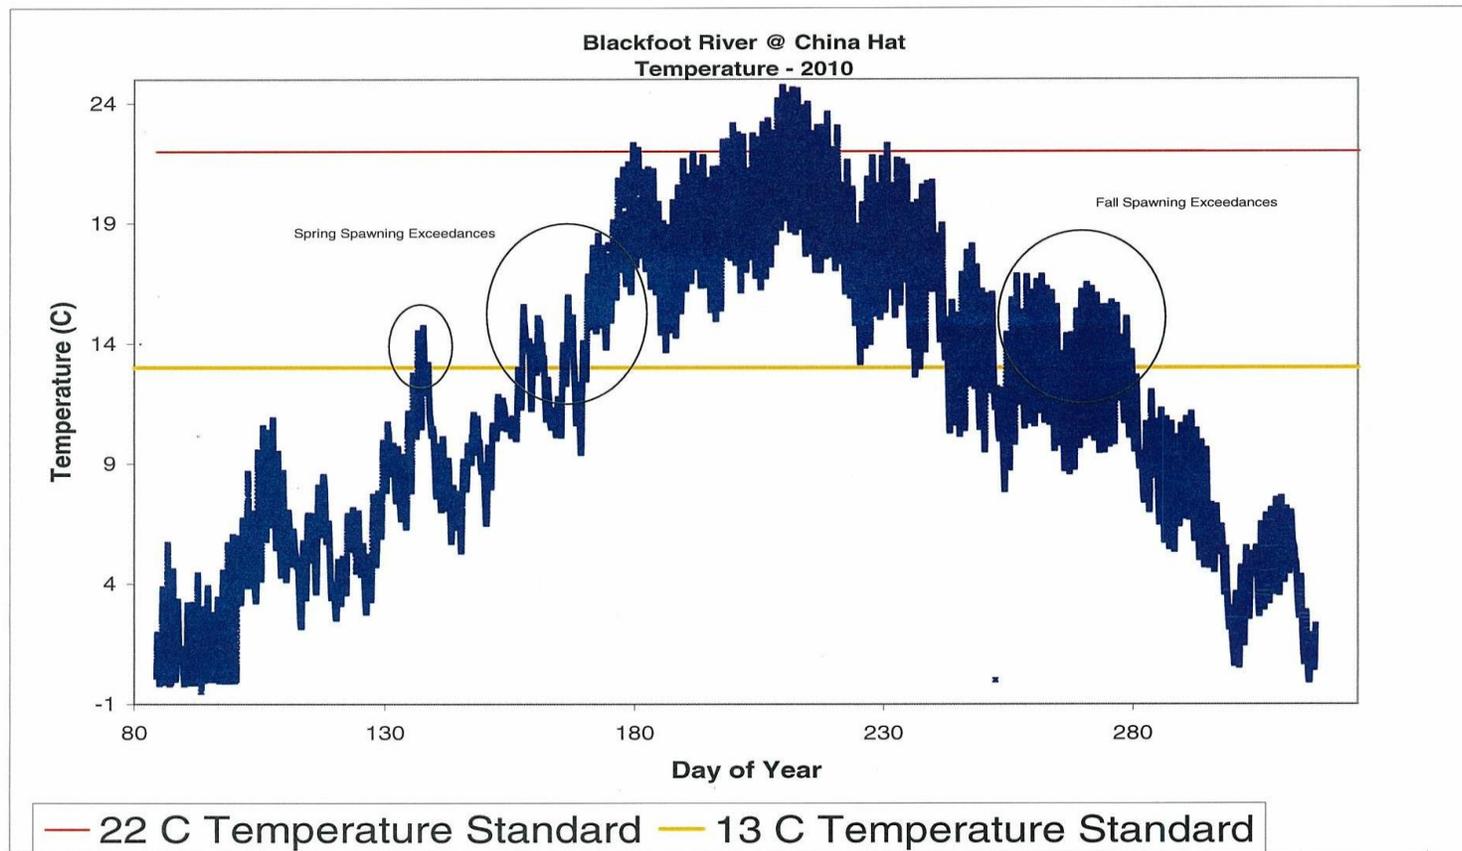
Figure C-2. Temperature data for the Blackfoot River at China Hat Bridge in 2010.

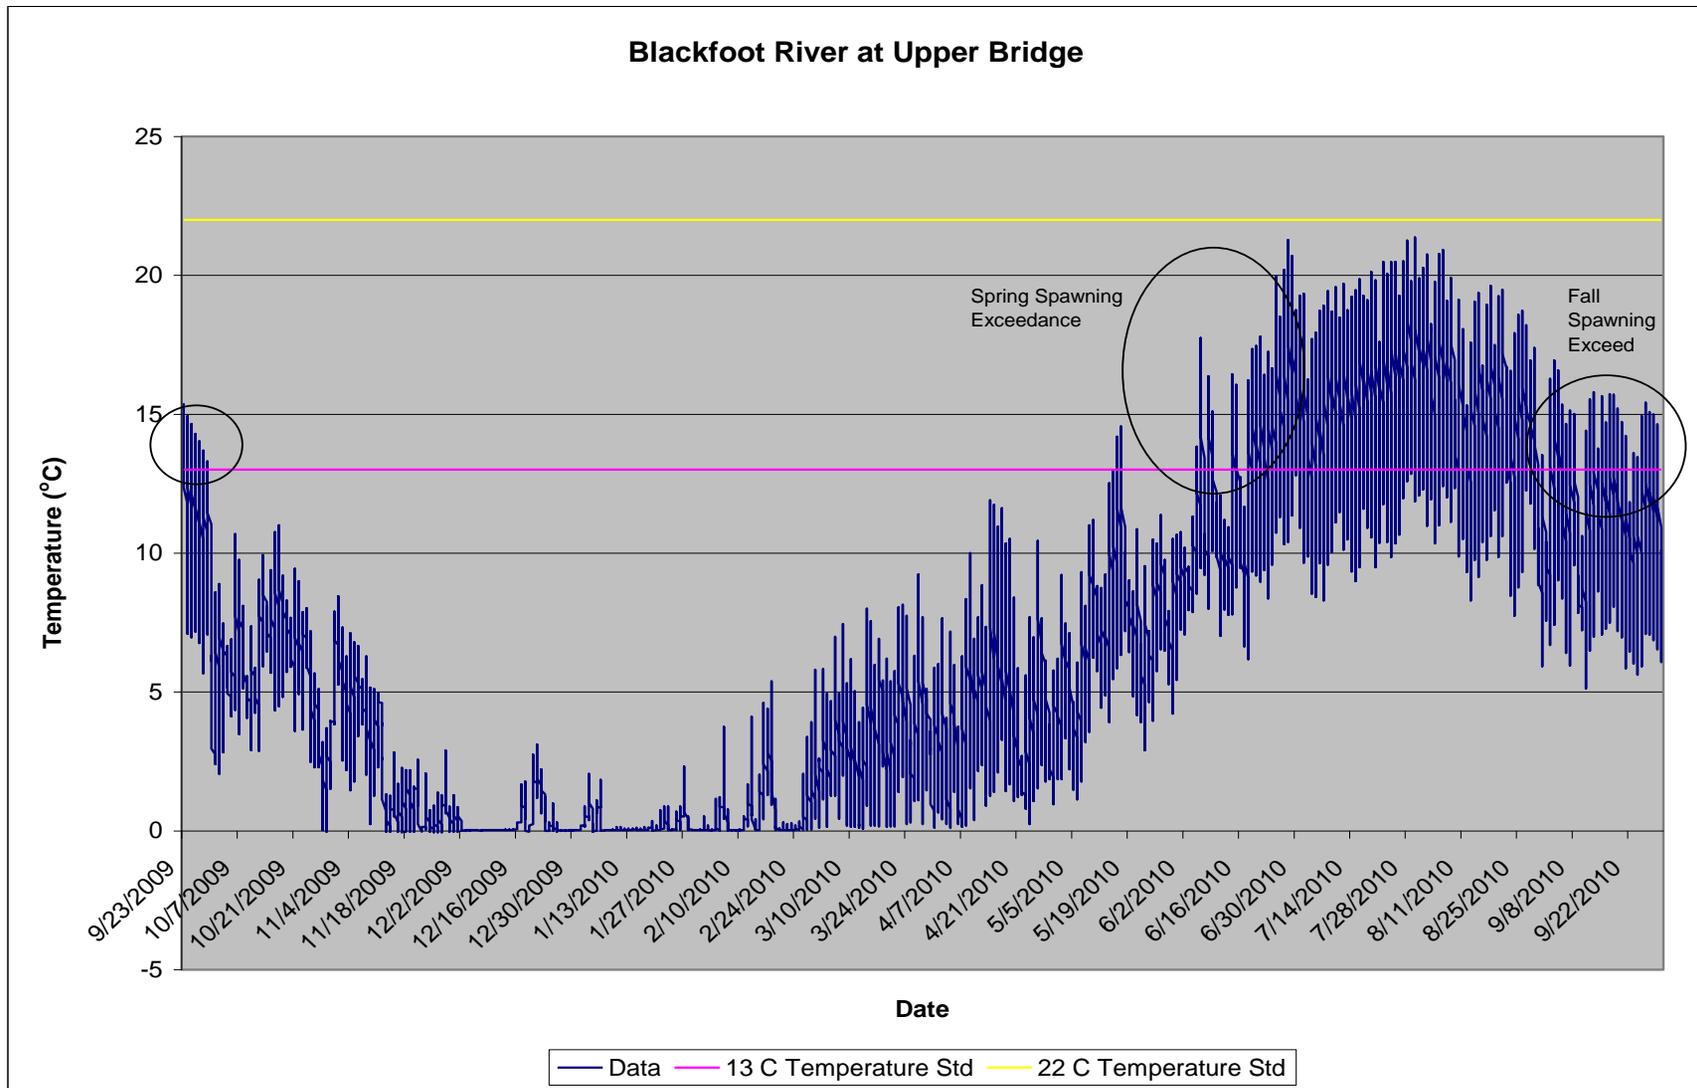
Figure C-3. Temperature data for the Blackfoot River at Upper Bridge in 2009–2010.

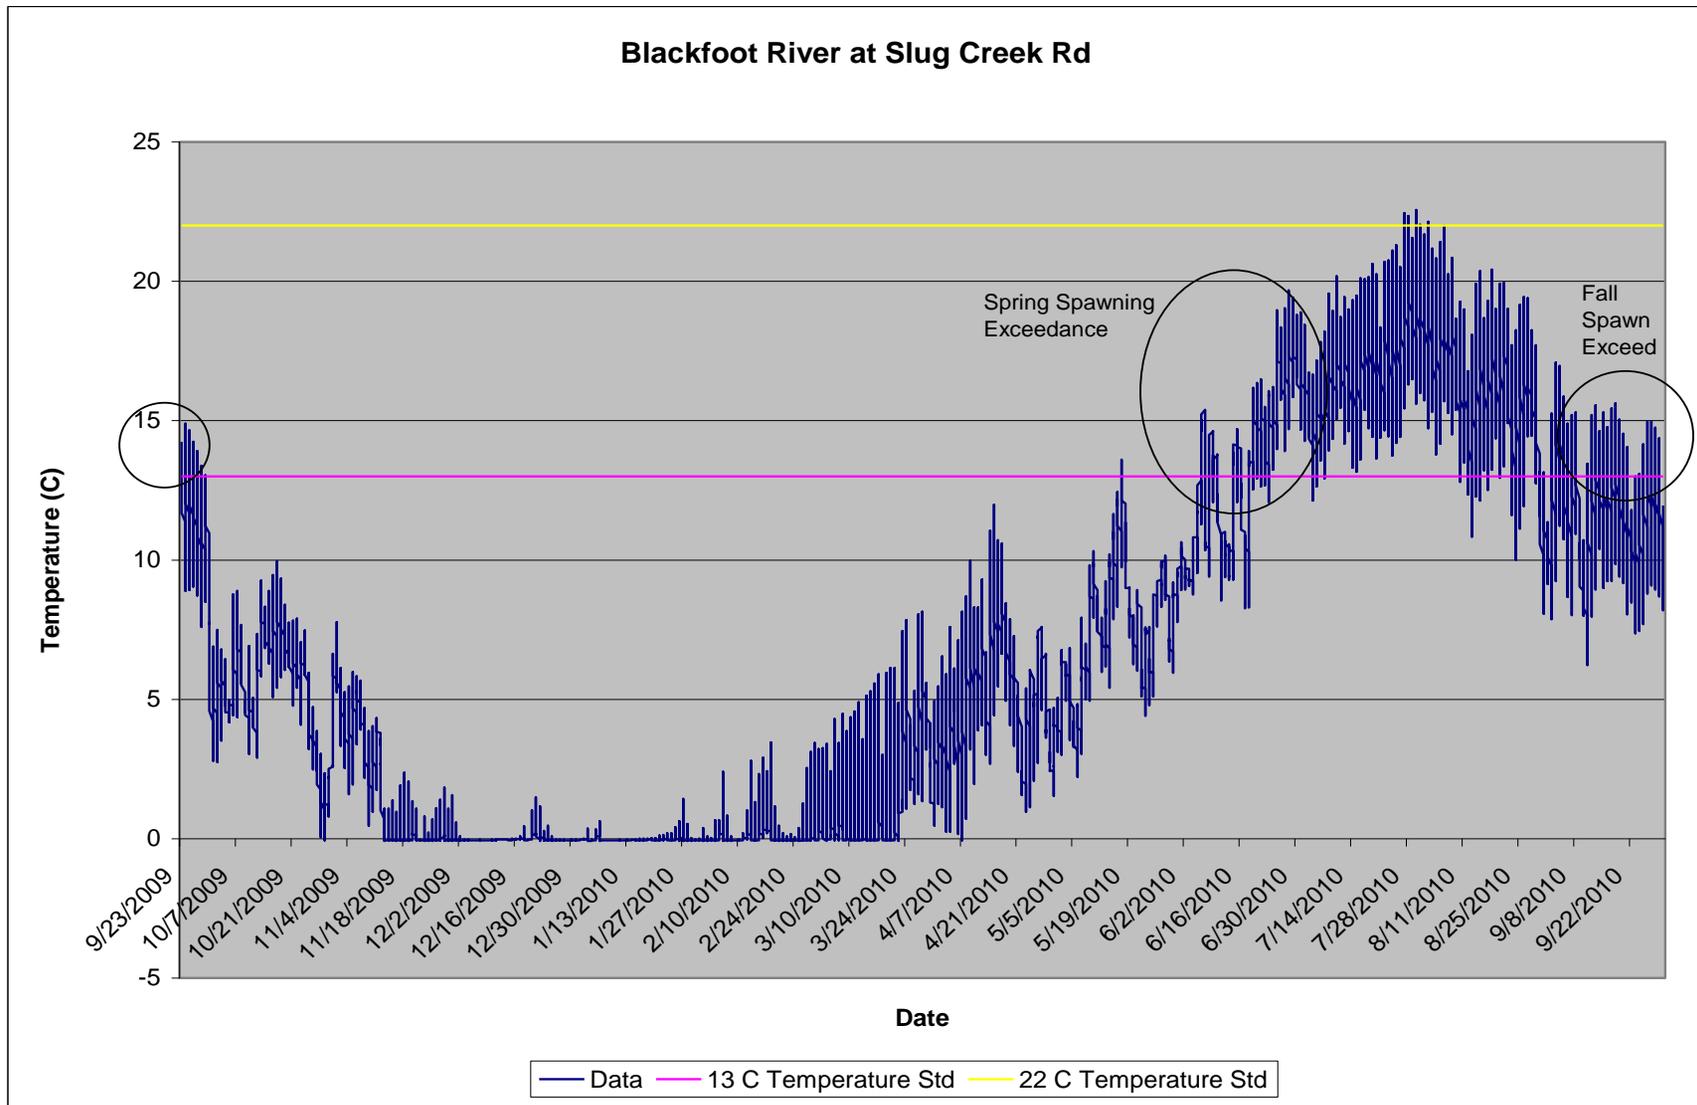
Figure C-4. Temperature data for the Blackfoot River at Slug Creek Road in 2009–2010.
