# Blackfoot River Subbasin Assessment and Total Daily Maximum Loads

Addendum

State of Idaho  
Department of Environmental Quality  
October 2012

**Prepared by  
Idaho Department of Environmental Quality  
Pocatello Regional Office  
444 Hospital Way #300  
Pocatello, ID 83201**

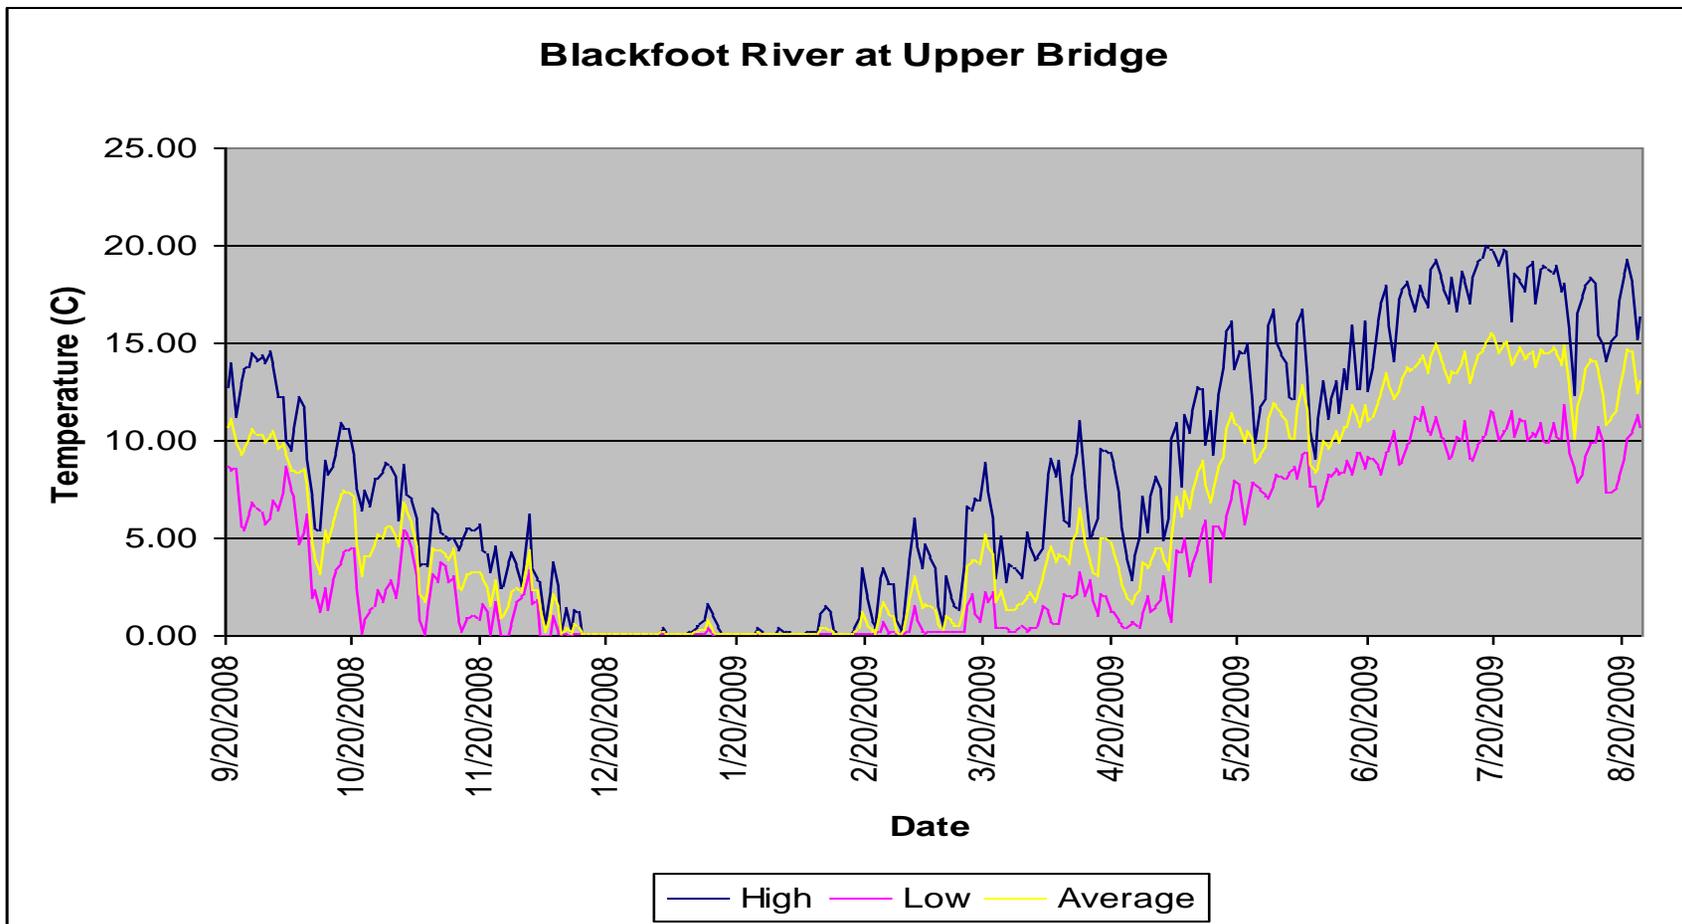
Figure C-5. Temperature data for the Blackfoot River at Upper Bridge in 2008–2009.
