# **Abbreviated Preliminary Assessment for Hornet Mine (aka Hornet Lode)**

Idaho County

**State of Idaho  
Department of Environmental Quality**

**November 2012**

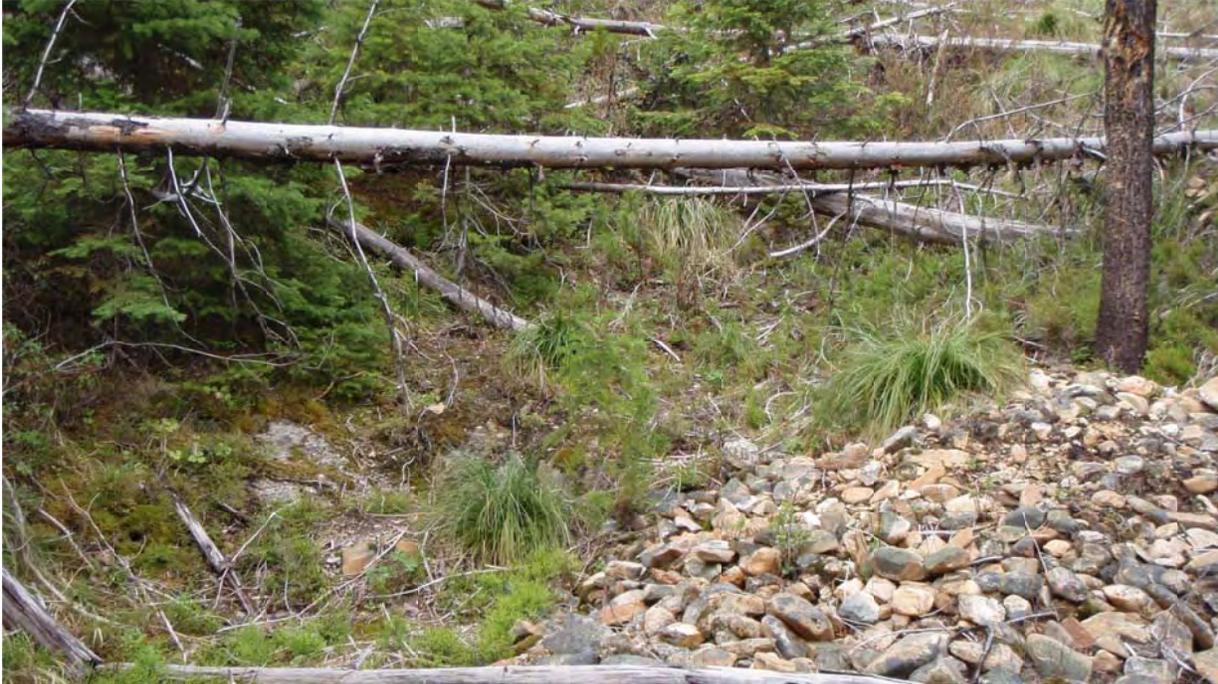
This site is very small, with one collapsed adit and a small dump. The dump is about 25 feet long, 10 feet wide, and 10 feet thick, and is covered mostly with stream cobbles and boulders. The source of the gravels was not determined. The total disturbed area at this site is less than 0.1 acre.

All of the Hornet Mine photographs in this section were taken by DEQ on May 29, 2012. Photo 1 is looking uphill at the Hornet Mine collapsed adit and part of the tailings/waste pile.

**Photo 1. Hornet Mine collapsed adit and part of the tailings/waste pile.**

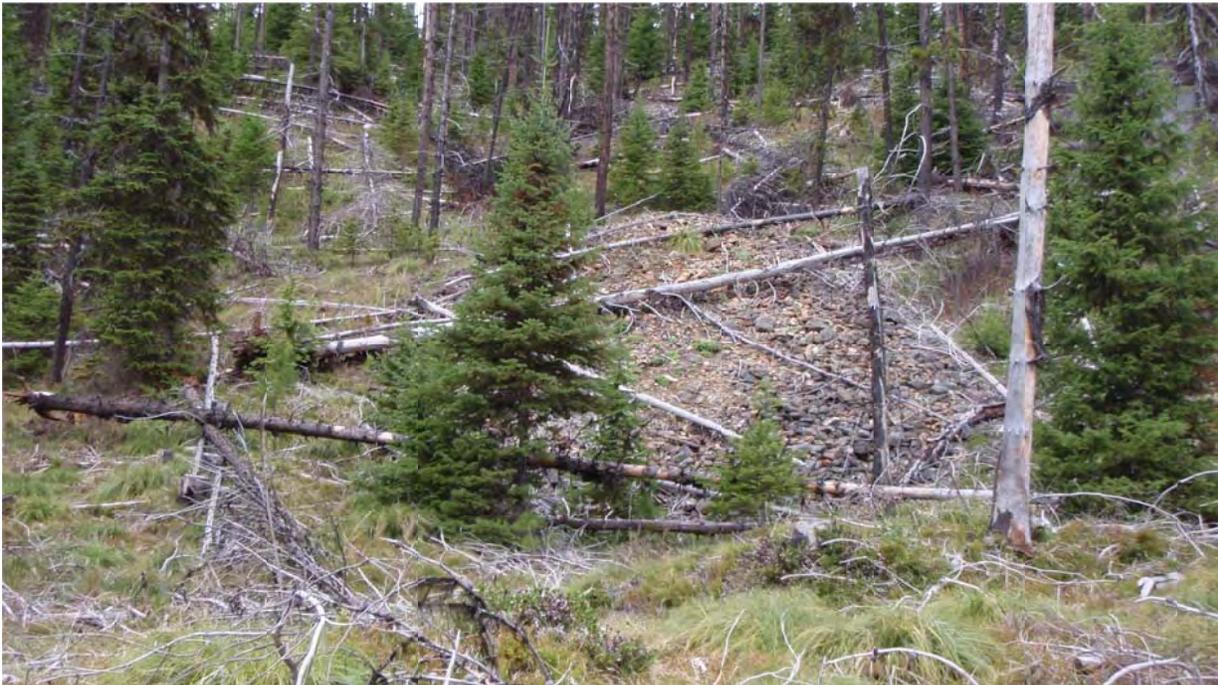
The Hornet Mine area is well vegetated and shows no sign of vegetation stress. Photo 2 is looking uphill at the Hornet Mine tailings/waste pile.

**Photo 2. Hornet Mine tailings/waste pile.**

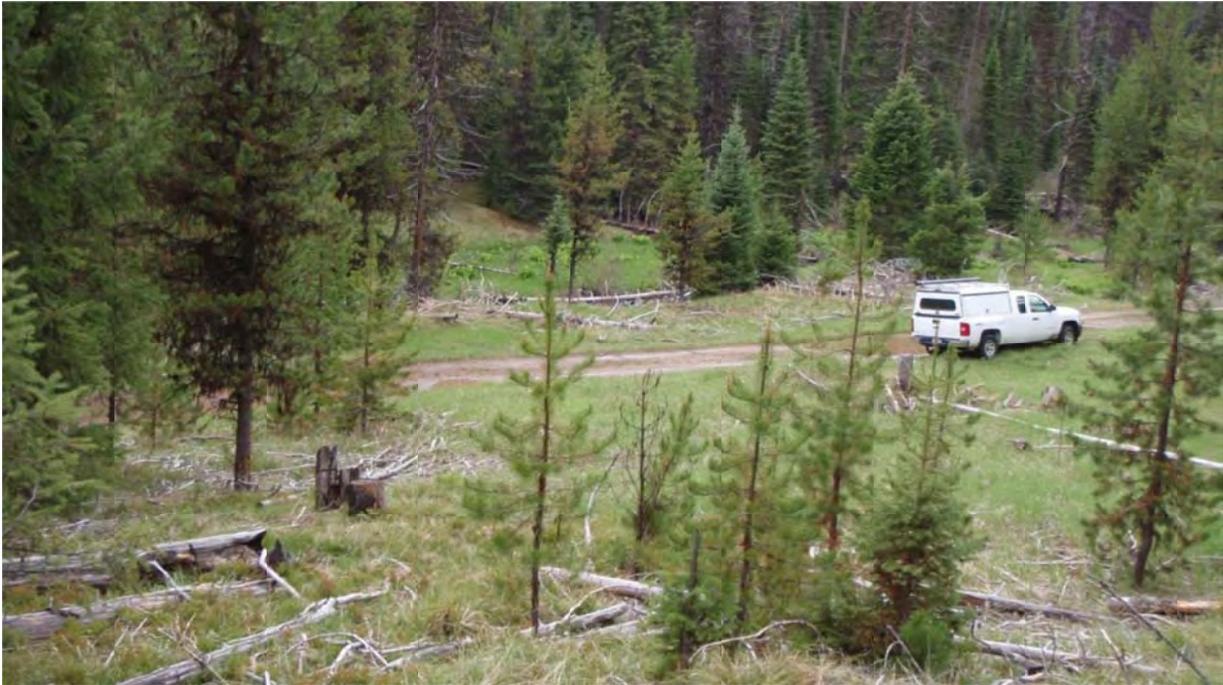
Photo 3 was taken from the Hornet Mine site looking downstream. Siegel Creek is approximately 15 yards from the road. The creek has been extensively placer mined. This entire area has been mined.

**Photo 3. Hornet Mine site looking downstream.**

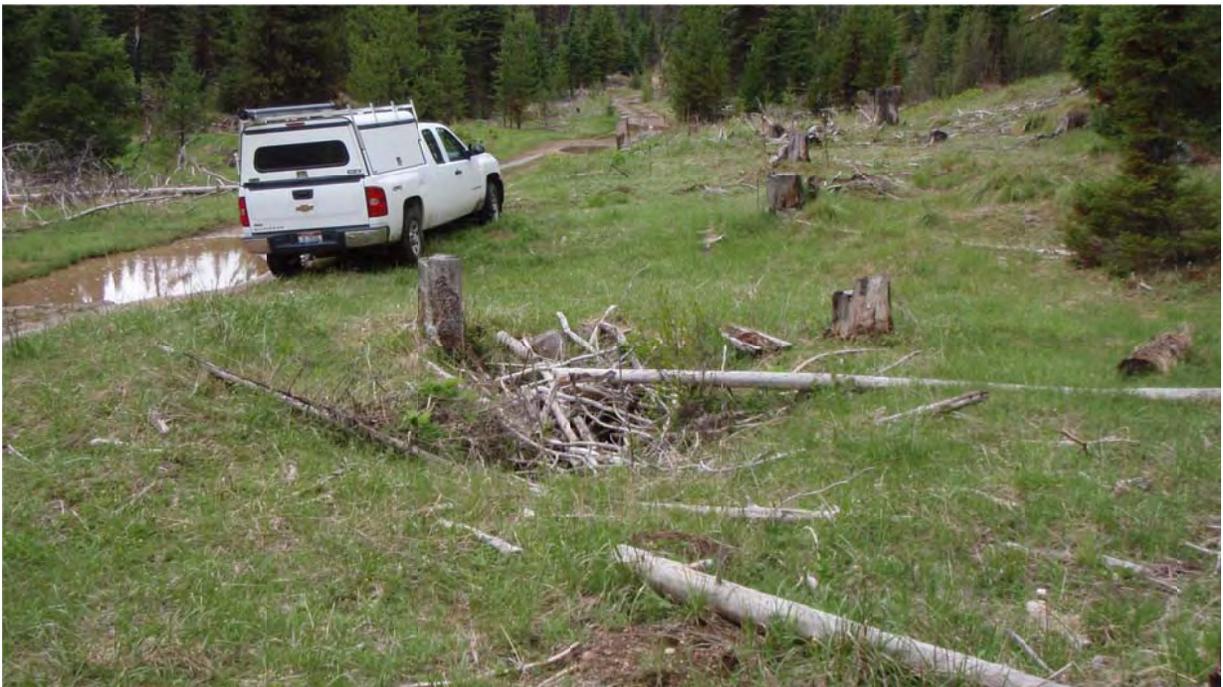
The hole in the center of Photo 4 was filled with debris. It may be a collapsed shaft not associated with the Hornet Mine or it may be a dog hole (exploratory hole/shaft).

**Photo 4. Debris filled hole near Hornet Mine site.**

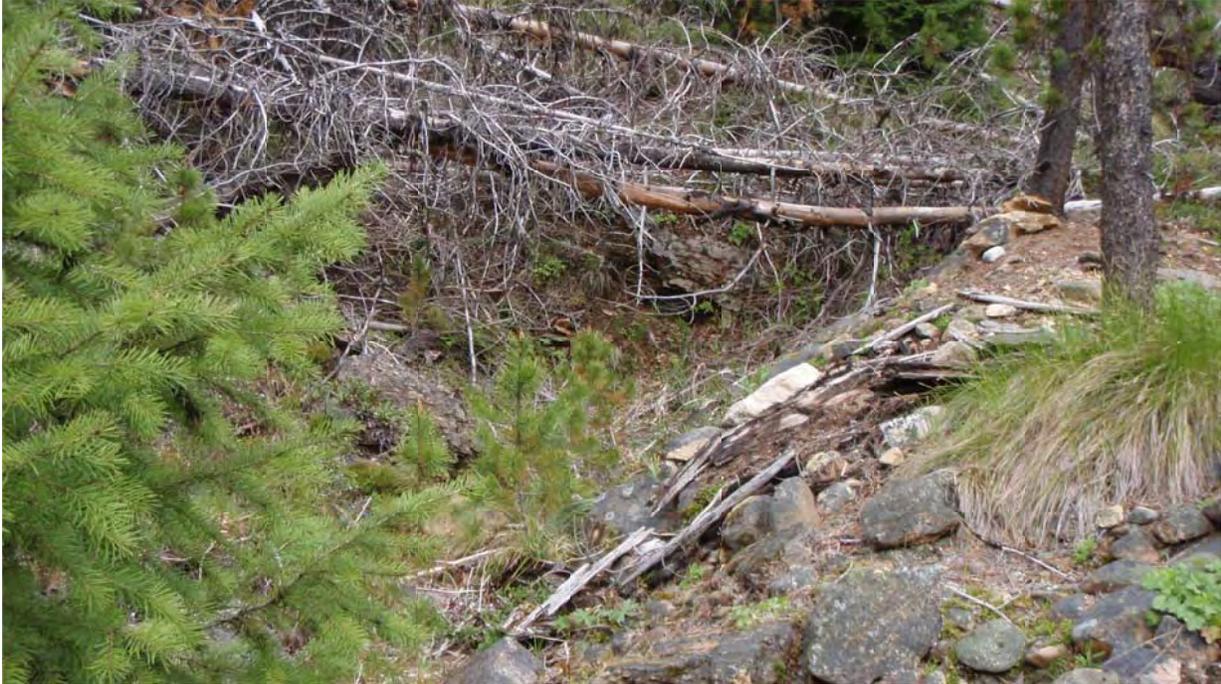
DEQ observed a small shaft several hundred feet down gradient from the Hornet Mine (Photo 5). This shaft may have been on the original Hornet Lode claim.

**Photo 5. Small shaft several hundred feet down gradient of Hornet Mine.**

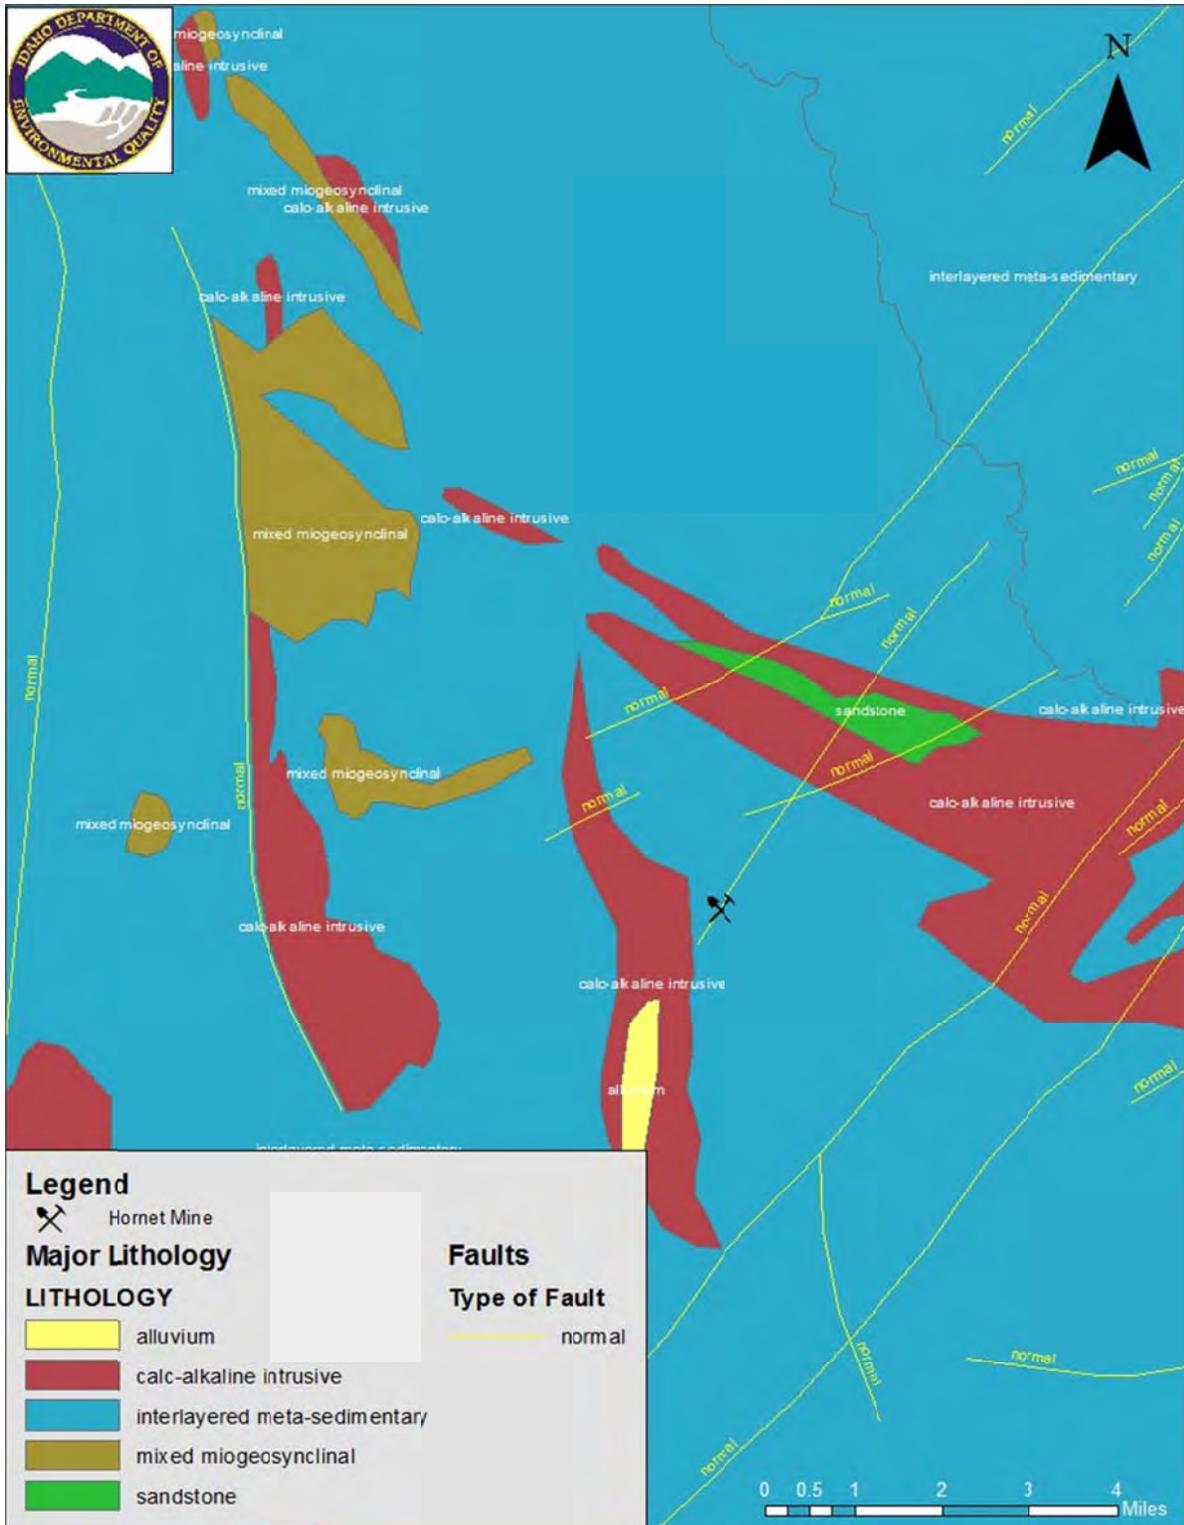
**Figure 3. Map of major lithology in the vicinity of the Hornet Mine.**

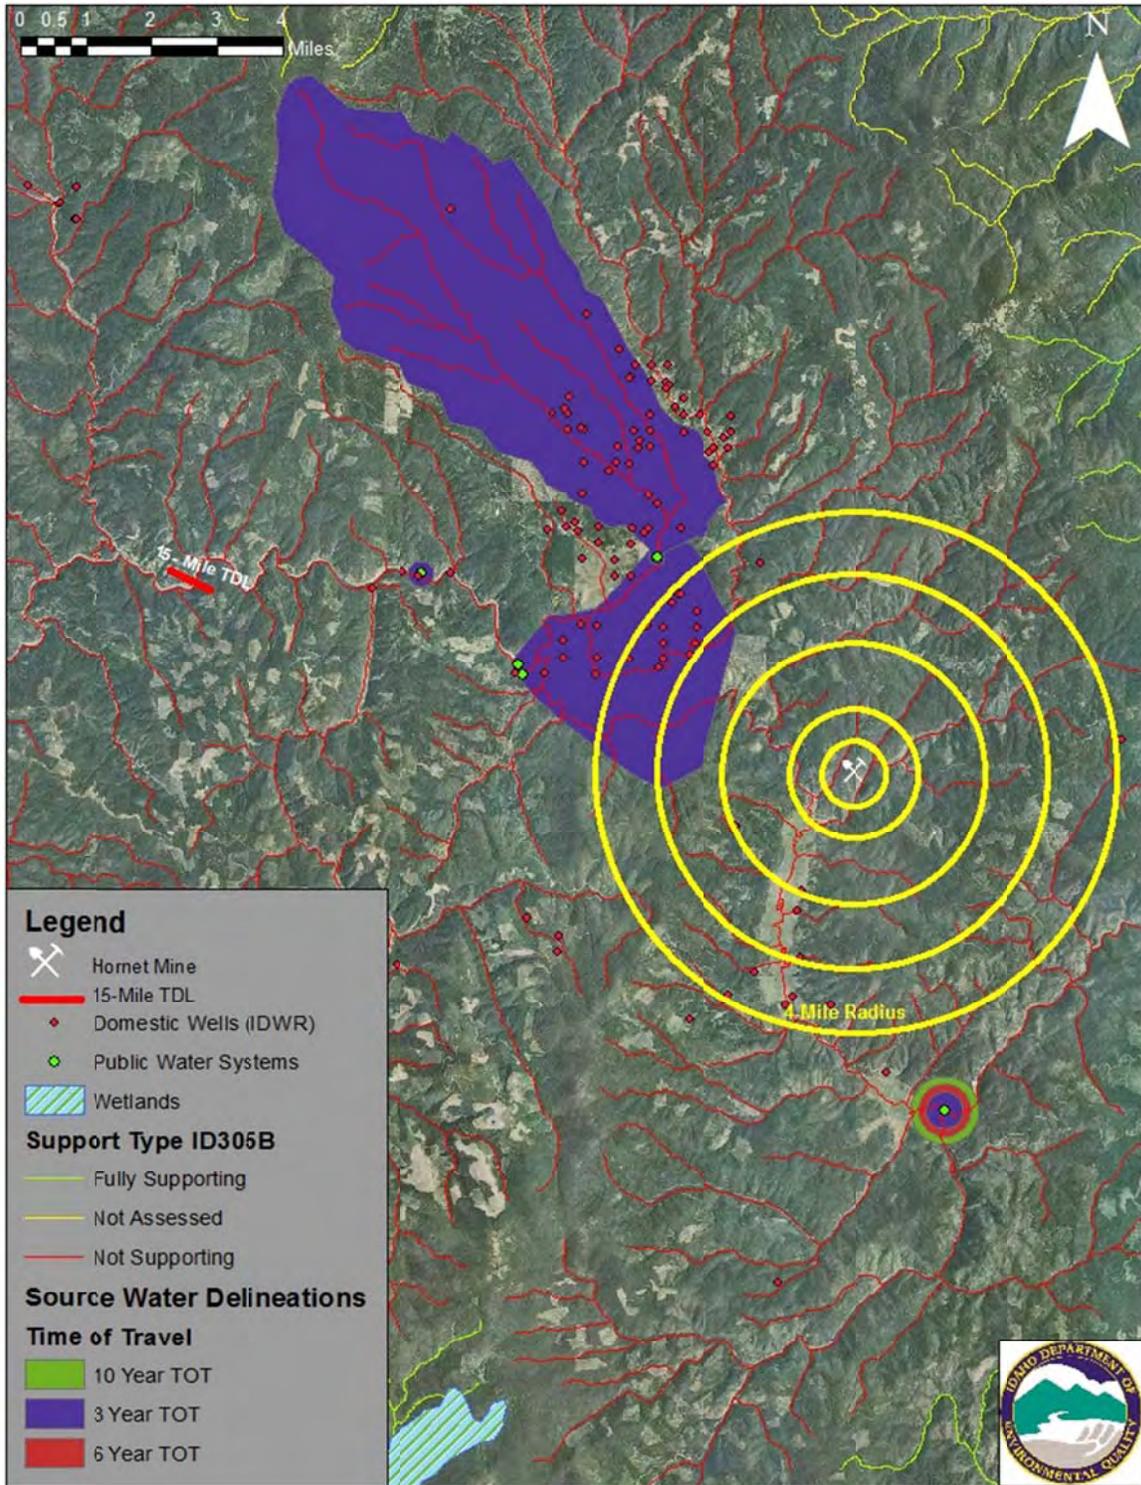
**Figure 4. Domestic well locations.**

There are domestic well locations within the 4-mile radius, but they are separated by structural geology. There are three public water systems within the 15-mil TDL. No significant wetlands are located within a 2-mile radius. Sensitive streams located in the vicinity of the Hornet Mine are also shown (indicated as "not supporting").
