**Abbreviated
Preliminary Assessment for
GVD Property
(Formerly a Kootenai County Landfill Site)**

Kootenai County

**State of Idaho
Department of Environmental Quality**

December 2012

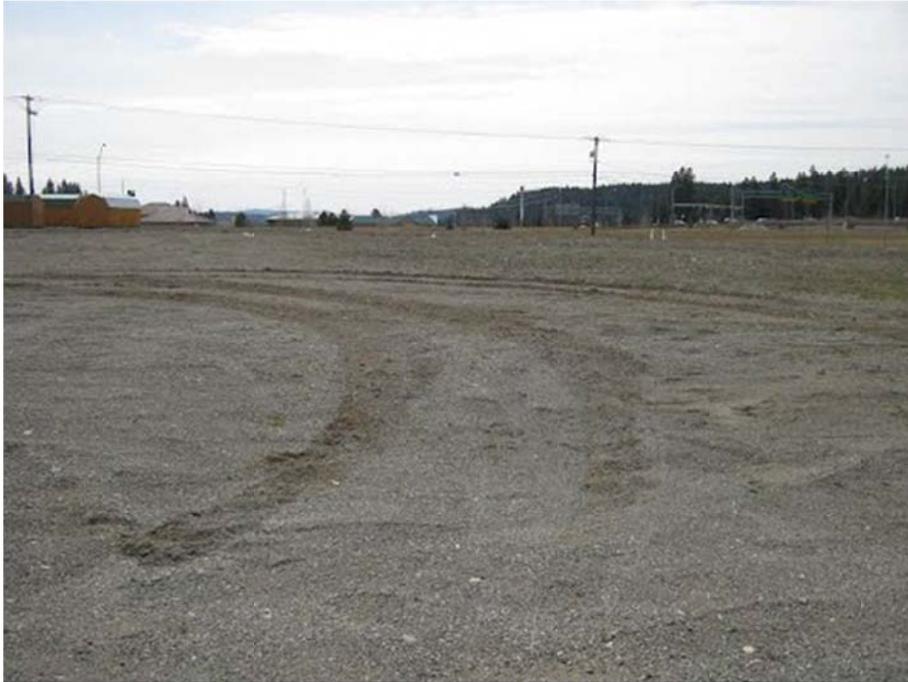
Photo 1. GVD property viewed from the northwest to southeast.

Photo 1 shows the currently vacant GVD property site.

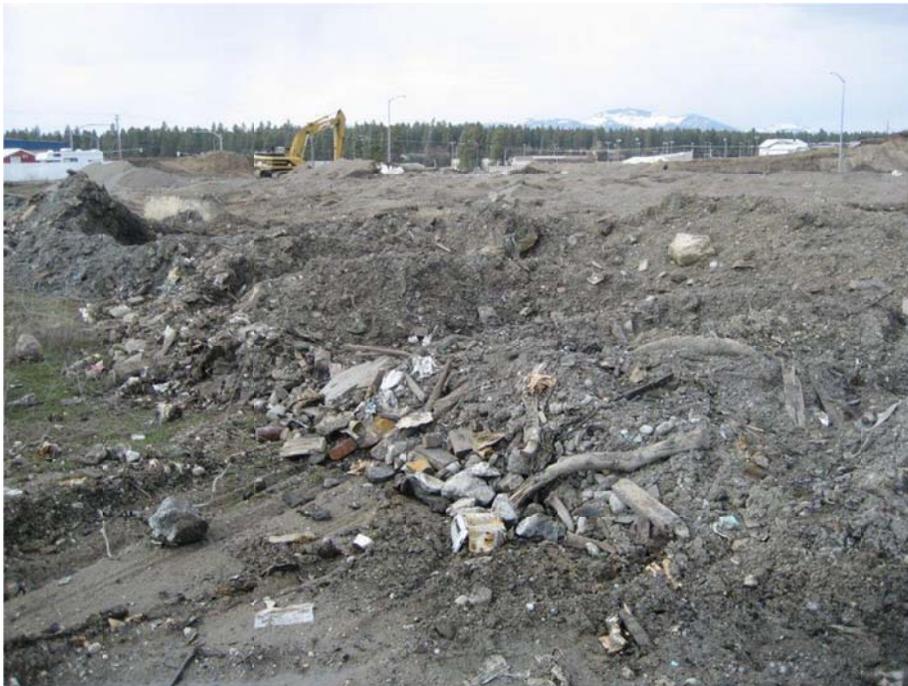
Photo 2. Solid waste located on the GVD Property following excavations in 2009.

Photo 2 shows the solid waste exposed during a 2009 excavation of the property.

As a result of DEQ's research and observations, the department recommends that the GVD property be referred to the DEQ solid waste removal program to work with the parties responsible for the landfill to remove the waste. Sections 2 through 5 provide further support for this determination.

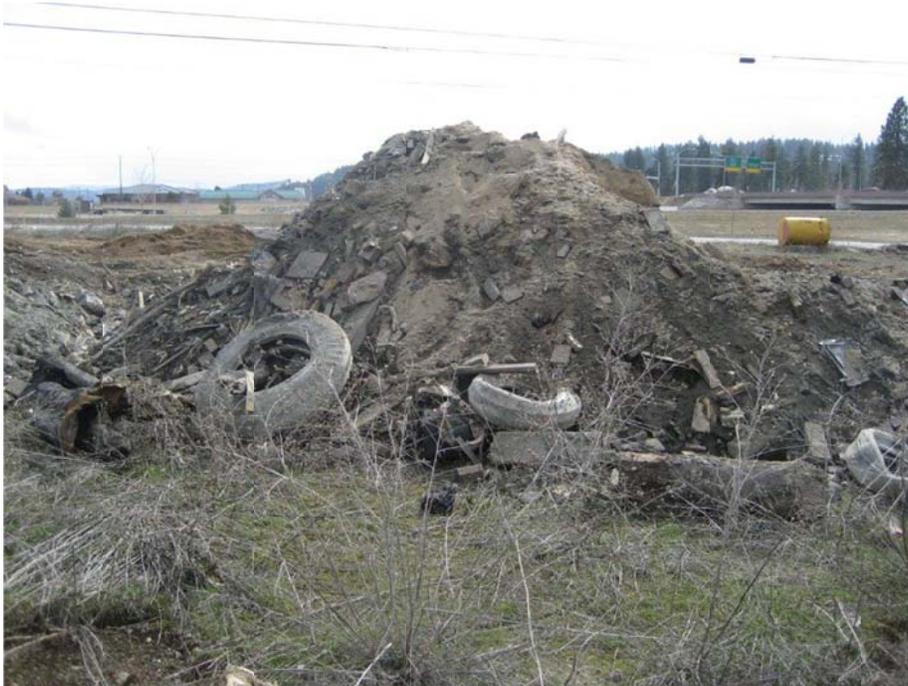
Photo 3. Solid waste excavated on the GVD property in 2009.

Photo 3 shows typical solid waste excavated on the GVD property in 2009.

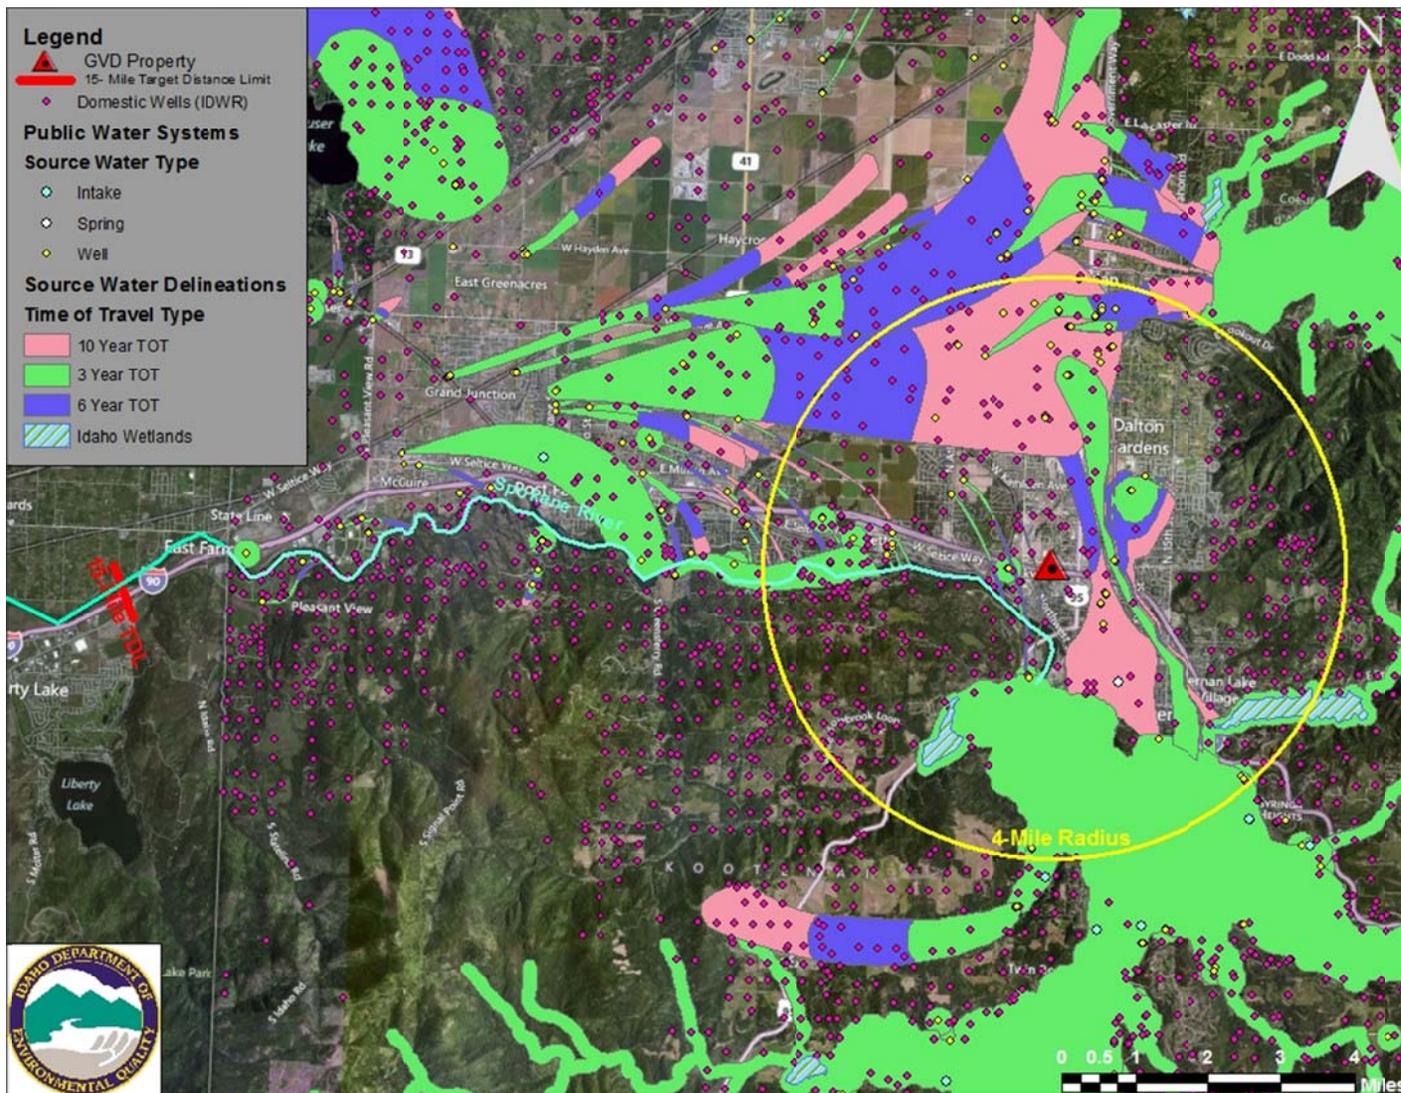
Figure 4. Domestic well and public water system locations.

There are several domestic well locations or public water systems within the 4-mile radius, 15-mile target distance limit (TDL). There are two significant wetlands within a 4-mile radius or in the general area.

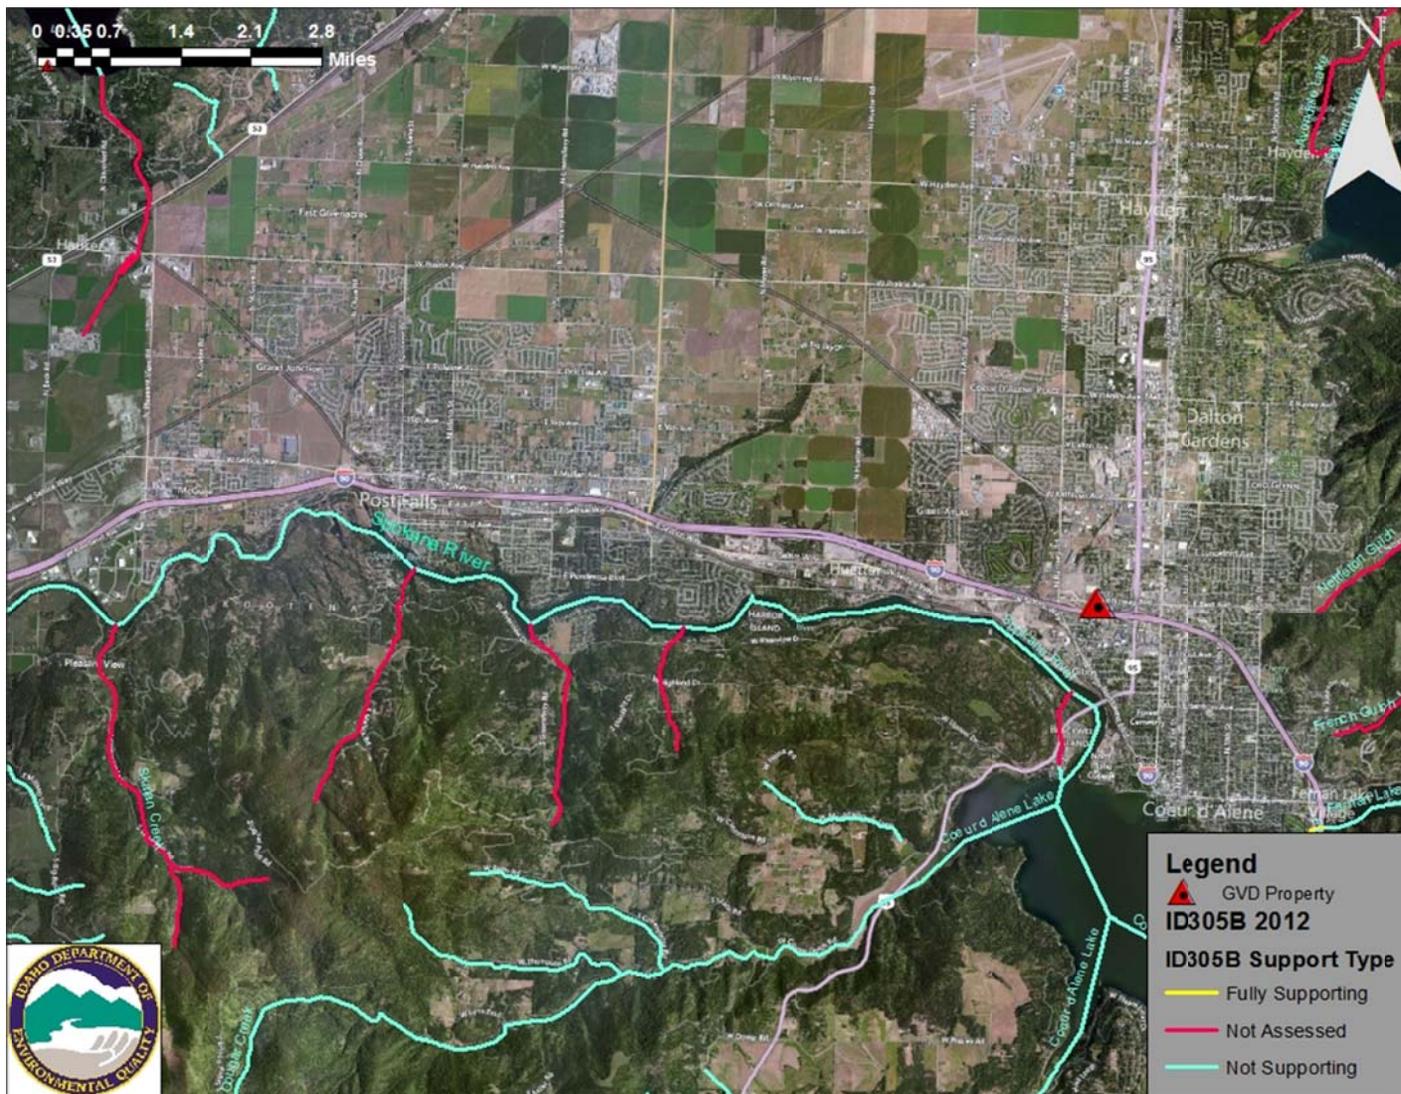
Figure 5. Sensitive streams located in the vicinity of the GVD property.
 The Spokane River is listed as “not supporting.”
