**WEISER AIRPORT
PRELIMINARY ASSESSMENT REPORT
WASHINGTON COUNTY, IDAHO**

**STATE OF IDAHO
DEPARTMENT OF ENVIRONMENTAL QUALITY**

December 2002

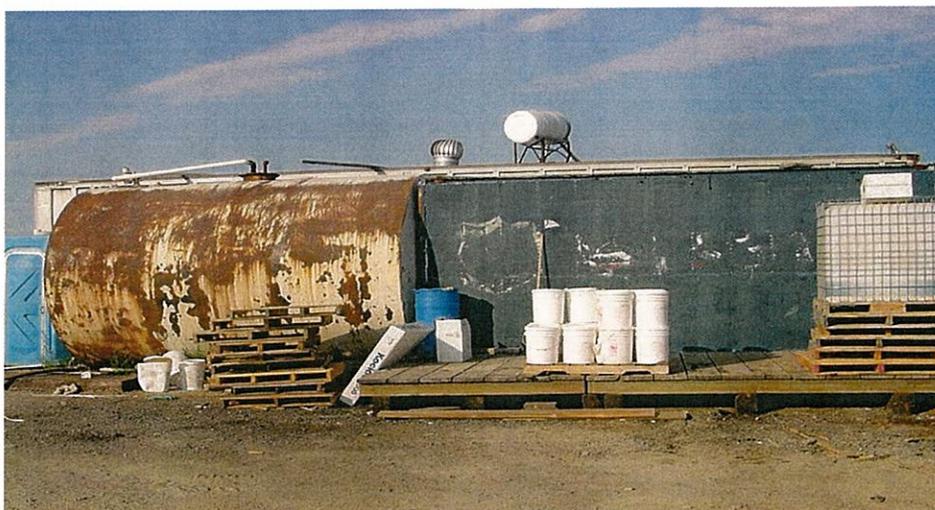
Mvc-005f

Water tank (left), storage sheds and chemical product on dock.

Mr. Thompson (verbal communication) estimated the capacity of the water tank at 4,000-gallons. Despite the presence of surface rust, the tank appears sound.

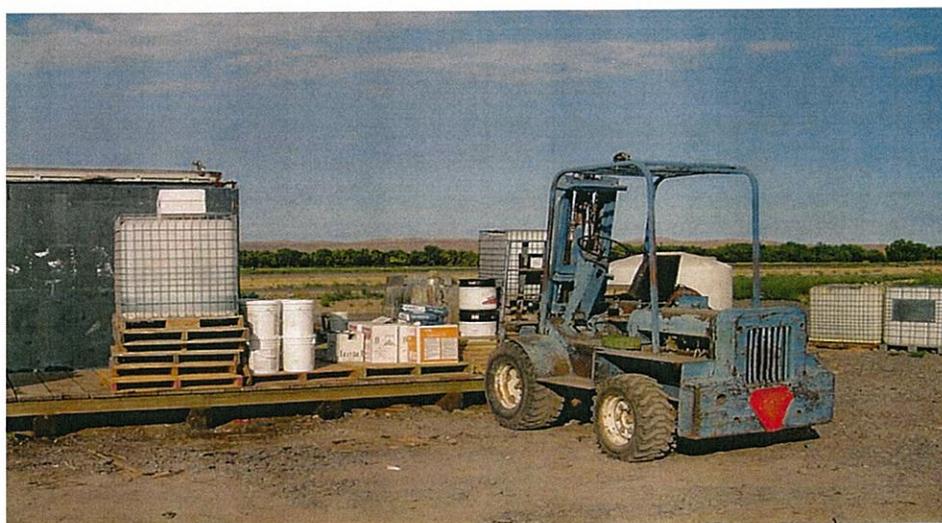
Photo Mvc-006f

Product storage and storage sheds (left)

Chemical product storage consisted of 5-gallon pails, 30-gallon drums, 20-pound boxes and 250-gallon tote containers. All of the containers appeared in good condition and were elevated above the ground.

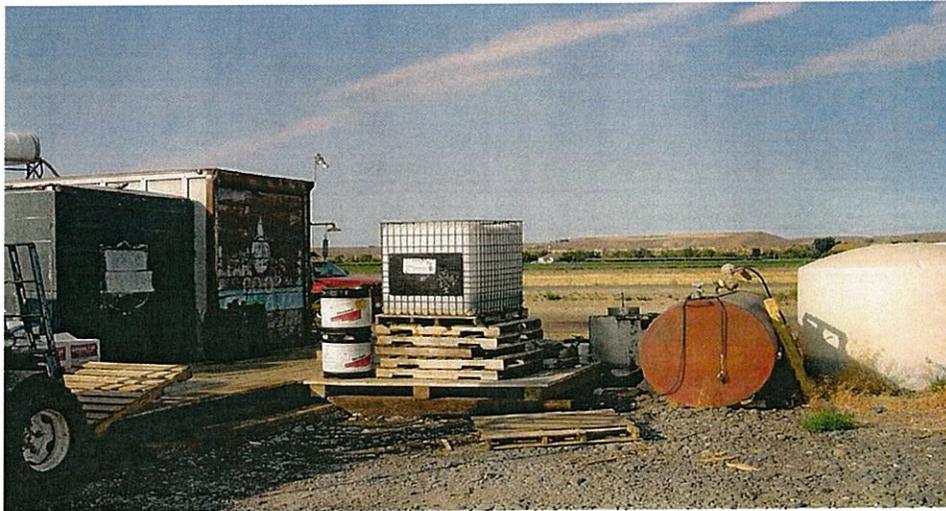
Mvc-007f

Storage sheds (left), fuel tank (right center) and mixing tank (right)

The operations center includes two metal cargo-type containers. The gray painted container measures 8 x 8 x 20 feet, and the white painted container measures 8 x 8 x 40 feet.

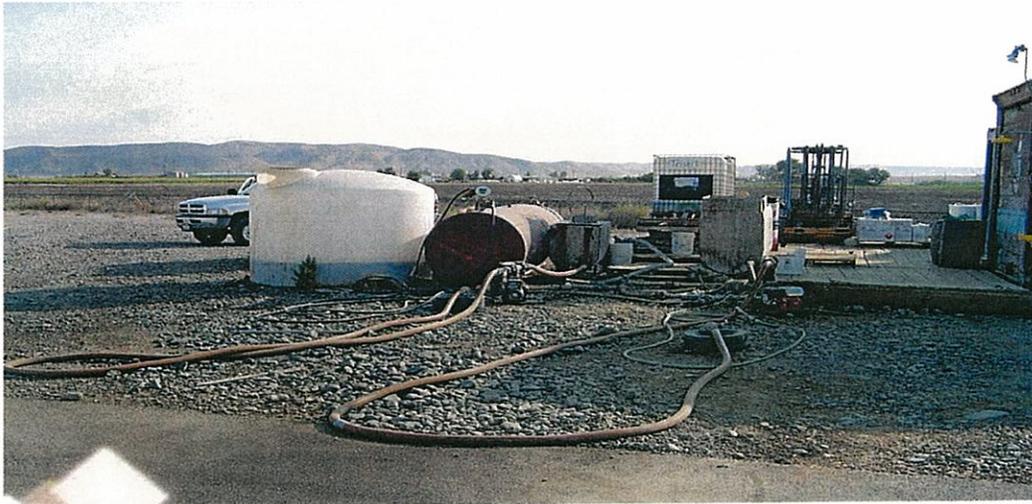
Mvc-001f

Fuel tank and hose (center), product loading hose (center right), mixing tank (left)

The operations center includes a 500-gallon fuel tank, pump and hose; chemical product loading pump and hose; and a 250-gallon mixing tank. At the time of the site visit, the mixing tank contained approximately 75 gallons of an unknown dark brown viscous material.

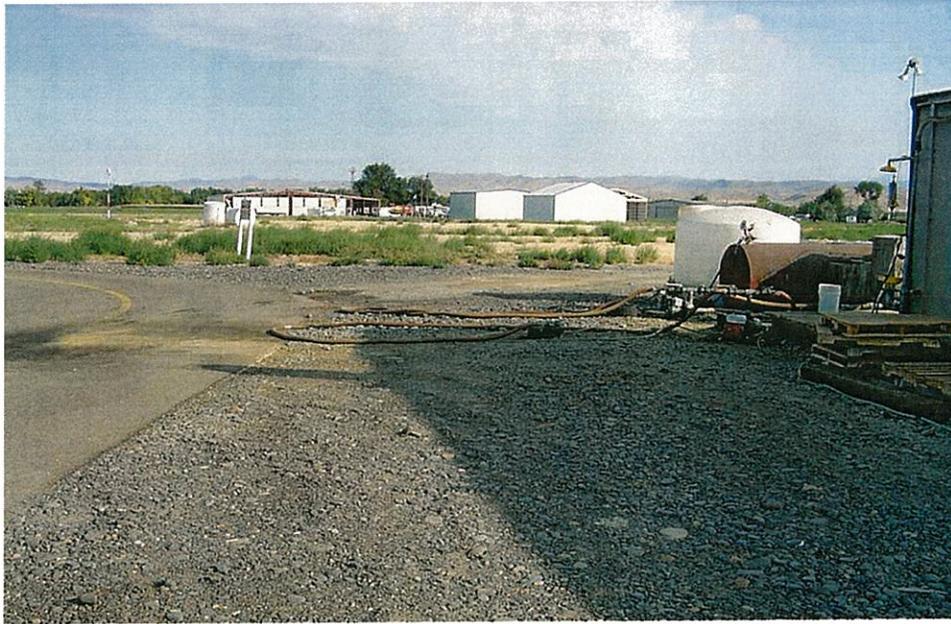
Mvc-002f

Tarmac (left), loading area (center), aircraft hangars (upper)

Staining (yellow) of the tarmac and adjacent ground is visible in the photograph. Examination of mixing tank and surrounding ground revealed release(s) of a dark brown material (Photos Mvc-009f and Mvc-010f).

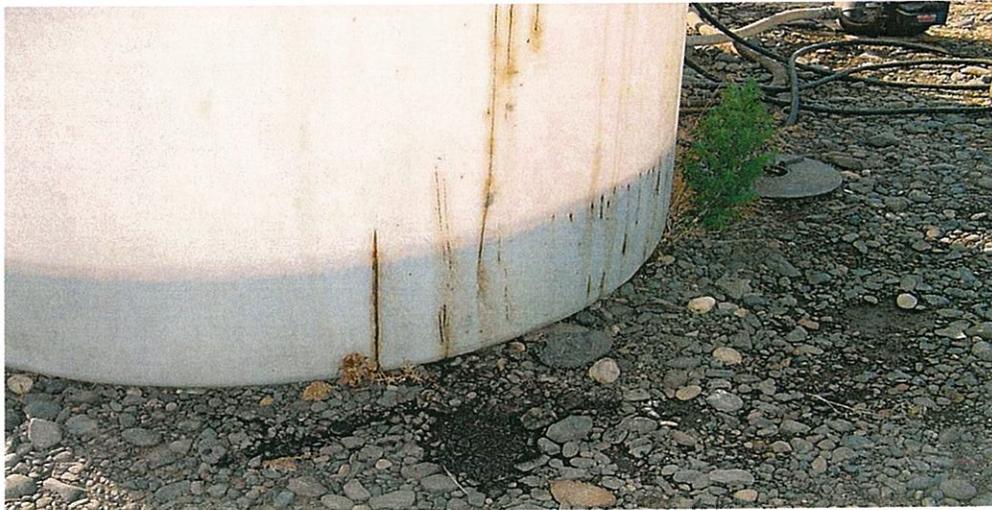
Mvc-009f

Release to ground from mixing tank (close up)

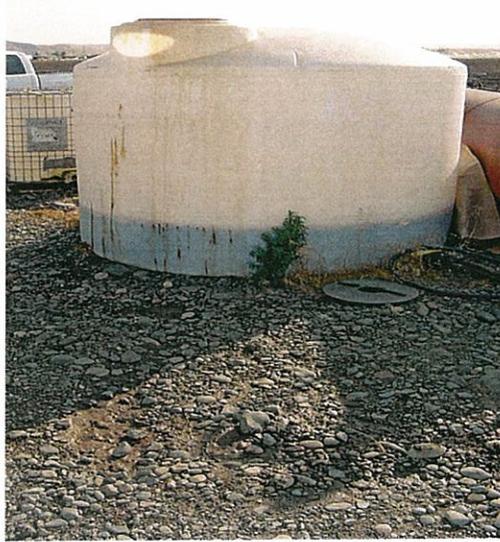
Mvc-010f

Dark brown material (foreground center) released from mixing tank

The released material extended 12 feet west from the mixing tank. This material covered approximately 24 square feet of ground. The ground north from the product loading area was stained, apparently from tank rinsate (Photo Mvc-013s). DEQ collected representative samples of the release material and stained soil (Appendix B).

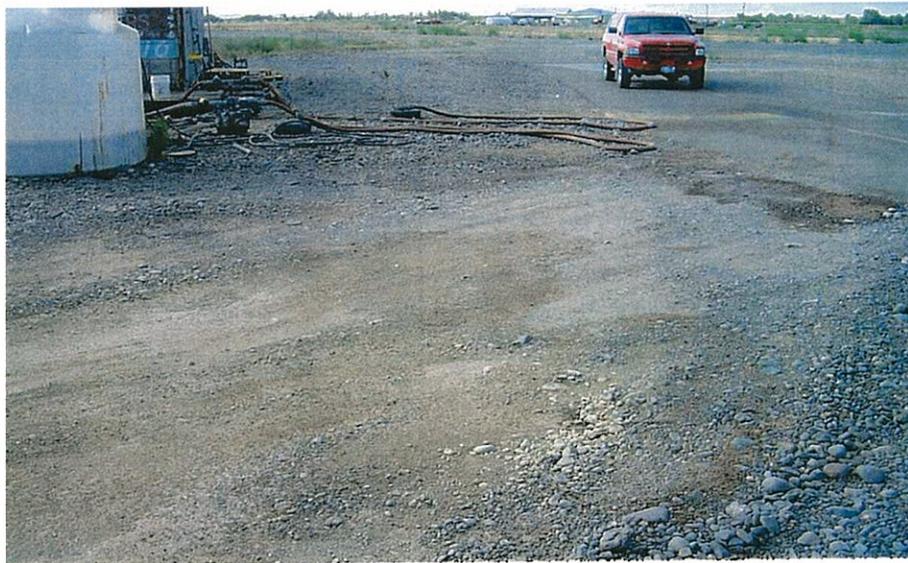
One concern in the refueling and loading area is the lack of containment. Based upon direct observation, chemicals have been released and are suspected to affect the shallow ground water (approximately 25 feet bgs). Apparently, aircraft wash effluent (Photo Mvc-013f) drain to gravel where it evaporates and/or infiltrates the subsurface.

Photo Mvc-013f
Stained ground (foreground and center) and on tarmac (upper right)

The product chemical loading area and the adjacent tarmac were heavily stained (light yellow). Additionally, stained soil measuring approximately 175 square feet was identified in an area north from the mixing tank. The compacted ground appeared to have been used to wash/rinse aircraft applicator tanks.

One probable point of entry (PPE), therefore, is the infiltration of chemical substances to ground water. Based upon direct observation of surface lithology (unconsolidated sand and gravel), subsurface geology and hydrology of the locale, access to shallow aquifer(s) could be possible.
