# **Preliminary Assessment and Site Inspection Report for the Clayton Slag Pile**

Custer County

**State of Idaho  
Department of Environmental Quality**

**January 2014**

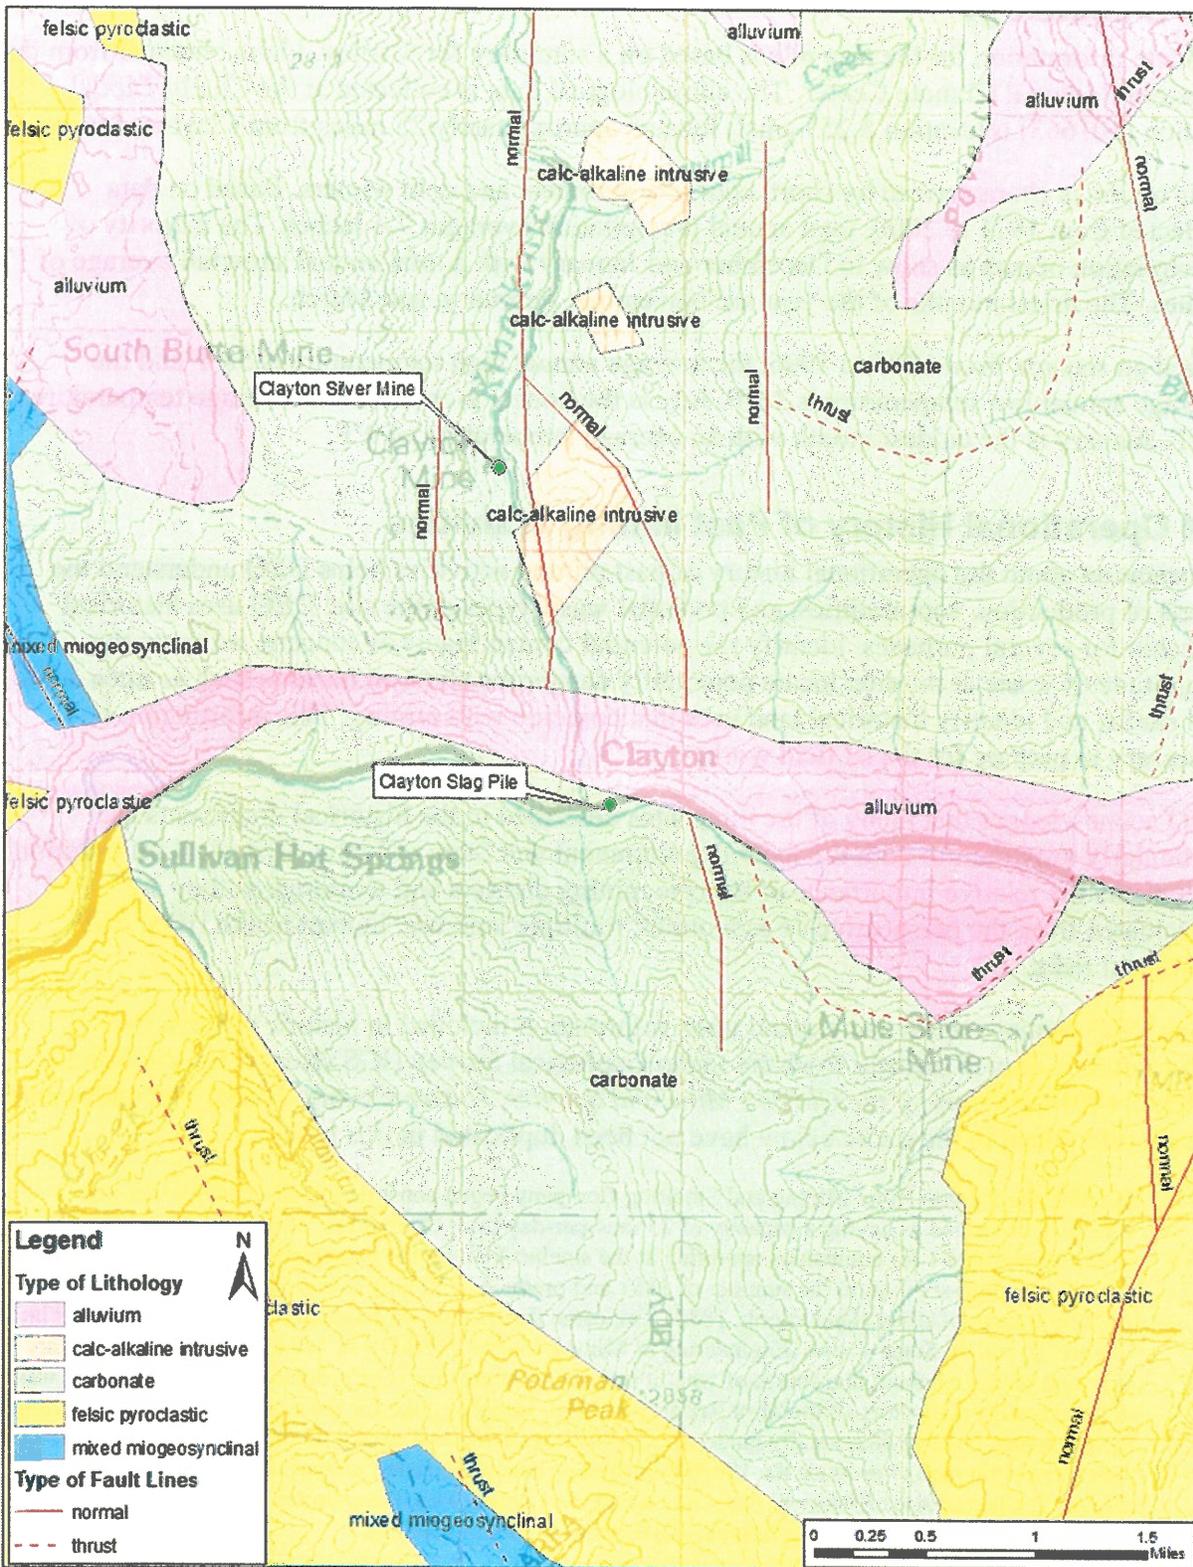
Figure 2. Map of major lithology in the vicinity of the Clayton Slag Pile.

A map of the major lithology in the vicinity of the slag pile is shown in Figure 2. The following information identifies the general geology and lithology for this area as it relates to past mining activities; specifically the Clayton Mine site located 1.5 miles north of the slag pile (location shown on Figure 2). Since DEQ cannot improve or expand upon information included in historic reports, this information is quoted directly from the U.S. Geological Survey Open-File Report *Case Study of the Environmental Signature of a Recently Abandoned, Carbonate-Hosted Replacement Deposit: The Clayton Mine, Idaho* (Hammarstrom et al., 2010). The tables and figures referenced in the quote below have not been duplicated in this report.

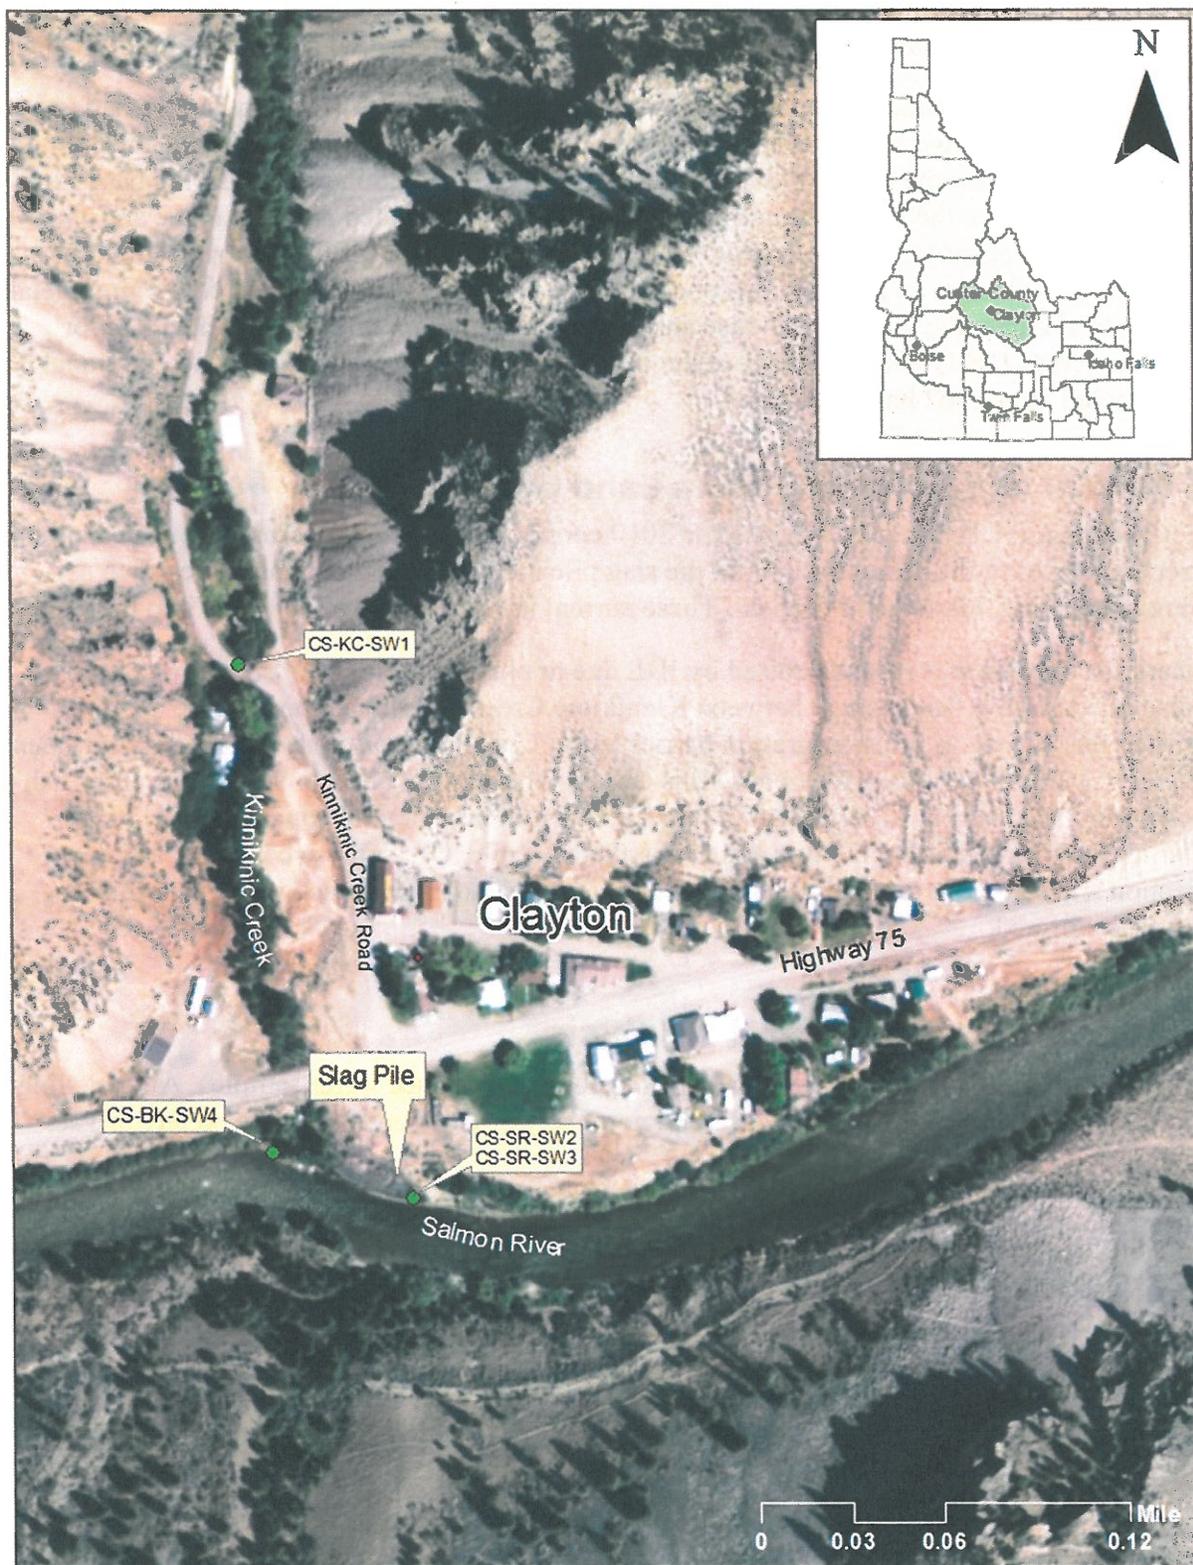
Figure 3. Sample Locations.

Four grab surface water samples (Figure 3) and one field blank were collected near the slag pile:

- Surface water (CS-KC-SW1, Photo 1)—Kinnikinic Creek
- Surface water (CS-SR-SW2 and CS-SR-SW3 duplicate, Photo 2)—Salmon River at the downstream edge of the slag pile (~5 ft downstream)
- Surface water (CS-BK-SW4, Photos 3 and 4)—Background location; Salmon River ~30 feet upstream of the confluence with Kinnikinic Creek
- Field Blank (CS-FB-SW5)—Quality Assurance/Quality Control (QA/QC) sample

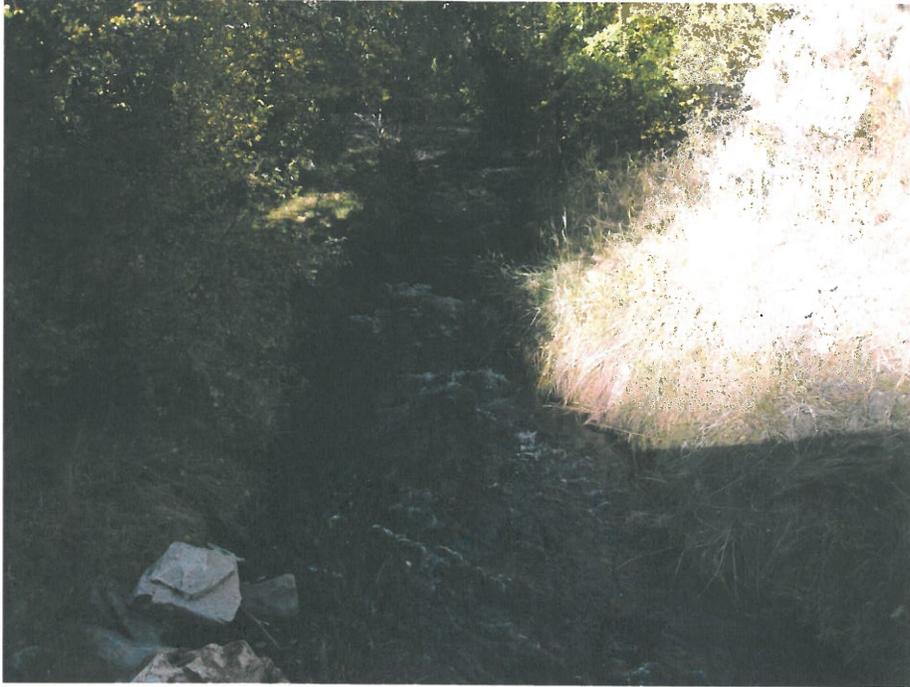
**Photo 1. Kinnikinic Creek sample location.**

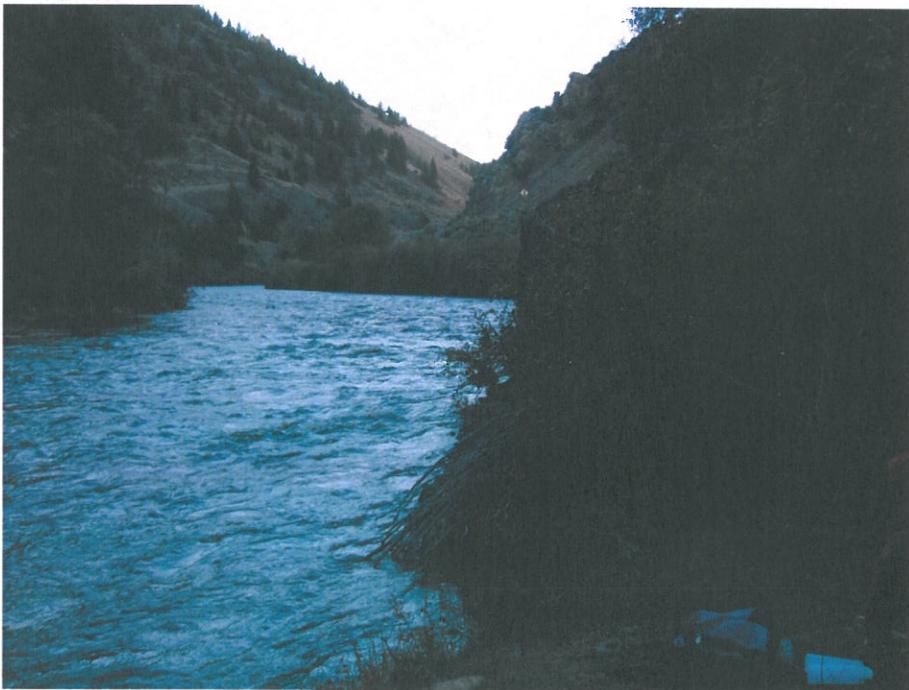
**Photo 2. Salmon River sample location at the downstream edge of the slag pile.**

- **Clayton Slag Pile:** Comparisons of Pb concentrations at the background and downstream of the slag pile locations demonstrate that contributions of Pb from the slag pile are minimal. Pb downstream of the slag pile is only slightly higher than background, an observed difference of 3 to 5% higher.

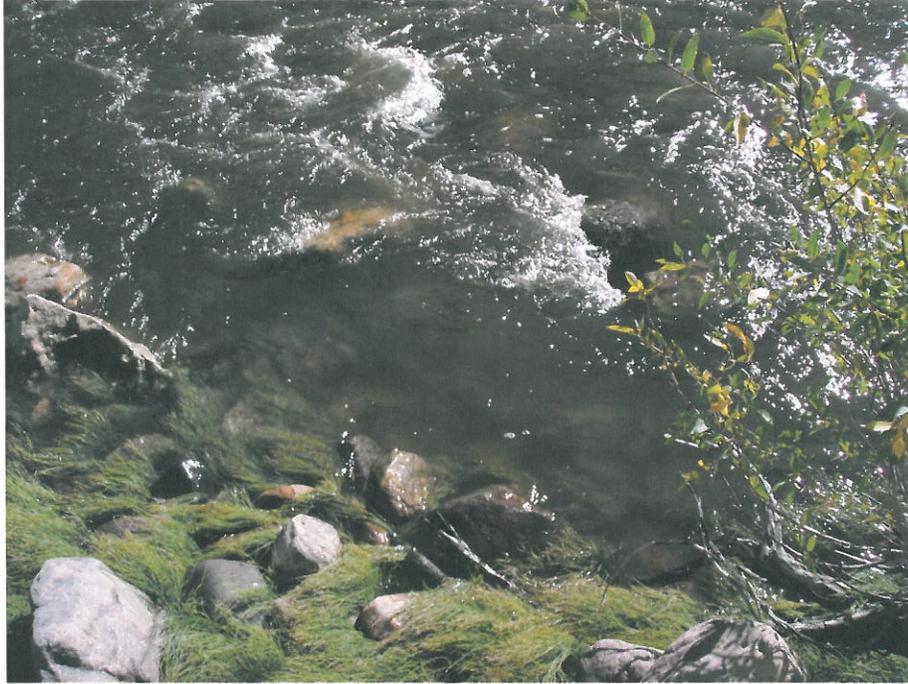
**Photo 3. Salmon River sample location upstream of the confluence with Kinnikinic Creek.**

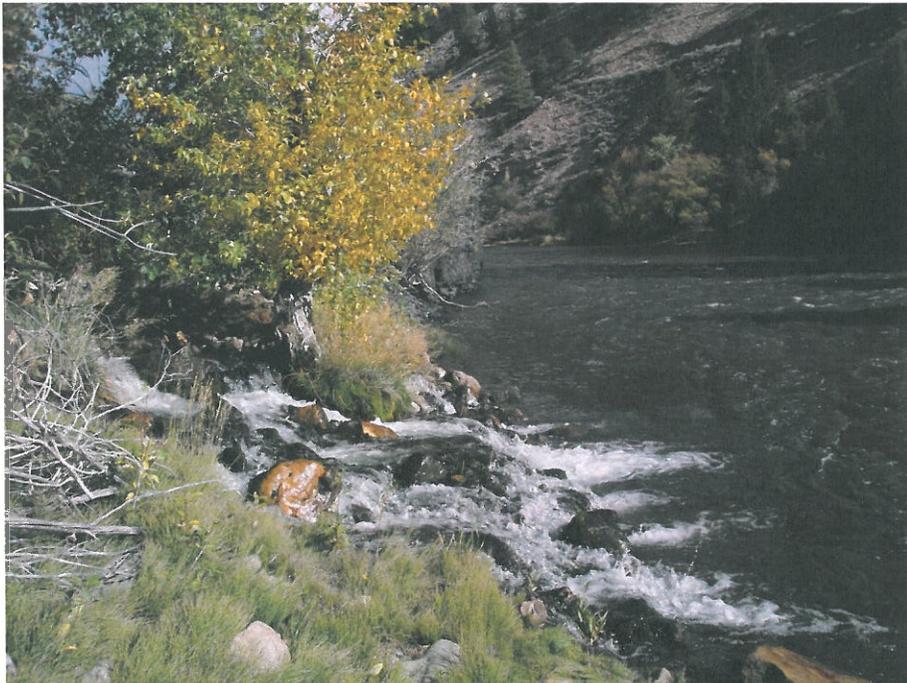
**Photo 4. Kinnikinic Creek flowing into the Salmon River.**

- **Kinnikinic Creek:** No metals loading from Kinnikinic Creek to the Salmon River above background concentrations was observed during this PA/SI; therefore, past remedial actions near the Clayton Silver Mine (conducted in 2001) continue to be effective at reducing loading to Kinnikinic Creek. Fe and Mn concentrations in Kinnikinic Creek are substantially lower than Salmon River background and Pb concentrations are similar to background.
