Abbreviated Preliminary Assessment for E C Ray Mine

Blaine County

**State of Idaho
Department of Environmental Quality**

June 2014

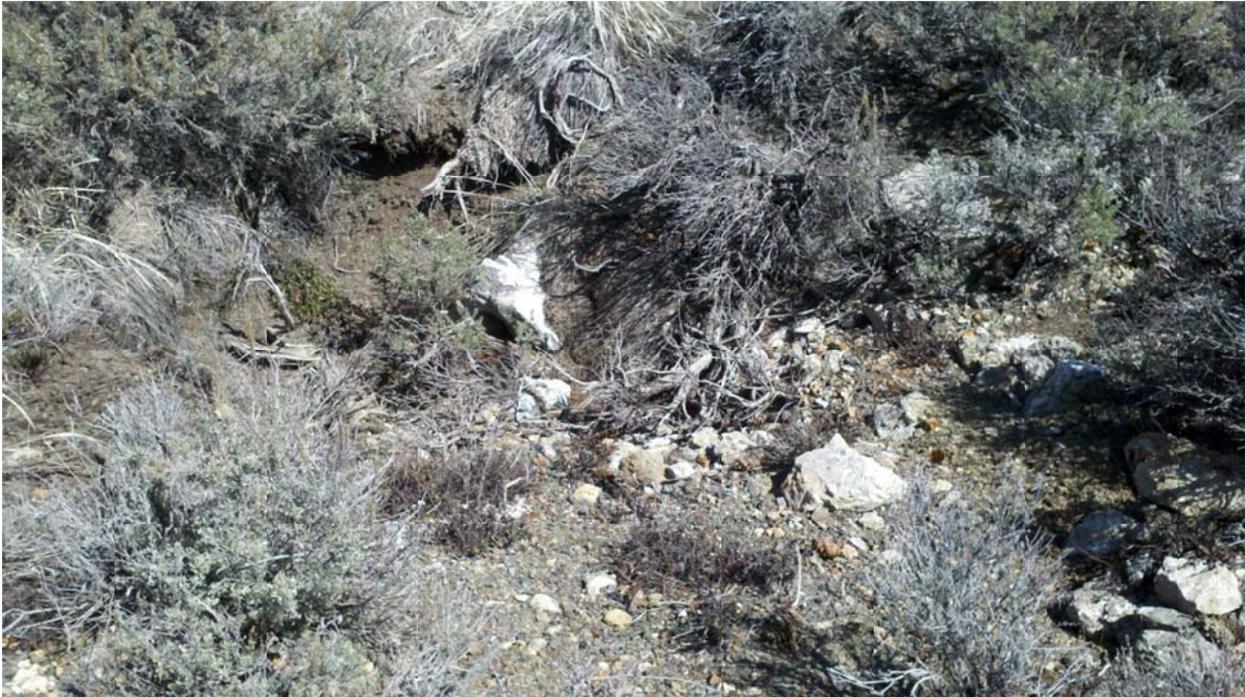
E C Ray Mine site observations and photographs were collected during the DEQ site inspection on May 12, 2014. The weather was approximately 48°F, clear, and sunny with wind out of the east. One "dog hole" was observed on the western boundary of the claim. No remnants of hazardous or deleterious materials from mining activities were observed on the ground surface surrounding the "dog hole" (Photo 1) or on other areas of the property. The site is well vegetated (Photo 2) and no active water sources were draining from the property.

Photo 1. Small dog hole observed on western boundary of the claim.

Regarding question 5: A reconnaissance level preliminary assessment was conducted to determine if any potential sources or associated releases could be identified due to historical mining practices. No concerns were identified during desktop research. During the site inspection, only minor evidence of mining was observed consisting of one small dog hole on the western boundary of the claim. The area was well vegetated around the dog hole indicating that materials excavated were mostly soil-like materials.

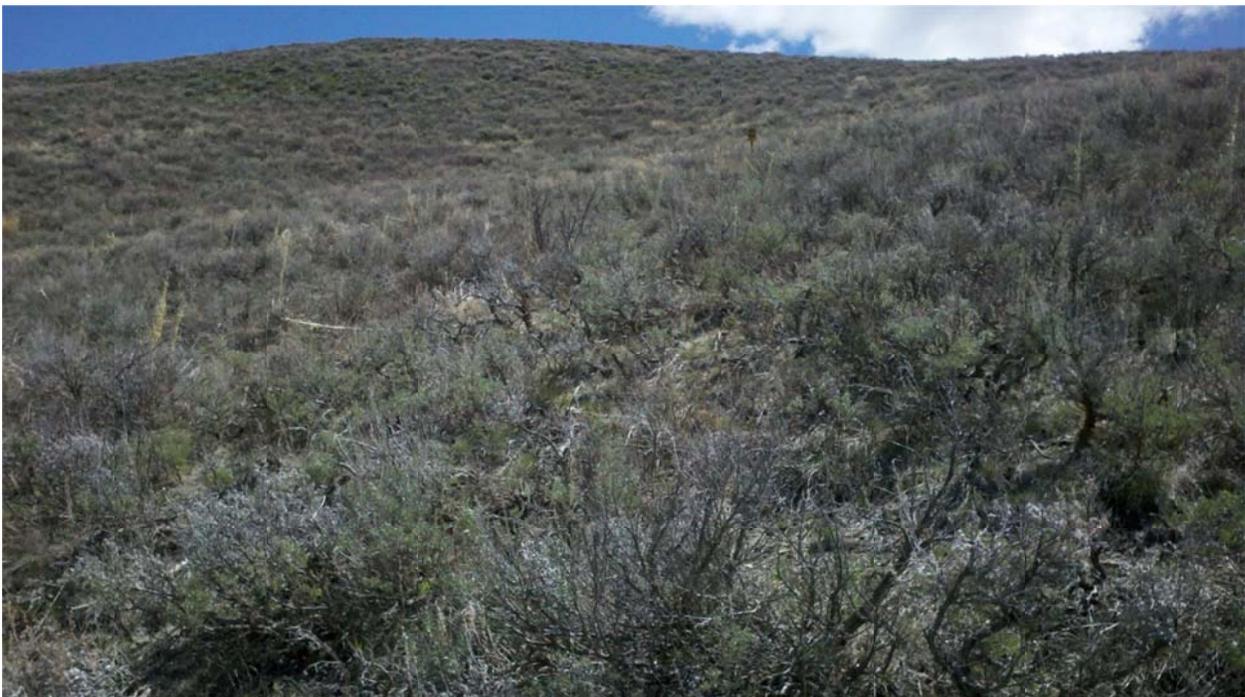
Photo 2. General site photo looking east from the western edge of the E C Ray Claim.

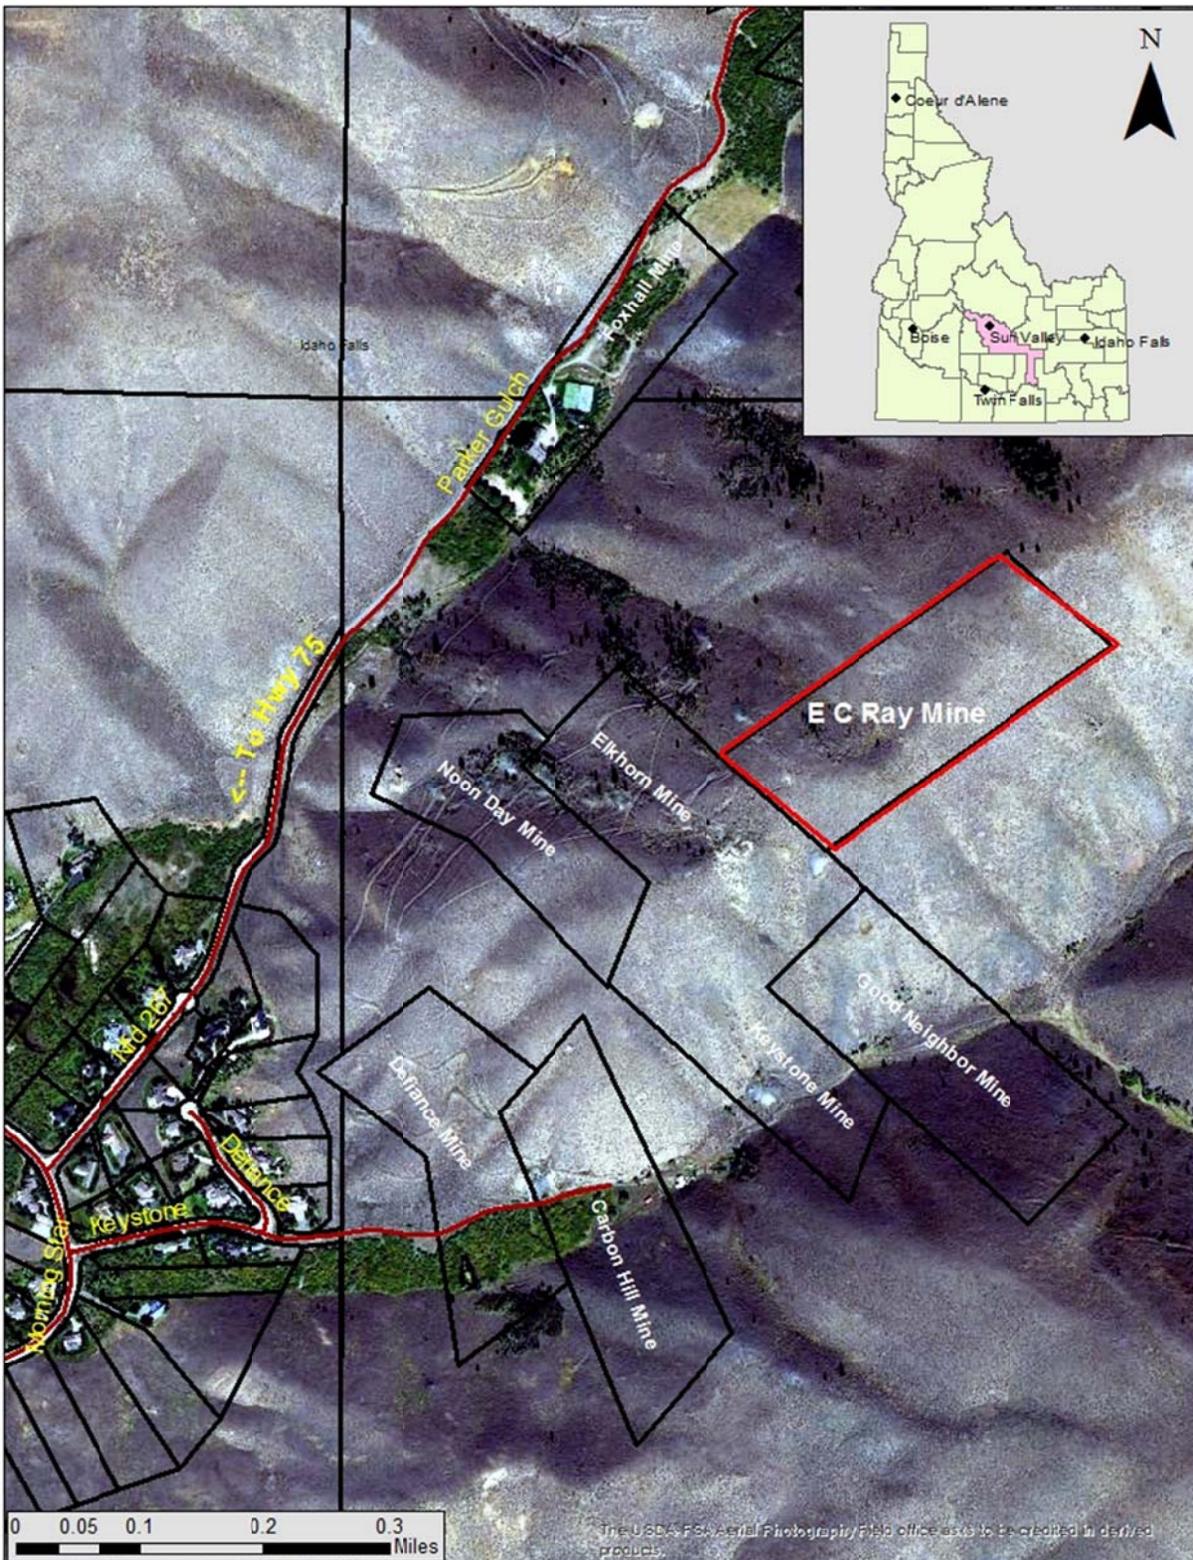
The E C Ray Mine is located east of Sun Valley, Idaho (Figure 1). An aerial map was also used to determine if there was evidence of mine activity or waste present at the site (Figure 2).

Figure 2. Aerial view of the E C Ray Mine in Blaine County, Idaho.

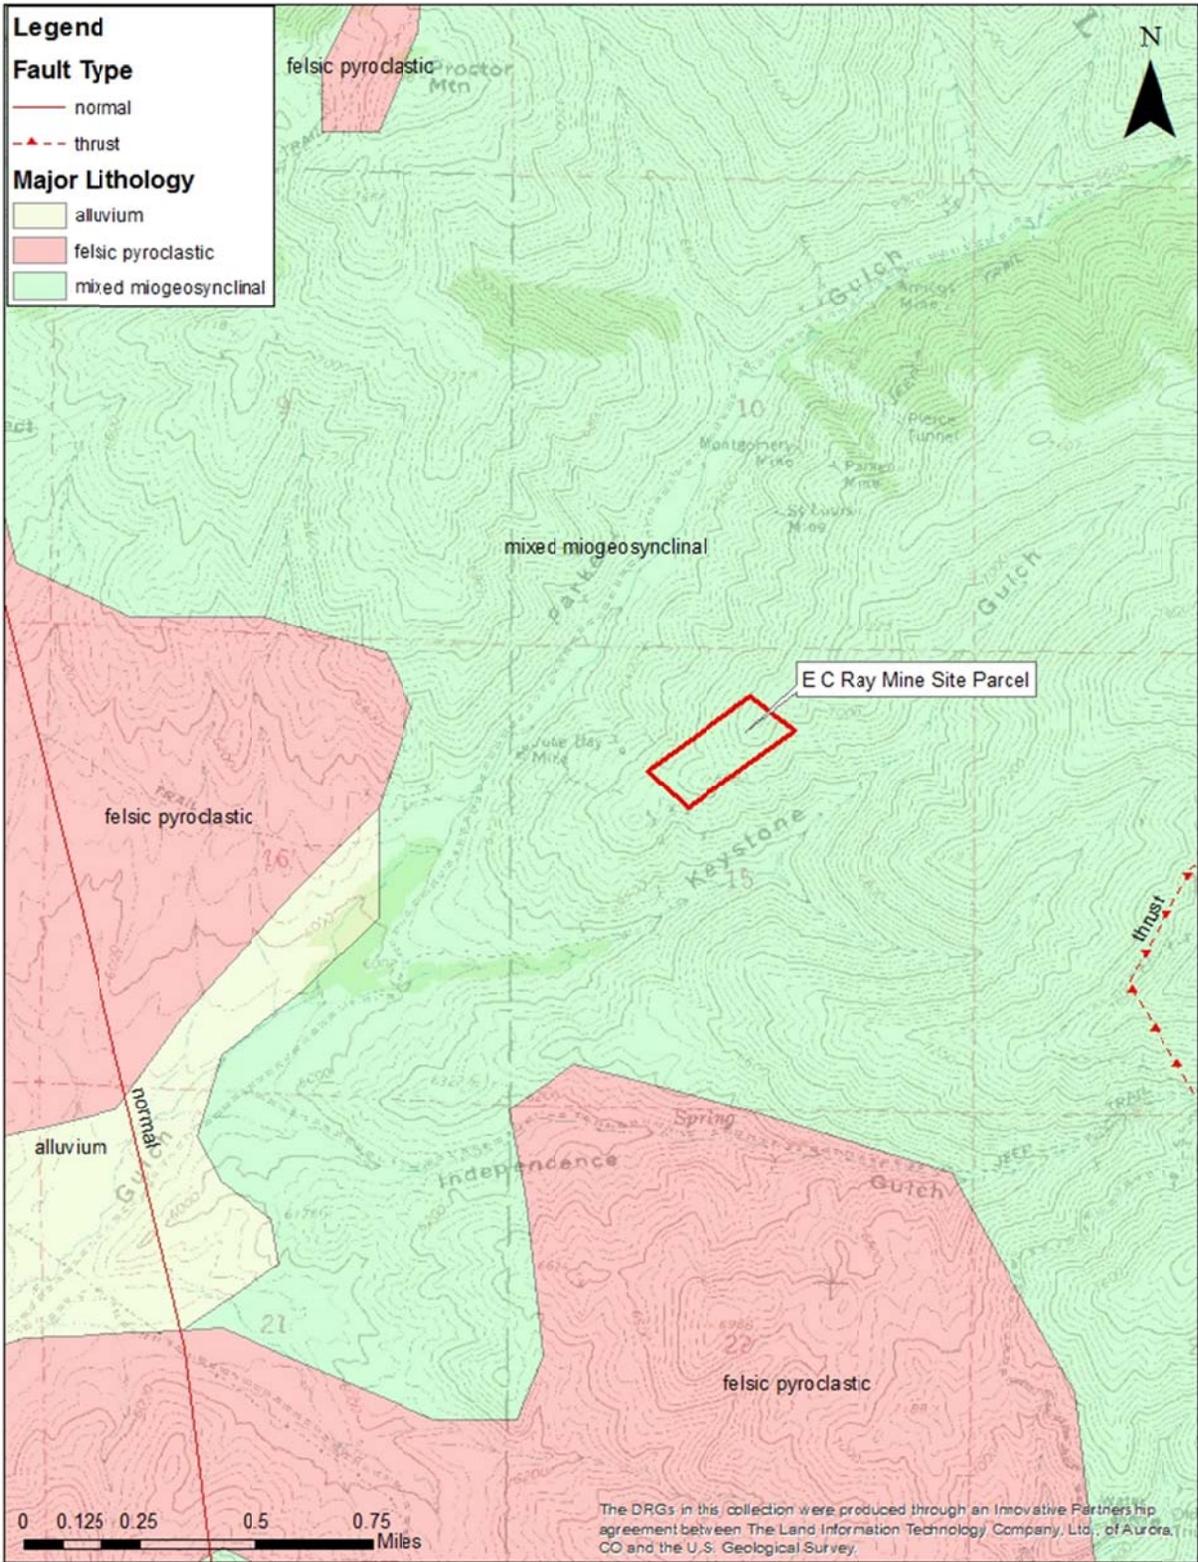
Specific site location details are included in the above checklist. The generalized geology of this area is shown in Figure 3 with a description included in Section 2 of this report.

Figure 3. Map of major lithology in the vicinity of the E C Ray Mine.

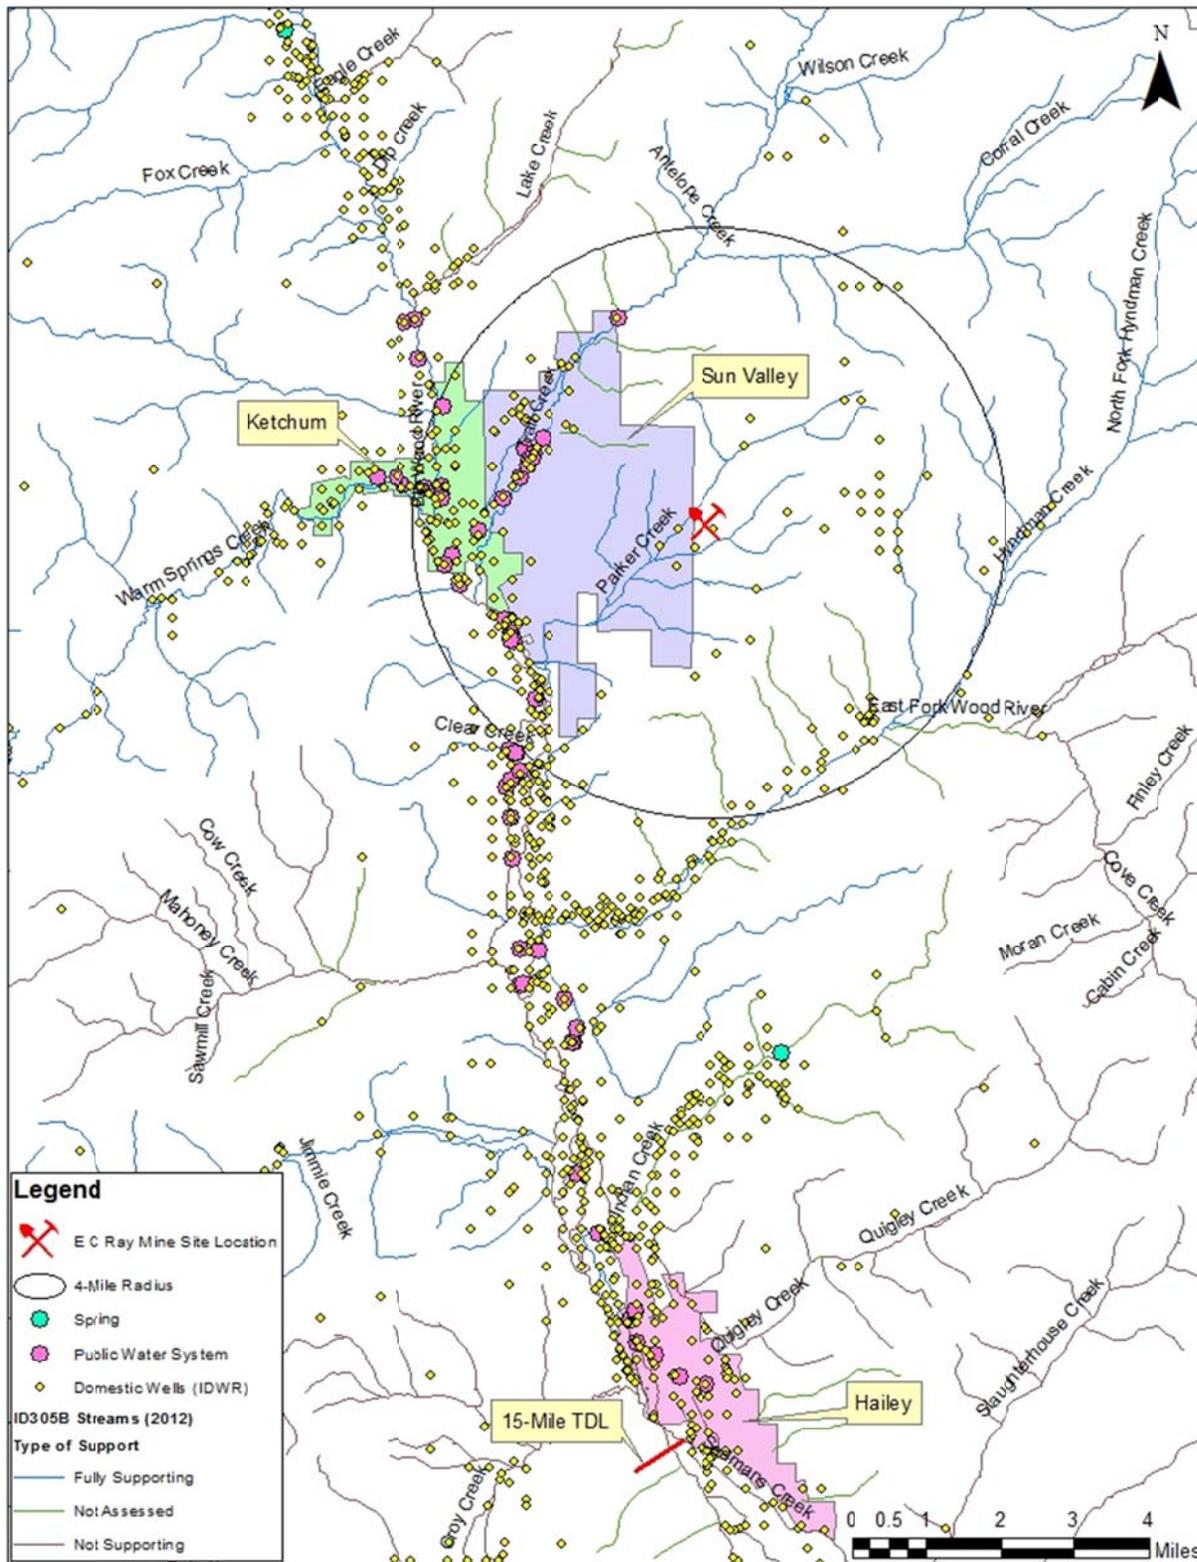
The E C Ray Mine is located along a ridge with Parker Gulch drainage to the north and Keystone Gulch drainage to the south. Both drainages are located within the Big Wood River subbasin. Evidence of past mining (i.e., the “dog hole” observed during the site visit) was observed on the western side of the property suggesting that the probable point of entry (PPE) for the surface water pathway is into the unnamed drainage which would flow to the Parker Creek. At the time of the site visit, no water was observed in the unnamed drainage. Parker Creek, a tributary to the Big Wood River, was running water. The site visit was conducted in the spring at a time of the year when water is expected to be present. The 15-mile target distance limit (TDL) follows Parker Creek and ends just west of Hailey city limits on the Big Wood River (Figure 4). There are wetlands in the immediate vicinity of the E C Ray Mine site location and downstream of the site along Parker Creek within a 2-mile radius (Figure 5). Potential ground water pathways include 33 public drinking water systems and approximately 550 domestic wells located within a 4-mile radius of the mine site location, including three domestic wells located along the Parker Gulch drainage (Figure 4).

Figure 4. Domestic well and public water system locations.

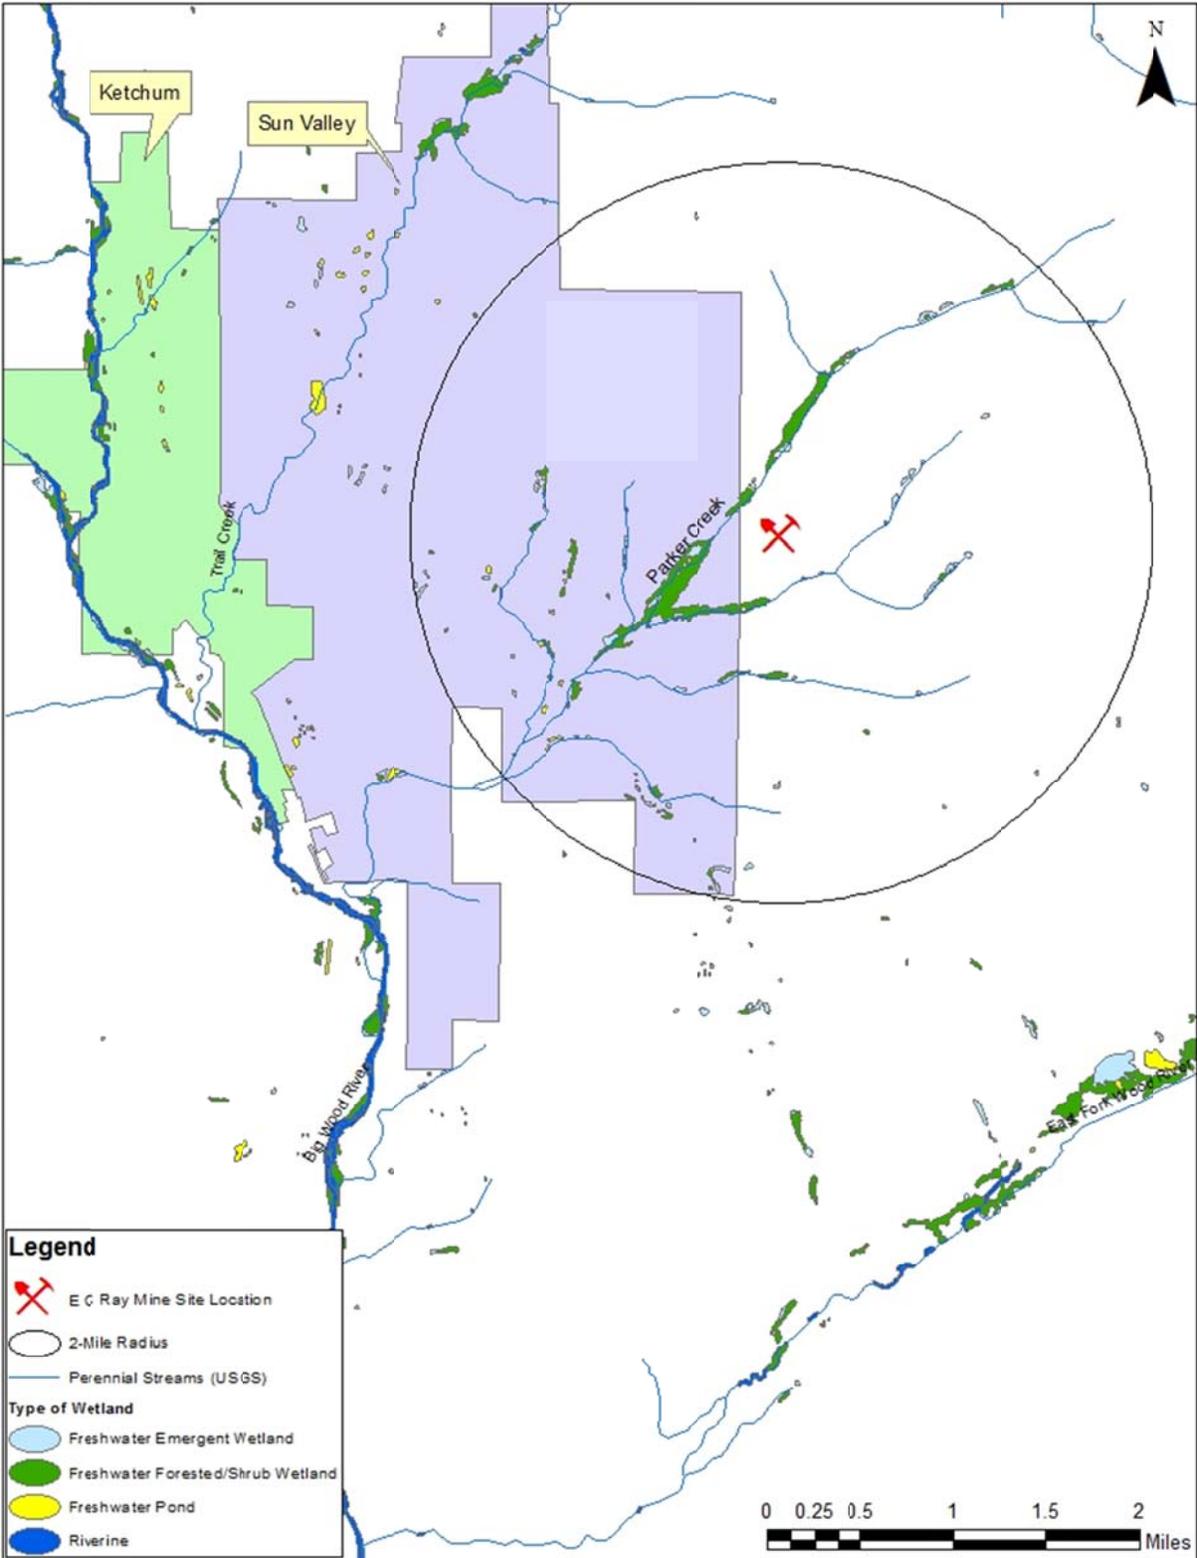
Figure 5. Wetland locations.
