Camas Creek Subbasin Assessment and Total Maximum Daily Load

Final, August 2005

**Prepared by:
Jennifer Claire
Twin Falls Regional Office
Department of Environmental Quality
601 Pole Line Road, Suite #2
Twin Falls, Idaho 83301**

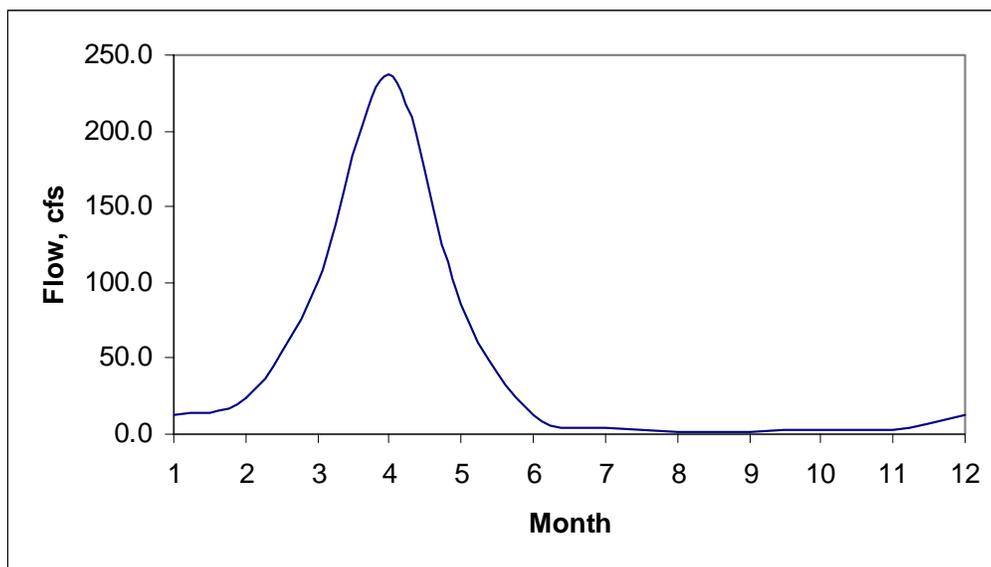
Figure 3. Camas Creek Subbasin average hydrology.

A number of natural and anthropogenic activities or conditions occur in the Camas Creek Subbasin that impact the hydrology of the subbasin. Figure 3 depicts the average annual hydrograph for several of the water bodies (this data includes flow data collected from 1970 to 2003).

Spring runoff in the subbasin is early and rapid. The majority of the flow occurs in March and April. Less than 1 cubic feet per second (cfs) of flow occurred in July, August, September, and November.

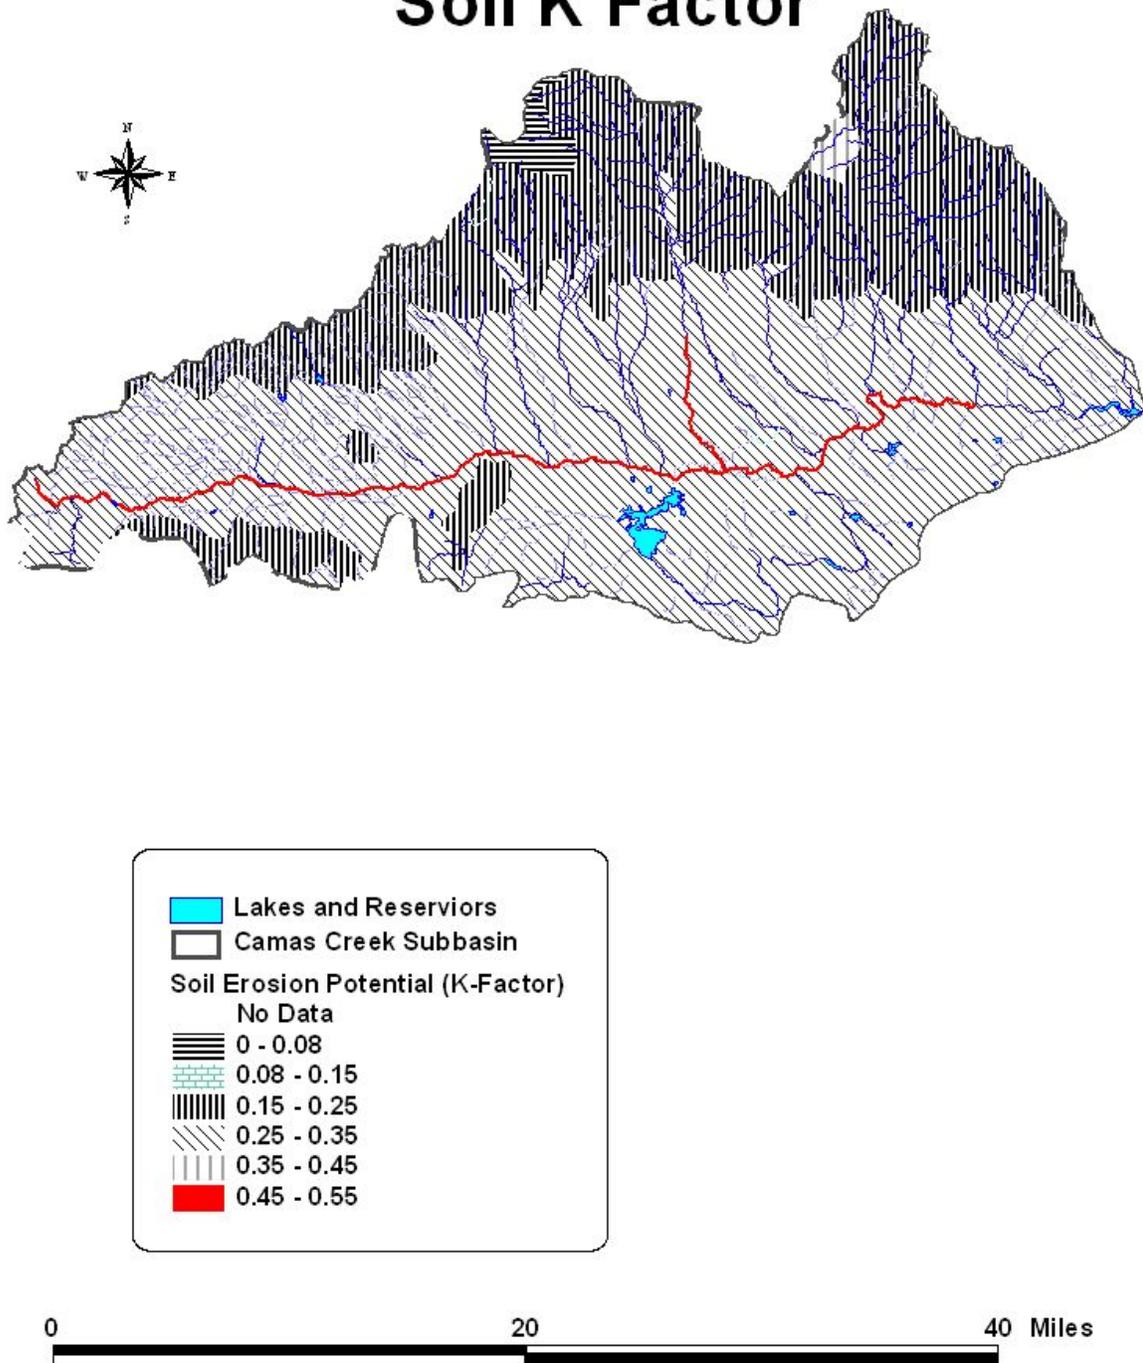
Figure 6. Soil erosivity (K factors) of the Camas Creek Subbasin.

K factor is a measure of the susceptibility of soil to erosion and runoff . Soils with K factor values of 0.05 to 0.15 are resistant to detachment; soils with K factor values of 0.05 to 0.2 tend to be easily detached but have low runoff. Soils with higher K factors of 0.25 to 0.4 are moderately susceptible to detachment and have moderate runoff. Soils with K factors of 0.4 or greater are easily detached and have high rates of runoff (MSU 2005).

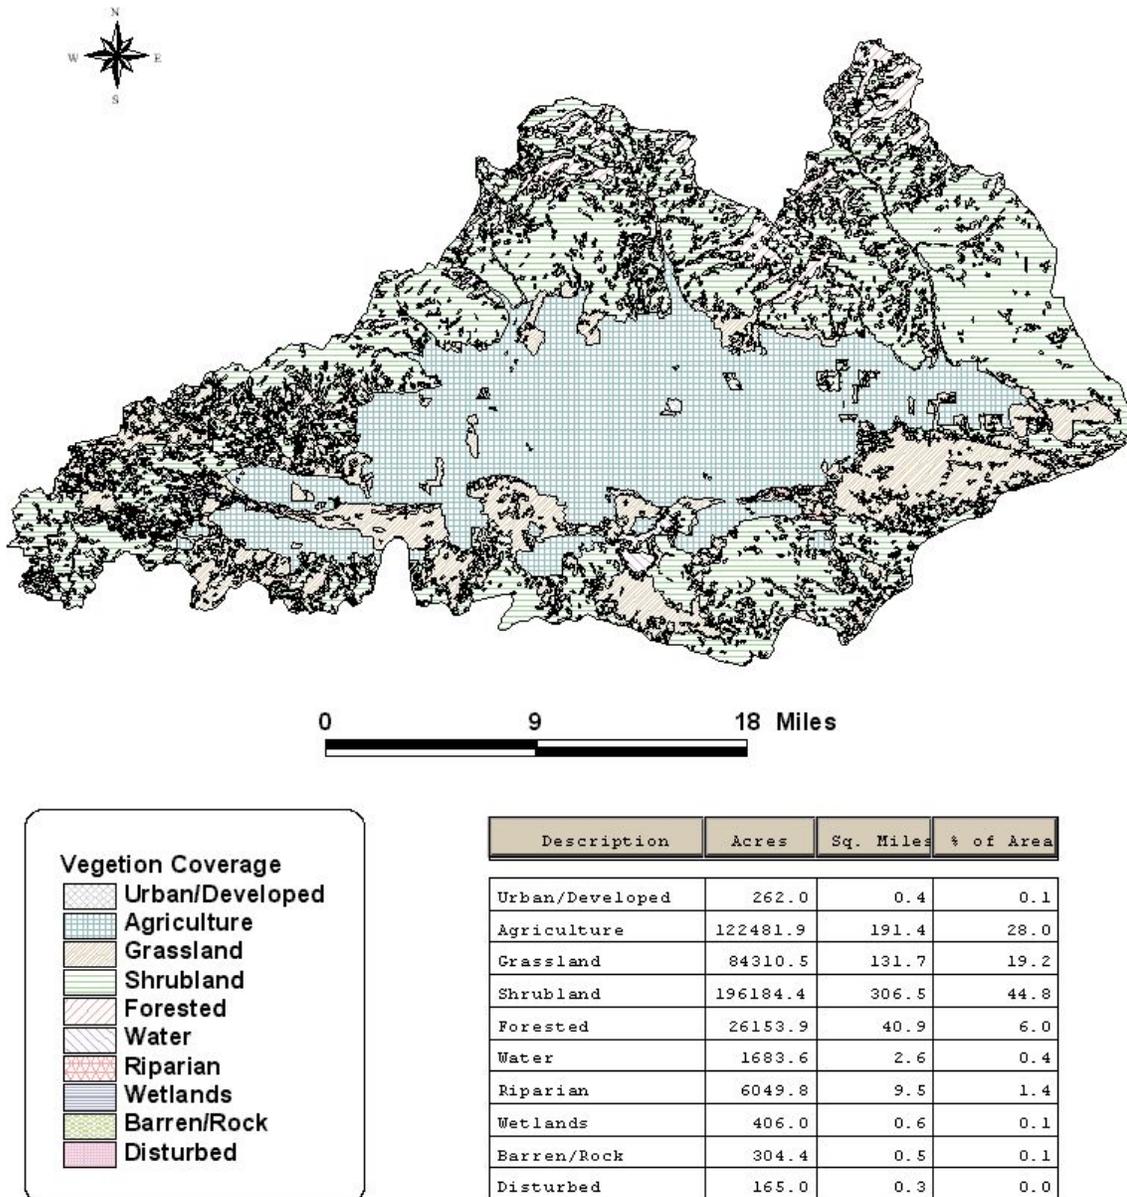
Figure 7. Vegetation coverage of the Camas Creek Subbasin.

The Camas Creek Subbasin vegetation consists mainly of agriculture, grassland, and shrubland (Figure 7). There is very little (2.1 % of the area) urban/developed, water, riparian, wetland, barren/rock, and disturbed vegetation in this subbasin. Agriculture vegetation accounts for 28% of the subbasin area and occurs in the center of the subbasin. Grassland occurs in 19.2% of the area and is found dispersed around the edges of the agriculture vegetation, but mostly to the south. Shrubland covers the remainder of the area at 44.8%, with a little bit of forested vegetation (6.0%) occurring in the north region (ArcView Coverage, 1992-1996).

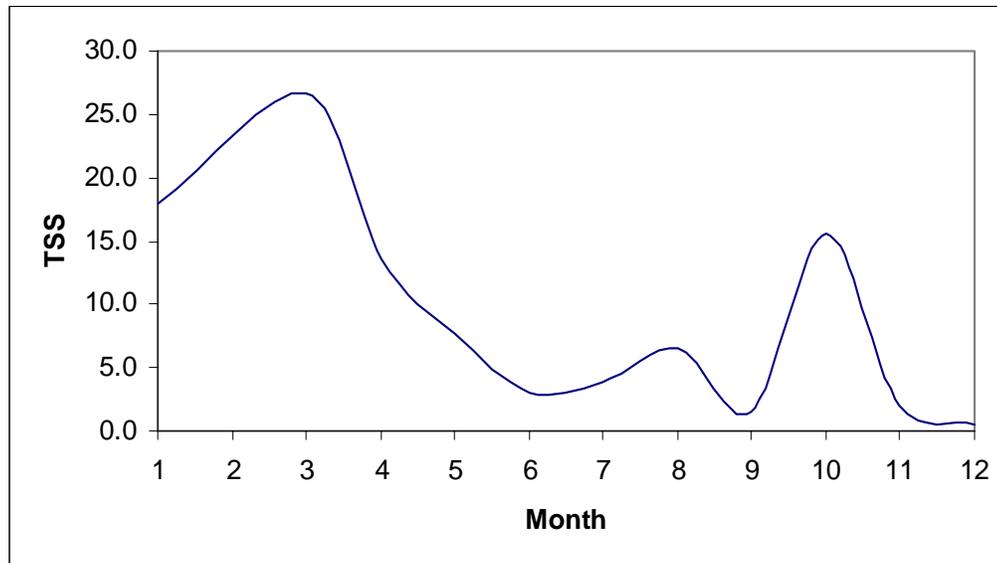
Figure 8. Average annual TSS (mg/L) in the subbasin.

There are two peak discharges of TSS, the first peak occurs during the spring runoff months and the second peak occurs in the fall during base flow events. Higher concentration of TSS would be expected during spring runoff as the stream flows would likely be higher and more washload and suspended bed-material would be transported. A peak in the fall is less likely to be expected as velocities are low and are less likely to be carrying suspended bed-material loads. The peak is likely due to anthropogenic activities occurring in the subbasin, although late season precipitation events could also contribute to sediment loads during base flow events.

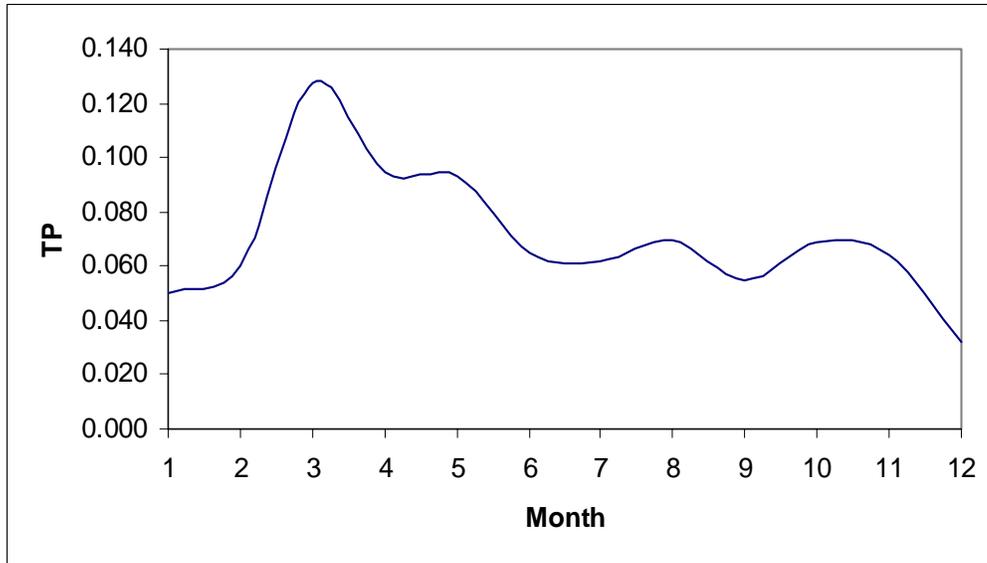
Figure 9. Average annual TP (mg/L) in the subbasin.

Figure 9 depicts the average annual discharge of TP in the Camas Creek Subbasin. There is one peak discharge of TP; the event occurs during the spring runoff months and early summer months when flow in the subbasin is highest. Peak discharges of TP in the runoff period would be expected as sediments are generally transported during high flows. The TP quantity would be elevated because TP has a high tendency to bind with sediments, therefore as sediment is transported so too is TP. The TP values throughout the rest of the year are fairly stable.

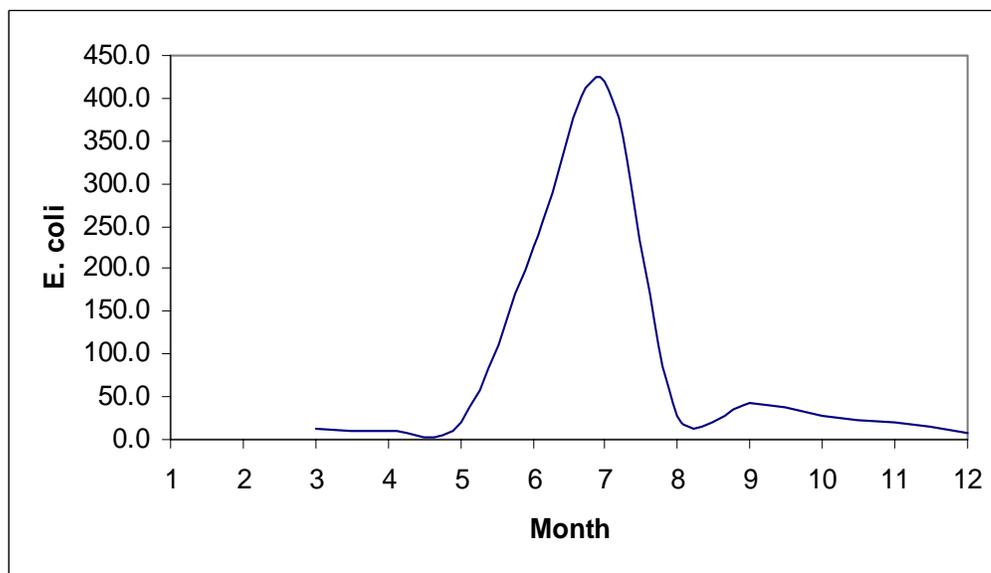
Figure 10. Average annual *E. coli* in the subbasin.

There are apt to be fluctuations in the bacteriological content of water in surface waters. These fluctuations tend to occur in the spring and fall when snow melt and rainfall introduce wash from the surrounding lands (Prescott 1931). Bacteria in the Camas Creek Subbasin were measured in the form of *Escherichia coli* (*E.coli*). Figure 10 depicts the average annual discharge of *E. coli* in the subbasin. *There are peaks in E. coli in the subbasin during the summer months.* These peaks are likely due to anthropogenic activities as there is less surface wash from precipitation events during the summer.

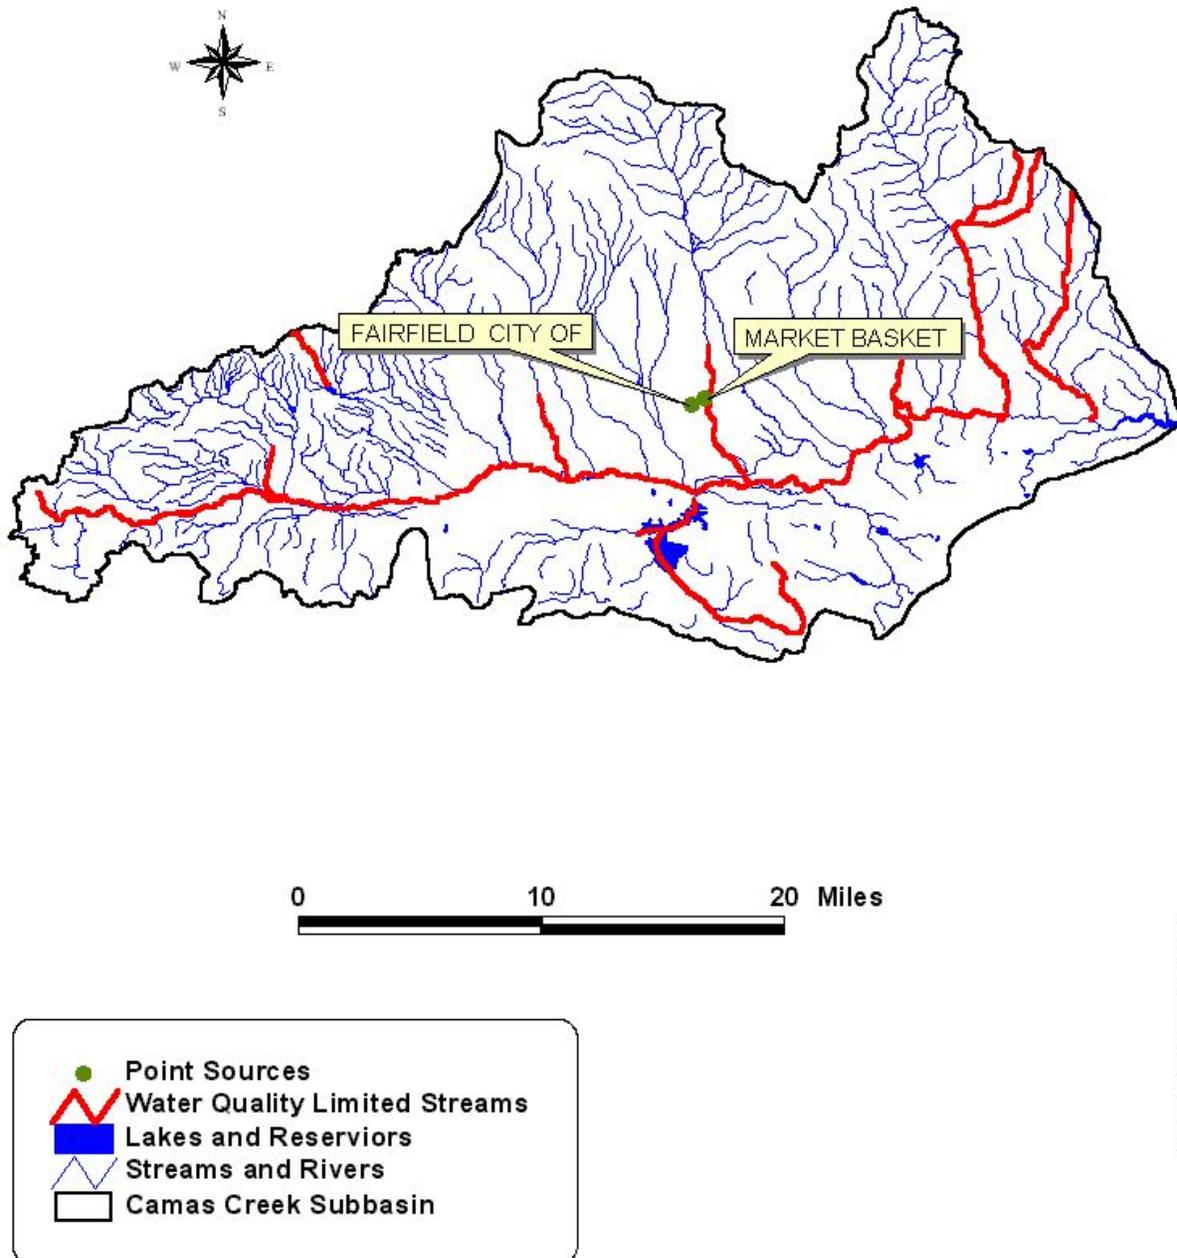
Figure 16. Point source facilities in the Camas Creek Subbasin.

The City of Fairfield is the only *National Pollutant Discharge Elimination System* (NPDES) permitted facility in the Camas Creek Subbasin (Table 14 and Figure 16). Market Basket in Fairfield has had an NPDES permit, however, it is now on the city’s system. The treatment train of the system is lagoons and rapid infiltration basins. The receiving water is an unnamed drainage ditch that drains into Soldier Creek and then eventually into Camas Creek. Prior to 1988 flow from the ditch reached Soldier Creek, but since this date the ditch has dried up. According to Discharge Monitoring Reports, the facility has discharged in the past very rarely. The facility has discharged from January to June of 1976, October to December of 1978, April to June of 1984, 1985, and 1988, and March of 1986 (DEQ 2004).

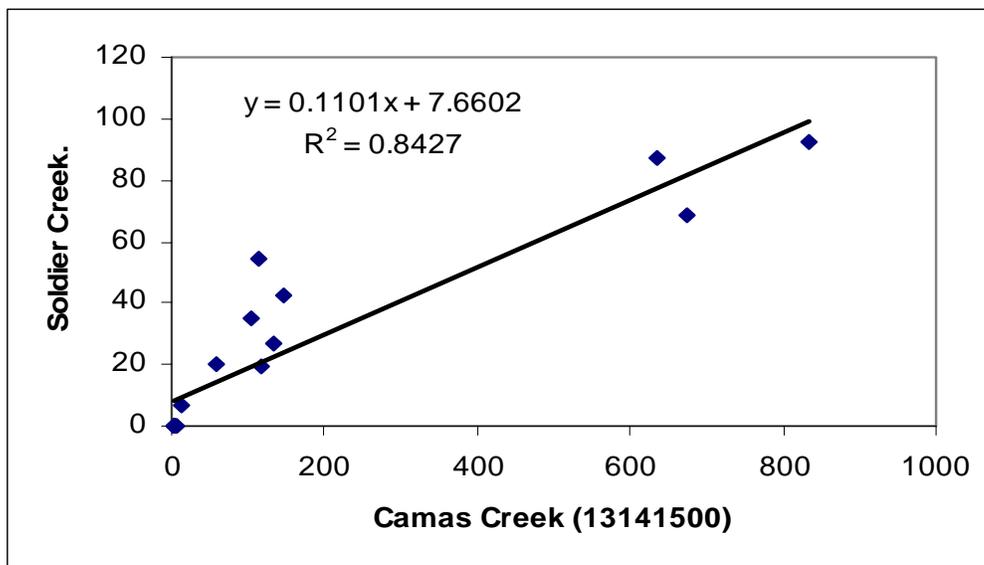
Figure 19. Soldier Creek flow (cfs) regression analysis.

The Camas Creek gauging station (13141500 – Camas Creek near Blaine, ID) is a functioning station that was used in predicting Soldier Creek flow. Soldier Creek and Camas Creek are in the same general areas, have similar ecoregions, and similar amounts of development. These similarities result in the assumption that precipitation and runoff in the Camas Creek and Soldier Creek watersheds was similar, as well as being similar throughout the period of record. Based on this assumption a linear regression model of Camas Creek flow versus Soldier Creek flow was performed using data collected on the same day (Figure 19). *The statistical values of the regression analysis ($p=0.000$, $r^2=0.843$) indicate that this model can be used to determine a predicted average flow for Soldier Creek (Figure 20).*

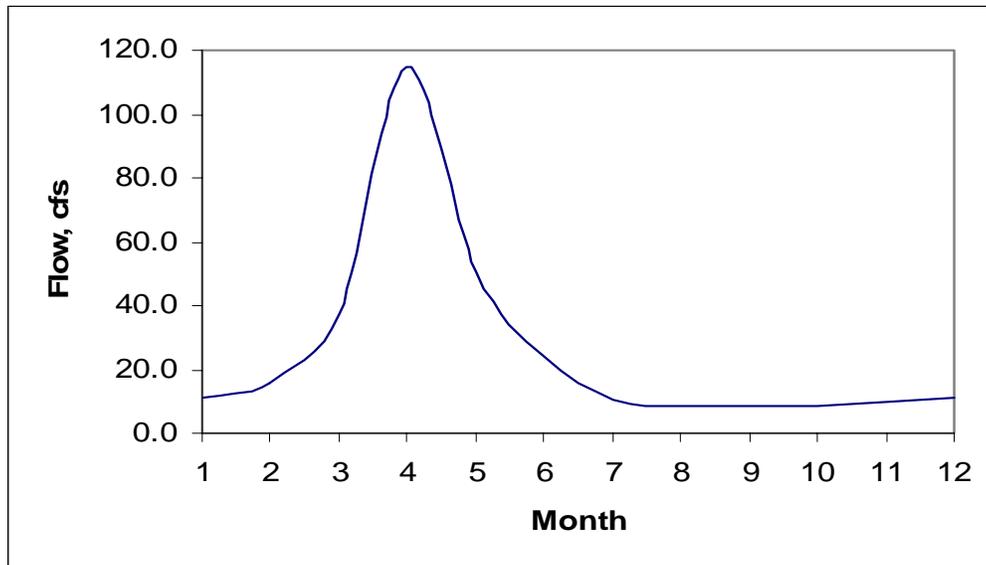
Figure 20. Soldier Creek predicted hydrograph.

Flows are the largest impact to beneficial uses within Soldier Creek. Predicted flows for Soldier Creek tend to peak rapidly in April. *This rapid peak is likely a result of south facing slopes as well as historic channel straightening.* High flow for Soldier Creek occurs in April and averages 114 cfs, with low flows occurring from June to March. The hydrograph predicts base flows, but does not show the *dry periods (July to March)* that have occurred likely due to drought, water diversions, and aquifer level fluctuations.

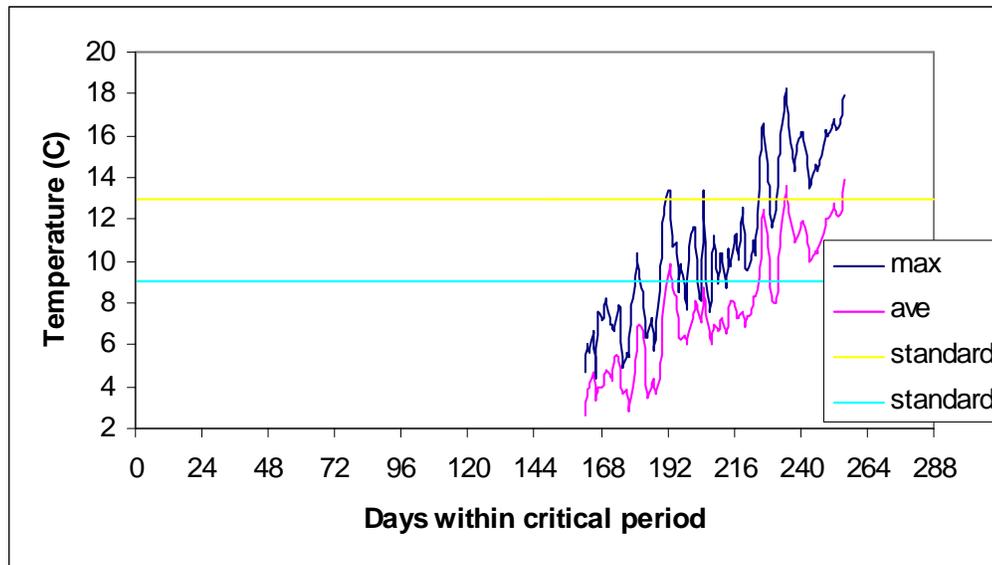
Figure 21. Soldier Creek SS temperatures (2003).

Temperature elevations may be being influenced by a number of activities, such as the following:

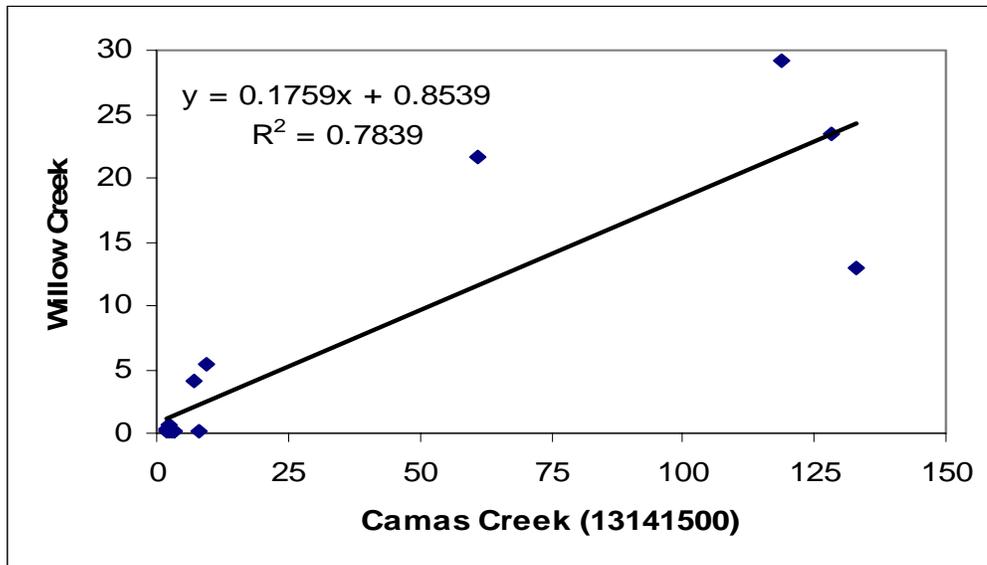
Figure 22. Willow Creek flow (cfs) regression analysis.

The Camas Creek gauging station (13141500- Camas Creek near Blaine, ID) is a functioning station that was used in predicting Willow Creek flow. Willow Creek and Camas Creek are in the same general areas, have similar ecoregions, and similar amounts of development. These similarities result in the assumption that precipitation and runoff in the Camas Creek and Willow Creek watersheds was similar, as well as being similar throughout the period of record. Based on this assumption a linear regression model of Camas Creek flow versus Willow Creek flow was performed using data collected on the same day for both watersheds (Figure 22). *The statistical values of the regression analysis ($p=0.000$, and $r^2=0.784$) indicate that this model can be used to determine a predicted average flow for Willow Creek (Figure 23).*

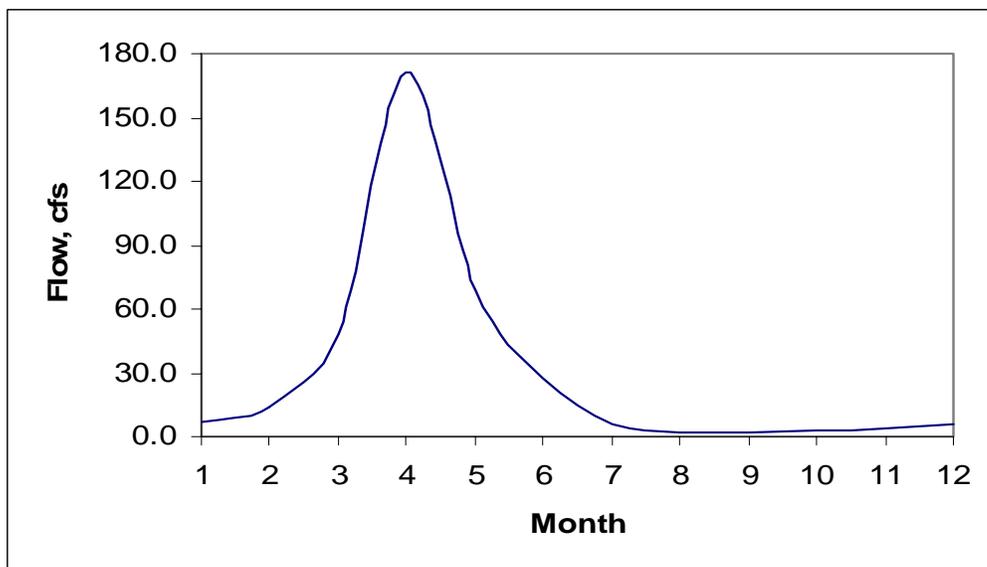
Figure 23. Willow Creek predicted hydrograph.

Flows do not appear to be impacting beneficial uses of Willow Creek. Predicted flows for Willow Creek tend to peak rapidly in April. This rapid peak is likely a result of south facing slopes. High flow for Willow Creek occurs in April and averages 171.5 cfs, with low flows occurring from June to March. The hydrograph predicts base flows, but does not show the dry periods that have been recorded as occurring in middle stretches of Willow Creek during drought years. *Willow Creek has perennial flows in the upper portion of the watershed and the lower portion of the watershed. Willow Creek contributes perennial flow to Camas*

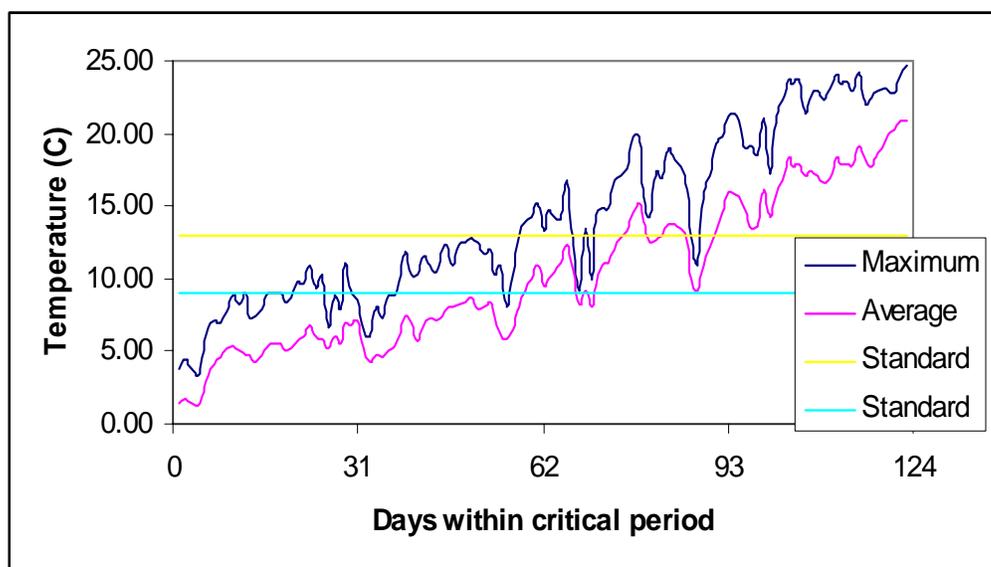
Figure 24. Willow Creek SS temperatures (2002).

Temperature elevations may be being influenced by a number of activities, such as the following:

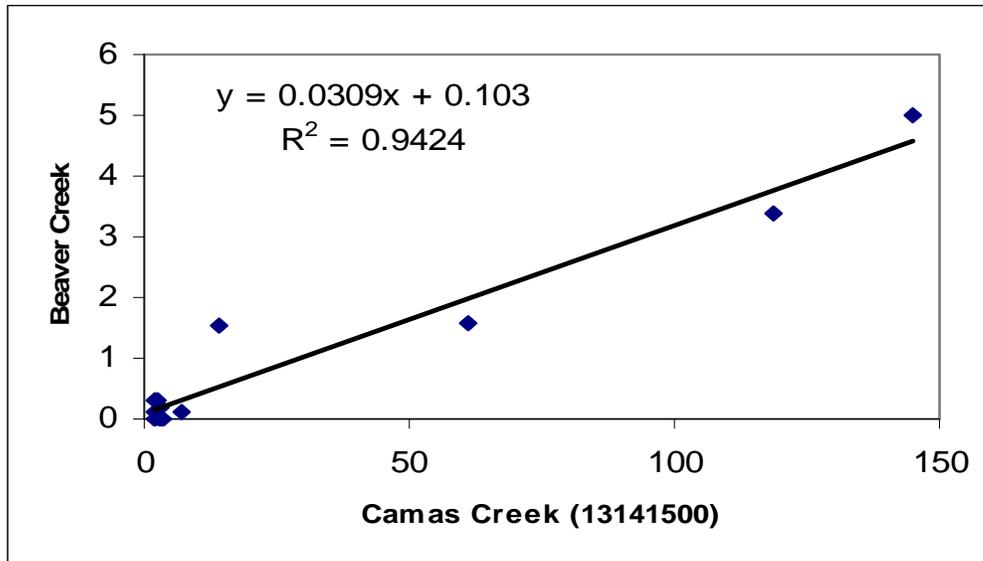
Figure 25. Beaver Creek flow (cfs) regression analysis.

The Camas Creek gauging station (13141500-Camas Creek near Blaine, ID) is a functioning station that was used in predicting Beaver Creek flow. Beaver Creek and Camas Creek are in the same general areas, have similar ecoregions, and similar amounts of development. These similarities result in the assumption that precipitation and runoff in the Camas Creek and Beaver Creek watersheds was similar, as well as being similar throughout the period of record. Based on this assumption, a linear regression model of Camas Creek flow versus Beaver Creek flow was performed using data collected on the same day (Figure 25). *The statistical values of the regression analysis ($p=0.000$, $r^2=0.942$) indicate that this model can be used to determine a predicted average flow for Beaver Creek (Figure 26).*

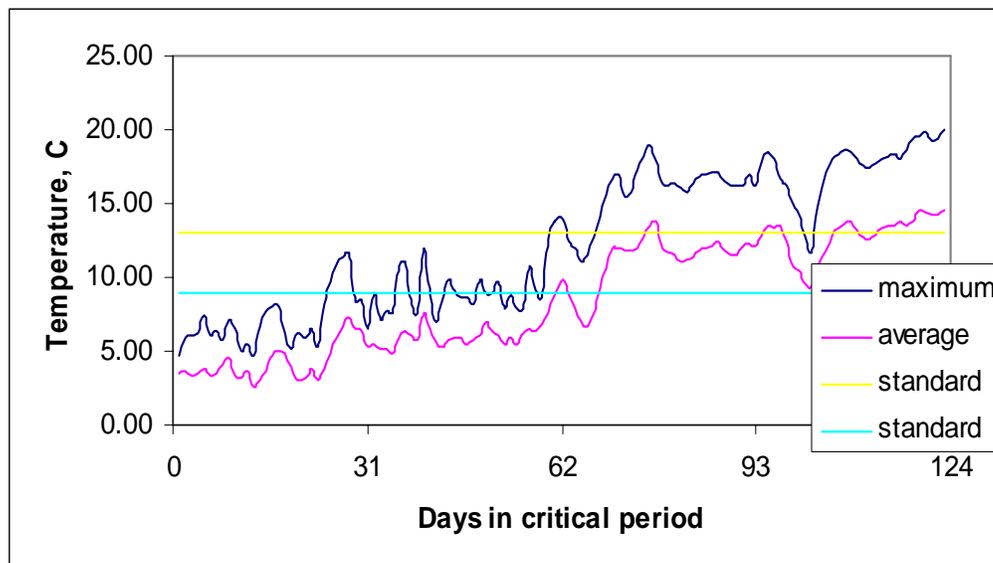
Figure 27. Beaver Creek SS temperatures (2003).

Temperature elevations may be influenced by a number of activities, such as the following:

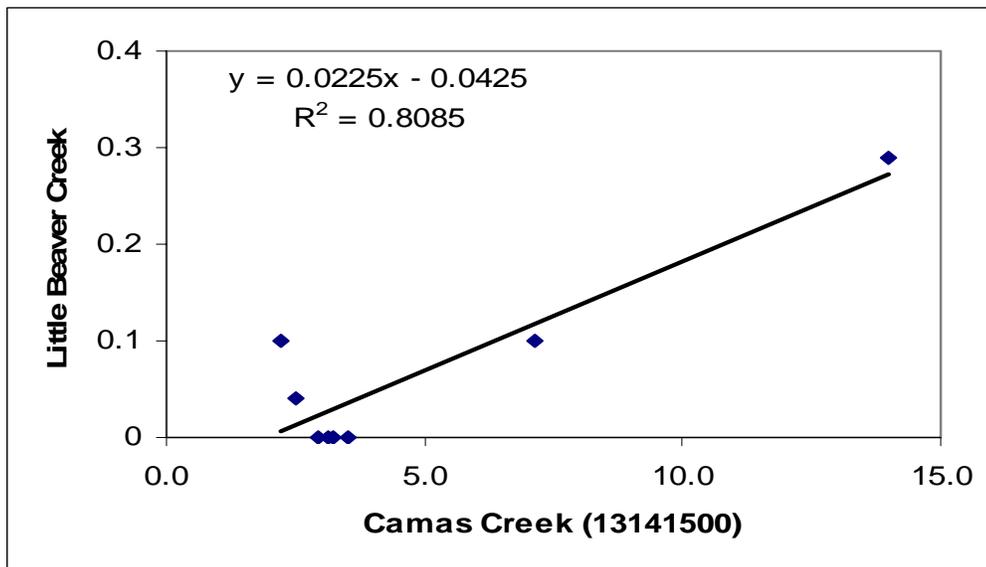
Figure 28. Little Beaver Creek flow (cfs) regression analysis.

The Camas Creek gauging station (13141500-Camas Creek near Blaine, ID) is a current station that was used in predicting Little Beaver Creek flow. Little Beaver Creek and Camas Creek are in the same general areas, have similar ecoregions, and similar amounts of development. These similarities result in the assumption that precipitation and runoff in the Camas Creek and Little Beaver Creek watersheds was similar as well as being similar throughout the period of record. Based on this assumption a linear regression model of Camas Creek flow versus Little Beaver Creek flow was performed using data collected on the same day (Figure 28). *The statistical values of the regression analysis ($p=0.002$, $r^2=0.809$) indicate that this model can be used to determine a predicted average flow for Little Beaver Creek (Figure 29).*

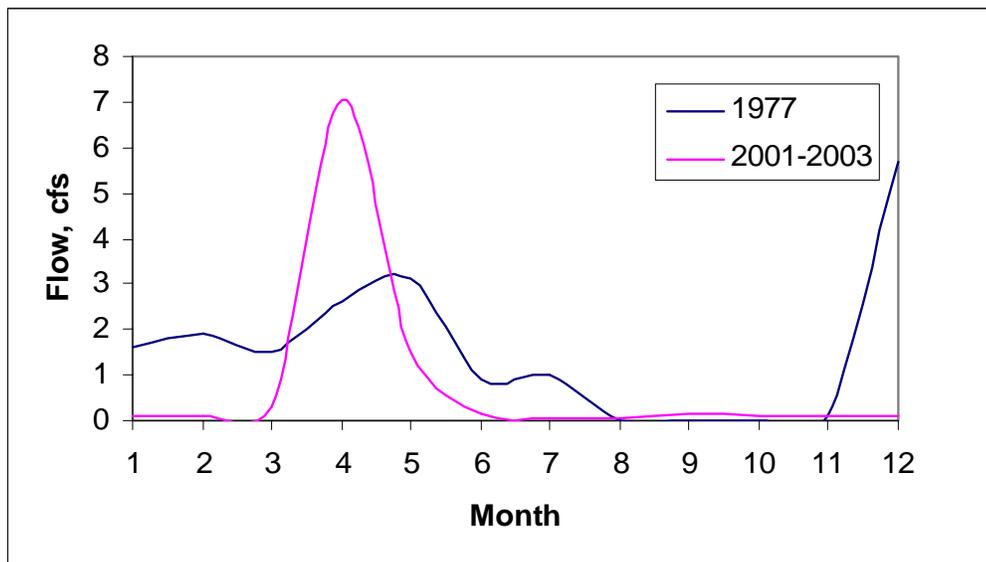
Figure 31. Camp Creek actual hydrograph in drought years (1977, 2001-2003).

The Camas Creek gauging station (13141500) near Blaine, Idaho is a current station that was used in predicting Camp Creek flow. Camas Creek and Camp Creek are in the same general areas, have similar ecoregions, and similar amounts of development. These similarities result in the assumption that precipitation and runoff in the Camas Creek and Camp Creek watersheds was similar as well as being similar throughout the period of record. Based on this assumption a linear regression model of Camas Creek flow versus Camp Creek flow was performed using data collected on the same day. *The statistical values of the regression analysis ($p=0.002$, $r^2=0.582$) indicate that this model is not the best predictor of average flow for Camp Creek, as a result historical and current actual data was used to show the flow conditions of Camp Creek during drought years (Figure 31).*

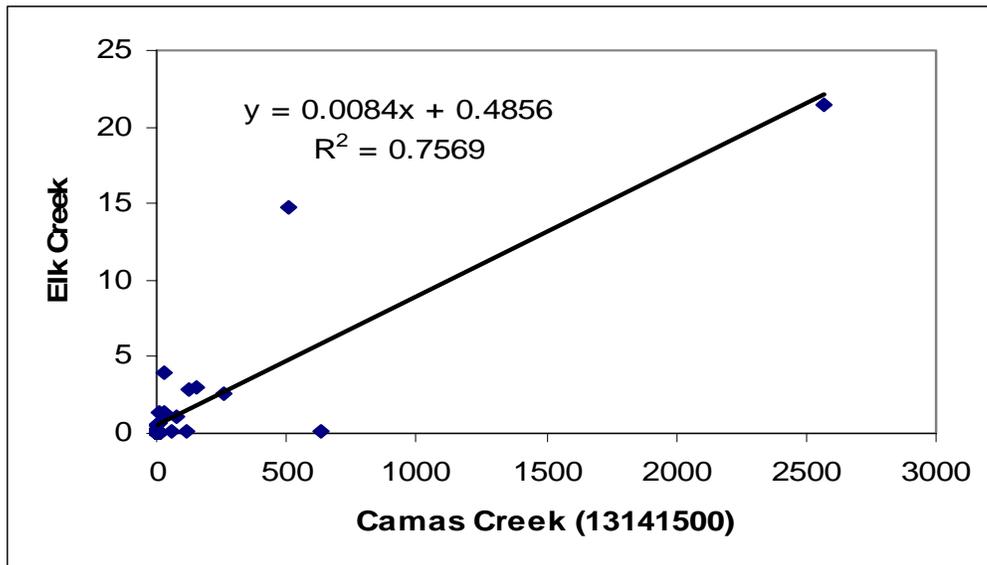
Figure 33. Elk Creek flow (cfs) regression analysis.

in the assumption that precipitation and runoff in the Camas Creek and Elk Creek watersheds was similar as well as being similar throughout the period of record. Based on this assumption a linear regression model of Camas Creek flow versus Elk Creek flow was performed using data collected on the same day (Figure 33). *The statistical values of the regression analysis ($p=0.000$, $r^2=0.757$) indicate that this model can be used to determine a predicted average flow for Elk Creek (Figure 34).*

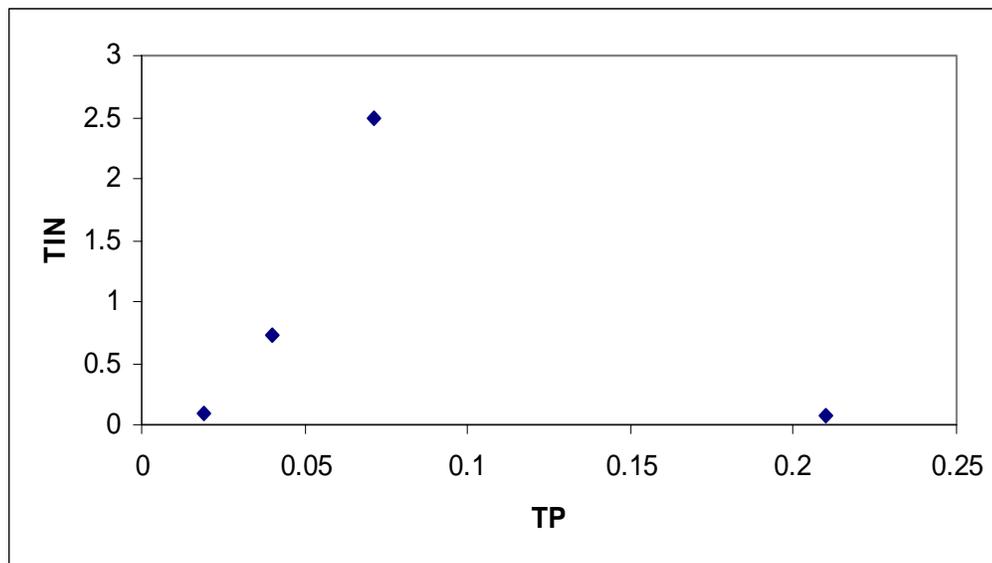
Figure 35. Comparison of TP (mg/L) and TIN (mg/L) values.

The elevated TIN values at first appear to be a concern, however, in relation to nuisance aquatic vegetation, TIN and TP values together are truly the important values. If both TP and TIN values were elevated then there would likely be a nuisance aquatic plant problem. *A comparison of TP and TIN values indicates that when TP levels are higher TIN levels are lower and when TIN levels are higher TP levels are lower (Figure 35). Aquatic nuisance vegetation is not a problem in this water body as there is only about a mile of the stream (half a mile in the headwaters and half a mile at the mouth) that has flow during the growing period. However, it appears that if perennial flows are returned to the creek, nutrient levels may need to be further studied.*

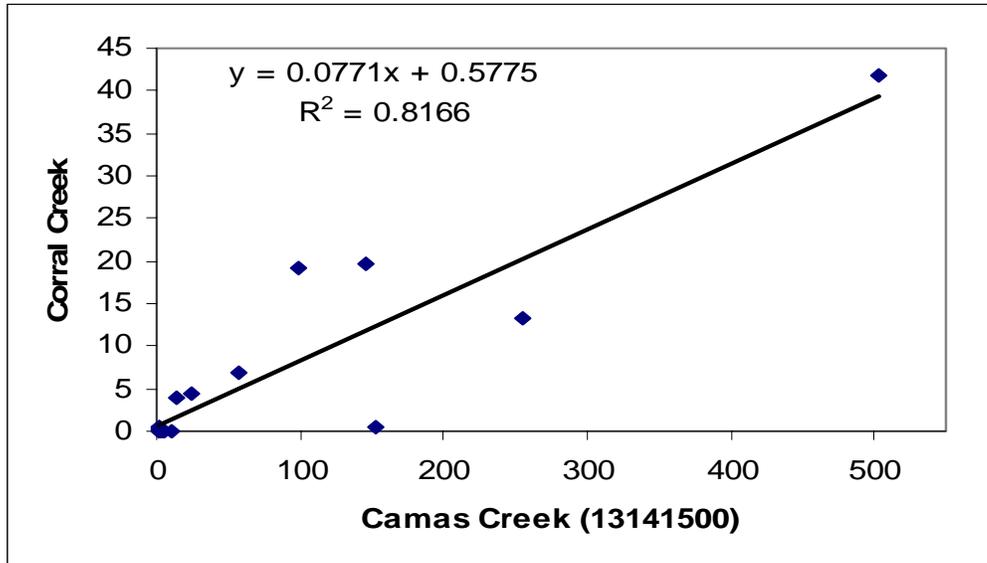
Figure 36. Corral Creek flow (cfs) regression analysis.

The Camas Creek gauging station (13141500) near Blaine, Idaho is a current station that was used in predicting Corral Creek flow. Corral Creek and Camas Creek are in the same general areas, have similar ecoregions, and similar amounts of development. These similarities result in the assumption that precipitation and runoff in the Camas Creek and Corral Creek watersheds was similar as well as being similar throughout the period of record. Based on this assumption a linear regression model of Camas Creek flow versus Corral Creek flow was performed using data collected on the same day (Figure 36). *The statistical values of the regression analysis ($p=0.000$, $r^2=0.817$) indicate that this model can be used to determine a predicted average flow for Corral Creek (Figure 37).*

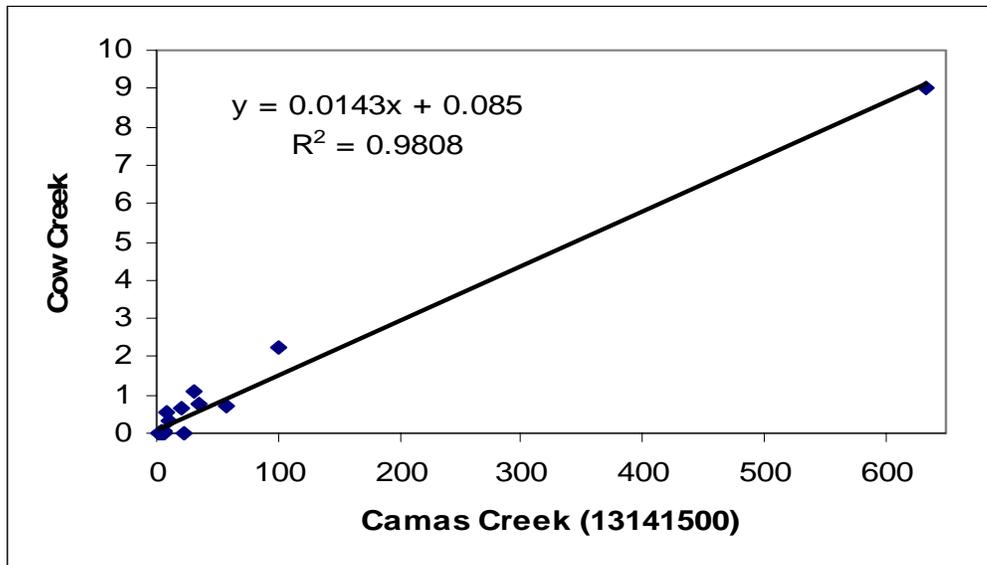
Figure 39. Cow Creek (above the reservoir) flow (cfs) regression analysis.

The Camas Creek gauging station (13141500) near Blaine, Idaho is a current station that was used to predict Cow Creek flow. Cow Creek and Camas Creek are in the same general areas, have similar ecoregions, and similar amounts of development. These similarities result in the assumption that precipitation and runoff in the Camas Creek and Cow Creek watersheds was similar as well as being similar throughout the period of record. Based on this assumption a linear regression model of Camas Creek flow versus Cow Creek flow was performed using data collected on the same day (Figure 39). *The statistical values of the regression analysis ($p=0.000$, $r^2=0.981$) indicates that this model can be used to determine a predicted average flow for Cow Creek (above the reservoir) (Figure 40).*

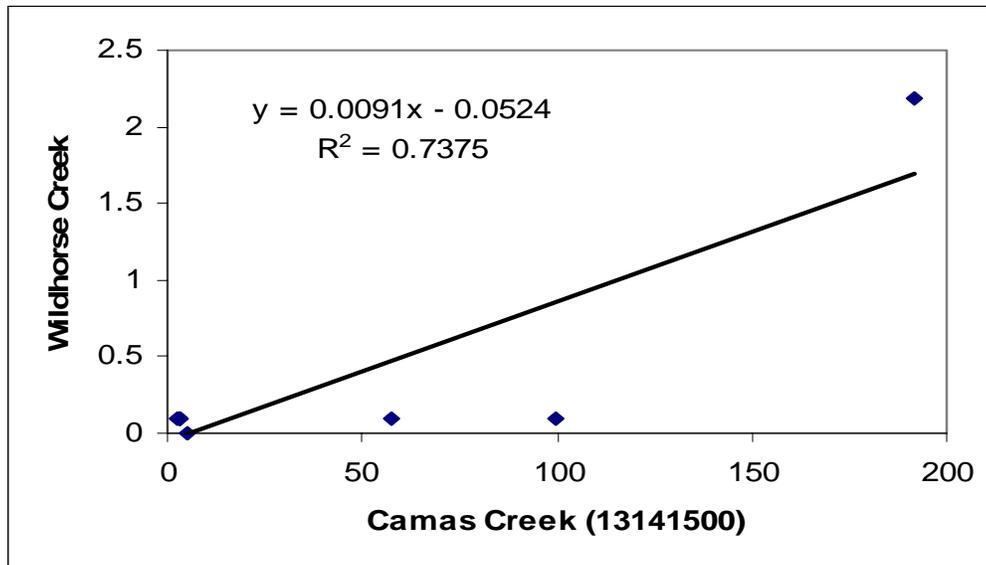
Figure 41. Wild Horse Creek flow (cfs) regression analysis.

The Camas Creek gauging station (13141500) near Blaine, Idaho is a current station that was used in predicting Wild Horse Creek flow. Wild Horse Creek and Camas Creek are in the same general area, have similar ecoregions, and similar amounts of development. These similarities result in the assumption that precipitation and runoff in the Camas Creek and Wild Horse Creek watersheds was similar as well as being similar throughout the period of record. Based on this assumption a linear regression model of Camas Creek flow versus Wild Horse Creek flow was performed using data collected on the same day (Figure 41). *The statistical values of the regression analysis ($p=0.003$ and $r^2=0.738$) indicate that this model can be used to determine a predicted average flow for Wild Horse Creek (Figure 42).*

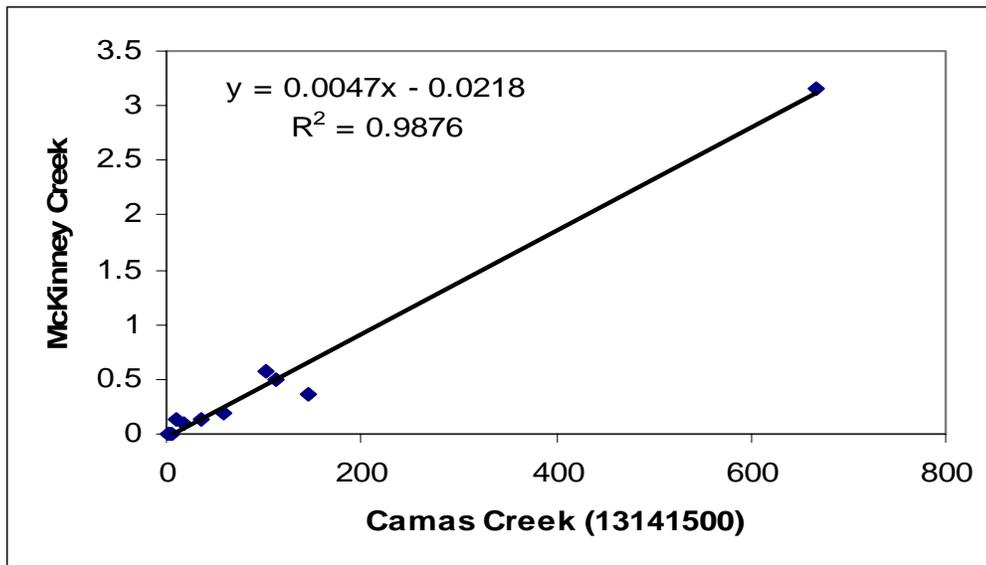
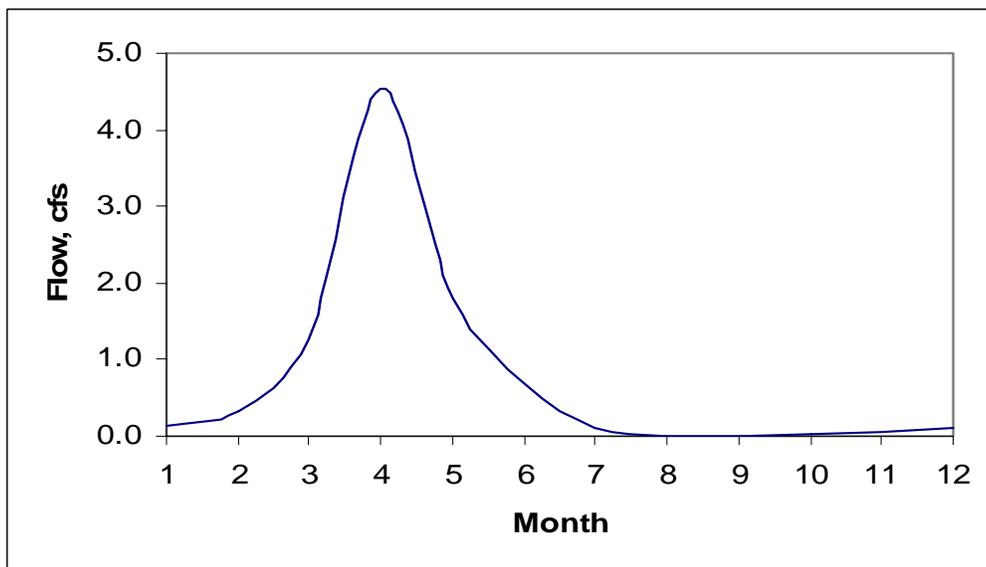
Figure 45. McKinney Creek predicted hydrograph.

statistical values of the regression analysis ($p=0.000$, $r^2=0.738$) indicates that this model can be used to determine a predicted average flow for McKinney Creek (Figure 45).

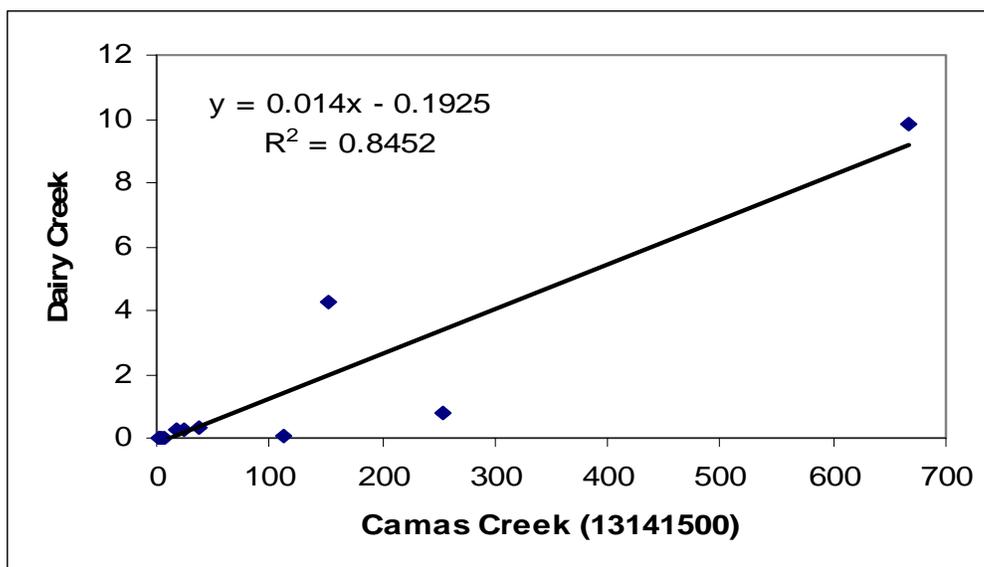
Figure 46. Dairy Creek flow (cfs) regression analysis.

The Camas Creek gauging station (13141500), near Blaine, Idaho, is a current station that was used in predicting Dairy Creek flow. Dairy Creek and Camas Creek are in the same general areas, have similar ecoregions, and similar amounts of development. These similarities result in the assumption that precipitation and runoff in the Camas Creek and Dairy Creek watersheds was similar as well as being similar throughout the period of record. Based on this assumption a linear regression model of Camas Creek flow versus Dairy Creek flow was performed using data collected on the same day (Figure 46). *The statistical values of the regression analysis ($p=0.000$ and $r^2=0.845$) indicate that this model can be used to determine a predicted average flow for Dairy Creek (Figure 47).*

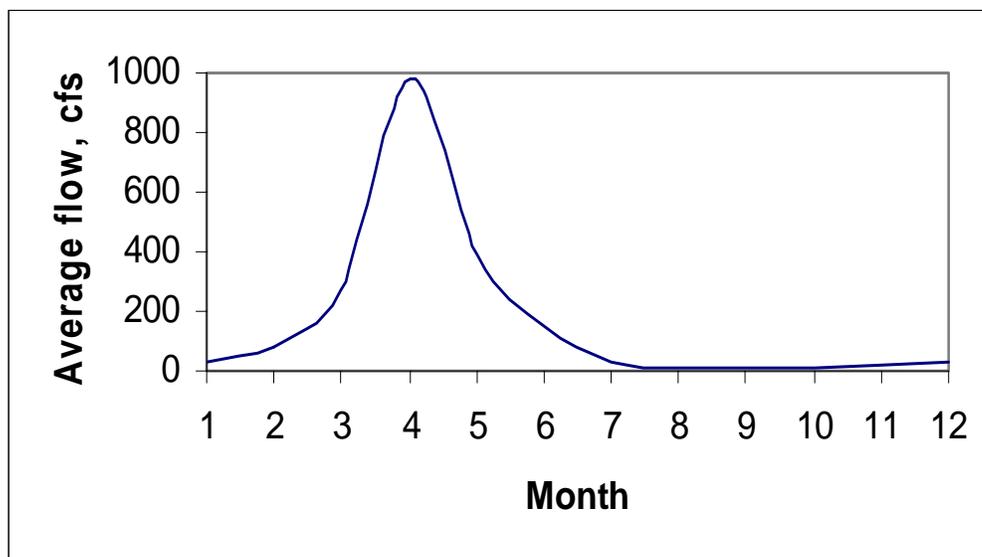
Figure 48. Camas Creek annual hydrograph.

Flows are impacting the water quality and beneficial uses of Camas Creek. Camas Creek has a gauging station that has been in place near the confluence with Magic Reservoir since 1912. This gauging station (13141500) data were used to create the hydrograph of Camas Creek (Figure 48). Flows for Camas Creek tend to increase in late March and decrease in early May. High flow for Camas Creek occurs in April and averages 970.2 cfs, with low flows occurring from June to March.

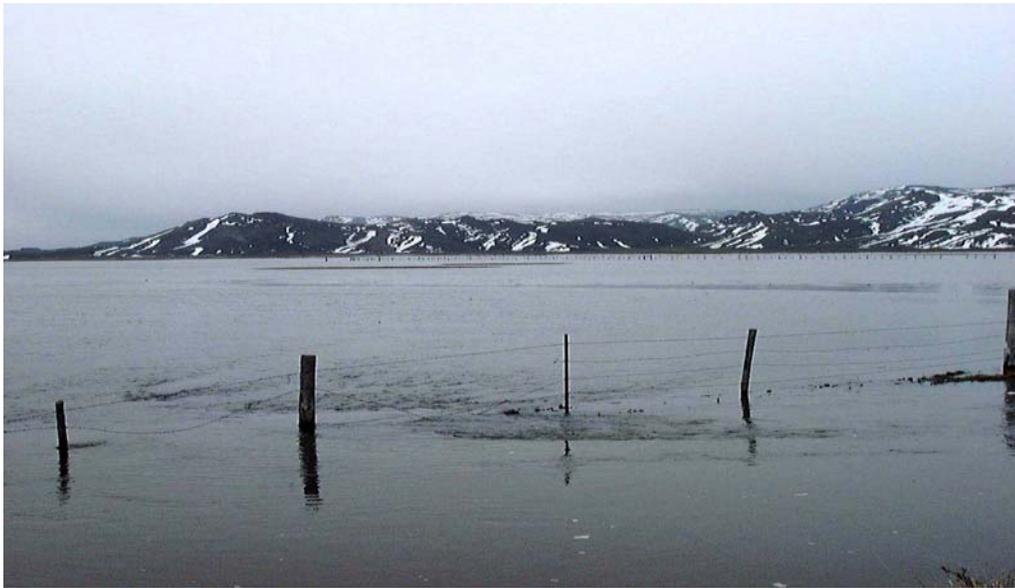
Figure 49. Camas Creek in spring runoff.

body goes dry during the summer; however, during spring runoff the valley bottom is covered in water (Figure 49).
