Idaho Nonpoint Source Program
Field Evaluation Annual Report

2004

Idaho Department of Environmental Quality

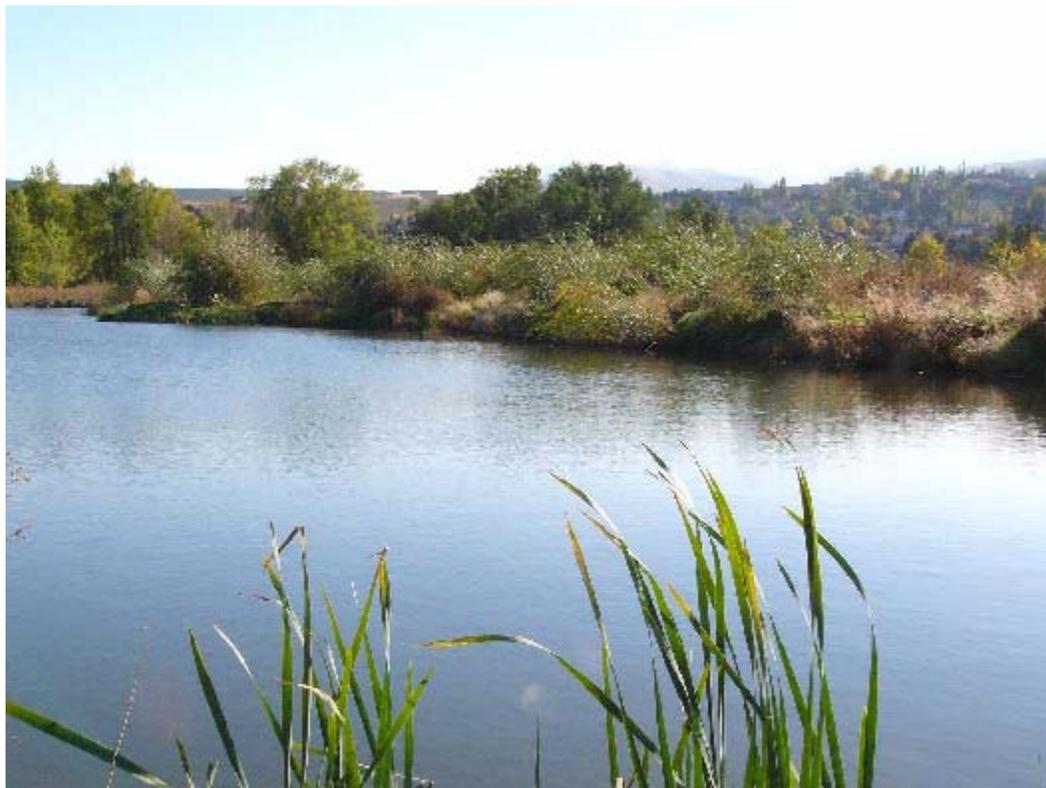
Figure 4. After one growing season, the settling pond banks looked very good.

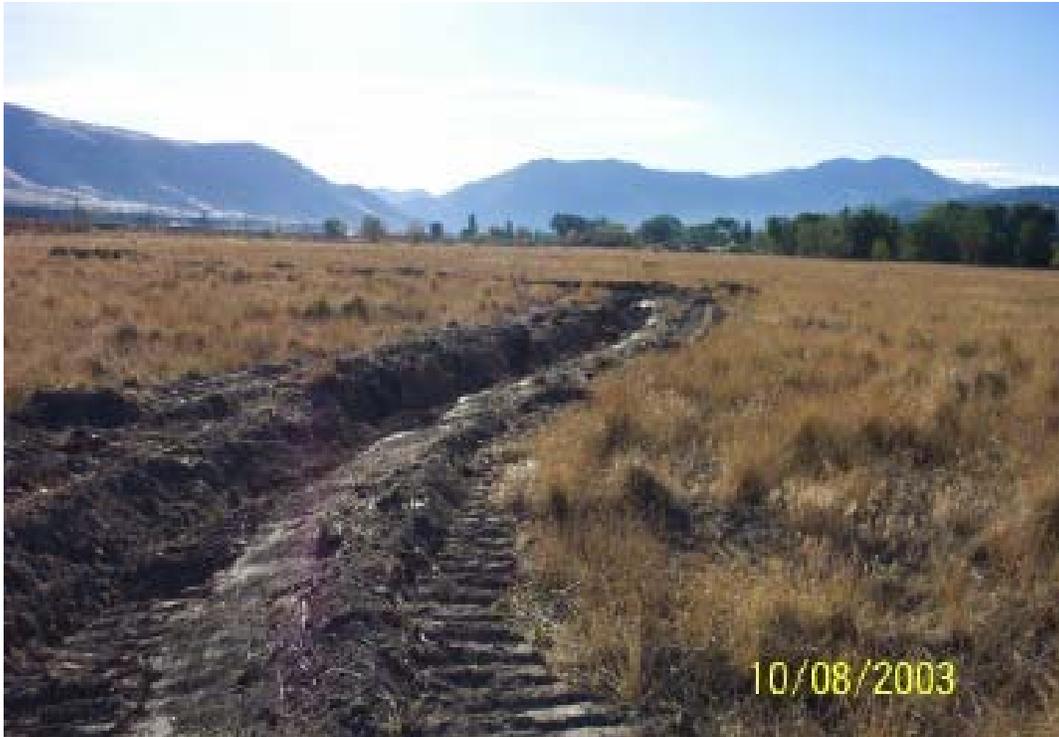
Figure 5. Inflow and outflow canals had to be constructed.

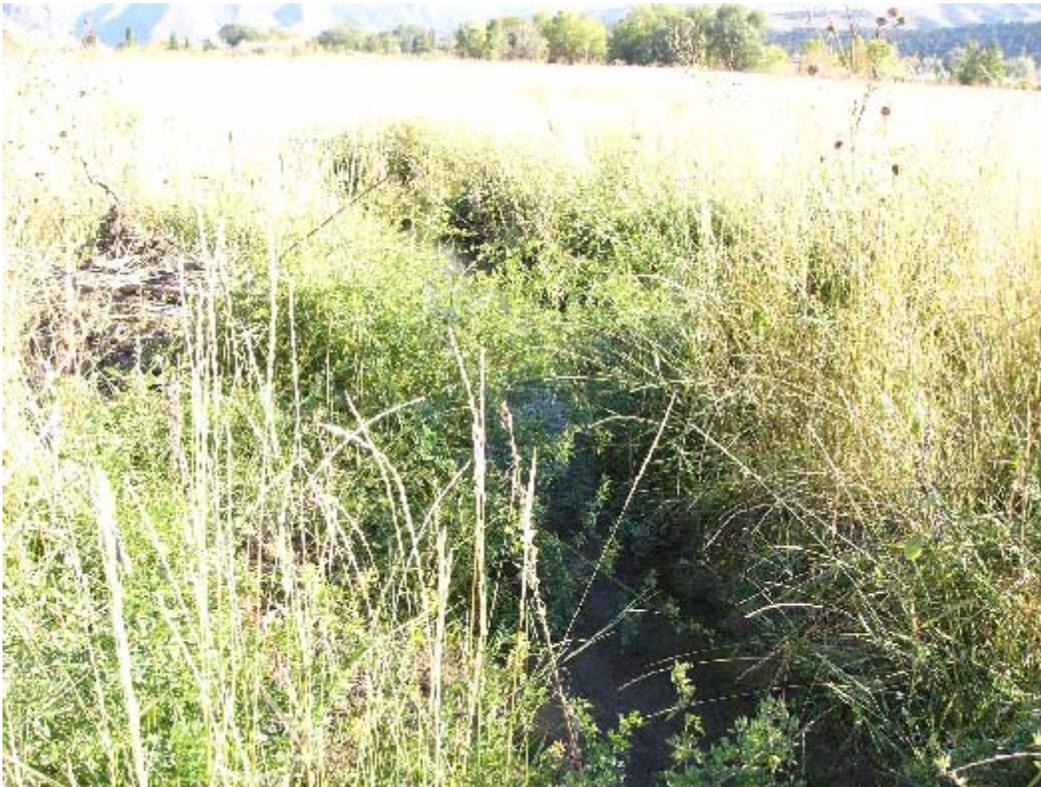
Figure 6. The inflow and outflow canals after one growing season.

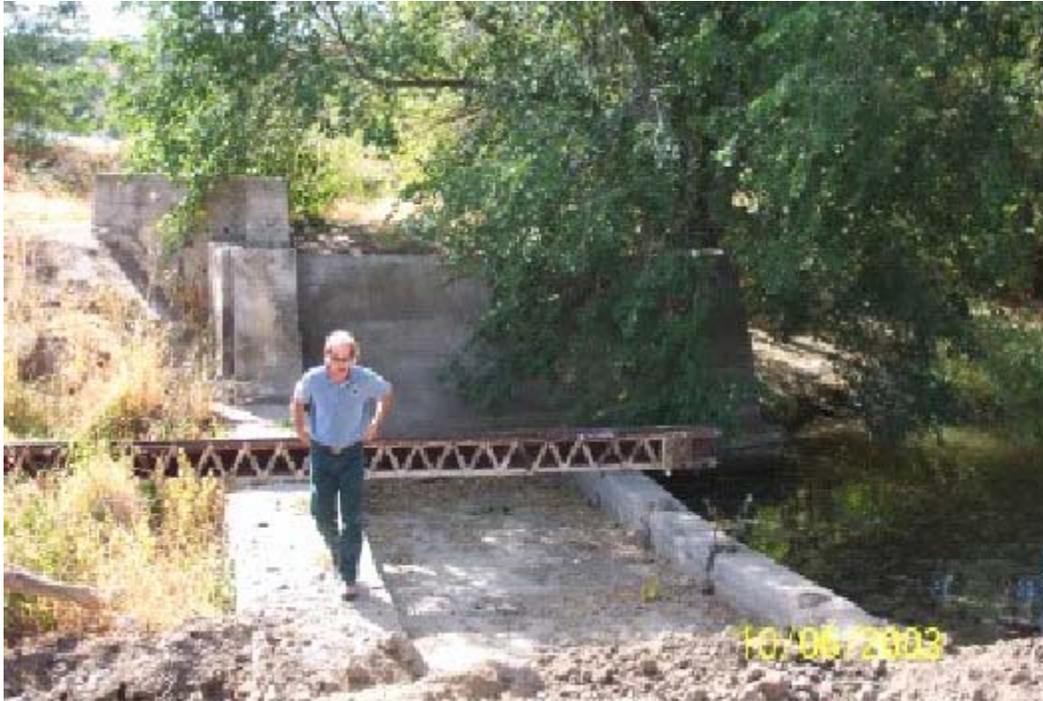
Figure 7. This old irrigation diversion dam was removed.

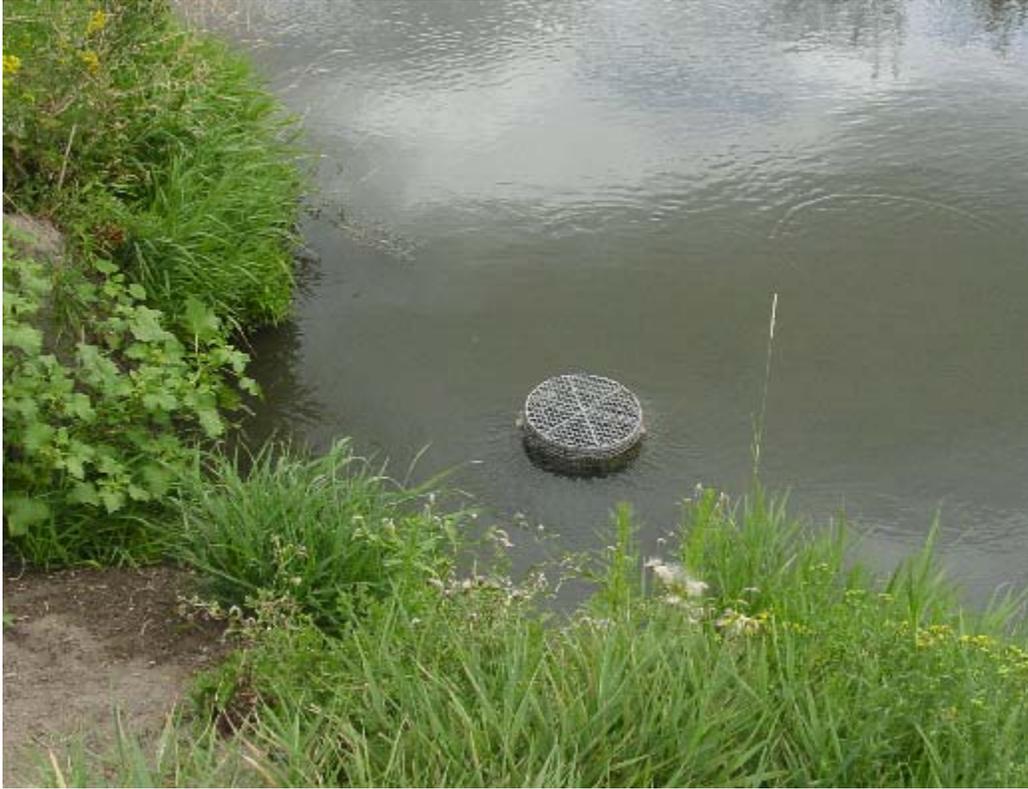
Figure 9. The water intake for the settling pond.

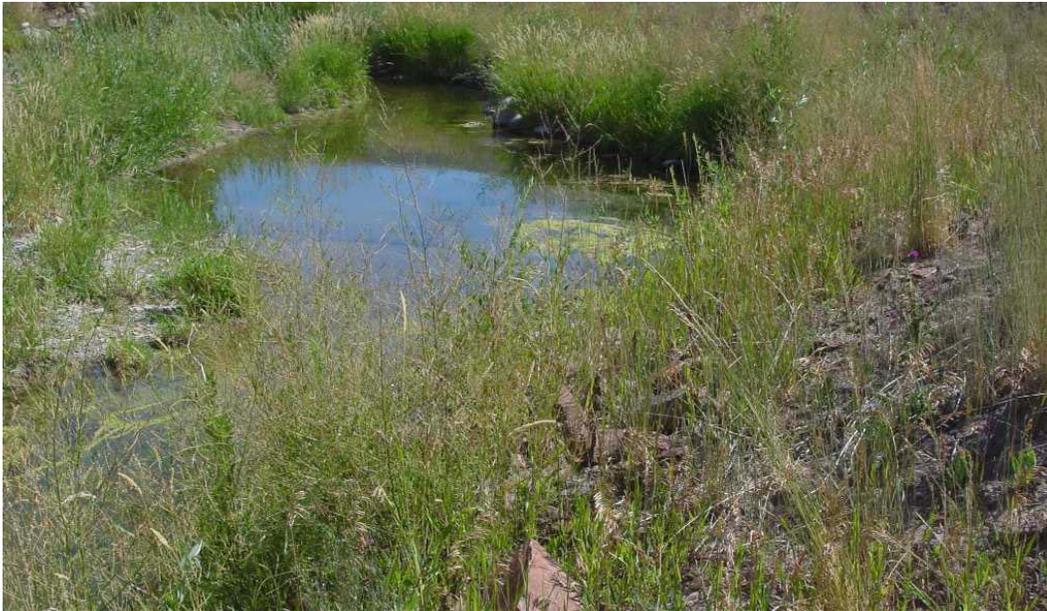
Figure 35. Illustration of the effectiveness of bank barbs at protecting degraded areas. The emergent vegetation near the bottom of the photo exists on an aggraded gravel bar produced by barb placement upstream.

Barbs are used to deflect the flow of the water away from sensitive areas to encourage growth of riparian vegetation. This method is also highly effective in promoting re-growth of riparian vegetation. Rock for the barbs is provided by nearby quarries—a benefit to the project and the local economy. This method provides a very small cost benefit ratio, and it will continue to be used on Thomas Fork. Other benefits produced by implementing barbs include the creation of pool riffle sequences and the reduction of stream width during low flow. Examples of the improvements realized using barbs can be seen in Figure 35.

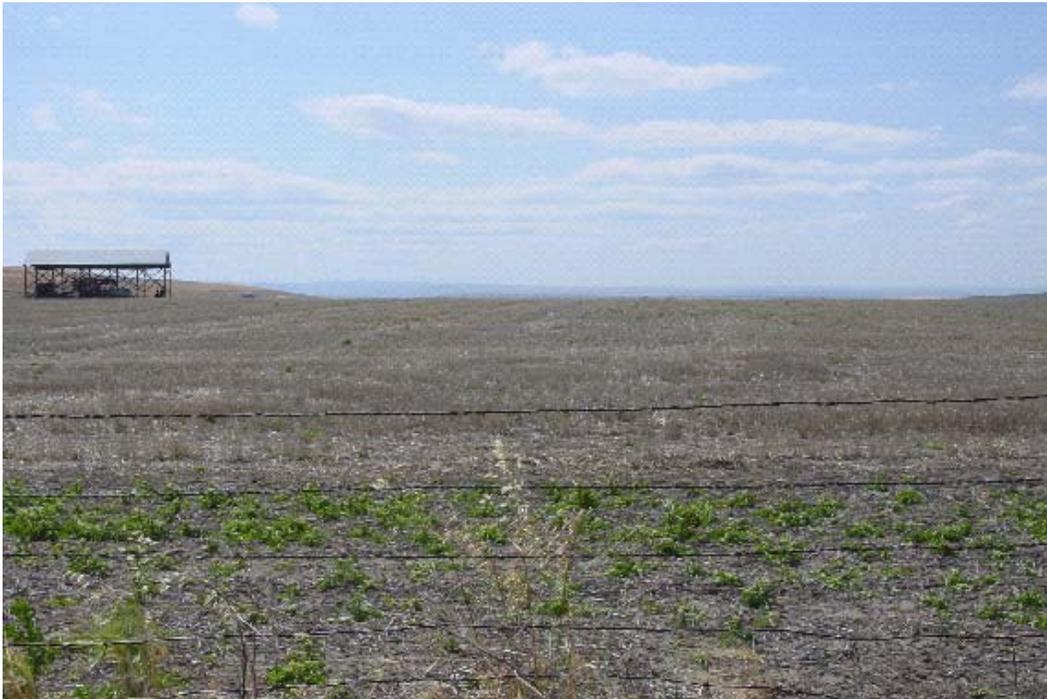
Figure 36. Low till farming techniques involve barely scratching the land surface and protecting the soil profile rather than disking and turning the soil over.

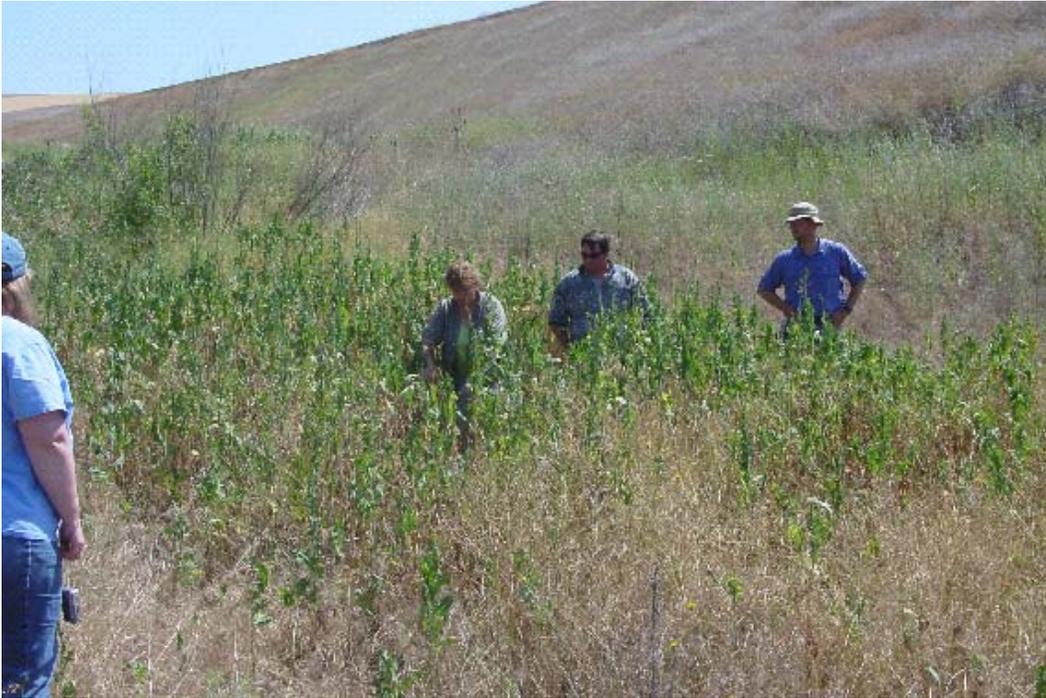
Figure 38. These folks are standing in a storm water and irrigation catchment basin that allows sediment to settle out.

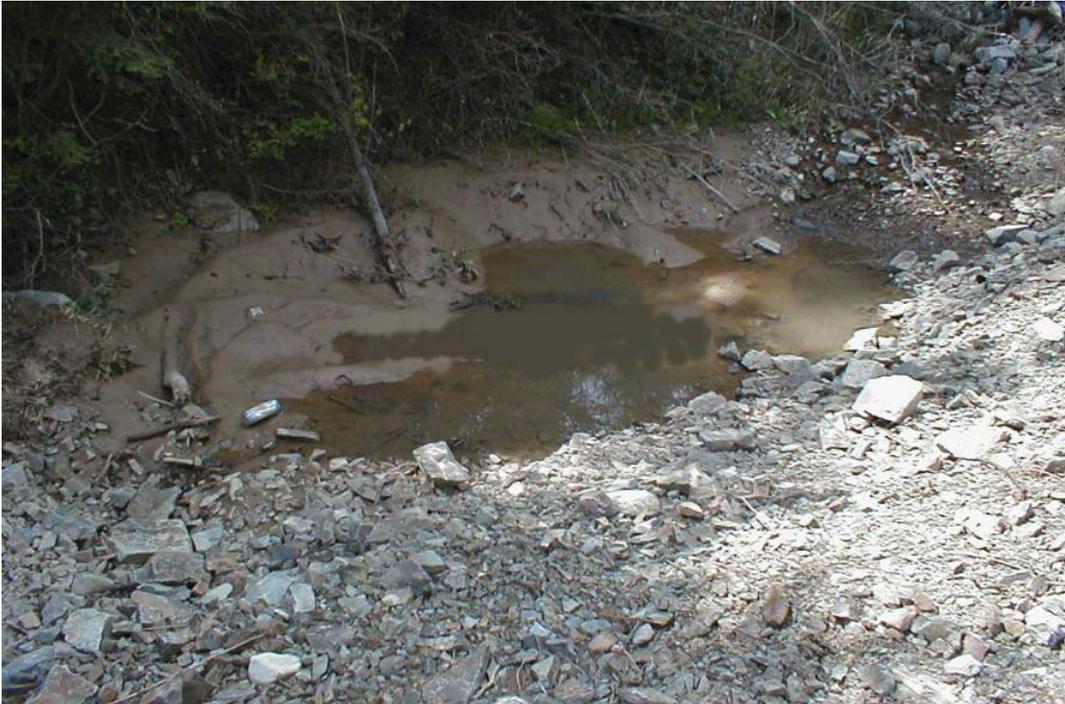
Figure 51. Although erosion has been greatly reduced, some sediment is still generated and needs to be trapped. The lake is about a half mile below this point.

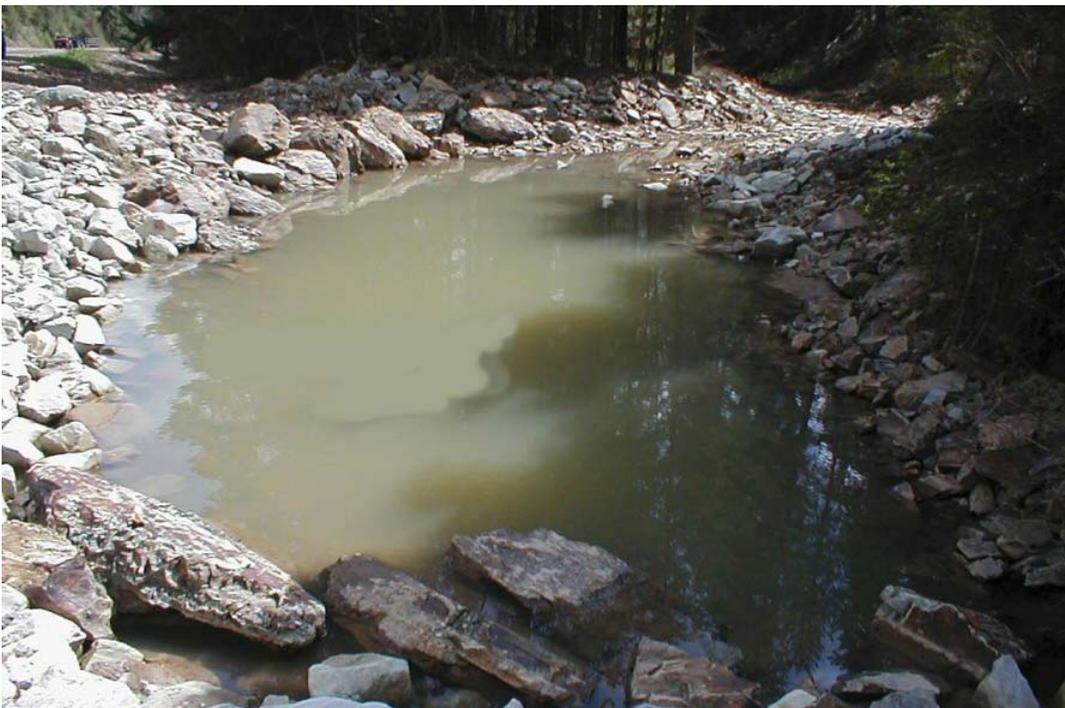
Figure 52. The lake is only about a quarter mile from this point. The valley is wider and has a lower gradient, allowing room for the stream channel to be removed from its former position adjacent to the road.

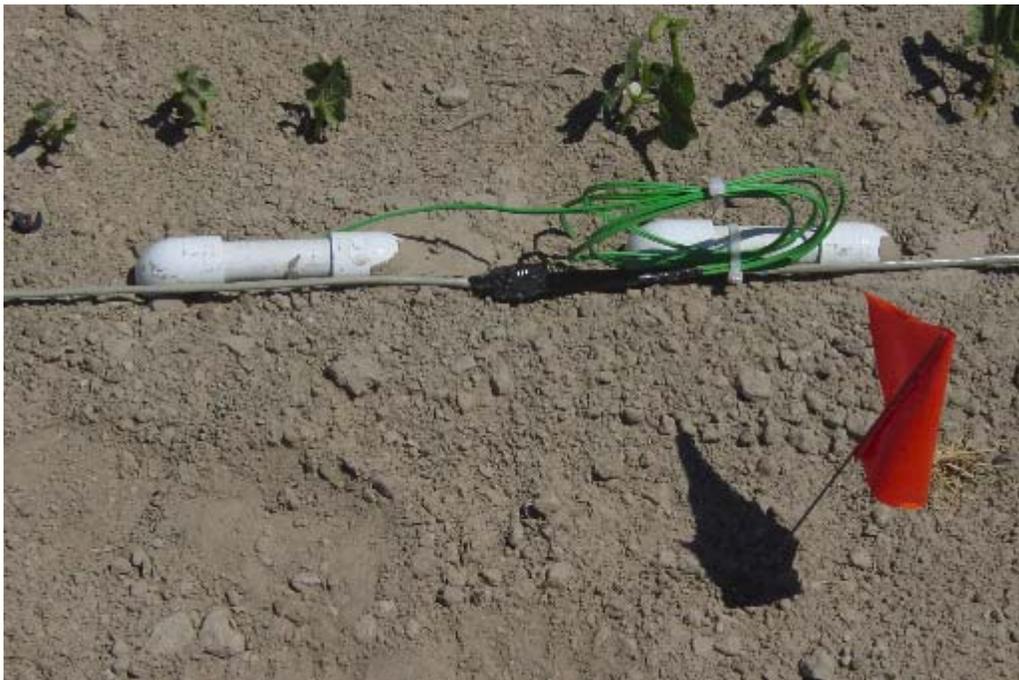
Figure 59. A moisture sensor connected to a surge system.

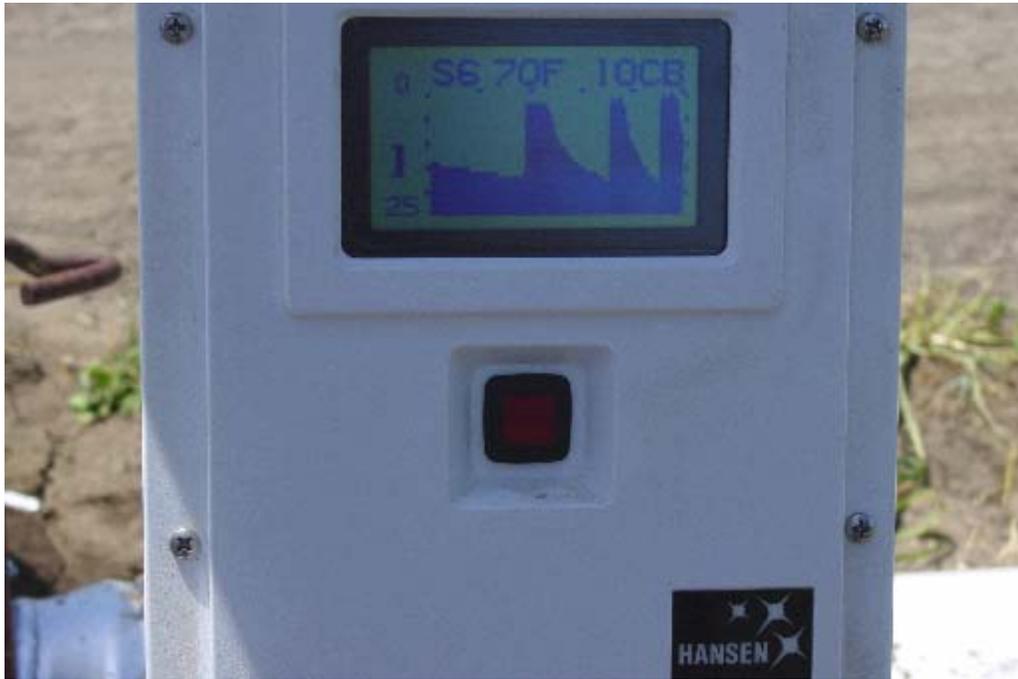
Figure 60. This is the monitor for the moisture sensor.

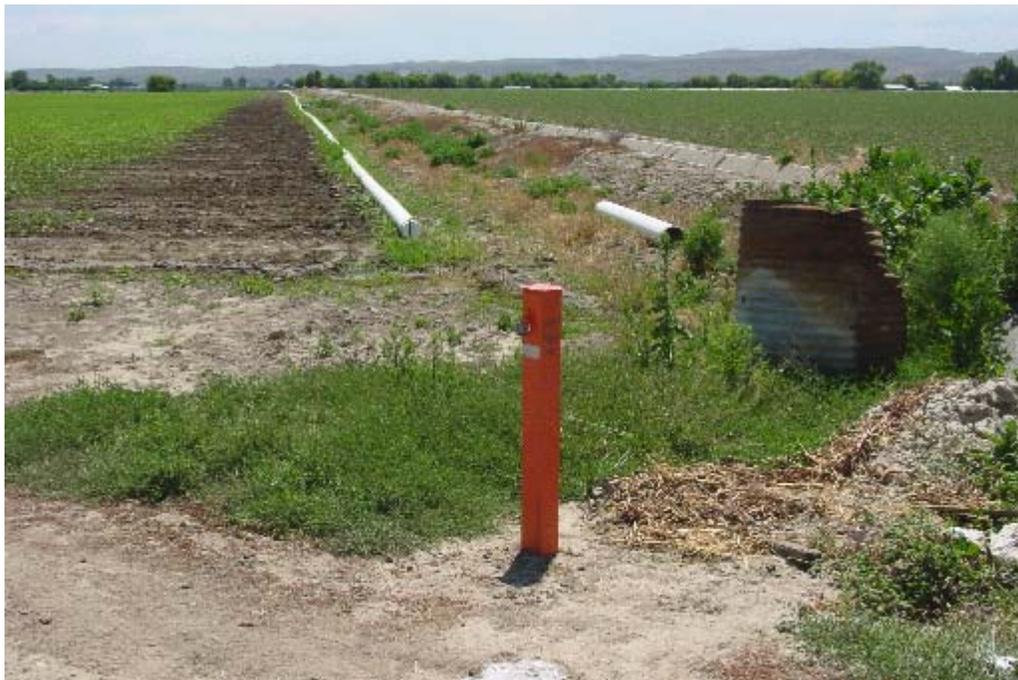
Figure 61. One of fifteen monitor wells in the Weiser nitrogen non-attainment area.

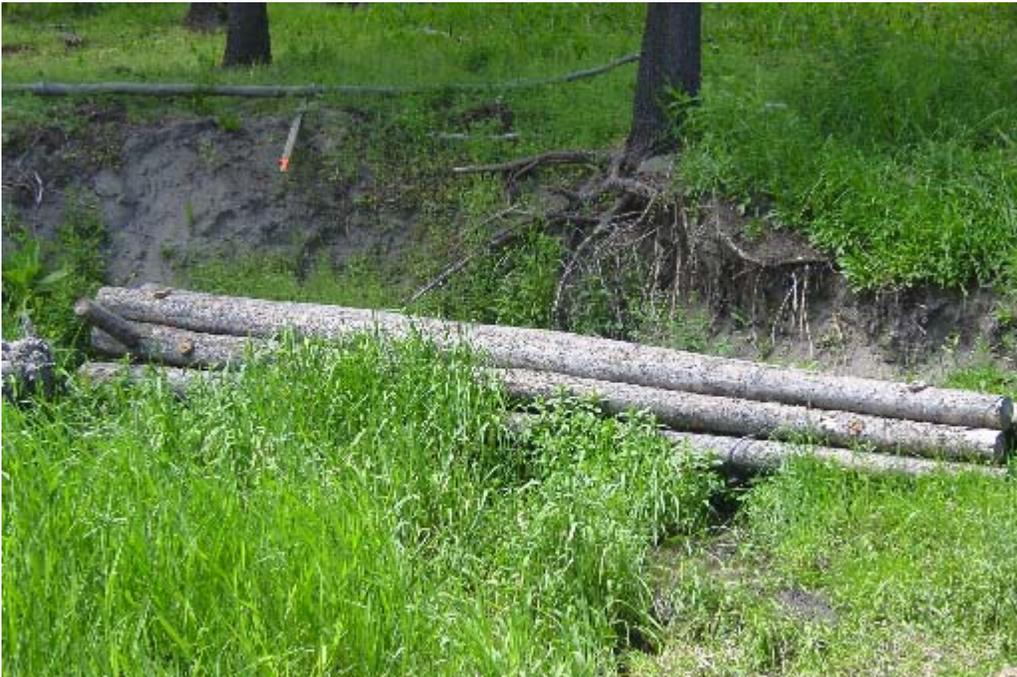
Figure 76. Prefabricated structures with the trademark name "ELWd Structures" were employed on 11 areas along Mud Creek to repair the damage.

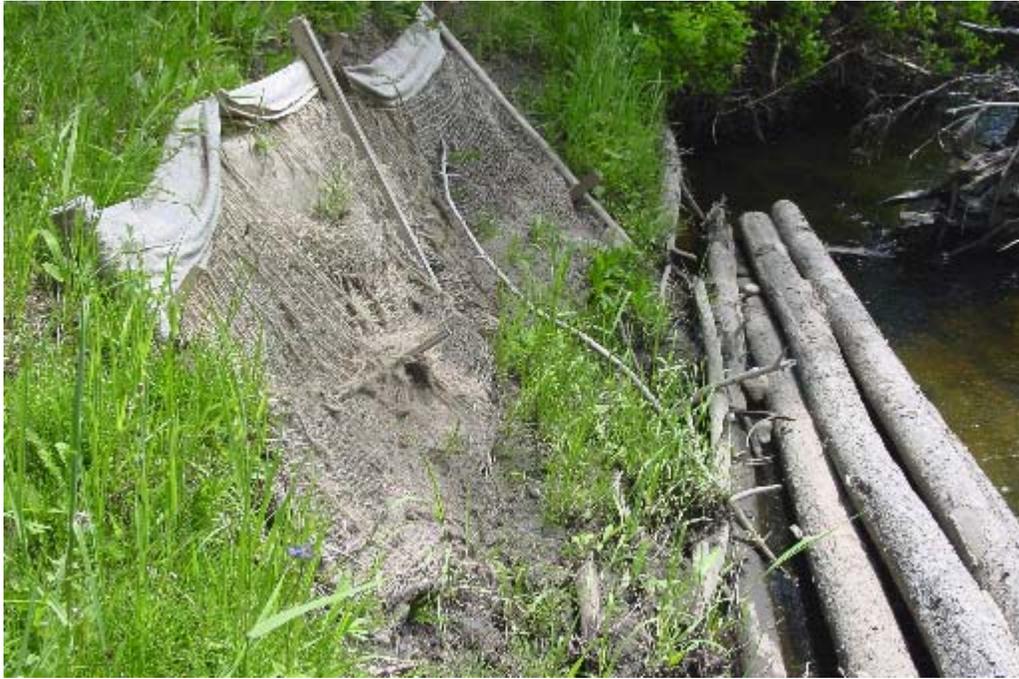
Figure 77. Biodegradable geonetting is stapled over the damaged area and the ELWd structures are anchored in place with heavy steel cables and stakes.

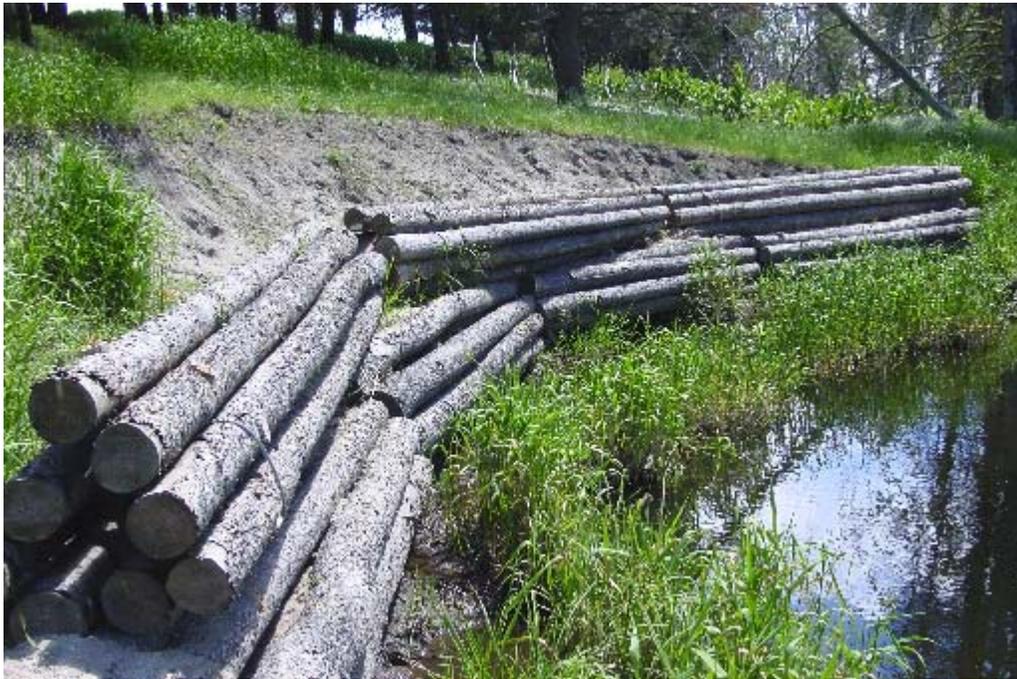
Figure 81. Some of the damaged areas require several ELWd structures in line.

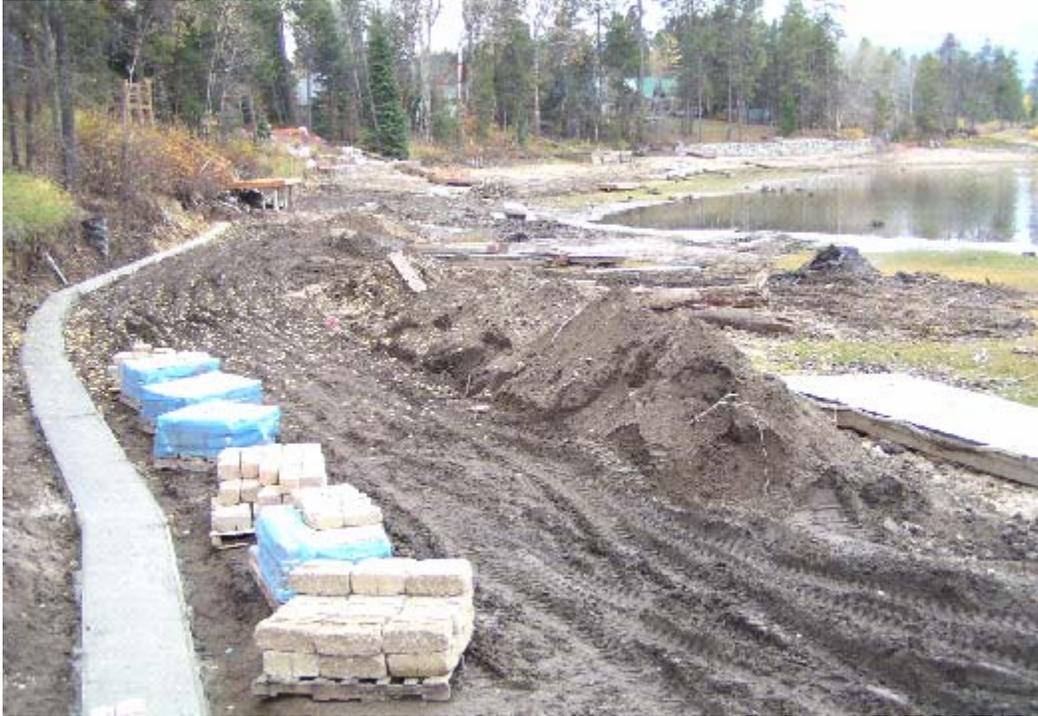
Figure 83. During high water periods, unprotected shoreline becomes a major source of sediment and nutrients to Cascade Reservoir. Well engineered and built retaining walls are the best solution to this source of water pollution.

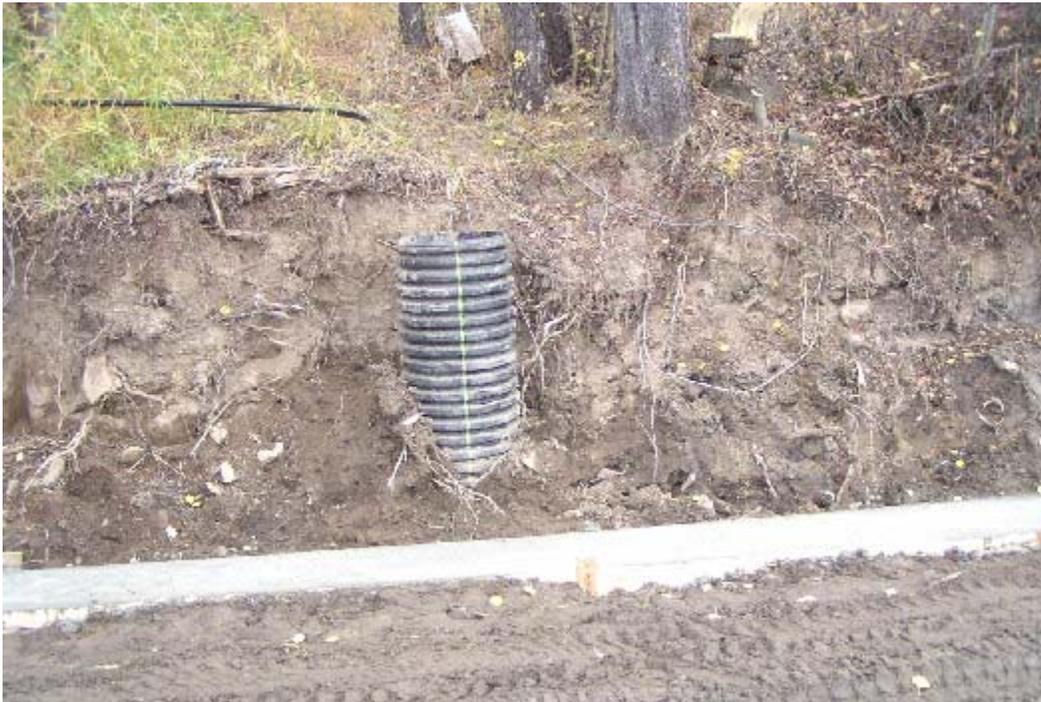
Figure 85. French drain pipe runs along the shore side of the retaining wall and drains into this sump. This prevents water and ice pressure against the wall.

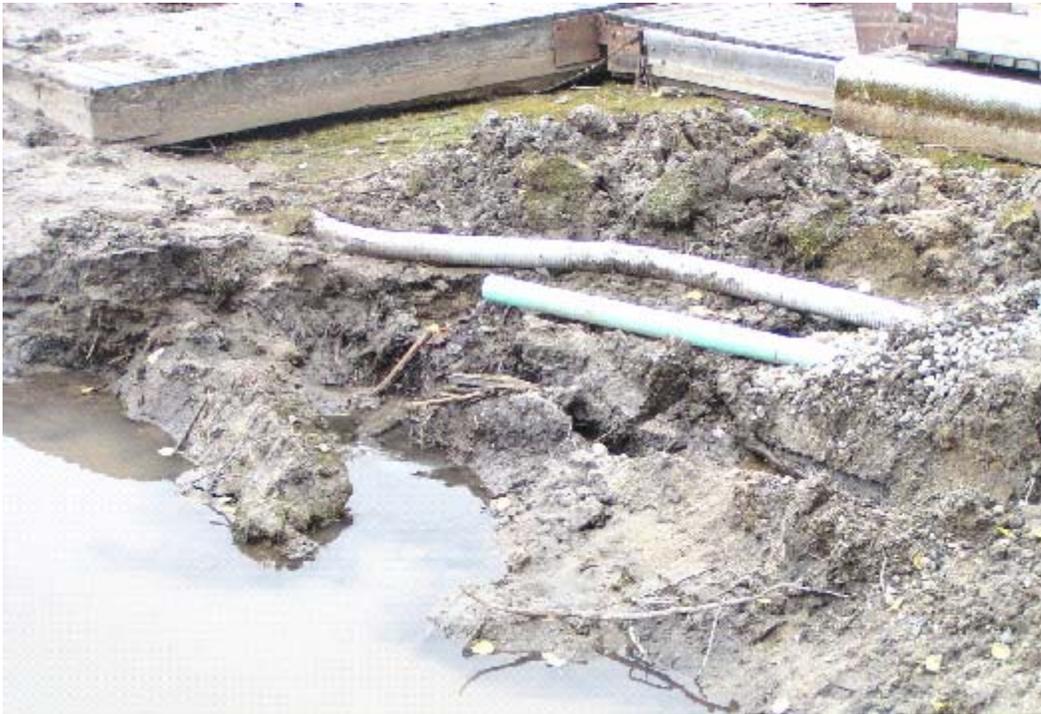
Figure 86. The drain and sump system discharges to the lake.

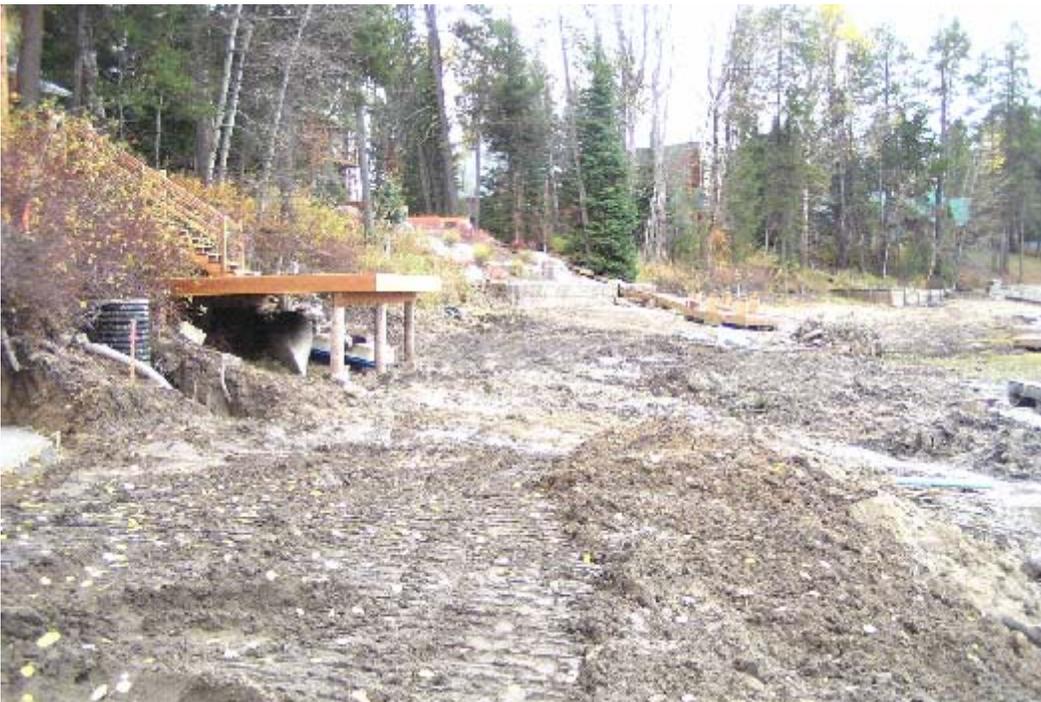
Figure 87. This span of wall will look similar to the one in the distance once completed. All of the work described can only be completed during low water level periods on the lake.

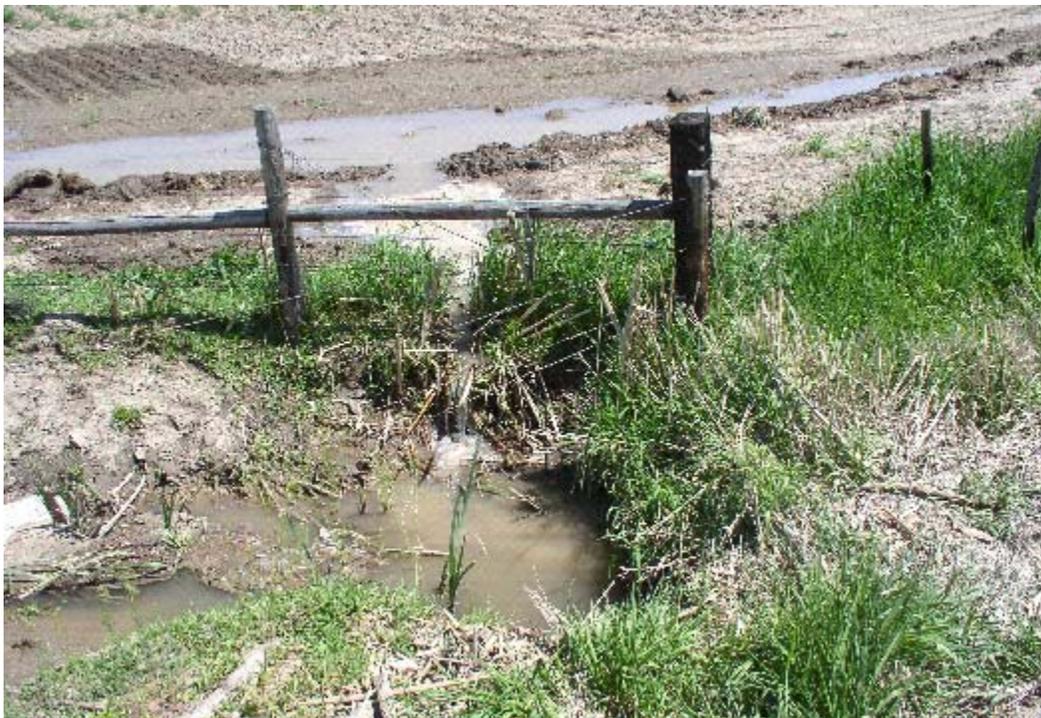
Figure 103. Here is more contaminated irrigation water. Untreated irrigation return water is a major contributor of silt and nutrients to the Lower Payette River.

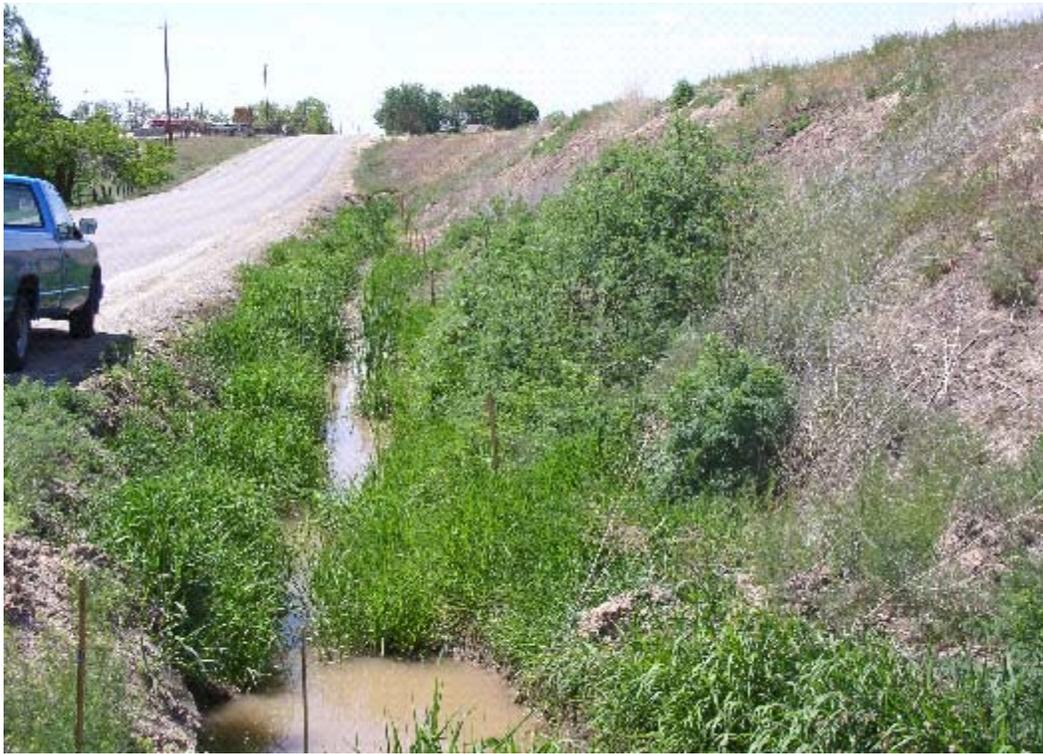
Figure 104. This section of open ditch will be replaced with PVC irrigation pipe.

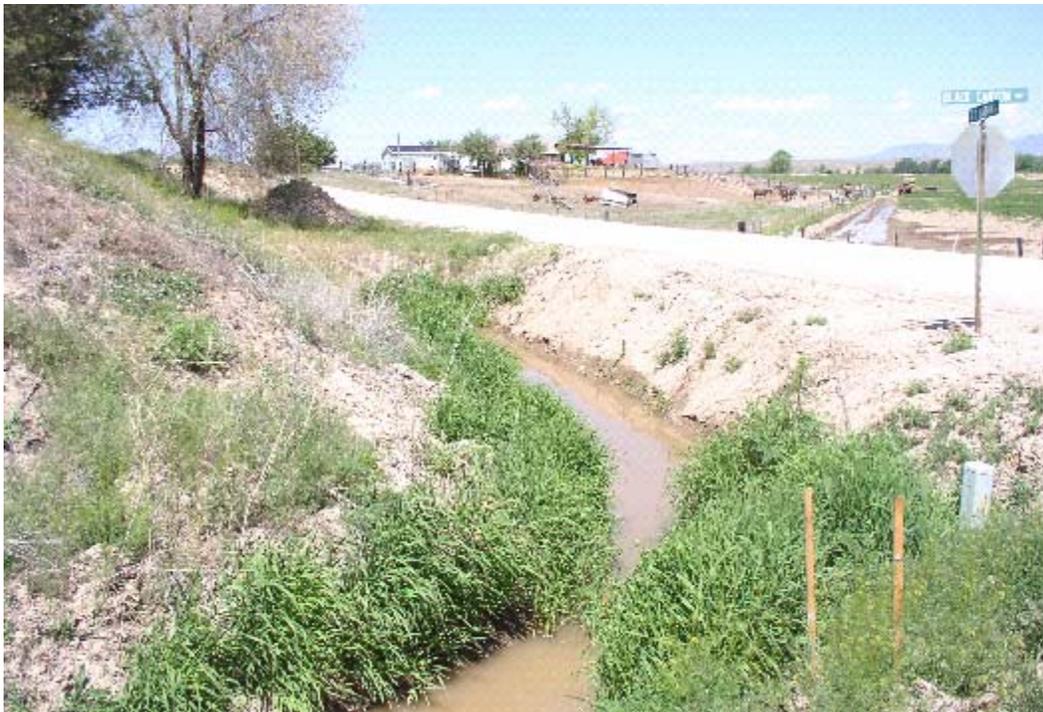
Figure 105. Silt and nutrients are generated by high-energy flow through irrigation ditches and from this roadbed. The installation of PVC pipe to transfer irrigation return flow will reduce silt in irrigation water.

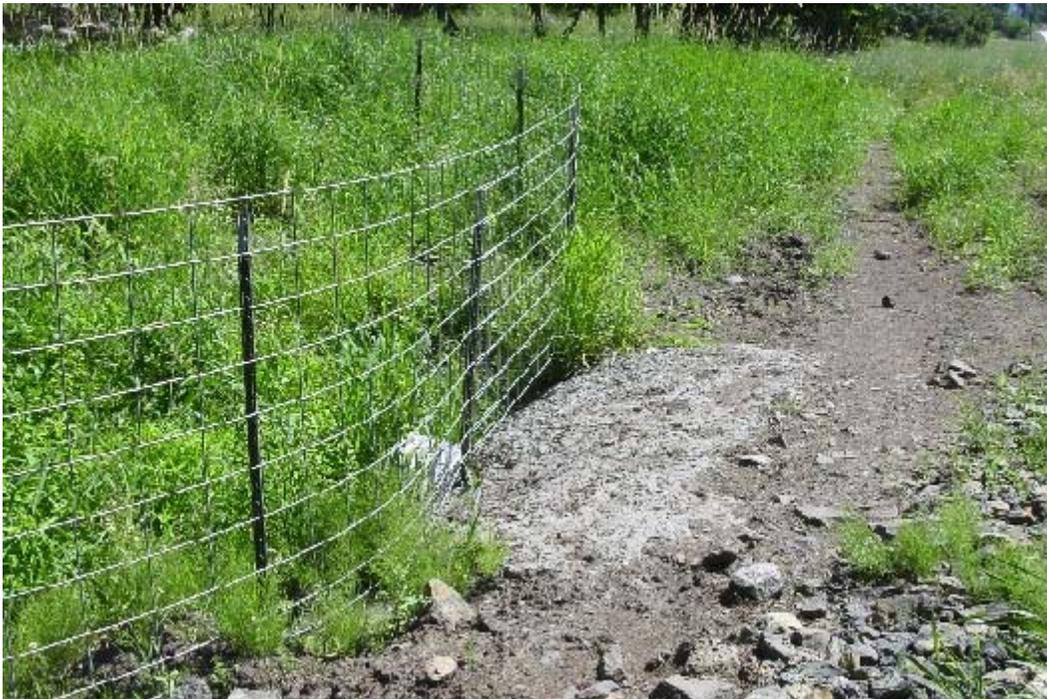
Figure 123. This hardened crossing keeps the cattle and sediment out of the creek.

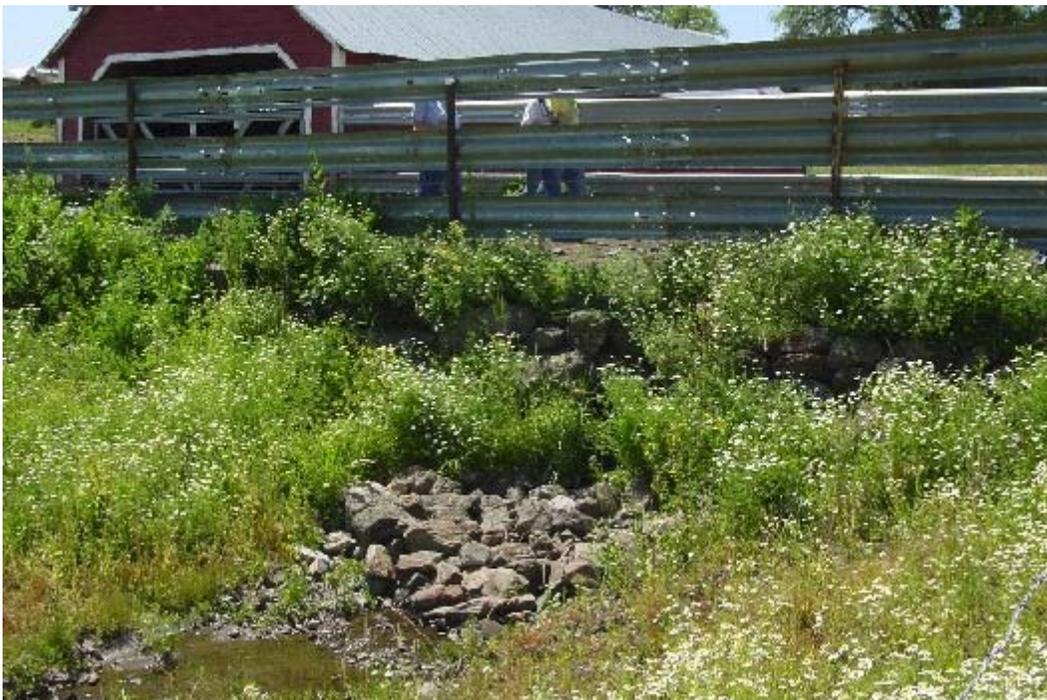
Figure 125. The creek was piped under the cattle crossing—instead of allowing water to run on the surface where cattle walk.

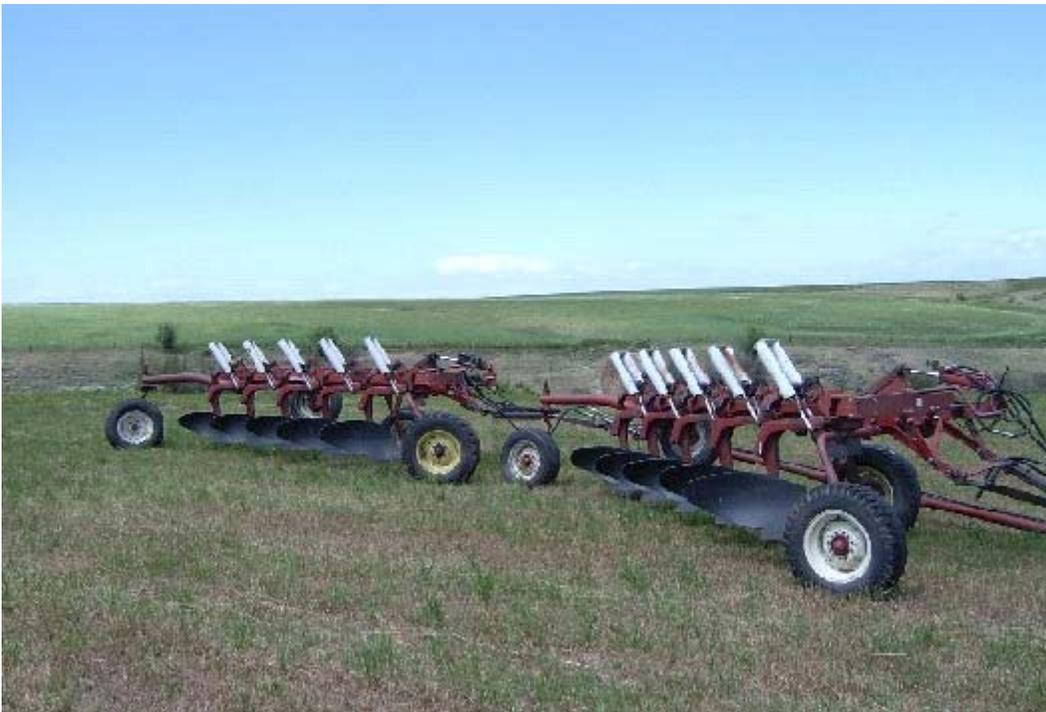
Figure 127. This plow can be adjusted to cause minimal disturbance to the field, creating less sediment runoff while allowing better soil profile and crop yield.

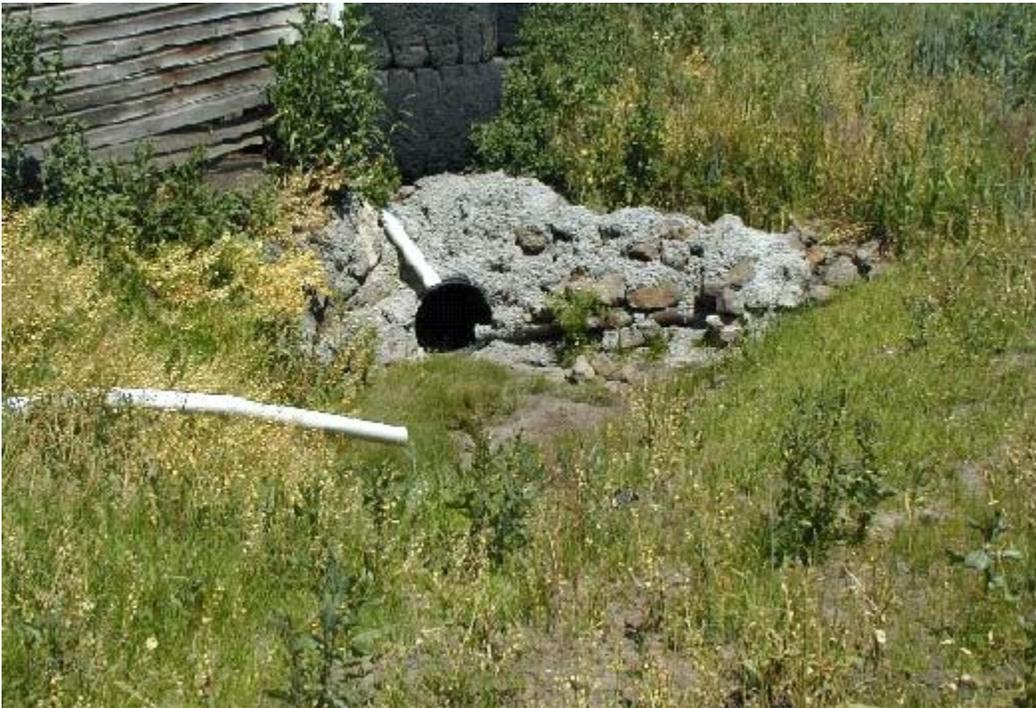
Figure 130. Captured storm water is piped to an infiltration pond where pollutants are greatly reduced prior to contact with groundwater.

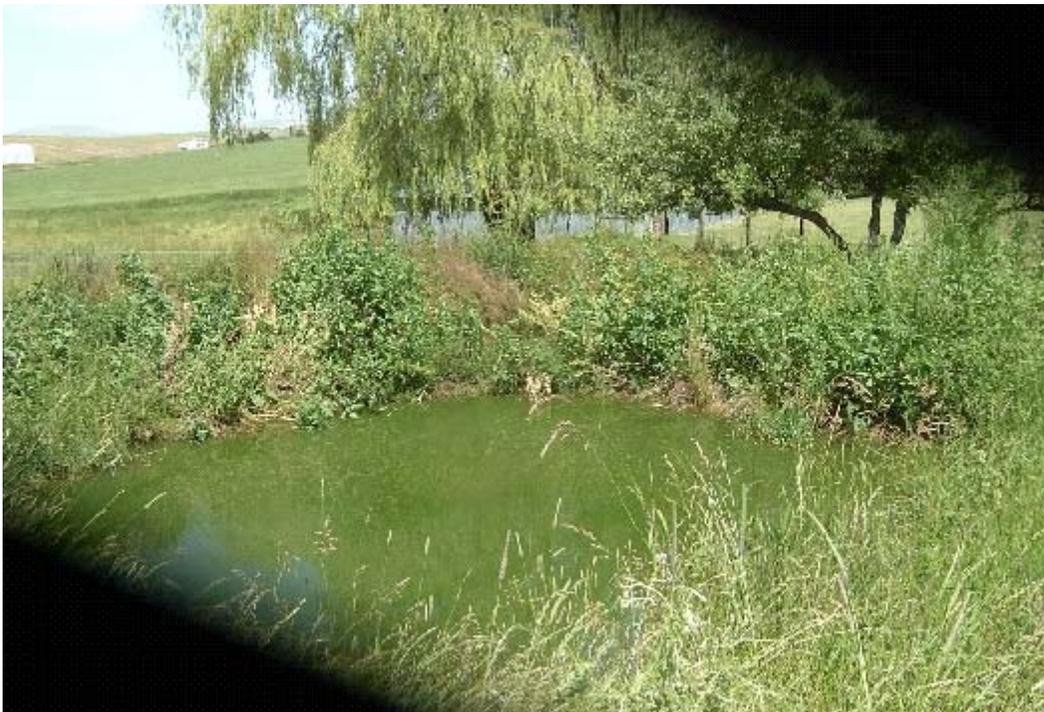
Figure 131. Residential sewage lagoons treat septic waste in sealed ponds, rather than letting untreated waste flow to surface water or to groundwater.

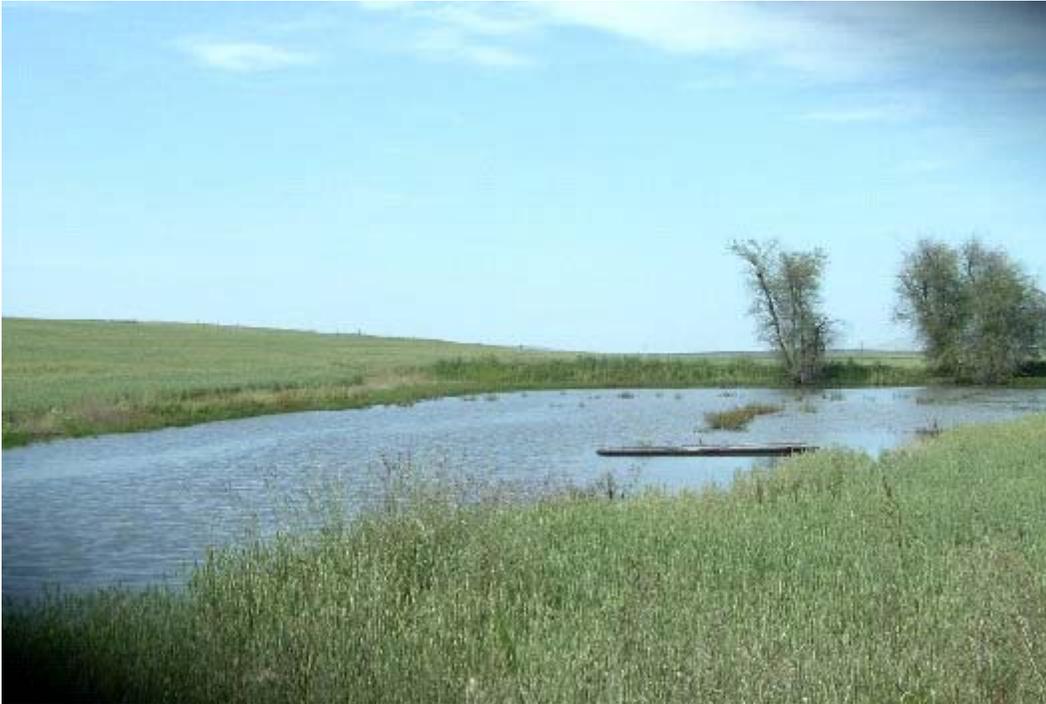
Figure 132. Numerous sediment basins have been installed in waterways in wheat fields. The trapped nutrient-laden sediment is routinely hauled back up on the fields, where it can nourish the crops.

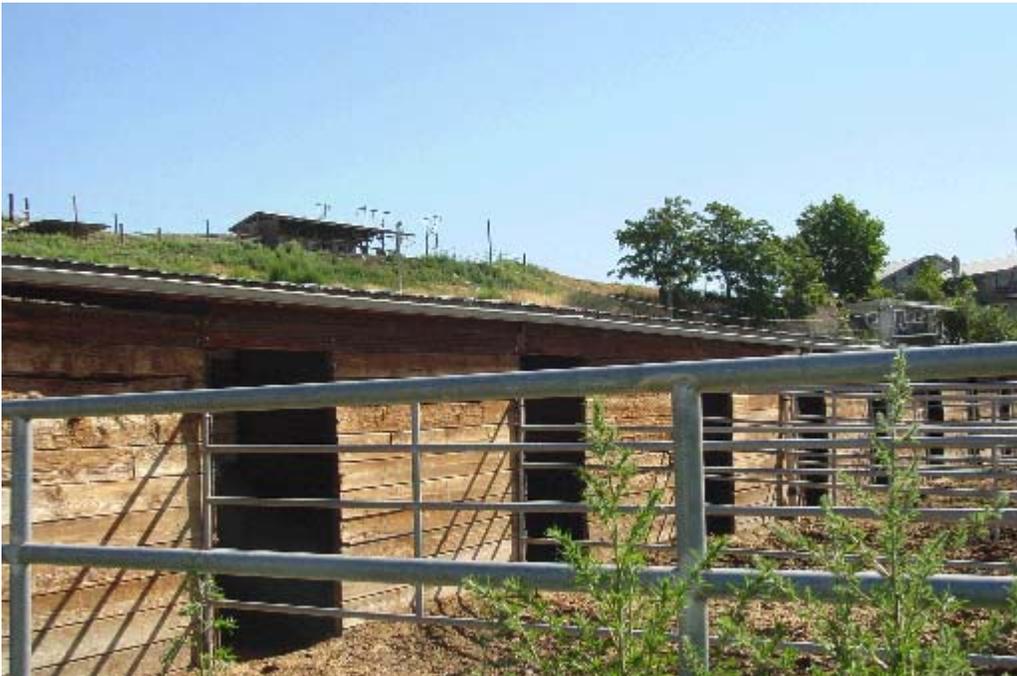
Figure 136. All buildings that used to shed storm water to the creek are now guttered. The storm water is conveyed to infiltration trenches and no longer comes in contact with horse manure.
