Idaho Nonpoint Source Program
Field Evaluation Annual Report

2004

Idaho Department of Environmental Quality

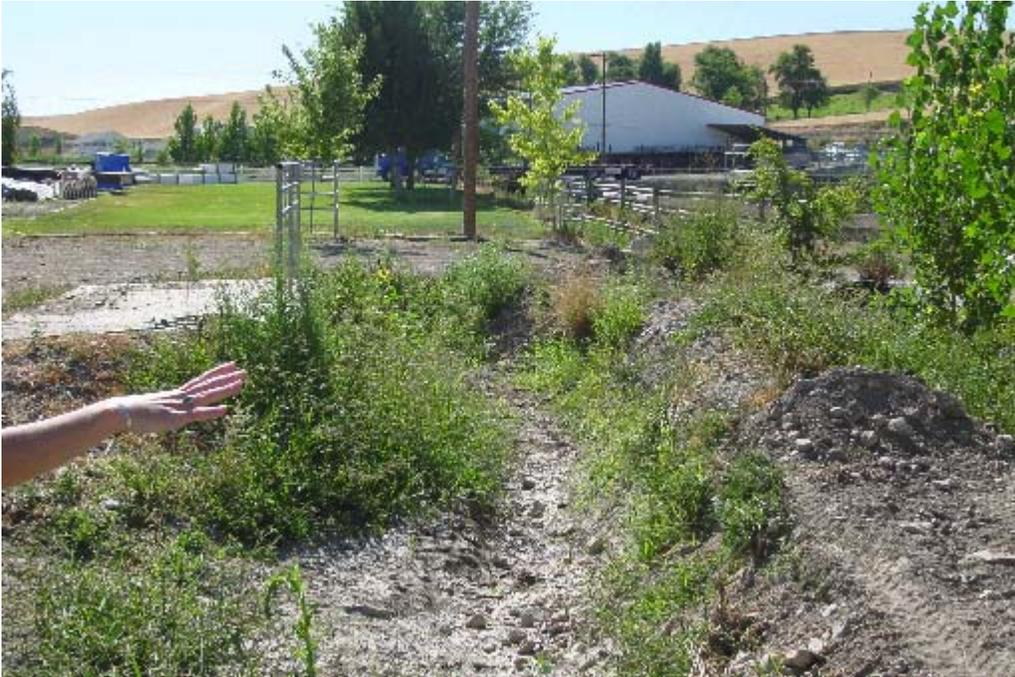
Figure 137. A berm was added to the right side of the creek and the concrete horse trailer wash station on the left side of the photograph is no longer used.

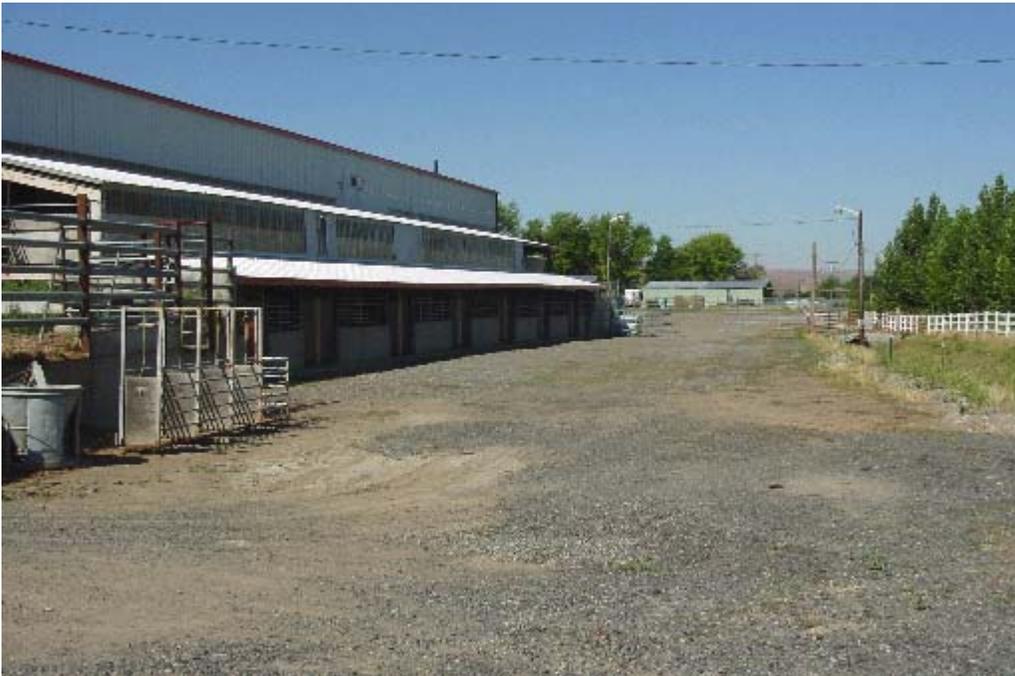
Figure 140. This parking lot used to slope towards the creek; it has now been resloped away from the creek. Storm water from this area is collected in a settling pond, where water now evaporates or slowly infiltrates.

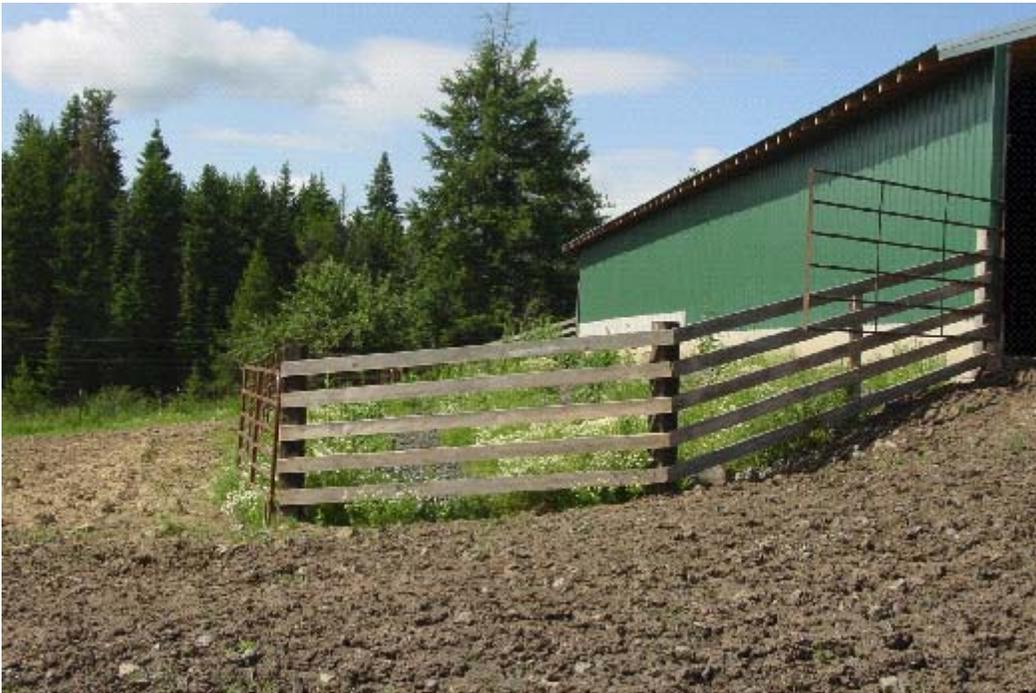
Figure 142. Now, storm water from the barn roof runs to an infiltration trench that is fenced off from the cattle.

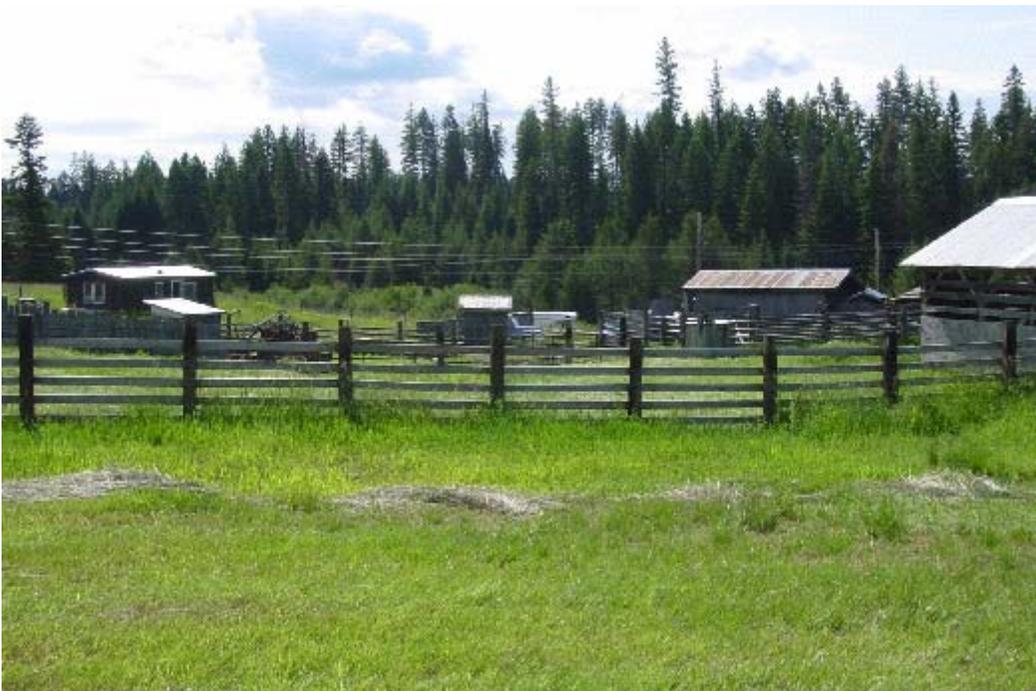
Figure 143. Storm water from above this AFO is being diverted around the facility to prevent contamination.

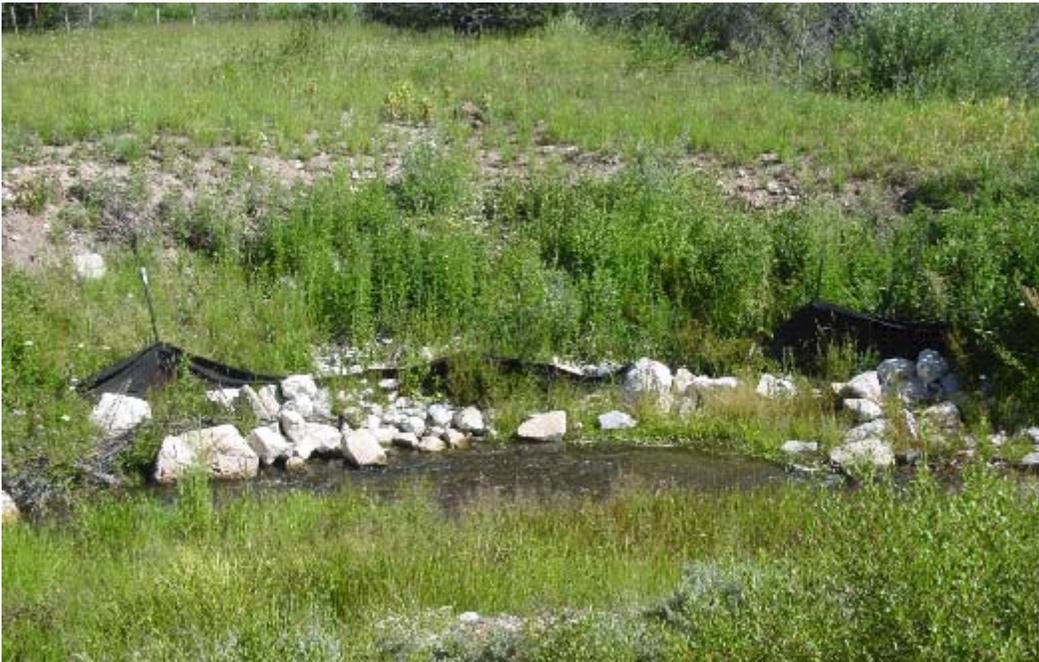
Figure 155. Vegetation is coming in nicely and the biodegradable silt fencing is breaking down.

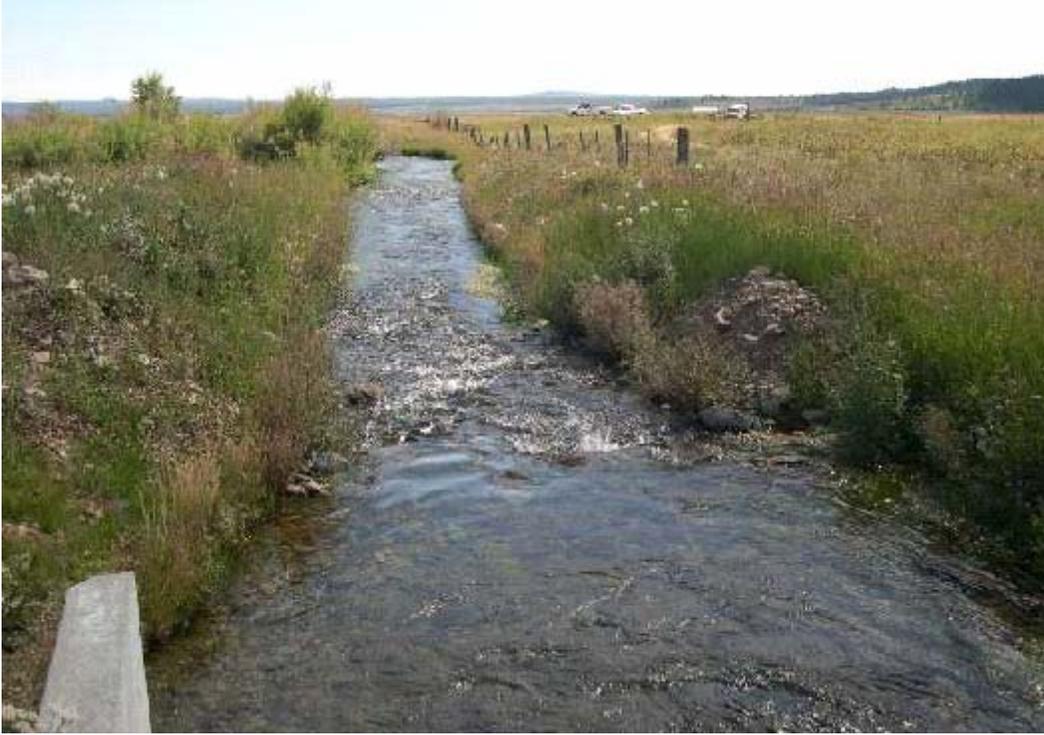
Figure 197. This photograph was taken from atop the concrete head gate and looks down the irrigation diversion. Concrete head gates greatly reduce erosion and sedimentation.
