Black Horse, Hillside and Big Bonanza Mines

Preliminary Assessment Report

Blaine County
State of Idaho

December 2007

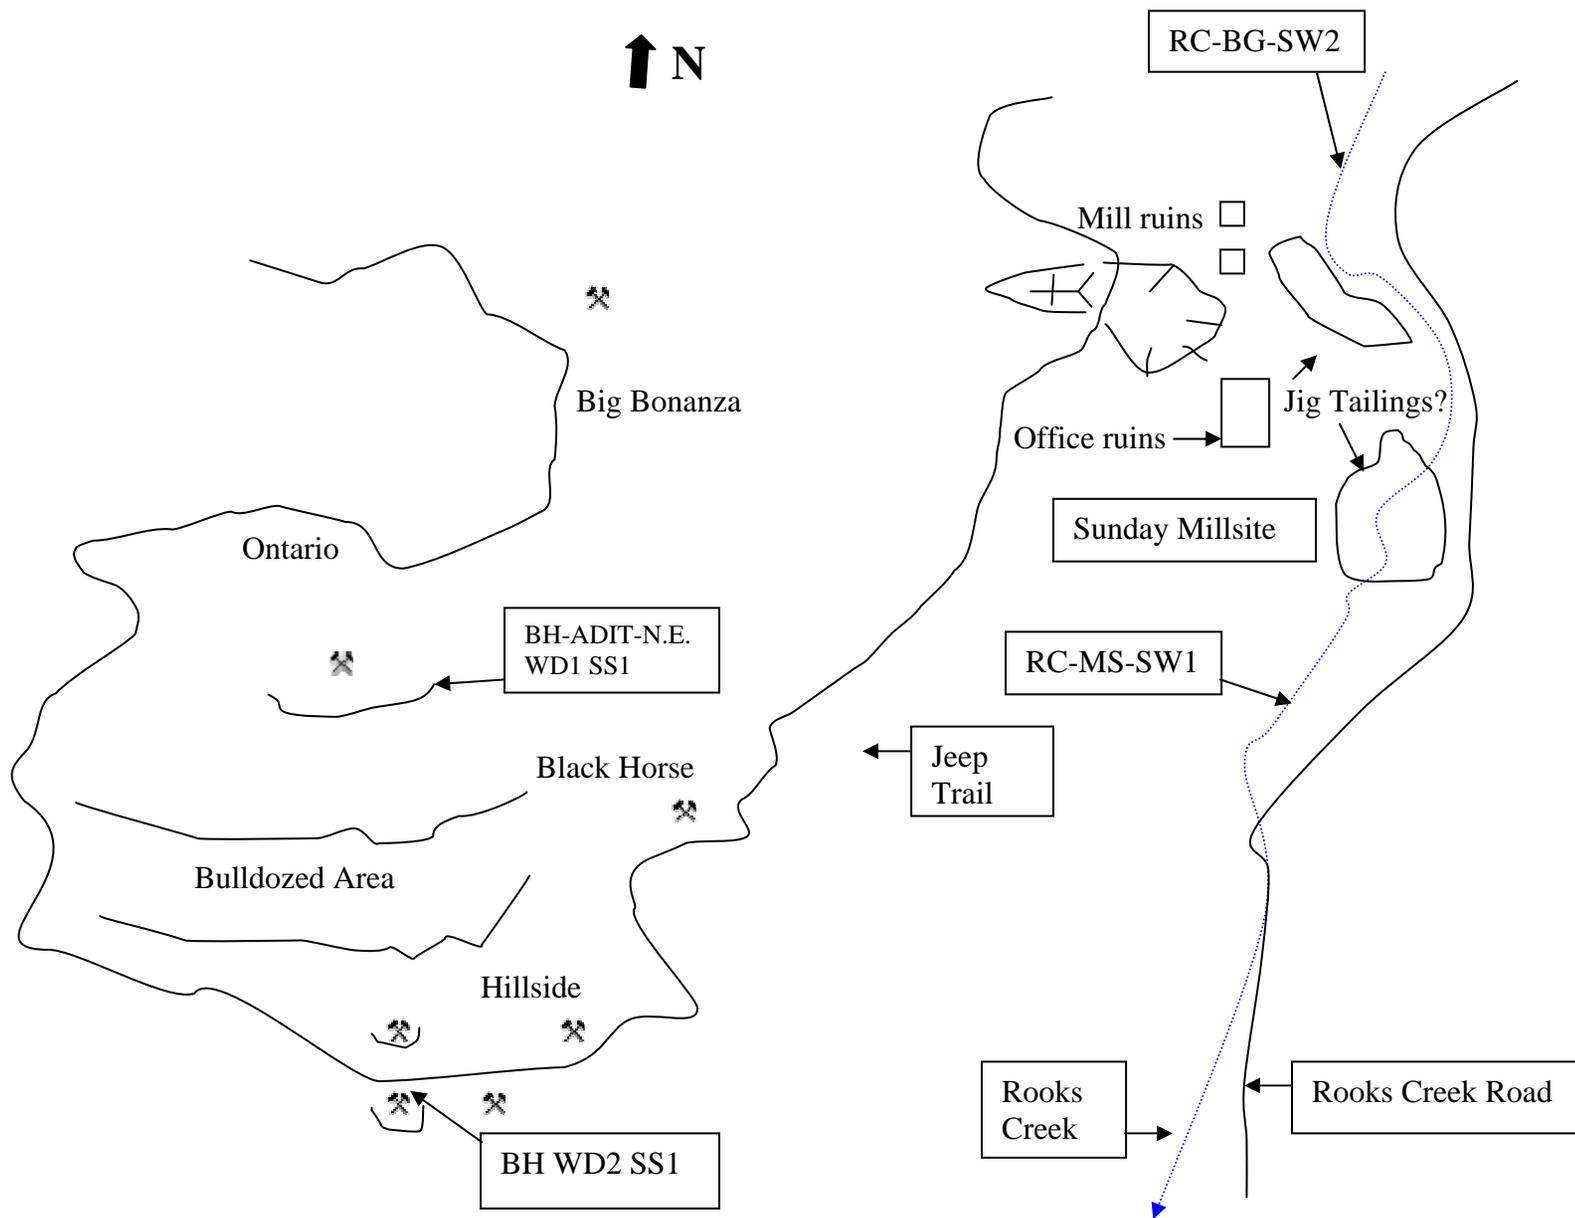
FIGURE 2

Black Horse, Hillside & Big Bonanza Claims

The Black Horse claim includes of some exploration trenches and a few very small prospect holes. The Hillside claim includes one collapsed adit, designated as Adit 2 (see Figure 2, preceding page), and several prospects. The volume of the Adit 2 waste dump was estimated at 250 cubic yards. The Big Bonanza Lode claim includes several small prospects.

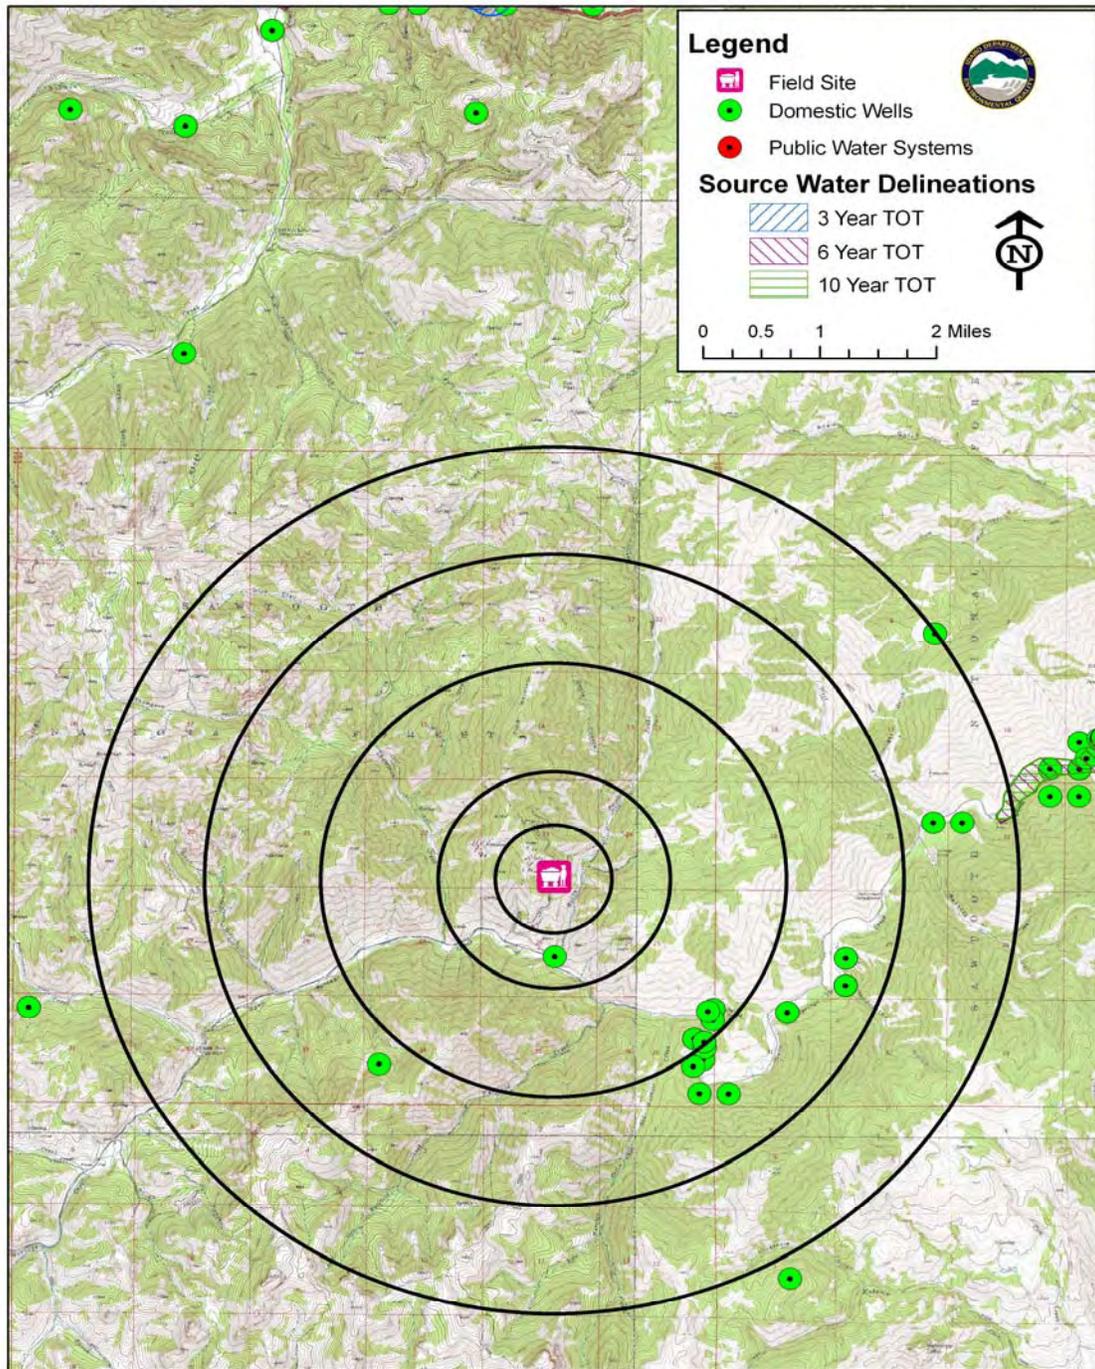
Figure 3

IDEQ used a refined computer model approved by EPA to determine the 3-year (Zone 1B), 6-year (Zone 2), and 10 year (Zone 3) time of travel associated with the Big Wood River Aquifer and its sources (IDEQ 2000). This information is illustrated in Figure 3.

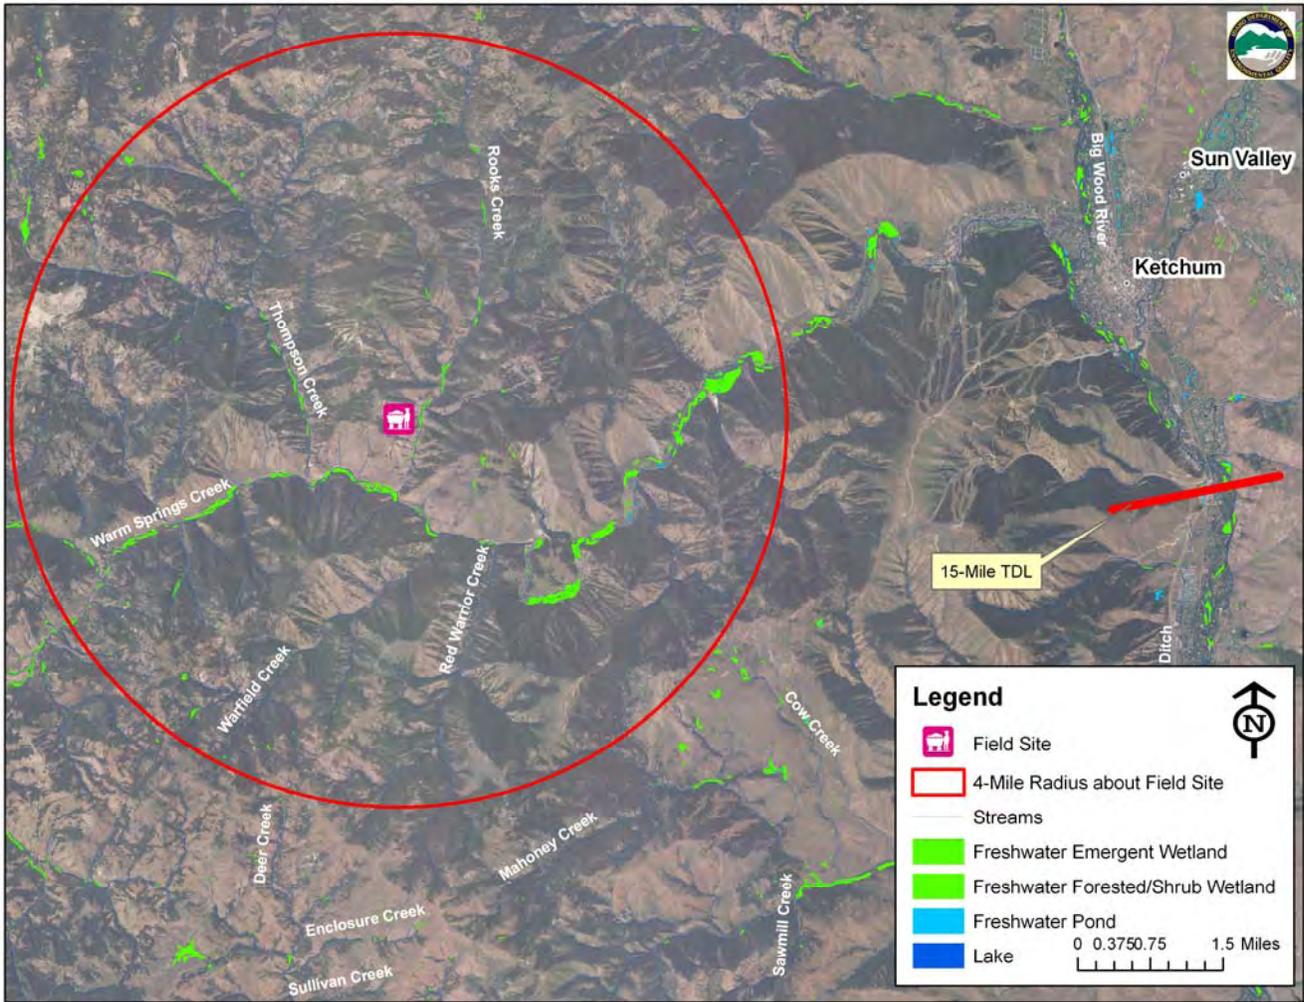
Figure 4

There are no drinking water intakes within the 15-mile Total Distance Limit (TDL). The following TDL in-water segment was calculated from the lowest elevation workings on the Hillside claim. The ephemeral drain's streambed merges with Rook's Creek to the southeast at 0.3 miles. Rook's Creek flows to the south to its confluence with Warm Springs Creek at 1.1 miles. Warm Spring Creek continues to the east where it is enjoined by Warfield Creek at 1.75 miles, by Red Warrior Creek at 2.3 miles, by West Fork of Warm Springs Creek at 6.1 miles and numerous unnamed tributaries and thermal springs before merging

with the Big Wood River at 13.75 miles. The Big Wood River continues to the south for the remainder of the 15-mile TDL (see Figure 4).

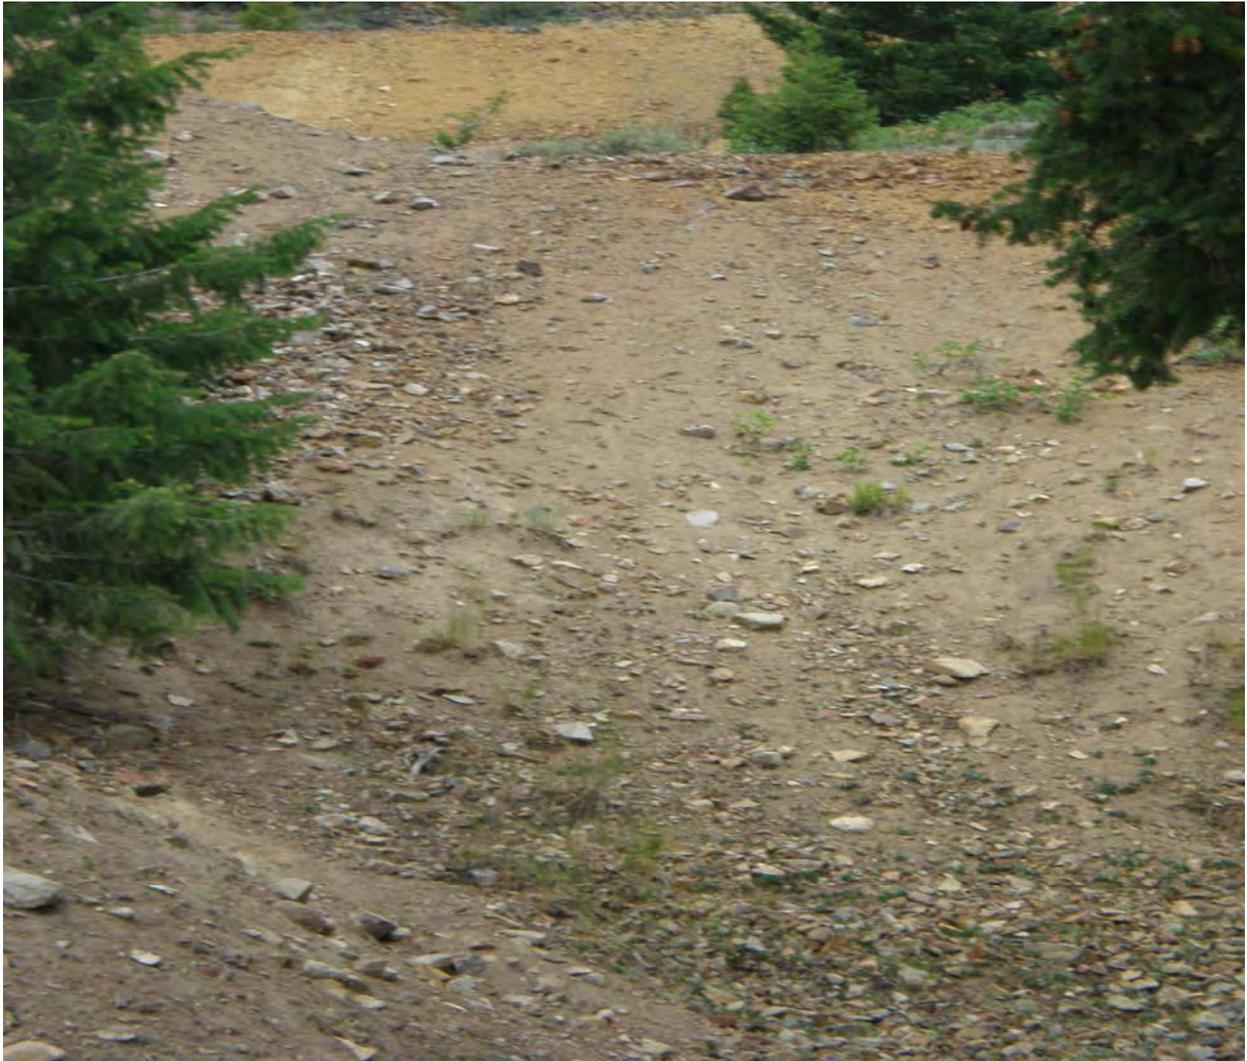
Caved portal of Adit 2 (Hillside claim); exploration trenches (above)

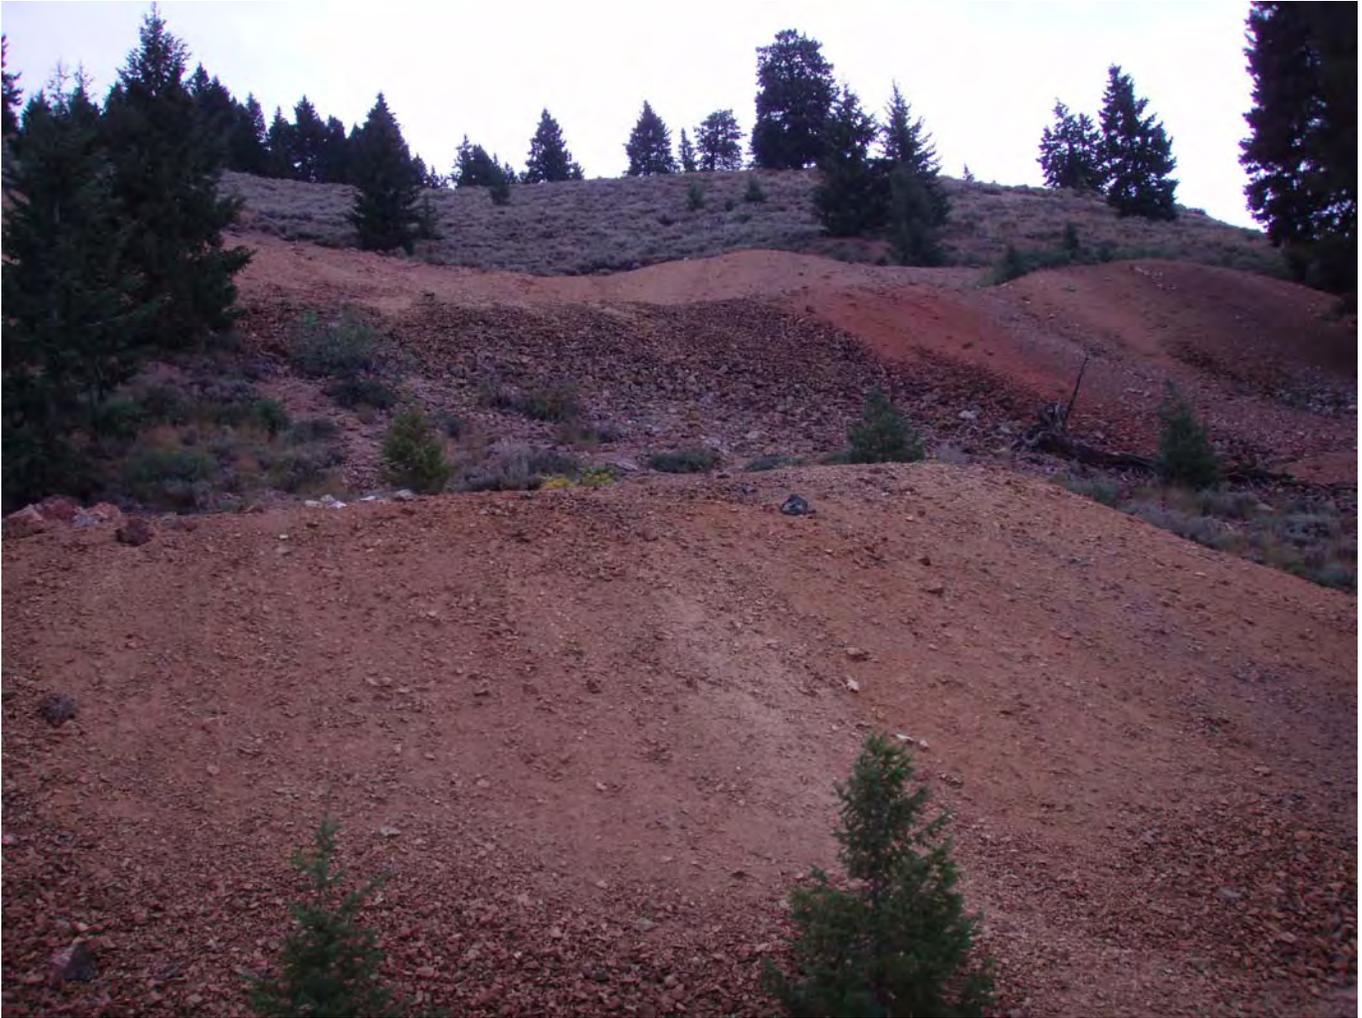
Exploration trench (Black Horse) at upper right; iron oxides *and sulfides* apparent.

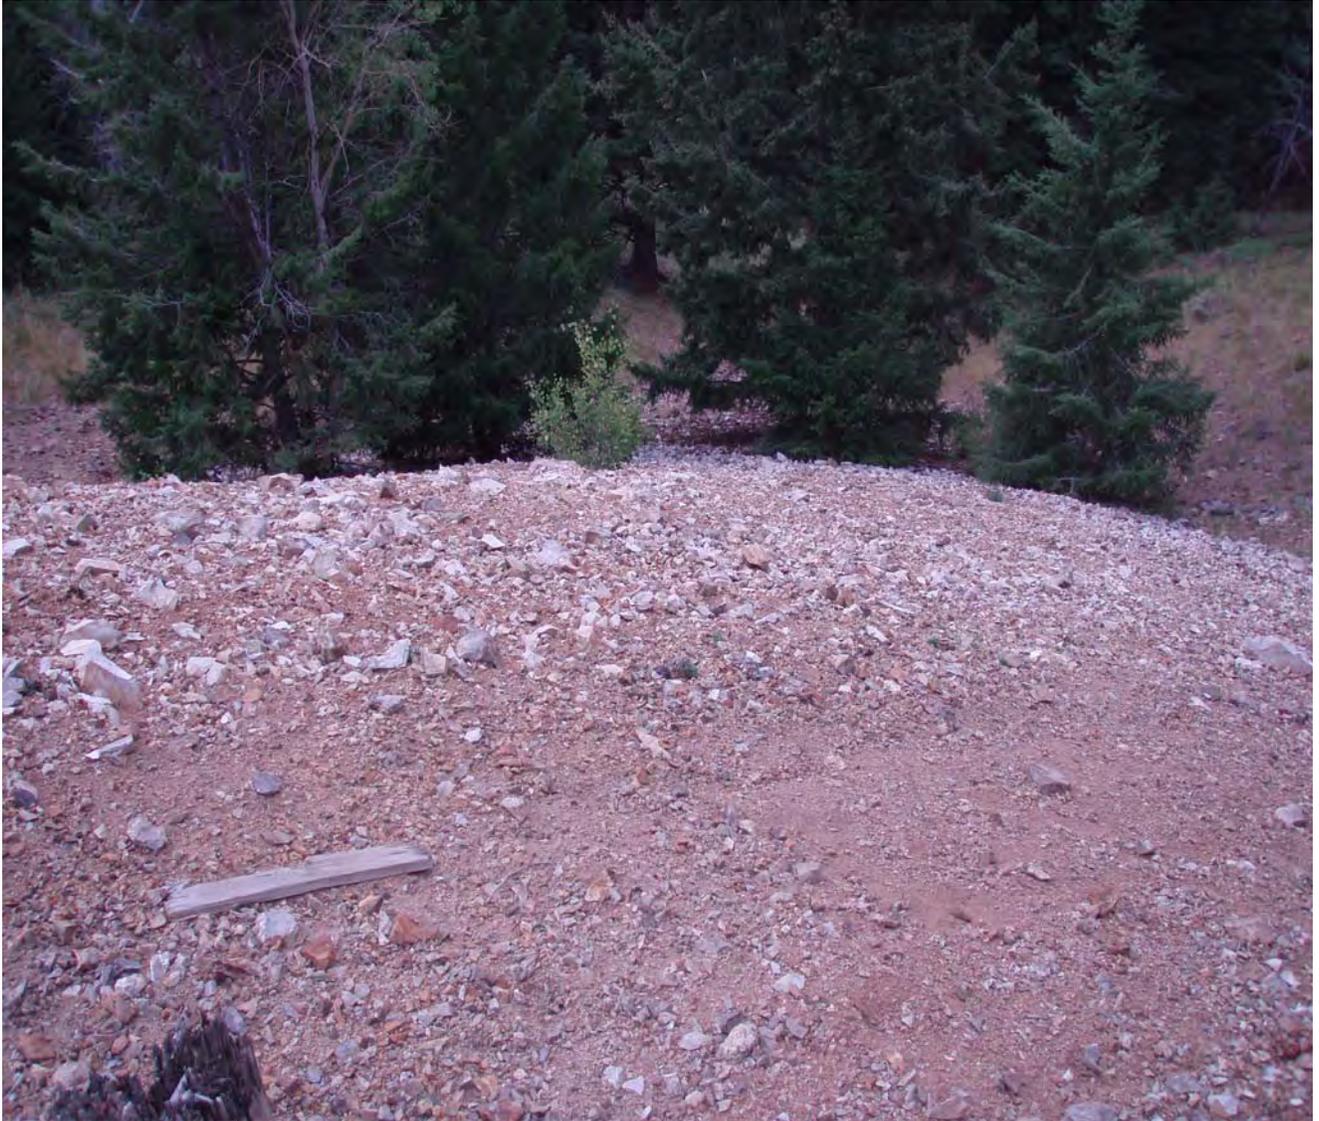
Waste Dump below Adit 2 (Hillside claim); <250 cubic yards
