BULLION MILL

(AKA: APACHE MILL, BULLION CREEK SUBDIVISION - LOT B)

PRELIMINARY ASSESSMENT REPORT

Blaine County
State of Idaho

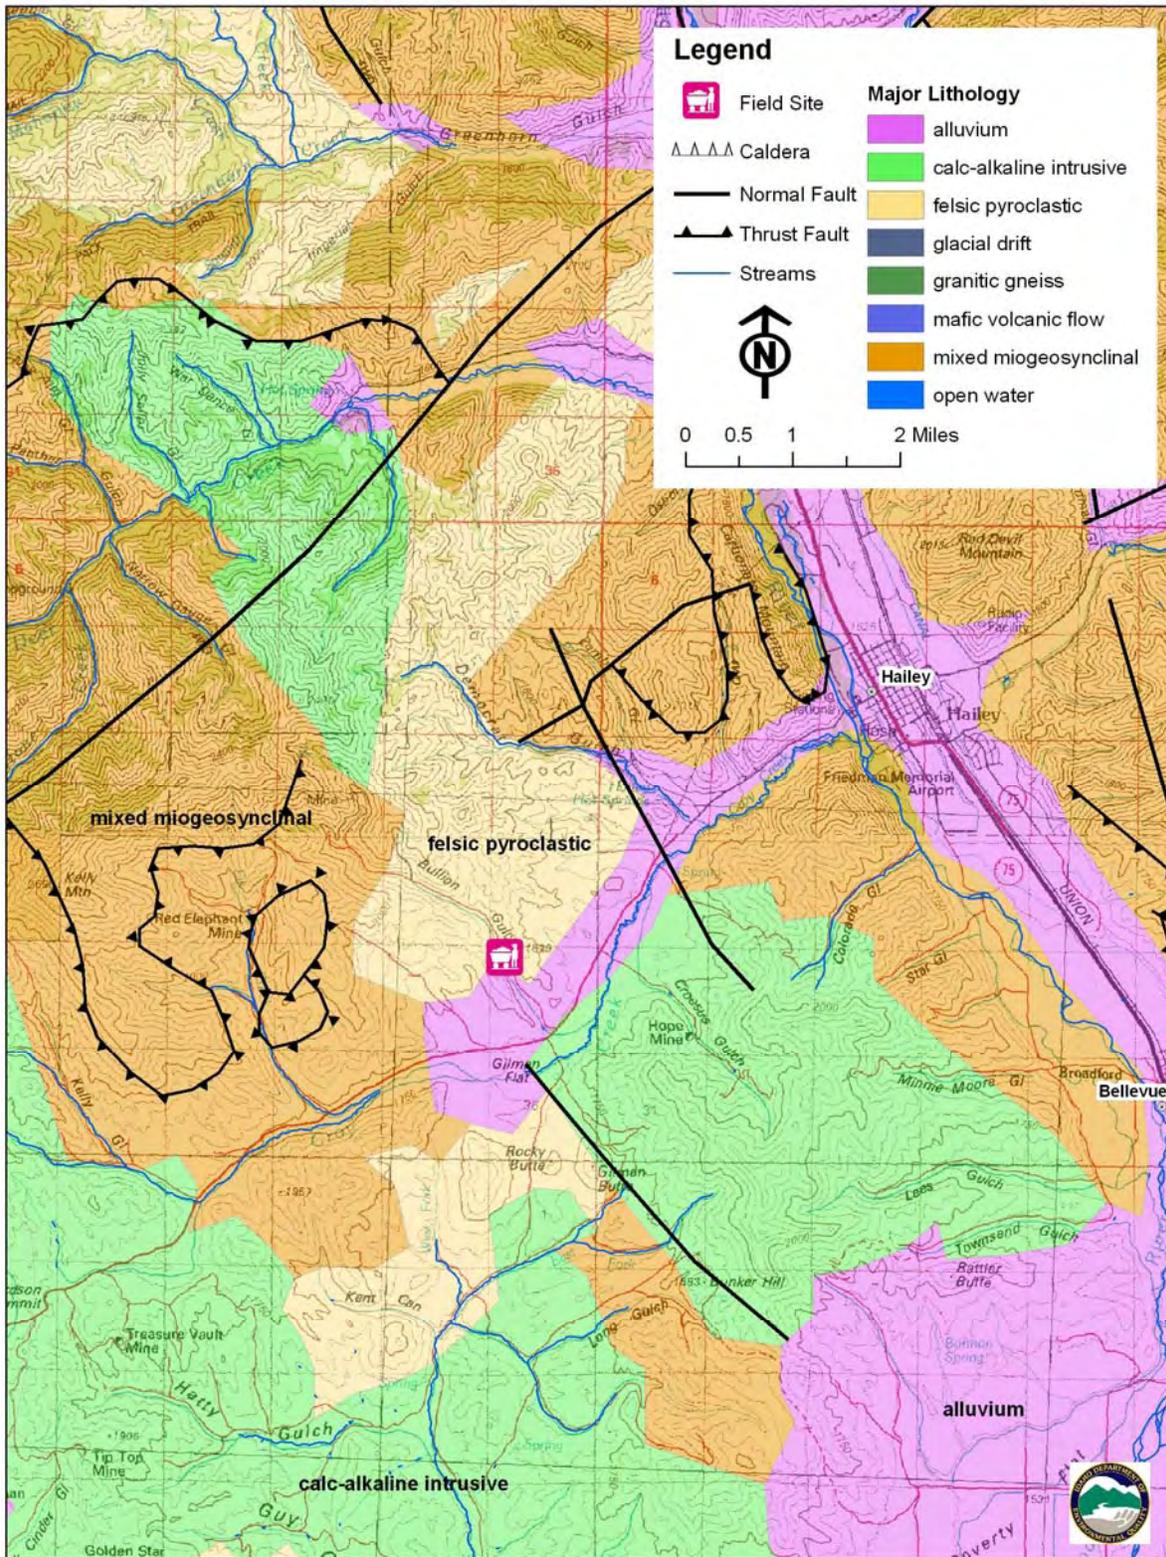
Generally speaking the Croy Creek basin is hosted by sheared and altered quartz monzonite intrusives, with a basal chert-pebble conglomerate; of the Wood River formation. Figure 3 shows the generalized geology of the Bullion Mill area.

Figure 3. Geology of the Bullion Mill area (Map source: USGS 24k).

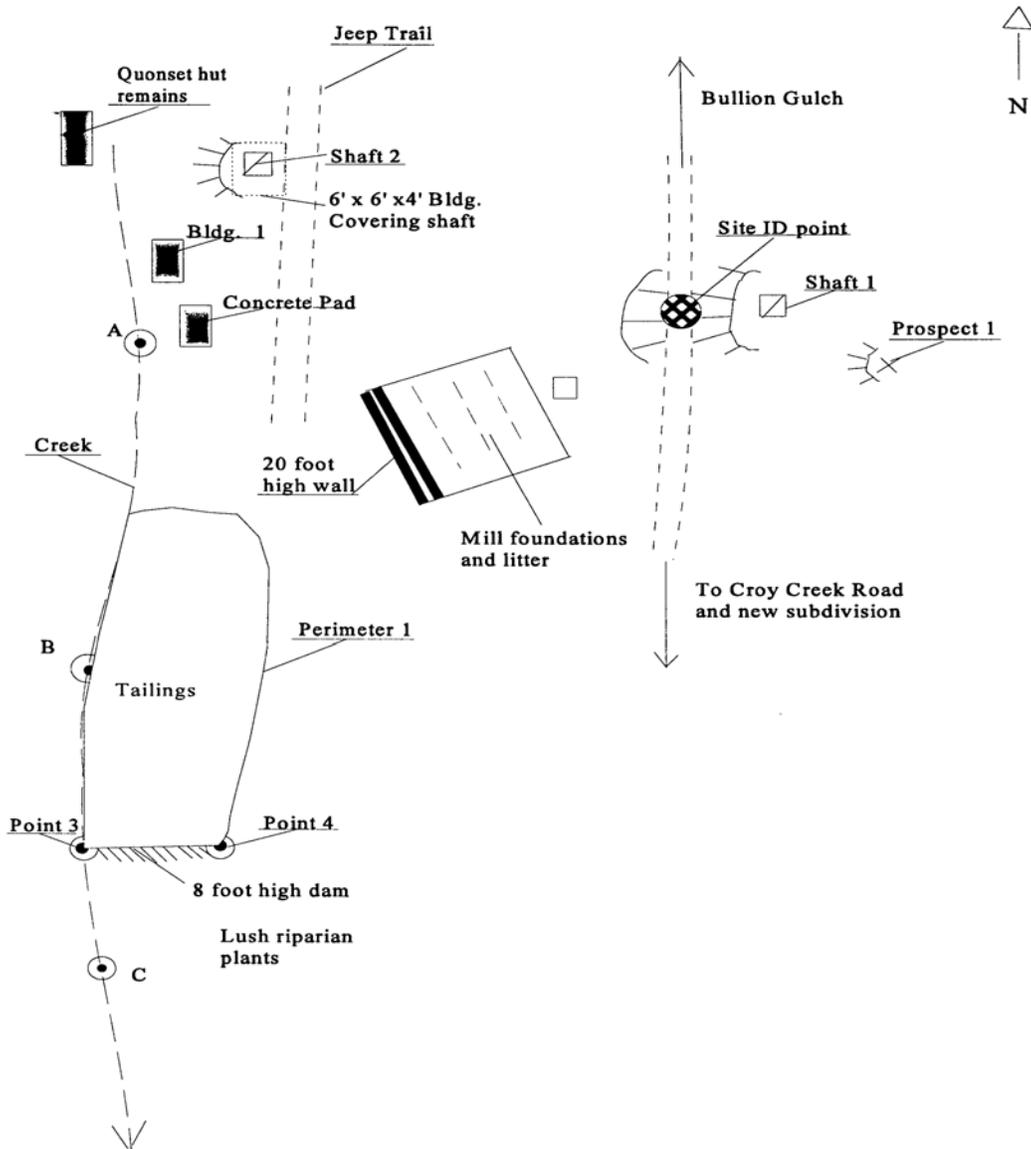
Figure 4. Bullion Mill site sketch map (IGS, 2005, p. 34).

Figure 28-1. Sketch map of the Bullion Mill site.

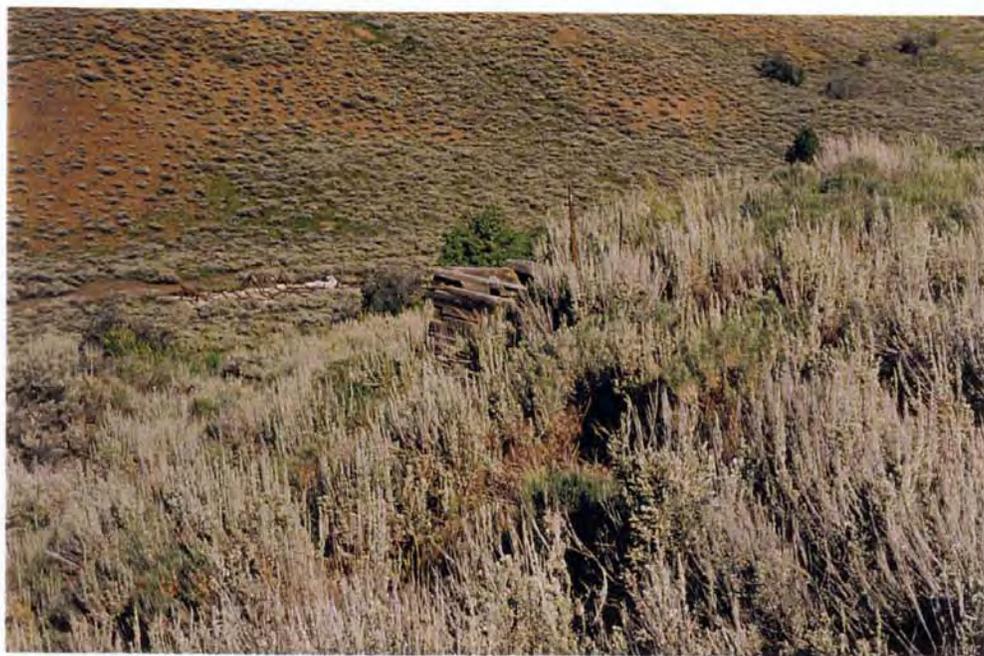
Figure 28-3. Shaft 1 at Bullion mill site is just a few timbers. Concrete pad in background is across road. Picture is looking to southwest. (Roll 98-9, neg. #6738, frame #19; photograph by V. S. Gillerman; July 16, 1998).

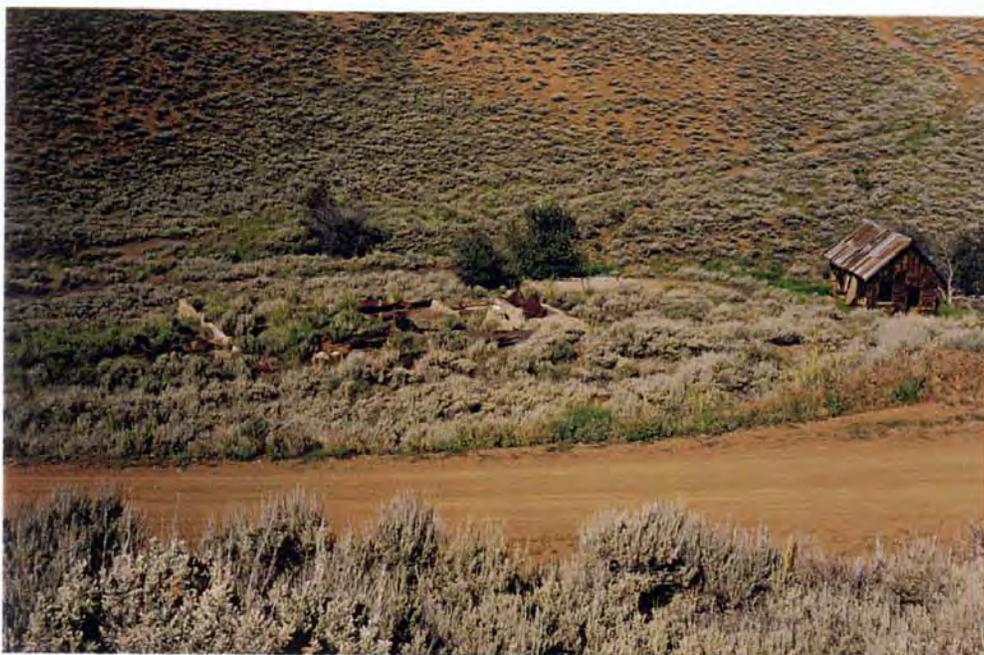
Figure 28-4. Bullion mill foundation with old building in back. Picture is looking to southwest. (Roll 98-9, neg. #6738, frame #20; photograph by V. S. Gillerman; July 16, 1998).

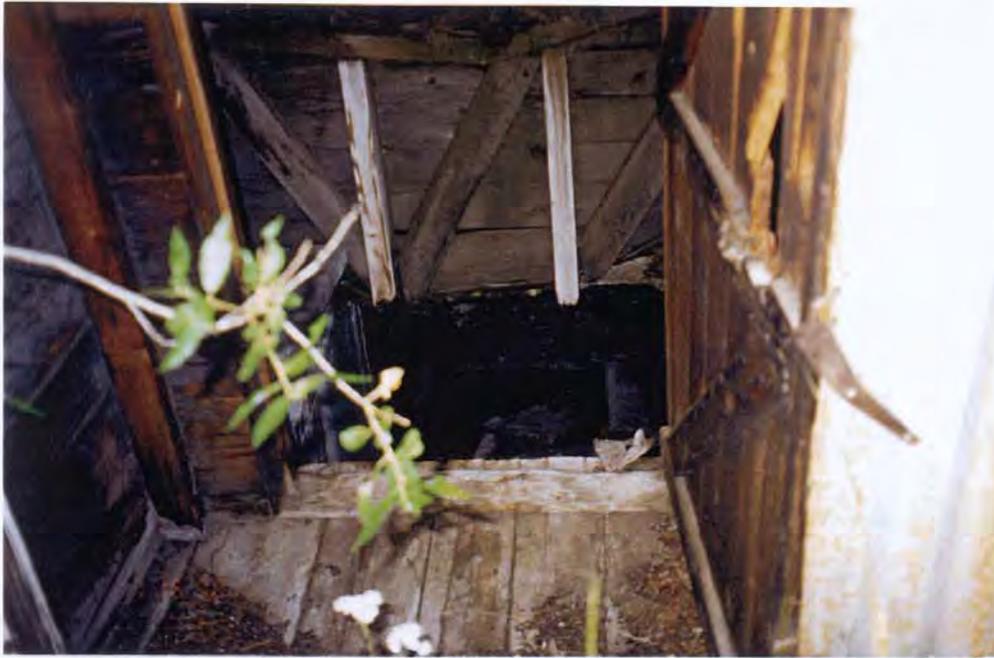
Figure 28-7. Bullion mill shaft # 2 interior - a decline open to 30 feet. Structure is caving in, but there is recent can at bottom of shaft. Picture is looking to northeast. (Roll 98-9, neg. #6738, frame #23; photograph by V. S. Gillerman; July 16, 1998).

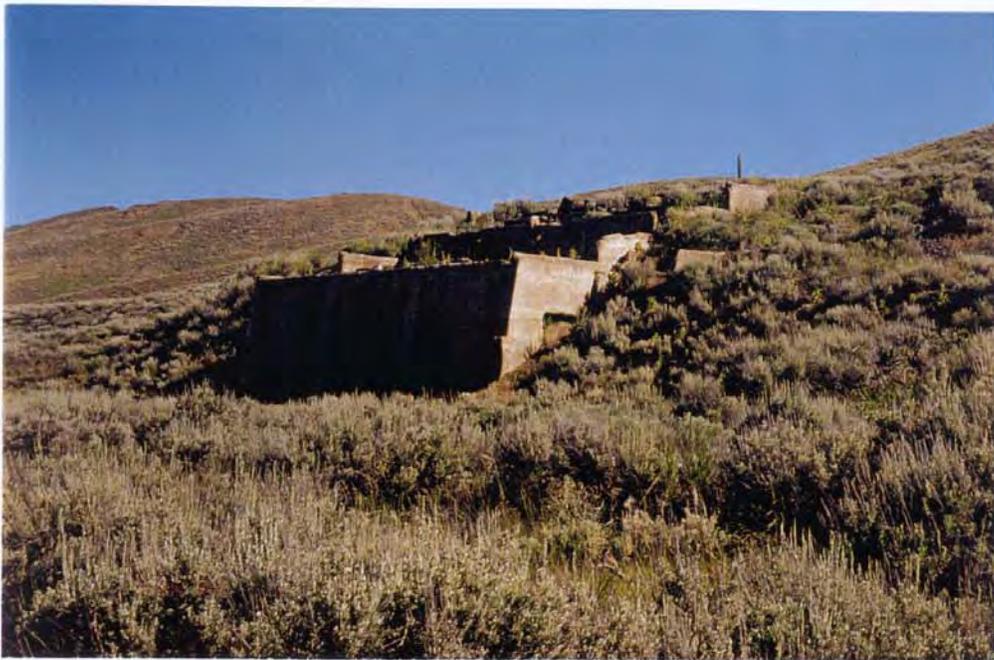
Figure 28-8. The Bullion mill site from lower elevation. Picture is looking to north. (Roll 98-9, neg. #6738, frame #24; photograph by V. S. Gillerman; July 16, 1998).

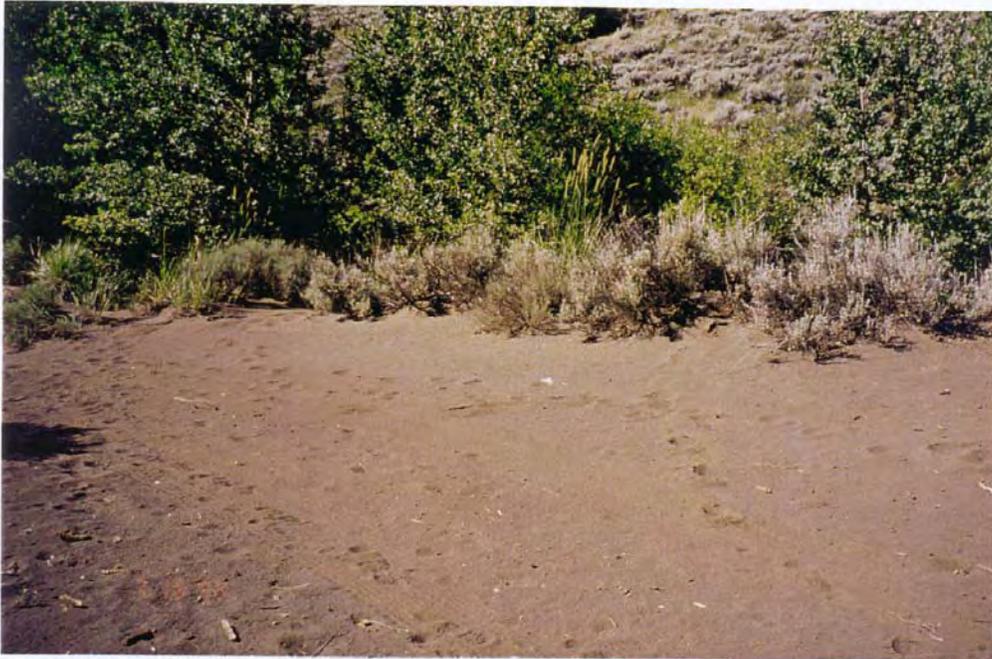
- **Tailings Pile 1** - *The tailings pile measured 538 feet long by an average of 234 feet wide covering an area of approximately 125,892 square feet. Three tailings samples (BMTP01SS, BMTP02SS, and BMTP03SS) were collected. Analytical results from samples BMTP01SS and BMTP02SS indicates the*

presence of nine TAL metals at significant concentrations with respect to background concentrations (Table 6-8). Analytical results from sample BMTP03SS indicates the presence of seven TAL metals at significant concentrations with respect to background concentrations (Table 6-8).

Figure 28-9. Bullion mill tailings, fine and sand sized, with campfire, party remains, and human litter. Sage brush grows on tailings, and there is lush riparian vegetation and aspen along adjacent creek. Picture is looking to south. (Roll 98-9, neg. #6738, frame #25; photograph by V. S. Gillerman; July 16, 1998).

Based on the completeness of pathways between contaminated soils/tailings with recreational receptors, and potentially residential receptors, DEQ is making two recommendations to the owner; First is that the owner short circuits the pathways for exposure to recreational users at the site, and second that a reclamation plan is developed for the site to eliminate the erosion of tailings and soils at the site that have been destabilized by past activities. Relative to the first, DEQ suggests that there are a number of ways to short circuit the pathways including but not limited to posting the property, fencing the property, capping the tailings and contaminated soils in place, or removal and either reprocessing or disposal in a capped repository.

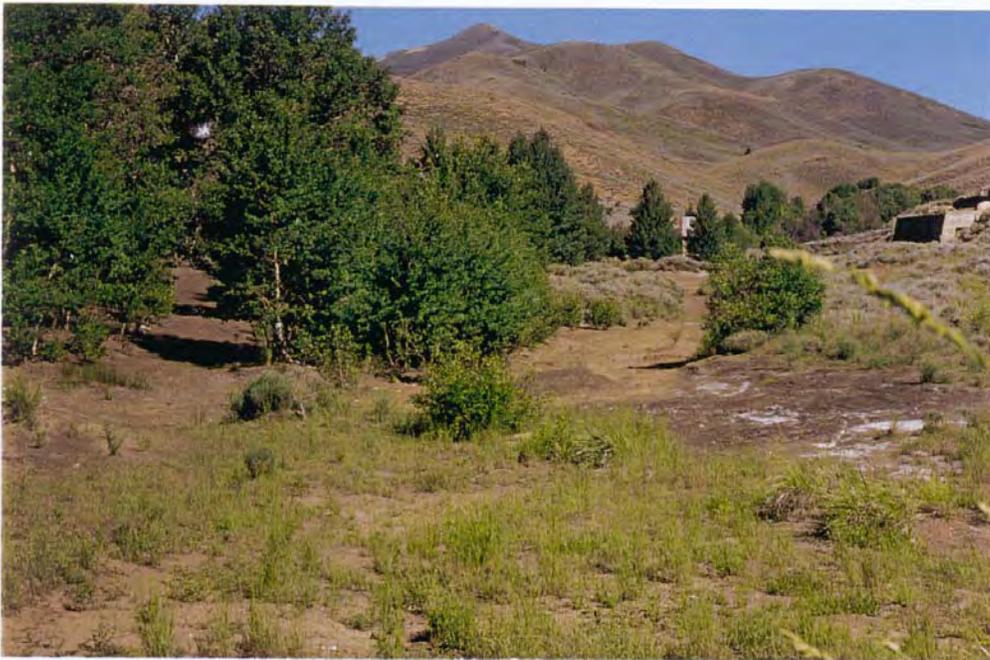
Figure 28-10. Bullion mill tailings, un-vegetated and also with good sage and aspen cover. Note local caliche (?) on top. Picture is looking to northwest. (Roll 98-10, neg. #6737, frame #01; photograph by V. S. Gillerman; July 16, 1998).

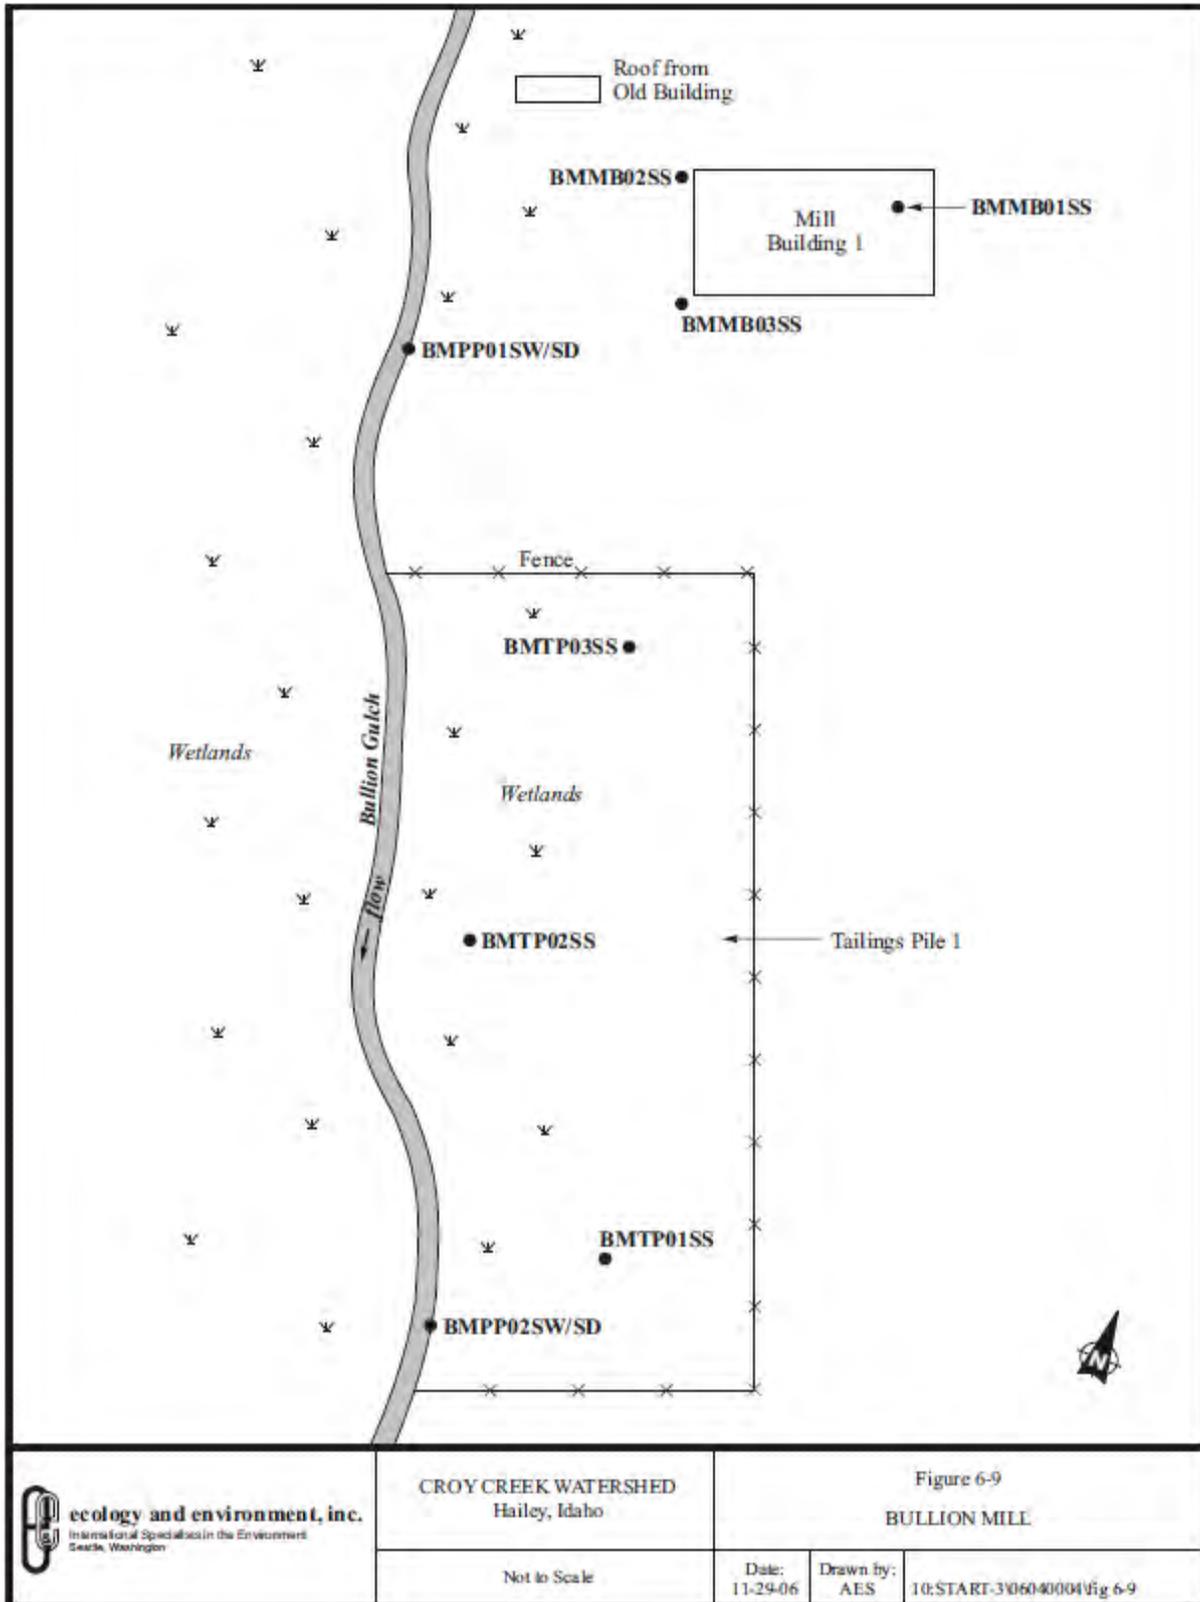
DEQ and E & E collected two background samples from locations upgradient of the mines/mills of Bullion Gulch, three soil samples at the mill building, three tailings samples and two probable points of entry soil/sediment samples. Figure 5 shows the sample locations at the millsite. Background sample locations are described, but not shown.

Figure 5. Drawing of Bullion Mill sampling locations, tailings, and structures (from E&E, 2007).

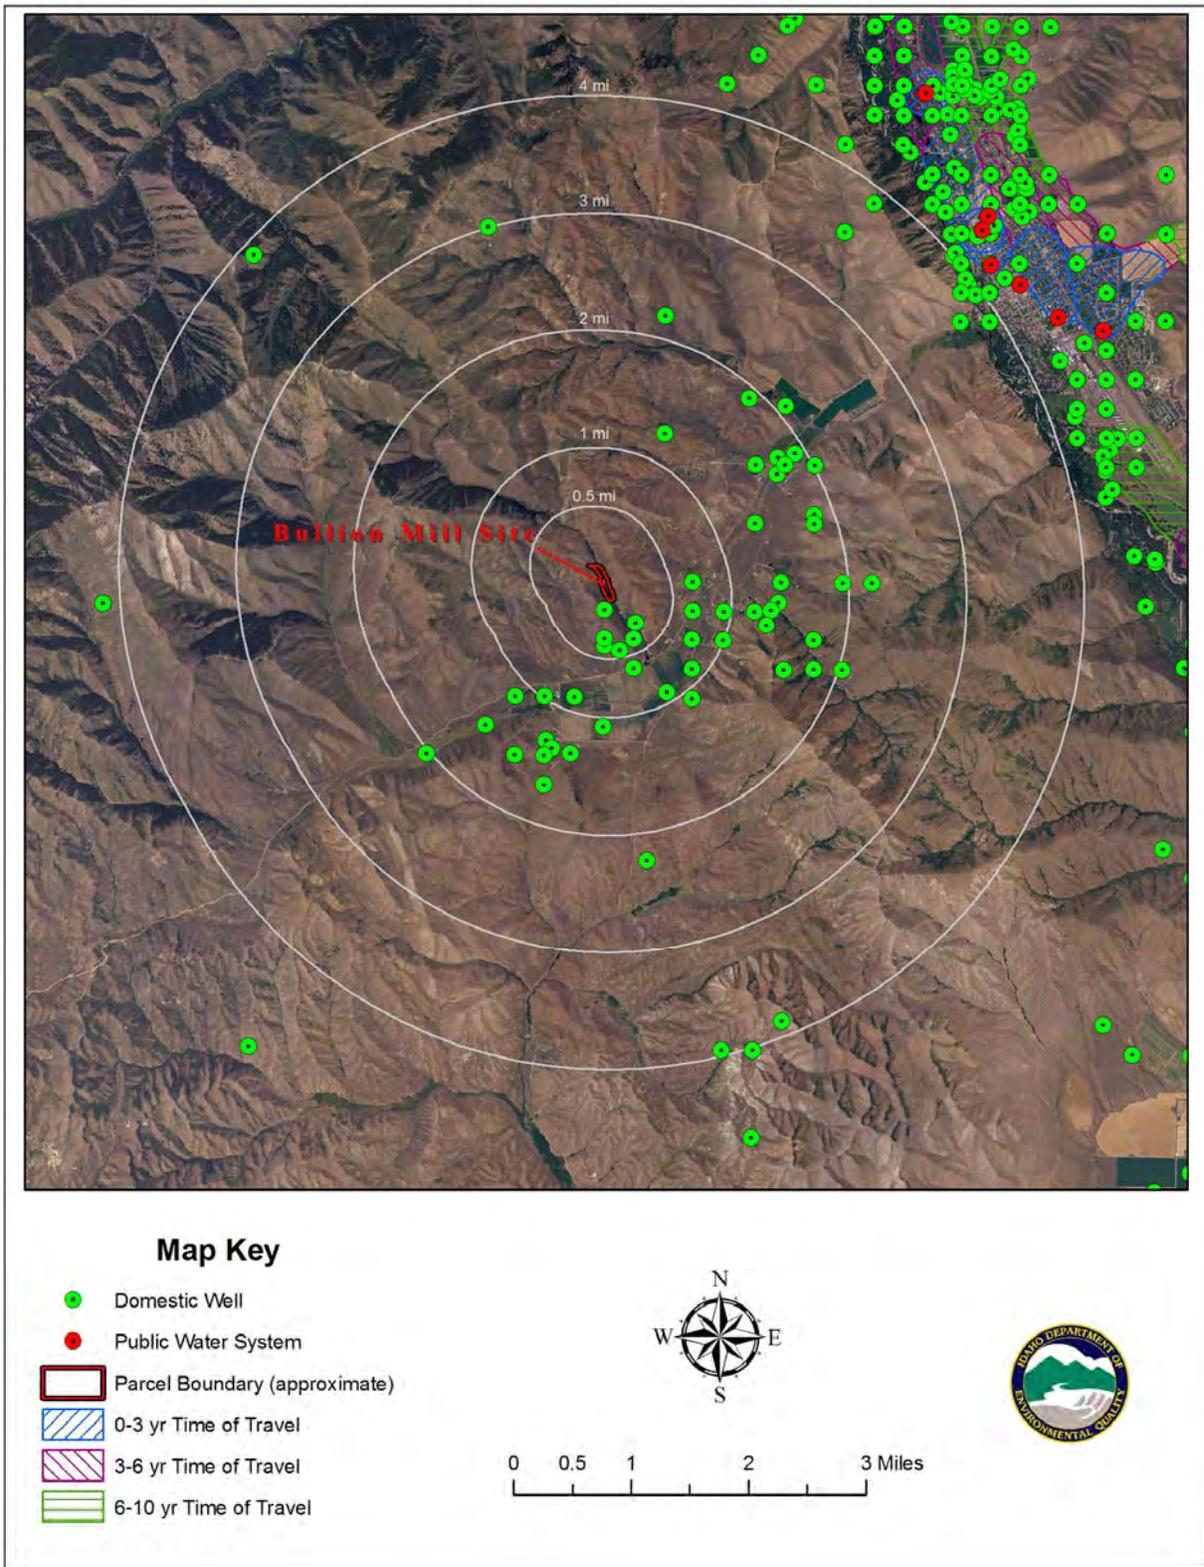
The closest domestic drinking water well lies approximately 0.17 miles south-southwest of the Bullion millsite. There are 28 wells located within a distance of 1 mile; 72 wells located within a distance of 1 to 2 miles of the sites; seven wells within 2 to 3 miles; and 17 wells within 3 to 4 miles of the Bullion millsite. The majority of these wells are located at residences within and immediately adjacent to the Croy Creek Road area (Figure 6).

Figure 6. Drinking water well locations and source water delineations (Map source: NAIP 2004).

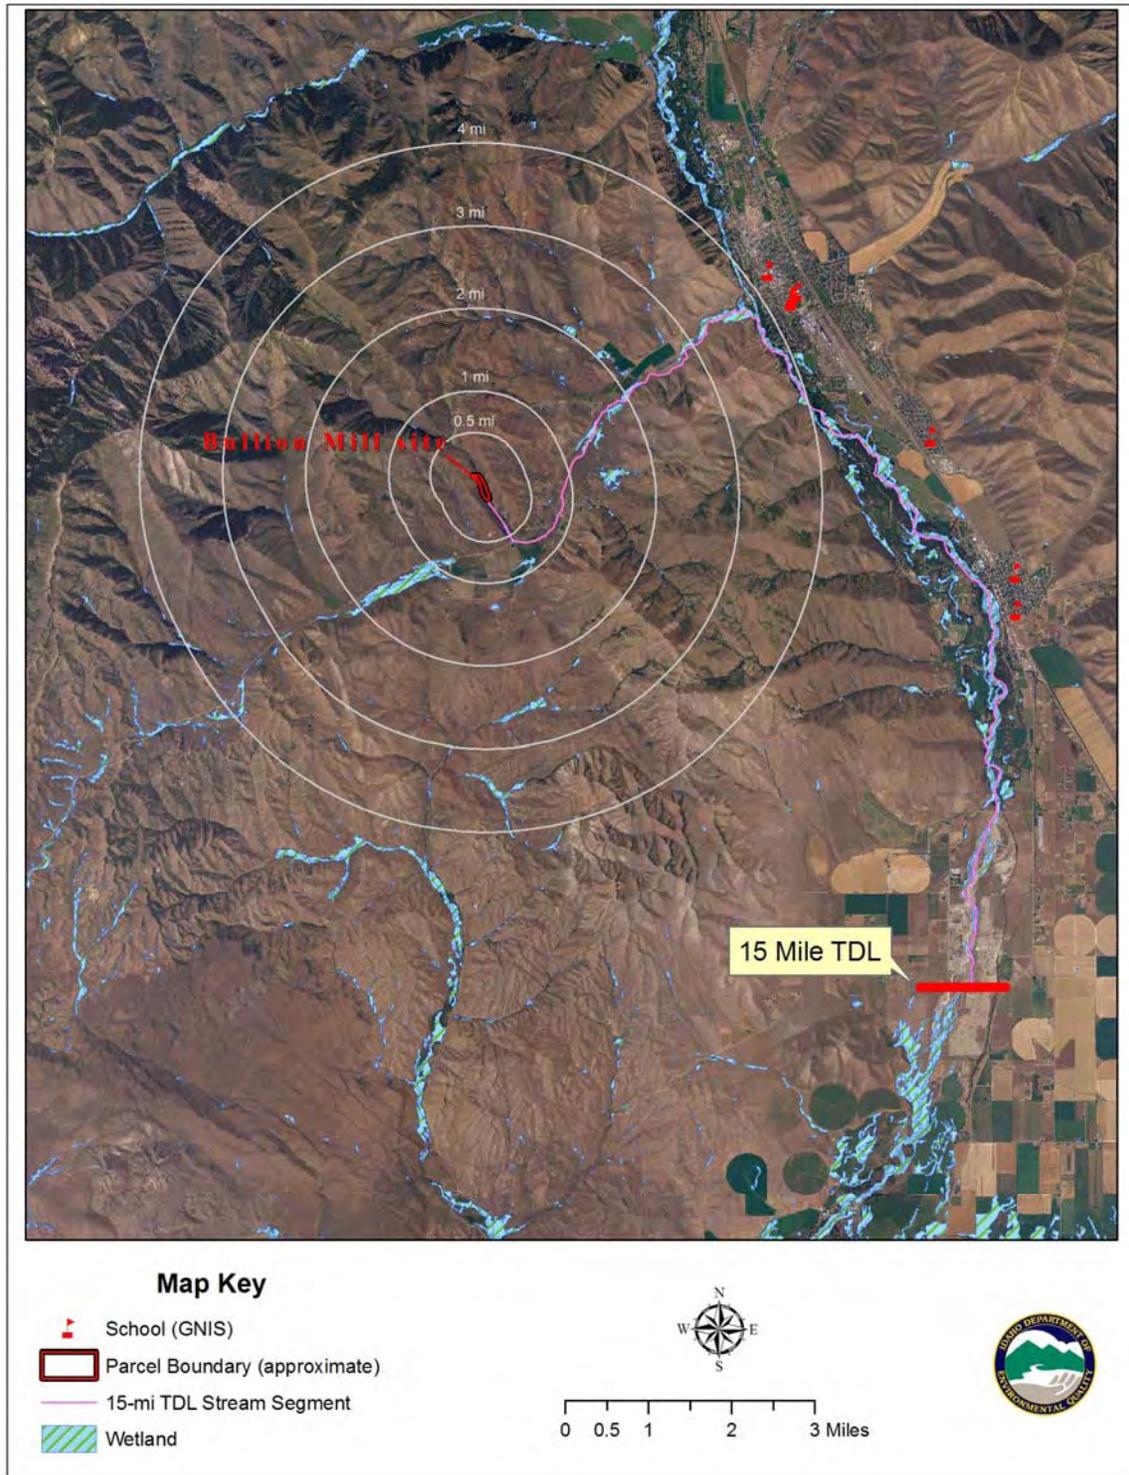
Significant (approximately 14 miles) wetlands, however, do exist along Croy Creek, from approximately 0.95 miles down stream of the mill site to the 15-mile TDL on the Big Wood River (Figure 7). Though wetlands are noted in Figure 5 by E & E (2007), their existence is

Figure 7. Wetlands and 15-Mile TDL map (Source Fair 100k, Sunv 100k, NAIP 2004).
