STATE OF IDAHO
DEPARTMENT OF
ENVIRONMENTAL QUALITY

Subject: Abbreviated Preliminary Assessment Report for Crooks Corral
Elevated Placer

ABBREVIATED PRELIMINARY ASSESSMENT CHECKLIST

Site Name: Crooks Corral Elevated Placer

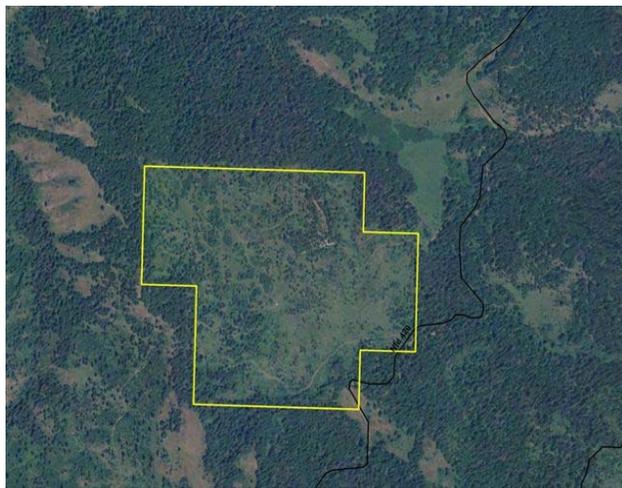
Photo showing private property boundary of Crooks Corral Placer.
Area outside the yellow borders is USFS land.

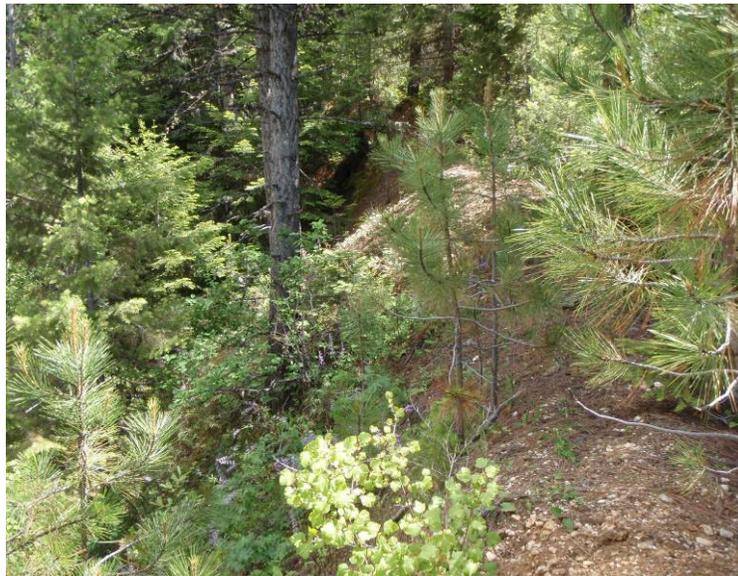
Photo of the well vegetated and stable waste dump.

There are no air borne, surface or ground water pathways to any water sources or residences. The on site cabin is up gradient from the waste dumps and potable water is hauled to the site. Although elevated metal concentrations exist at the waste dumps, the area is well vegetated and stable. Human exposure to the waste would be minimal to none. The waste dump could be fenced off to prevent any livestock access if deemed necessary.

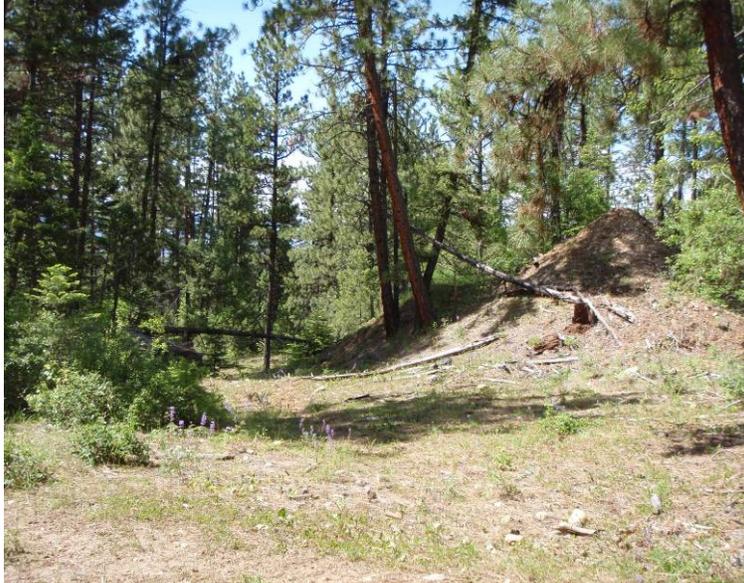
Photo of the down gradient waste dump.

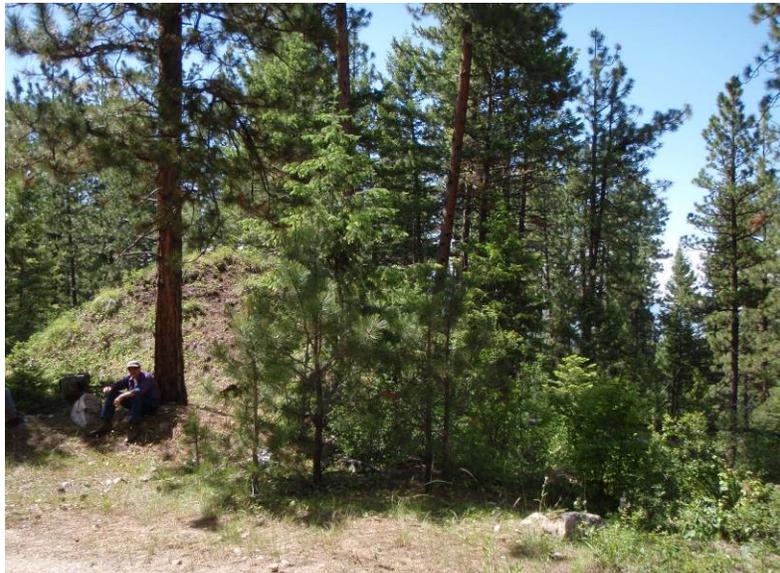
Photo of another well vegetated and stable waste dump.

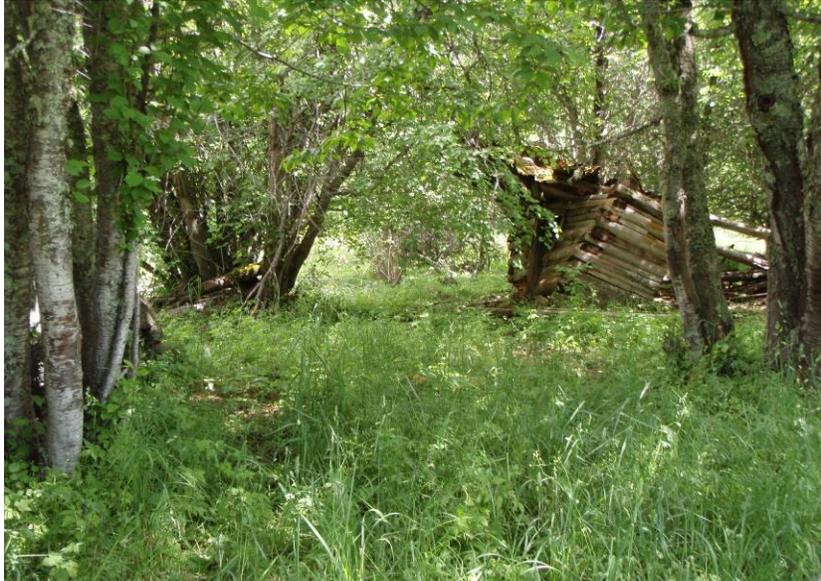
Photo of the Hardin Mill site. The mill site is on USFS property, east of the patented ground. It is assumed this site was utilized to process some of the Crooks Corral material and other mines in the general area.

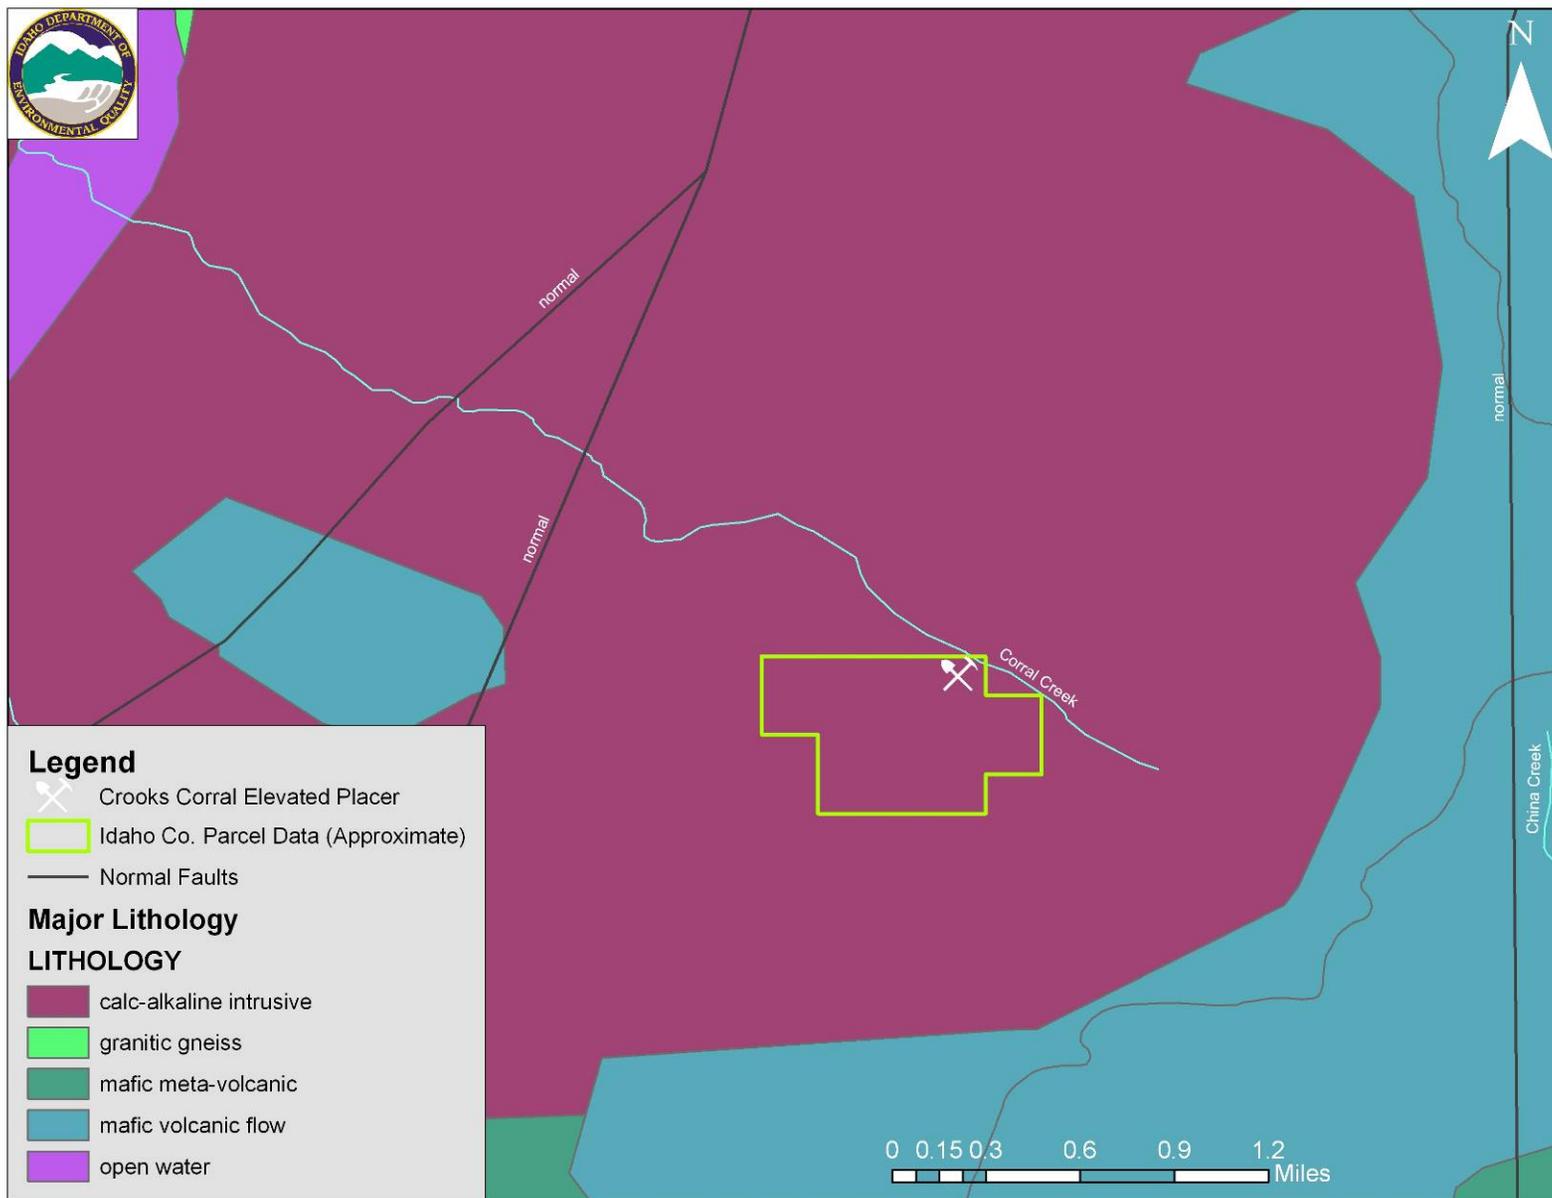
Figure 3. Major Lithology of the Crooks Corral Elevated Placer
 (Map Source: SDE Feature Class, USGS 1995. Idaho DEQ GIS ArcSDE 9.2 Geodatabase)

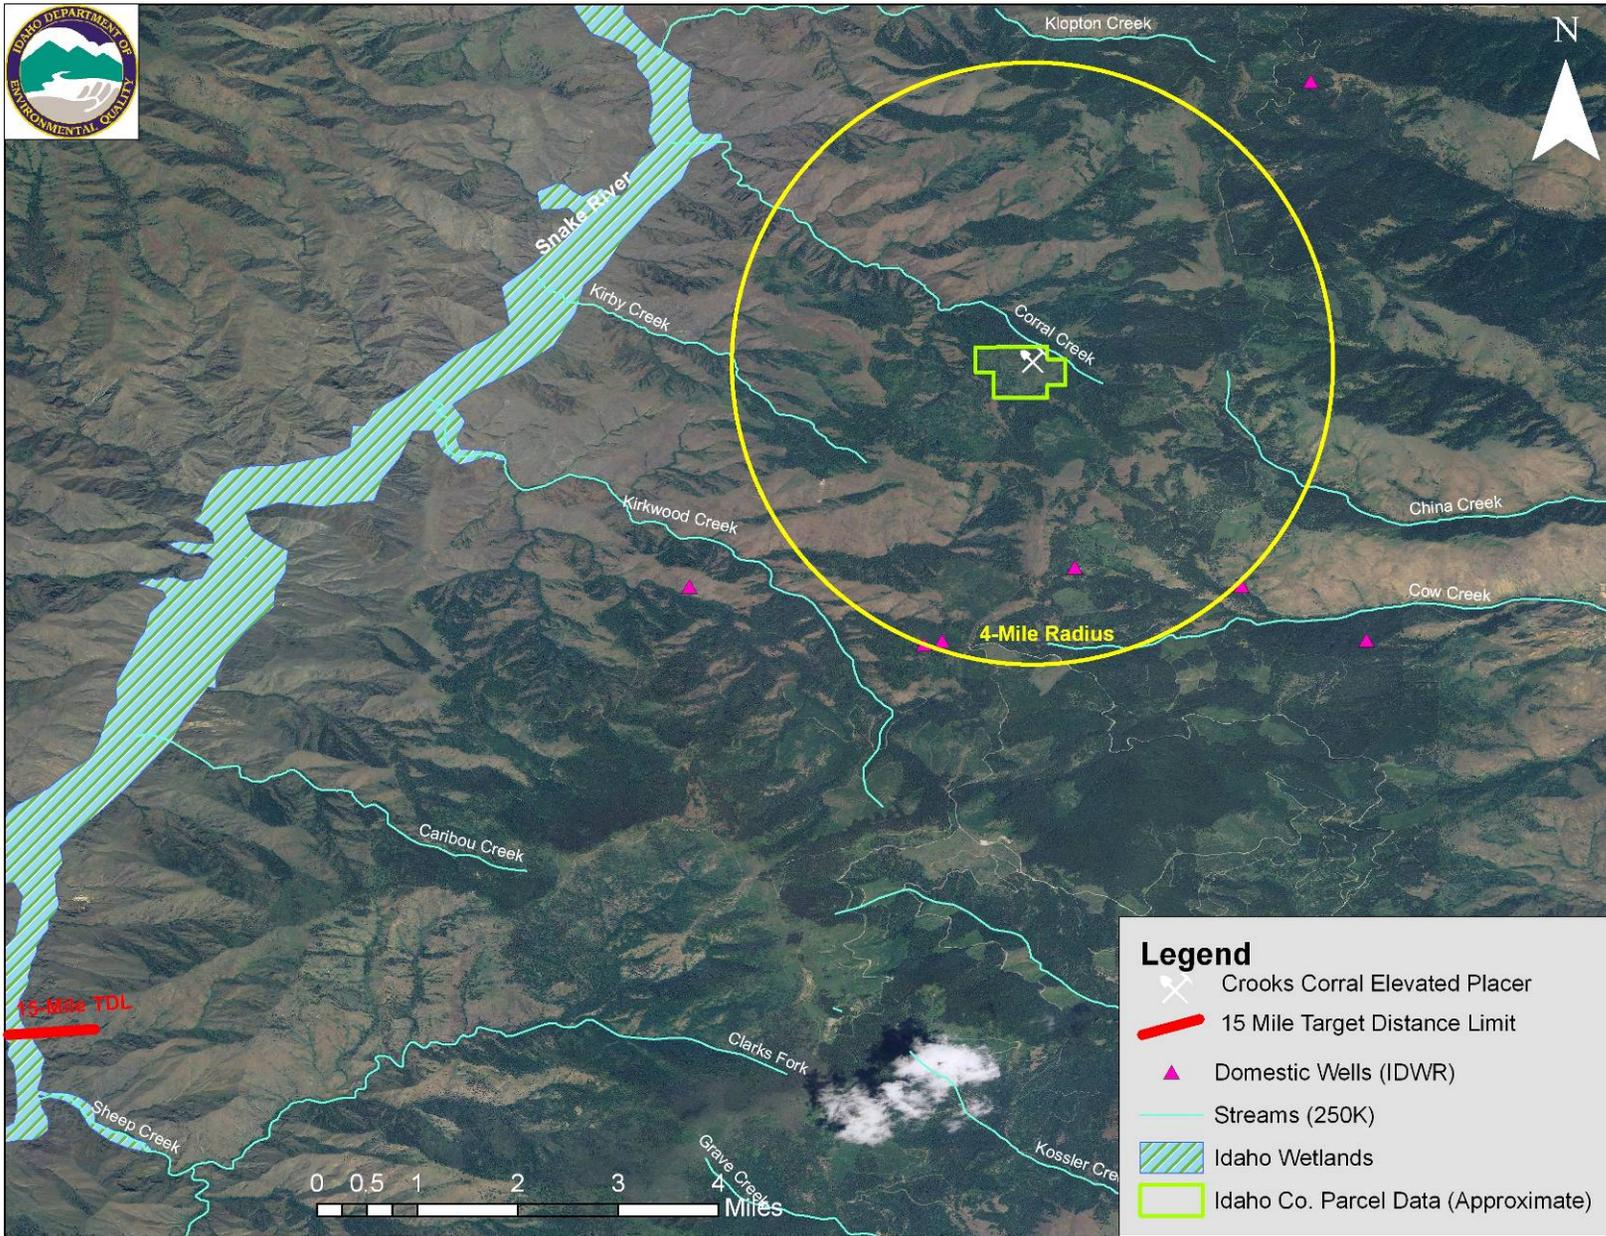
Figure 4. Domestic Well Locations. There are no public water systems in the area's 15 Mile Target Distance Limit (TDL). Wetlands run along the Snake River. (Map Source: 2004 National Agriculture Imagery Program (NAIP)).

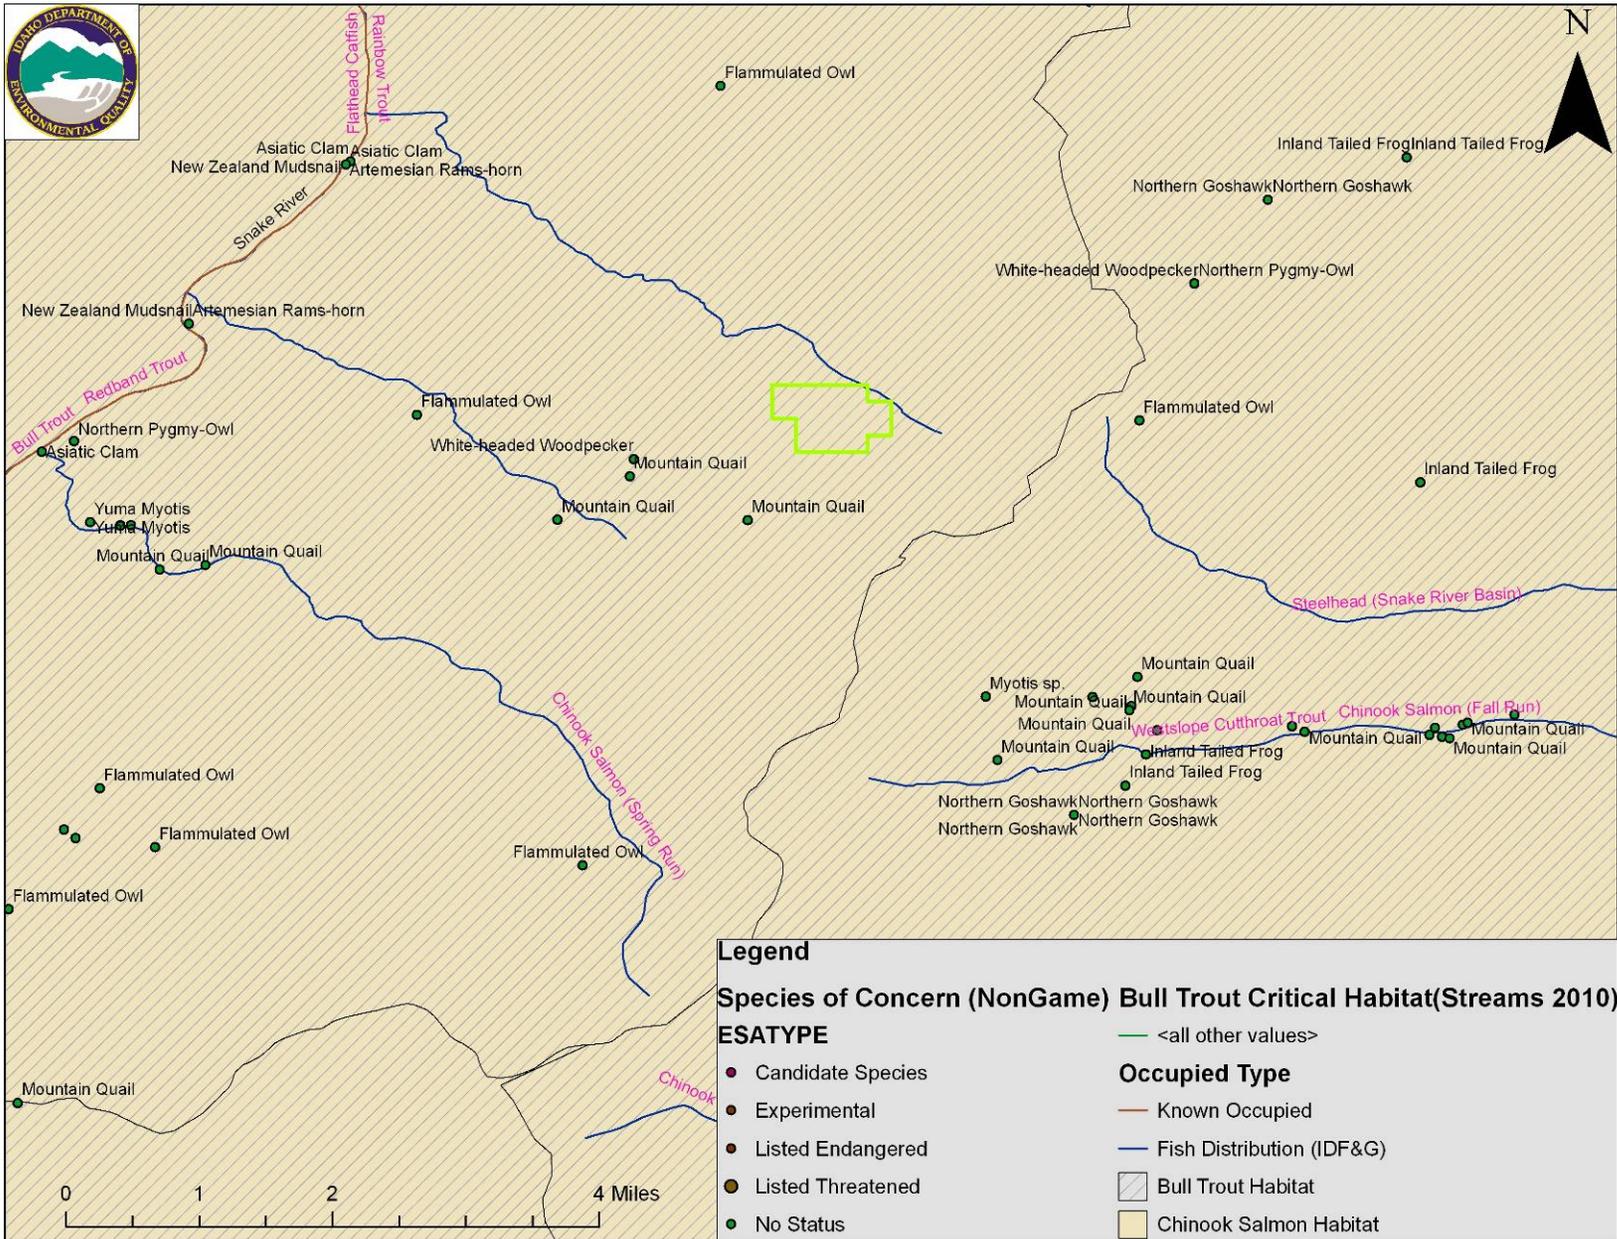
Figure 5. Sensitive Species Near Crooks Corral Elevated Placer. Species of Concern (Animals) and Fisheries.
 (Map Source: SDE Feature Dataset, Animal Conservation Database. Idaho DEQ GIS ArcSDE 9.2 Geodatabase)

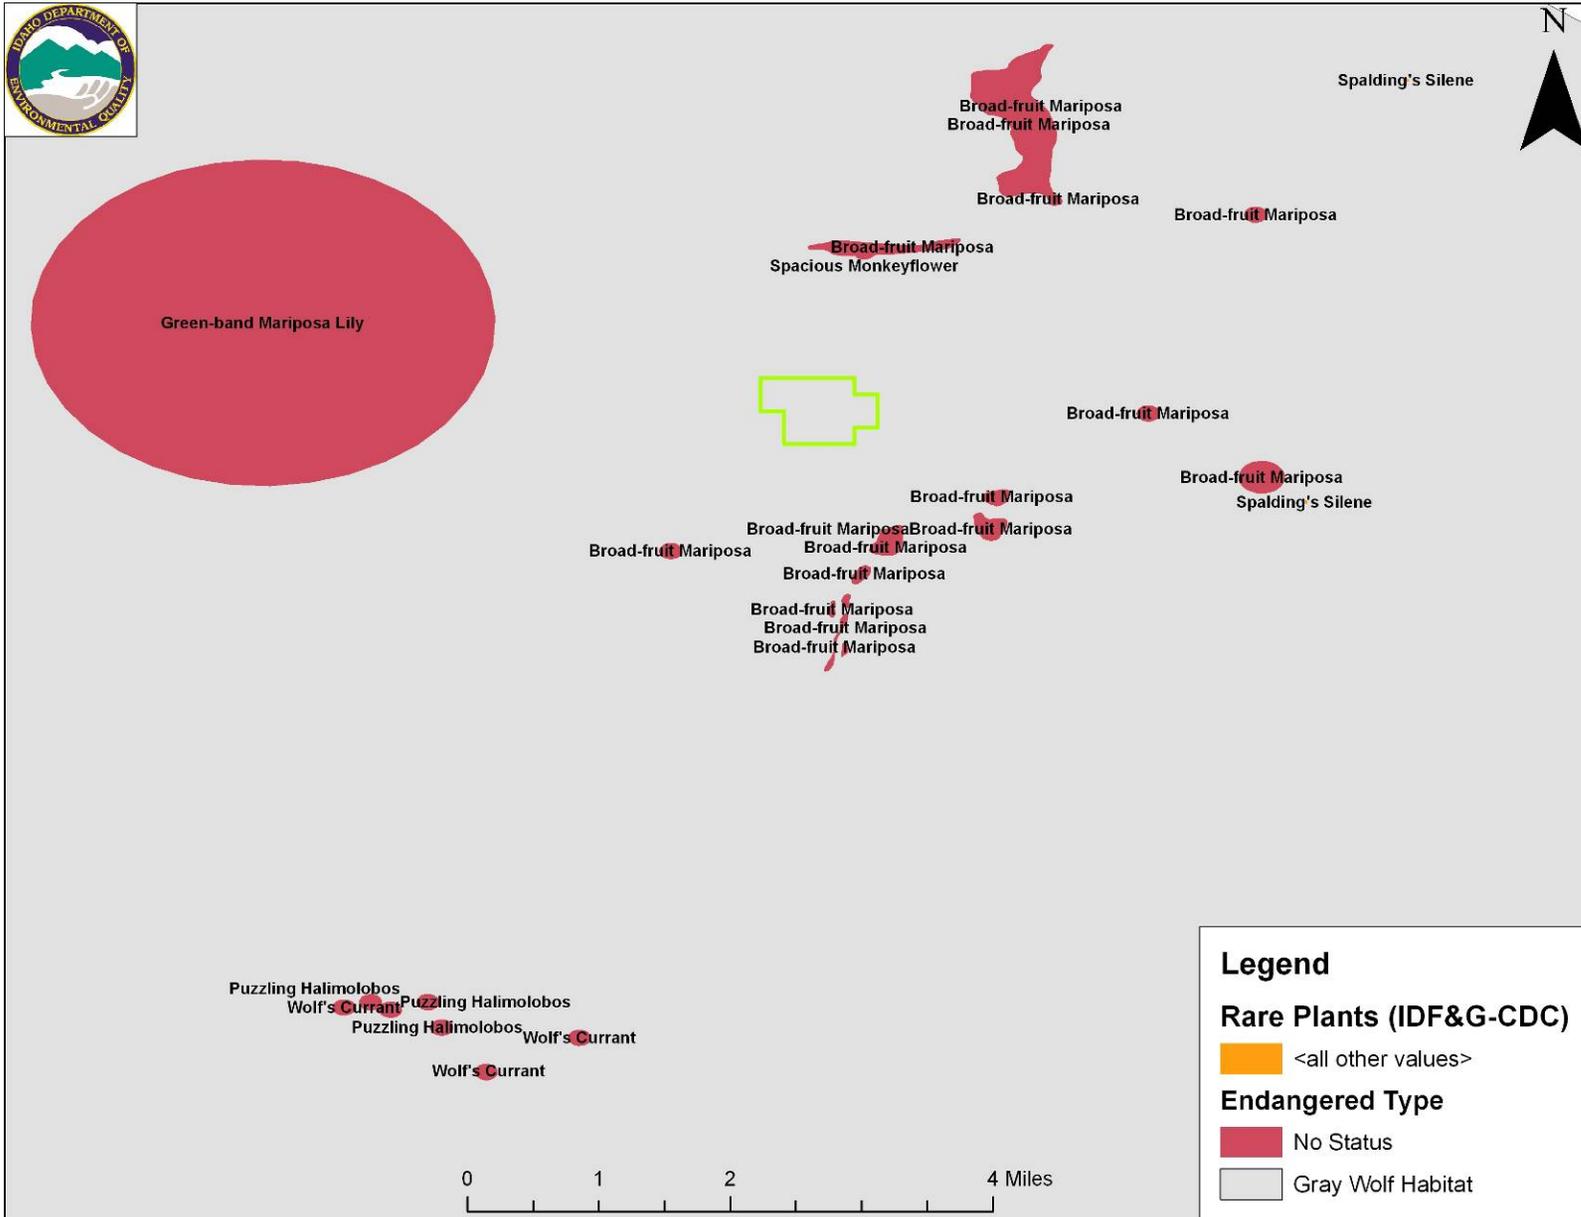
Figure 6. Sensitive Species Near Crooks Corral Elevated Placer. Species of Concern (Plants) and Gray Wolf Habitat. (Map Source: SDE Feature Dataset, Animal Conservation Database. Idaho DEQ GIS ArcSDE 9.2 Geodatabase)
