Subject: Site Assessments of the Penman Mine and Homestake Mine/Badger Shafts,  
Orogrande Area, Idaho County, Idaho

## ABBREVIATED PRELIMINARY ASSESSMENT

**Site Name:** Penman Mine

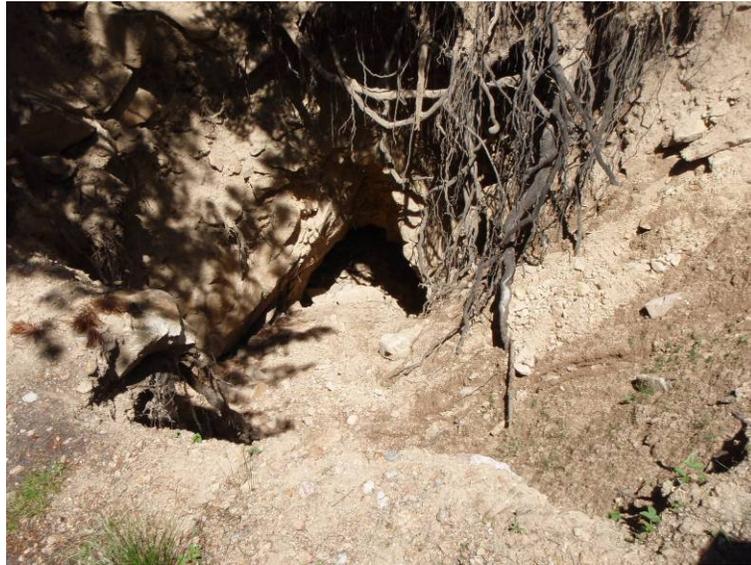
Penman Shaft 1 is partially collapsed. As the shaft continues to collapse, it is cutting into the access road. The shaft is eroding the road away. This is a dangerous situation and access to the road should be restricted. The shaft does not discharge and no surface water is within close proximity to this site, thus no pathways exist to surface waters.

Photo 1. Penman Shaft 1, partly collapsed (7/29/10)

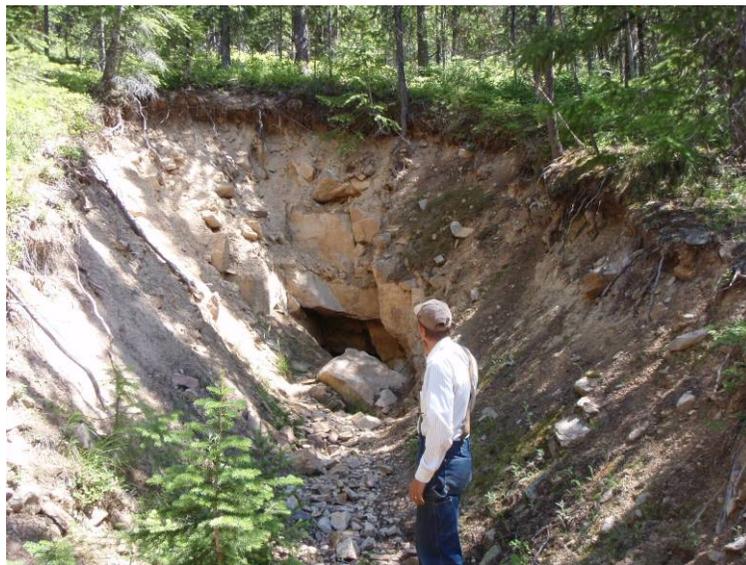
Penman Adit 1 is an open adit that showed evidence of recreational use. This is a dangerous adit and access into the mine should be restricted. Penman Adit 1 waste dump is below the adit. The waste dump contains approximately 10,000 cubic yards of material. No visible sulfides or highly mineralized material remains. The waste dump is country rock. Vegetation is evident on the top and the toe of the waste dump. The adit does not discharge water. No streams or water bodies are within close proximity to this site, thus no pathways exist to surface waters.

Photo 2. Penman Adit 1, note the large rock that fell from top of the adit opening (7/29/10)

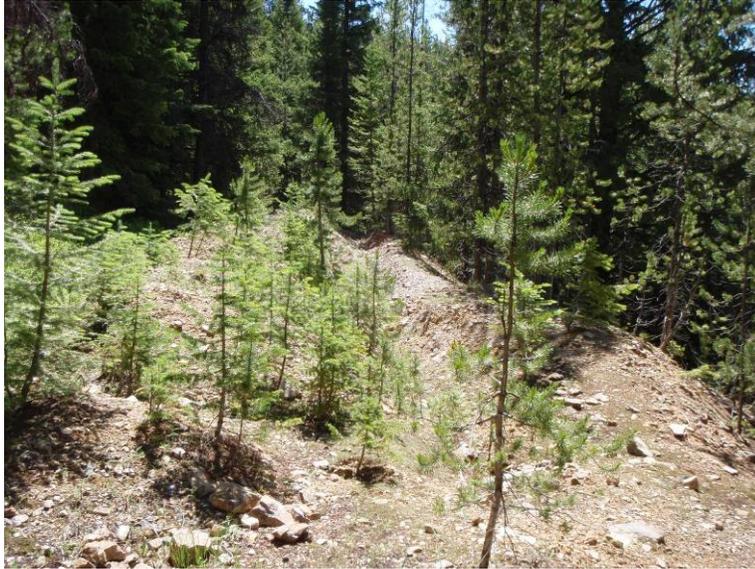
Photo 3. Penman waste dump, trees growing on top and toe of the dump (7/29/10)

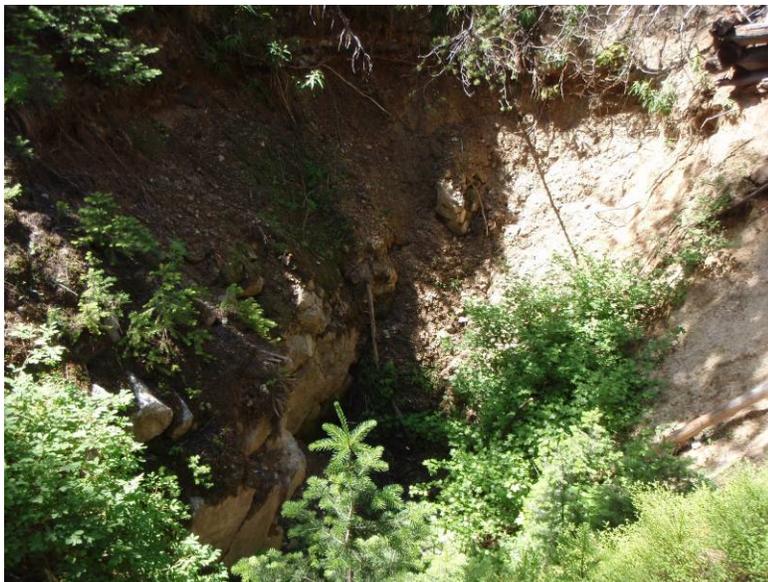
Penman Shaft 2 is collapsed with vegetation well established. The shaft does not discharge and no surface water is within close proximity to this site, thus no pathways exist to surface waters.

Photo 4. Penman Shaft 2, collapsed with vegetation (7/29/10)

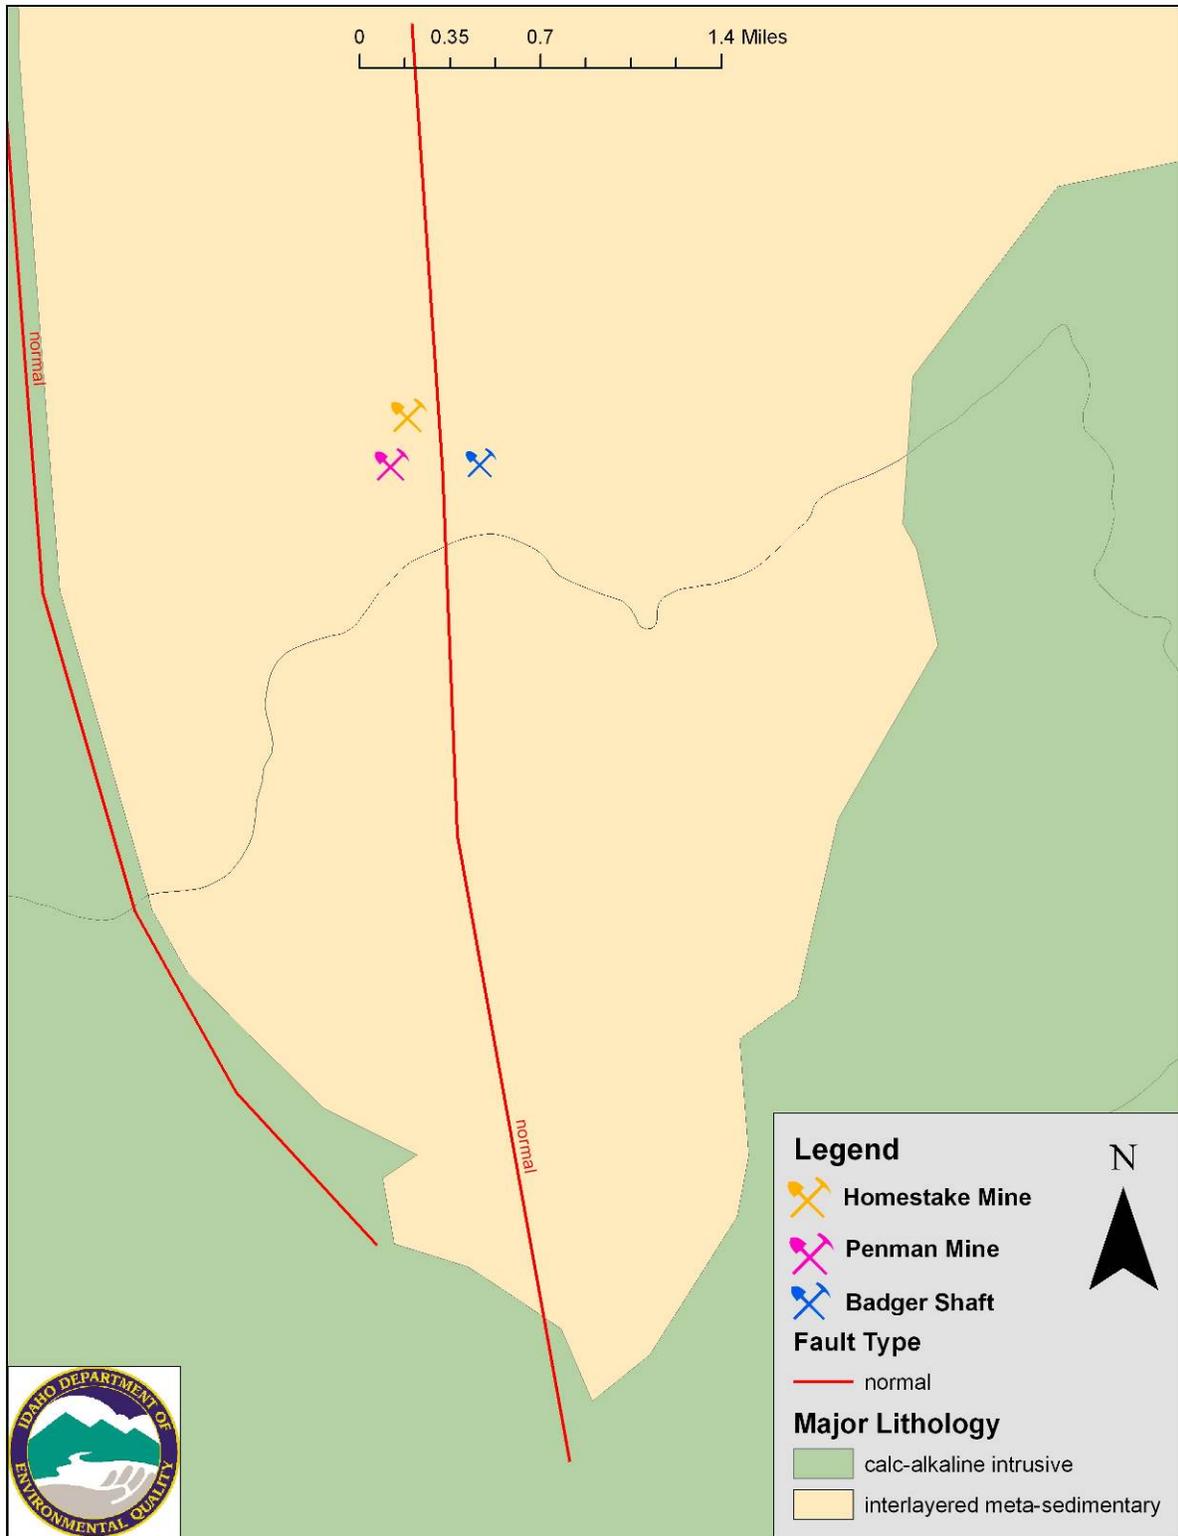
Map 2. Major Lithology of Homestake Mine, Badger Shaft, and Penman Mine and Surrounding Area (Map Sources: SDE Feature Class, USGS 1995 and Idaho DEQ GIS ArcSDE 9.2 Geodatabase)

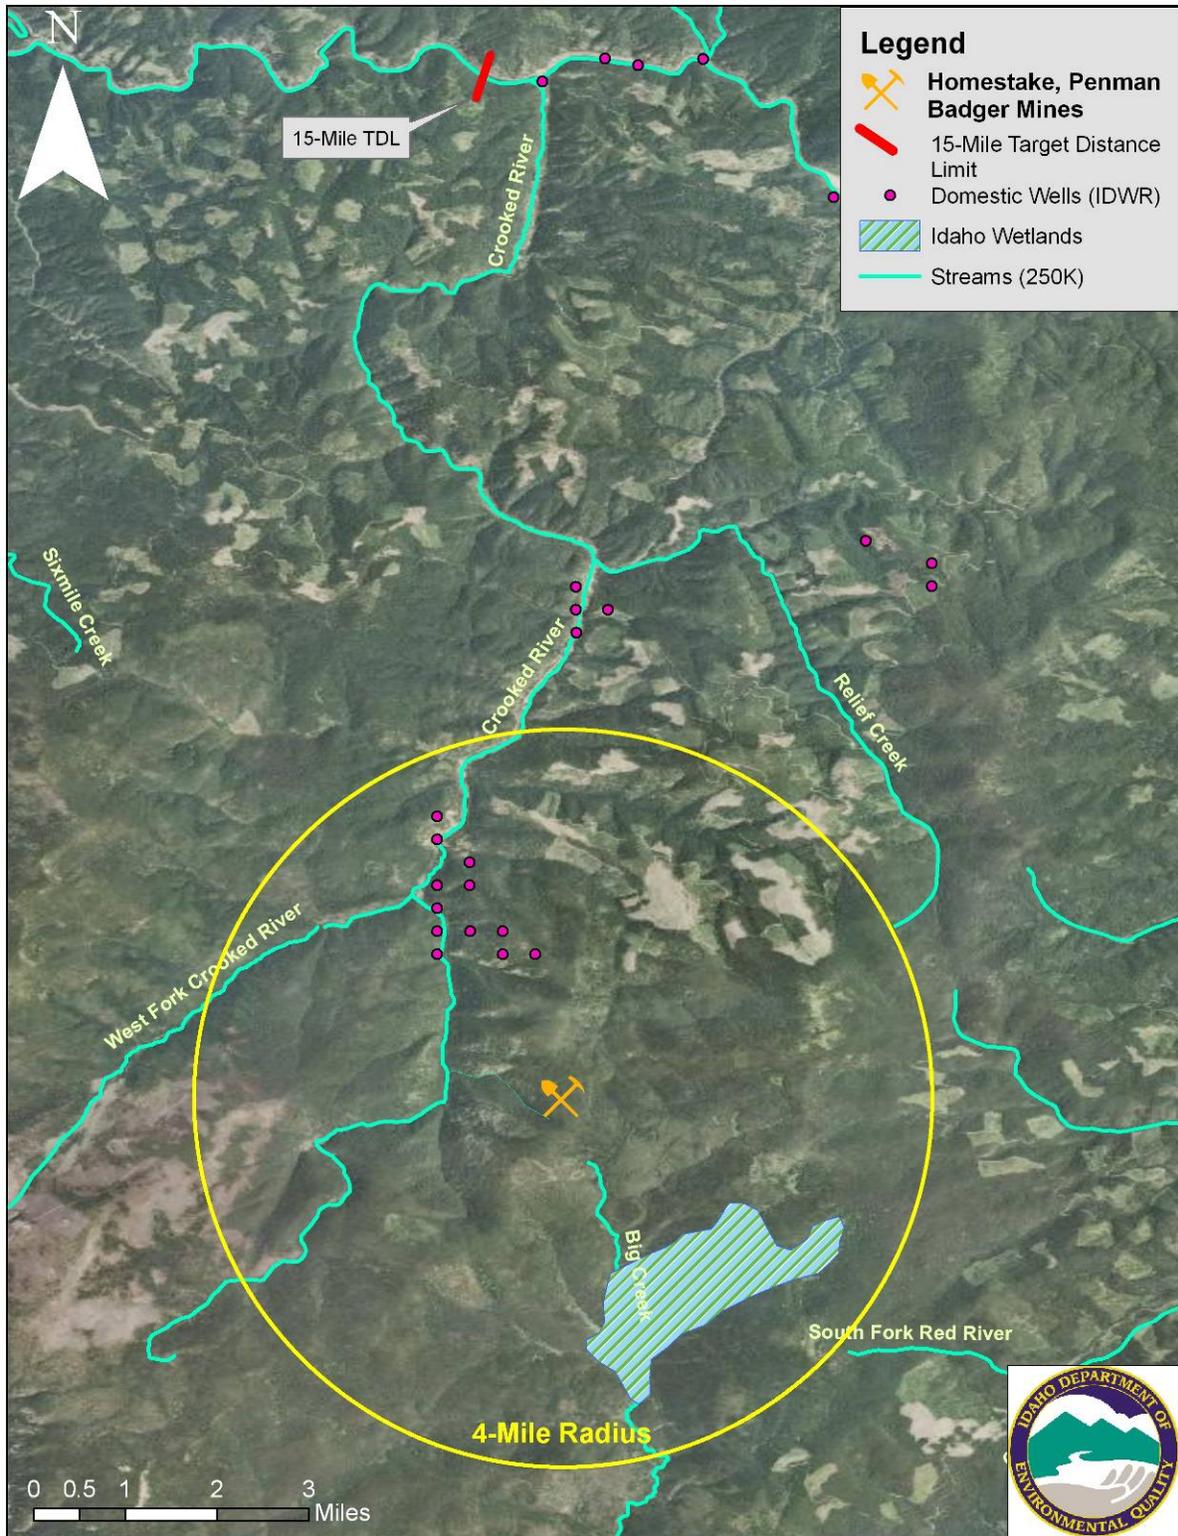
Map 3. Domestic Well Locations. There are no public water systems within the four mile radius, 15 mile target distance limit (TDL). Wetlands run along Big Creek, however they are segregated by structural geology. (Map Source: 2009 Natural Color 1-meter NAIP Idaho Map)

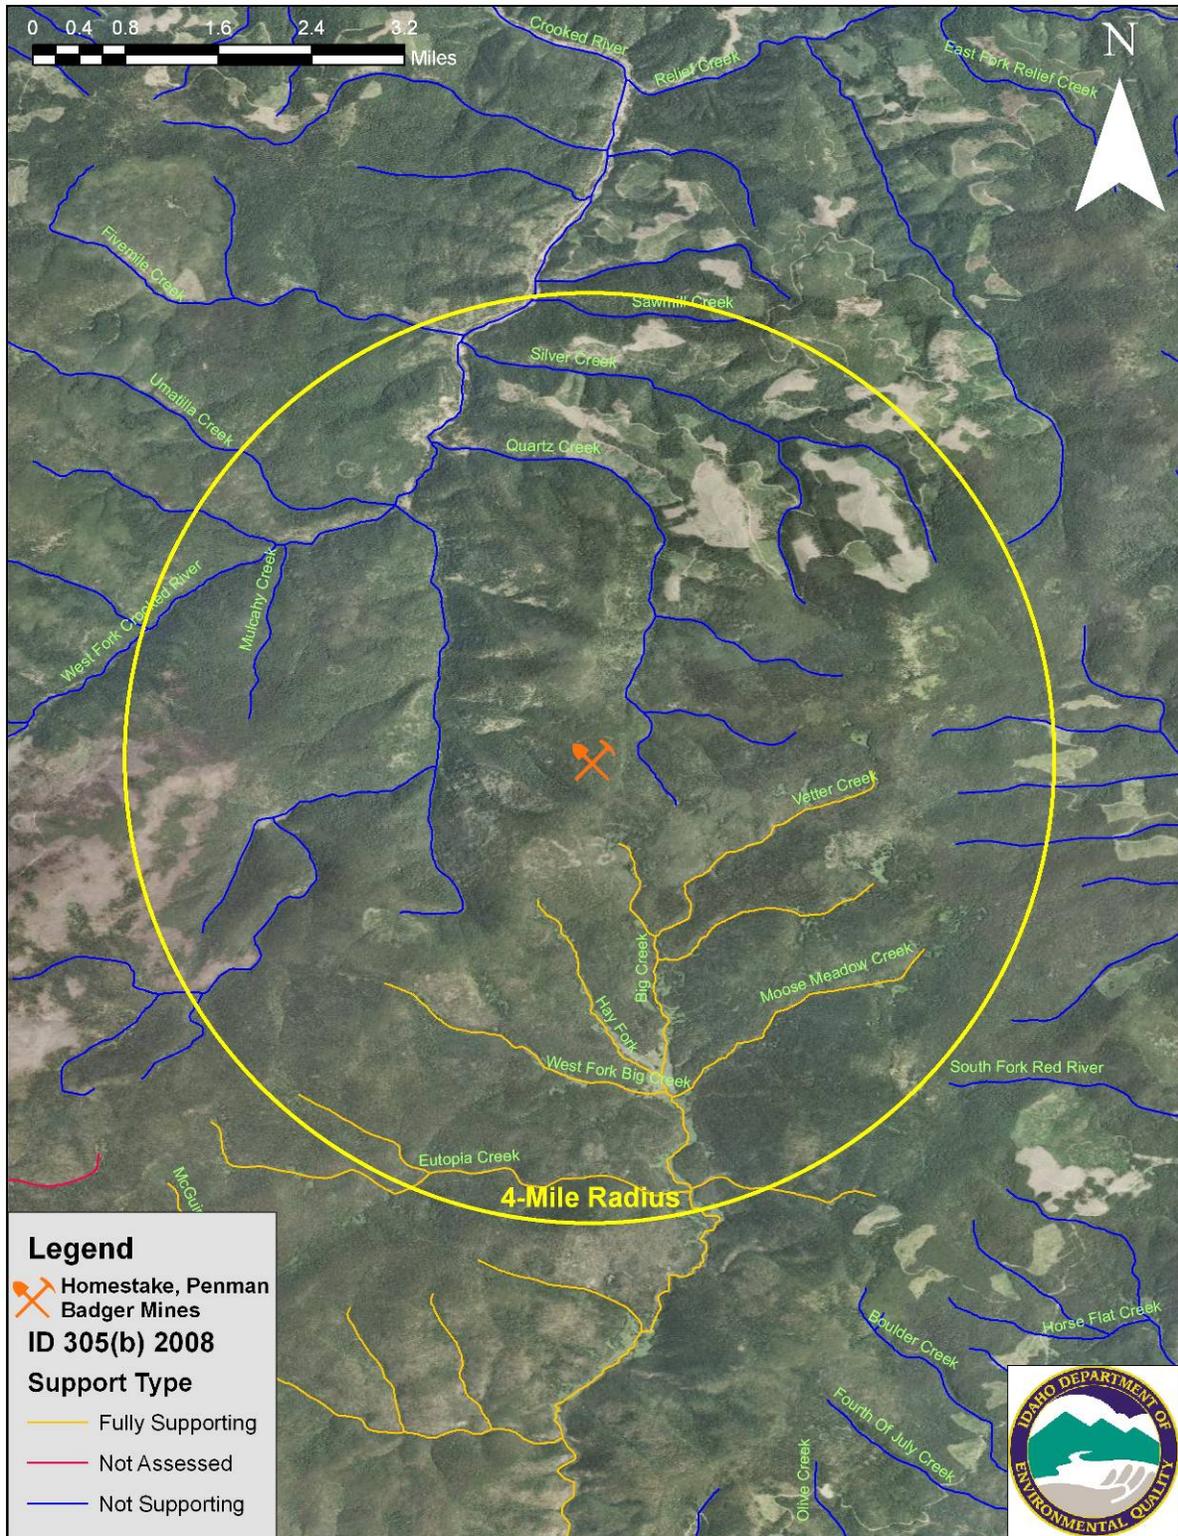
Map 5. Sensitive Waterways within Four Mile Radius and Surrounding Area (Map Sources: SDE Feature Dataset, Animal Conservation Database and Idaho DEQ GIS ArcSDE 9.2 Geodatabase, 2009 Natural Color 1-meter NAIP Idaho Map)
