**TIN CUP MINE & MILL  
PRELIMINARY ASSESSMENT REPORT  
LEMHI COUNTY, IDAHO**

**STATE OF IDAHO  
DEPARTMENT OF ENVIRONMENTAL QUALITY**

December 2002

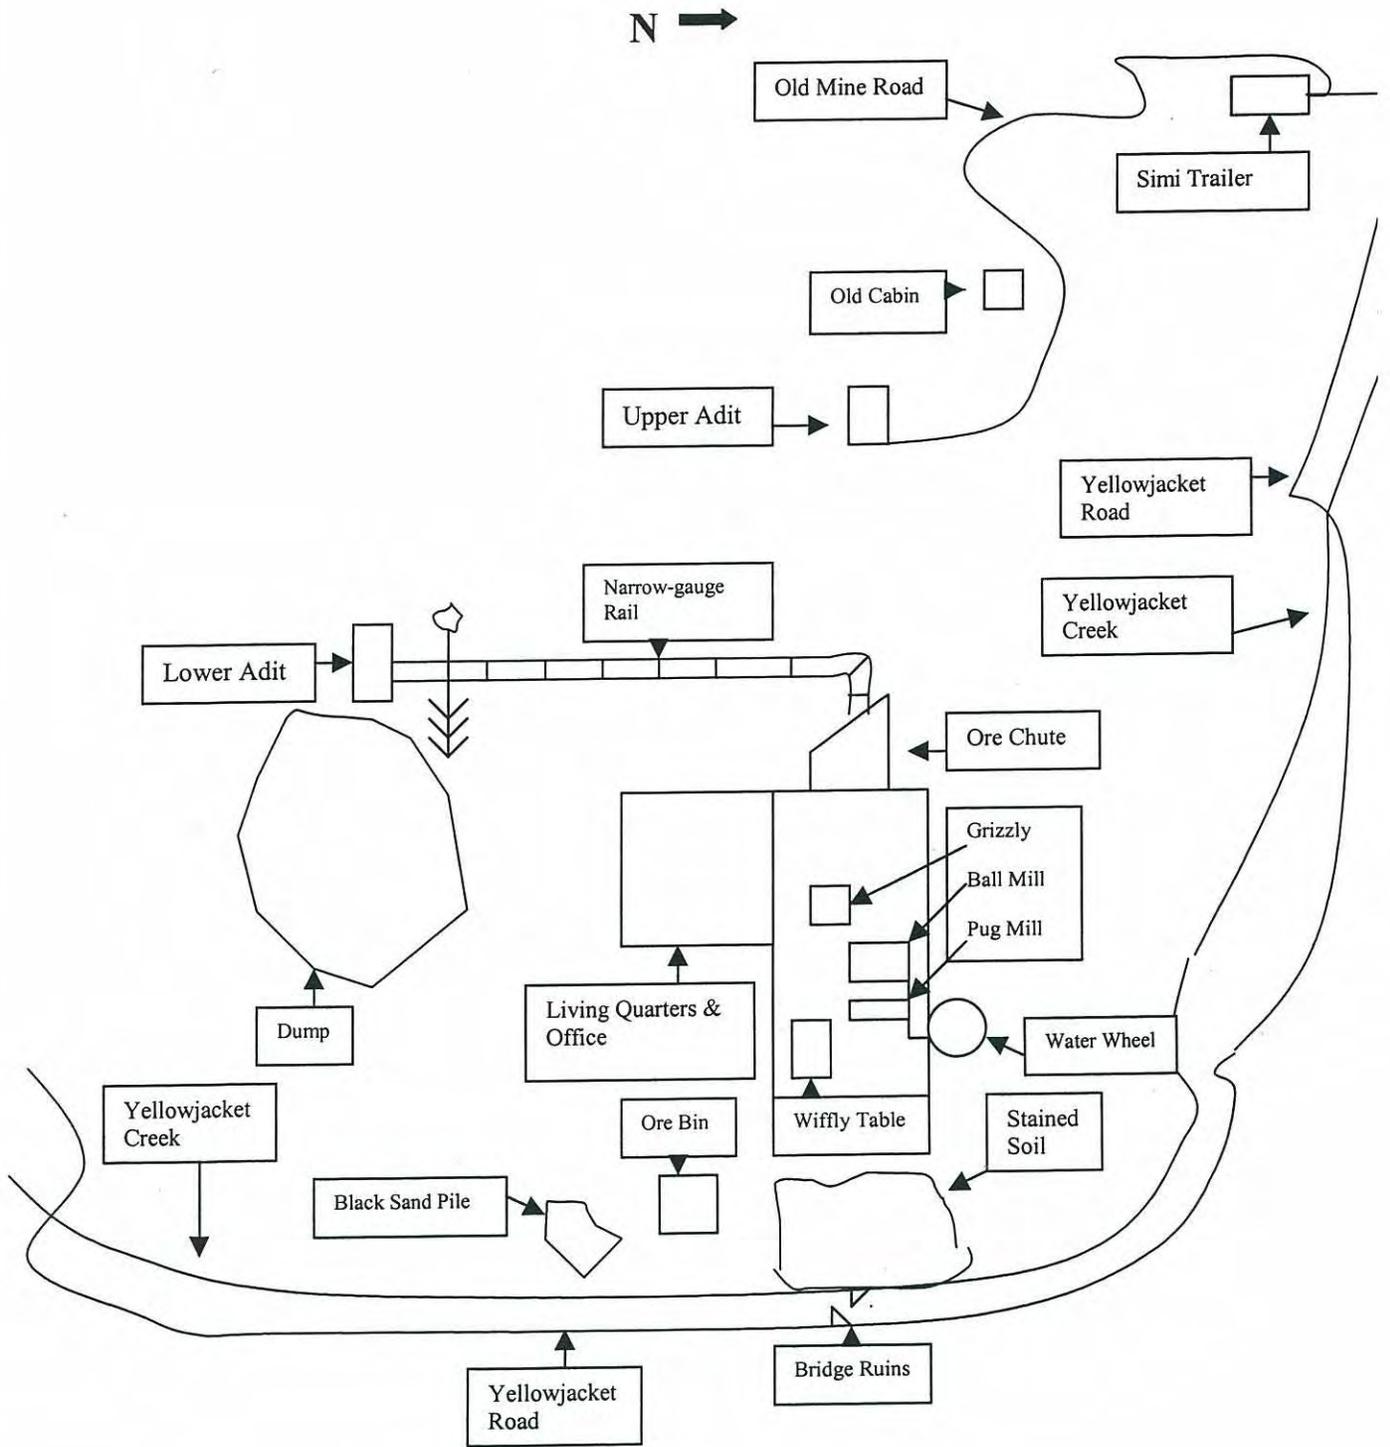
Figure 2-2  
SITE MAP

Mill was located on a separate claim operated by a Mr. Baker (Figure 2-2). According to the Lemhi County Assessors Office in Salmon, the Mine is not a patent claim. The Simis filed annual assessments on four claims, the Tin Cup 1, 2, 3 and 4, with the Lemhi County Clerk in 1987, 1988, 1993 and 2001. A thorough review of records by the County Clerk, however, did not reveal any claims by "Baker" near the Tin Cup.

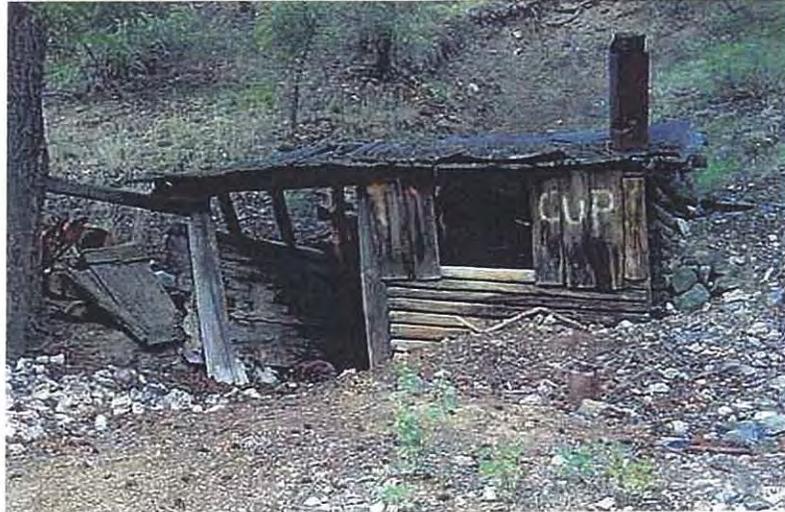
Mvc-001  
Upper Adit

The upper adit site was not fenced and easily accessible from the adjacent Yellowjacket Road, but access to the Simi's vacation property and to the old mine road (behind the Simi's trailer) was posted with "Private Property" and no trespassing signage. The adit could also be reached by climbing the steep hillside above the Mill. Site features include the old cabin in ruins (not pictured), an adit and a rudimentary smelter (Photo Mvc-001).

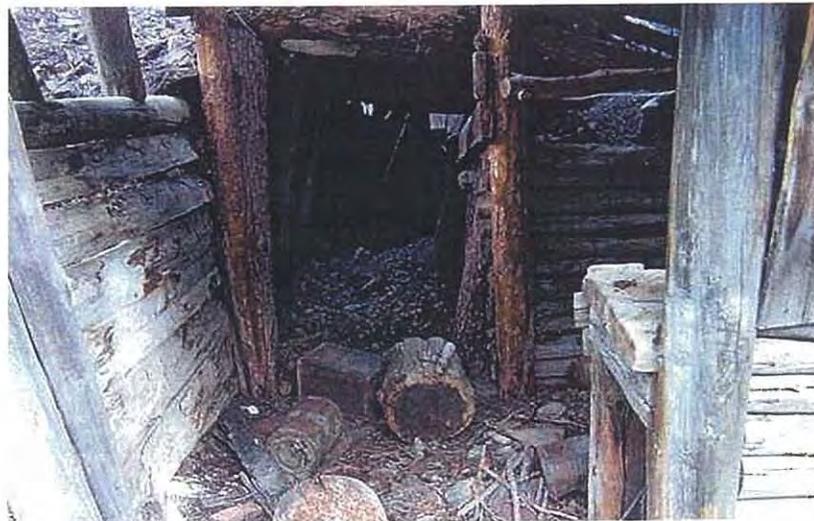
Mvc-003  
Upper Adit Portal and Smelter Room

The adit appeared caved a few yards beyond the portal, while the "smelter room" contained several black powder canisters of unknown quantity (Photo Mvc-003). The upper adit

which appeared caved did not contain any standing water, nor was there evidence of drainage.

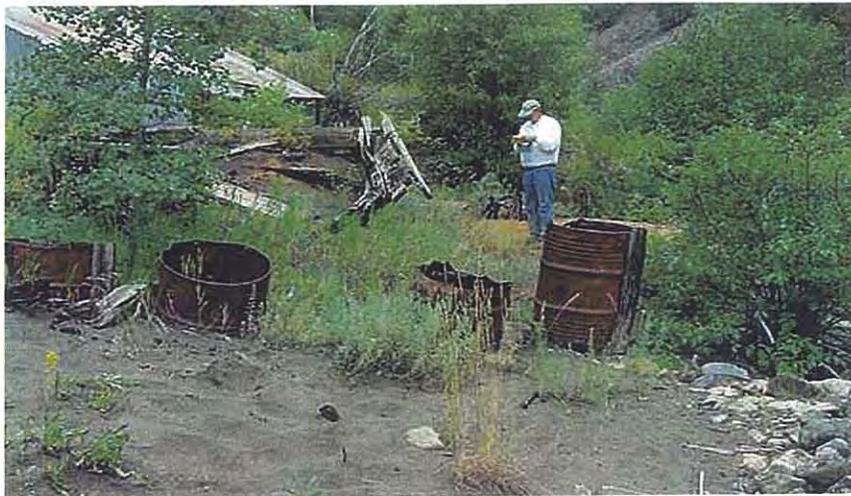
Mvc-006  
Tailings Piles

A pile of black sand, located amid rusty barrels (Photo Mvc-006) was encountered at the south approach to the Mill. An ore bin located a few yards beyond the drums appeared to contain similar material. The sand was not identified elsewhere on the site.

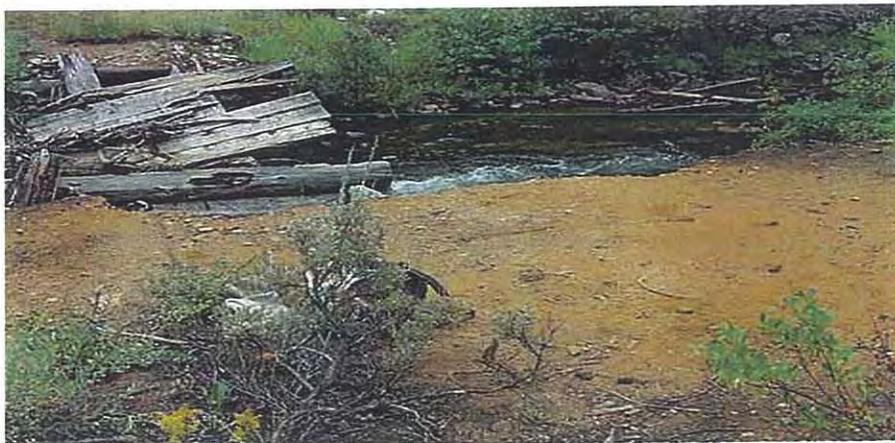
Mvc-005  
Stained Soil (foreground), bridge ruins in Yellowjacket Creek

The soil adjacent to the eastside of the Mill was stained a dark yellow color (Photo Mvc-005). Closer inspection, while collecting a soil sample (Appendix B), revealed the soil remained stained four inches beneath the surface.

The DEQ collected representative soil samples from the black sand and stained soil (Appendix B). Total metals analysis of the stained soil indicated risk levels of barium, cadmium, chromium, lead, selenium and silver are below  $1 \times E^{-6}$  (or 1 in 1,000,000), conservatively assuming an industrial exposure scenario, while risk from arsenic is approximately  $3.2 \times E^{-5}$ , and mercury is approximately  $5.8 \times E^{-5}$ , using the same exposure scenario. Total metals analysis of the black sand indicated risk levels of barium, cadmium, chromium, lead, selenium and silver are below  $1 \times E^{-6}$  (or 1 in 1,000,000), conservatively assuming an industrial exposure scenario, while risk from arsenic is approximately  $3.2 \times E^{-5}$ , using the same exposure scenario (EPA, 2002).

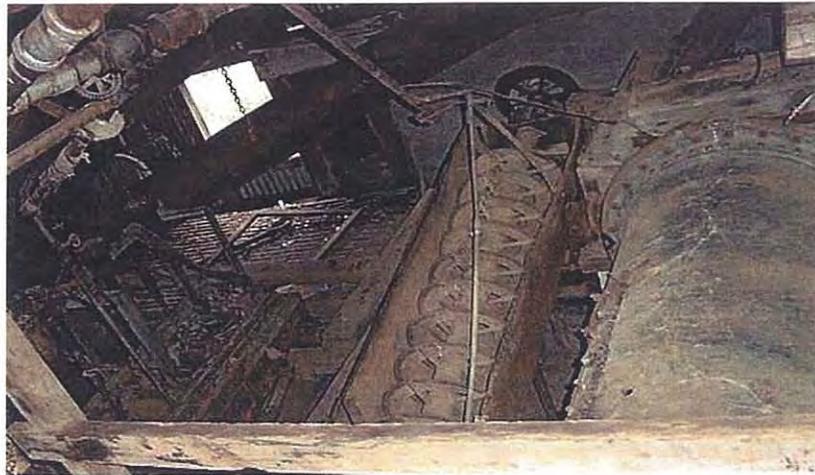
Mvc-004

The lower adit appeared to be open, but safety concerns prohibited further inspection beyond the covered portal. Standing water was observed in the adit, but no discharge was noted. A narrow-gauge rail led from the lower adit to an ore chute at the apex of the Mill. Apparently, the ore cars were conveyed by block and tackle to the Mill. An uprooted fir had fallen across the rail at the portal. The Mill building appeared to have been built in stages over several years (Photo Mvc-007). The uppermost portion consists of rough-cut timbered ore chute; the middle portion, constructed of concrete blocks, housed the living quarters and office, while the lower portion housed the operations. The roof is covered with tin sheets and appears sound as the equipment inside had not rusted severely (Photo Mvc-004).

Ball mill (right), pug mill (center),  
wiffly table (left center, beneath window)

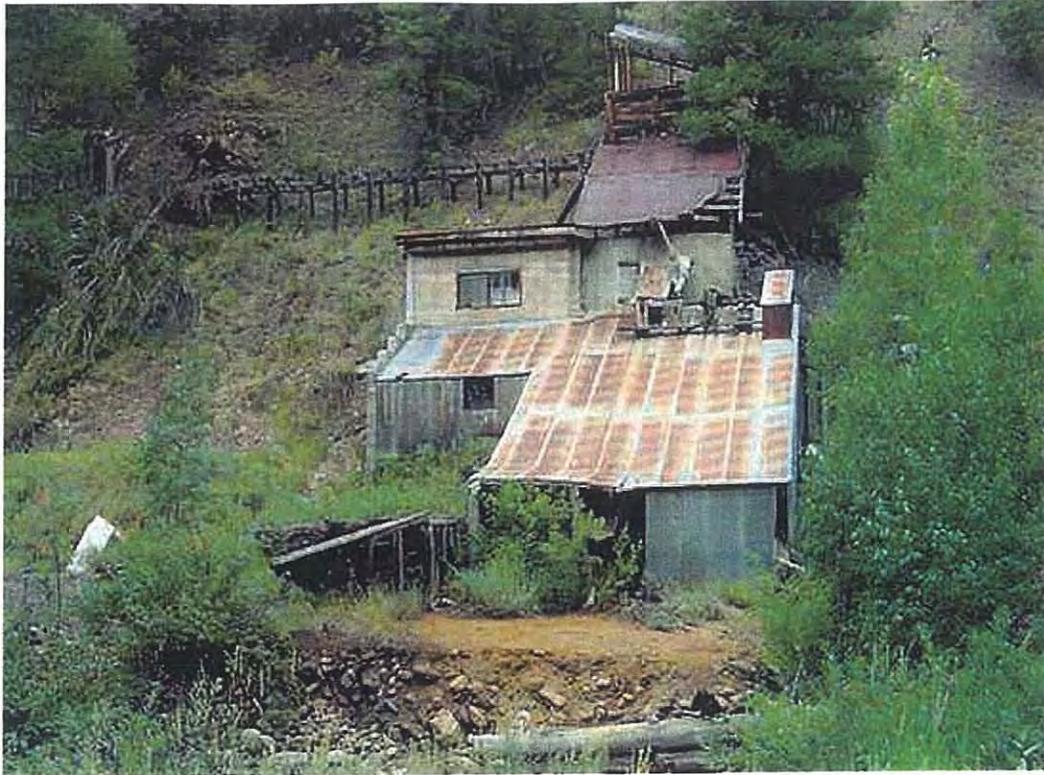
Mvc-007

Covered portal of lower adit (top left), rail to ore chute (top), water wheel on right side of building (hidden by branches), stained soil (bottom center), ore bin (bottom left)
