# Yellowdog Creek, Idaho

## Water Quality Success Story

North Fork Coeur d'Alene River Subbasin  
Watershed Advisory Group (WAG)

December 15, 2011

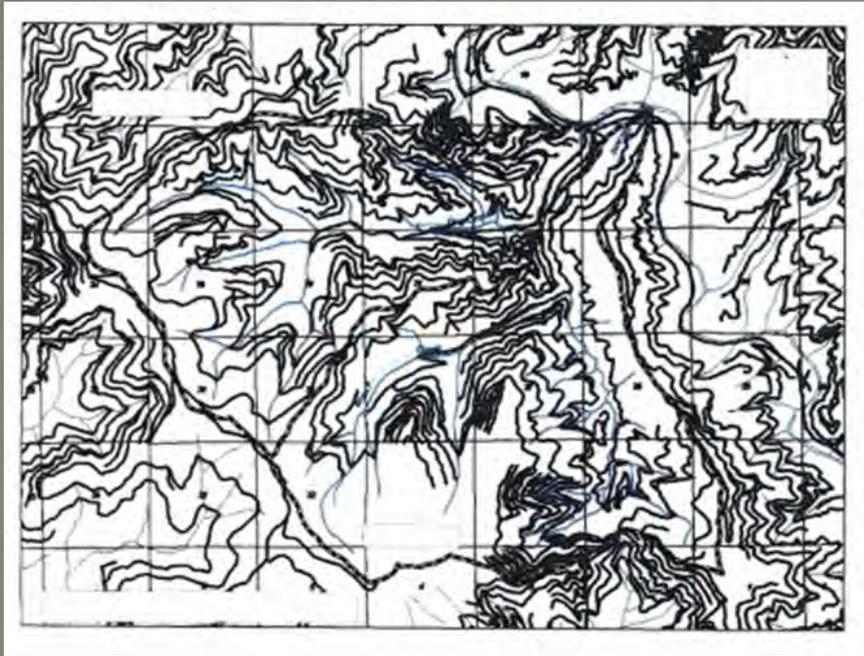
*Road density in Yellowdog and Downey Creek watersheds, before.*

- More than 60% of Yellowdog and Downey Creek watersheds harvested at least once
- > 170 miles of road
- > 120 stream crossings
- Rain-on-snow events common
- Major floods in 1964, 1974, 1981, and 1996

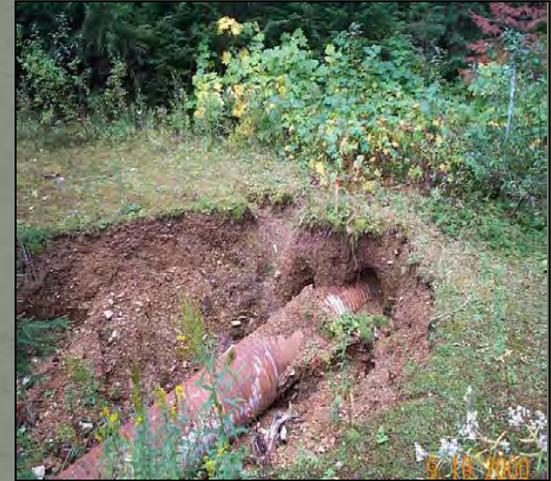
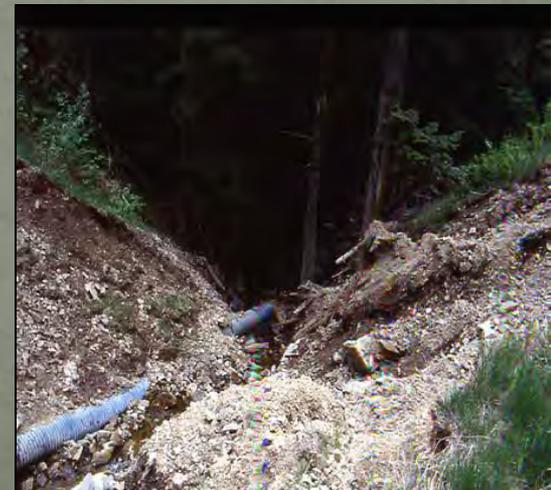
- Failed headwater stream channel crossings
- Washed out riparian roads
- Reduced access to floodplain
- Tons of sediment delivered to stream (fine and coarse sediment, bedload)
- Degraded habitat
- In late 1980s and early 1990s, data already showed water quality issues

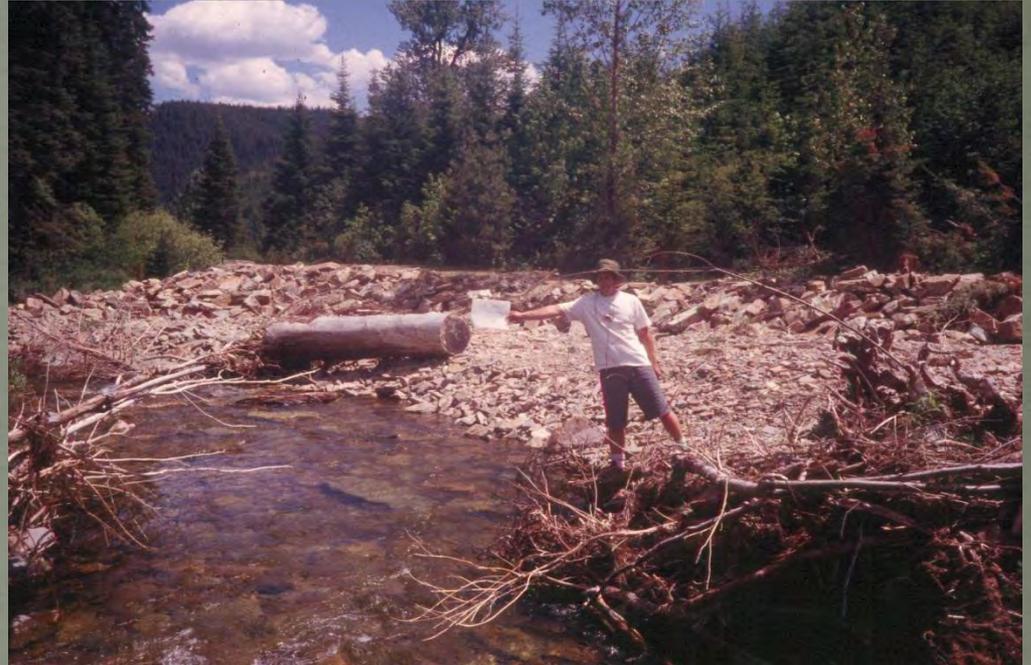
*Photo from DEQ BURP monitoring in 1996 shows washed out riparian road along Yellowdog Creek.*

- 1994 EPA added Yellowdog Creek to 303(d) List of Impaired Waterbodies for sediment
- 1996 DEQ bioassessment (BURP)
- Two 1996 BURP sites both indicated impairment of cold water aquatic life.

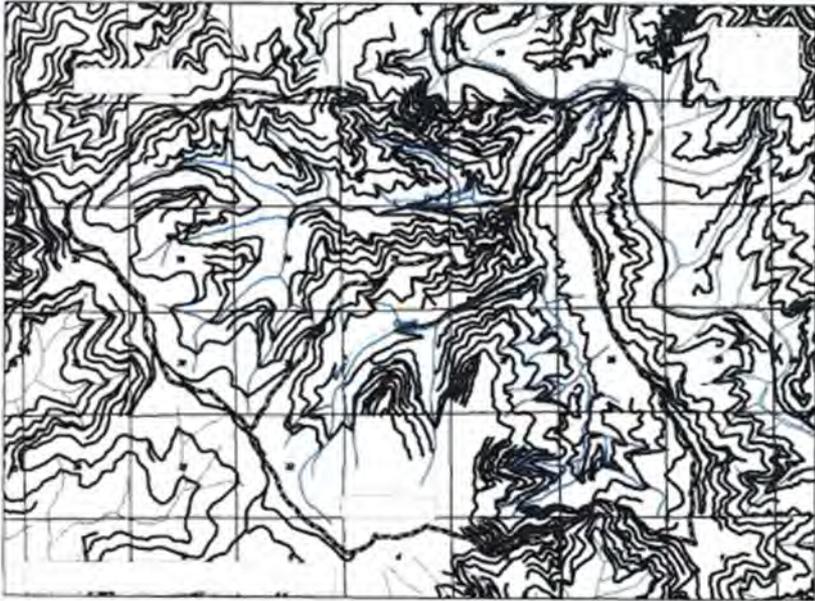
*Road density in Yellowdog and Downey Creek watersheds, before.*

Road density in Yellowdog Creek Watershed reduced from 6.2 miles/sq. mile to 2.6 miles/sq. mile.

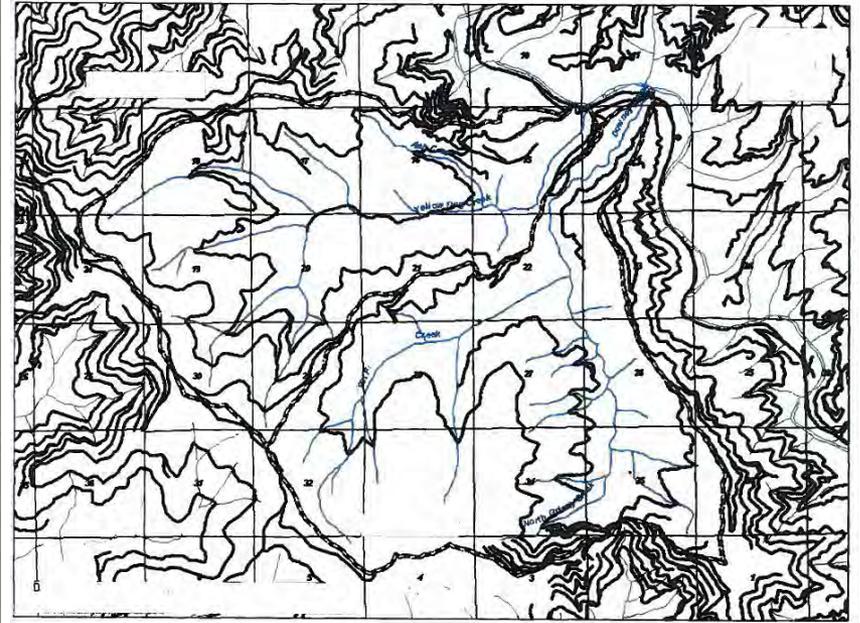
*Road density in Yellowdog and Downey Creek watersheds, after.*

- US Forest Service led restoration in Yellowdog and Downey Creek watersheds (“Down Doggy” Restoration Project)
- Funded by timber sale receipts
- Numerous partnerships
- Approx. \$1 million
- Decommissioned 46 miles of road
- Removed 111 stream crossings
- Removed lower 2 miles of road adjacent to Yellowdog Creek

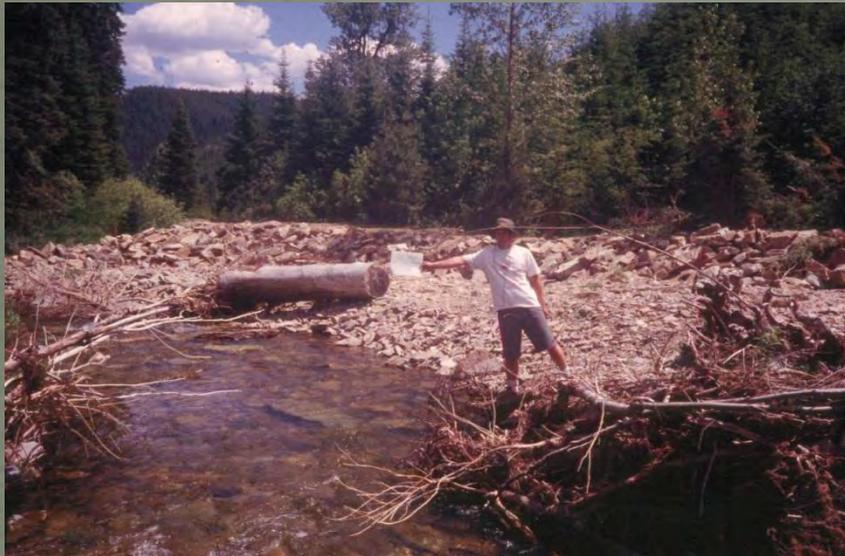
*Yellowdog Creek, 1996*

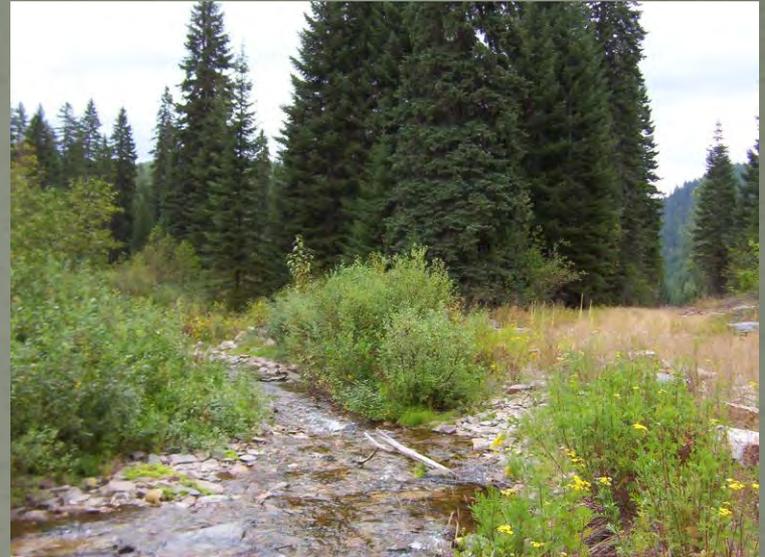
*Yellowdog Creek, 2005*

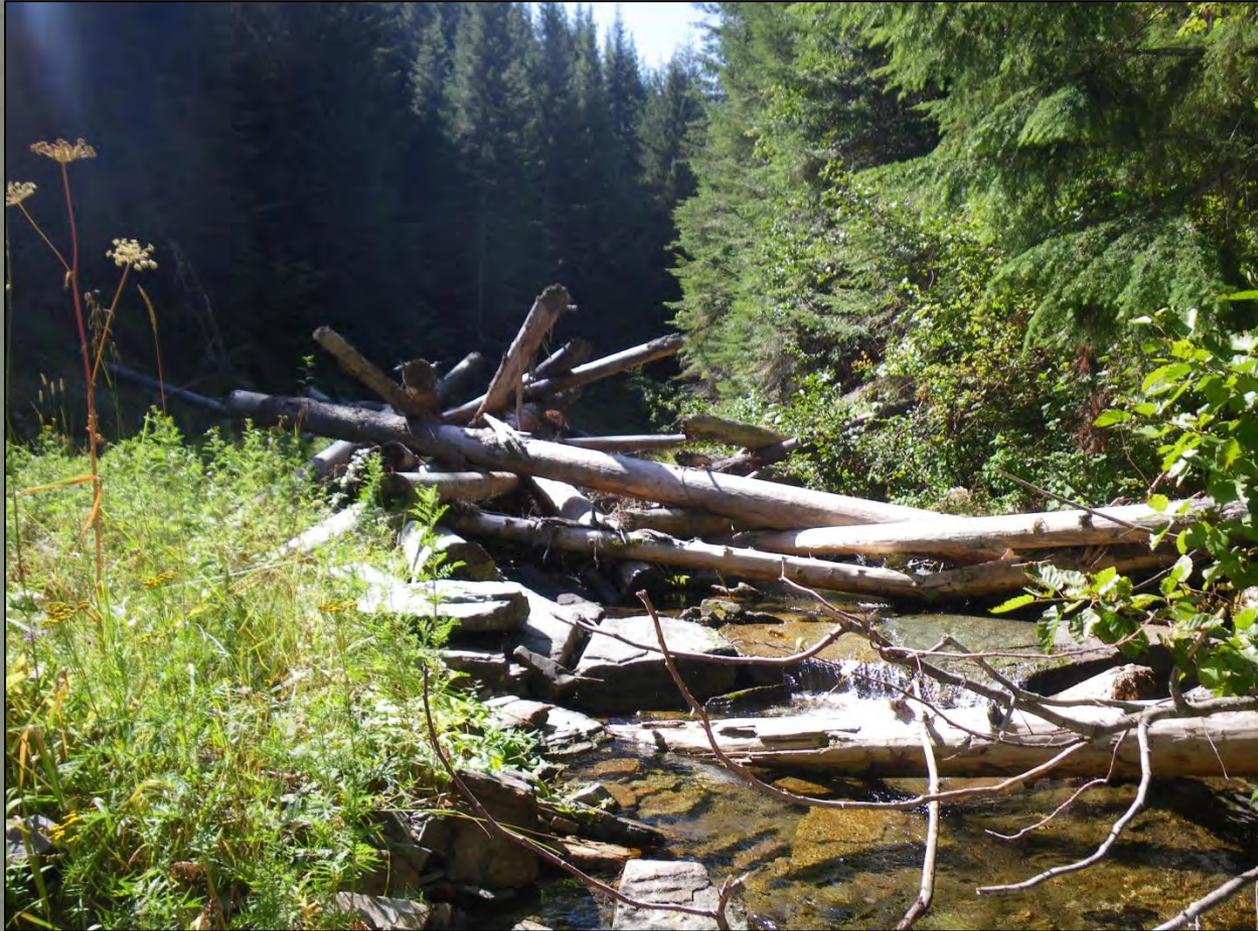
*Constructed log jam and boulder pool-forming structure in Yellowdog Creek, 2009.*

- Instream restoration
- 765 Logs
- More than 100 boulder structures
- Help stabilize the stream channel by providing grade control and dissipating energy.
- Improve aquatic habitat by providing cover, pools and increased complexity.

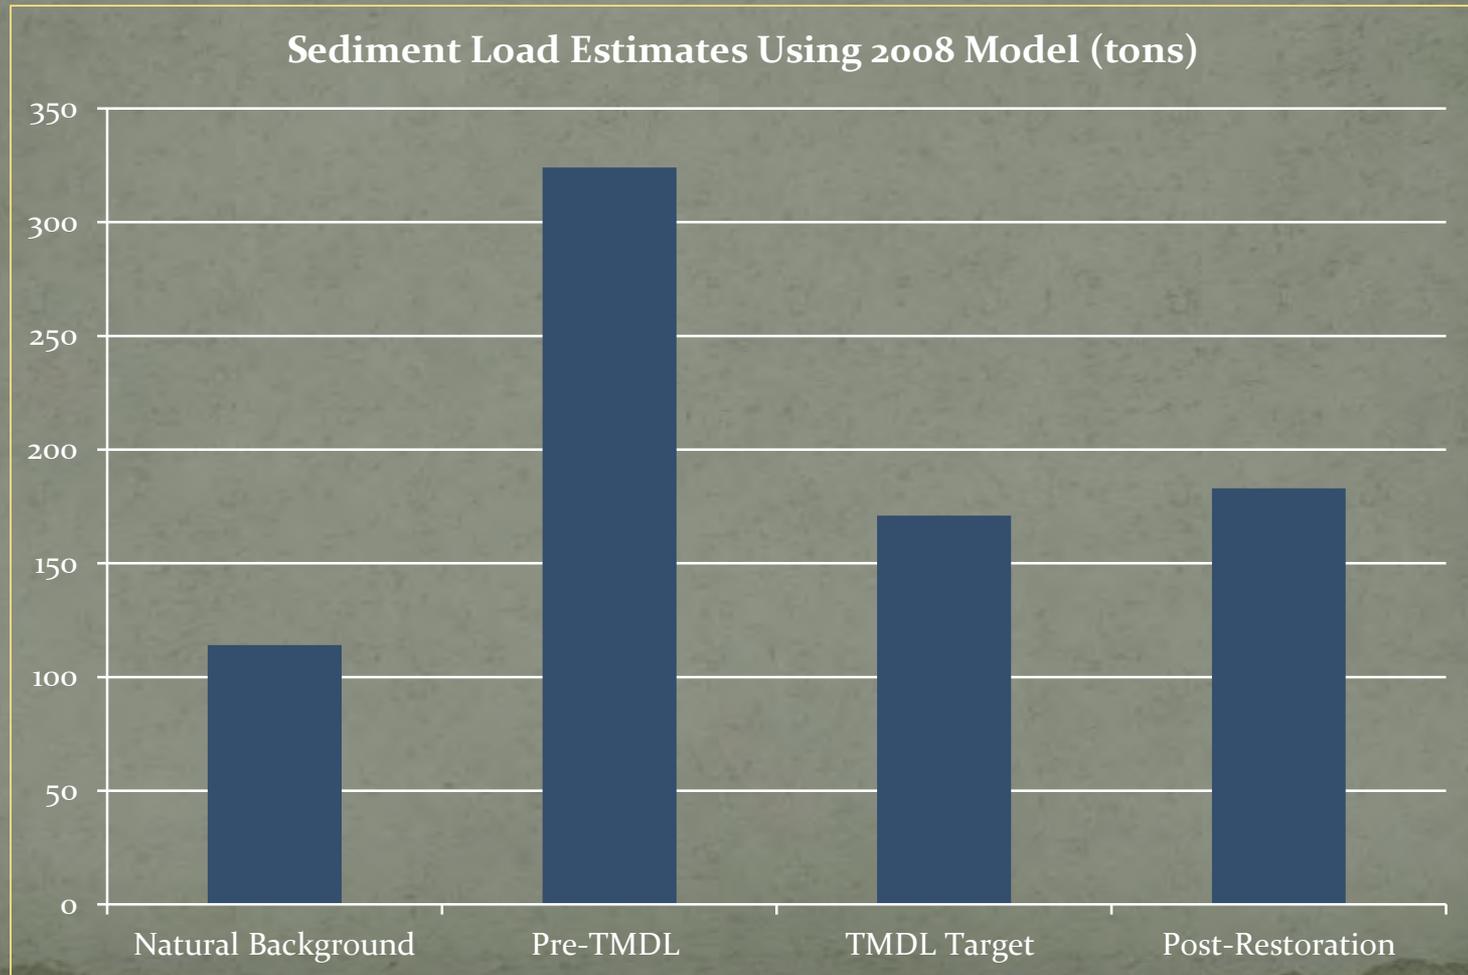
- Modeling based on sediment TMDL model and GIS

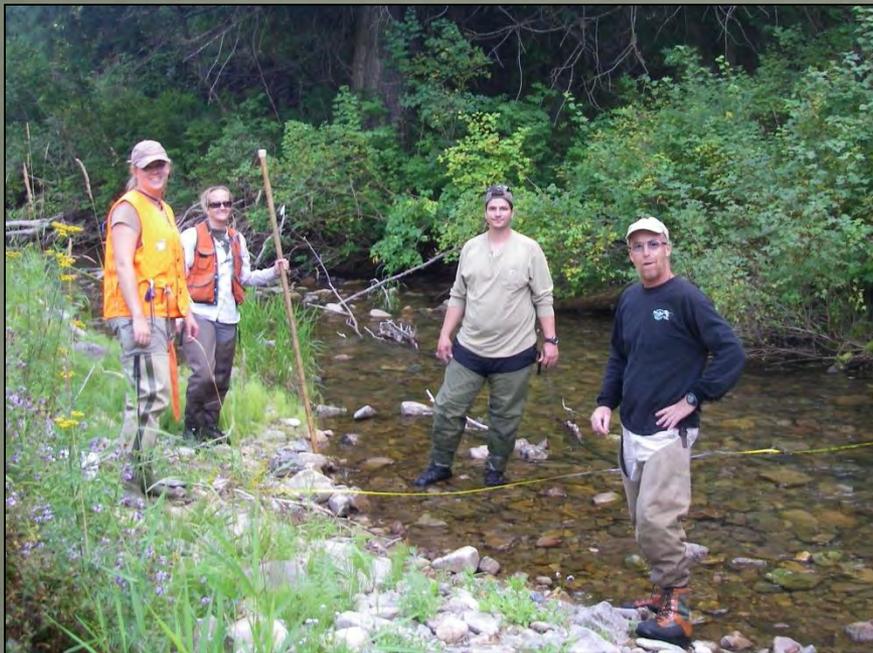
*DEQ-USFS interagency crew, 2009.*

- Interagency BURP crew
- Rapid bioassessment:
  - Fish
  - Macroinvertebrates (Bugs)
  - Physical Habitat

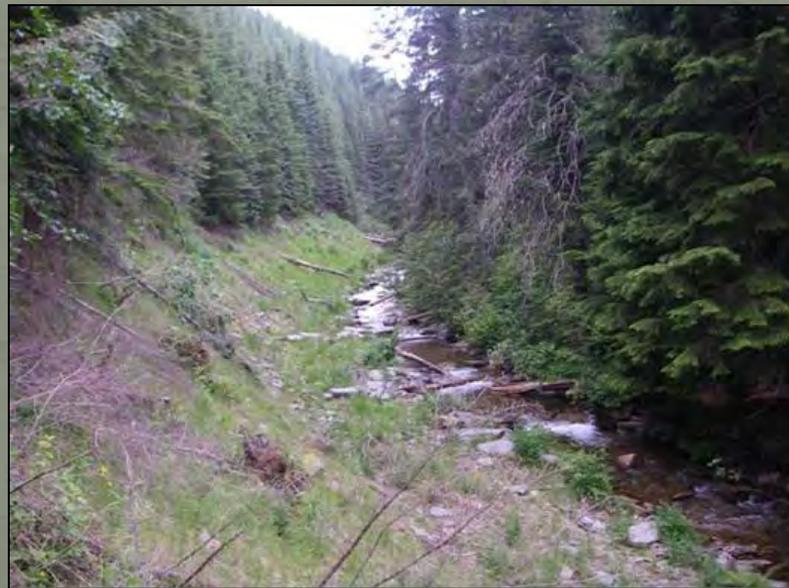
- Stream habitat index score – Good, only low metric was bank angle
- Macroinvertebrates – Good, Observed  $\approx$  Expected from reference conditions (1.05)

*Yellowdog Creek overview, 2009.*

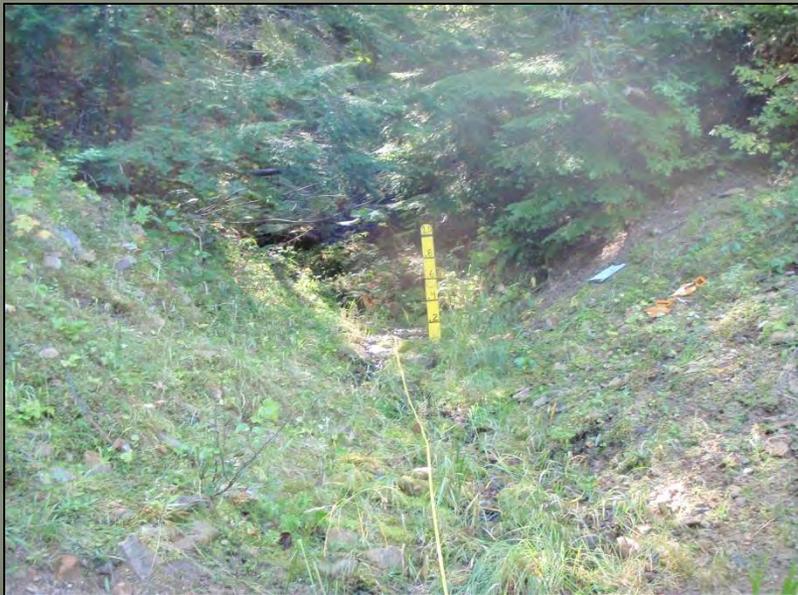
*Stream crossing treatment with culvert removal in Yellowdog Creek, 2009.*

- Visited road decommissioning sites and culvert removal sites to evaluate stability, cover and sediment delivery.
- Most sites well covered, stable and not contributing problematic amounts of sediment to streams.

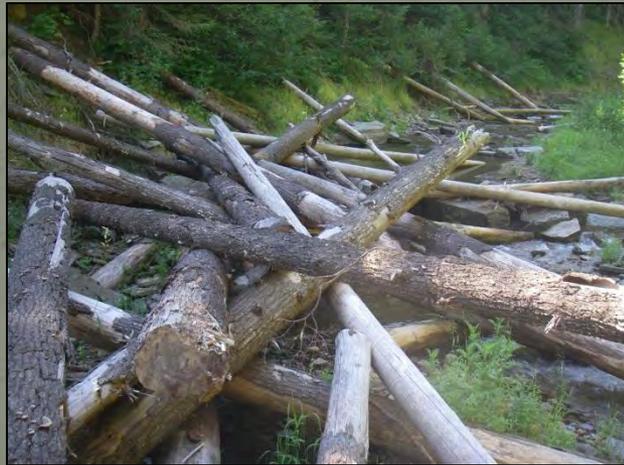
- Watershed restoration by USFS has reduced sediment loads substantially by treating forest roads and improving stream habitat.
- Stream habitat and the cold water aquatic life community is no longer impaired by sediment.

*Yellowdog Creek, 2011.*
