Subject: Abbreviated Preliminary Assessment of the Lone Pine Mine and
Mother Lode Mine, Idaho County, Idaho

ABBREVIATED PRELIMINARY ASSESSMENT

Site Name: Lone Pine Mine and Mother Lode Mine

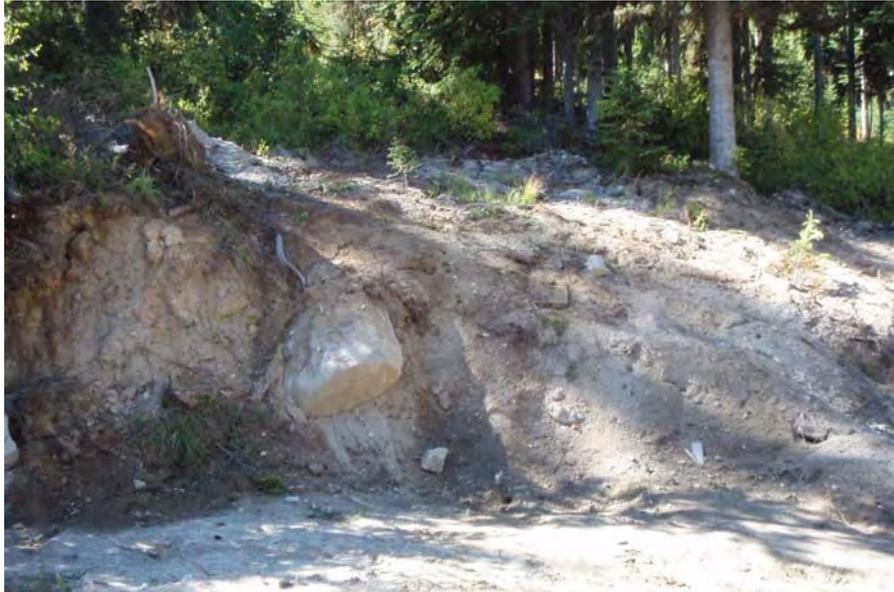
Lone Pine Mine Adit 1 was closed in 2010. As shown in Photo 1, the native material is decomposed granitic material.

Photo 1. Lone Pine Adit 1; Latitude 45.48395°N and Longitude -116.05484°W

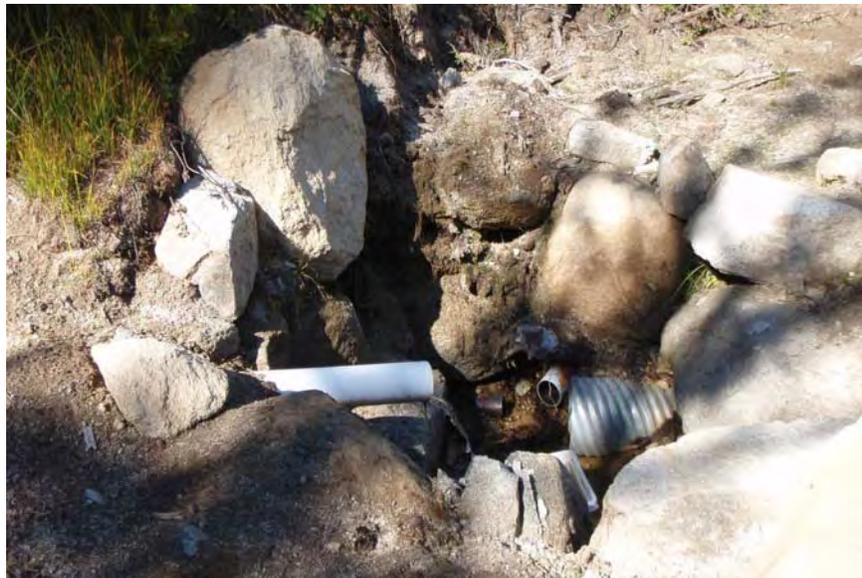
Lone Pine Mine Adit 1 was discharging water at approximately five gallons per minute (gpm). As shown in Photo 2, the pipe drains into a culvert on the right which then eventually meets and mixes with Adit 2 drainage.

Photo 2. Lone Pine Mine Adit 1 drainage pipe.

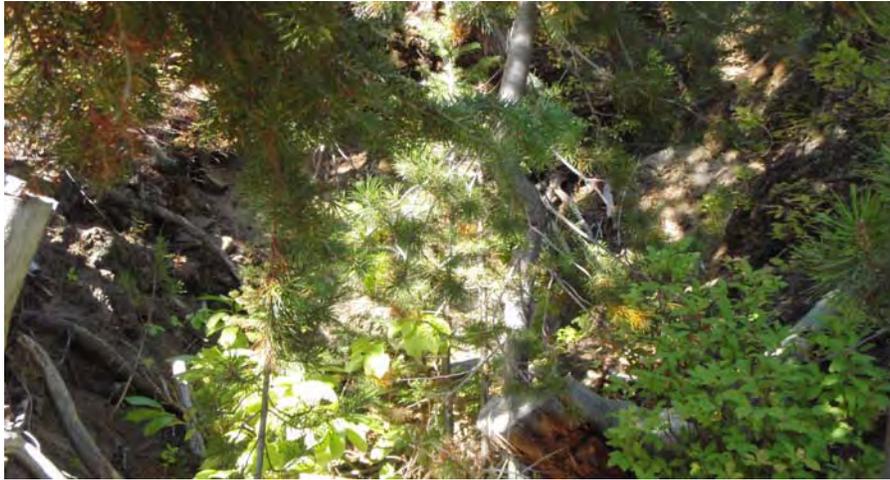
Lone Pine Mine Adit 2 is collapsed and well vegetated. No mineralization was evident. The waste material was spread and mixed in the cabin parking area.

Photo 3. Lone Pine Mine Adit 2.

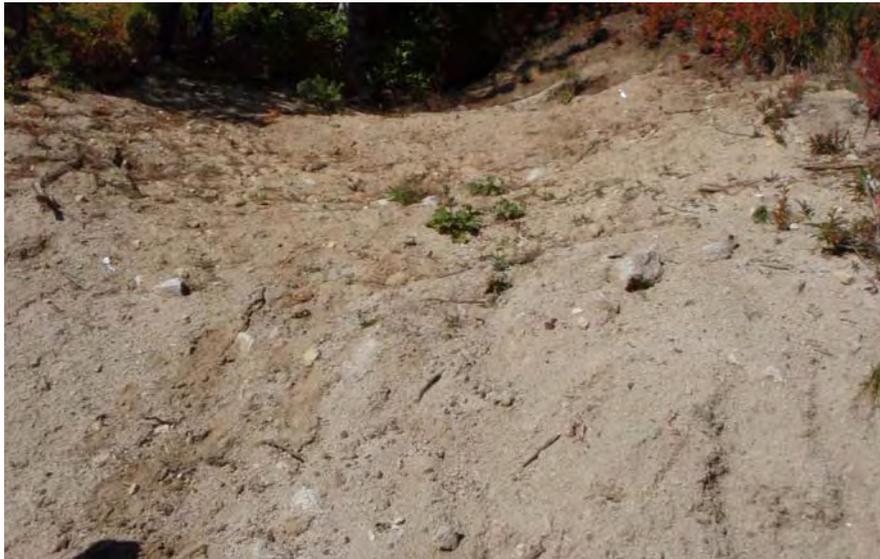
Photo 4. Lone Pine Mine Adit 2 is at the top of the photo.
Note native decomposed rock with no mineralization.

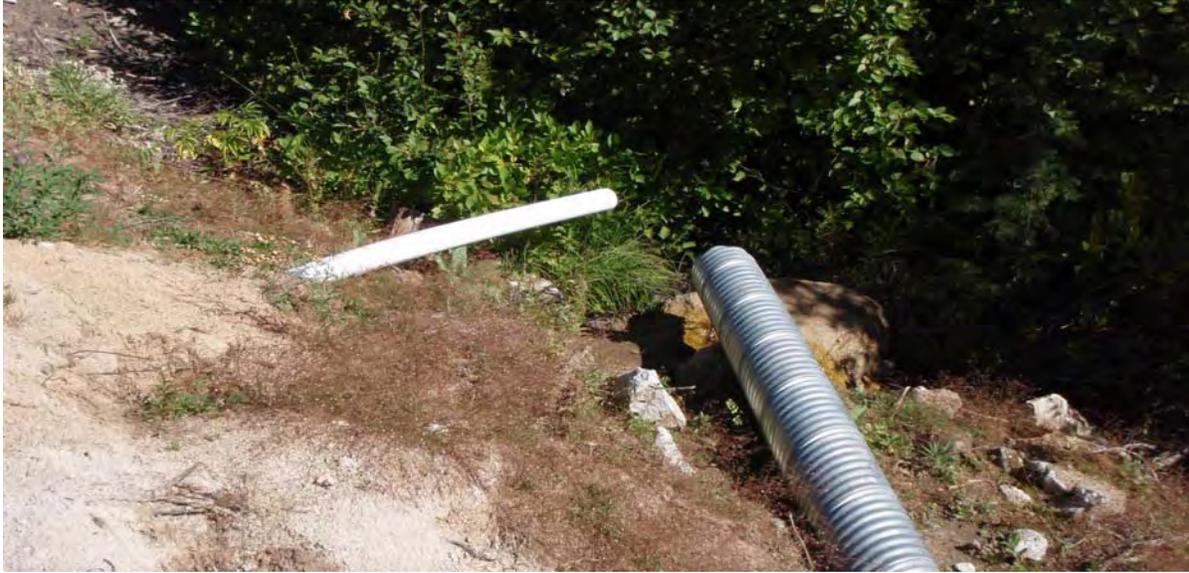
Photo 5 shows the drainage pipe (white pipe) from Lone Pine Mine Adit 2 and the culvert drainage water from Lone Pine Mine Adit 1. They come together at the northeast corner of the cabin parking area.

Photo 5. Drainage pipe from Lone Pine Mine Adit 2 and drainage water from Lone Pine Mine Adit 1; Latitude 45.48415°N and Longitude -116.05511°W.

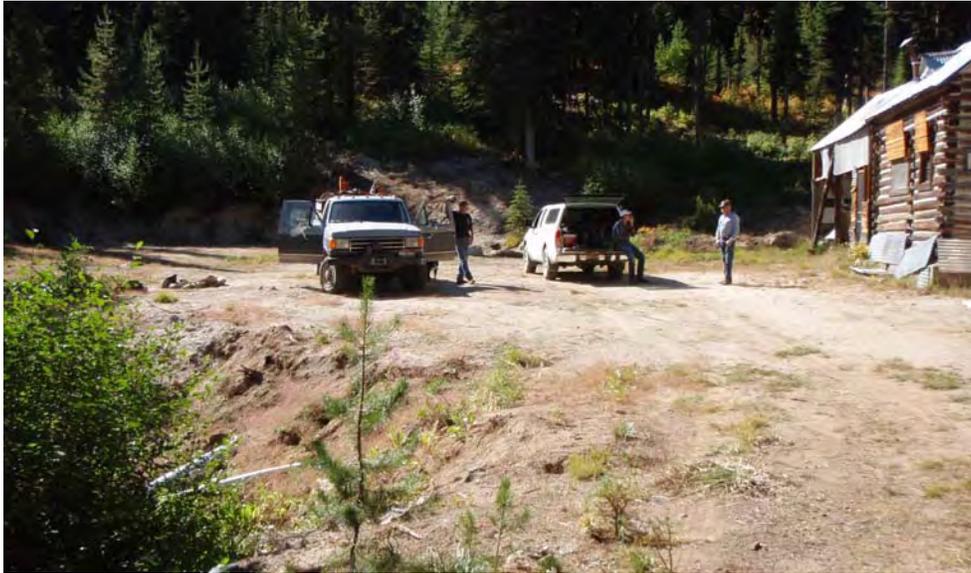
Photo 6 shows closed Lone Pine Adit 1 behind and between the two trucks. The waste material has been spread and mixed to form the parking area for the cabin. No mineralization was evident in the waste material. Lone Pine Mine Adit 2 is to the right and behind the cabin. Its waste material was spread and mixed as well into the parking area.

Photo 6. Lone Pine Mine Adit 1 (behind and between two trucks), parking area, and cabin.

Although no mineralization was evident, the waste dump/parking area could provide an airborne pathway to occupants of the cabin. The cabin is rarely occupied, but when occupied, dust control/abatement would be an excellent preventative measure to minimize human contact with the waste dump material.

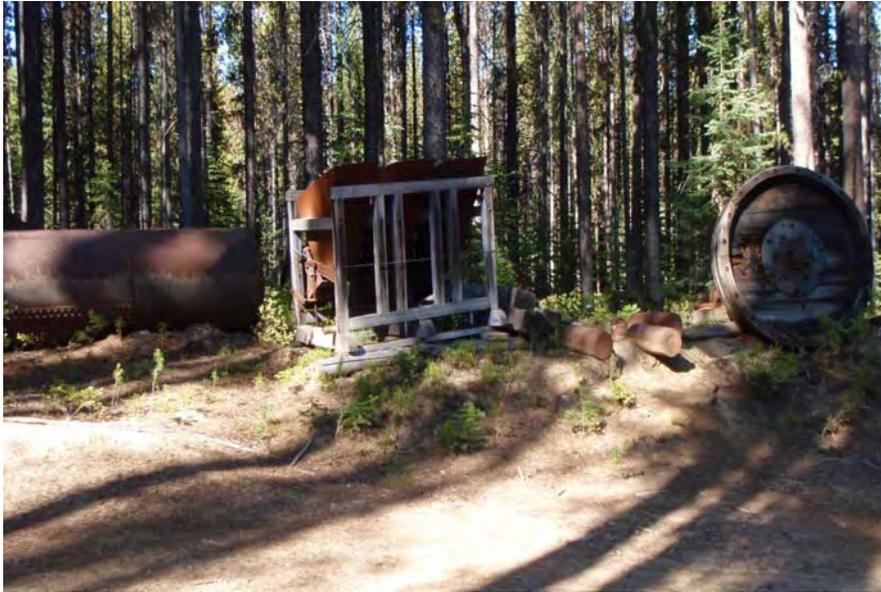
Pieces of a disassembled three-stamp mill are at the junction of FS Roads 76283 and 76283A. This is probably the mill that was formerly at the Gilt Edge Mine (IGS 2003).

Photo 8. Pieces of a disassembled three-stamp mill.

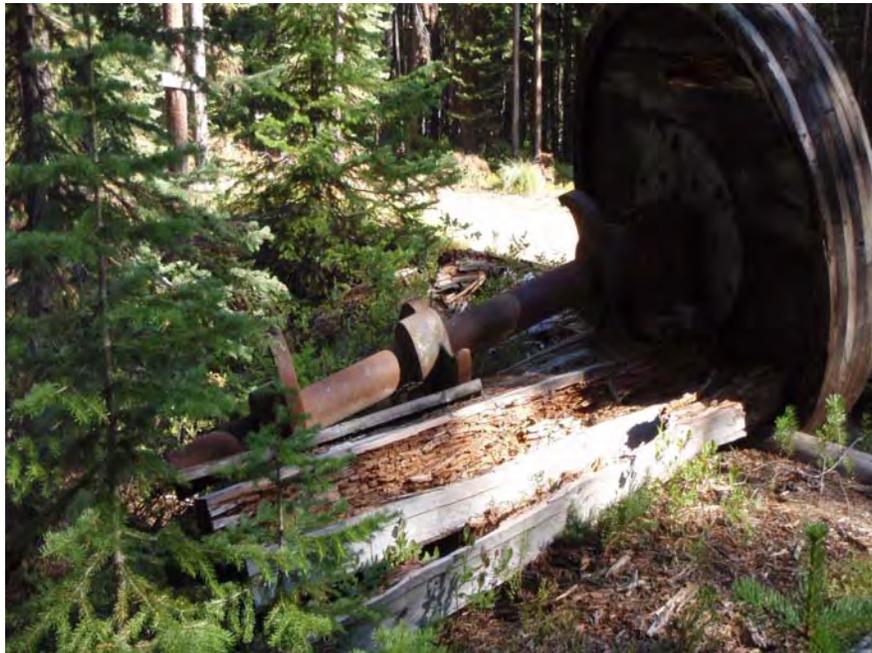
Photo 9. Flywheel with shaft and cams for three-stamp hammer mill.

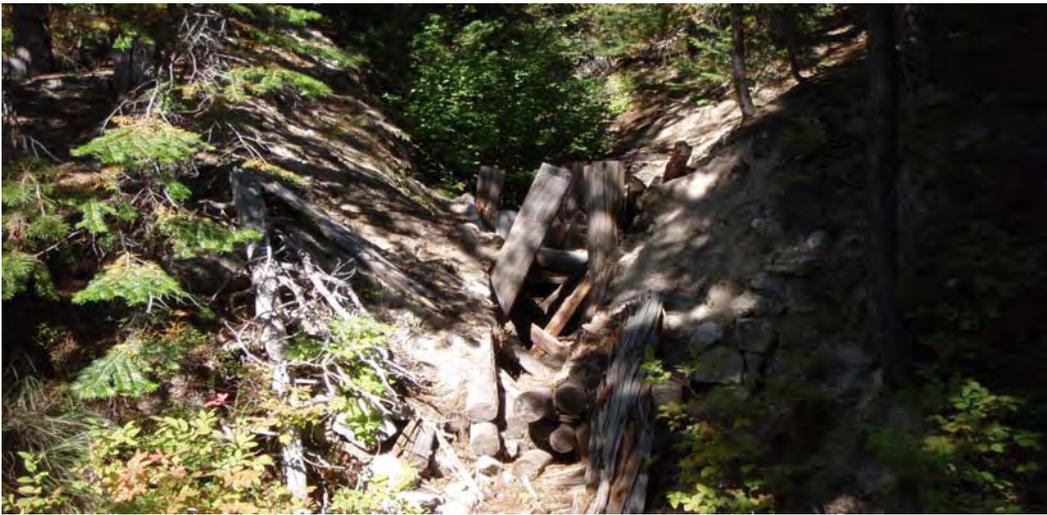
Photo 10 shows the 20 yards of timber supports and then the collapsed Mother Lode Mine adit. No mineralization was evident. The adit was dry with no discharge.

Photo 10. Mother Lode Mine collapsed adit; Latitude 45.48178°N and Longitude -116.05652°.

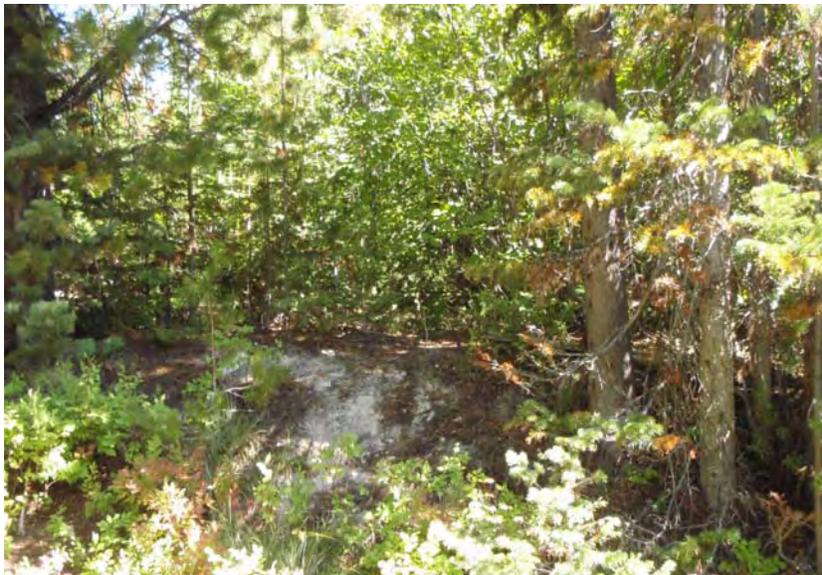
A road now exists between the Mother Lode Mine waste dump and the collapsed adit. The waste dump is mixed into the road. Though difficult to estimate, the dump size is approximately 9 yards x 9 yards x 2 yards. As shown in Photo 11, the dump is well vegetated and stable. Waste material left consisted of native material with no mineralization evident.

Photo 11. Mother Lode Mine waste dump.

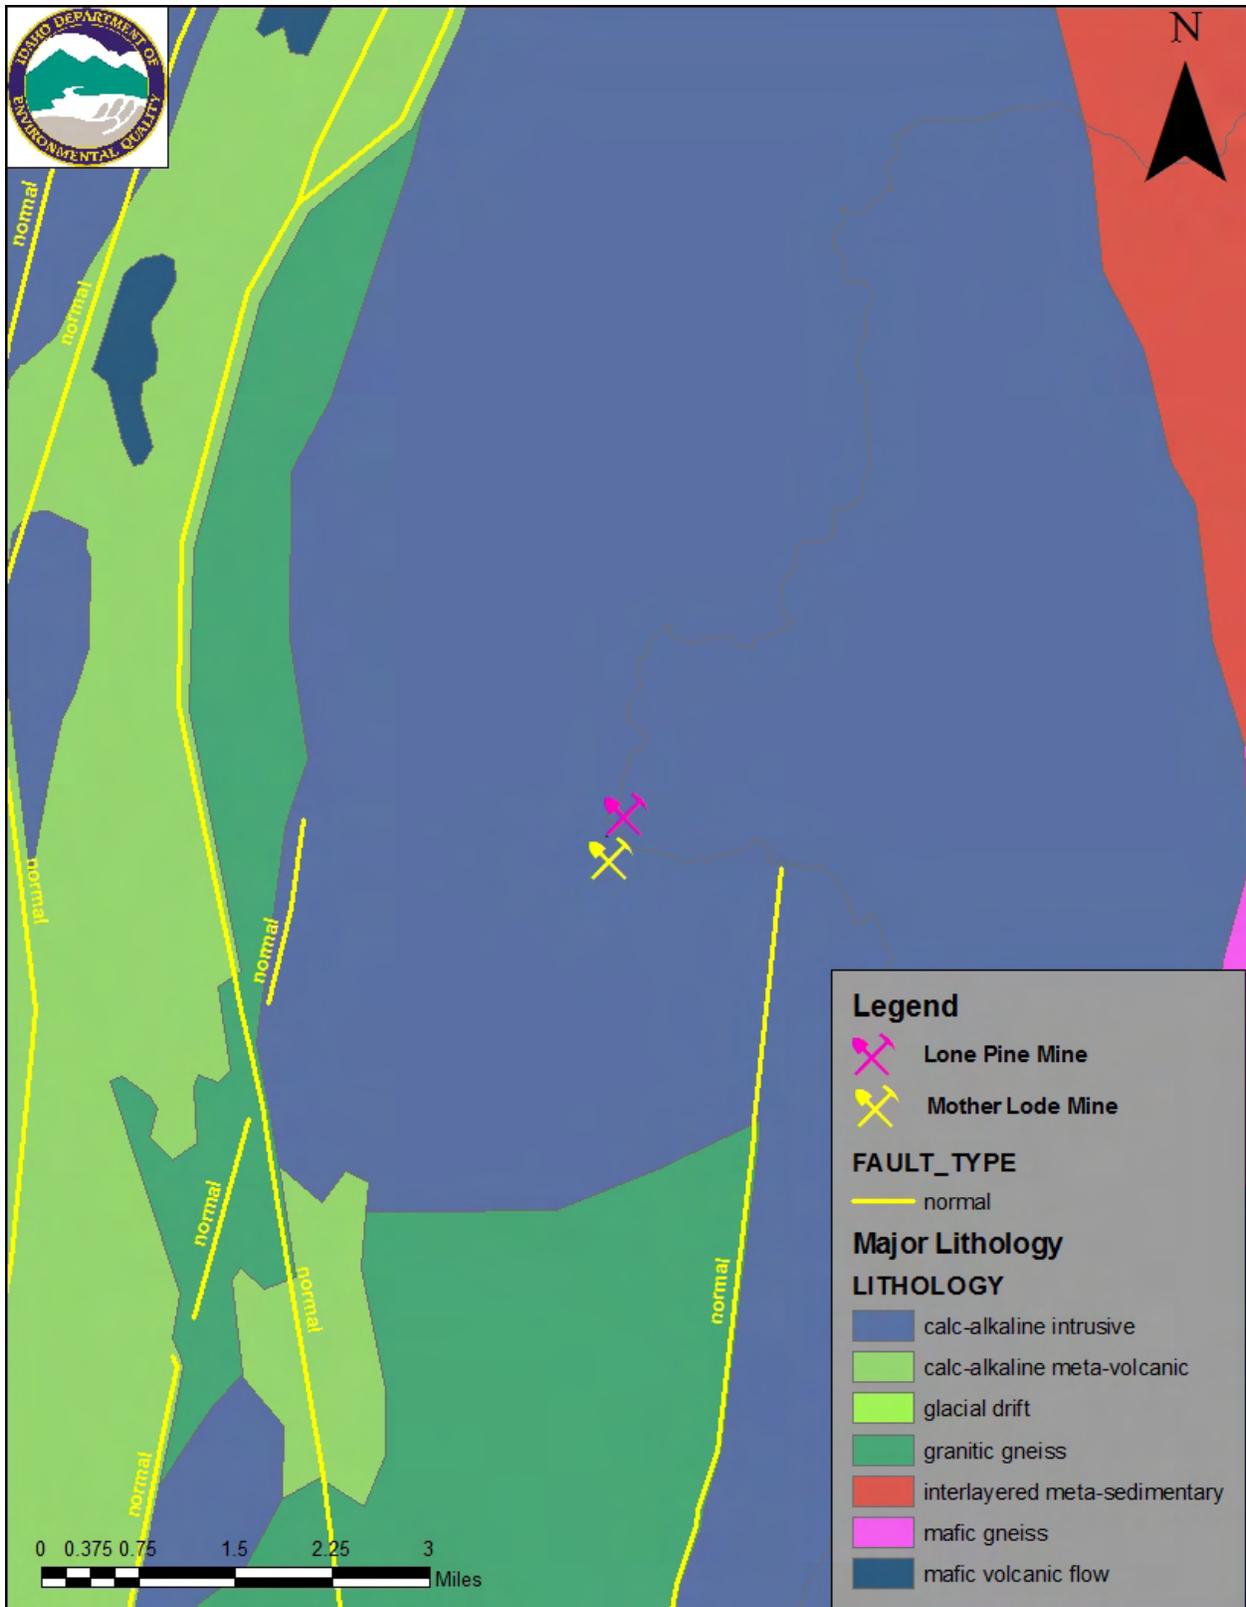
Figure 2. Major Lithology of the Lone Pine Mine and Mother Lode Mine and Surrounding Area (Map Source: SDE Feature Class, USGS 1995. Idaho GIS ArcSDE 9.2 Geodatabase)

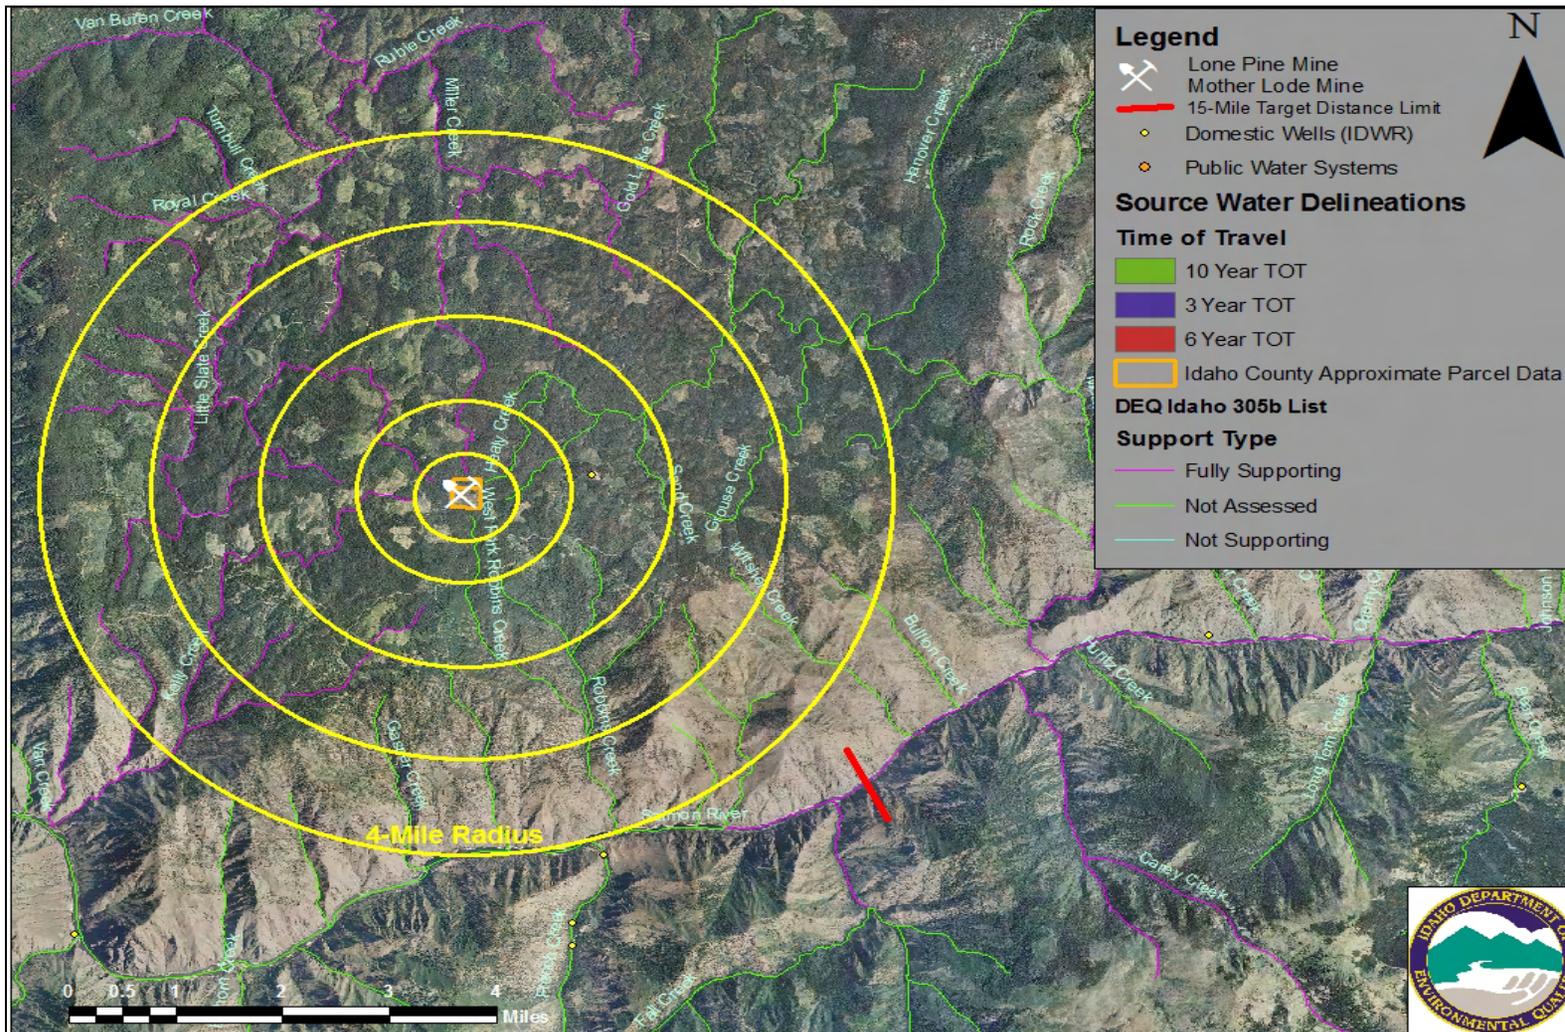
Figure 3. There is one domestic well within two miles of the Lone Pine and Mother Lode Mines. No Public Water Systems within the 4-mile radius, 15-mile TDL. There are no significant wetlands within a 2-mile radius or in the general area. Sensitive streams located in the vicinity of the Lone Pine Mine and Mother Lode Mine are also shown.
 (Map Source: Idaho GIS ArcSDE 9.3 Geodatabase, National Agricultural Imagery Program (NAIP) 2009 1-meter)

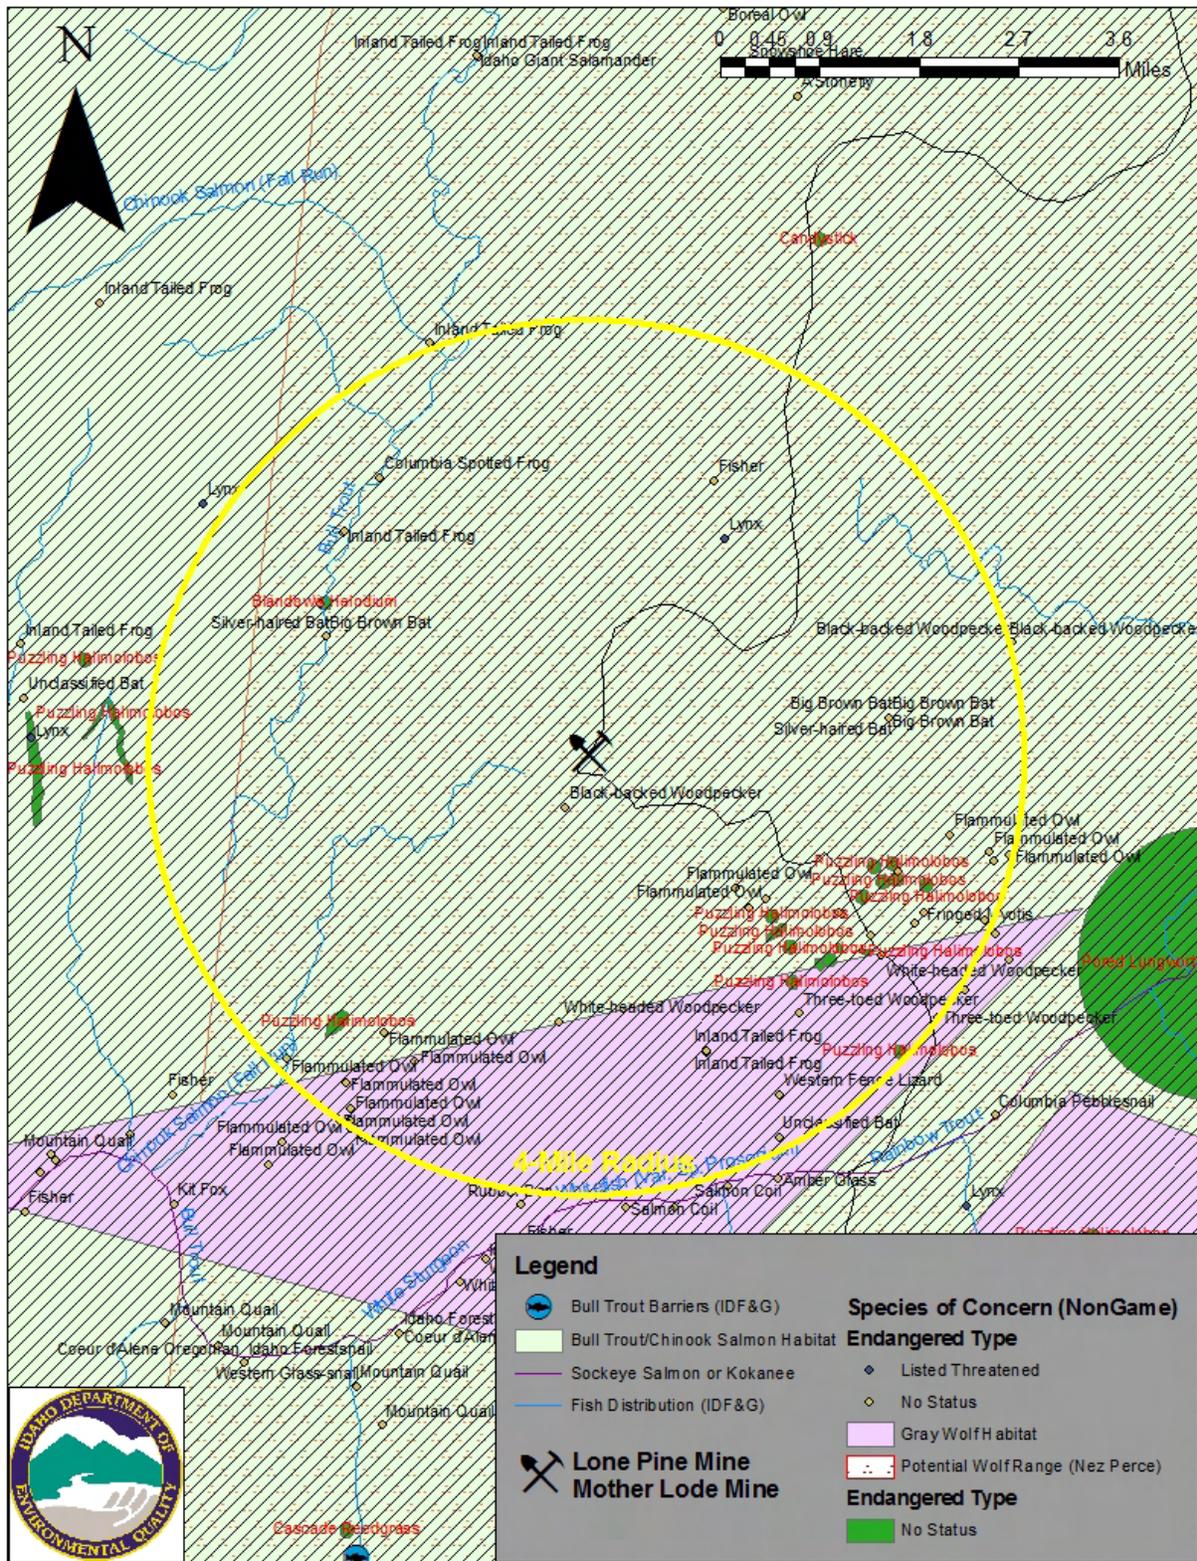
Figure 4. Sensitive Species Within 4-Mile Radius and Surrounding Area of the Lone Pine Mine and Mother Lode Mine. Species of Concern: Non-Game Animals and Plants. Fisheries Within 4- Mile Radius and Surrounding Area. (Map Source: SDE Feature Dataset, Animal Conservation Database. Idaho GIS ArcSDE 9.2 Geodatabase)
