Subject: Abbreviated Preliminary Assessment of the Waverly Mine, Idaho County, Idaho

## ABBREVIATED PRELIMINARY ASSESSMENT

**Site Name:** Waverly Mine

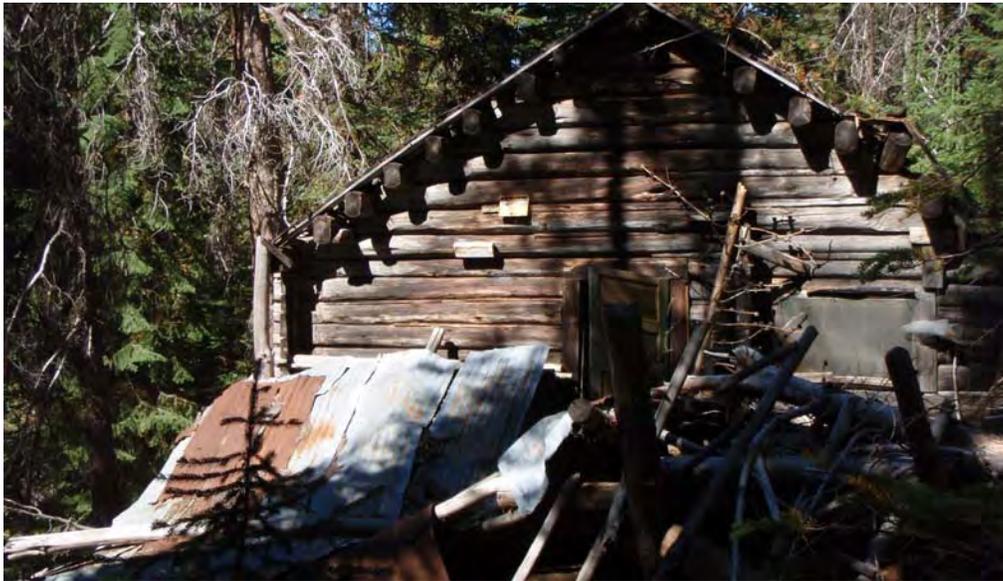
Photo 1 shows a collapsed and broken down cabin at the northwest end of the Waverly Mine Adit 1 trough. The waste dump lies below and on the same side of the drainage as the cabin. The waste dump is approximately 175 feet by 18 feet by 10 feet. The waste material consists of granitic like, non-mineralized material.

**Photo 1.** Collapsed and broken down cabin at Latitude 45.50619°N and Longitude -116.04227°W

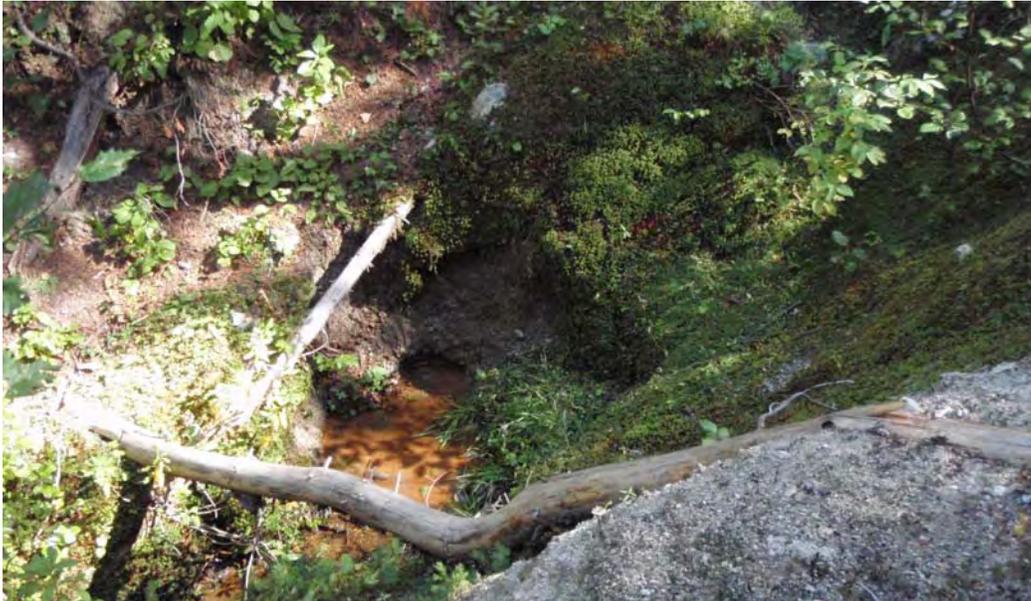
As shown in Photos 2 and 3, water is flowing from Waverly Mine Adit 1 at approximately 5 gpm. The water is orange in color, presumably iron stained. The collapsed adit is well vegetated with alders and plants growing along the stream and in the water. A surface water sample was taken 20 feet below/downstream of Adit 1.

**Photo 2.** Collapsed Adit 1 at Latitude 45.50582°N and Longitude -116.04227°W.

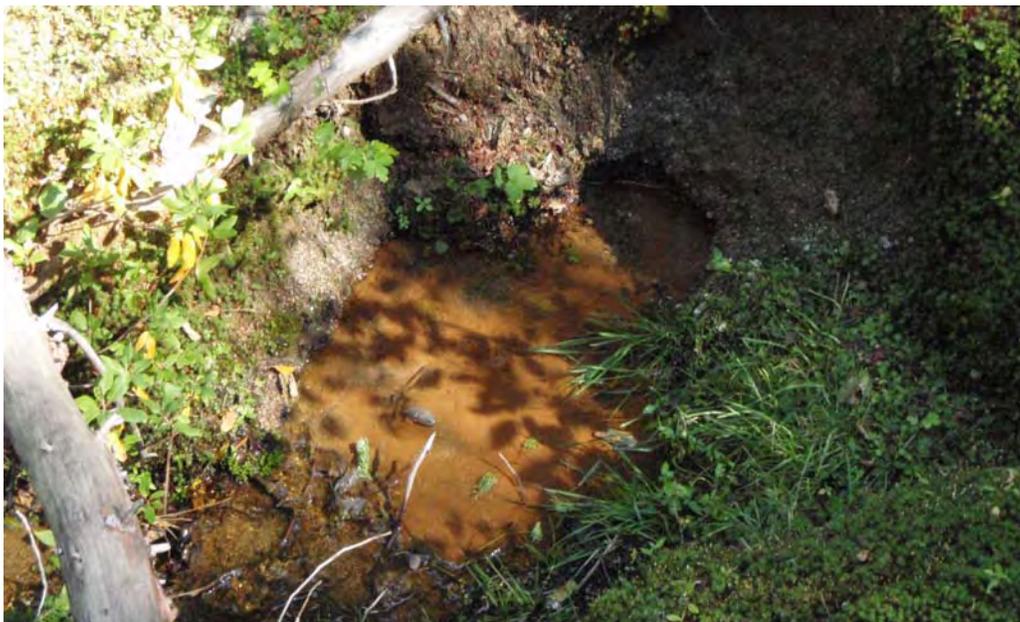
**Photo 3.** Water discharging from Adit 1.

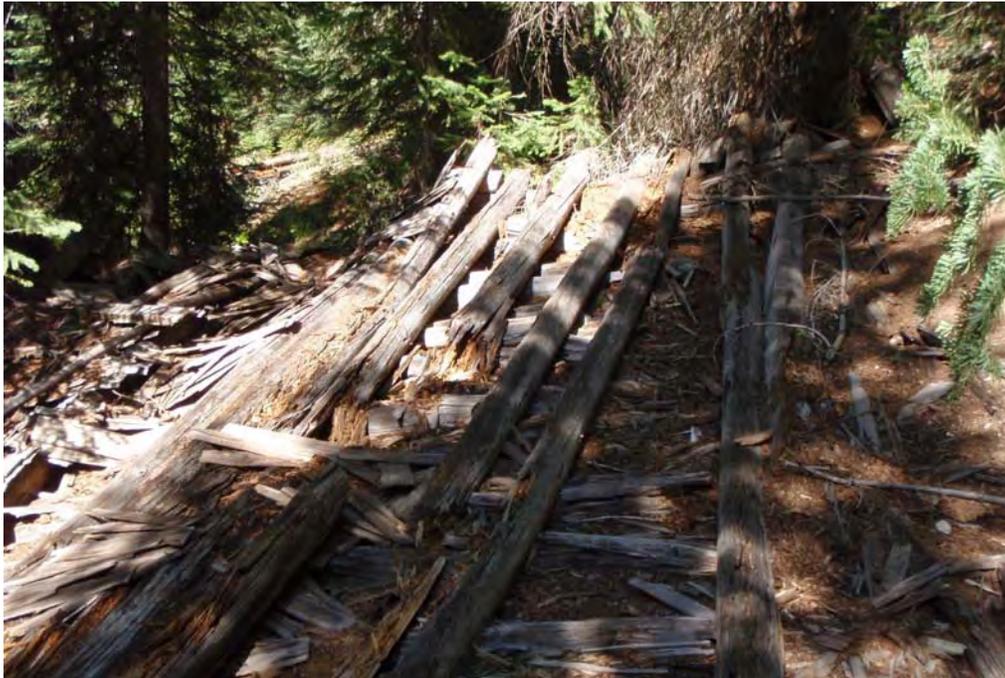
**Photo 4.** Collapsed building below/downstream from the collapsed Adit 1 at Latitude 45.50625°N and Longitude -116.04239°W.

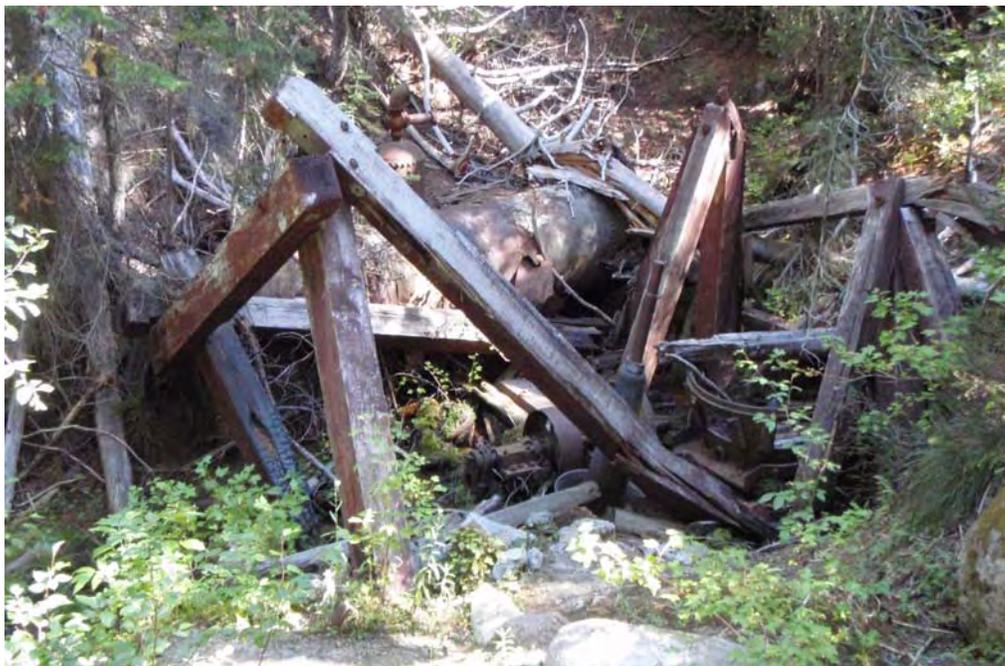
**Photo 5.** Collapsed mill below the workings at Latitude 45.50677°N and Longitude -116.04276°W.

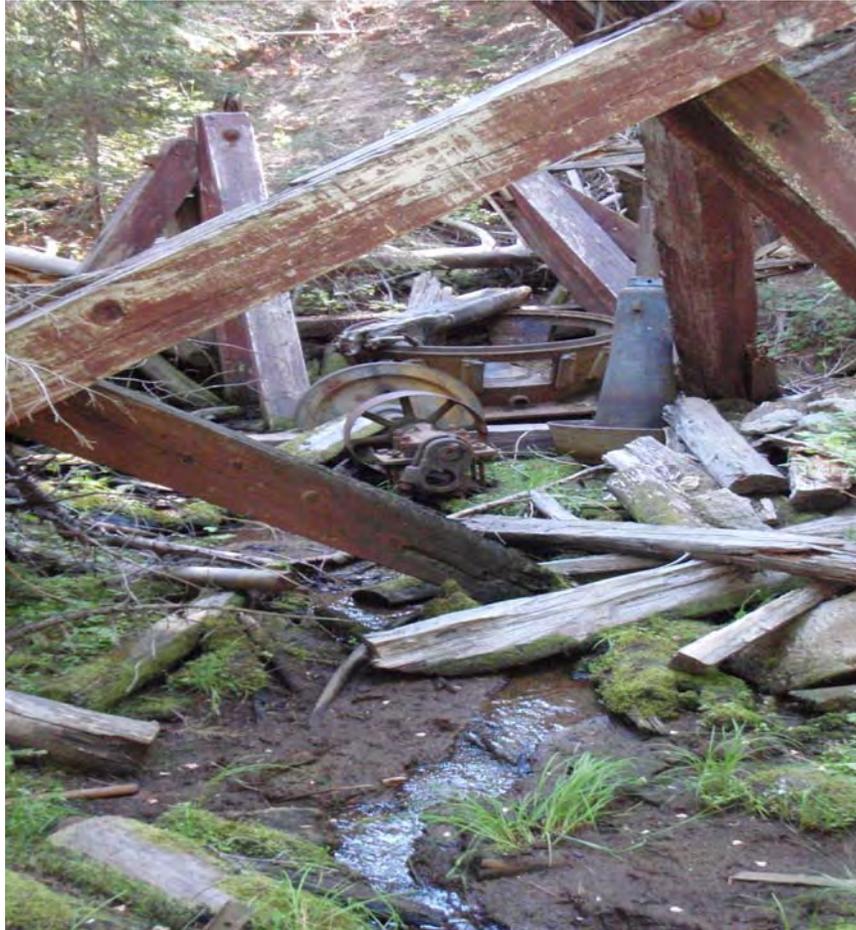
Photo 6 is taken from the upstream side of the mill remnants.

**Photo 6.** Collapsed mill built directly in the drainage channel.

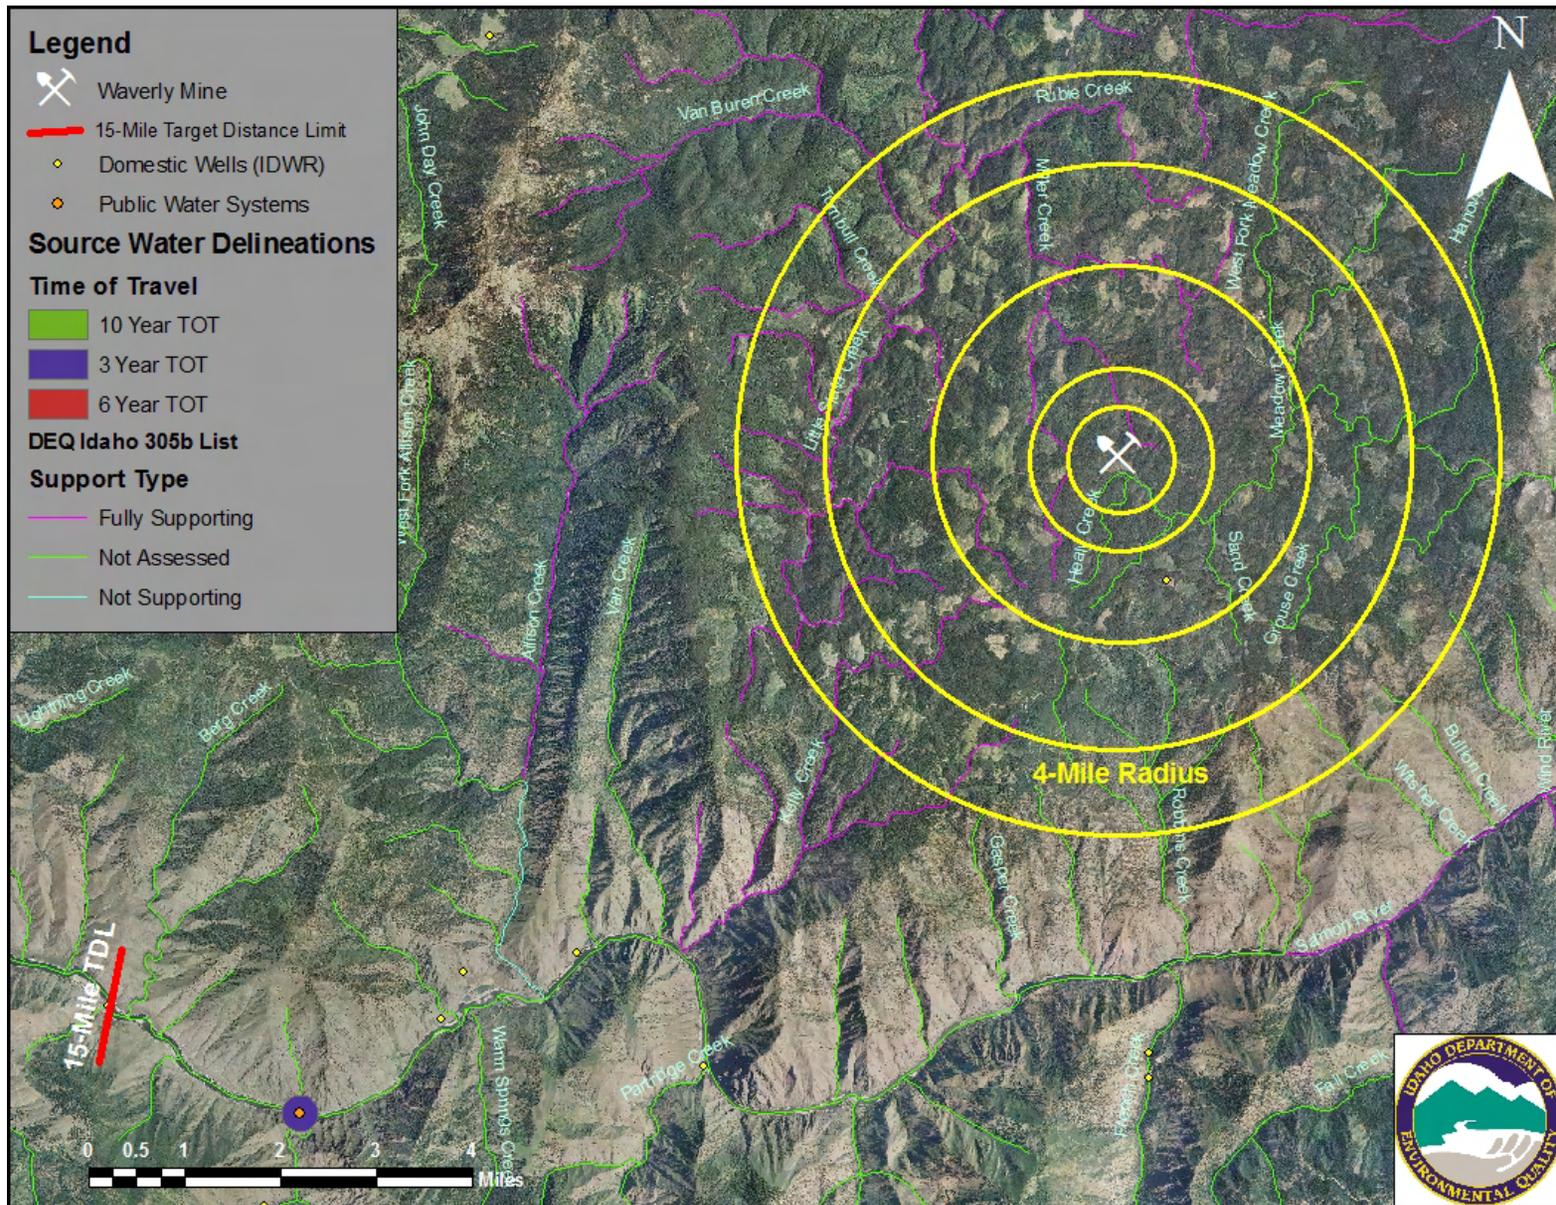
**Figure 3.** There are no domestic well locations or Public Water Systems within the 4-mile radius, 15-mile TDL. There are no significant wetlands within a 2-mile radius or in the general area. Sensitive streams located in the vicinity of the Waverly Mine are also shown. (Map Source: Idaho GIS ArcSDE 9.3 Geodatabase, National Agricultural Imagery Program (NAIP) 2004)

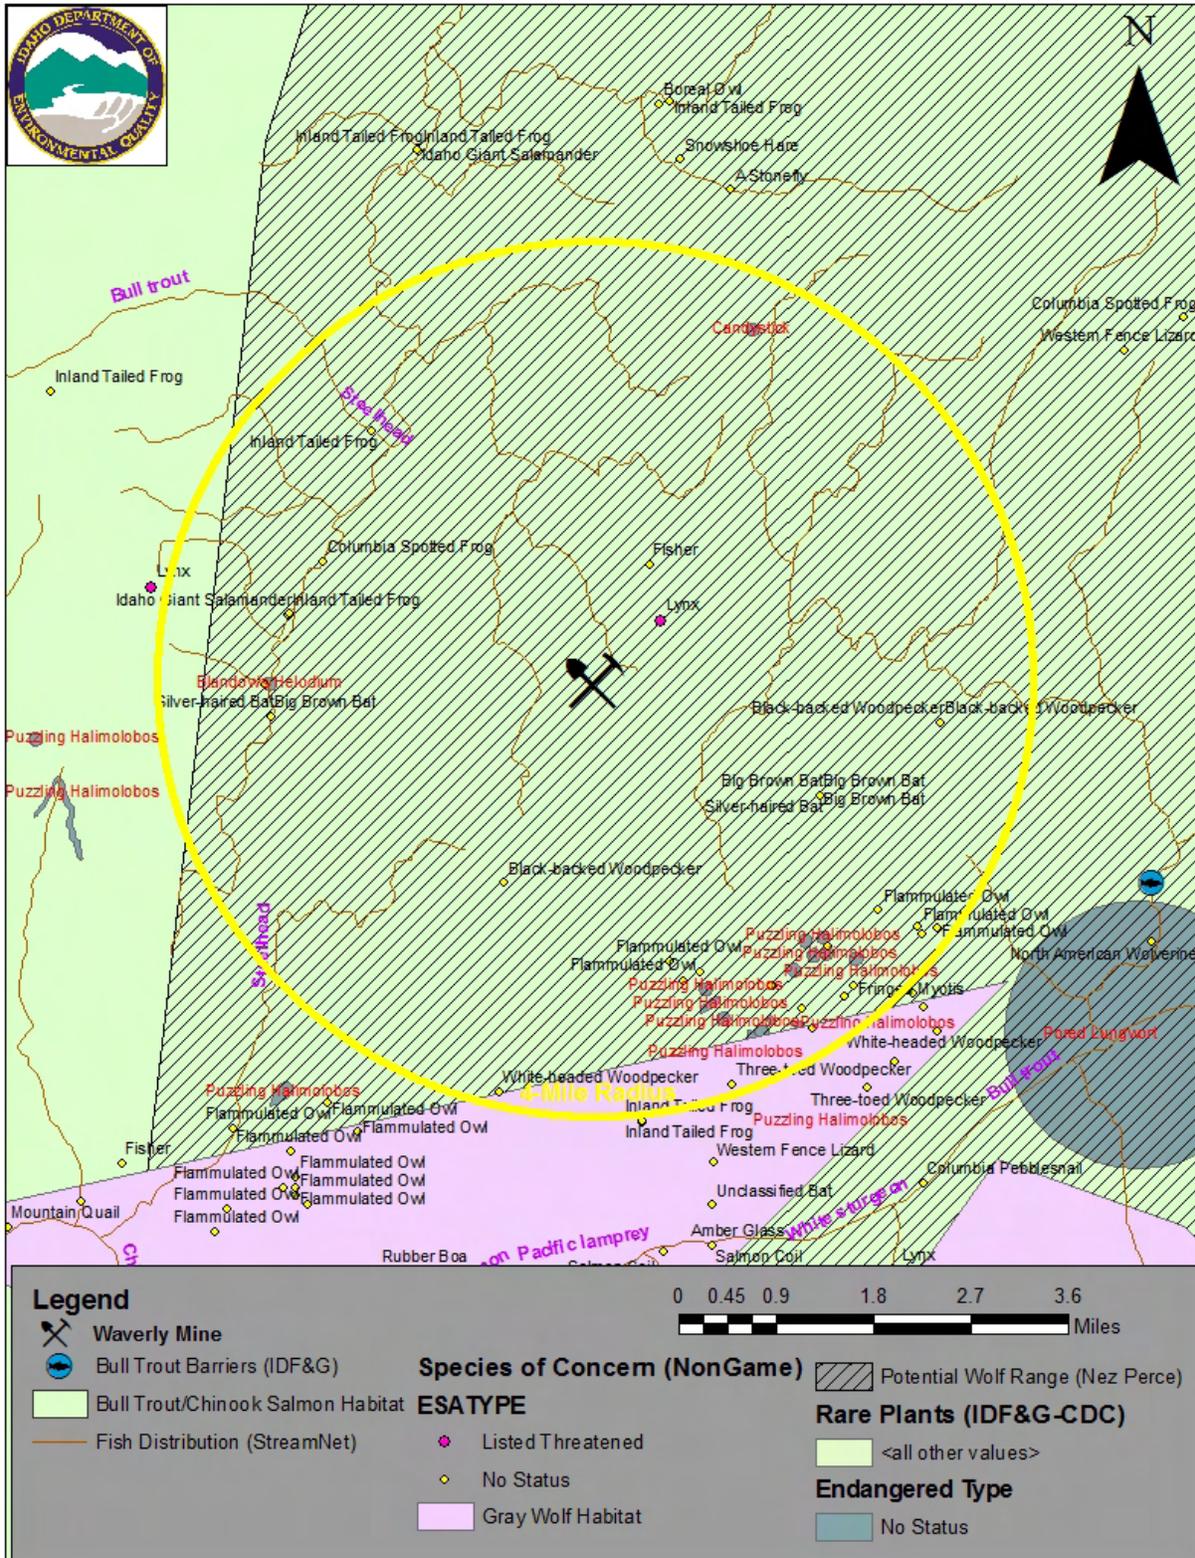
**Figure 4.** Sensitive Species Within 4-Mile Radius and Surrounding Area of the Waverly Mine. Species of Concern: Non-Game Animals and Plants. Fisheries Within 4- Mile Radius and Surrounding Area. (Map Source: SDE Feature Dataset, Animal Conservation Database. Idaho GIS ArcSDE 9.2 Geodatabase)
