Abbreviated Preliminary Assessment for Craigmont Landfill

Lewis County

**State of Idaho
Department of Environmental Quality**

November 2012

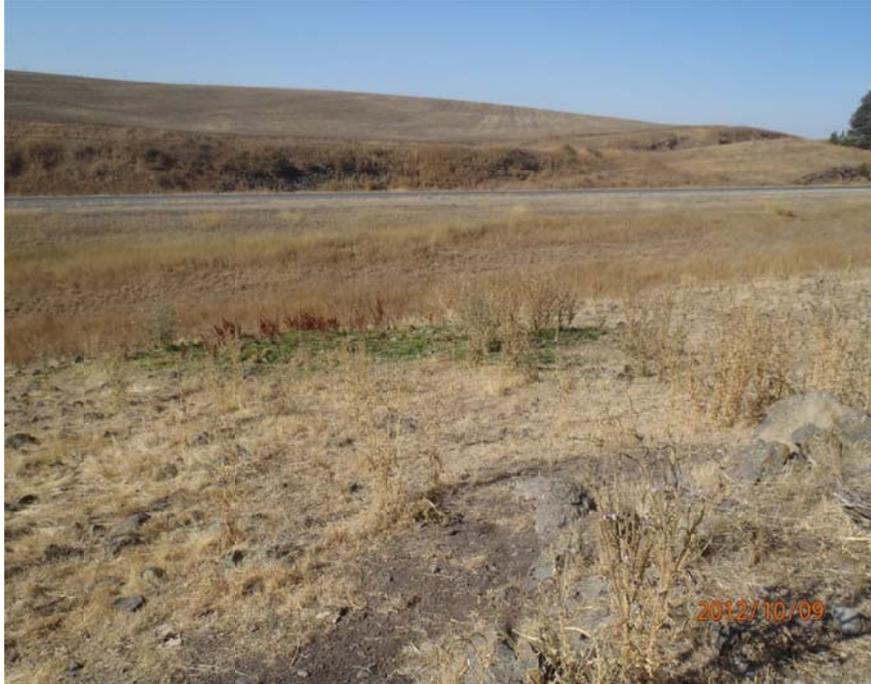
Photo 1. Craigmont Landfill.

Photo 1 shows Craigmont Landfill (now a cattle pasture) with Highway 95 in the background. The one bare spot on site appears to be from a physical surface disturbance.

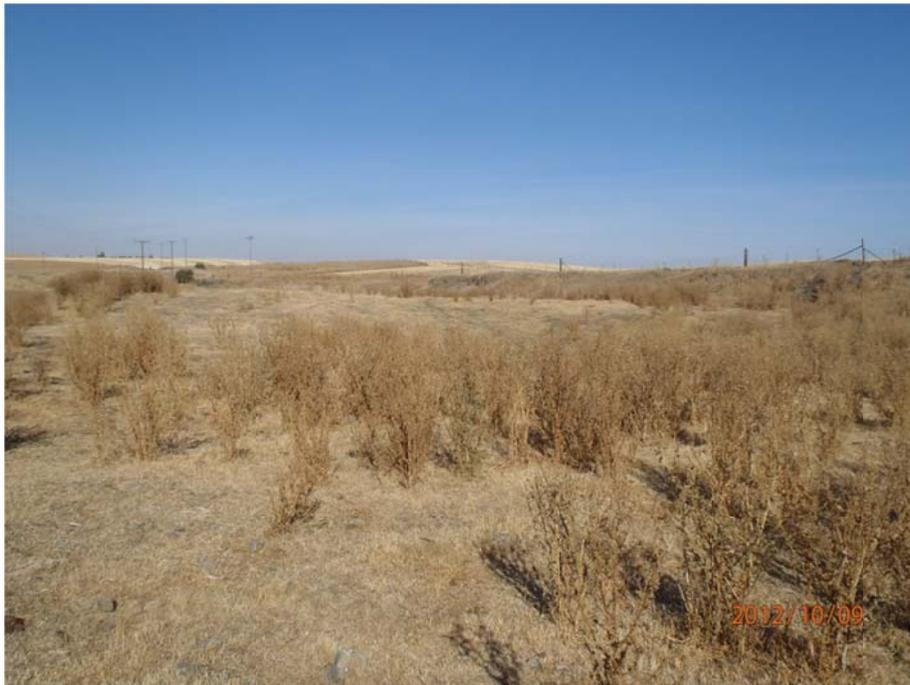
Photo 2. Craigmont Landfill.

Photo 2 is an overview of the Craigmont Landfill (currently a cattle pasture).

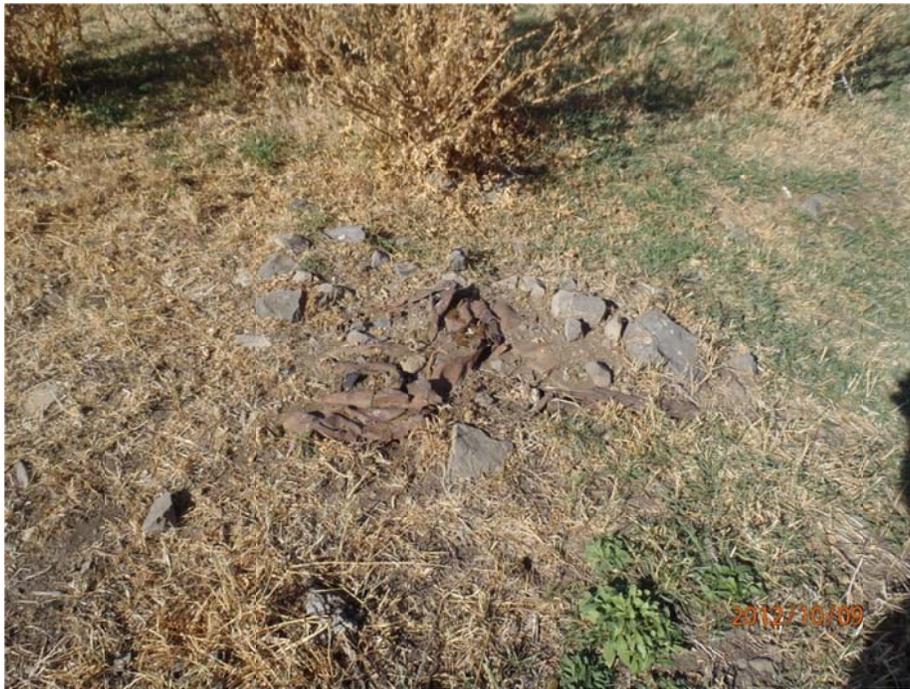
Photo 3. Rusty iron from the Craigmont Landfill.

Photo 3 shows some still visible rusty iron from the landfill.

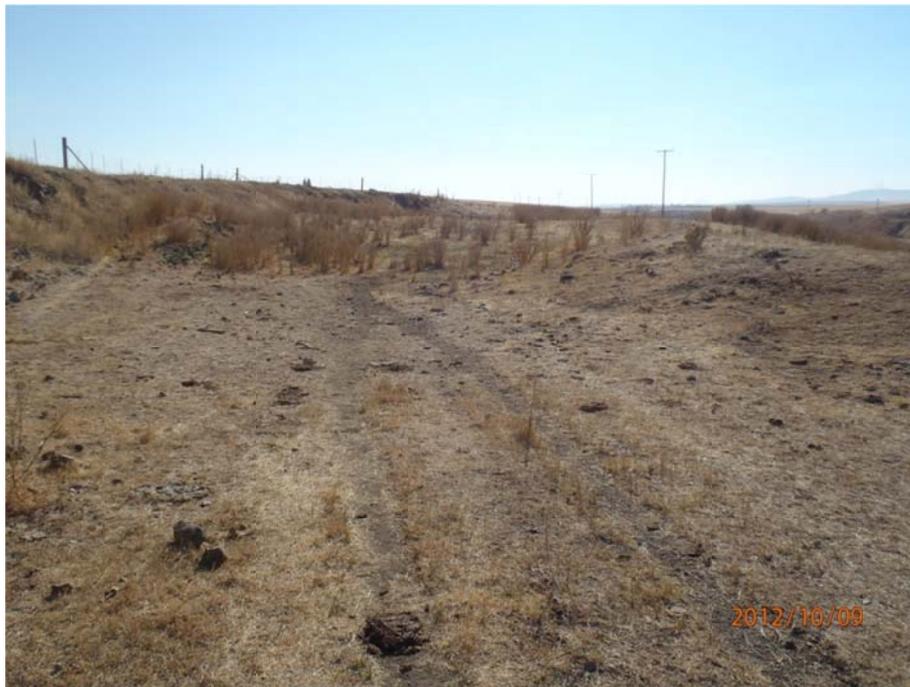
Photo 4. Craigmont Landfill.

Photo 4 shows another view of the Craigmont Landfill.

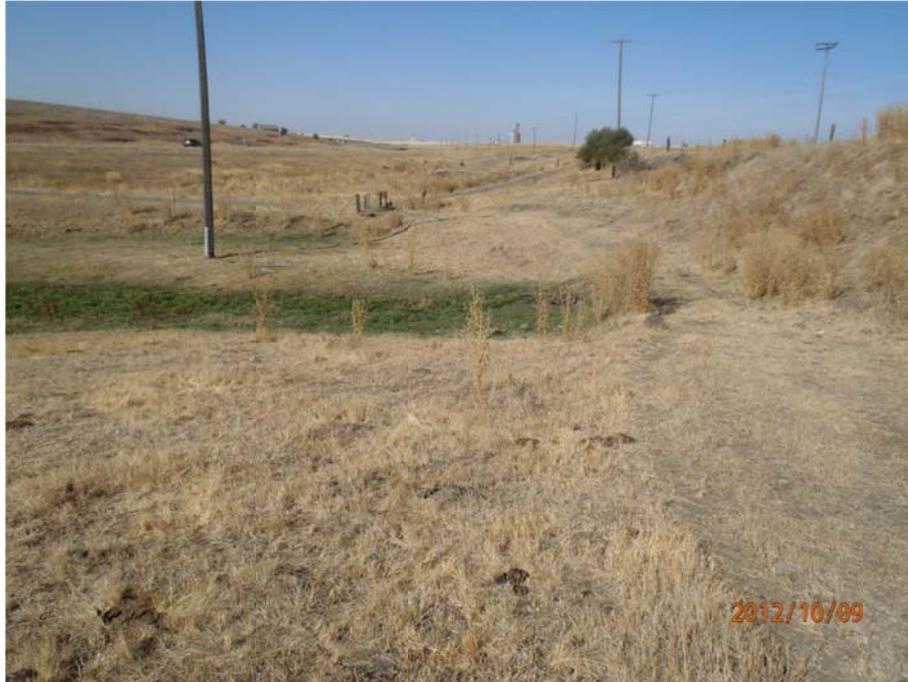
Photo 5. Spring 75 yards up gradient of Craigmont Landfill.

Photo 5 shows a spring 75 yards up gradient of the Craigmont Landfill.

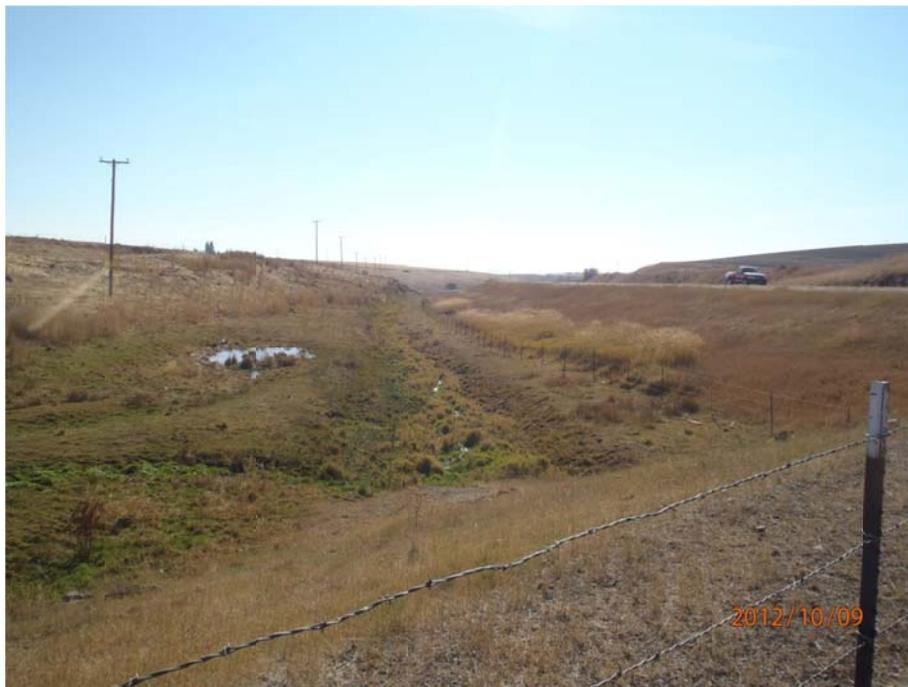
Photo 6. Seasonal stream between Highway 95 and Craigmont Landfill.

Photo 6 shows a seasonal stream that flows between Highway 95 and Craigmont Landfill. Most of the water comes from the wastewater treatment lagoons.

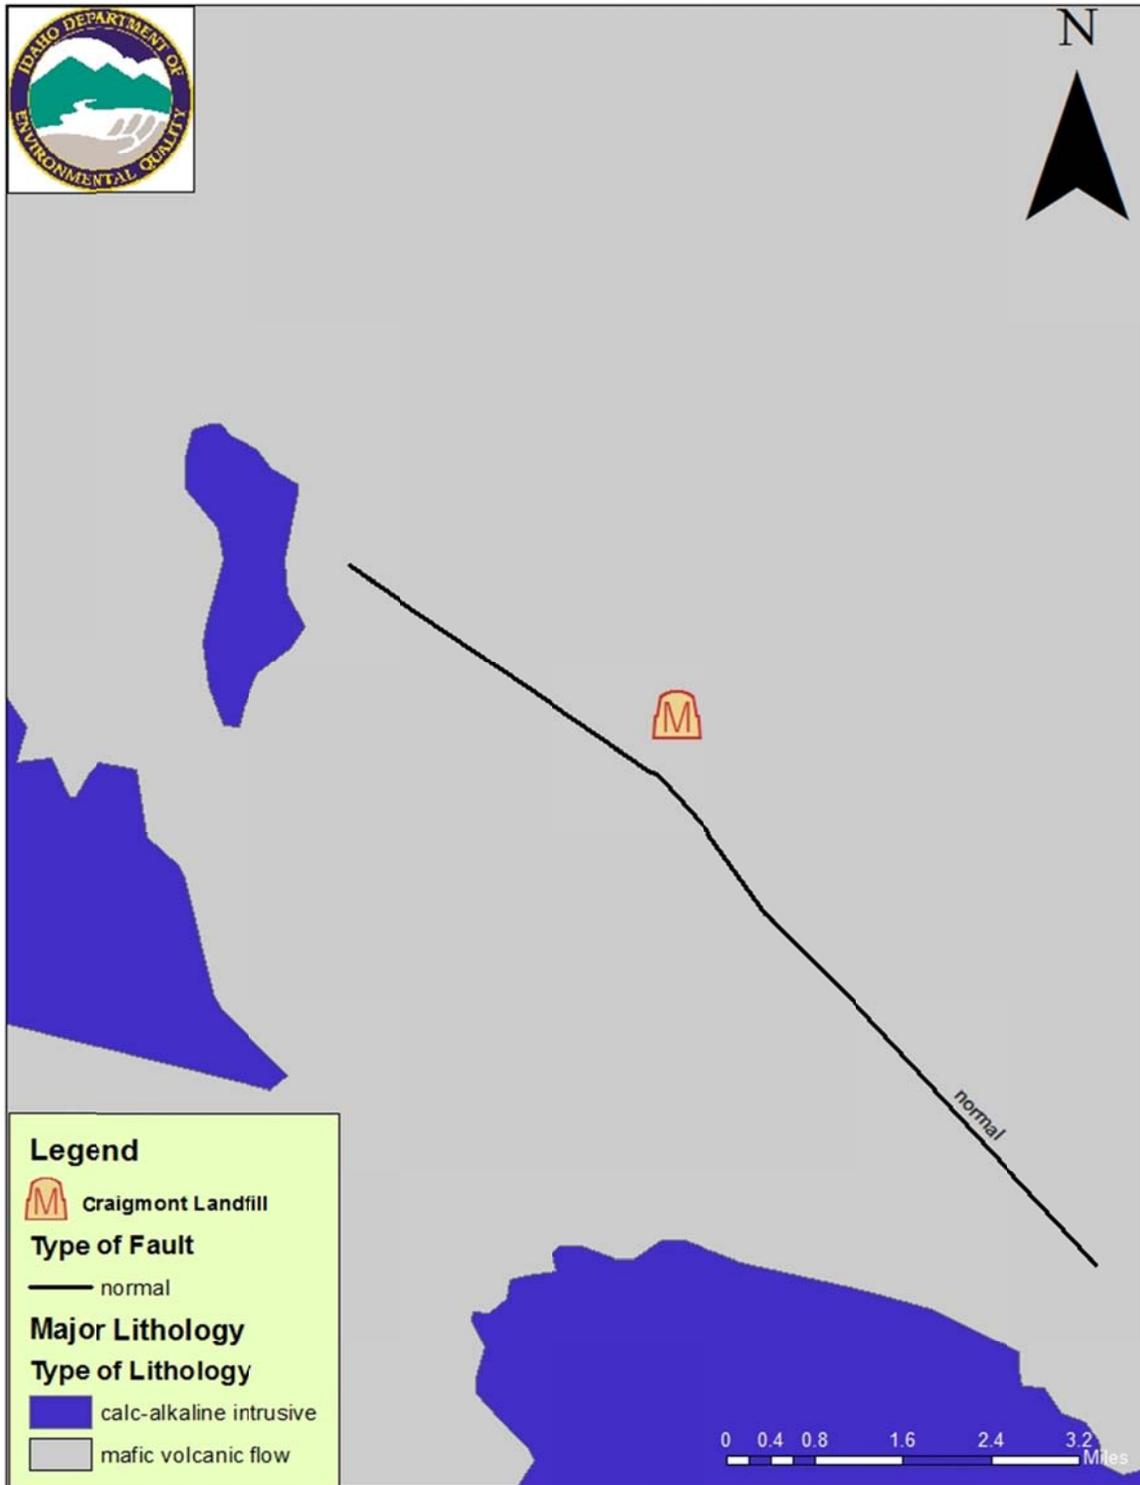
Figure 2. Map of major lithology in the vicinity of the Craigmont Landfill.

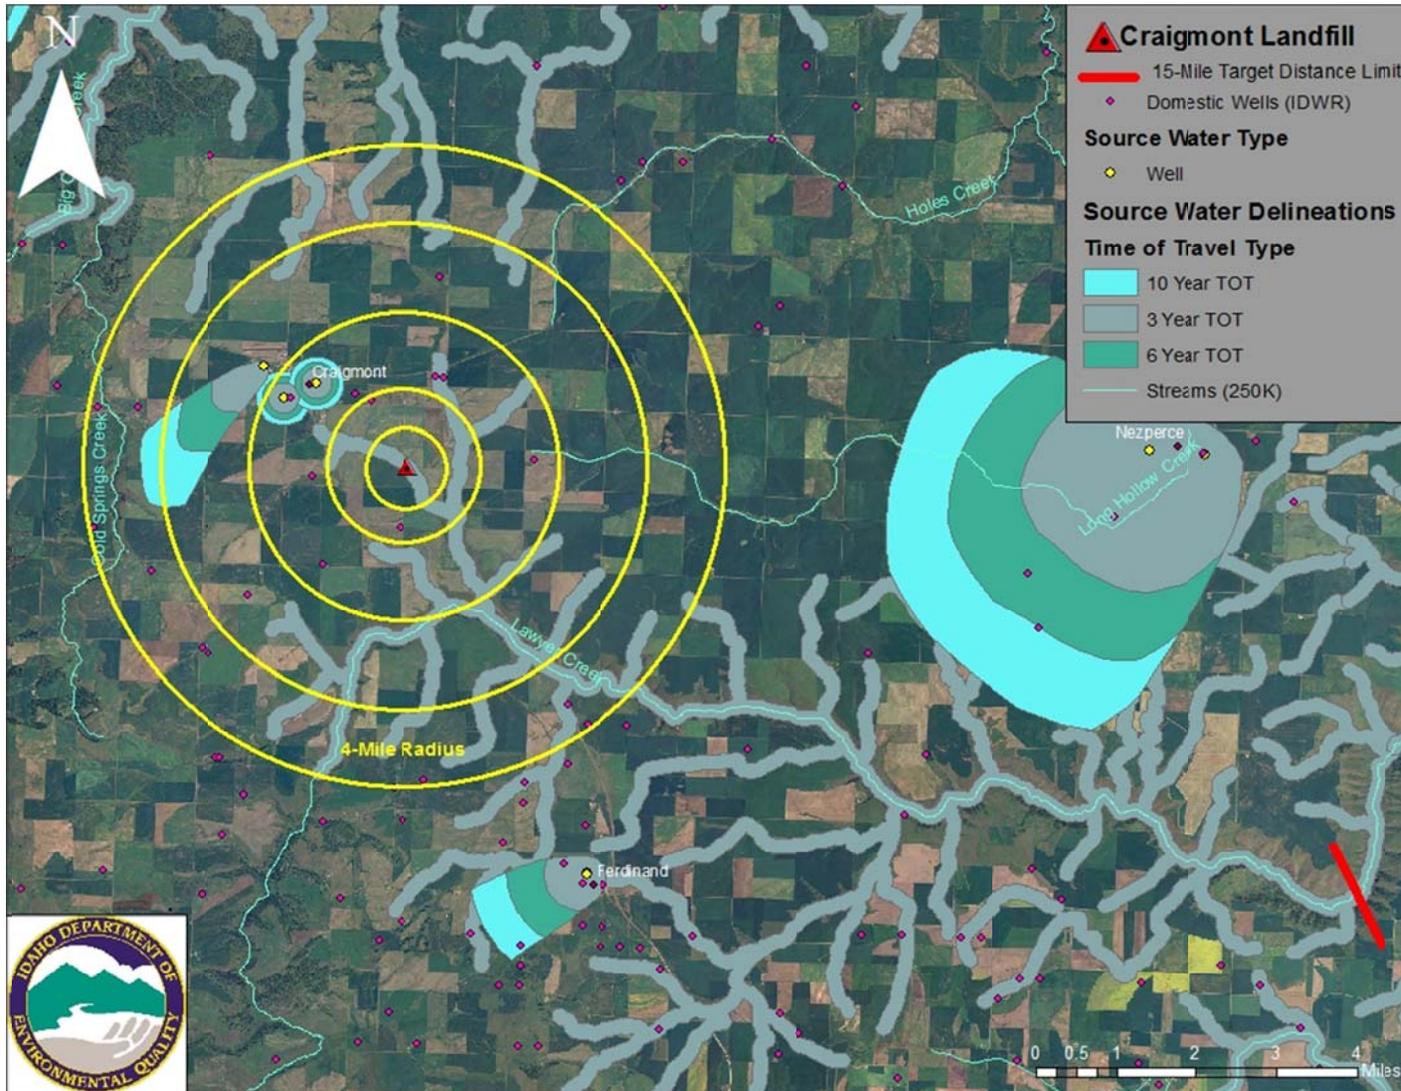
Figure 3. Domestic well locations.

There are approximately 23 domestic well locations and 3 public water systems within the 4-mile radius, 15-mile TDL. There are no significant wetlands within a 2-mile radius or in the general area.

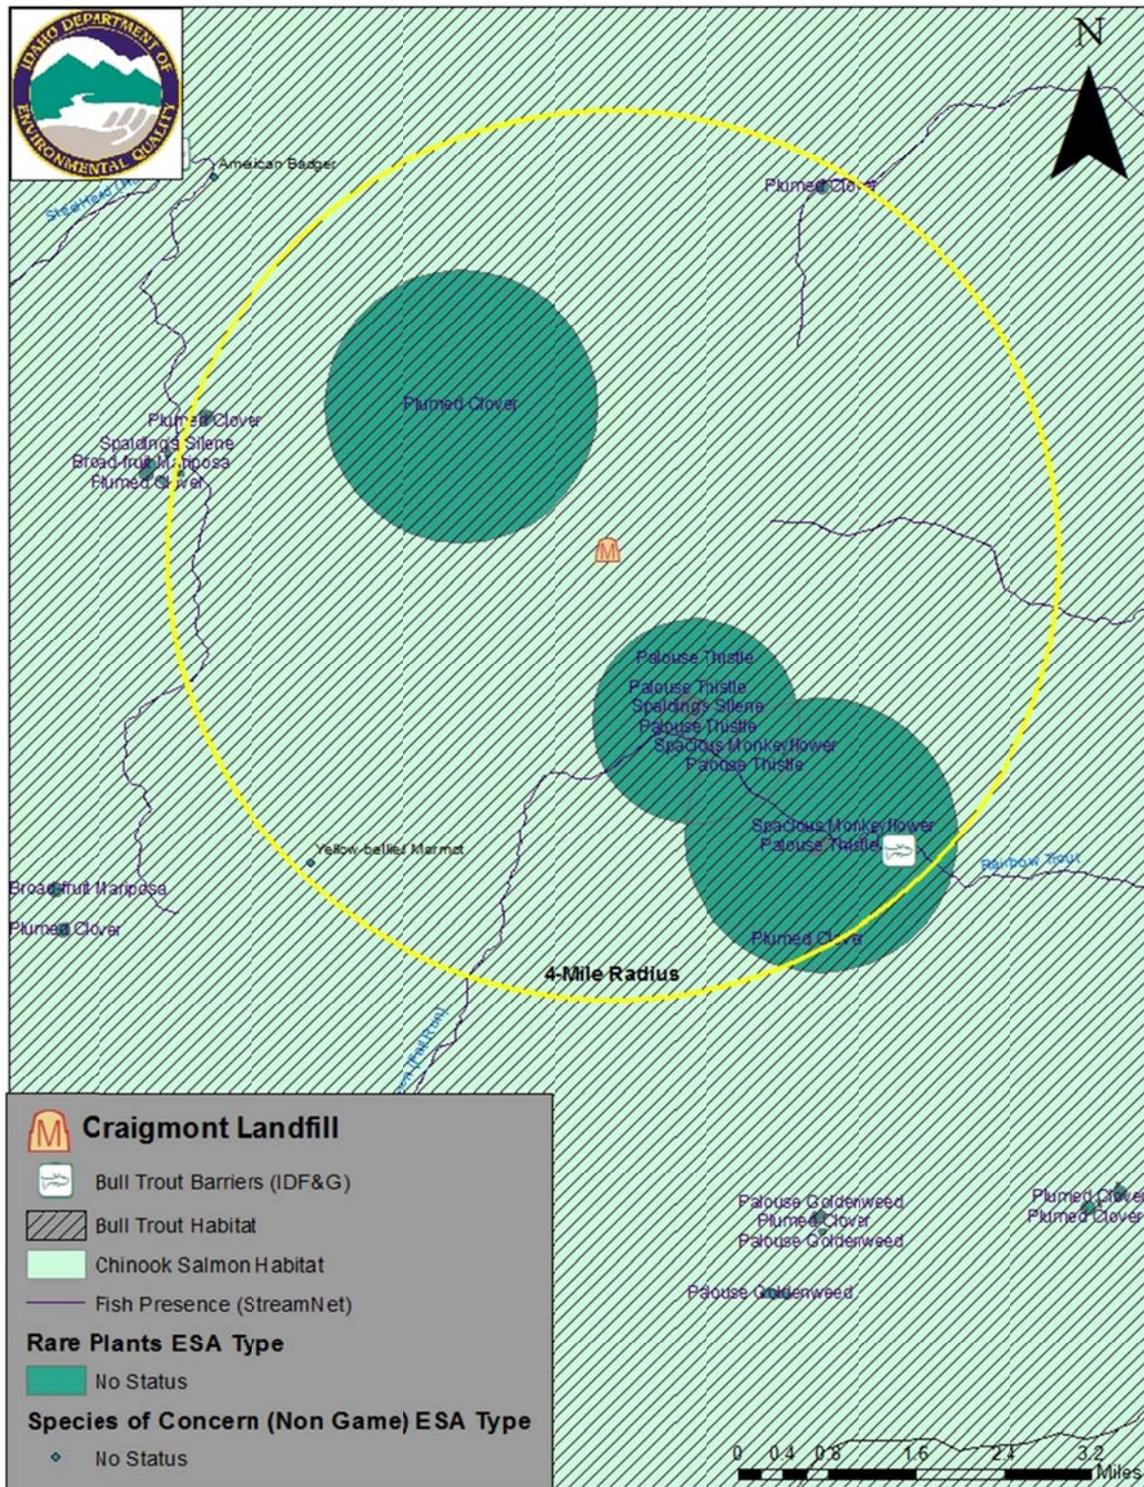
Figure 4. Plant, nongame animal, and fishery sensitive species within 4-mile radius and surrounding area of the Craigmont Landfill.
